REHABILITATION OF NATIONAL ROUTE R56 SECTION 8 FROM MATATIELE (KM130.15) TO THE KZN BORDER (KM168.71)

Aquatic Biodiversity Assessment

Report No: EP657-01

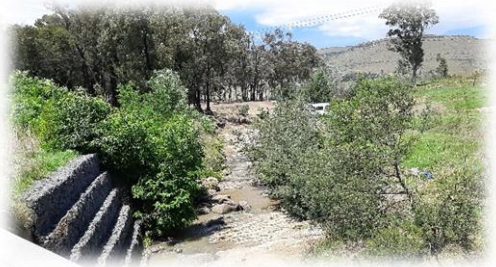
Located along an unnamed non-perennial tributary of the Botsola (Kinira) River, immediately west of Matatiele.
T3MZIM-CMPSN	30°21'48.17" S 28° 52'33.21" E

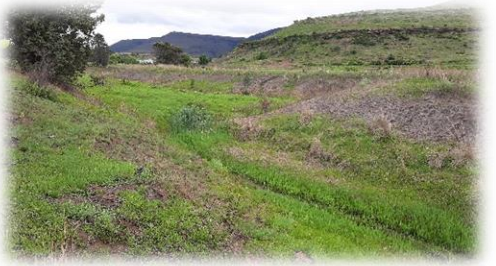
Located along an unnamed non-perennial tributary of the Mzimvubu River, directly upstream of a culvert crossing of the R56.
T3MZIM-EDNDL	30°22'16.28" S 28° 55'33.01" E

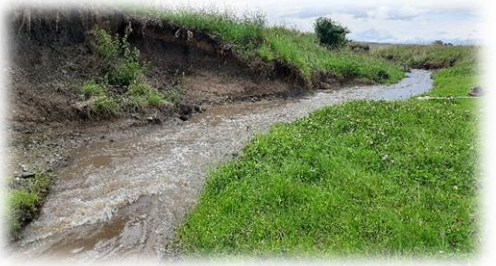
Located along an unnamed tributary of the Mzimvubu River, upstream of a dam situated on parent farm Edendale 185 and downstream of bridge crossing of the R56

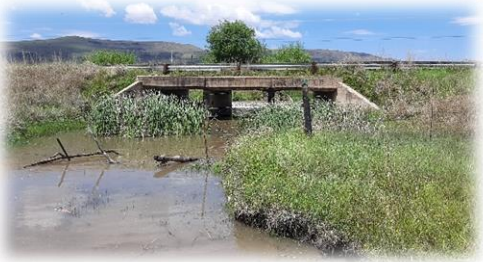
<p>T3MZIM-ALING</p>	<p>30°23'14.07" S 28°58'14.65" E</p>

<p>Located along an unnamed tributary of the Mzimvubu River, immediately upstream of a small dam situated on parent farm Alingthun 181. The site is downstream of culvert crossing of the R56.</p>
<p>T3MZIM-DSR56</p>	<p>30°24'14.50" S 29° 03'28.08" E</p>	 	<p>Located along the main stem of the Mzimvubu River upstream of the R56 bridge crossing.</p>
<p>T3MZIM-RSTFN</p>	<p>30°25'35.83" S 29° 08'39.85" E</p>	 	<p>Located along an unnamed tributary of the Con Amore Stream, directly downstream of a culvert crossing of the R56.</p>
<p>T3MZIM-STRYD</p>	<p>30°26'02.65" S 29° 10'15.26" E</p>	 	<p>Located along the perennial stream referred to as the Con Amore Stream (for the purposes of this report).</p>
