ESTABLISHMENT OF A NEW ROADWAY TO SERVE KENHARDT PV FACILITIES

Terrestrial BioDiversity Assessment of the proposed road routing serving Kenhardt PV facilities, Kenhardt, Northern Cape Province

S C Bundy BSc MSc (Pr.Sci. Nat.) SDP Ecological and Environmental Services cc

December 2020. Rev January 2021

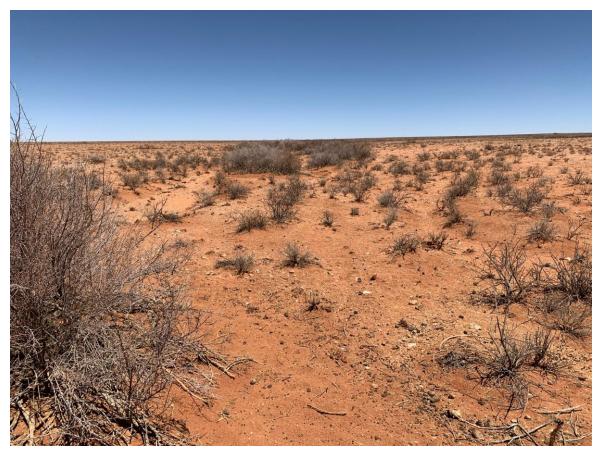
Figure 7. Image indicating nature of dendritic drainage or rills within subject site.

Figure 6 also indicates a number of rills or erosion points that are associated with the area. Together these rills present "dendritic drainage systems", which as described above, can be temporary in nature and may also be the product of other factors, such as the movement of livestock. Evidently these features have not been considered to be of hydrological significance and are not identified as presenting the features associated with a watercourse. Figure 7 below shows an image of typical dendritic drainage identified on site.

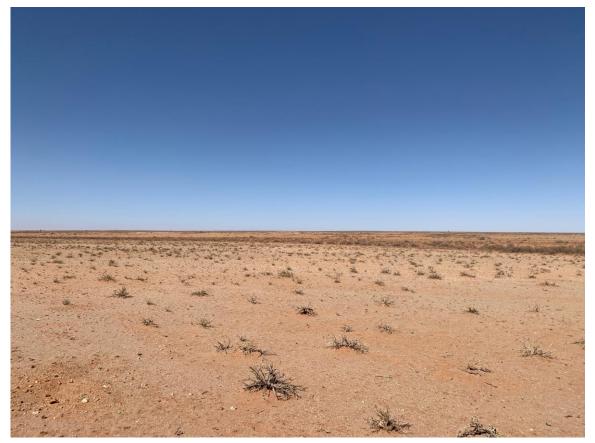
Figure 8. Sparse vegetation cover is encountered along the proposed route

On account of the significant drought that has prevailed for some time within the region, as well as the extensive grazing of livestock on the property, much of the proposed route remains ostensibly devoid of vegetation (Figure 8, above). The dominant vegetation form along the route comprises primarily of a *Rhigozum trichotomum* associes, and at points the graminoids *Schmidtia pappophoroides* and *Stipagrostis ciliata*. A list of species located in or proximal to the proposed route is presented in Table 1, below.

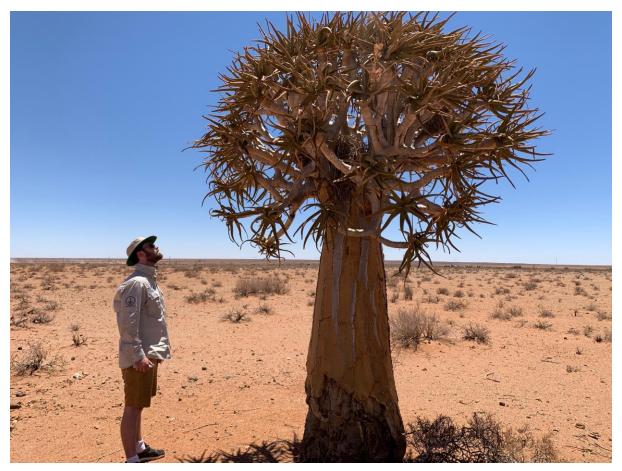
Figure 10. A. dichotoma proximal to road route on PV 2.. Note stick nest within branches.

As indicated above, nests of larger raptor species were identified in a number of *A dichotoma*. Upon inspection it was found that all nests had been recently abandoned with no fledglings in occupancy. Howsoever, one *A dichotoma* did present a family of Lanner Falcon (*Falco biarmicus*), - two adults and two juveniles. Some of the nests encountered, constructed of stick materials, would be consistent with this species. Other nests identified within *A dichotoma* are probably associated with the Chanting Goshawk (*Melierax canorus*), which also constructs nests of stick, but such nests are larger than that of *F biarmicus*, and the remains of small mammals, essentially prey items at the nest, would be consistent with *M canorus*.
