## APPENDIX D: SPECIALIST REPORTS

Annexure A: Wetland Rehabilitation Extract

## **Aquatic Ecosystem Assessment and Rehabilitation Plan Associated with Unauthorised Cultivation of Eighteen Fields in Schoemanskloof**

**Draft 1.0**

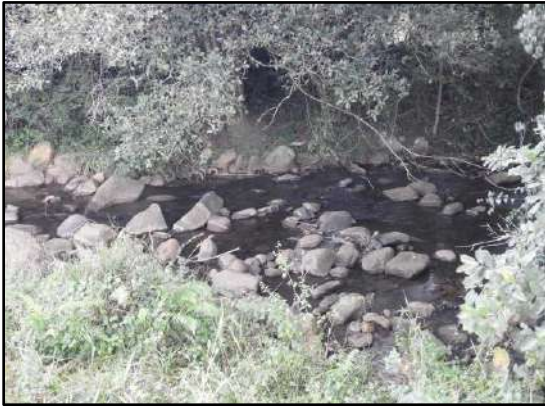
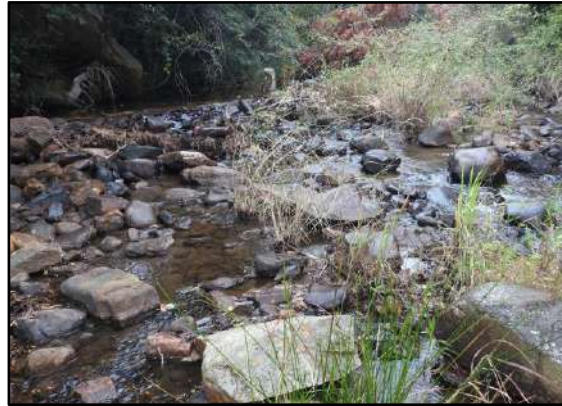
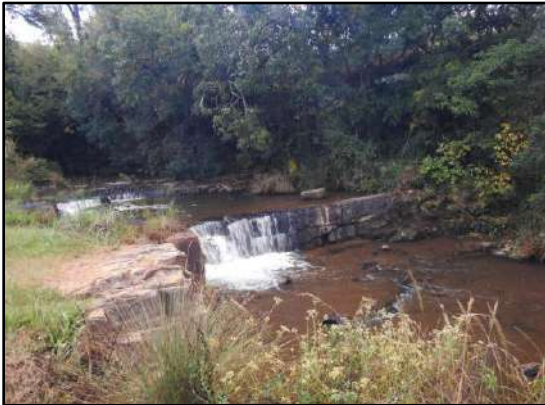
**Figure 2-3. Aquatic Sampling Sites – Sterkspruit (SP01 to SP03).**

a) SP01 (upstream control) on the farm Sterkspruit. [2018-05-14].

b) SP02 (impact site) on the farm Sterkspruit. [2018-05-14].

c) SP03 (impact site) on the farm Deon. [2018-05-20].

Water quality, aquatic macroinvertebrates and fish were sampled at thirteen sites within the Study Area (Table 2-2). The sites were selected in relation to the eighteen fields that had been cultivated, and existing ecological monitoring sites were used where feasible. Five sites comprised upstream control sites, and eight were downstream of the unauthorised developments and therefore potentially impacted (Table 2-2). Three sites were on the Sterkspruit (SP01 to SP03); four sites were on tributaries of the Crocodile River (TR01 to TR04), and six sites were on the Crocodile River (CR01 to CR06) (Figure 2-5). The distribution of aquatic sampling sites is shown in Figure 2-2.

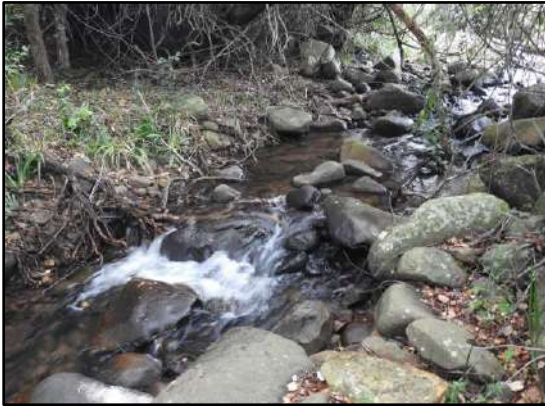
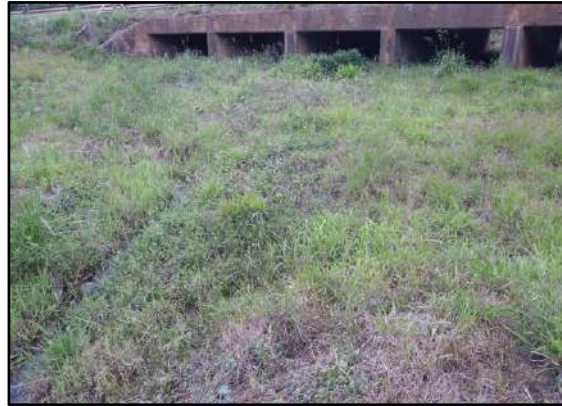
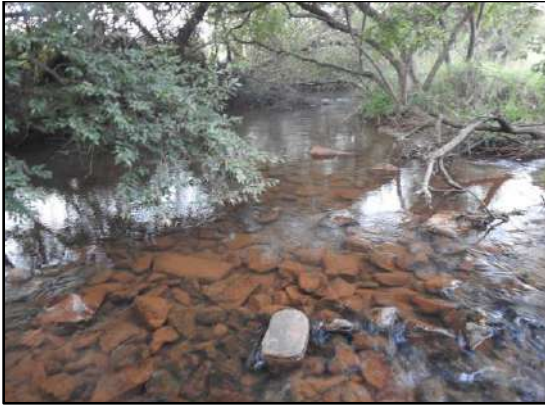
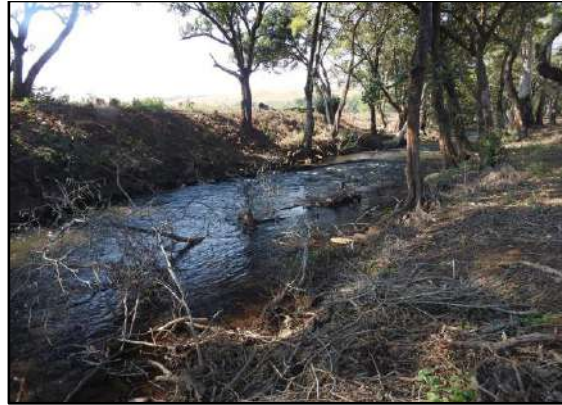
**Figure 2-4. Aquatic Sampling Sites – Tributaries (TR01 to TR04).**

a) TR01. Jungle Stream (upstream control) on the farm Sterkspruit. [2018-05-20].

b) TR02. Un-named Mountain Stream (upstream control) on the farm Rietvlei Macs. [2018-05-20].

c) TR03. Devils Creek (impact site) on the farm Koedoeshoek. [2018-05-20].

d) TR04. Houtbosloop (impact site) on the farm Montrose. [2018-05-28].

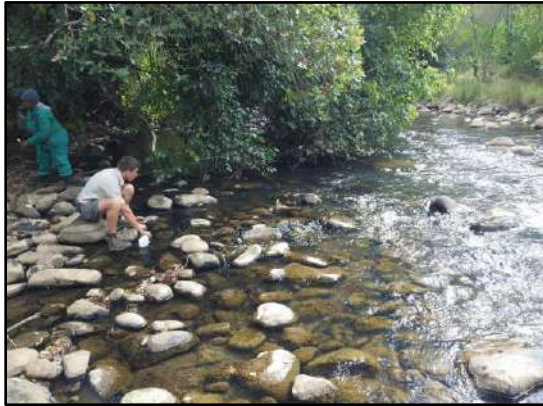
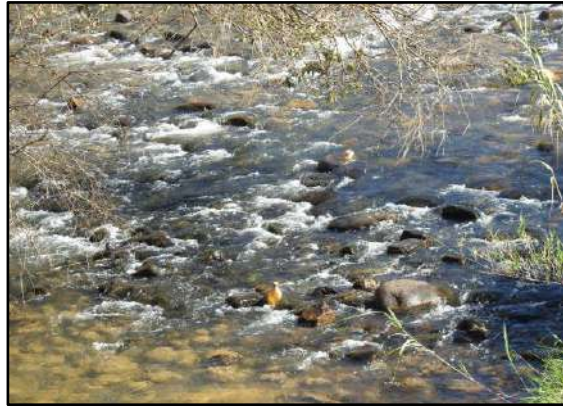
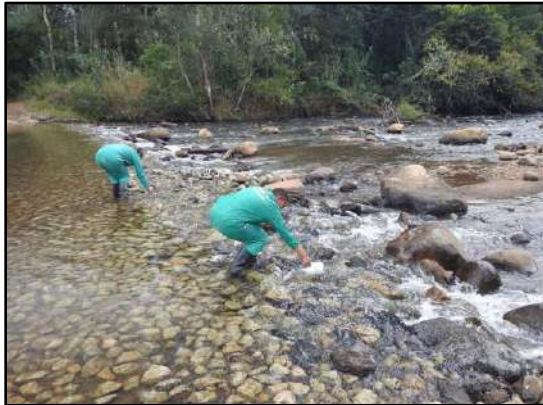
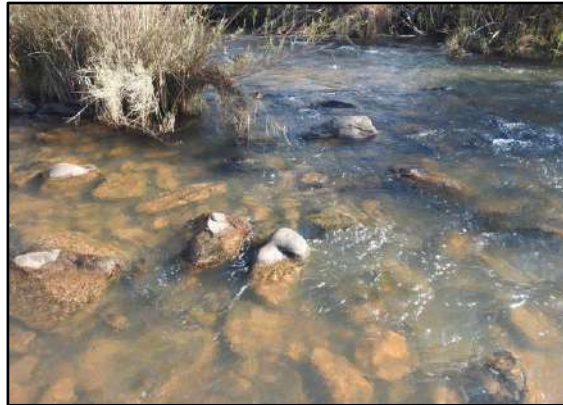
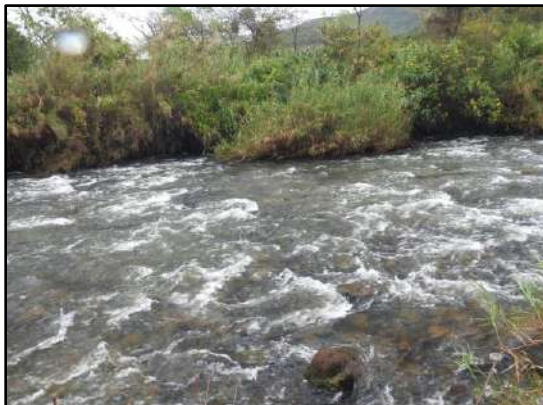
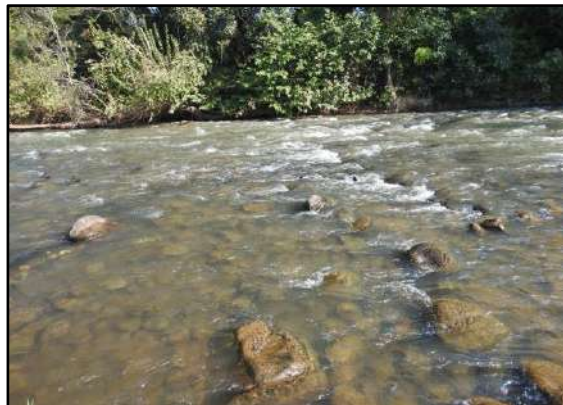
**Figure 2-5. Aquatic Sampling Sites – Crocodile River (CR01 to CR06).**

a) CR01 (upstream control) on the farm Deon. [2018-05-16].

b) CR02 (impact site) on the farm Spilpunt. [2018-05-15].

c) CR03 (impact site) on the farm Koedoeshoek. [2018-05-14].

d) CR04 (impact site) on the farm Koedoeshoek. [2018-05-28].

e) CR05 (control site) on the farm Montrose 1. [2018-05-28].

f) CR06 (impact site), downstream of Montrose 2. [2018-05-28].

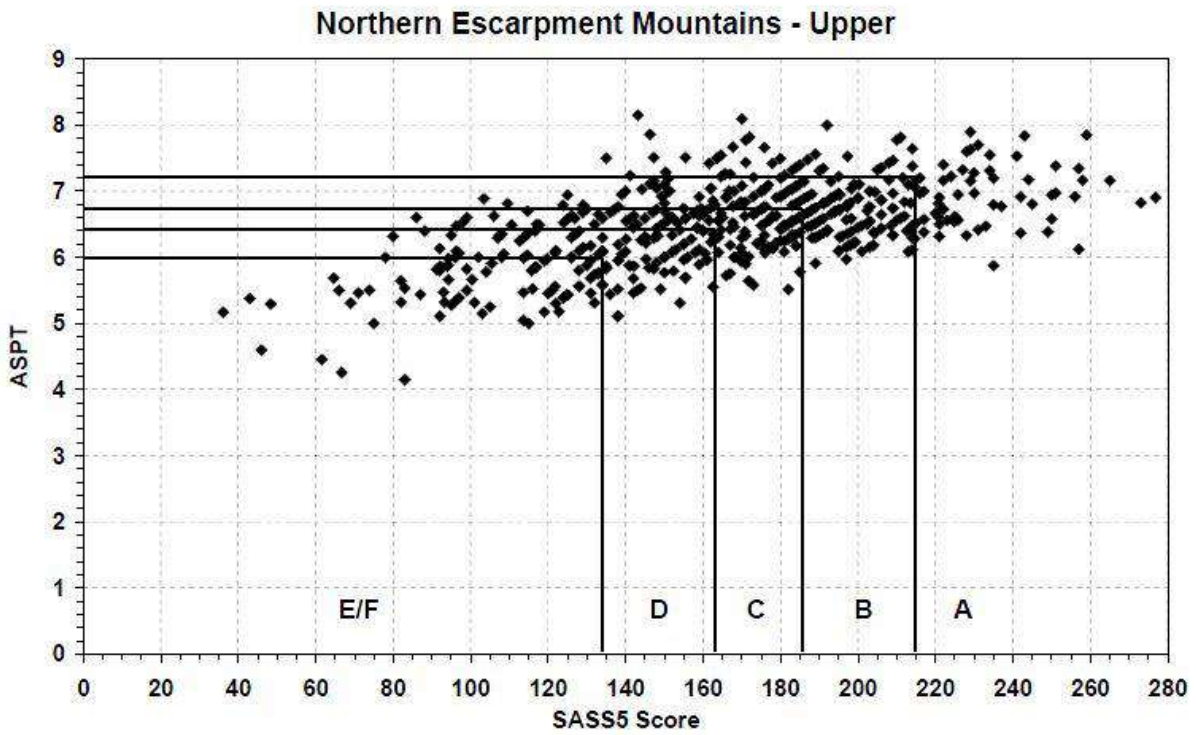
Figure 3-1. Guideline used to delineate the Present Ecological State Categories in terms of SASS5 biomonitoring results in the upper portion of the Northern Escarpment Mountains Ecoregion (Dallas 2007).

Aquatic macroinvertebrates were sampled at the twelve of the thirteen aquatic monitoring sites using the standard SASS5 biomonitoring method (Dickens and Graham 2002). Aquatic macroinvertebrates were not sampled at Site TR02 because of inadequate suitability of instream habitats. The SASS5 results were classified into one of six Present Ecological State categories, ranging from *Natural* (Category A), to very *Critically Modified* (Category F). The limits for each category varied depending the Level I Ecoregion and the geomorphological zone, according to the method of Dallas (2007) (Figures 3-1 to 3-3).

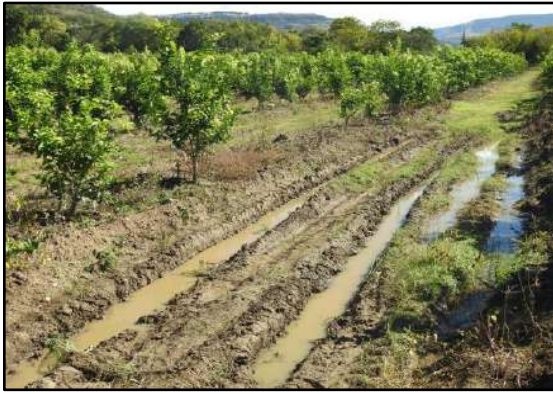
- **Hillslope Seeps.** Hillslope Seepage Wetlands were impacted at several locations, notably on the farms Sterkspruit, Dubai 1 and I Swart. Many of the seepage wetlands have been drained and cultivated (Figure 5-1a).

a) Hillslope Seep on I Swart.

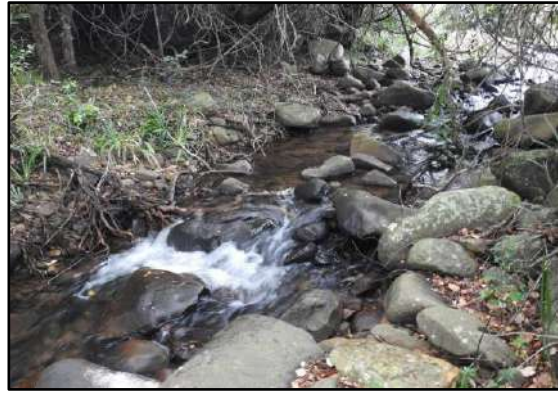
- **Mountain Stream.** Clearing of natural vegetation on the farm Sterkspruit impacted the lower reaches of Junglespruit before its confluence with the Sterkspruit (Figure 5-1b).

b) Mountain Stream: Junglespruit at TR01.

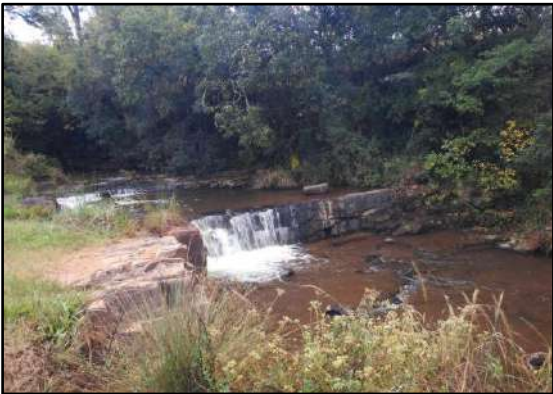
- lower reaches of Sterkspruit on the farm Deon (Figure 5-1c); and
  - Devil's Creek downstream of Koedoeshoek Dam.
- **Upper Foothill.** Two stretches of river were classified as Upper Foothills as follows:

c) Transitional Stream: Sterkspruit on the farm Deon at SP03.

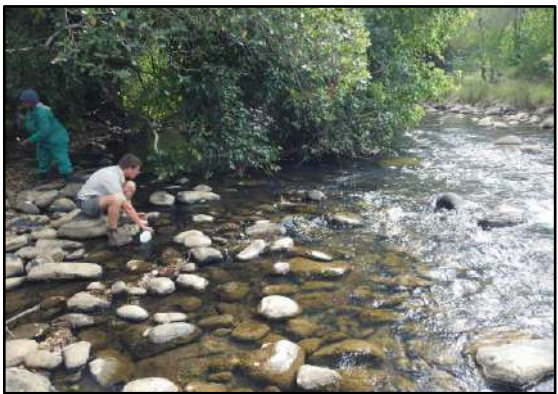
- Crocodile River upstream of the farm Mooiland (Figure 5-1d); and
  - lower reaches of Houtbosloop.
- **Lower Foothill.** Two stretches of river were classified as Lower Foothills as follows:

d) Upper Foothill: Crocodile River at CR01.

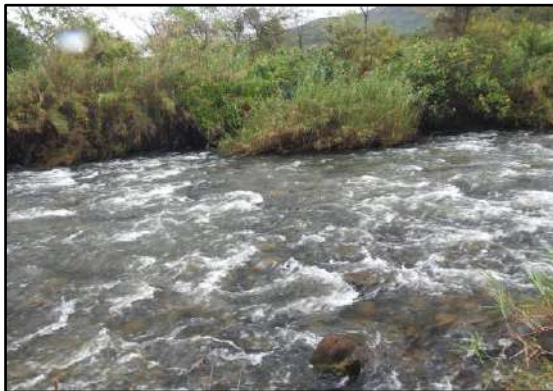
- Crocodile River between Mooiland and Koedoeshoek, upstream of Montrose Falls;
  - Crocodile River on the farms Montrose 1 and 2, downstream of Montrose Falls (Figure 5-1e).

e) Lower Foothill: Crocodile River at CR06.

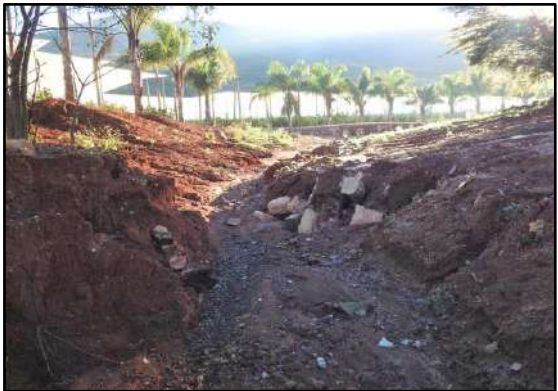
Unauthorised clearing of natural vegetation also impacted on a number of Episodic Drainage Lines (Figure 5-1f). These were not assessed in detail for this report because they do not support aquatic biota and are not a priority for rehabilitation of ecosystem functions, although they are classified as watercourses in terms of the National Water Act.

f) Episodic Drainage Line on Koedoeshoek.

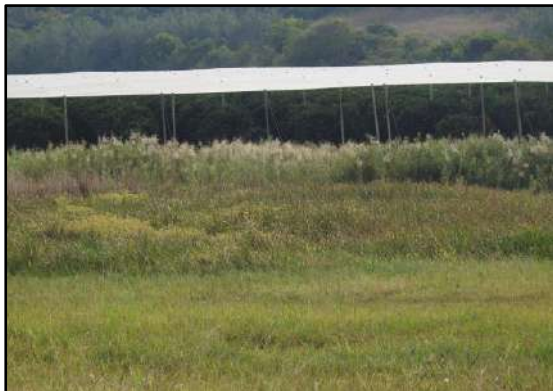
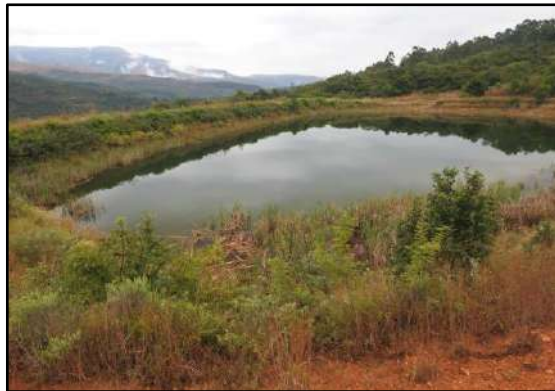
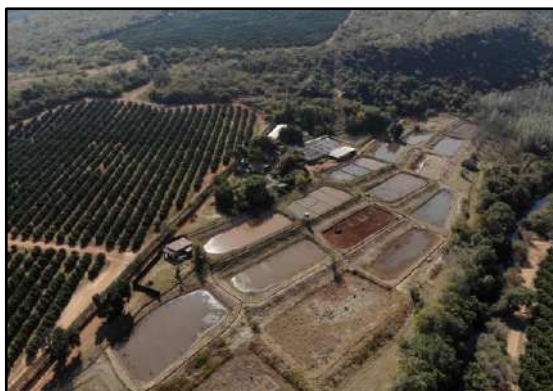
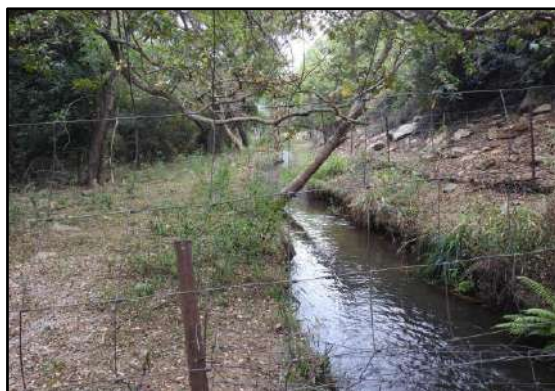
**Figure 5-2. Aquatic Ecosystems Types within the Study Area not Impacted Directly by Unauthorised Clearing, Photographed in May 2018.**

- **Valley-Bottom.** One Valley Bottom wetland covering an area of some 3.7 hectares was present in the Study Area on the farm Koedoeshoek (Figure 5-2a). This wetland is currently channelled, but is likely to have been naturally un-channelled;
- **Dams (in-channel).** The Study Area included a number of in-channel farm dams, notably Koedoeshoek Dam, two dams on the farm Rietvlei, and two dams on the farm Mooiland (Figure 5-2b);
- **Fish Farm Dams.** The Study Area included one fish farm on the left bank of the Crocodile River on the farm Mooiland, adjacent to MU 14a (Figure 5-2c); and
- **Canals.** Two irrigation canals that divert water from the Sterkspruit and Crocodile River on the farm Sterkspruit were identified within the Study Area (Figure 5-2d).

a) Valley Bottom Wetland on Koedoeshoek.

b) Farm Dam on Mooiland.

c) Fish Farm on the left bank of the Crocodile River, on the farm Mooiland.

d) Irrigation canal diverting water from the Sterkspruit on the farm Sterkspruit (MU 1e).

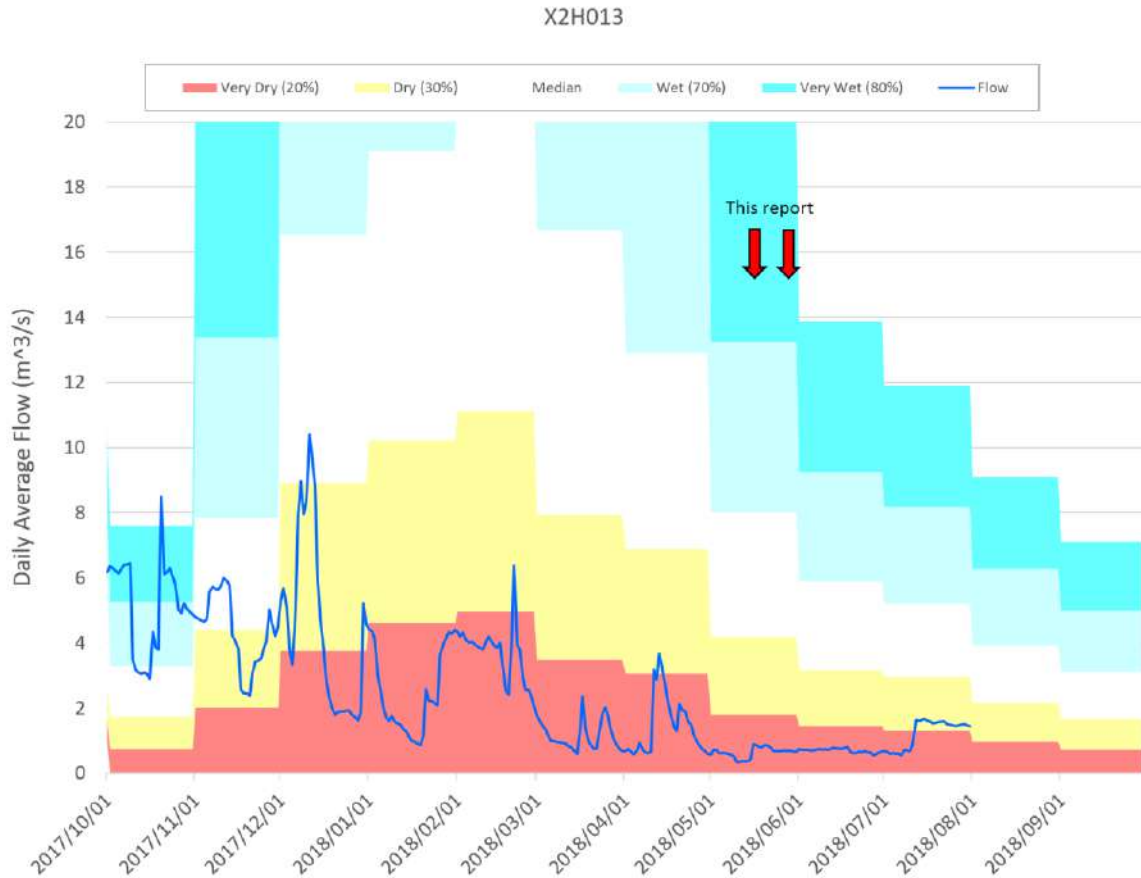
**Figure 5-3. Daily average flow in the Crocodile River at Montrose (X2H013), starting in October 2017. Shading indicates daily average flow percentiles between 1959 and 1983 (24 years), before the completion of Kwena Dam. Red arrow indicates timing of the biomonitoring surveys for this report.**

Flows during the field surveys for this report were low and ideal for biomonitoring at all sites surveyed. Daily average flow data recorded in the Crocodile River at Montrose show that flows during the 2017/2018 wet season were low and declined steadily as the season progressed, and no significant high flow events were recorded for the season (Figure 5-3). Flows during and prior to the field surveys for this report were below the 20<sup>th</sup> percentile of historical data at Montrose before the completion of Kwena Dam, between 1959 and 1983 (i.e. 24 years). Flows in the Crocodile River during the 2017/2018 season are therefore classified as drought flows (Figure 5-3).

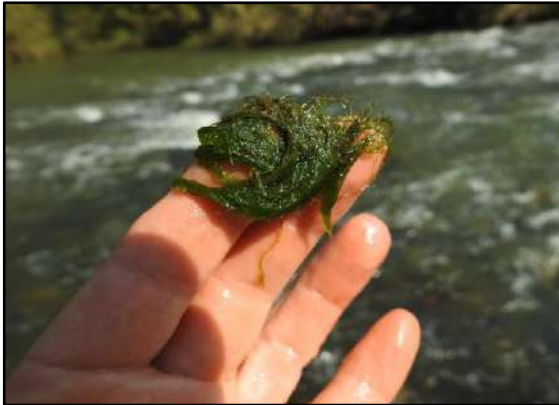
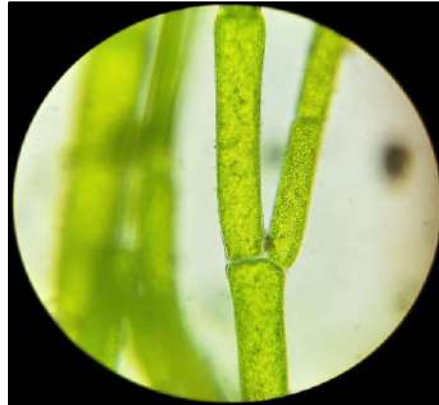
**Figure 5-7. Benthic Algae.**

Benthic algae were not noticeably present at aquatic sampling sites in May 2018, except for the Crocodile River at Montrose (CR05 and CR06), where the filamentous alga *Cladophora glomerata* was present in low abundance estimated at 5% cover in riffle and rapid habitats at CR05 and CR06 (Figure 5-7). The presence of this alga is attributed to the influence of poor-quality water from the Elands River. The results show that unauthorised clearing of natural vegetation on the eighteen fields investigated for this report did not influence the abundance of benthic algae in receiving watercourses at the time of the survey.

a) Benthic alga *Cladophora glomerata* recorded on rocks in the Crocodile River at Montrose 1. [CR05, 2018-05-28].

b) *Cladophora glomerata*.

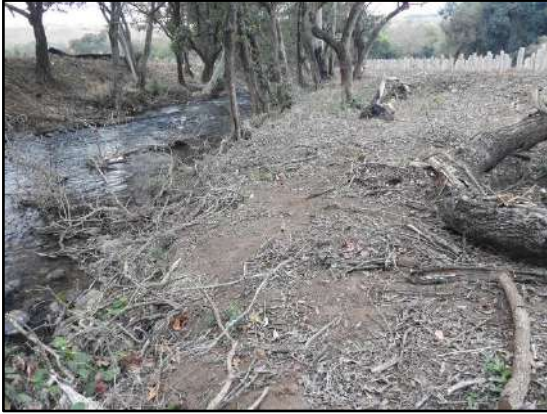
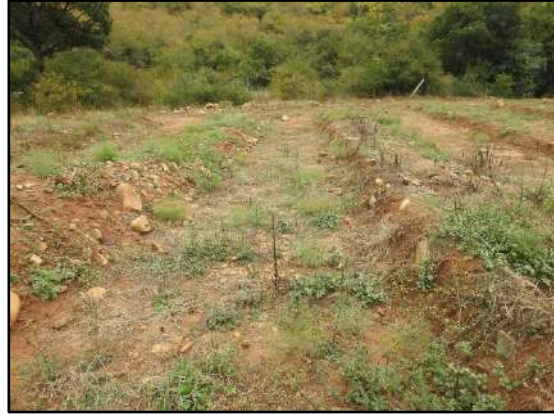
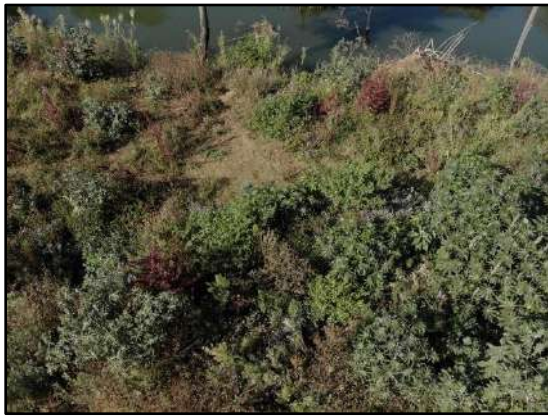
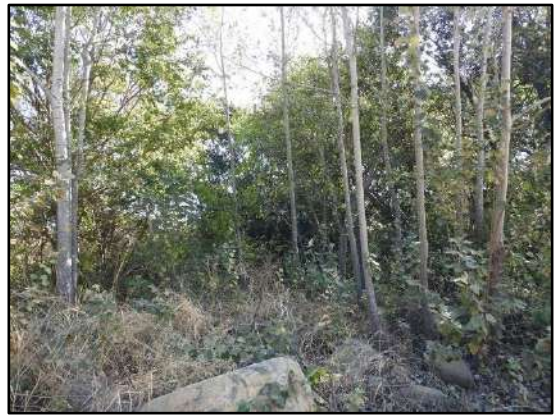
**Figure 5-12. Alien Vegetation – Successional Phases.**

Disturbed areas are typically colonised initially by annual herbs, followed by alien shrubs and eventually a climax community of alien woody species. The successional phases of alien vegetation colonisation observed in the Study Area are shown in Figure 5-12. A total of 40 species of nationally declared alien invasive plant species was recorded within the Study Area during field surveys in 2018 (Table 5-3). Most of the alien species recorded are likely to have been present in the Study Area before clearing took place, but disturbance of soils associated with clearing has created ideal conditions for excessive proliferation of alien invasive species. For the proposed management plan the declared alien plant species are prioritised here into three categories (Table 5-3) as follows:

a) Riparian vegetation clearing and soil disturbance. [MU 17d, 2018-07-06].

b) Initial colonisation of pioneer annual herbs. [MU 01, 2018-05-14].

c) Intermediate colonisation of annual shrubs. [MU 18b, 2018-07-04].

d) Climax colonisation of alien woody vegetation. [MU 14a, 2018-07-04].

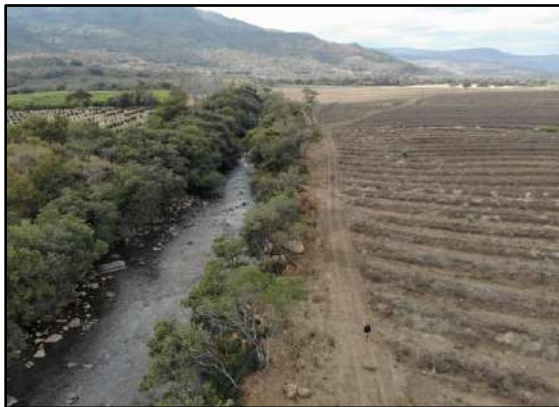
Vegetation clearing impacted directly on 66.54 hectares of riparian habitat (Figure 6-1a), and 32.02 hectares of seepage wetland habitat (Figure 6-1b). Clearing is likely to have had a small impact on the flow regime, even for wetlands that have been drained, but clearing is likely to have mobilised sediments and therefore impacted on downstream water quality. Sediments are mobilised mainly during storm events, but the field surveys for this report were undertaken during clear weather and low flows, so there was no direct evidence of elevated sediments, apart from embedded stream substrates noted in the lower Sterkspruit, at SP03. The reduction in fish species composition and abundance recorded in the Sterkspruit at SP03 in July 2018, is attributed to elevated concentration of suspended sediments carried in stormwater runoff from areas in the catchment where vegetation had been cleared. Mobilisation of sediments is expected to stabilise once orchards are established, so this is a short-term consequence of vegetation clearing. The biggest impact of vegetation clearing has been destruction and fragmentation of riparian and wetland habitats, and the associated loss of wildlife habitat and terrestrial migration corridors; increased carbon emissions from burning of large trees; reduced buffering capacity and bank stability provided by riparian habitats; and proliferation of alien invasive vegetation. The impact of vegetation clearing on instream biota was shown by the biomonitoring survey conducted for this report to be low, except for fish in the Sterkspruit and Houtbosloop. However, the impact on riparian biota was high, particularly for conservation important plants, most notably *Breonadia salicina*. The spatial scale of the impact of vegetation clearing on riparian and wetlands habitats was regional, and the duration of impact is permanent. The risk of vegetation clearing on riparian and wetland habitats was rated according to the Risk Matrix as **Moderate**.

a) Cleared Riparian Zone on the farm Deon. [MU 02b, S25.38278 E30.53111, 2018-07-05].

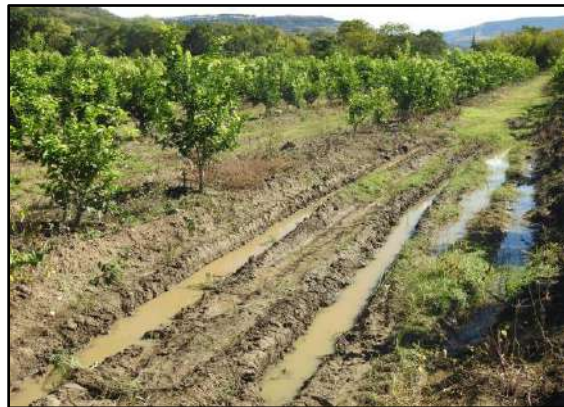
b) Cultivated Seepage Wetland on the farm I Swart. [S25.38791 E30.55552; 2018-05-21].

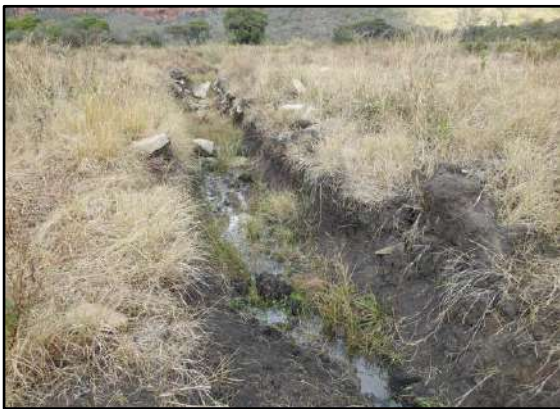
Trenching has drained an estimated total of 32.02 hectares of seepage wetland habitat that was intended for agricultural development (Figure 6-2). Most of these former wetland areas in the lower portions of the Study Area were productive orchards in 2018. Operation of orchards is likely to need periodic maintenance and control of weeds, particularly in agricultural drains, so the application of herbicides to drains is likely, and this is expected to impact the quality of water draining from these areas. Agricultural development in the upper portions of the Study Area, particularly Sterkspruit and Deon, was stopped in 2018 by a directive from the Department of Environmental Affairs and Tourism. Here, wetlands were drained but no further development took place, and so these wetlands as they stand are prone to encroachment of terrestrial plant species. The spatial scale of the impact of agricultural drains on wetlands habitats was regional, and the duration of impact is permanent. The risk of agricultural drains on wetland habitats was rated according to the Risk Matrix as **Moderate**.

a) Drain through seepage wetland on the farm Sterkspruit. [MU 01e, 2018-07-05].

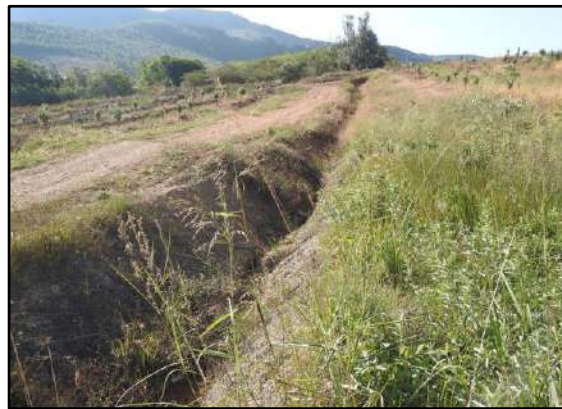
b) Drain through seepage wetland on the farm Rietvlei. [S25.38332 E30.56299, 2018-07-14].

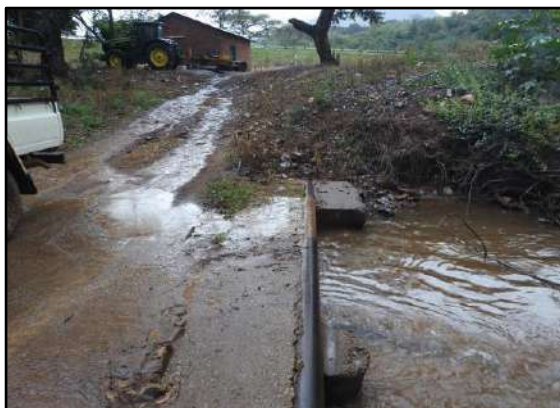
Access roads close to watercourses and unprotected stream crossings increase the drainage network and this increases sediment transport in downstream watercourses. Access roads and unprotected stream crossings also increase the magnitude of high flow events, and this has the potential to destabilise stream banks and lead to bank erosion. The impact of unprotected streams crossings on turbidity in the Houtbosloop was shown when runoff from washing of equipment ran for some distance along the road before entering the Houtbosloop, as shown in Figure 6-3. Vehicle traffic also increases the risks of hydrocarbon contamination of surface waters, particularly at stream crossings where water levels are elevated. The spatial scale of the impact of access roads and unprotected stream crossings on downstream surface water quality is localised, and the duration of impact is usually short. The risk of access roads and unprotected stream crossings on surface water quality was rated according to the Risk Matrix as **Moderate**.

a) Culvert over Houtbosloop on the farm Montrose, near TR04. [MU 17d, S25.43197 E30.74875, 2018-05-28].

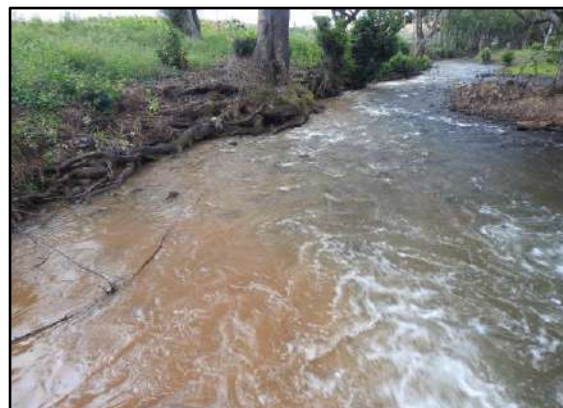
b) Suspended sediments mobilised by equipment washing upslope of culvert over Houtbosloop near TR04. [MU17d, 2018-05-28].

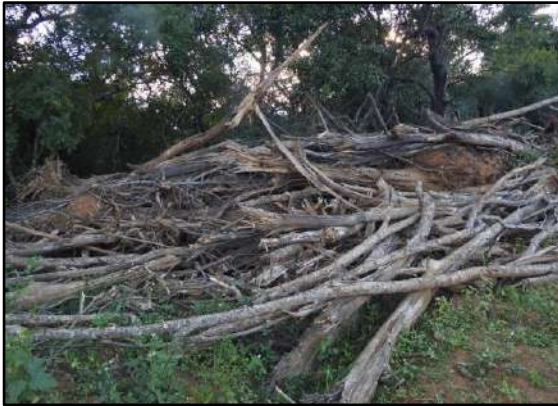
a) Woody Debris in the Riparian Zone on the farm Dubai 2. [MU 06a, S25.38305 E30.54906, 2018-05-21].

Clearing of riparian vegetation for agricultural development on the eighteen fields investigated for this report has led to piles of woody debris in riparian zone and in some places the main river channels (Figure 6-4). Many of the wood piles have been burnt and the hot fires produced have removed organic material from the underlying soils and this has localised but long-term impacts on local soil quality. The wood piles that remain within flood lines are likely to restrict high flows, and this could have long-term detrimental impacts on bank stability and erosion at a local scale. Woody snags in river channels are likely to restrict low and high flows, and this could also have long-term detrimental impacts on bank stability and erosion at a local scale. The risk of woody debris on stream flows was rated according to the Risk Matrix as **Low**.

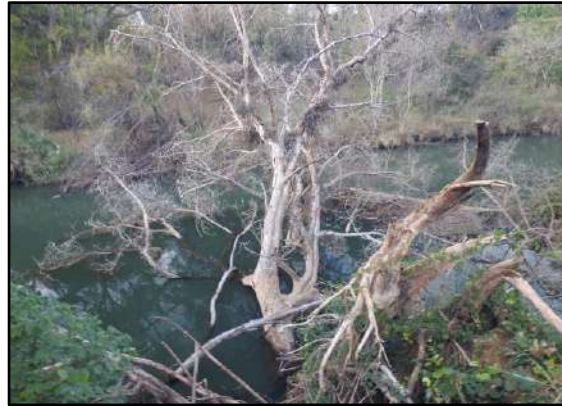
b) Woody Debris in Crocodile River at Montrose 1. [MR17c, S25.43467 E30.75096; 2018-07-04].

4) Impact of Woody Debris on Stream Flow	<ul style="list-style-type: none"> <li>● Ensure that woody debris are removed from river channels in all MUs by mid-2019.</li> <li>● Ensure that all woody debris are removed from riparian zones in all MUs by mid-2020.</li> </ul>	<p><b>4a) Woody Debris in River Channels.</b> Woody debris in river channels must be removed and either burnt in one area that is dedicated for incineration of woody debris, with permit for burning if needed, or otherwise stacked in piles outside watercourses and left as "insect hotels". Large woody debris should not be burnt in situ because of the detrimental impacts this has on soil properties and associated runoff of ash.</p> <p><b>4b) Woody Debris in Riparian and Wetland Habitat.</b> Woody debris in all MUs must be removed and treated the same as described above.</p>	Once-off

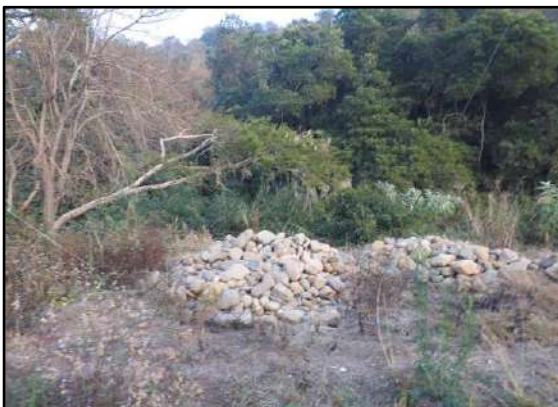
Clearing of riparian vegetation for agricultural development on the eighteen fields investigated for this report has led to large piles of stones and in some places building rubble being deposited in the riparian zone (Figure 6-5). The stone packs and rubble impede vegetation growth and alter the characteristics of the riparian zone and may reduce the diversity of plant species. Furthermore, the stone packs and rubble within flood lines are likely to restrict high flows, and this could have long-term detrimental impacts on bank stability and erosion at a local scale. The risk of stone packs and rubble on riparian habitats was rated according to the Risk Matrix as **Low**.

a) Stone packs in riparian zone of Crocodile River on the farm Rietvlei Macs. [MU12a, S25.39008 E30.57632, 2018-07-05].

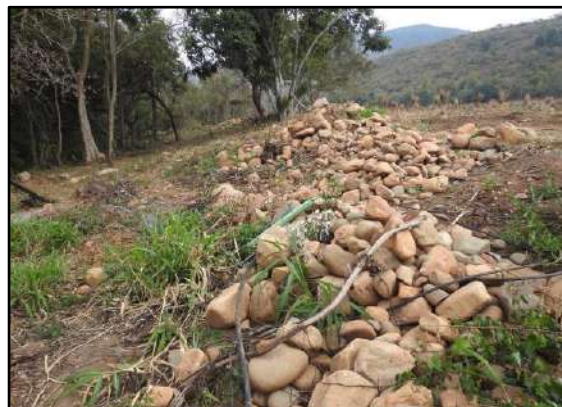
b) Stone packs in riparian zone of Crocodile River on the farm Montrose 1. [MU 17b, S25.43780 E30.74397, 2018-07-04].

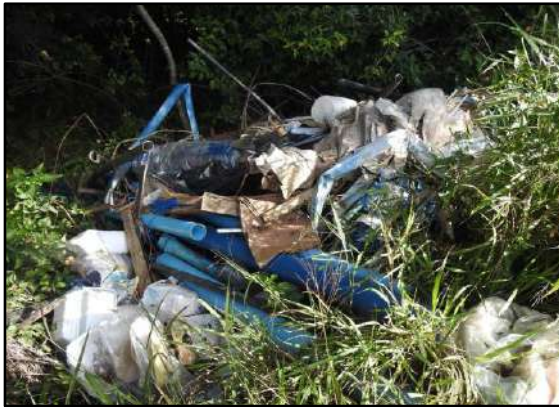
Agricultural development on the eighteen fields investigated for this report has led to the disposal of excess materials in the riparian zone, particularly fencing materials, metal offcuts, timber offcuts, plastic irrigation pipes, potting bags and other plastics (Figure 6-6a). The riparian zone has also been used for the disposal of tyres (Figure 6-6b). Furthermore, riparian zones in areas with productive orchards were used for disposing branches from pruning of orchards. Dead branches left within the riparian zone increase the risks of fire, and this could have detrimental impacts on biodiversity, particularly larger, indigenous riparian trees. The solid waste impedes vegetation growth and alters the characteristics of the riparian zone and may reduce the diversity of plant species. The risk of solid waste disposal on riparian habitats was rated according to the Risk Matrix as **Moderate**.

a) Solid waste on Hiennuman. [MU 03a, S25.37793 E30.53908, 2018-05-21].

6) Impact of Solid Waste Disposal on Riparian Habitats	<ul style="list-style-type: none"> <li>● Ensure that solid wastes do not pose a threat to surrounding environment.</li> </ul>	<p><b>6a) Solid Waste Removal.</b> Remove solid wastes from riparian and wetland habitats and dispose of appropriately. No burning, except for smaller branches and twigs.</p> <p><b>6b) Solid Waste management.</b> Provide adequate waste bins at strategic locations. Bins must be covered to prevent movement of wind-blown waste.</p> <p><b>6c) Environmental Awareness.</b> All staff and contractors must be made aware of the environmental standards and the waste management strategy during induction. The induction process must include rules and regulations regarding disposal of wastes.</p>	Initial clearing followed by annual follow-up.

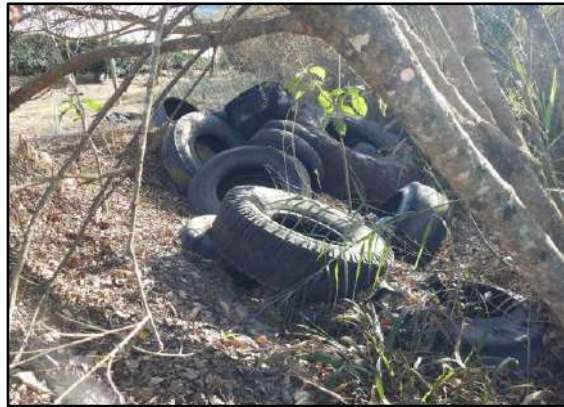
b) Tyres in riparian zone at Koedoeshoek. [MU 16e, S25.40991 E30.63539, 2018-07-03].

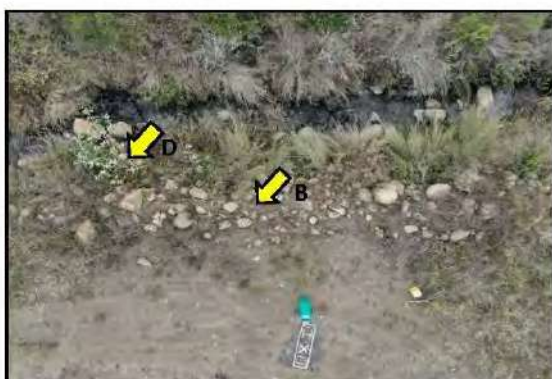
Figure C. Stone packs (B), and *Solanum mauritianum* (D). [2018-07-05].

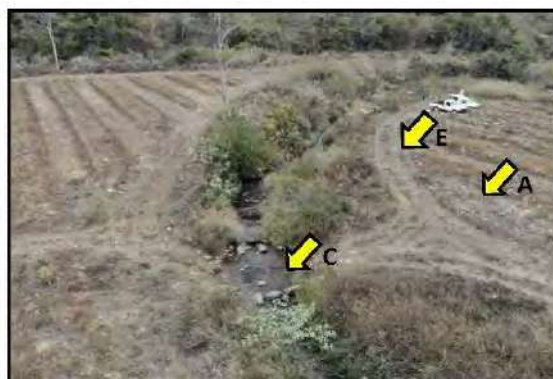
Figure D. Clearing of Riparian Zone (A); unprotected stream crossing (C) [2018-07-05].

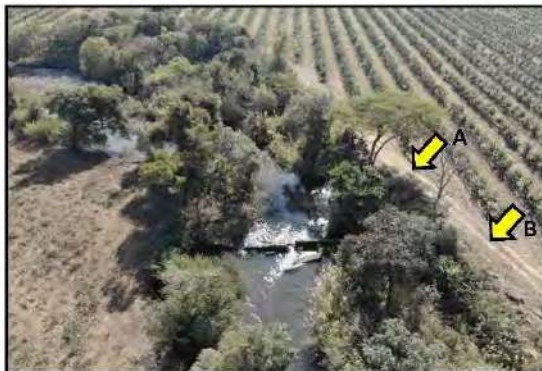
Figure C. [2018-07-05].

- 1 Failed weir (Figure C).

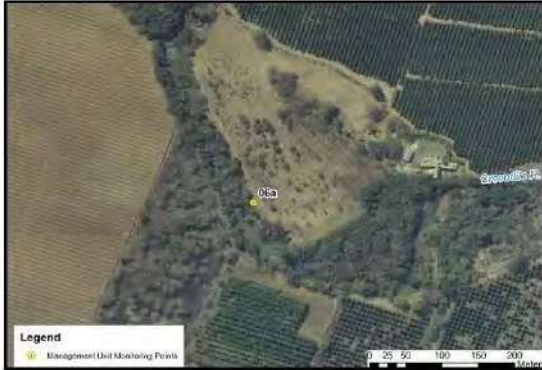
**Figure A.** Aerial photograph 2015.

Management Unit 06a covers 2.53 hectares of riparian habitat and is situated on the left bank (facing downstream) of the Crocodile River on the farm Dubai 2. The length of the riparian zone is 627 m.

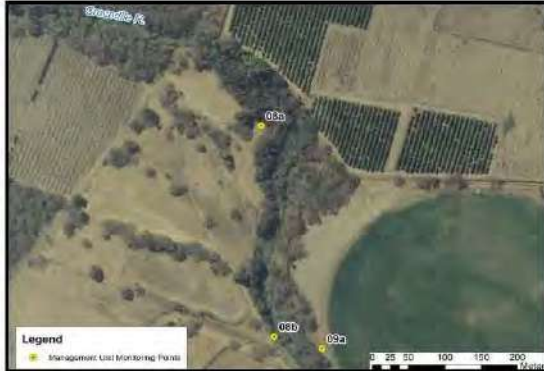
Figure A. Aerial photograph 2015.

Management Unit 08a covers 1.74 hectares of riparian habitat and is situated on the right bank (facing downstream) of the Crocodile River between two agricultural drains on the farm I Swart. The length of the riparian zone is 373 m.

- 1 Clearing in Riparian Zone (A).
- 2 Stone packs along stream margin.
- 3 Alien vegetation.
- 4 Road within Riparian Zone.
- 5 Solid waste (burnt tyres).

- 1a) Control alien invasive woody vegetation from riparian zone.
- 1b) Plant indigenous trees in riparian zone (450 trees).
- 1c) Recontour areas disturbed by bulk earthworks, where necessary.
- 3c) Realign access roads outside Management Unit.
- 5a) Remove stone packs and/or rubble from riparian zones and rehabilitate disturbed areas.
- 6a) Remove solid wastes and dispose of appropriately (no burning).

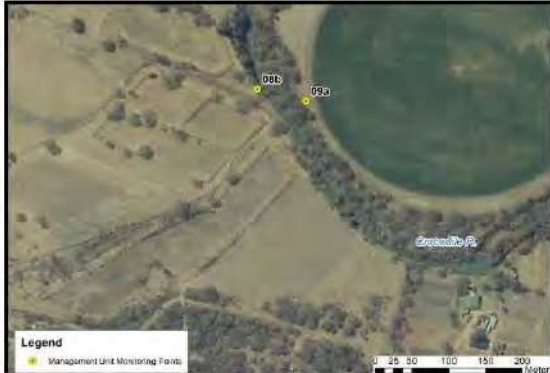
Figure A. Aerial photograph 2015.

Management Unit 08b covers 2.27 hectares of riparian and wetland habitat and is situated on the right bank (facing downstream) of the Crocodile River between an agricultural drain and the lower boundary of the farm I Swart. The length of the riparian zone is 461 m.

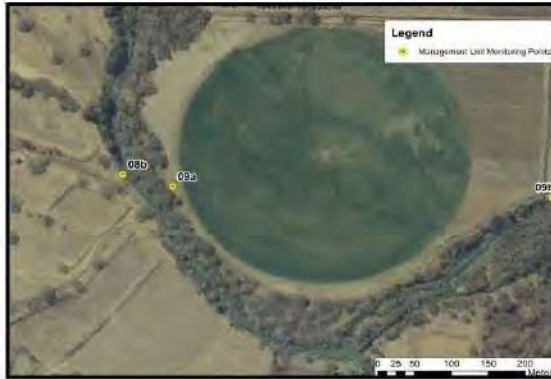
Figure A. Aerial photograph 2015.

Management Unit 09a covers 3.17 hectares of riparian habitat on the left bank (facing downstream) of the Crocodile River between the upstream property boundary and an agricultural drain on the farm Spilpunt. The length of the riparian zone is 920 m.

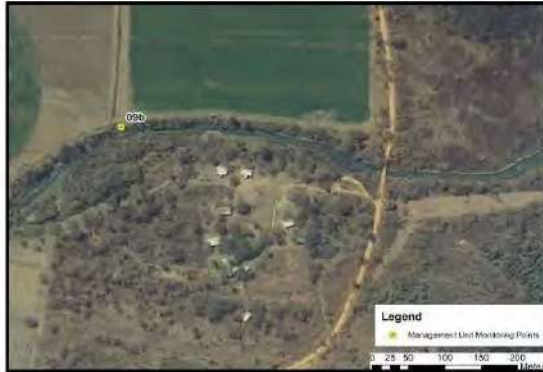
Figure A. Aerial photograph 2015.

Management Unit 09b covers 0.86 hectares of riparian habitat on the left bank (facing downstream) of the Crocodile River between an agricultural drain and the downstream property boundary of the farm Spilpunt. The length of the riparian zone is 339 m.

- 1a) Control alien invasive woody vegetation from riparian zone.
- 1b) Plant indigenous trees in riparian zone (63 trees).
- 5a) Remove stone packs and/or rubble from riparian zones and rehabilitate disturbed areas.
- 6a) Remove solid wastes and dispose of appropriately (no burning).

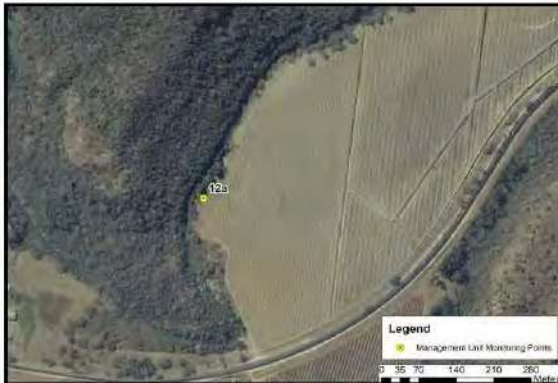
Figure A. Aerial photograph 2015.

Management Unit 12a covers 2.50 hectares of riparian habitat on the right bank (facing downstream) of the Crocodile River between the upstream property boundary and an agricultural drain on the farm Rietvlei Macs. The length of the riparian zone is 760 m.

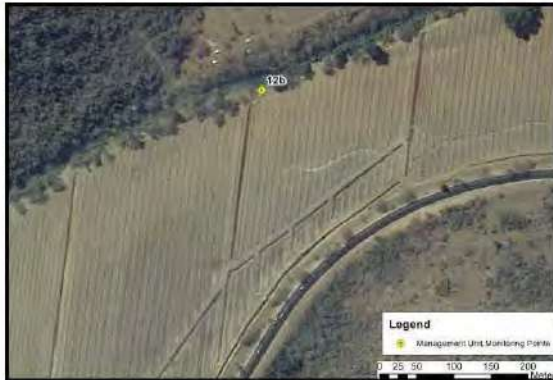
Figure A. Aerial photograph 2015.

Management Unit 12b covers 1.67 hectares of riparian habitat on the right bank (facing downstream) of the Crocodile River between two agricultural drains on the farm Rietvlei Macs. The length of the riparian zone is 471 m.

Solid waste (burnt tyres).

- 1a) Control alien invasive woody vegetation from riparian zone.
- 1b) Plant indigenous trees in riparian zone (344 trees).
- 1c) Recontour areas disturbed by bulk earthworks, where necessary.
- 5a) Remove stone packs and/or rubble from riparian zones and rehabilitate disturbed areas.
- 6a) Remove solid wastes and dispose of appropriately (no burning).

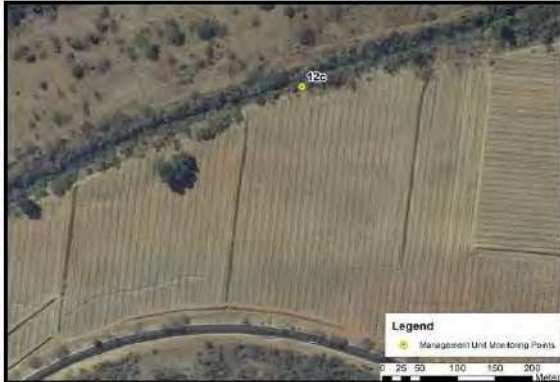
Figure A. Aerial photograph 2015.

Management Unit 12c covers 2.14 hectares of riparian habitat on the right bank (facing downstream) of the Crocodile River between two agricultural drains on the farm Rietvlei Macs. The length of the riparian zone is 459 m.

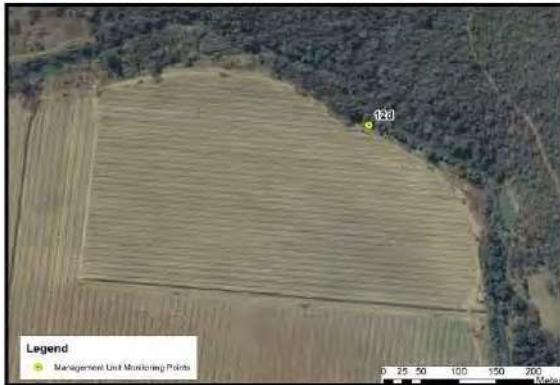
Figure A. Aerial photograph 2015.

Management Unit 12d covers 3.80 hectares of riparian habitat on the right bank (facing downstream) of the Crocodile River between two agricultural drains on the farm Rietvlei Macs. The length of the riparian zone is 802 m.

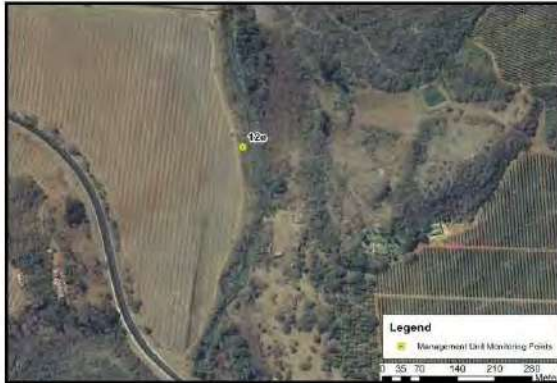
Figure A. Aerial photograph 2015.

Management Unit 12e covers 2.07 hectares of riparian and wetland habitat on the right bank (facing downstream) of the Crocodile River between an agricultural drain and the lower boundary of the farm Rietvlei Macs. The length of the riparian zone is 691 m.

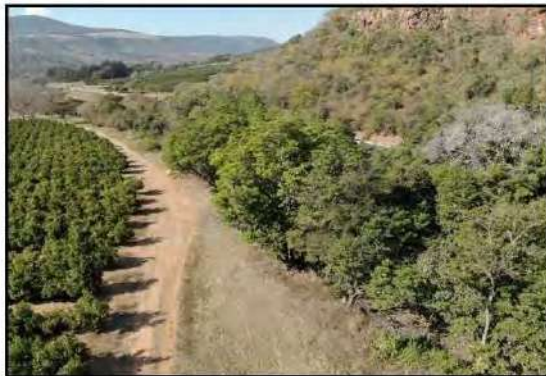
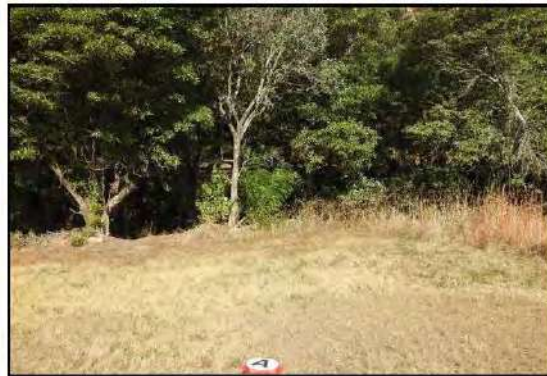
Figure C. [2018-07-04].

Management Unit 13a covers 1.23 hectares of riparian habitat on the left bank (facing downstream) of the Crocodile River on the farm Loxley. The length of the riparian zone is 192 m.

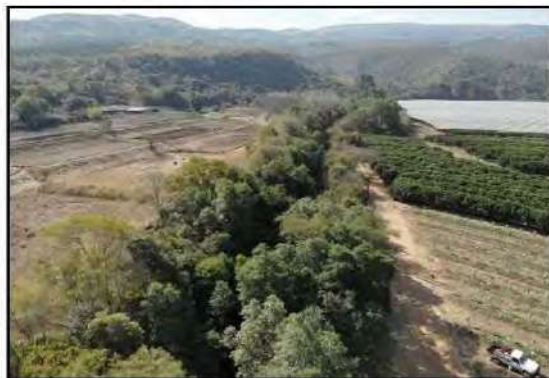
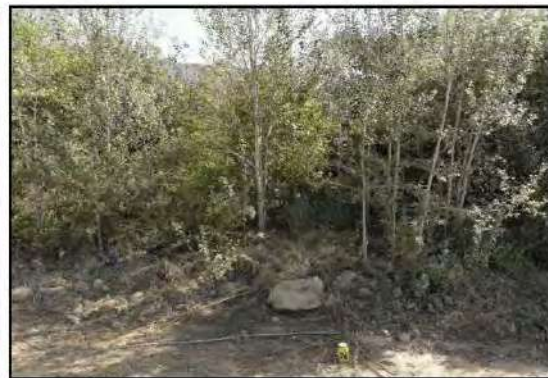
Figure C. [2018-07-04].

Management Unit 14a covers 1.15 hectares of riparian habitat on the right bank (facing downstream) of the Crocodile River between the upstream property boundary and an access road on the farm In Die Middel. The length of the riparian zone is 444 m.

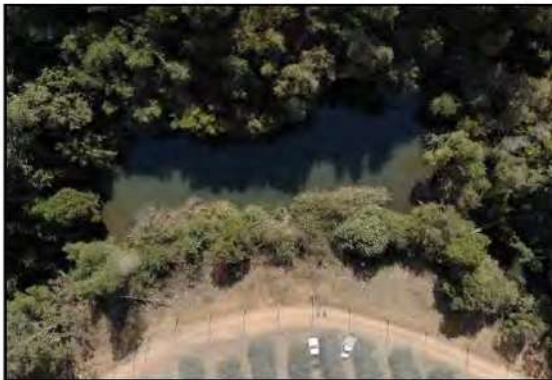
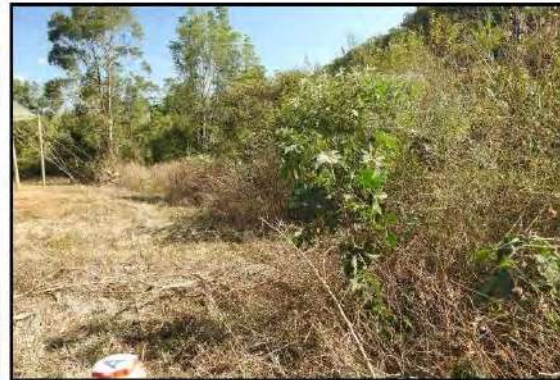
Figure C. [2018-07-04].

Management Unit 14b covers 1.83 hectares of riparian habitat on the right bank (facing downstream) of the Crocodile River between two access roads on the farm In Die Middel. The length of the riparian zone is 568 m.

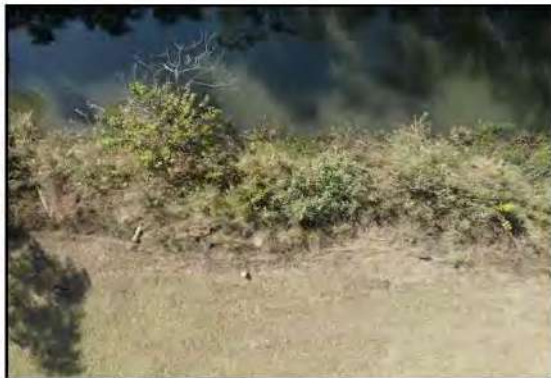
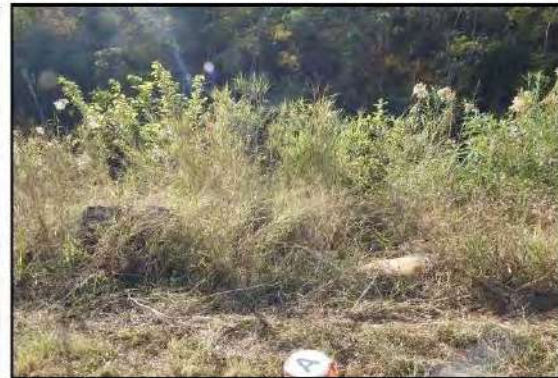
Figure C. [2018-07-05].

Management Unit 14c covers 1.77 hectares of riparian habitat on the right bank (facing downstream) of the Crocodile River between two access roads on the farm In Die Middel. The length of the riparian zone is 480 m.

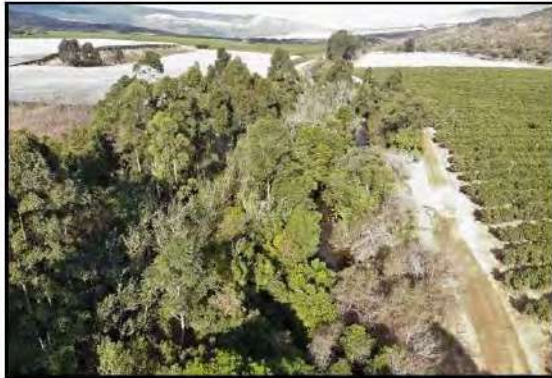
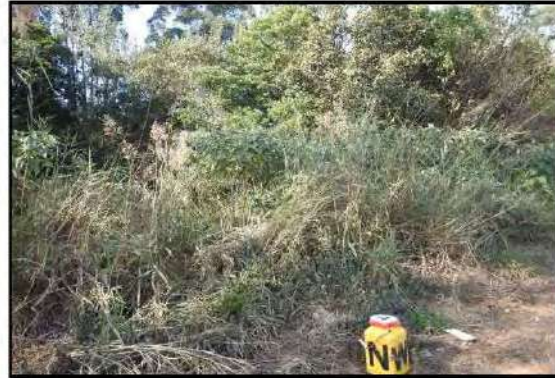
Figure C. [2018-07-03].

Management Unit 14d covers 2.89 hectares of riparian habitat on the right bank (facing downstream) of the Crocodile River between two access roads on the farm In Die Middel. The length of the riparian zone is 753 m.
