## APPENDIX D: SPECIALIST REPORTS

Annexure A: Wetland Rehabilitation Extract

## **Aquatic Ecosystem Assessment and Rehabilitation Plan Associated with Unauthorised Cultivation of Eighteen Fields in Schoemanskloof**

**Draft 1.0**

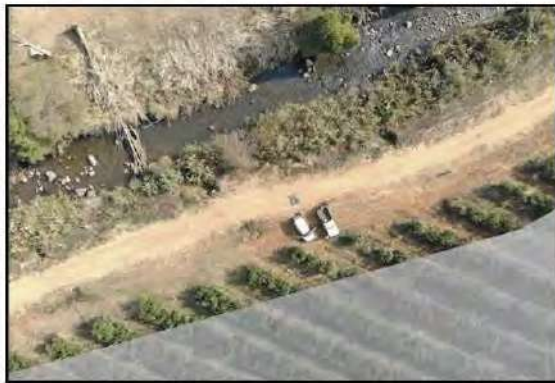
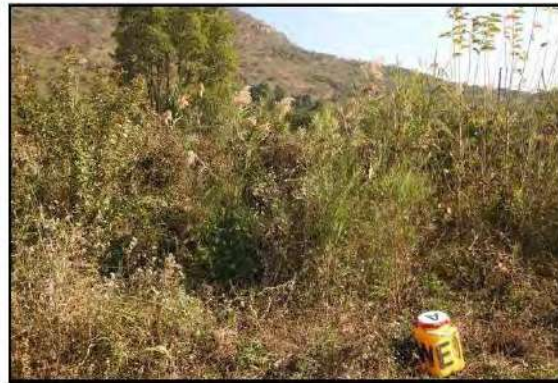
Figure C. [2018-07-03].

Management Unit 15a covers 0.95 hectares of riparian habitat on the left bank (facing downstream) of the Crocodile River between an access road and a bridge on the farm Mooiland. The length of the riparian zone is 394 m.

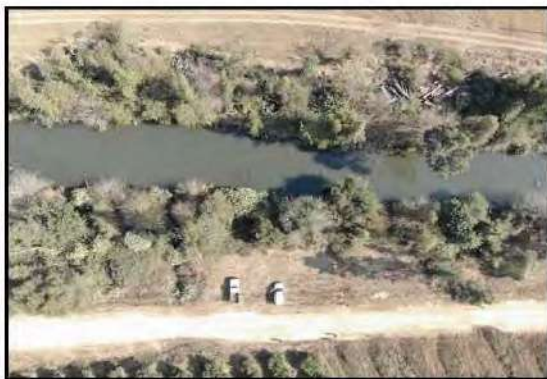
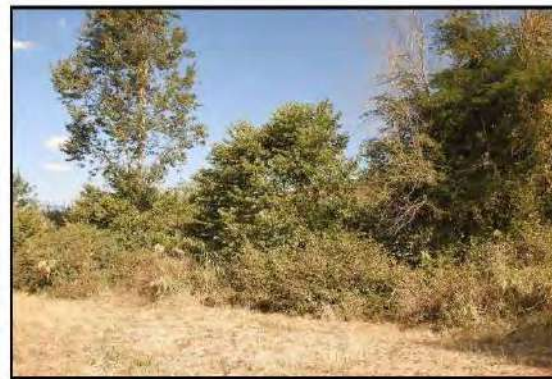
Figure C. [2018-07-03].

Management Unit 15b covers 1.15 hectares of riparian habitat on the left bank (facing downstream) of the Crocodile River between an access road and a bridge on the farm Mooiland. The length of the riparian zone is 458 m.

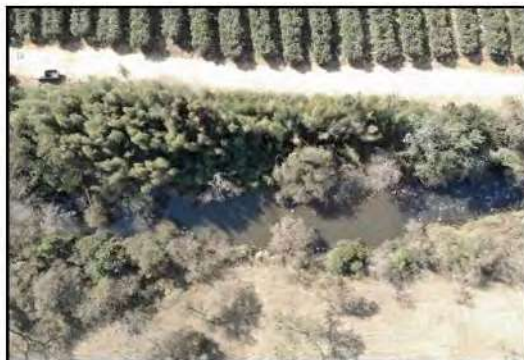
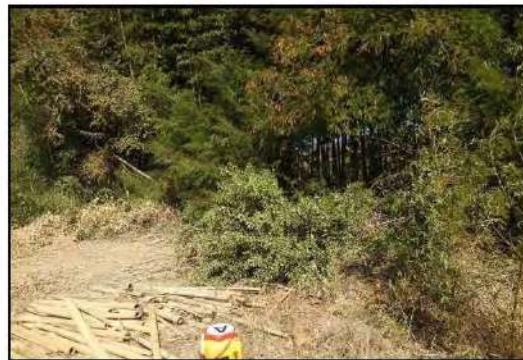
Figure C. [2018-07-03].

Management Unit 15c covers 0.64 hectares of riparian habitat on the left bank (facing downstream) of the Crocodile River between two access roads on the farm Mooiland. The length of the riparian zone is 344 m.

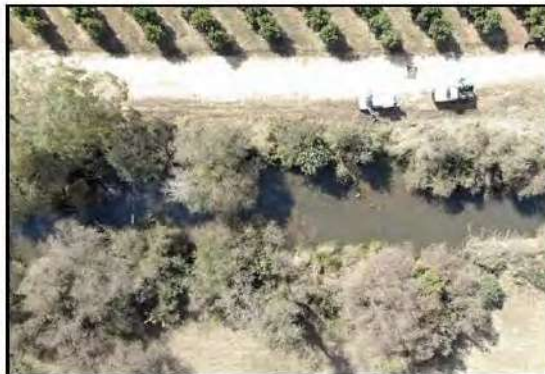
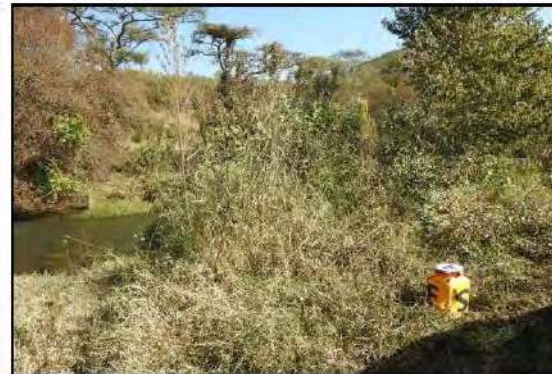
Figure C. [2018-07-03].

Management Unit 15d covers 0.57 hectares of riparian habitat on the left bank (facing downstream) of the Crocodile River between two access roads on the farm Mooliland. The length of the riparian zone is 302 m.

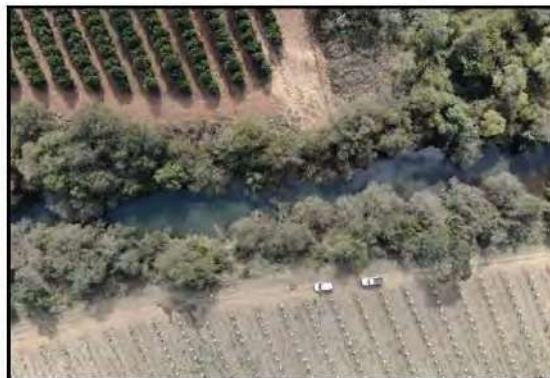
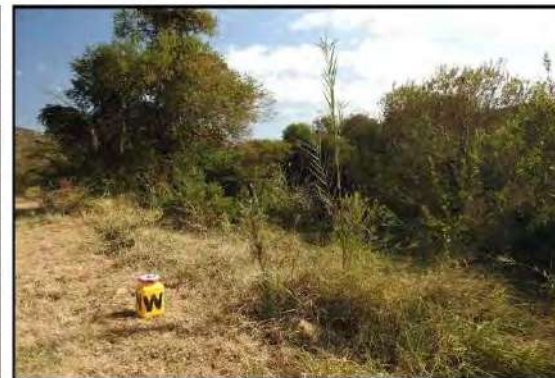
Figure C. [2018-07-03].

Management Unit 16a covers 1.50 hectares of riparian habitat on the right bank (facing downstream) of the Crocodile River on the farm Koedoeshoek, from Devil's Creek tributary junction downstream for a distance of 489 m.

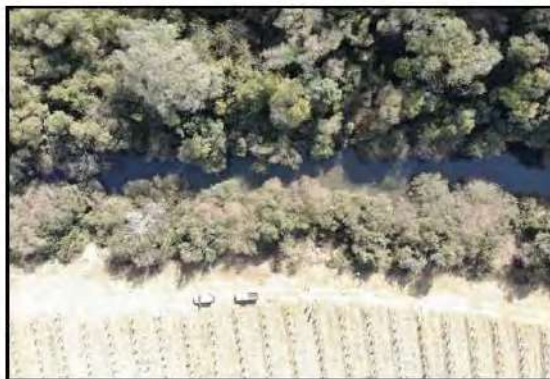
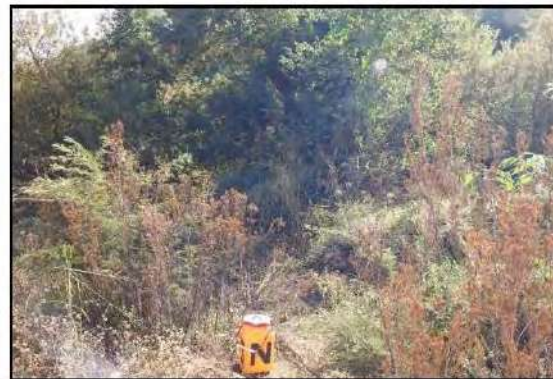
Figure C. [2018-07-03].

Management Unit 16b covers 1.11 hectares of riparian habitat on the right bank (facing downstream) of the Crocodile River on the farm Koedoeshoek. The distance of riparian habitat is 382 m.

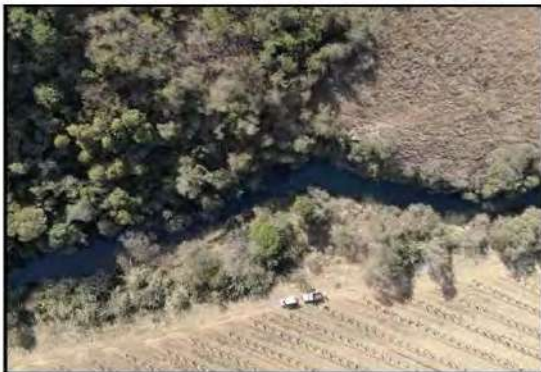
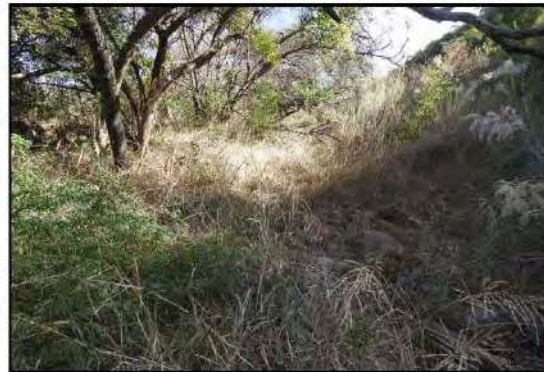
Figure C. [2018-07-03].

Management Unit 16c covers 0.80 hectares of riparian habitat on the right bank (facing downstream) of the Crocodile River between an access road and an agricultural drain on the farm Koedoeshoek. The length of the riparian zone is 308 m.

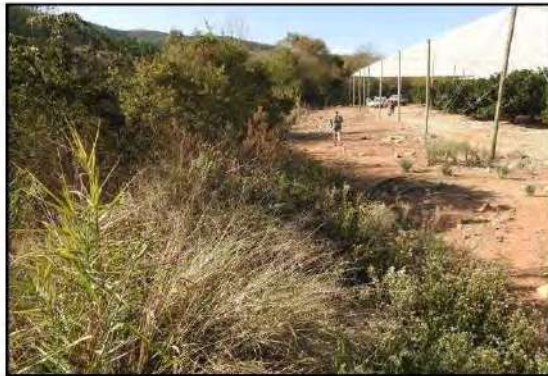
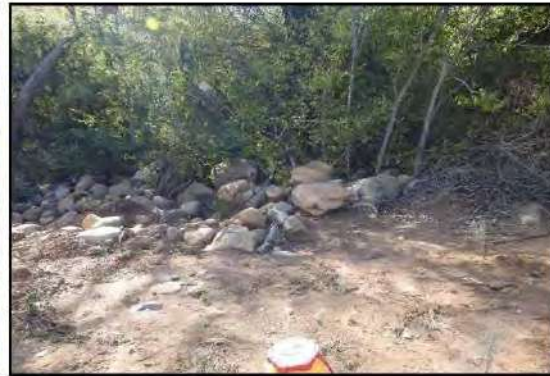
Figure C. [2018-07-03].

Management Unit 16d covers 1.14 hectares of riparian habitat on the right bank (facing downstream) of the Crocodile River between an agricultural drain and an access road on the farm Koedoeshoek. The length of the riparian zone is 339 m.

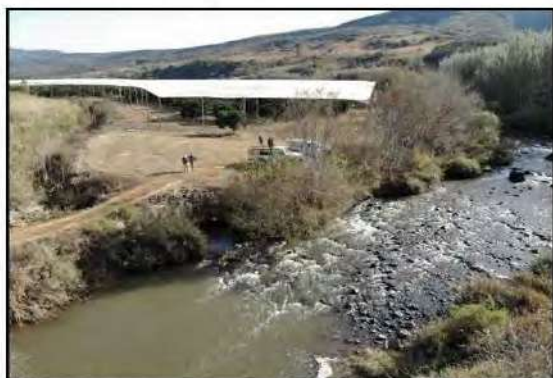
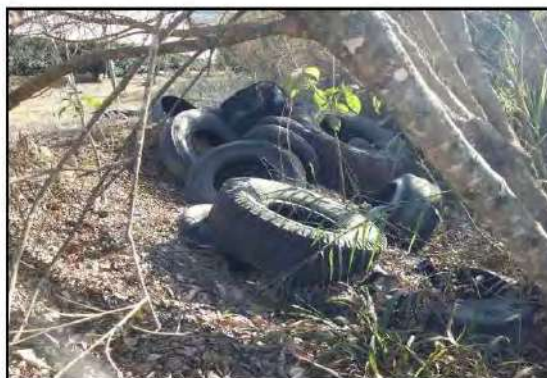
Figure C. [2018-07-03].

Management Unit 16e covers 0.58 hectares of riparian habitat on the right bank (facing downstream) of the Crocodile River between an access road and the main agricultural drain and wetland tributary junction on the farm Koedoeshoek. The length of the riparian zone is 253 m.

Criteria	Rating	Comment
1 Alien Vegetation	1.5	Four alien species recorded. Low abundance.
2 Rubbish Dumping	2.0	Tyres
3 Bank Erosion	2.0	Local erosion at stormwater discharge point
4 Inundation	0.0	None
5 Flow Modification	2.0	Stormwater slightly elevated; Kwena Dam
6 Water Quality	2.5	Turbidity
7 Vegetation Removal	4.0	Extensive removal of riparian vegetation.
8 Channel Modification	1.0	Incised
<b>Score:</b>	<b>15.0</b>	<b>Ecological Condition</b>
<b>% Modified:</b>	<b>38%</b>	<b>C: Fair</b>

- 1a) Control alien invasive woody vegetation from riparian zone.
- 5a) Remove stone packs and/or rubble from riparian zones and rehabilitate disturbed areas.
- 6a) Remove solid wastes (tyres) and dispose of appropriately (no burning).
- 7b) Stabilise discharge point to prevent bank erosion (no hanging culvert).

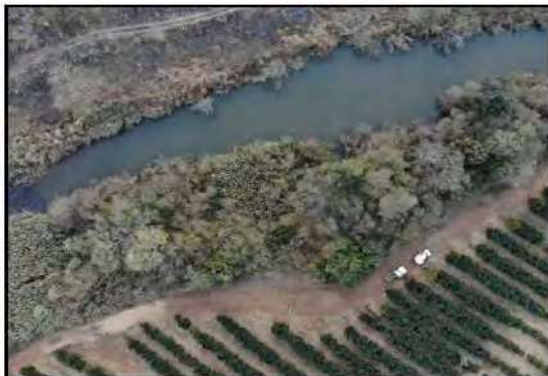
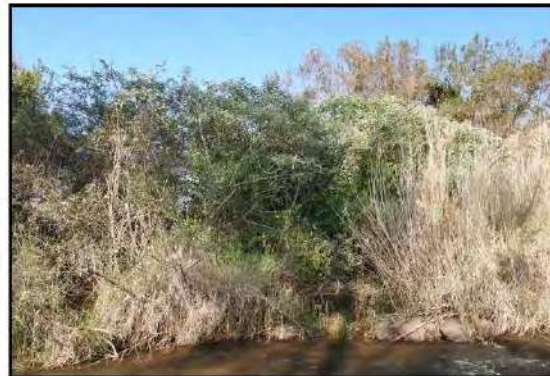
Figure C. [2018-07-03].

Management Unit 16f covers 1.31 hectares of riparian habitat on the right bank (facing downstream) of the Crocodile River between the main agricultural drain and wetland tributary junction and downstream boundary of the farm Koedoeshoek. The length of the riparian zone is 381 m.

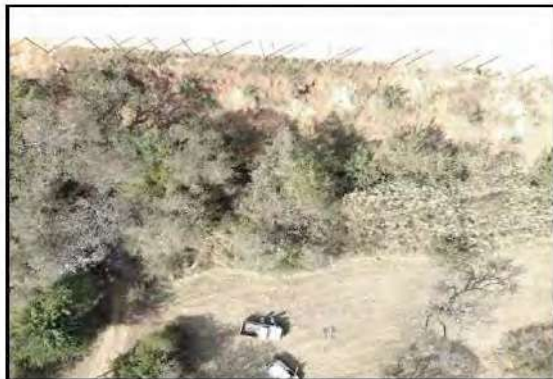
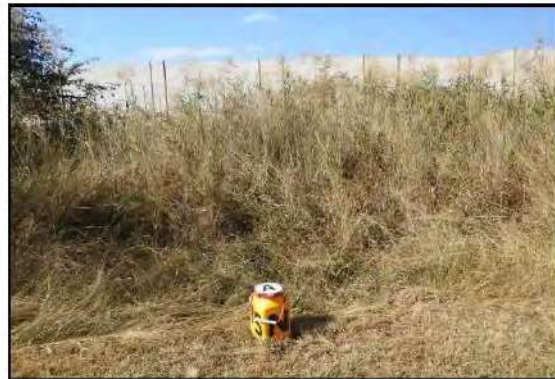
Figure C. [2018-07-03].

Management Unit 16g covers 0.98 hectares of riparian habitat on beither side of lower Devil's Creek, between the N4 highway and its junction with the Crocodile River on the fam Koedoeshoek. The length of the riprian zone is 554 m.

Criteria	Rating	Comment
1 Alien Vegetation	2.5	Nine alien species recorded. Mod. abundance.
2 Rubbish Dumping	1.0	Slight.
3 Bank Erosion	0.0	None
4 Inundation	0.0	None
5 Flow Modification	2.0	Koedoeshoek Dam
6 Water Quality	0.5	Turbidity
7 Vegetation Removal	3.0	Moderate removal of riparian vegetation.
8 Channel Modification	1.5	Siltation
<b>Score:</b>	<b>10.5</b>	Ecological Condition
<b>% Modified:</b>	<b>26%</b>	<b>B: Good</b>

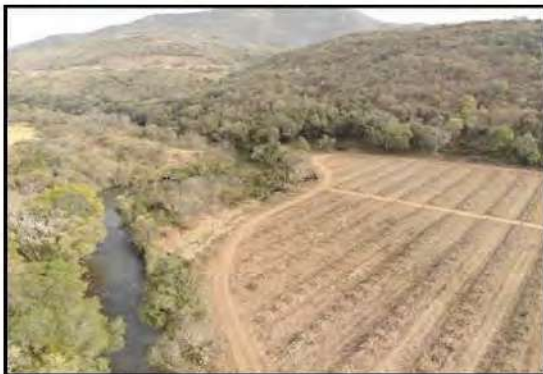
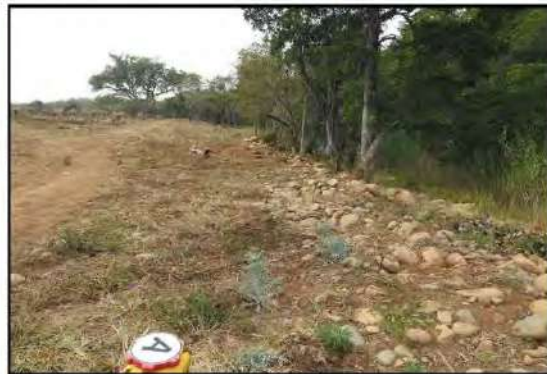
Figure C. [2018-07-04].

Management Unit 17a covers 2.98 hectares of riparian habitat on the left bank (facing downstream) of the Crocodile River between the upstream property boundary and an access road on the farm Montrose 1. The length of the riparian zone is 429 m.

Criteria	Rating	Comment
1 Alien Vegetation	3.5	Nine alien species recorded. Moderate abund.
2 Rubbish Dumping	1.5	Seedling bags.
3 Bank Erosion	0.5	Slight.
4 Inundation	0.0	None
5 Flow Modification	2.0	Stormwater slightly elevated; Kwena Dam
6 Water Quality	3.5	Turbidity; Salinity; Sulphates; <i>Cladophora</i> .
7 Vegetation Removal	4.0	Extensive removal of riparian vegetation.
8 Channel Modification	0.0	None
<b>Score:</b>	<b>15.0</b>	<b>Ecological Condition</b>
<b>% Modified:</b>	<b>38%</b>	<b>C: Fair</b>

- 1a) Control alien invasive woody vegetation from riparian zone.
- 1b) Plant indigenous trees in riparian zone (694 trees).
- 1c) Recontour areas disturbed by bulk earthworks, where necessary.
- 4a) Remove woody debris from Crocodile River.
- 5a) Remove stone packs and/or rubble from riparian zones and rehabilitate disturbed areas.
- 6a) Remove solid wastes (seedling bags) and dispose of appropriately (no burning).

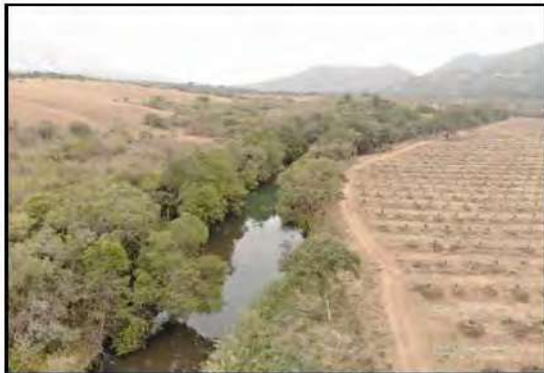
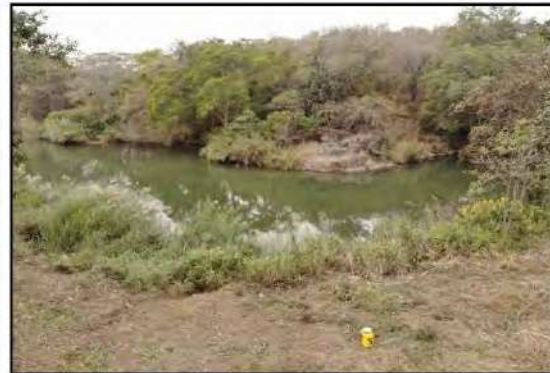
Figure C. [2018-07-04].

Management Unit 17b covers 2.74 hectares of riparian habitat on the left bank (facing downstream) of the Crocodile River between two access roads on the farm Montrose 1. The length of the riparian zone is 541 m.

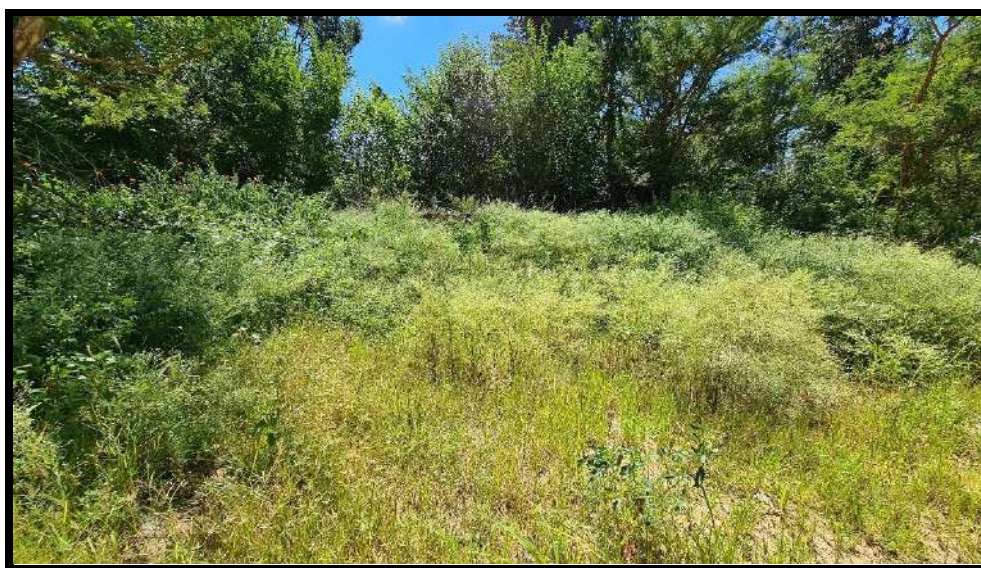
**Figure 2:** Riparian zone with signs of major Alien plant infestation

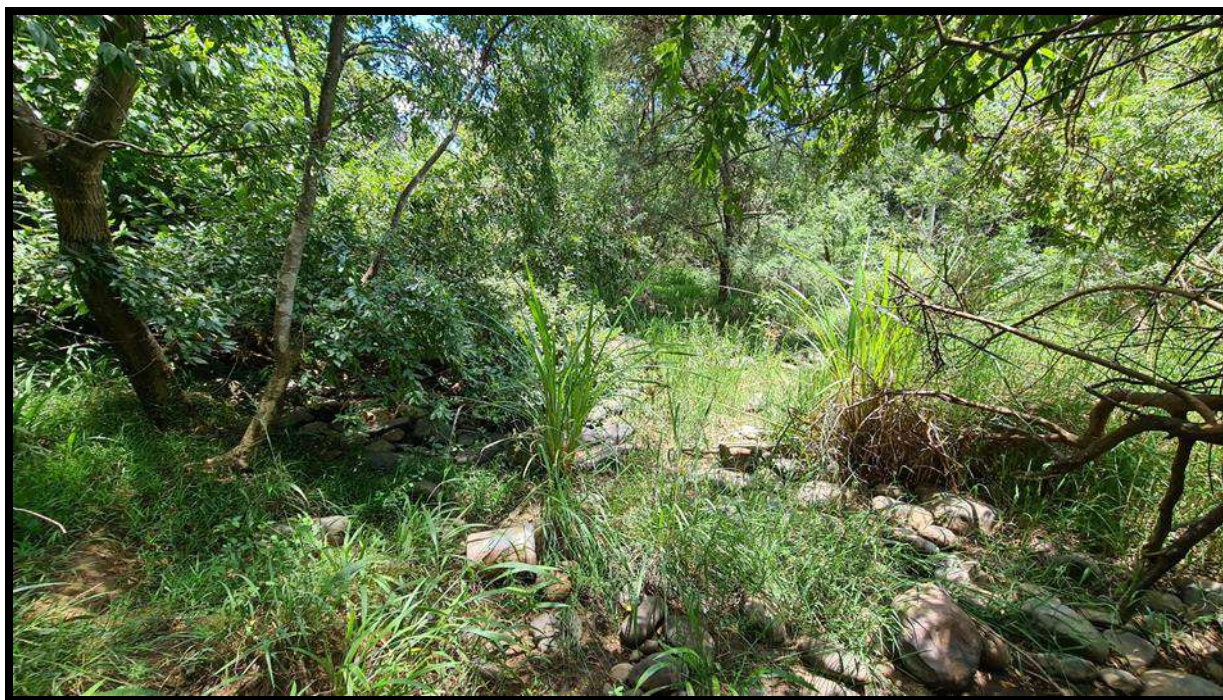
**Figure 3:** Picture of a patch of undisturbed riparian zone structure.

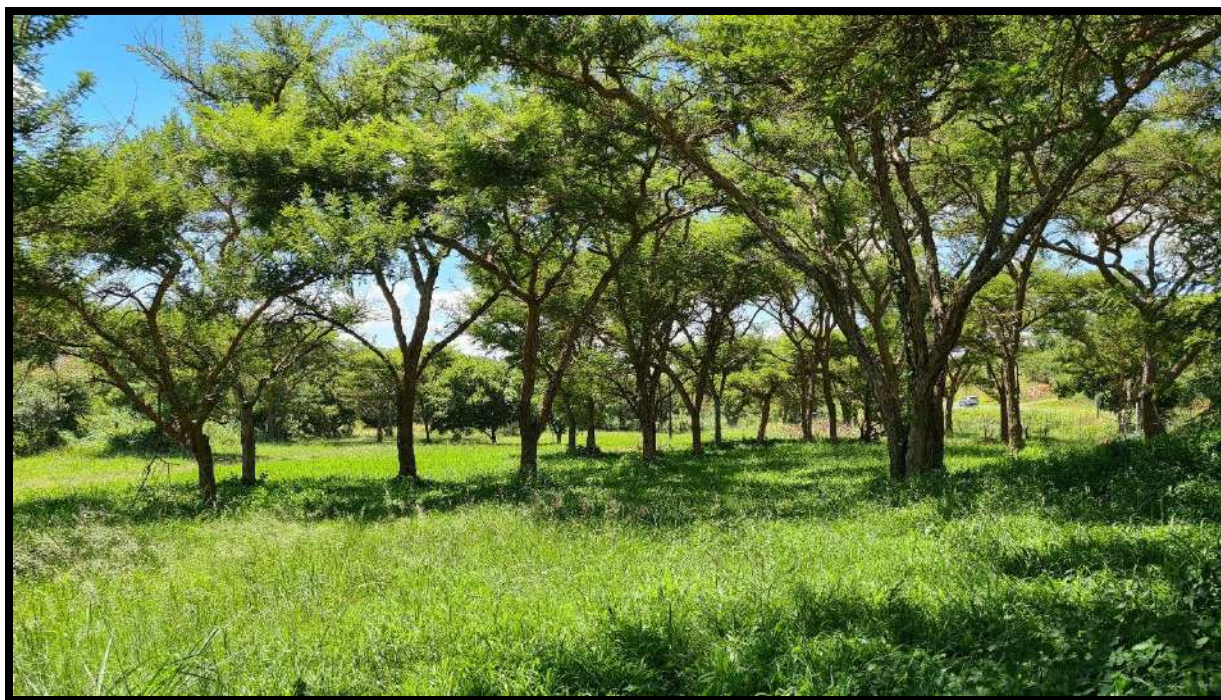
**Figure 4:** Picture of the structure of the open woodland dominated by *Vachillia erioloba* tall trees.

The structure of this vegetation community can be described as a tall, open woodland (Edwards, 1983). Large trees that dominate the zone include *Vachillia erioloba*, *V nilotica*, *Combretum apiculatum*, *C hererohense*, *Senegalia nigrescens* and *Peltophorum africanum*. Less common tall trees include *Ziziphus mucronata*, *Dalbergia melanoxylon*. Dominant shrubs include *Combretum zehyeri*, *C hererohense*, *C apiculatum*, *Peltophorum africanum*, *Grewia Flava*, and *Gymnosporia buxifolia*. The herbaceous layer was dominated by the graminoids *Panicum maximum*, *Digitaria eriantha*, *Heteropogon contortus*, *Eragrostis rigidior*, *E superba* and *Aristida* sp.

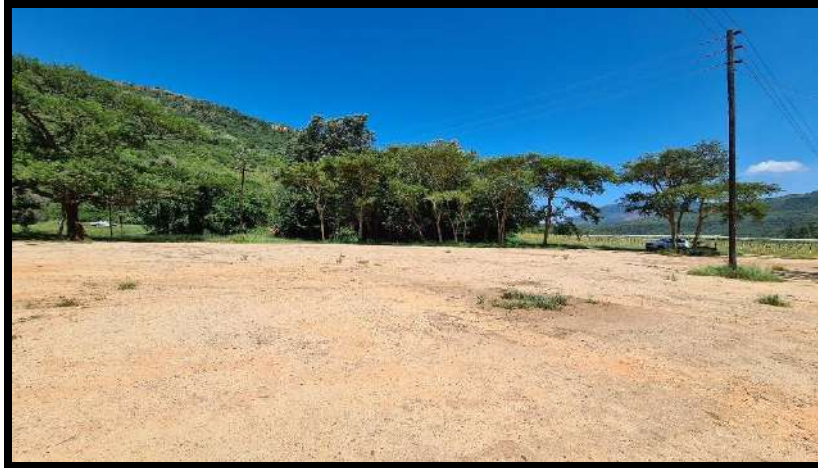
**Figure 5:** Open and cleared patch of roughly 10 000 m<sup>2</sup> (1 Ha)

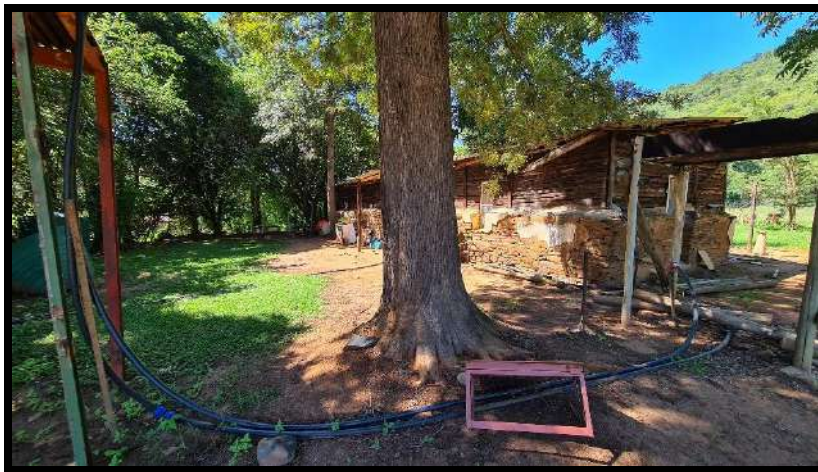
**Figure 6:** Existing infrastructure and disturbance in this zone.

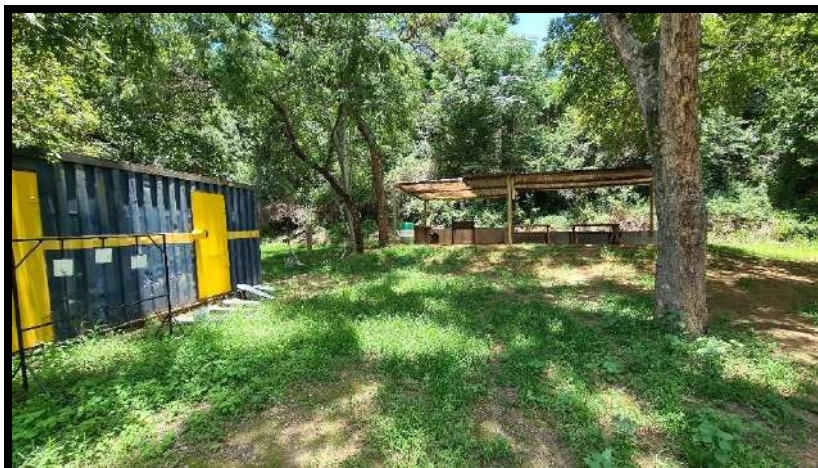
**Figure 7:** Existing infrastructure in the form of a shooting range with major disturbance in this zone.

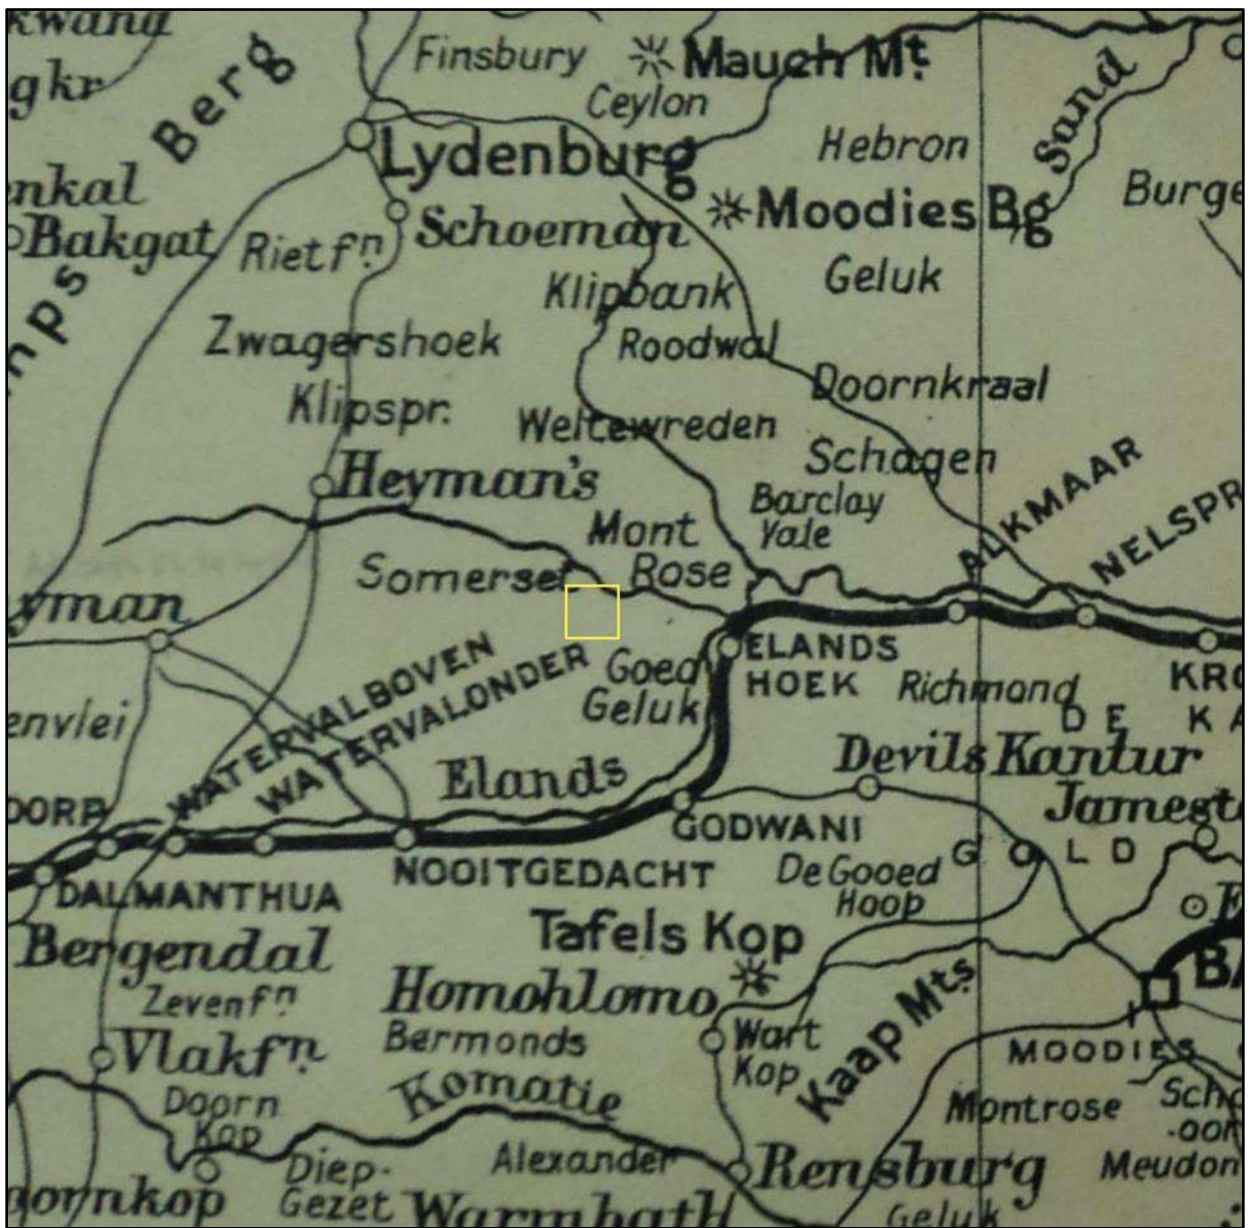
**Fig. 4.2.** A Map of the Transvaal and Orange River Colonies in the year 1900. The yellow border shows the approximate location of the area under investigation (Philip et al, 1900).

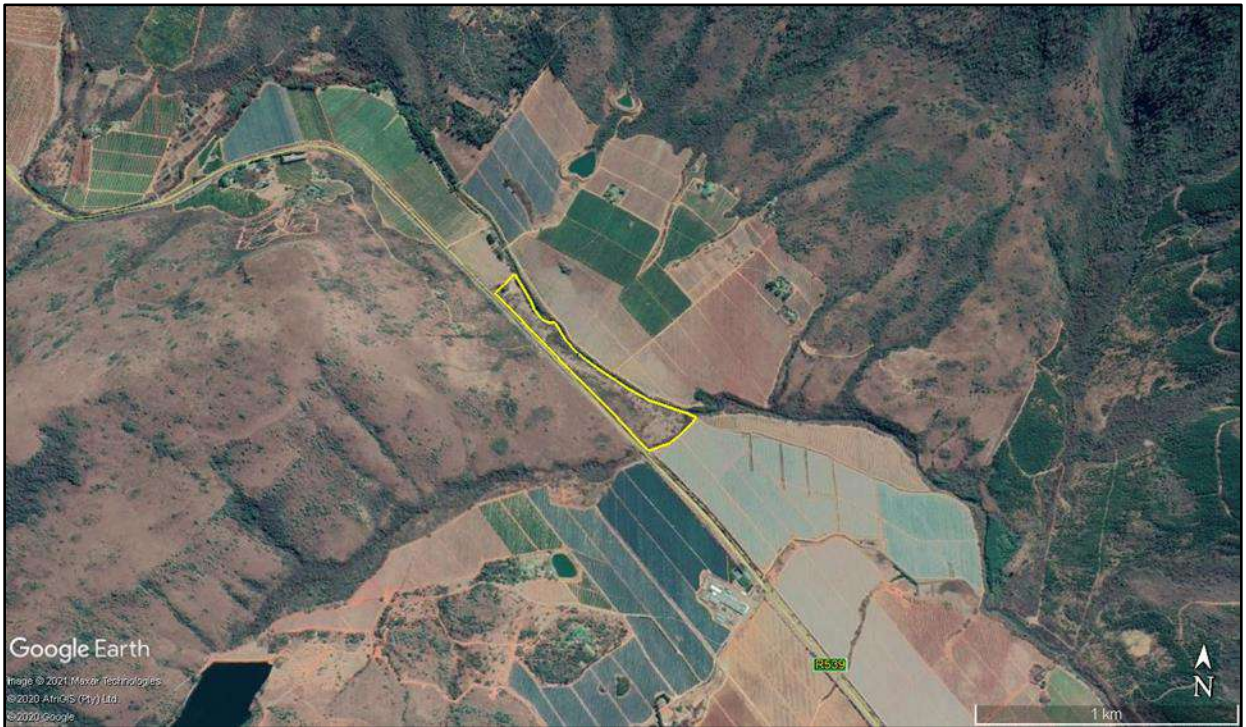
**Fig. 4.9.** A Google Earth image showing the approximate location of the study area (yellow border). No developments can be seen on the property (Google Earth, 2020).

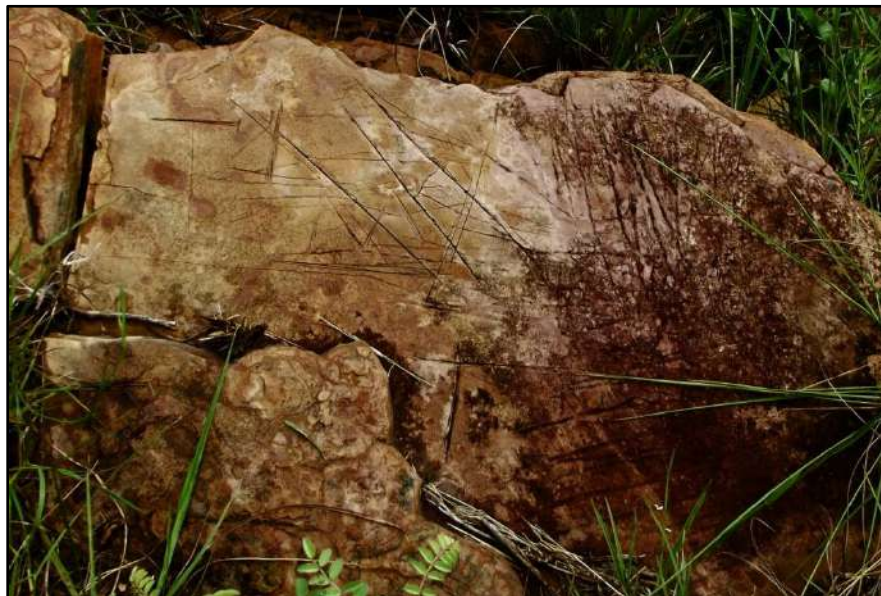
**Fig. 2.** Site GJS 1. A flat slate stone with random inscribed lines which may have been made by somebody whiling away time while keeping a lookout for enemy forces during the Anglo Boer War.

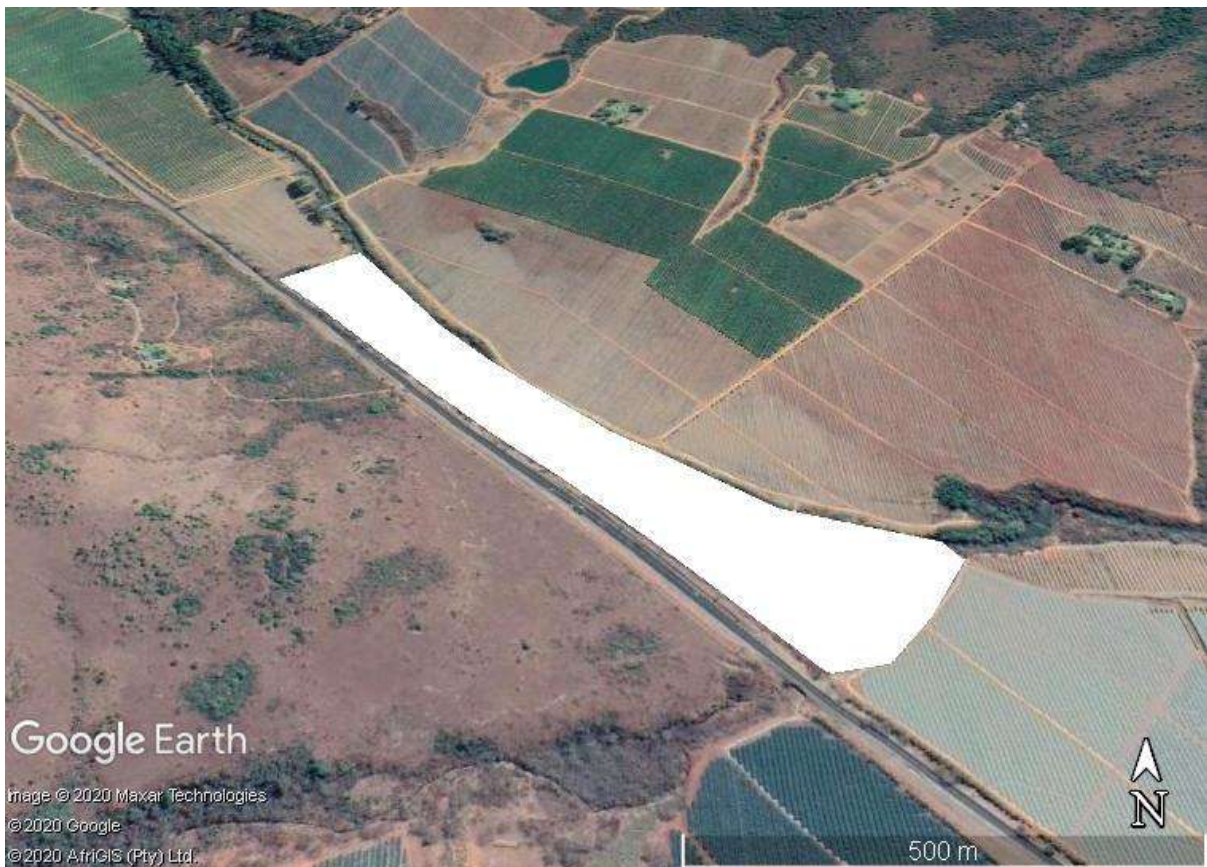
Figure 1: Google Earth map of the sections on Farms Geluk and Koedoeshoek for the proposed clearing of natural vegetation for agricultural development is indicated by the white polygon. Map supplied by HES.
