**HERITAGE IMPACT ASSESSMENT:
PROPOSED ACCESS ROAD ON THE REMAINDER AND
PORTION 4 OF THE FARM ONDER RUGZEER 168,
KENHARDT MAGISTERIAL DISTRICT,
NORTHERN CAPE PROVINCE**

1st draft: 08 December 2020

Final report: 18 December 2020

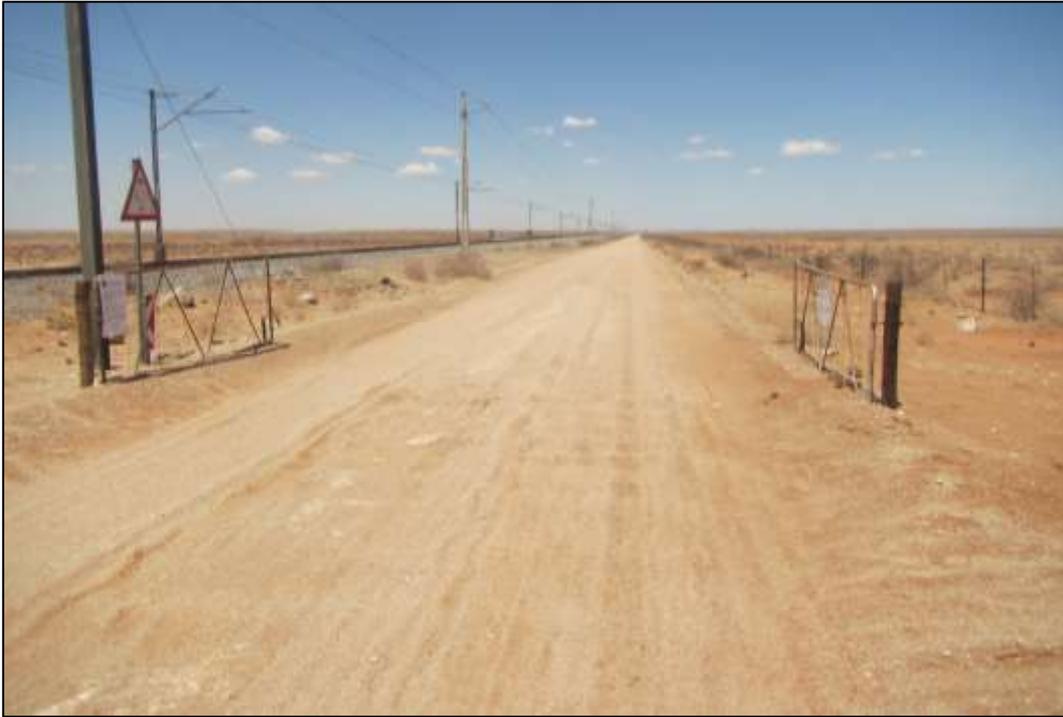
Figure 4: View towards the southwest along the existing Transnet service road (Option A) from the point at which access would be provided to the PV sites. PV1 lies to the right, PV2-6 lie to the left.

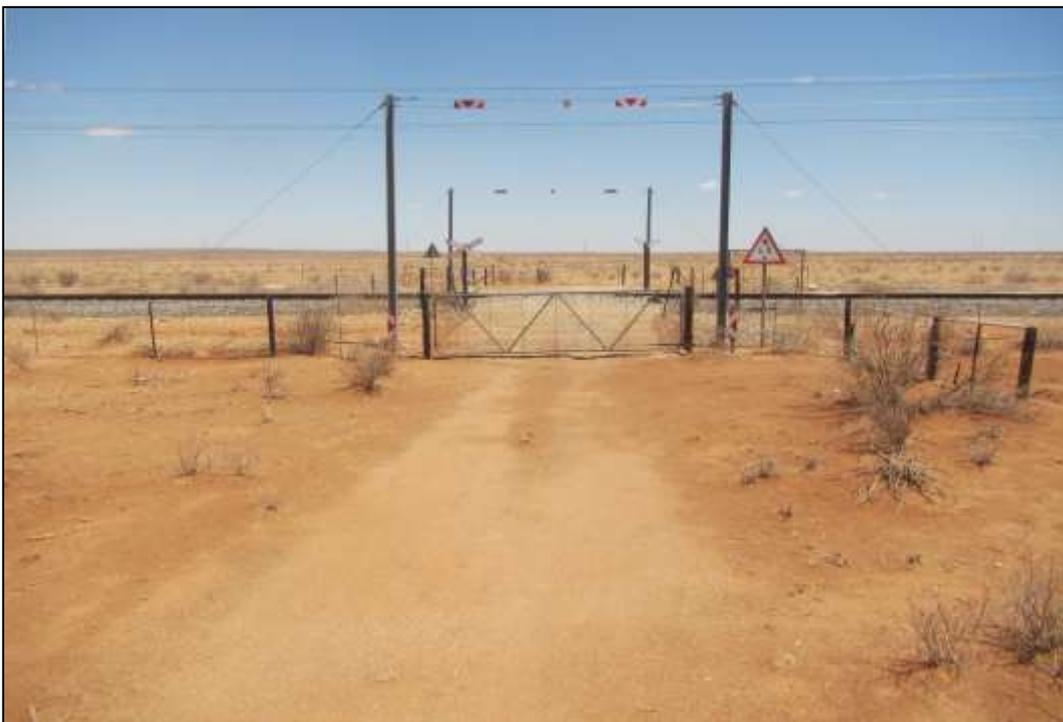
Figure 5: View towards the north across the existing level crossing where all access road options would cross the Transnet railway line. The Transnet service road is on the north side of the railway line.

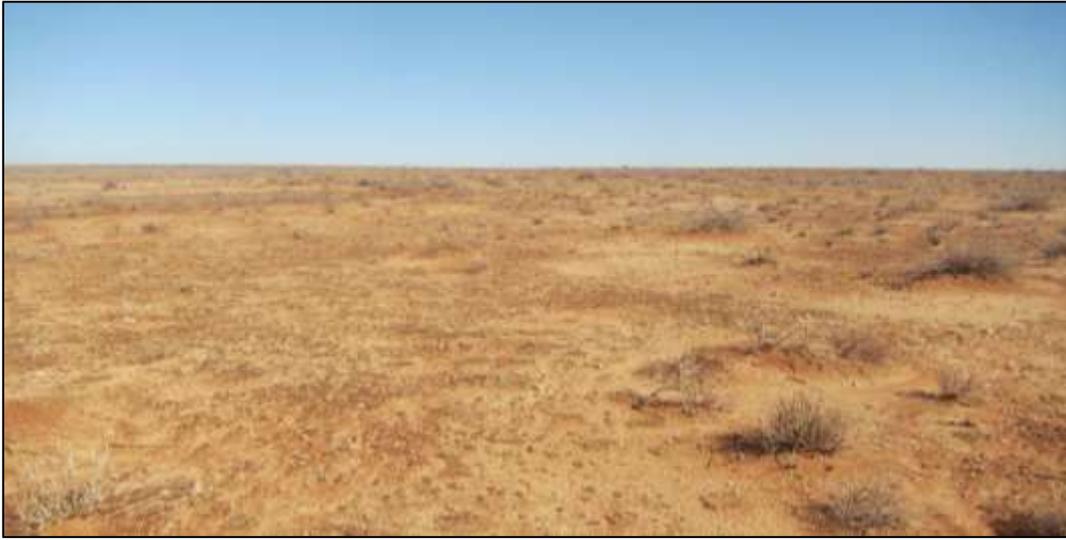
Figure 6: View towards the north along the southern part of Option C.

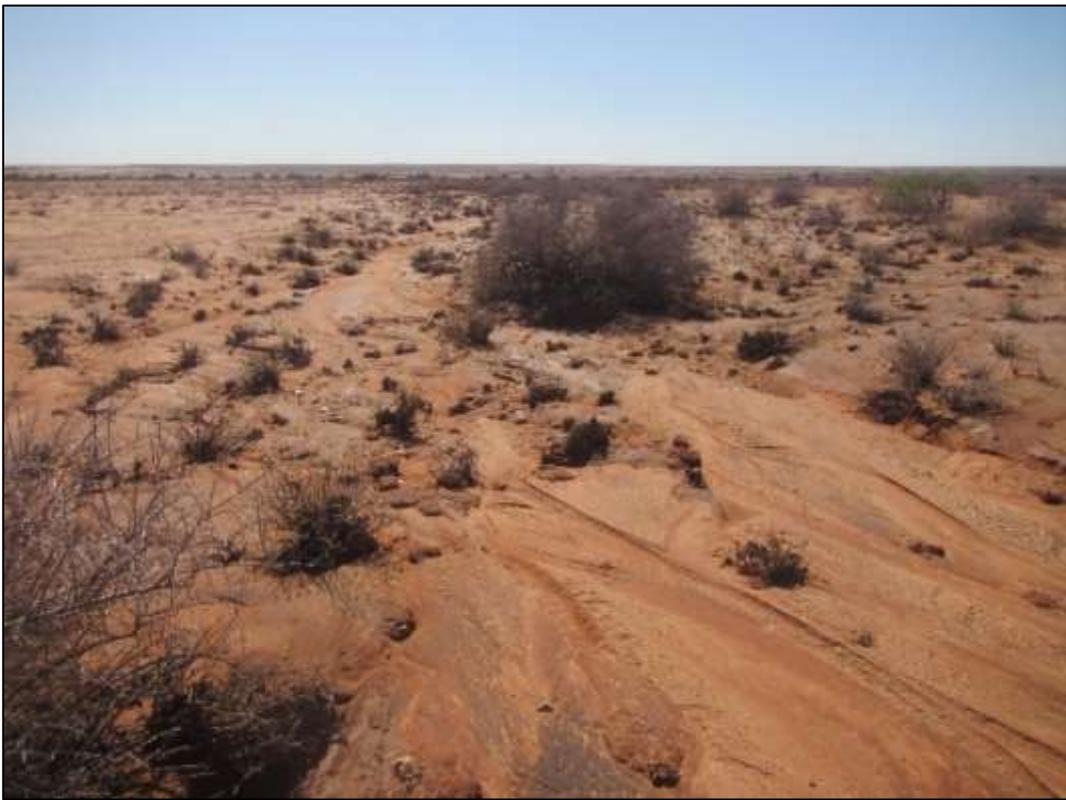
Figure 7: Looking northwards along Option C showing one of the small water course crossing points.

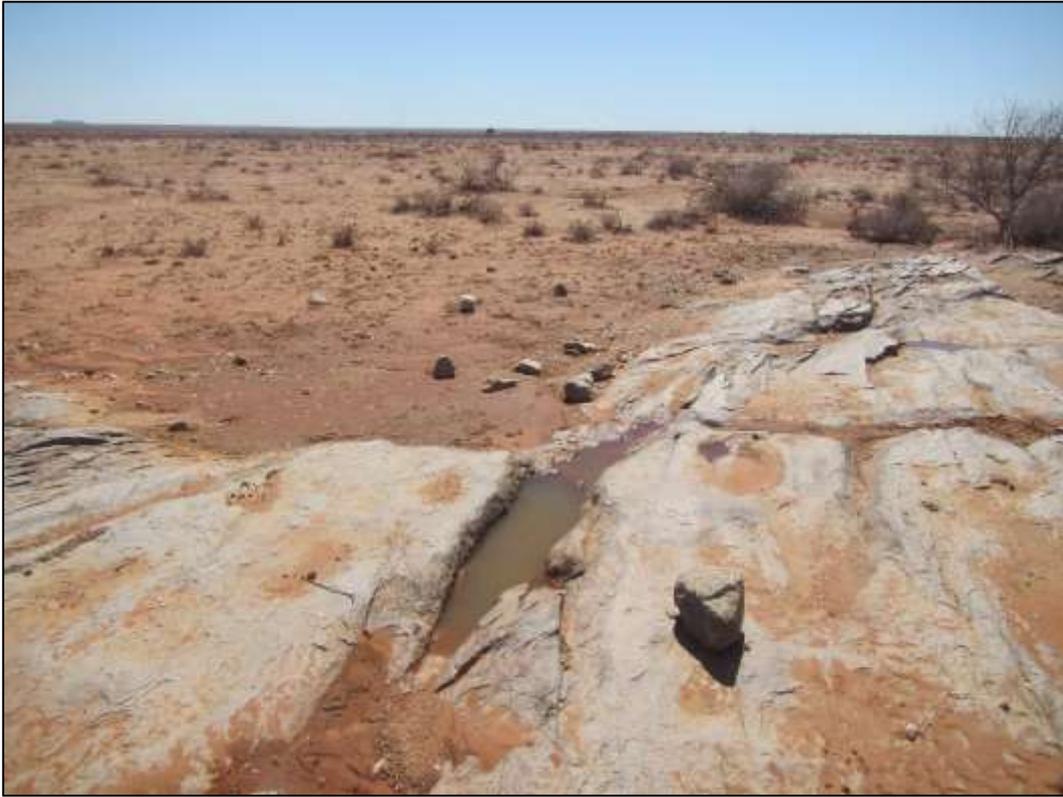
Figure 8: Looking towards the southeast over the largest bedrock outcrop seen. It has a hollow that has accumulated rainwater. The Option C alignment passes across this view in the background a short distance beyond this outcrop.

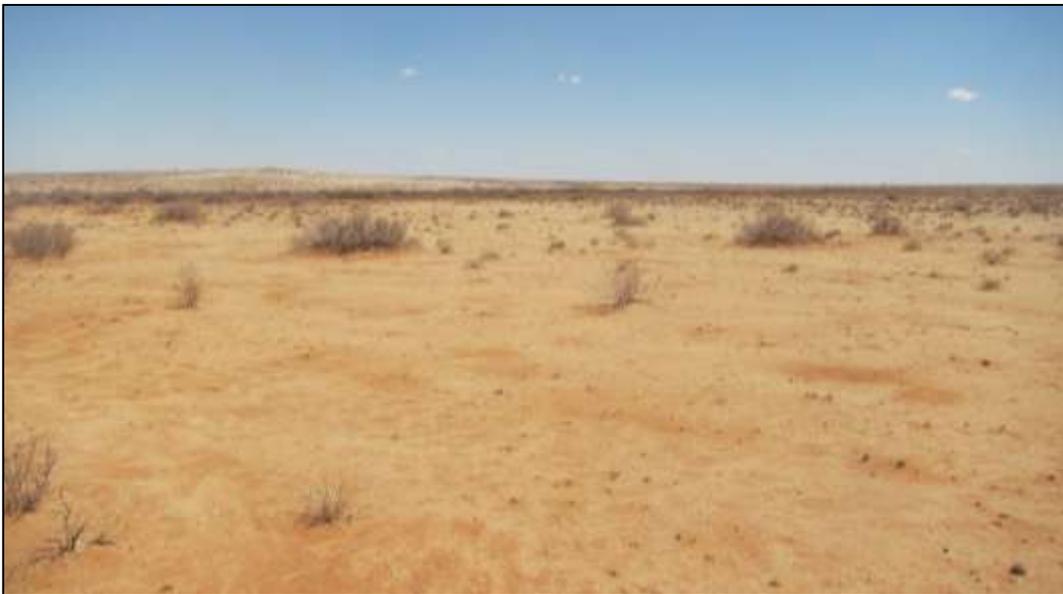
Figure 9: Looking north along Option C near the point where the substation access road branches eastwards. The alignment passes east (right) of the quartz-covered hill in the background.

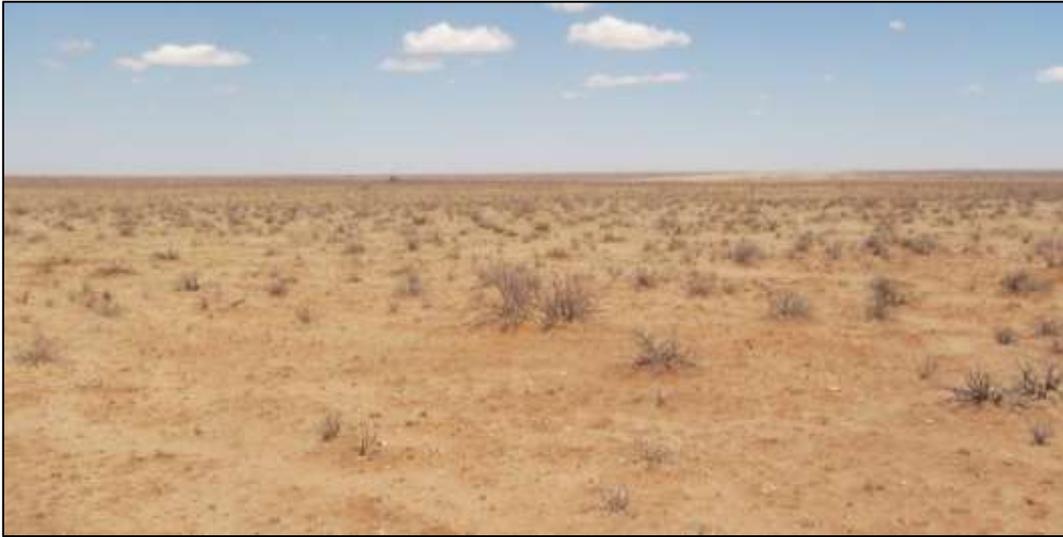
Figure 10: View towards the west along the substation access road (Option C).

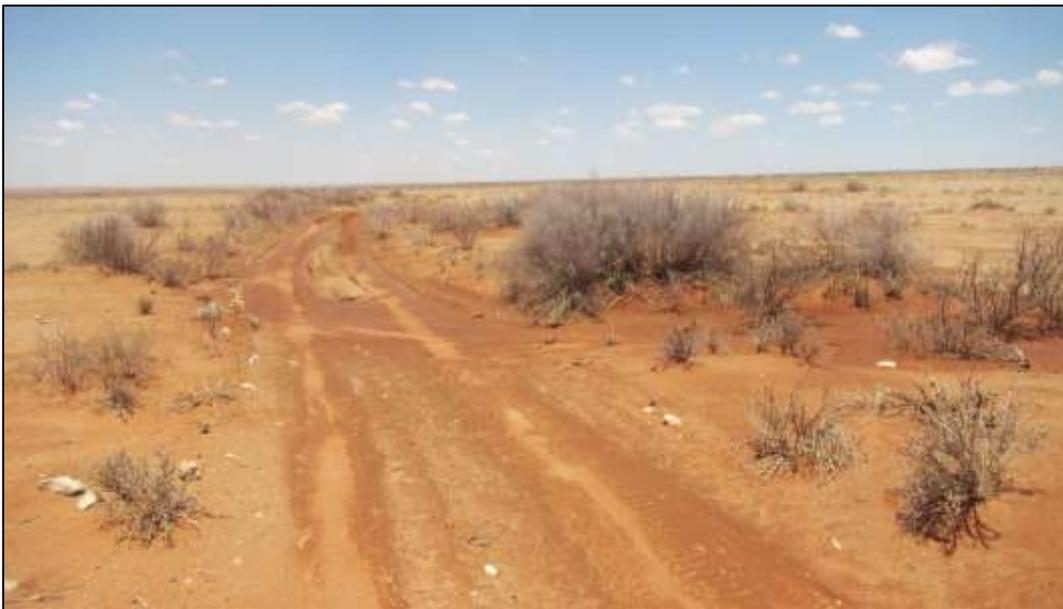
Figure 11: View towards the south along the central part of the existing farm track (Option B).

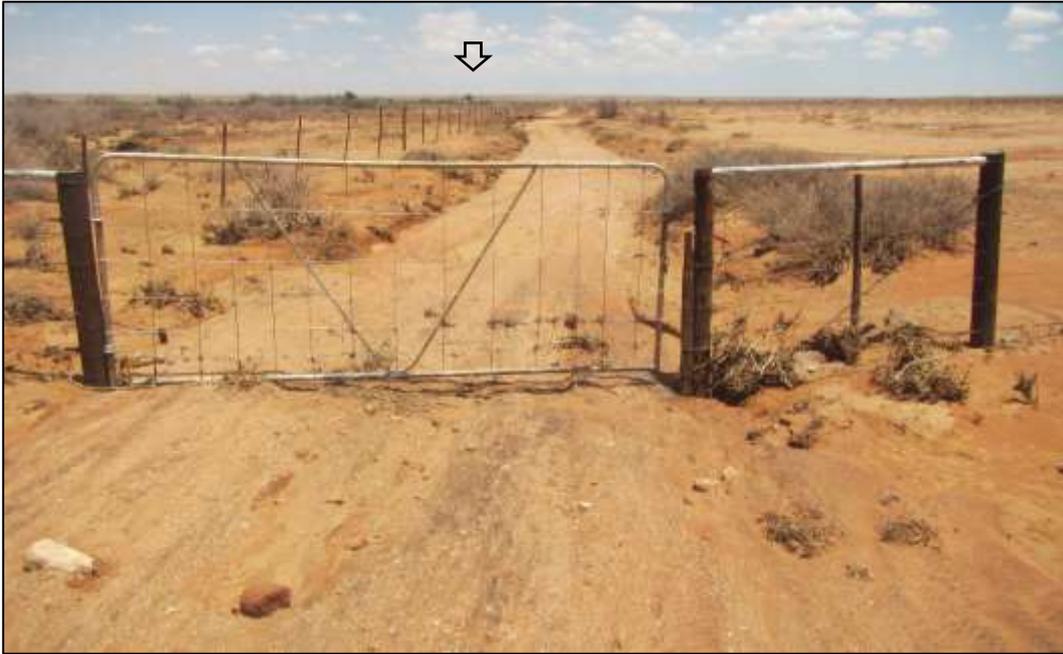
Figure 12: Looking southwards along the existing farm track (Option B) with the farmstead visible in the distance (arrowed).

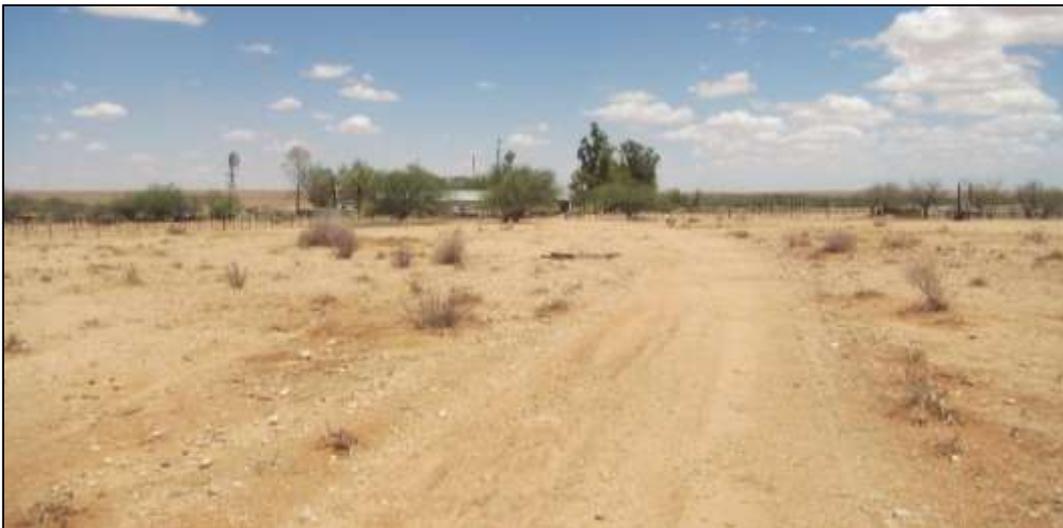
Figure 13: View towards the south where the farm track enters the farm complex. Option B would leave the track and pass just to the west (right) of the trees in order to not go through the farm complex.

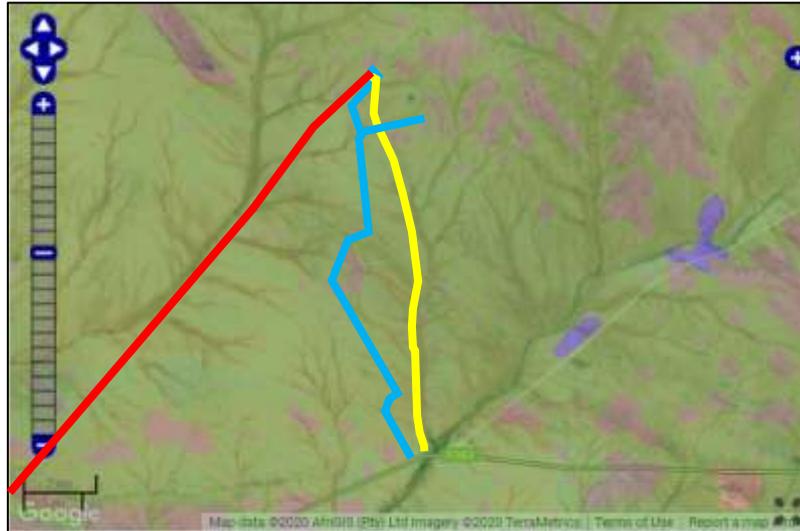
The SAHRIS Palaeosensitivity map shows that the study area is of moderate palaeontological sensitivity which means that a desktop study is required (Figure 14). Please see the separate palaeontological report compiled by Dr John Almond.

Figure 14: Extract from the SAHRIS Palaeosensitivity map showing the study area to be of largely medium palaeontological sensitivity.

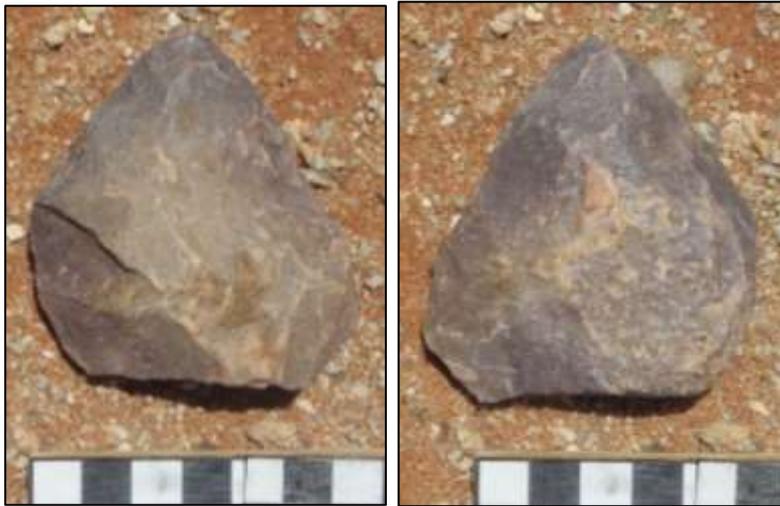
Figure 16: Both faces of a bifacially worked artefact. Scales in cm.

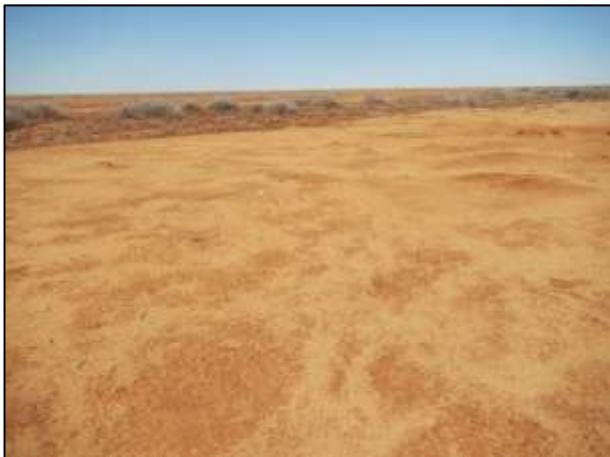
A few sites were recorded where the artefact scatters were dense enough. None of them were of high significance though. The best scatter (waypoint 866) was located not far from a small bedrock water source (waypoint 867; Figure 9) which may, in fact, have been the reason for the location of the site. In Bushmanland it is common to find archaeological sites located around such water sources. This and the other scatters seen were exclusively of stone artefacts with no other associated finds. Their density was very low. Only one isolated fragment of ostrich eggshell was seen during the survey. Figures 17 and 18 show the surface of the sites at waypoints 865 and 866.

Figure 17: The surface of the site at waypoint 865.

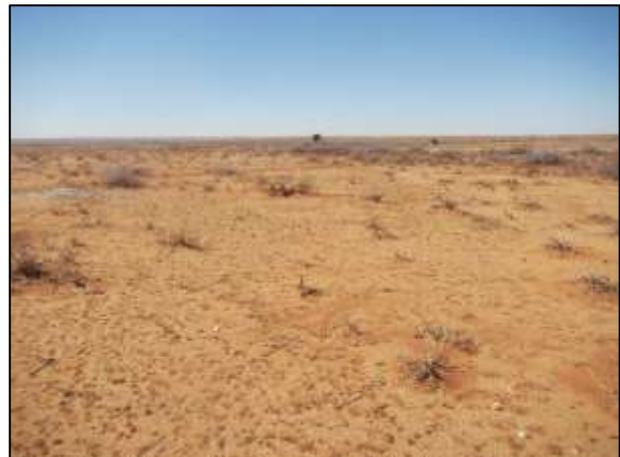
Figure 18: The surface of the site at waypoint 866.

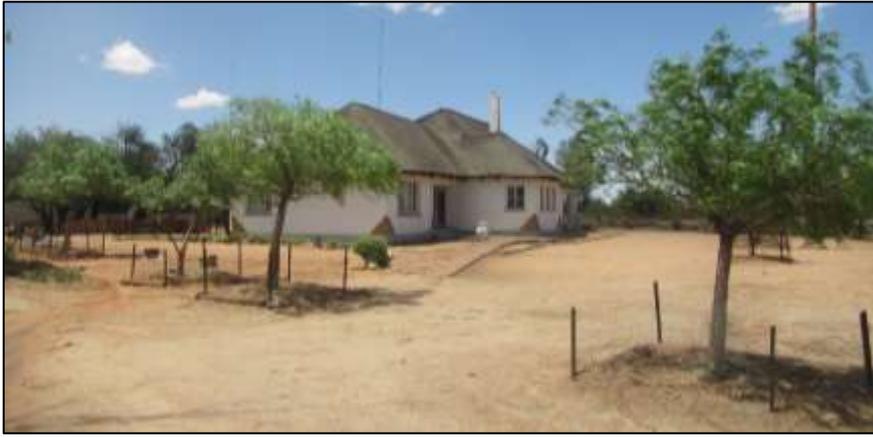
Aside from the few historical artefacts seen and mentioned above, the only historical resource was the farm complex. The complex appears to date to the mid-20th century (Figure 19 & 20) and is thus not very old. It is unknown whether any earlier structures were ever present on the farm. The house lies within a planted landscape of many trees including a line of gums alongside the driveway (Figure 21). The Option B road alignment has been designed to avoid the farmstead and its surrounding trees.

Figure 19: View of the large, thatched farmhouse.

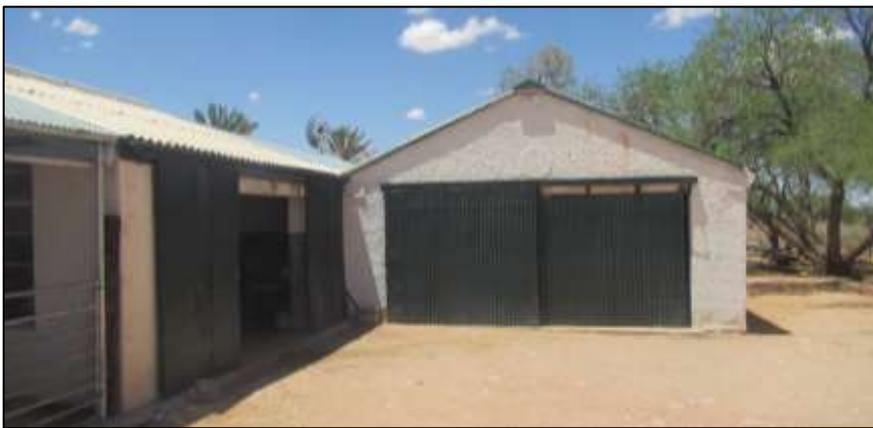
Figure 20: View of the barn with the '6 SEP 1945' inscription being on the raised cement circle above the doors.

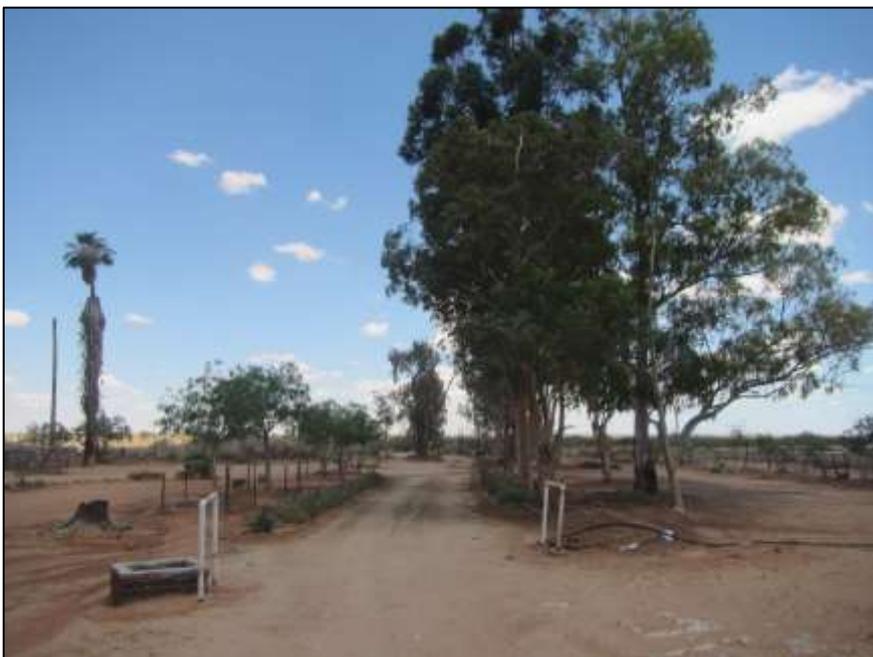
Figure 21: View down the driveway showing the gum and other trees.

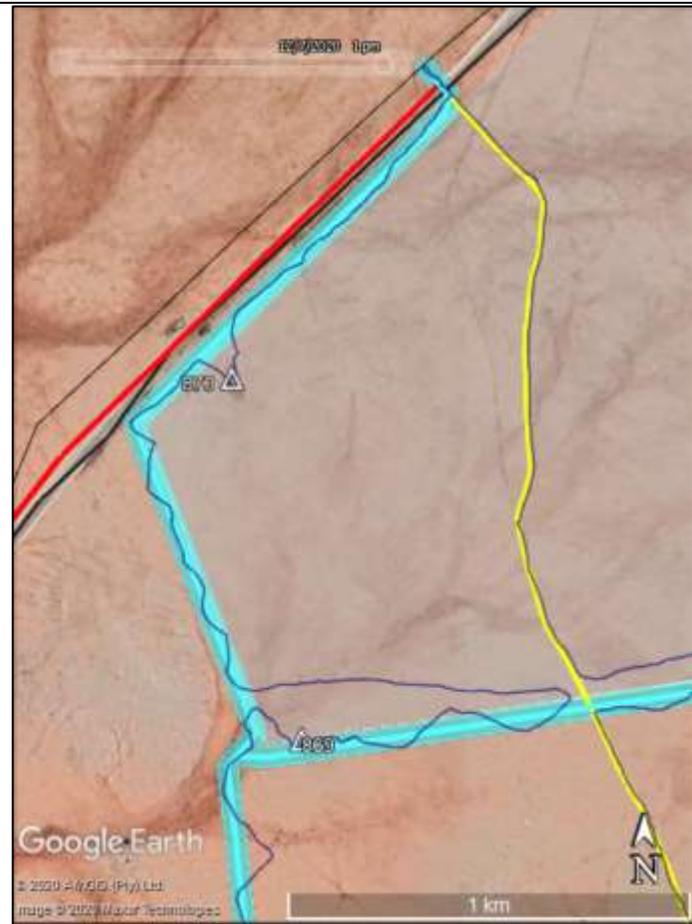
Sites in the northern part of the Option C corridor.
