NATIONAL ROUTE N11 SECTION 13

BIODIVERSITY IMPACT ASSESSMENT

Terrestrial and Aquatic Ecological Assessments for the Proposed Upgrade and Rehabilitation of the National Route N11 Section 13 from Mokopane (km 1,3) to the Groot Sandsloot River (km 24,0) in the Mogalakwena Local Municipality of the Waterberg District Municipality, Limpopo Province

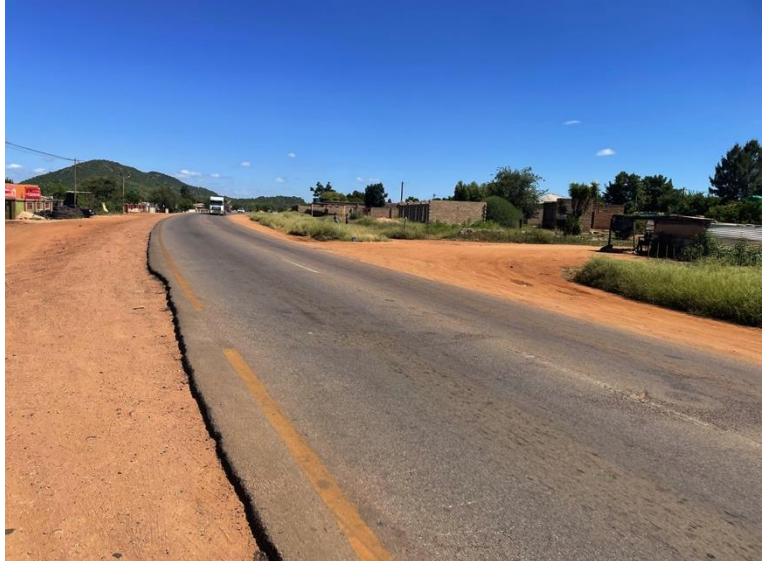
A photograph showing a paved road with a significant gap in the asphalt on the left shoulder, exposing the reddish-brown soil. The surrounding area is mostly bare with sparse, low-lying vegetation. In the background, there are some buildings and a hill under a clear blue sky.	<p>Study Site showing the lack of vegetation in the road reserve and the damaged and wash away edges of the road shoulder</p>

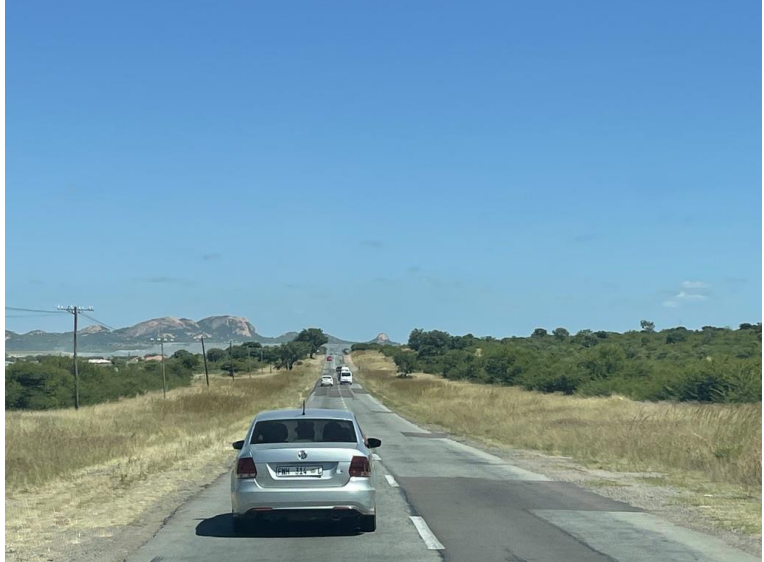
A photograph taken from a vehicle looking down a paved road. A white van is driving ahead in the same direction. The road is flanked by dry, sandy soil and very little vegetation. The sky is blue with a few white clouds. In the distance, there are low mountains.	<p>Study Site (N11 Sec 13) highlighting lack of vegetation in the road reserve, including trees and general bushveld</p>

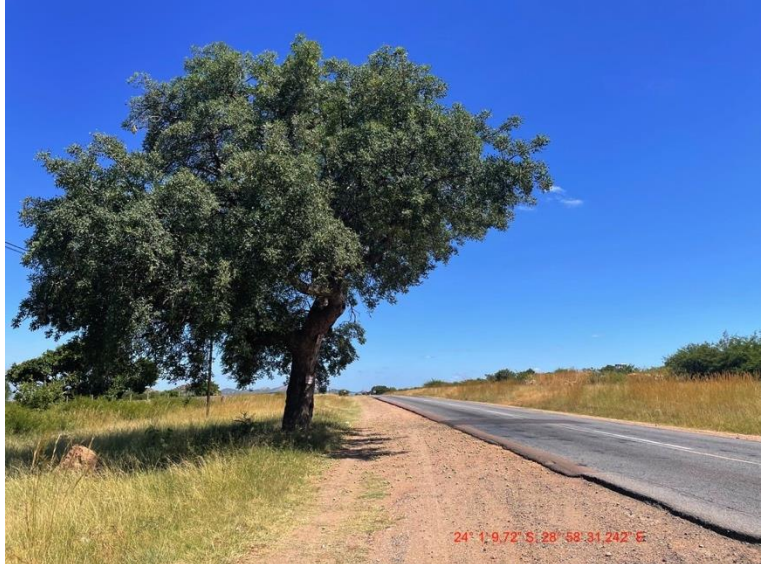
<p style="text-align: center; color: red; font-size: small;">24° 1' 9.72" S 28° 59' 31.242" E</p>	<p>Large marula tree growing close to the existing N11 Section 13. This tree will most likely need to be removed.</p>

There is one species of national protected tree within the study area, namely marula (*Sclerocarya birrea*). There are no provincially protected trees. The marula trees are scattered along the length of the study site within the road reserve. Removal of any of these trees will require a tree permit application and process through DFFE.

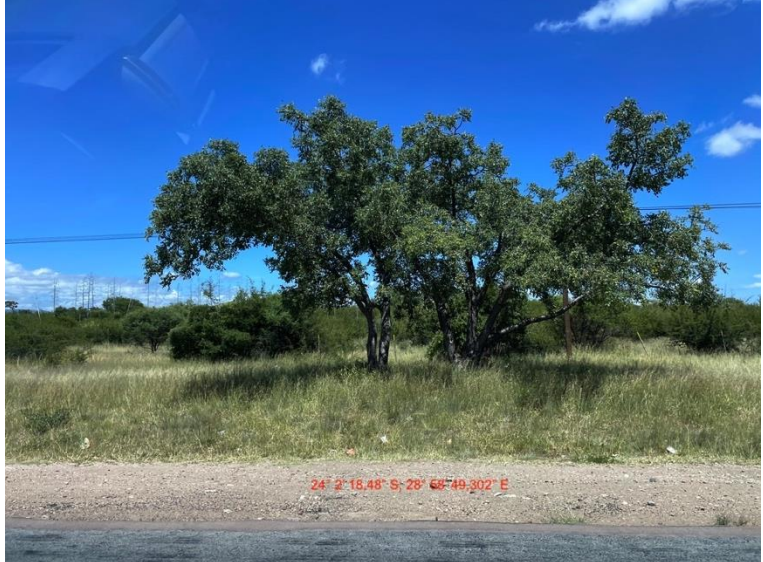
<p style="text-align: center; color: red; font-size: small;">24° 2' 18.48" S 28° 59' 49.302" E</p>	<p>A few small / medium marula trees growing along the outer edge of the road reserve. These trees might not need to be removed.</p>

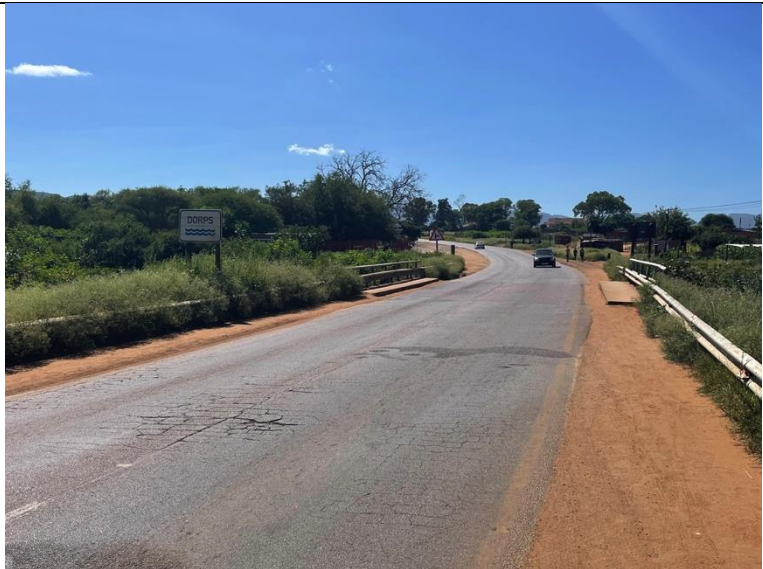
<p>Dorps River Bridge on the N11 (See R1 in Figure 8)</p>

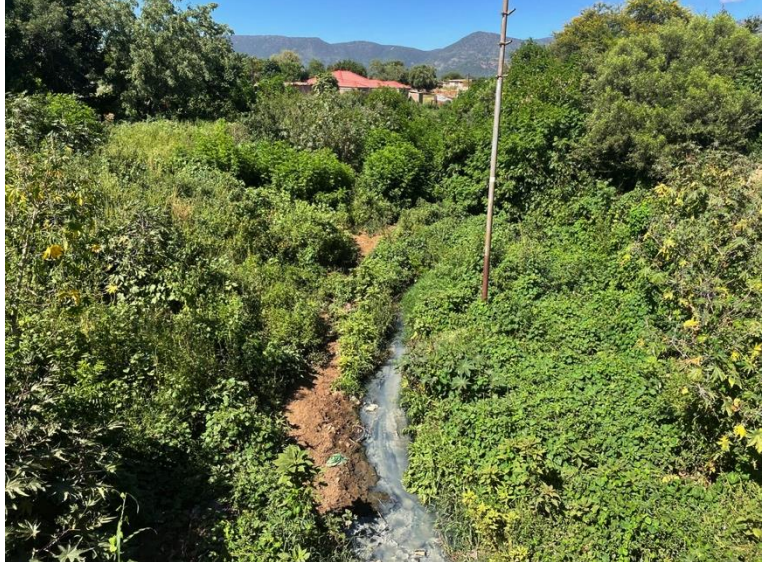
<p>Dorps River showing the small highly polluted narrow main channel and high levels of alien plant infestation. Most of the vegetation in picture is alien.</p> <p>During the time of the site visit the water was grey and smelly due to very high levels of raw sewage contamination</p>

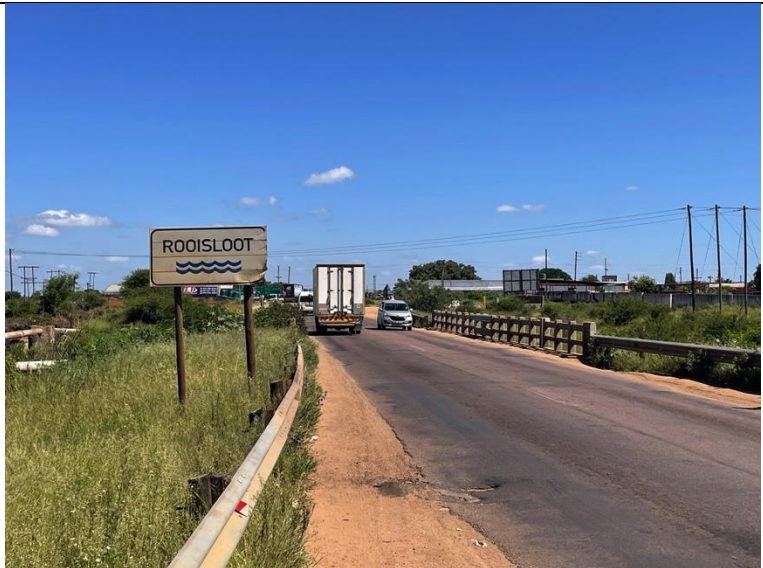
<p>Rooisloot Bridge on the N11 (see R2 in Figure 8)</p>

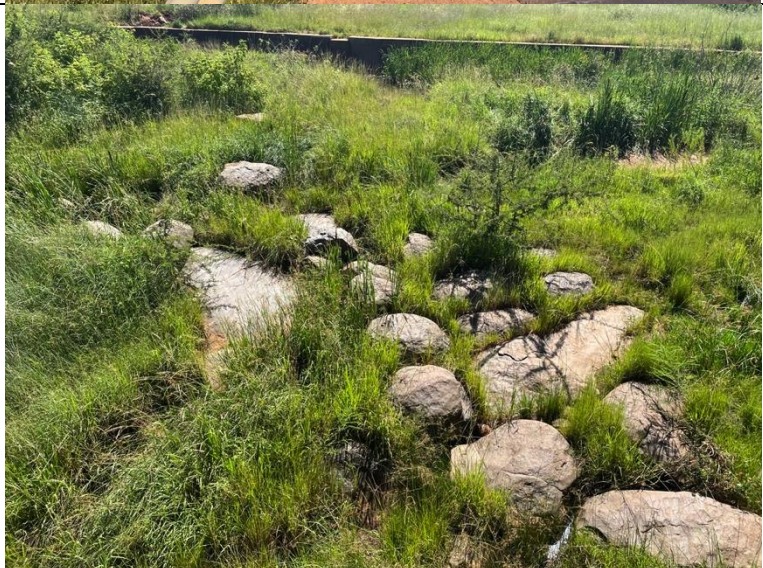
<p>Upstream of the Rooisloot with a narrow main channel. Notice the weir across the stream in the top of the picture</p>

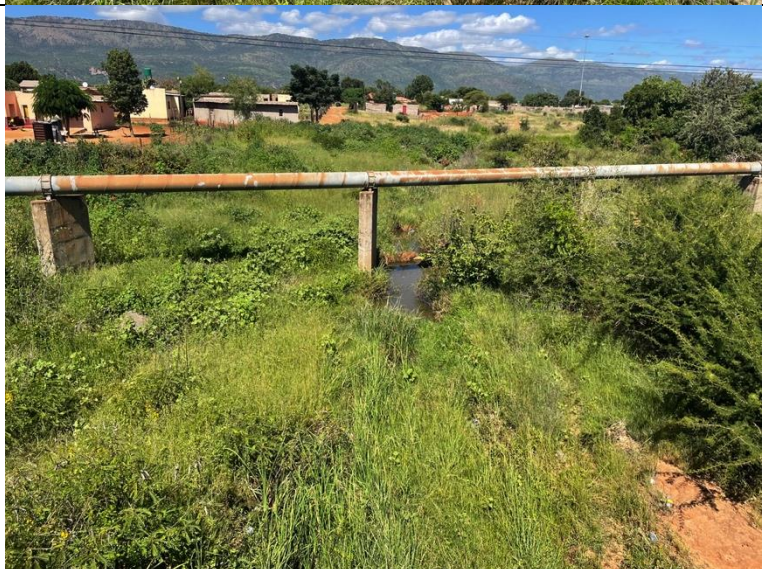
<p>Downstream of the Rooisloot. The stream is small with a fairly wide floodplain. The riparian vegetation is badly degraded with removal of resources by locals and infestation by alien invasive plants. The water was also polluted by did not have raw sewage running in it as in the case of the Dorps River (at the time of the site visit)</p>

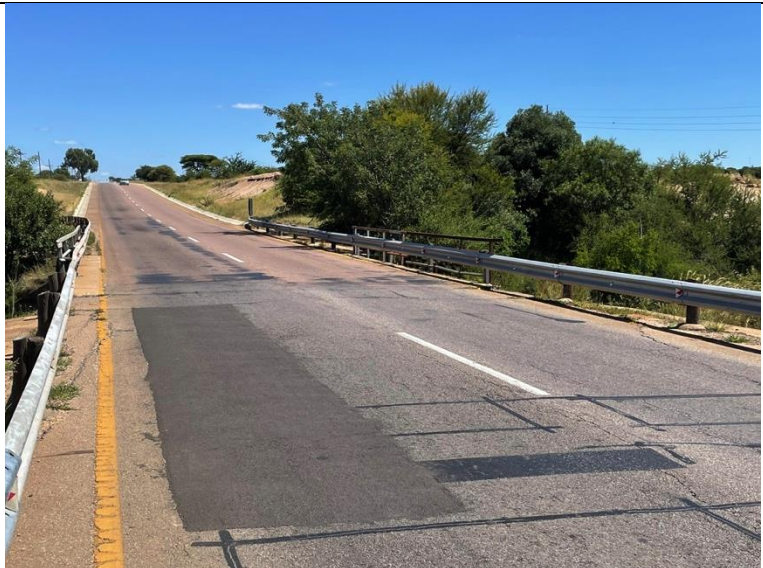
<p>Dithokeng Bridge on the N11 (see R3 in Figure 8)</p>
 	<p>The Dithokeng upstream of the N11. The flow was very low and stagnant during the site investigation, which was conducted after a lengthy period of above average rainfall. The stream has no distinctive riparian zone and moderately levels of alien plant infestation, compared to the Dorps and Rooisloot.</p>
 	<p>The Dithokeng immediately downstream of the N11. The flow was stagnant with small areas of ponding. The dominant small trees / shrubs in and along the river were indigenous, local thorn trees.</p>

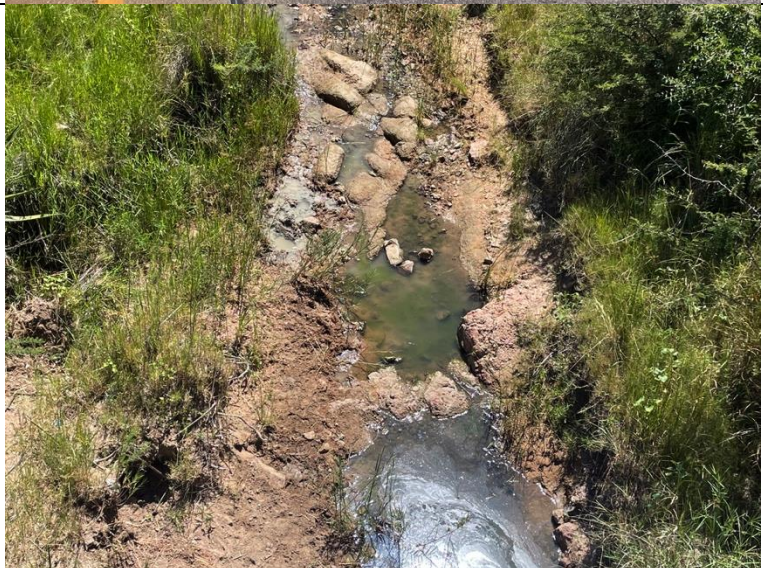
<p>Groot Sandsloot upstream of the bridge. The level of alien weed infestation is moderate to low and the water quality is much better than those of the first two river crossings. The stream is more rural with less built-up areas along its' course upstream.</p>

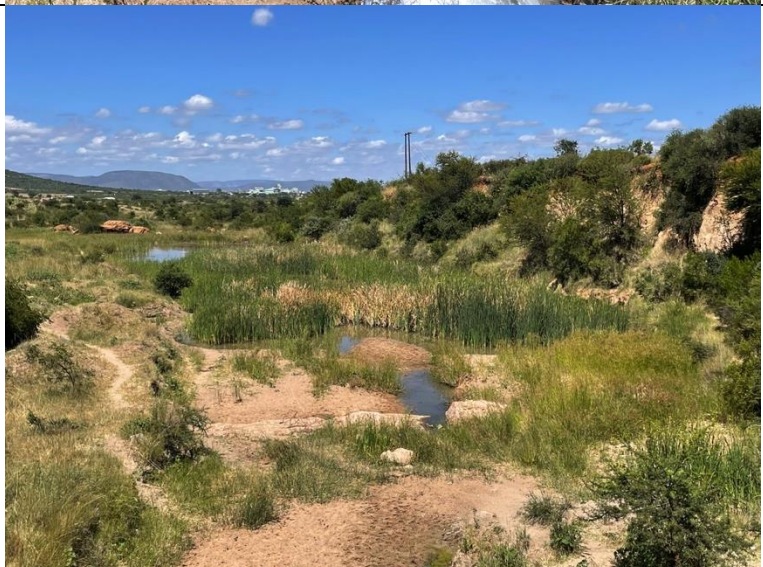
<p>Groot Sandsloot downstream of the bridge. The river has been badly altered by in-stream sand mining. The bulrushes and water ponding in the middle of the picture is the result of sand mining and not a natural feature</p>

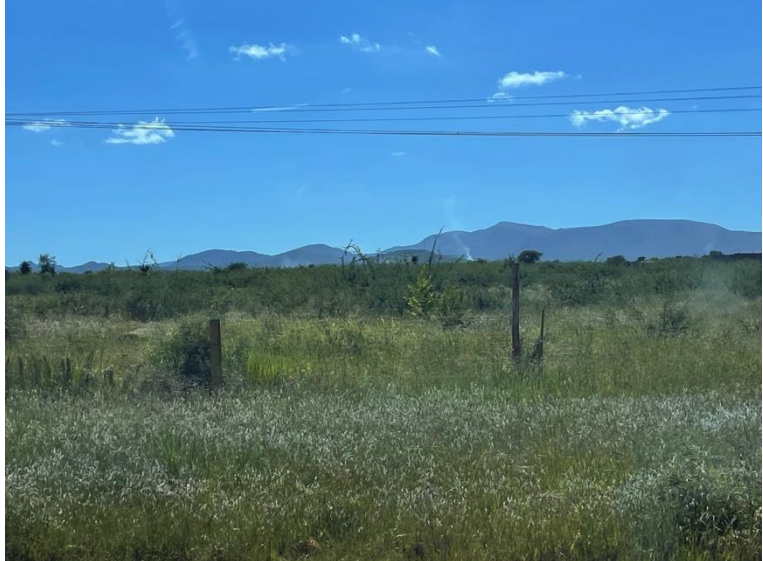
<p>Large flat area with heavy soils creating ideal conditions for thicker grass growth. This entire area has historically been heavily ploughed, cultivated and farmed. The area is not a watercourse as such. Present impacts include construction of houses and buildings in the area, and continued cultivation of the soils. There are a number of stormwater culverts under the road to facilitate free movement of surface water and avoid ponding. Looking east (See Figure 10)</p>

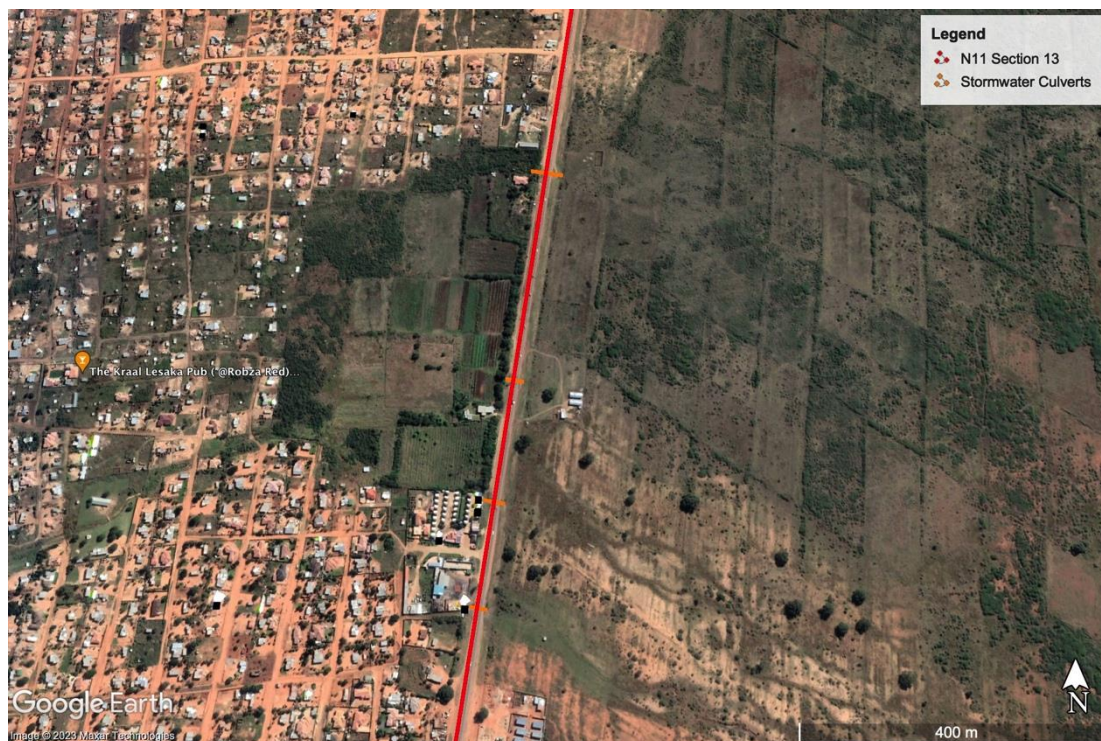
Figure 10: Large flat area with heavy soils near Mozombane Village

There is a large, very flat open plain near Mozombane Village. The area is between the Rooisloot and Dithokeng Streams (Figure 10). The area has heavier soils than surrounding areas and therefore surface stormwater remains longer in the area, creating ideal conditions for heavier plant growth. The area has historically been heavily and continually ploughed and cultivated because of these properties. Presently there are still numerous cultivated lands as well as large-scale development of houses and other structures in this area. This may lead to flooding during periods of high rainfall. There are numerous stormwater culverts under the N11 road to facilitate the free movement of surface stormwater and to prevent ponding. The area is not seen as a watercourse and was therefore not delineated.

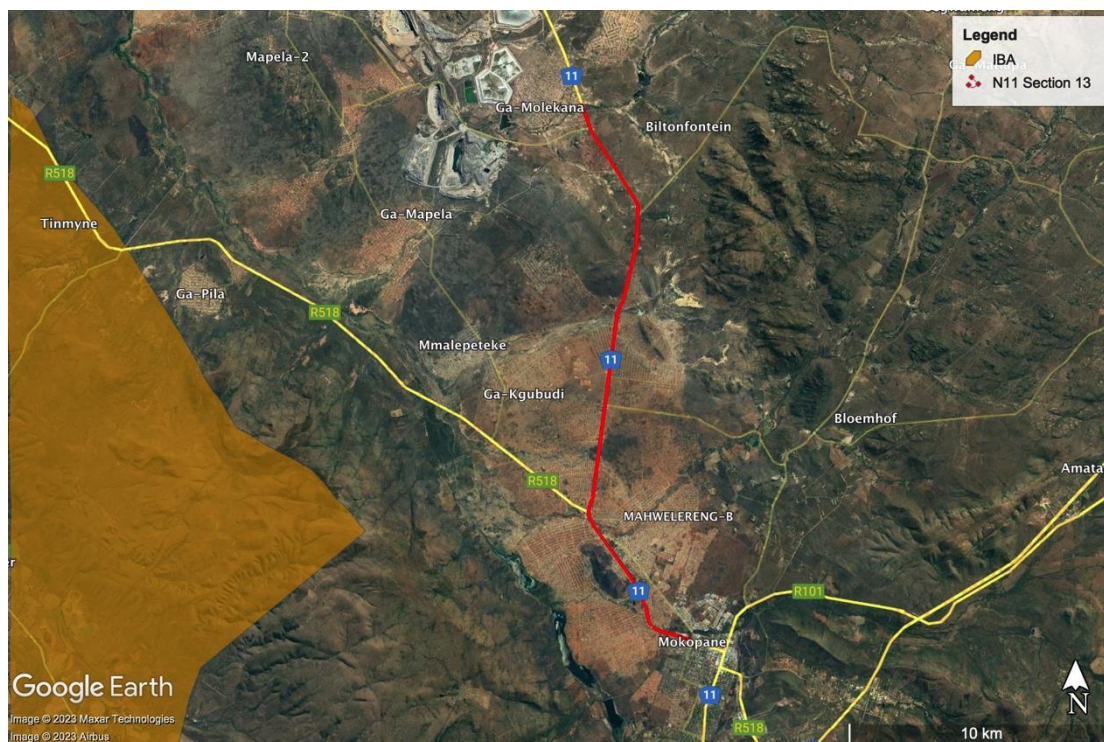
Figure 14: Important Bird Areas (IBAs)

The study area is not situated within an Important Bird Area (IBA). The closest IBA is the Waterberg System that includes the Waterberg Mountains and Nylsvley. The Waterberg IBA is located at varying distances of between 10km and 17km west of the study site (Figure 14). A number of birds common to the region were seen during field investigations included: laughing dove (*Streptopelia senegalensis*), cape turtle dove (*Streptopelia capicola*), hadeda ibis (*Bostrychia hagedash*), dark-capped bulbul (*Pycnonotus*

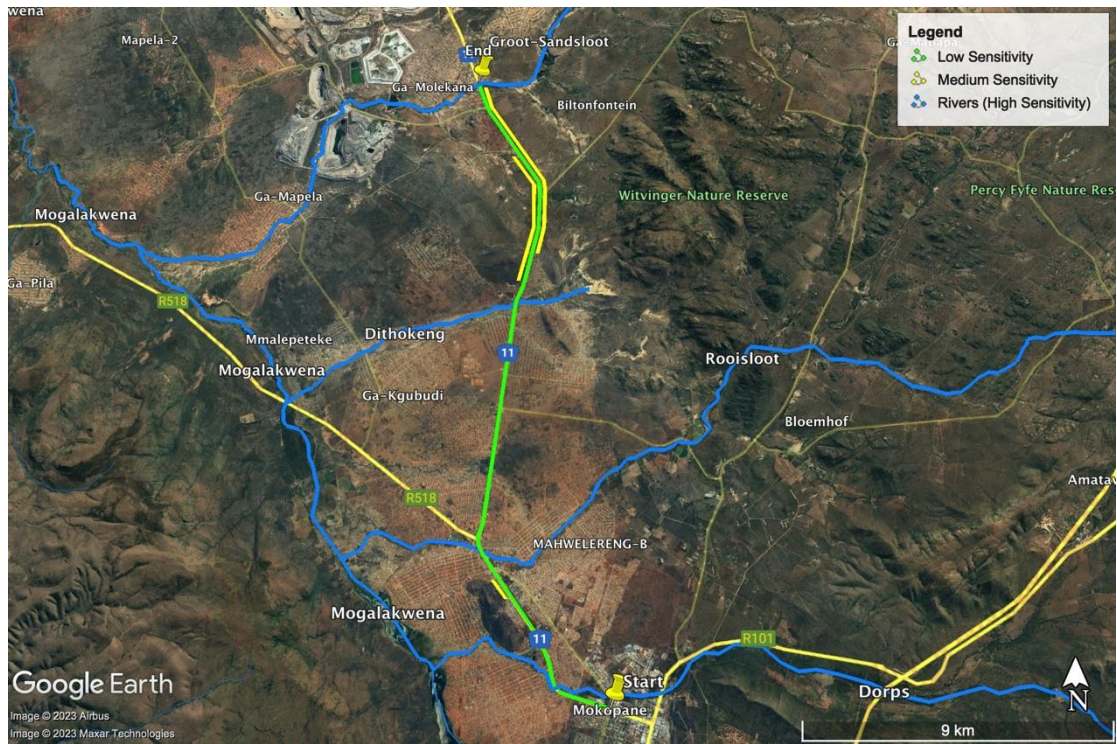
Figure 20: Sensitivity Map

The biodiversity sensitivity for the entire study site (road and road reserve) is 'Low'. The rivers have a sensitivity of 'High' and therefore so do the crossings (bridges). There are a few areas marked as 'Medium'. These are areas outside of the study site but adjacent to it and include some open bushveld in the north (which also includes the demarcated Witvinger Nature Reserve); and the inselberg in the south (west of the N11) (Figure 20).

The biodiversity sensitivity for the entire study site (road and road reserve) is 'Low'. The rivers have a sensitivity of 'High' and therefore so do the crossings (bridges). There are a few areas marked as 'Medium'. These are areas outside of the study site but adjacent to it and include some open bushveld in the north (which also includes the demarcated Witvinger Nature Reserve); and the inselberg in the south (west of the N11). The second map shows the the area in black and white to better highlight the demarcated sensitivities of the study site and adjacent areas.

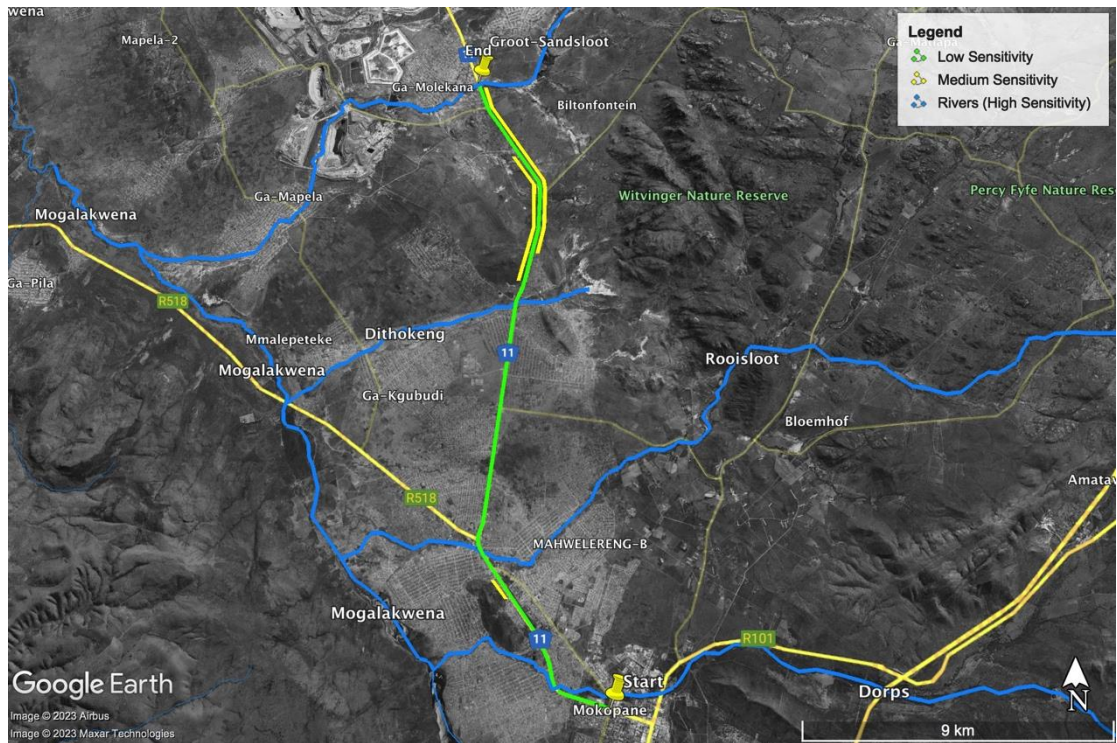
Figure 21: Sensitivity Map (B&W)

Figure 21 shows the area in black and white to better highlight the demarcated sensitivities of the study site and adjacent areas.
