# ESKOM CUPRUM BESS

## AQUATIC SITE SENSITIVITY VERIFICATION AND COMPLIANCE STATEMENT

SITE SENSITIVITY VERIFICATION (AQUATIC COMPONENT) FOR  
THE PROPOSED DEVELOPMENT OF A BATTERY ENERGY  
STORAGE SYSTEM (BESS) AND ASSOCIATED INFRASTRUCTURE  
AT THE CUPRUM SUBSTATION LOCATED WITHIN COPPERTON,  
NEAR THE TOWN OF PRIESKA, NORTHERN CAPE PROVINCE

DATE: JULY 2021

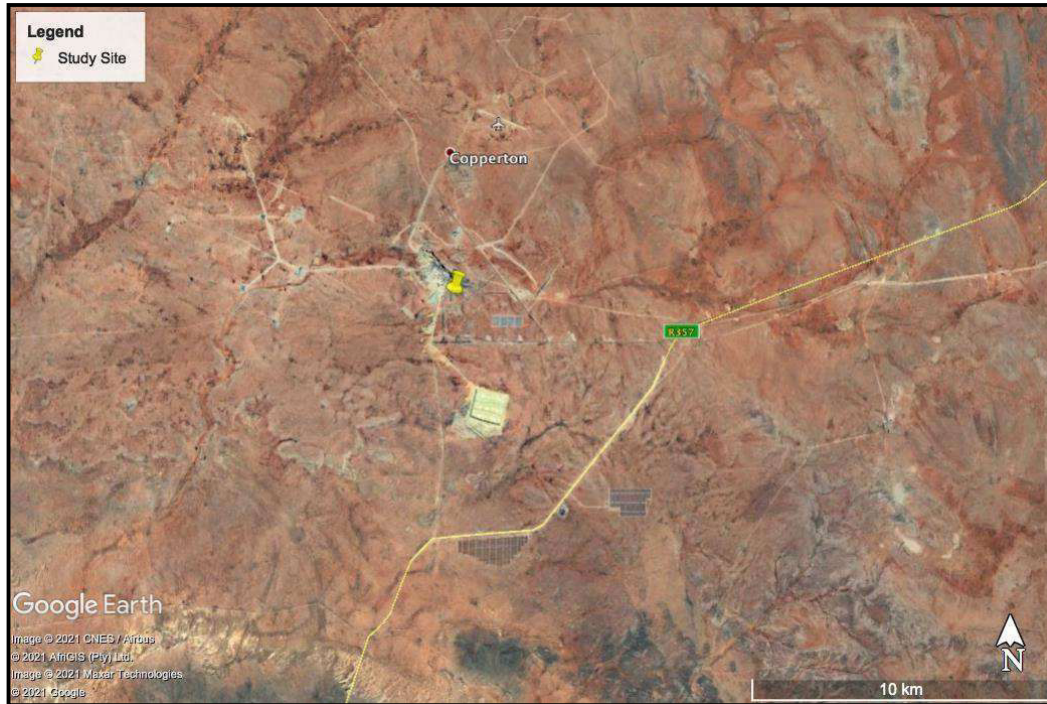
Figure 1: Site location

The study site is located at the existing Eskom Cuprum Substation. The study site is at Copperton, which is north of the R357 and approximately 54km southwest of the Town of Prieska. The site is within the Siyathemba Local Municipality of the Pixley ka Seme District Municipality, Northern Cape Province (**Figure 1, Figure 2**).

- Study Site (Approximate center): 29°57'37.95"S; 22°18'0.80"E.
- Eskom Cuprum Substation: 29°57'33.44"S; 22°18'1.08"E.
- Quarter Degree Square (QDS): 2922CD.
- Quaternary Drainage Area (QDA): D54D.

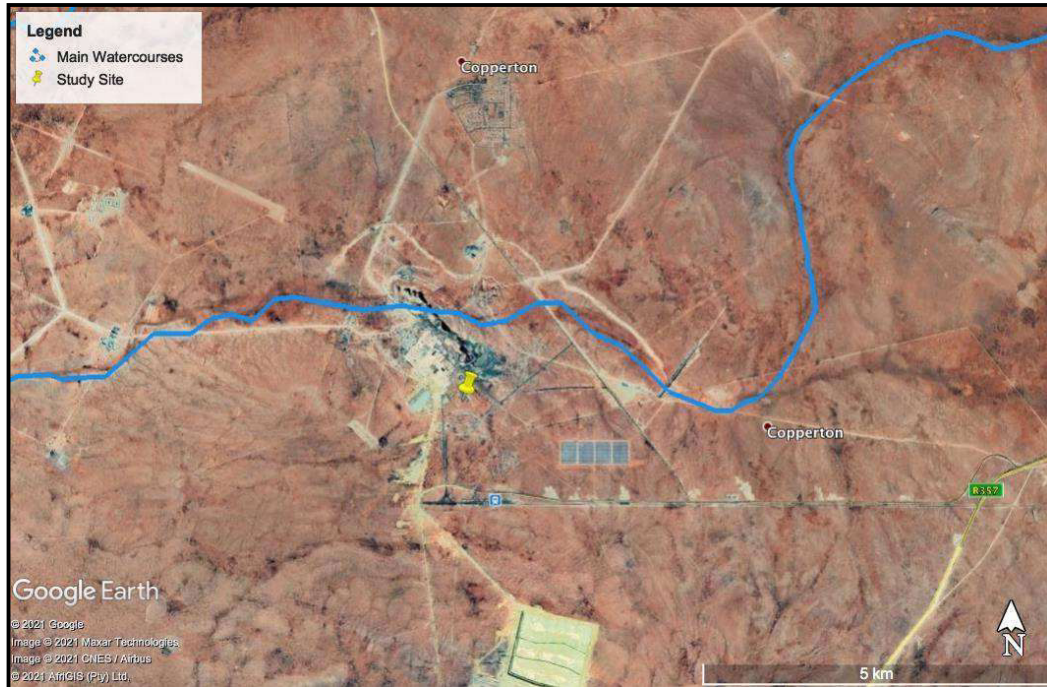
Figure 6: Main Watercourses in the area

Bastersput-se-Leegte is the closest stream / river to the site, which is approximately 1,2km north of study site. The 'river' is non-perennial, highly ephemeral in nature, and dry for most of the year and almost never flows from end-to-end. Baster-se-Leegte 'flows' from east to west and has been totally destroyed and cut off where it flows through the mining area in Copperton (Figure 6). Approximately 200m to 250m west and north of the study site are markings of stormwater surface waterflow (sheet flow) over the years. These have created notable white markings, along with dolomitic soils and geology, but are not distinctive watercourses and alter depending on various factors such as construction of roads, houses or mining in the area, such as found north of the site.

According to NFEPA (National Freshwater Ecosystem Priority Areas) maps and datasets ([www.bgis.sanbi.org](http://www.bgis.sanbi.org)) and National Wetland Map 5 (2018), there are no NFEPA watercourses in the study site, with the closest one being the non-perennial and highly ephemeral river, Bastersput-se-Leegte, which is north of the study site (Figure 6).

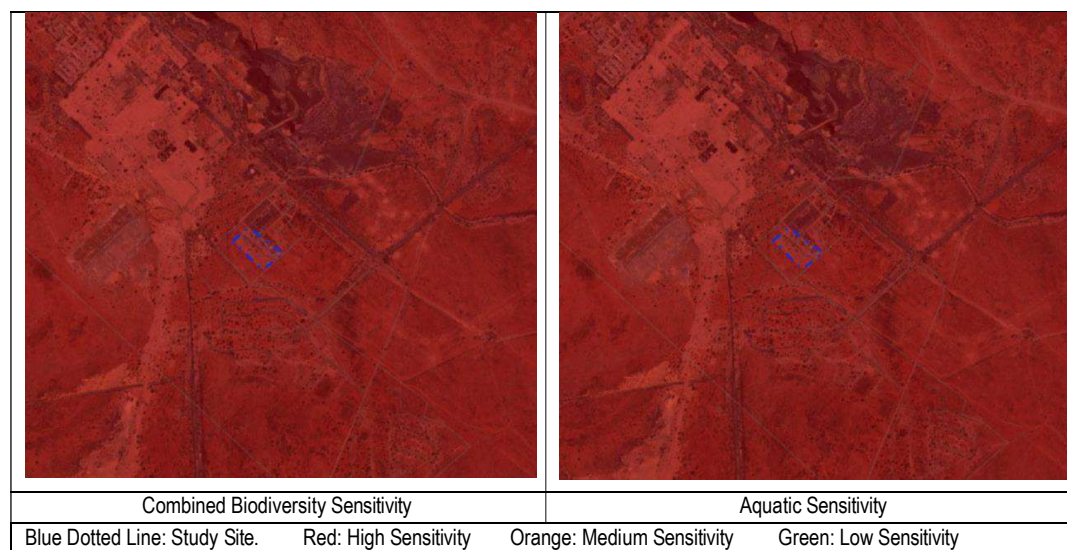
**Figure 7: DFFE Screening Tool Sensitivities**

- Aquatic biodiversity combined sensitivity: Very High.
- Terrestrial biodiversity combined sensitivity: Very High.

Figure 7, below, shows the maps as taken from the Screening Tool assessment.

- Aquatic biodiversity combined sensitivity: Low.
- Terrestrial biodiversity combined sensitivity: Low.

During ground-truthing the study area and immediate surrounding area was found to have an Aquatic Sensitivity of 'Low', and not as shown by the DFFE Screening Tool. The study site and local area are within an arid region, and therefore any watercourses or surface water systems present are viewed as sensitive. However, there are no watercourses within the study site or within a 500m radius of the outer boundaries of the site and therefore it is unclear why the DFFE screening tool assessment would show this area has sensitive in terms of the aquatic component.

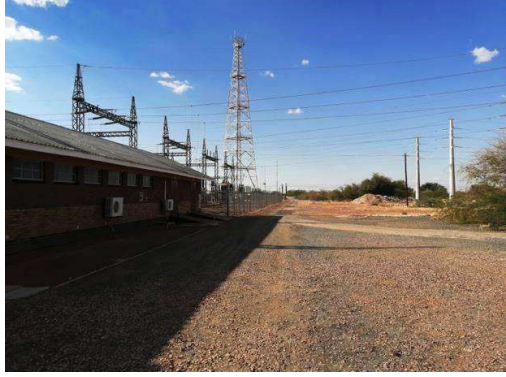
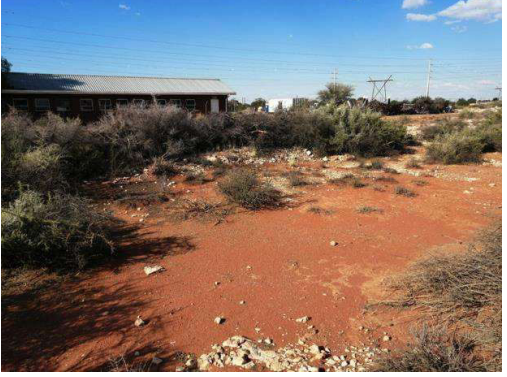
Buildings, power lines and other infrastructure at the substation and study site	Proposed area for the development south of the substation. Notice lack of grass cover, scattered shrubs and general aridness of the site

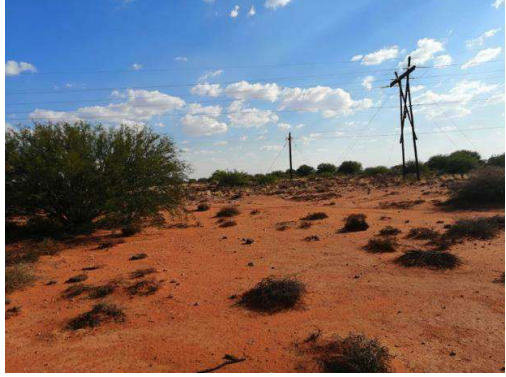
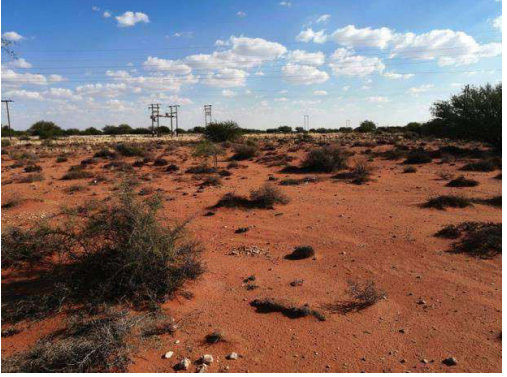
Study Site. Arid area with poor grass cover, lack of trees and scattered shrubs and forbs. The large shrub in left of picture is <i>Senegalia Mellifera</i>	Study site from another angle. <i>Pentzia spinescens</i> is the low spiny shrub in the foreground, which is common to the area

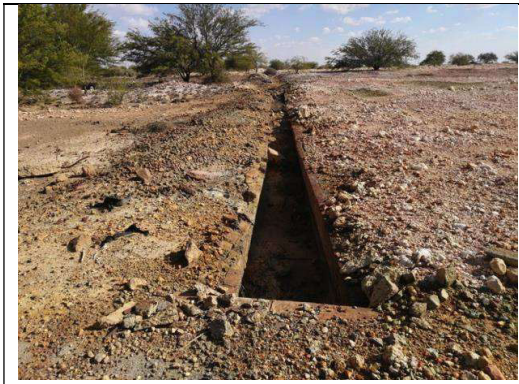
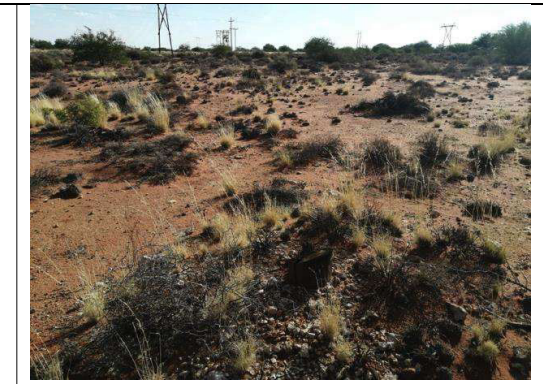
<p>Existing disturbances west of the substation, which is to be expected in a substation environment</p>	<p>Some white grasses (<i>Stipagrostis</i> spp) in the study area common to the arid regions of the Northern Cape</p>

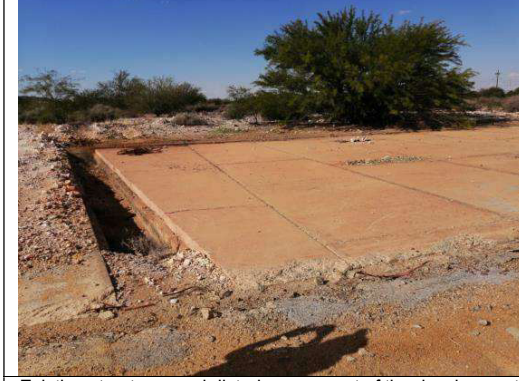
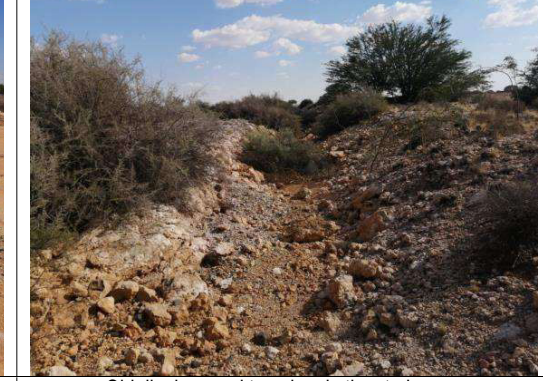
<p>Existing structures and disturbances west of the development</p>	<p>Old diggings and trenches in the study area</p>

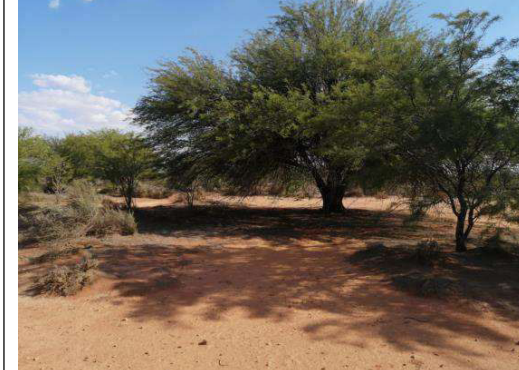
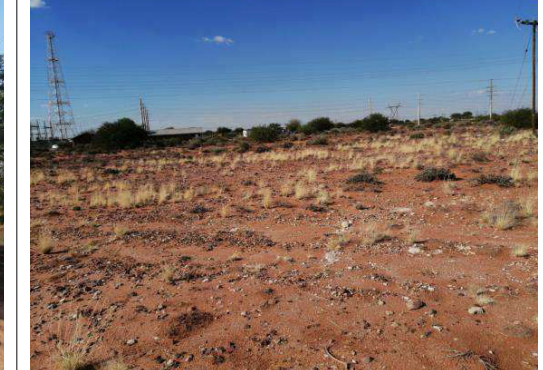
<p>A few scattered sweet thorn <i>Vachellia</i> (<i>Acacia</i>) <i>karoo</i> trees are found in the immediate area of the study site</p>	<p>Study Site and proposed area for the BESS setup, looking towards the Substation</p>
