Report to Vuba Imagineers on the Results of a Geotechnical Investigation for the Proposed Gumede Bridge Located in Ward 16 within the Umdoni Municipality, KwaZulu-Natal

Reference: 086-20.R01 Revision 0

Dated: 17 June 2020

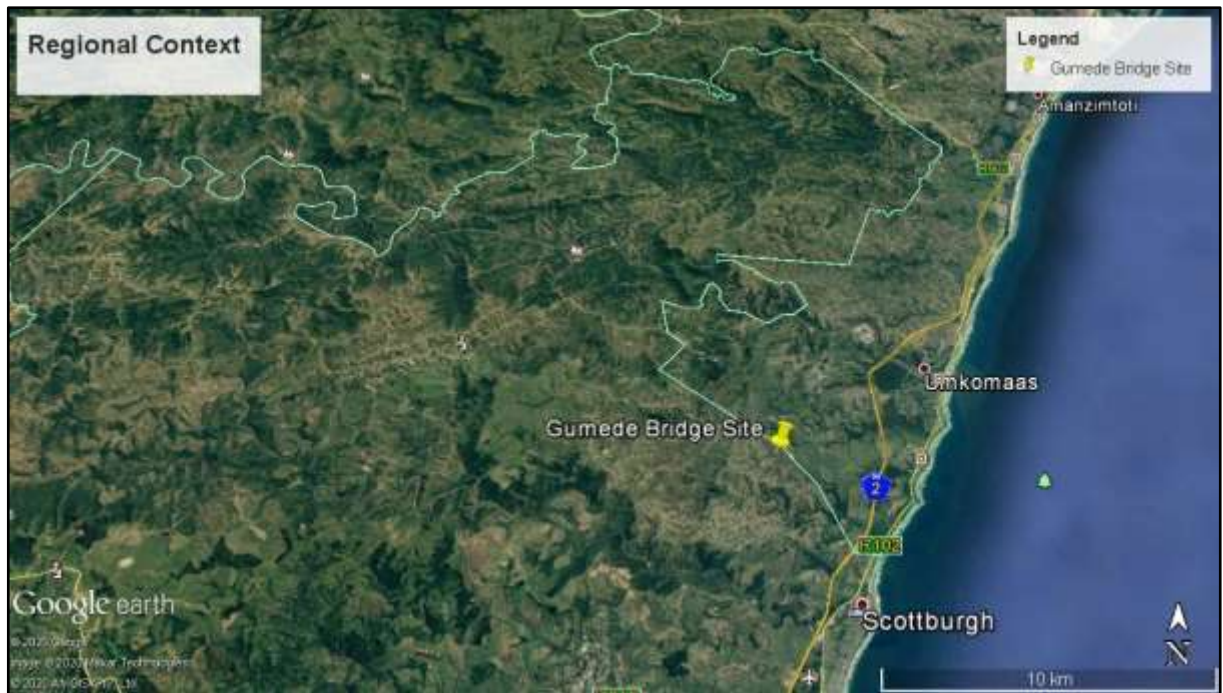
Plate 1: Plan showing the regional context of the site (satellite imagery sourced from Google Earth: 2020)

The regional and local contexts of the site are shown in Plate 1 and Plate 2, respectively. A General view across the site is shown in Plate 3 and Plate 4.

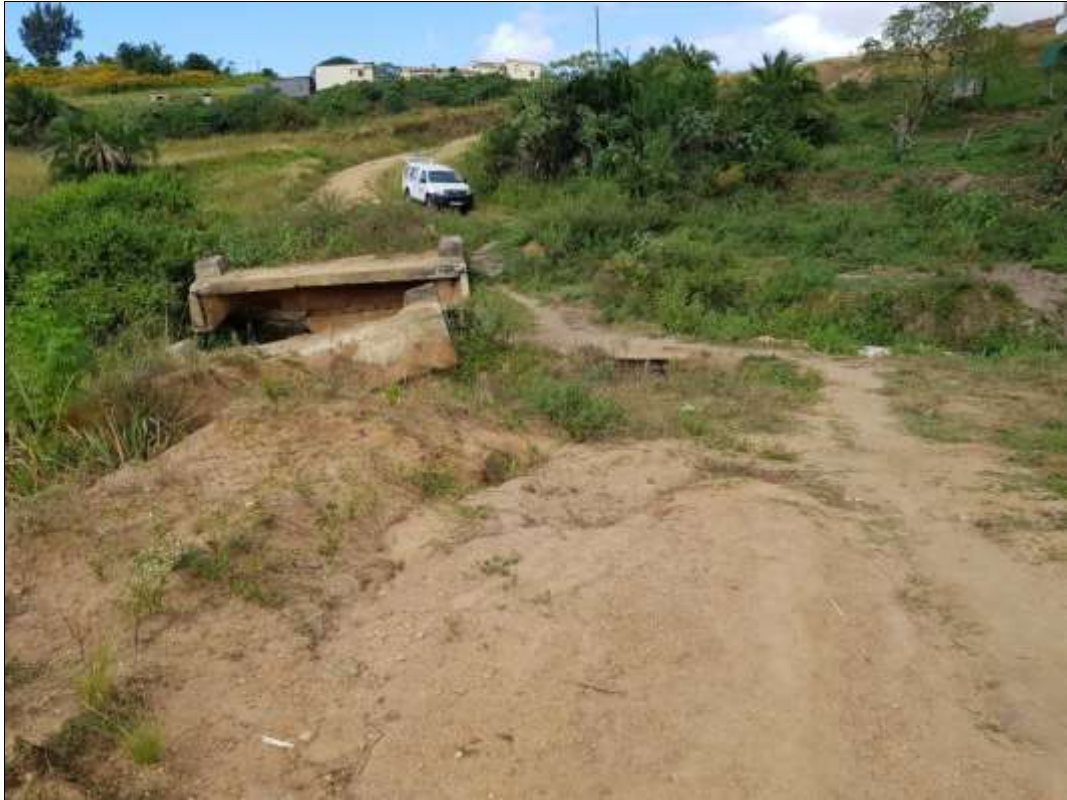
Plate 3: General view across the site viewing in a southerly direction. Note collapsed bridge.

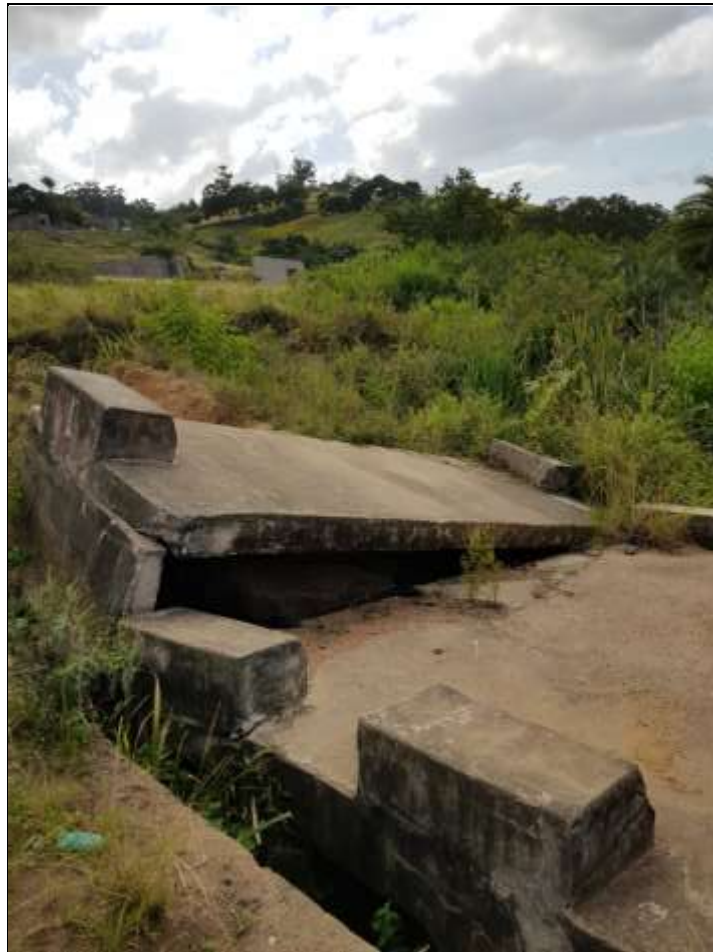
Plate 4: General view of collapsed concrete river bridge
