*Geotechnical Reconnaissance Study for  
Proposed Soyuz 4 Solar PV Park Solar  
Energy Facility near Britstown, Northern  
Cape.*

GEOSS Report No: 2023/02-26

*20 February 2023*

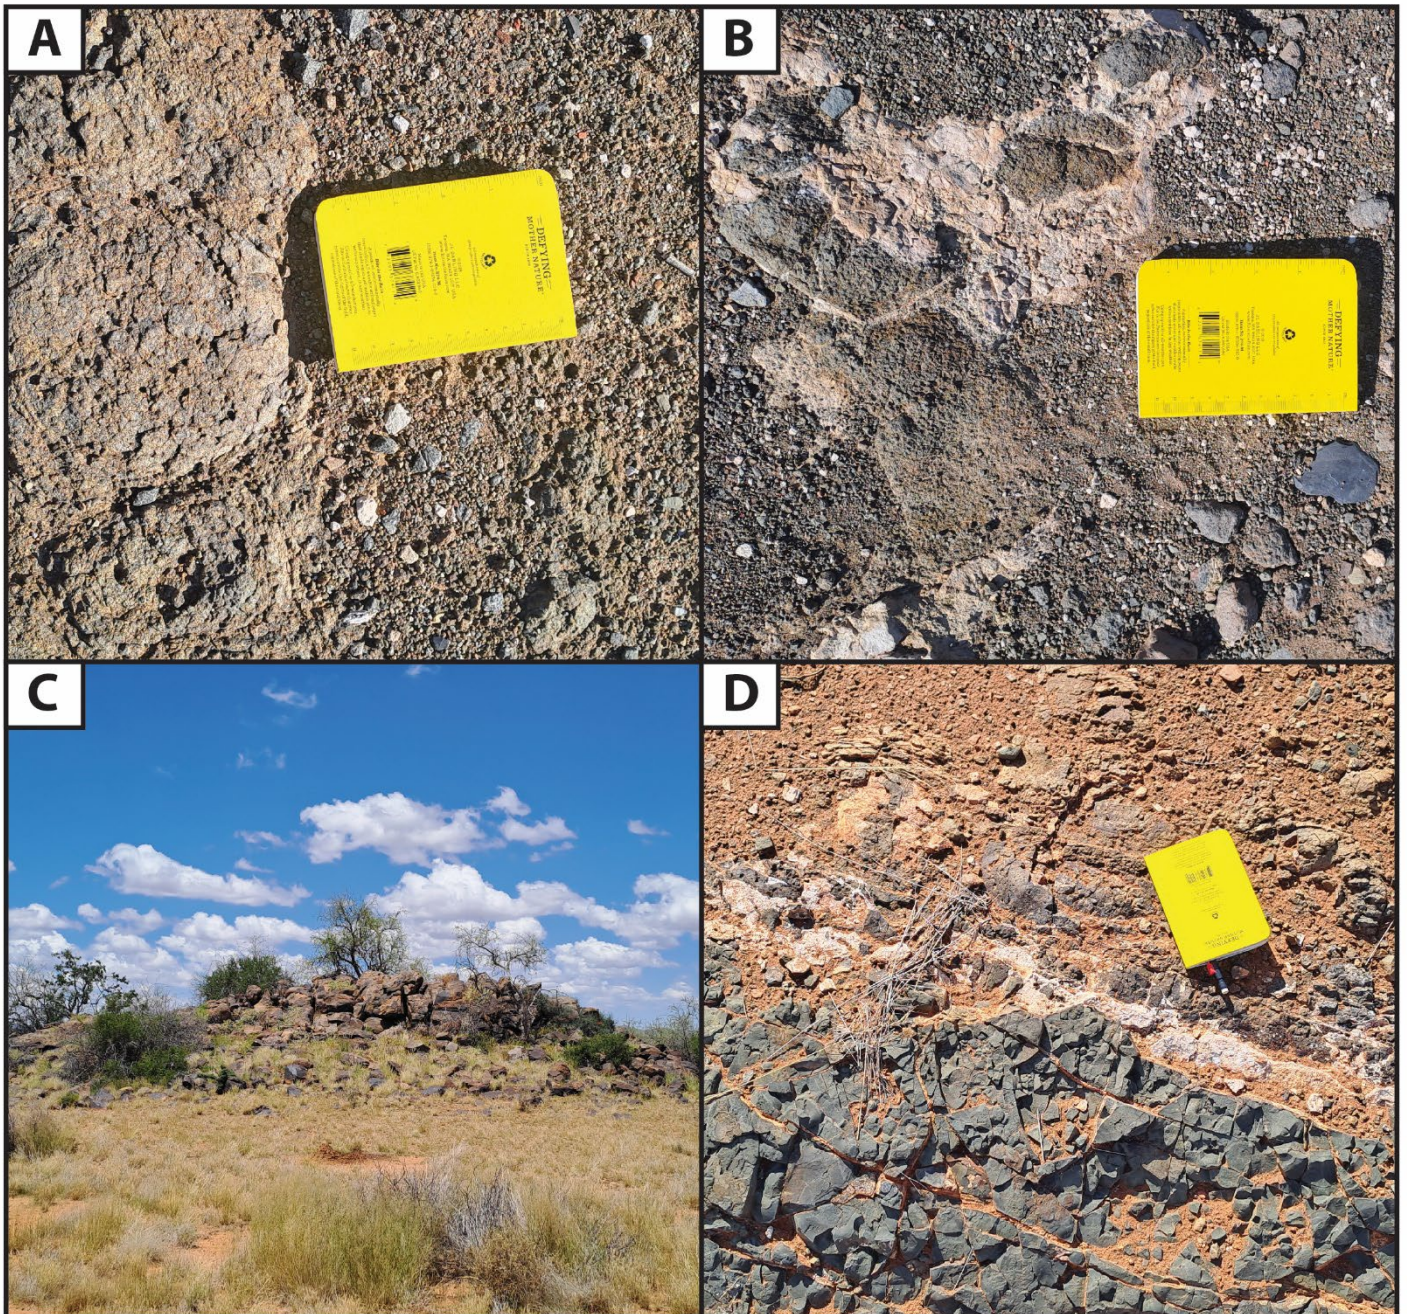
*Figure 14: Mosaic highlighting main features of Geotechnical Zone B. (A) shows outcrop of weathered dolerites at natural ground level. (B) shows outcrop of weathered dolerites with calcrete precipitating in fractures at natural ground level. (C) shows typical topographic high formed from a moderately weathered dolerite stock. (D) image showing contact between Tierberg Formation Shales and weathered dolerite. Note the slight baked texture in the shales in direct contact with the dolerites.*
