**HERITAGE IMPACT ASSESSMENT: PROPOSED ESIZAYO 132KV
TRANSMISSION INTEGRATION PROJECT, ON FARMS
STANDVASTIGHEID 210 REMAINDER
AND AURORA 285, WESTERN AND NORTHERN CAPE**

(Assessment conducted under Section 38 (8) of the National Heritage Resources Act (No. 25 of 1999) as part of a Basic Assessment)

Final Report: 1 December 2021

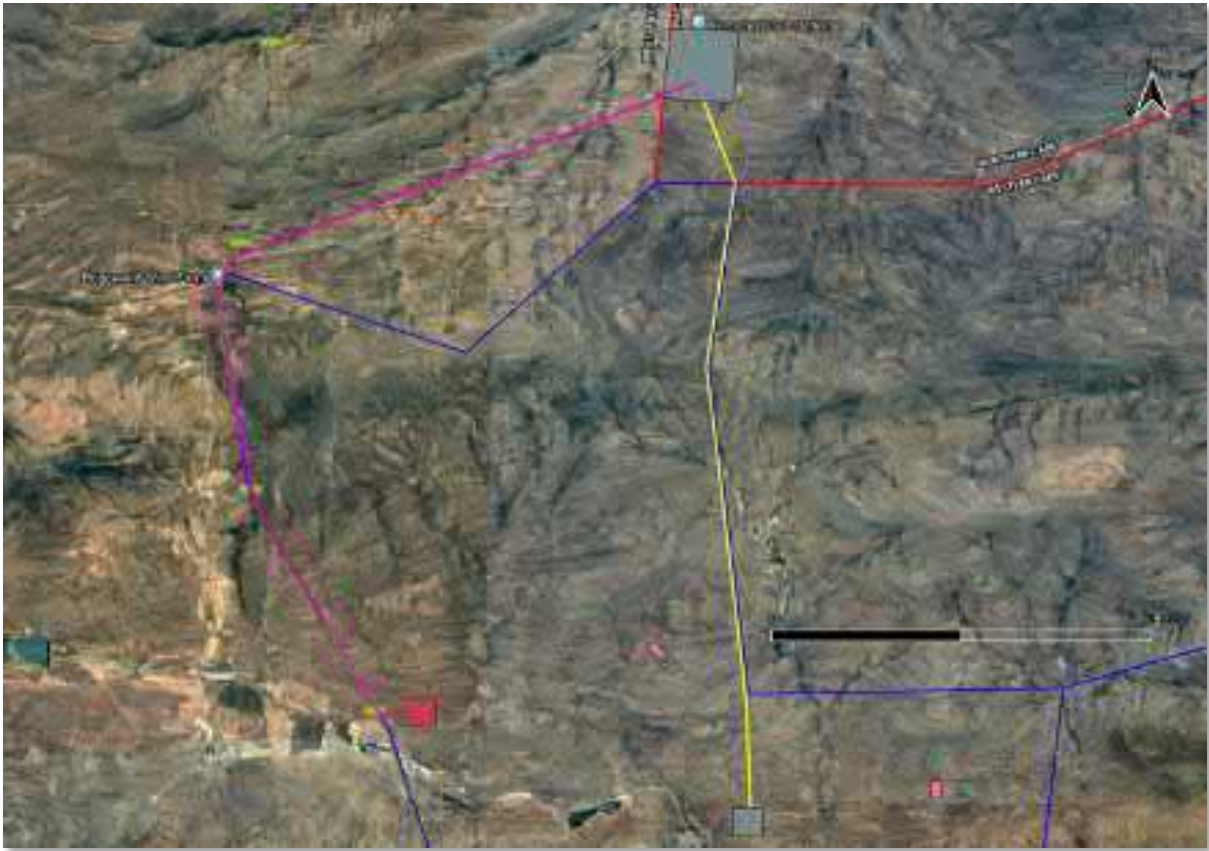
The OHL will connect the Esizayo WEF to the national grid via the existing Eskom Komsberg substation. The powerline is routed north from the approved substation on the farm Aurora 285, parallel to the boundary with the farm Aanstoot 72, to connect to the Komsberg substation situated on the farm Standvastigheid 210 Remainder (Figure 5).

The OHL will consist of steel single or double structures with kingbird conductor, between 15 and 20m above ground level. Standard overhead line construction methodology will be employed and will include drill holes (typically 2 – 3m in depth), plant poles and a string conductor. It is not envisaged that any large excavations and stabilized backfill will be

Figure 5: Comparison of the authorised (purple line) and proposed OHL route alignments (yellow line) for the Esizayo WEF (Source: Google Earth).

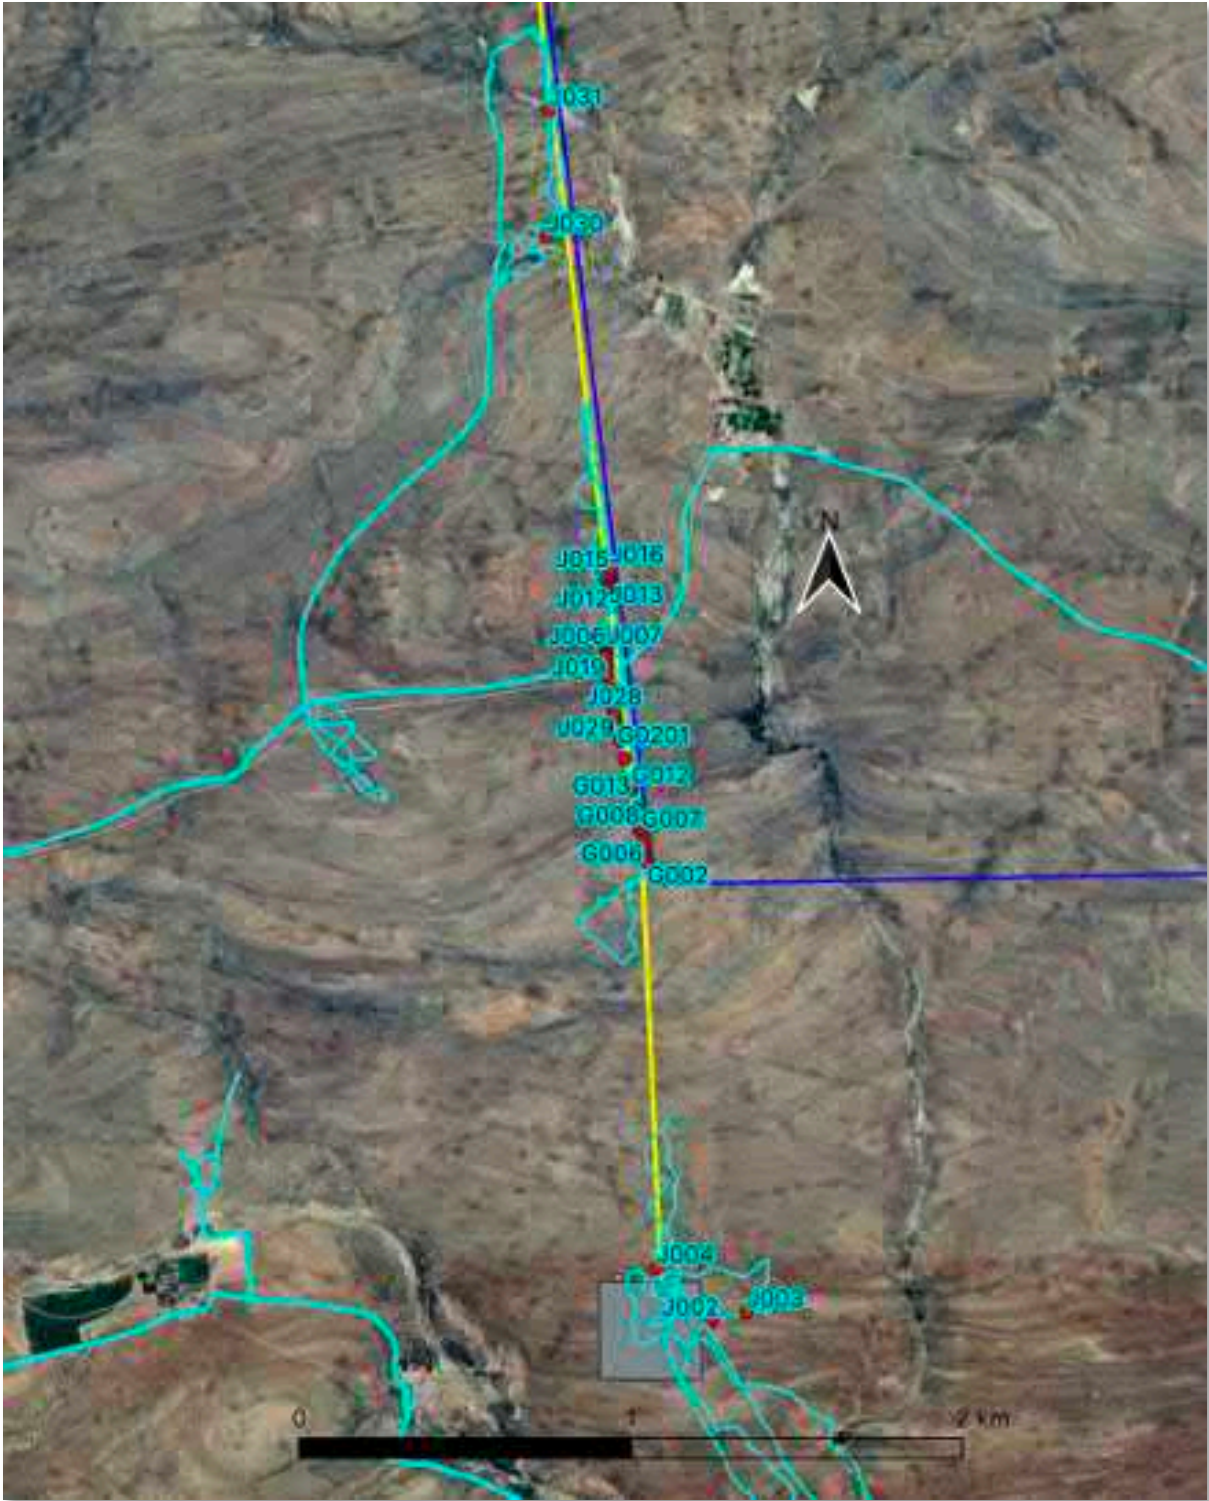
Figure 6: Trackplots (pale blue lines) and positions of heritage resources recorded during the recorded during the 2021 survey of the proposed new OHL route (Source: Google Earth).

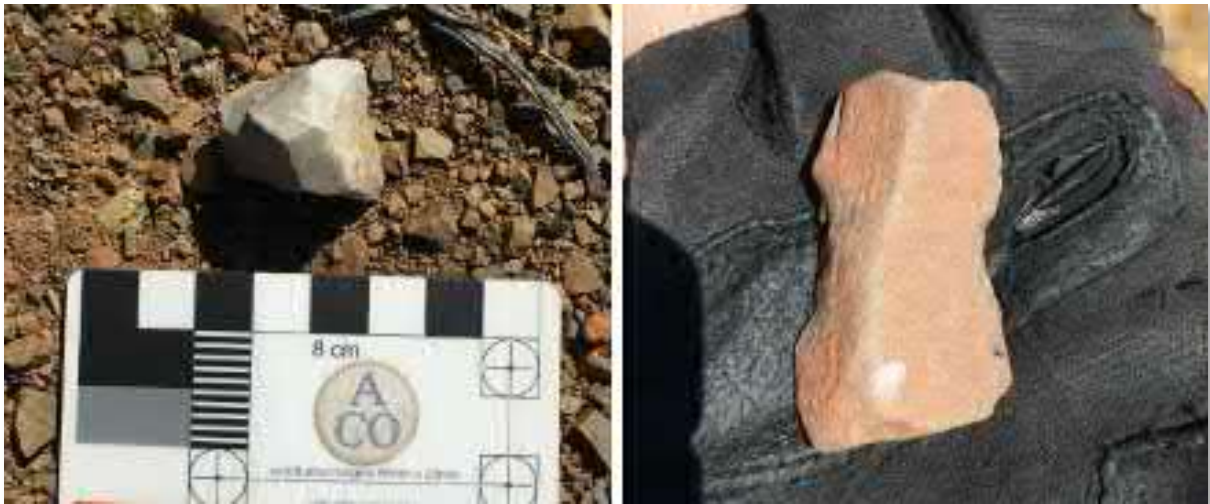
Plate 1: J002, a LSA chert core and J004, an extremely worn and patinated MSA flake (Photo: J Gribble).

Based on the walkover survey of the OHL, very little archaeological material and no archaeological sites have been identified on the route. The material that was identified has been assessed to be of very low significance and has been assigned a grading of Not Conservation Worthy. Should this material be damaged or destroyed during the construction of the OHL the loss to heritage will not be significant.

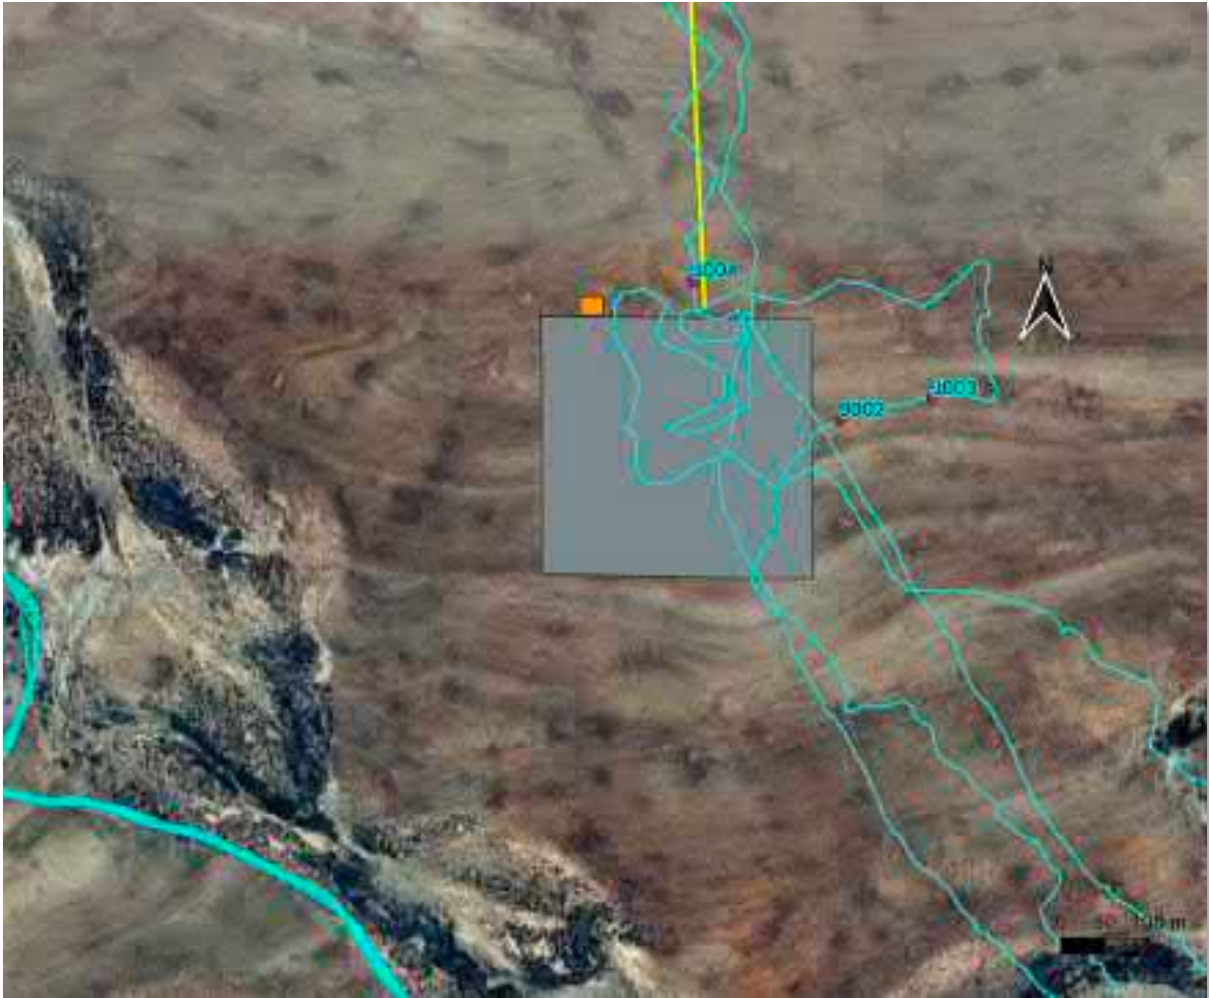
Figure 8: Locations of the three isolated stone artefacts dating to the Middle and Later Stone Ages (J002-J004) recorded north and east of the WEF substation during the 2021 OHL field survey (Source: Google Earth).

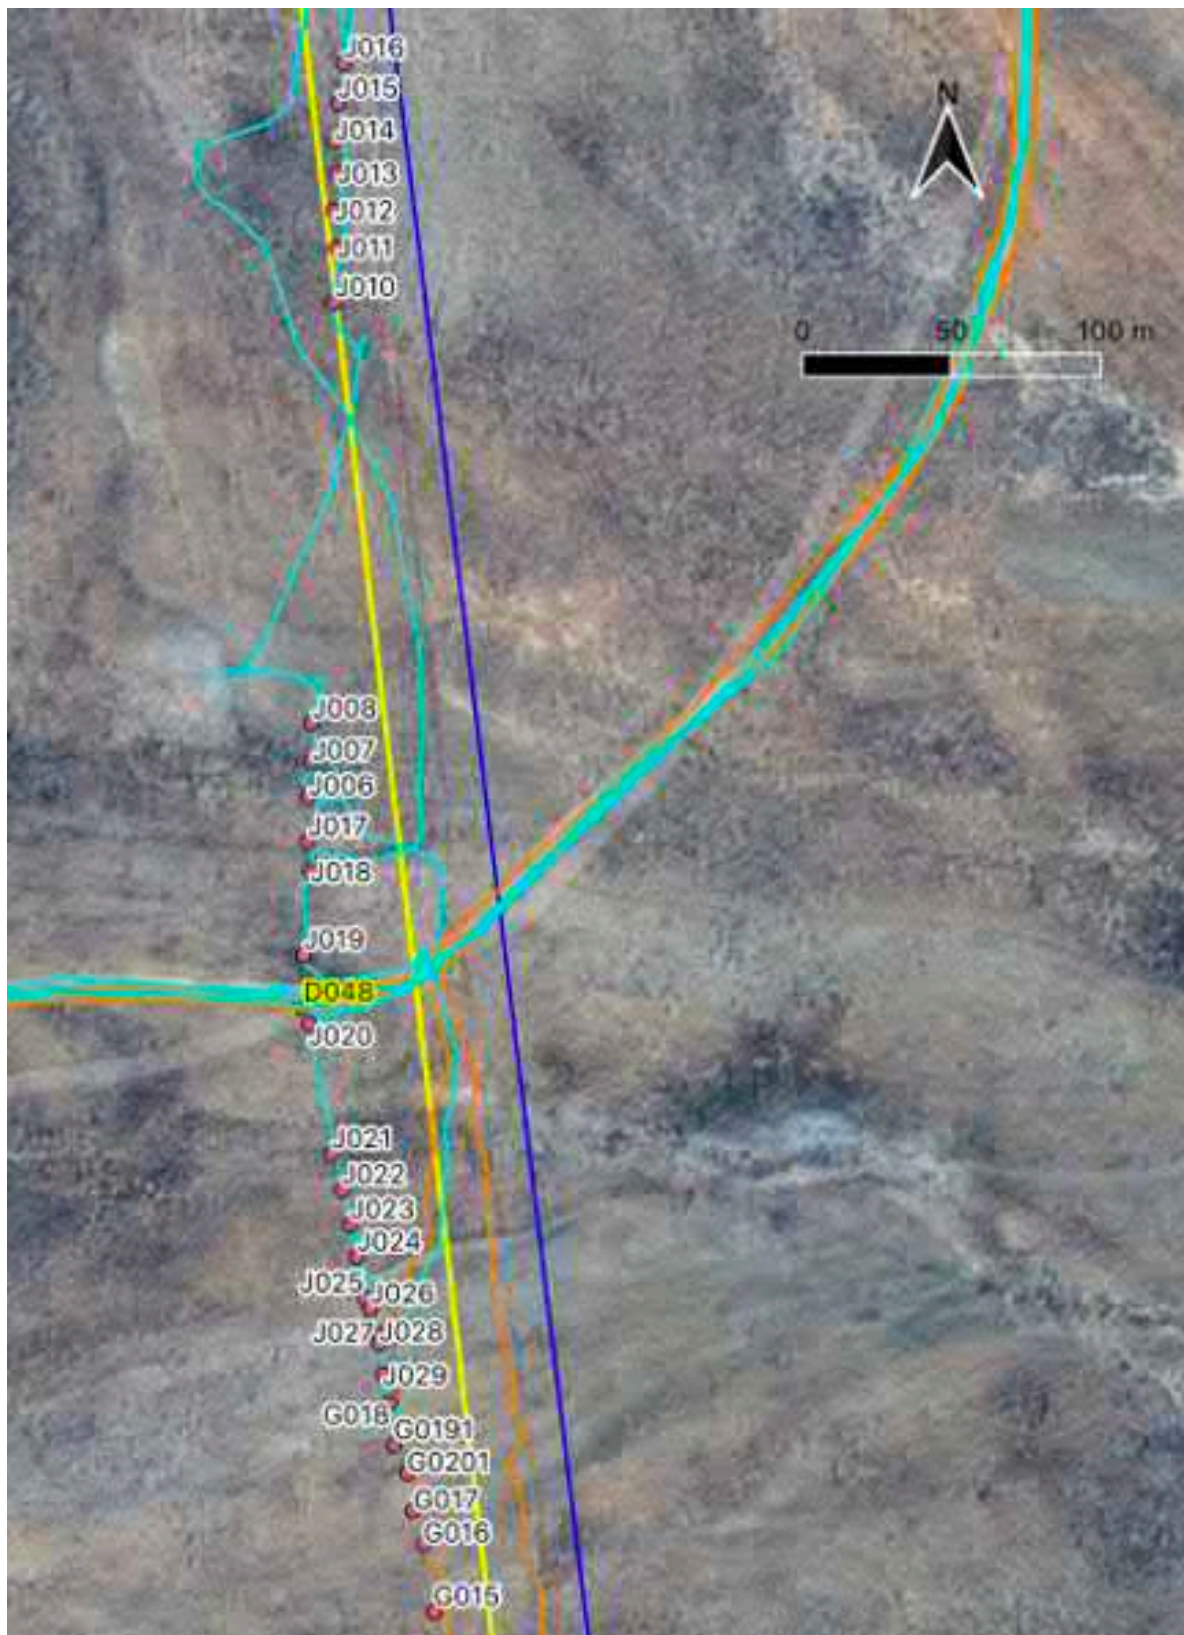
One of these markers (D048) (see Figure 9) was identified previously by Webley and Halkett (2017), but the recent survey indicated the presence of a gently curving line of at least 38 square, packed stone marker cairns constructed approximately 10-20 m apart. The cairns are roughly 1 x 1m square and up to 70 cm high (Plate 2, Appendix 3).

Figure 9: Line of stone boundary markers identified between the farms Aurora and Aanstoot in the east of the

WEF during the 2021 OHL survey (Source: Google Earth).

Built Environment: It is recommended that activities related to the construction of the proposed OHL avoid the line of packed stone boundary markers.

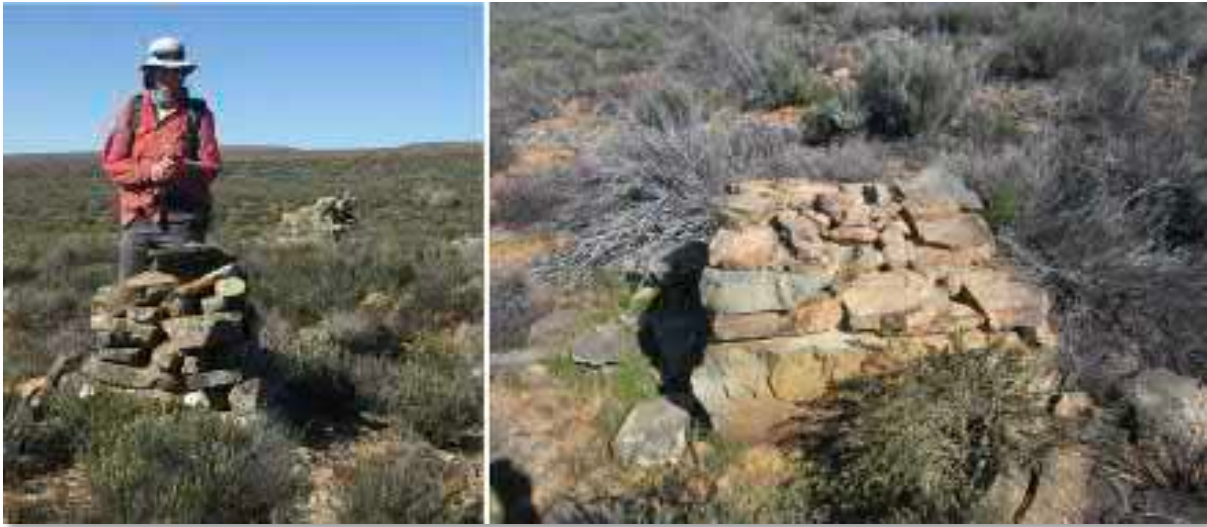
They are interspersed in places with the collapsed remains of packed stone walling and in one or two instances are represented by upright blocks of shale, rather than packed stone constructions. This historical built feature has been given a grading of 3B.

Plate 2: Examples of the packed stone markers recorded during the 2021 OHL walkdown survey (Photo: J Gribble / G Euston-Brown).
