# HERITAGE WALKDOWN REPORT

for the approved Iziduli Emoyeni Wind Energy Facility and associated infrastructure in the Eastern Cape

May 2022

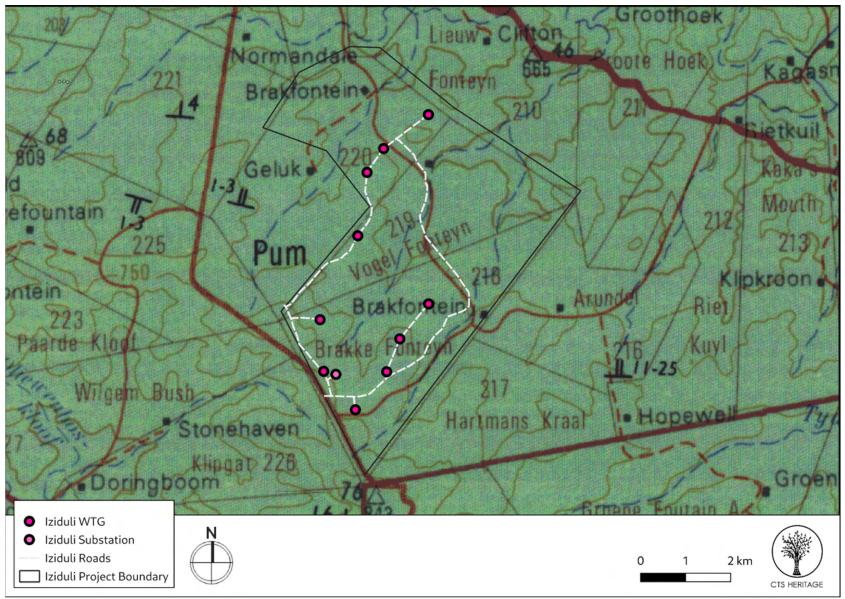
Figure 4.2: Geology Map. Extract from the CGS 3226 King Williams Town Map indicating that the development area is underlain by sediments of the Beaufort group, within the Middleton Formation of the Adelaide Subgroup (Pum).

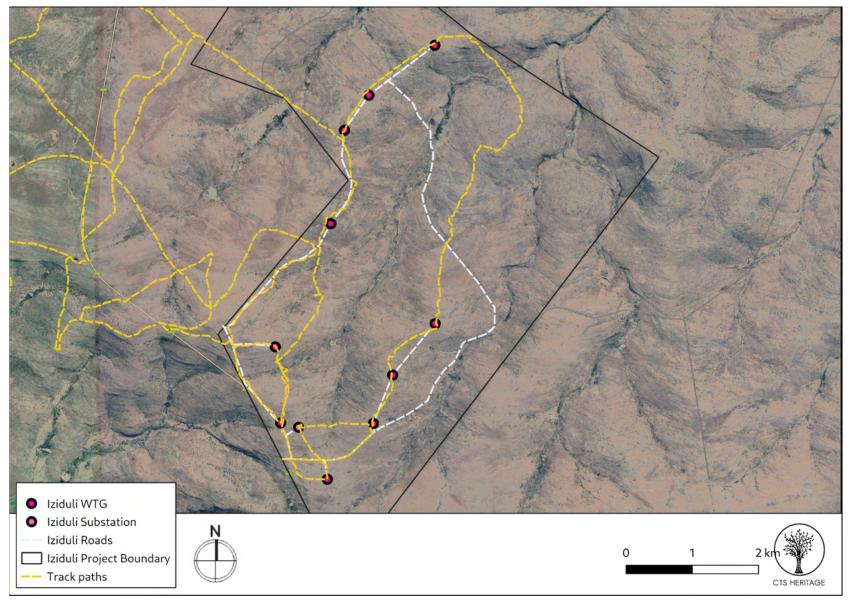
Figure 6.1: Overall track paths of foot survey (the road marked above that was not walked is along an existing road)

The survey was conducted on foot with the aid of a mountain bike where feasible. Notably, the relative absence of archaeological material on the high ground observed when surveying the neighbouring turbine locations continued with stone artefacts concentrated along the floodplains of the non-perennial systems. There was also material lining the lower slopes of the rocky hill ridge. There are no rock shelters or large boulders holding potential engravings in this area and the main river system (Great Fish River) runs further to the west and north west.

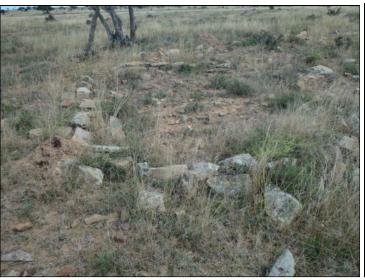
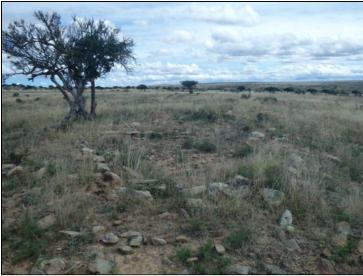
Figure 7.4: Observation 008

Obs#	Description	Туре	Period	Density	Co-ordinates		Grading
001	Quartzite unifacial core flake	Artefacts	MSA	0 to 5	-32.93551	26.1432	NCW
002	Quartzite flake with lateral retouch	Artefacts	MSA	0 to 5	-32.92724	26.14857	NCW
003	Siltstone flake unworked	Artefacts	MSA	0 to 5	-32.91422	26.15327	NCW
004	Broken quartzite upper grindstone	Artefacts	LSA	0 to 5	-32.906	26.15671	NCW
005	Quartzite, hornfels, siltstone flakes, cores	Artefacts	MSA, LSA	5 to 10	-32.90286	26.157	NCW
006	Quartzite core and flake	Artefacts	MSA	0 to 5	-32.90209	26.16	NCW
007	Circular kraal 2x2m	Structure	Historical	n/a	-32.902	26.1615	NCW
008	Circular kraal 4x4m	Structure	Historical	n/a	-32.89281	26.14167	NCW
009	Circular kraal 4x4m	Structure	Historical	n/a	-32.8999	26.13561	NCW
010	Oval kraal 4x3m	Structure	Historical	n/a	-32.9023	26.13621	NCW
011	Siltstone flake and core	Artefacts	MSA	0 to 5	-32.90585	26.13706	NCW
012	Stone walled ruin and kraal near dam	Structure	Historical	n/a	-32.91788	26.13168	IIIB

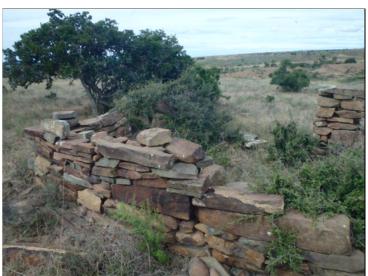
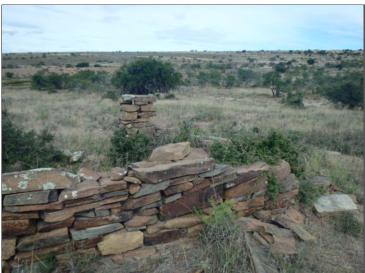
Figure 7.8 Observation 012

Around 20 observations were made primarily of weathered Middle Stone Age flakes and radial cores. The raw materials were locally sourced quartzites and siltstones which displayed very little evidence of large transport distances as access to the bedrock and river cobbles is readily available. Later Stone Age evidence was also present and higher grade hornfels cores and flakes were found that were most likely brought into the area from a number of possible karoo sources. All of the archaeological resources identified were low density, single incidence *ex situ* artefacts that have been determined to be Not Conservation-Worthy. One structure, a stone walled ruin (Observation 012), was identified within the area proposed for the Iziduli Emoyeni WEF development area. This site has been Graded IIIB and while no impact to this site is anticipated from the layout provided, it is recommended that a no-development buffer of 50m is implemented around this site.

- A no development buffer of 30m is recommended around palaeontological site 40762 located along the existing road
- A no-development buffer of 50m is recommended around Observation 012. This site is located more than 200m from any proposed infrastructure and so no impact is anticipated.
- As per SAHRA's requirements, all stone structures, stone kraals and enclosures within 200m from the construction area must be protected through temporary fencing. The only site located within 200m of proposed construction is Observation 009. No impact to this site is anticipated.
- The attached Chance Fossil Finds Procedure (Appendix 2) is implemented for the duration of construction activities for this project.

provided, it is recommended that a no-development buffer of 50m is implemented around this site.

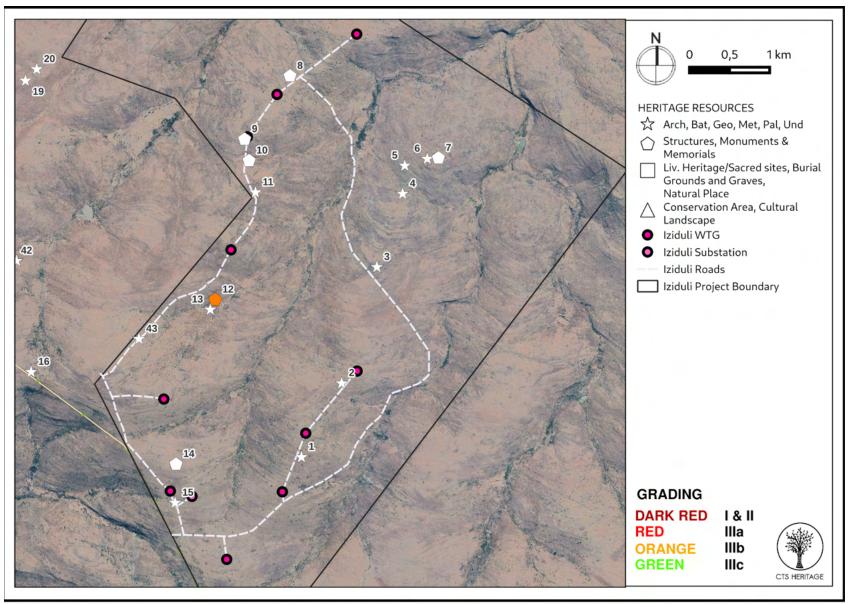
Figure 8.1: Map of heritage resources identified during the field assessment (2022) relative to the final proposed development footprint

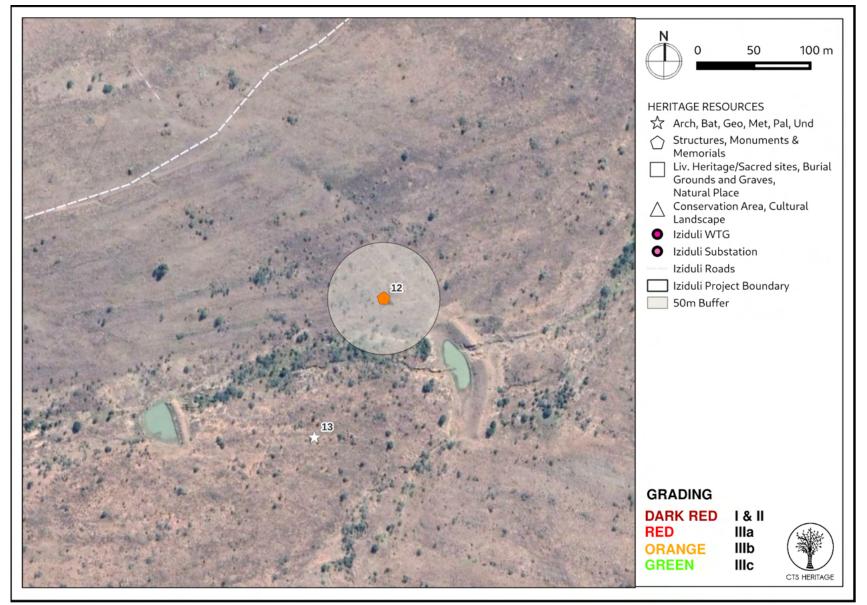
Figure 9.2: Map of all known significant heritage resources relative to the final proposed development footprint with recommended buffer - no impact anticipated

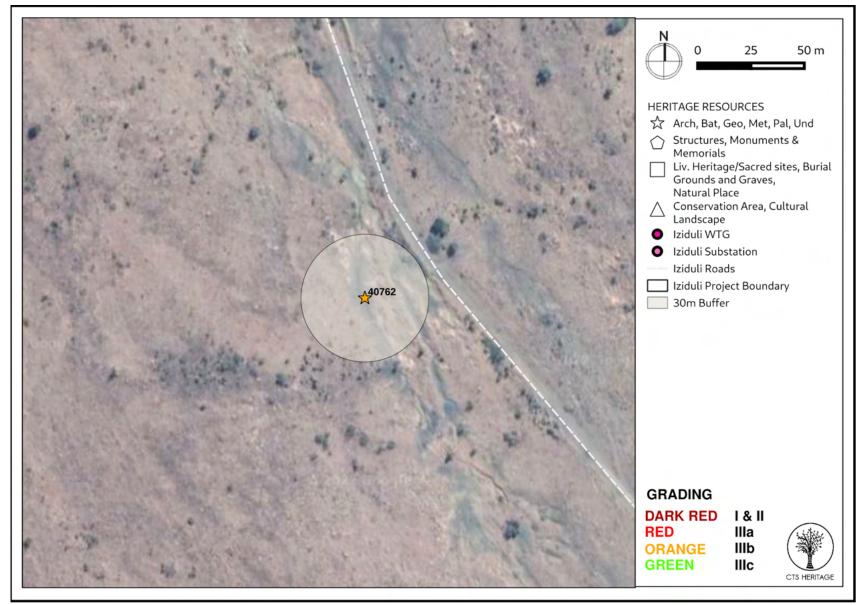
Figure 9.3: Map of all known significant heritage resources relative to the final proposed development footprint with recommended buffers - no impact anticipated

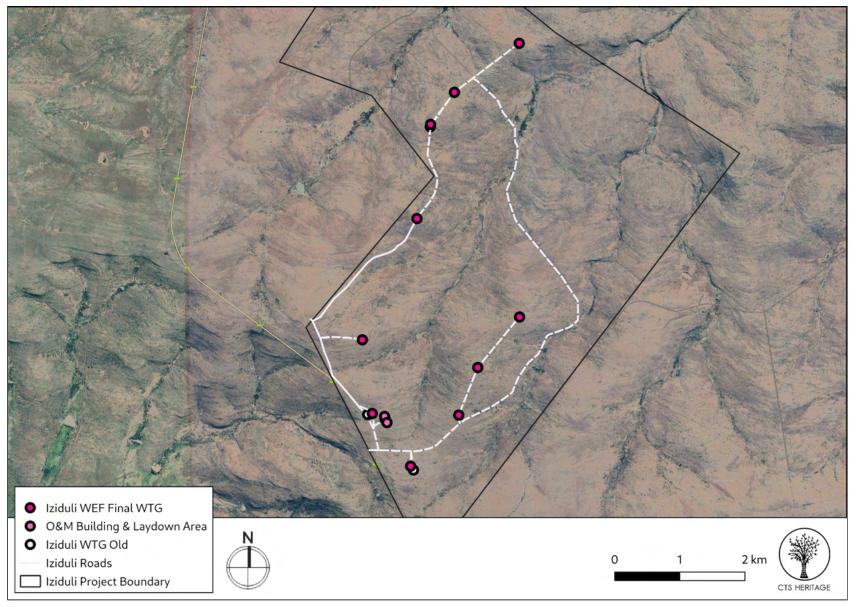
Figure 10.1: Final Layout of WEF mapped relative to layout that was walked

The Final Layout is mapped against the layout that was subjected to a walkdown in Figure 10. The differences in layout are minor from a heritage perspective and as such, the final layout is acceptable from a heritage perspective and it complies with all of the heritage recommendations put forward for this project.

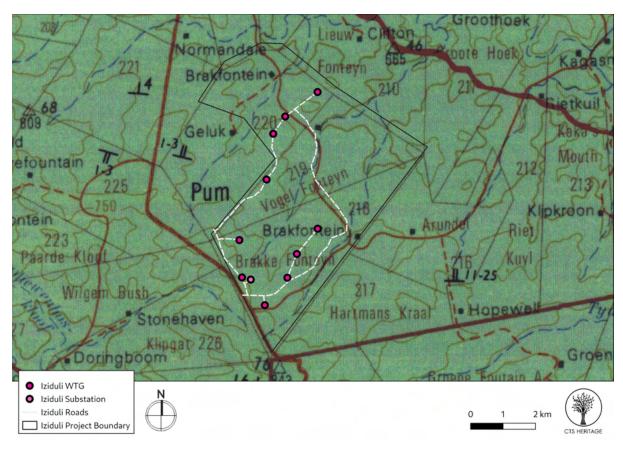
Figure 4: Geological map of the area around the Iziduli WEF south of Bedford indicated within the yellow rectangle. Abbreviations of the rock types are explained in Table 2. Map enlarged from the Geological Survey 1: 250 000 map 3226 King Williamstown.

The site lies in the southern margin of the Main Karoo Basin where the rocks of the Middleton Formation are exposed (Figure 4).

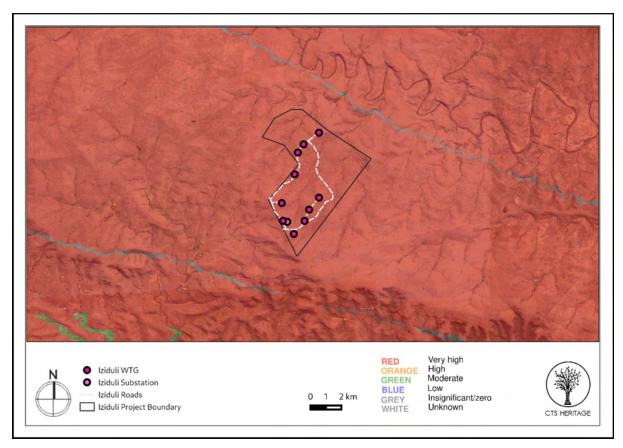
Figure 6: SAHRIS palaeosensitivity map for the site for the proposed Iziduli WEFs south of Bedford. Background colours indicate the following degrees of sensitivity: red = very highly sensitive; orange/yellow = high; green = moderate; blue = low; grey = insignificant/zero.

The palaeontological sensitivity of the area under consideration is presented in Figure 6. The site for development is in the very highly sensitive Middleton Formation (red).

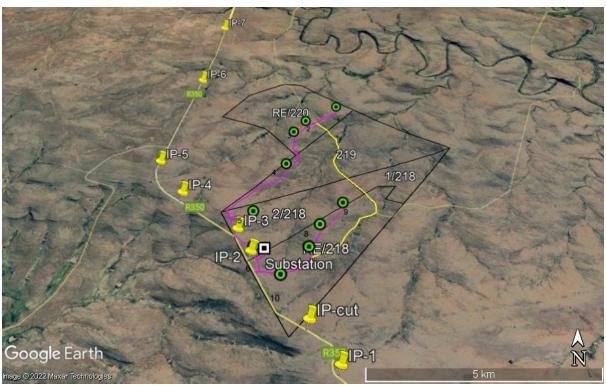
Figure 7: Annotated Google Earth map for the site stops and observations (refer to Table 3). Turbines - Green, proposed road - pink and existing road - yellow

The area was visited by palaeontologist Marion Bamford and student assistant Roxane Matias on 25-26 April 2022. The main site stops/GPS points, photographs and observations are provided in Figure 7 and Table 3. It should be note that access to the farms was prohibited because they are hunting farms and too dangerous to visit during the hunting season – current. From the public roads the higher ridges were viewed, as well as the exposed rock in the road cuttings. The latter were ideal for determining the richness (or not) of the fossils because the area is covered in soils and thin to thick vegetation.
