Heritage Impact Assessment (including Palaeontological Desktop Assessment) for a Mining Right Application on Portion 2 (At Last) of Farm No 232 near Delportshoop, and Portion 2, 3, 4, 5 and 6 of the Farm De Bad 155 near Schmidtsdrift, Northern Cape Province

(UPDATED)

(A)HSA Archaeological and Heritage Services Africa (Pty) Ltd

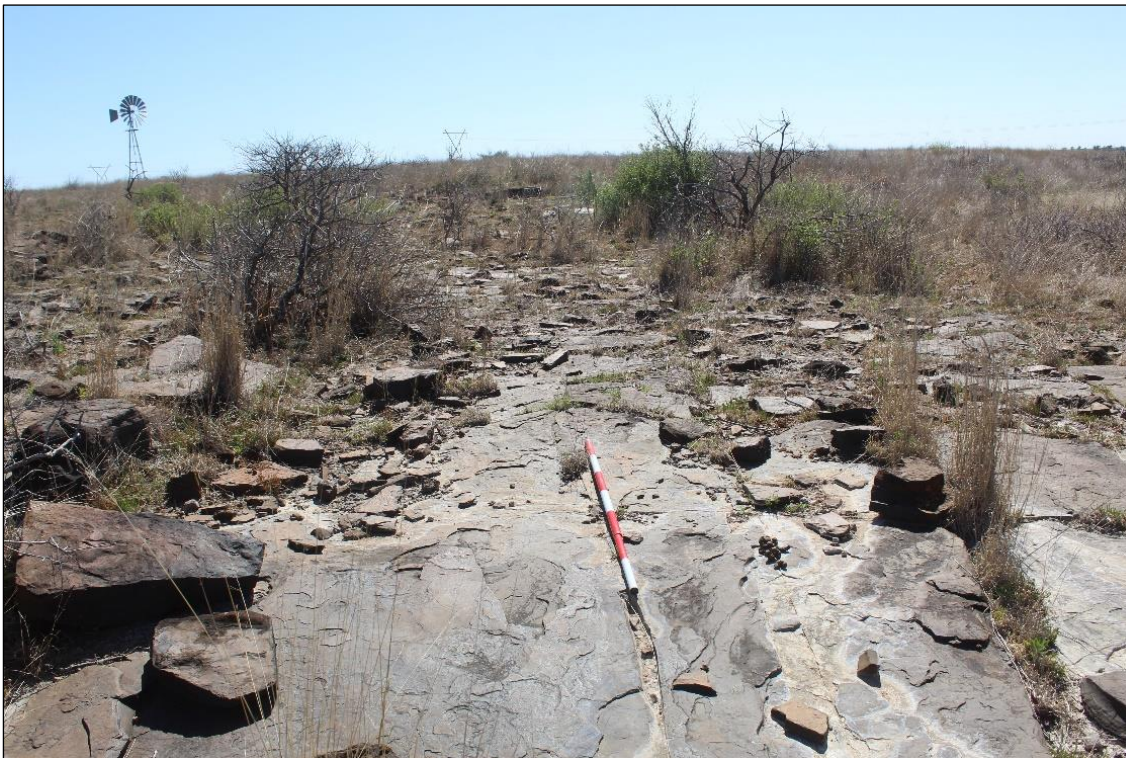
Figure 3: Dolomite bedrock exposed as the ground rises from the Vaal River floodplain to a flat veld below the Ghaap Plateau

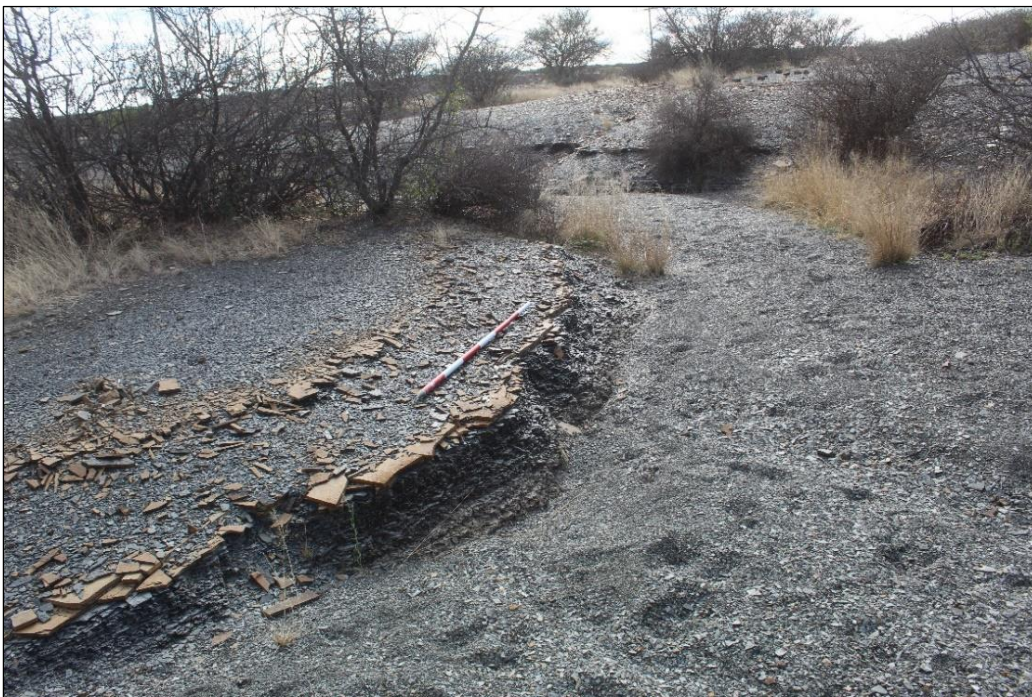
Figure 10: Weathered sediments on the edge of a dry stream show thin beds of sandstone

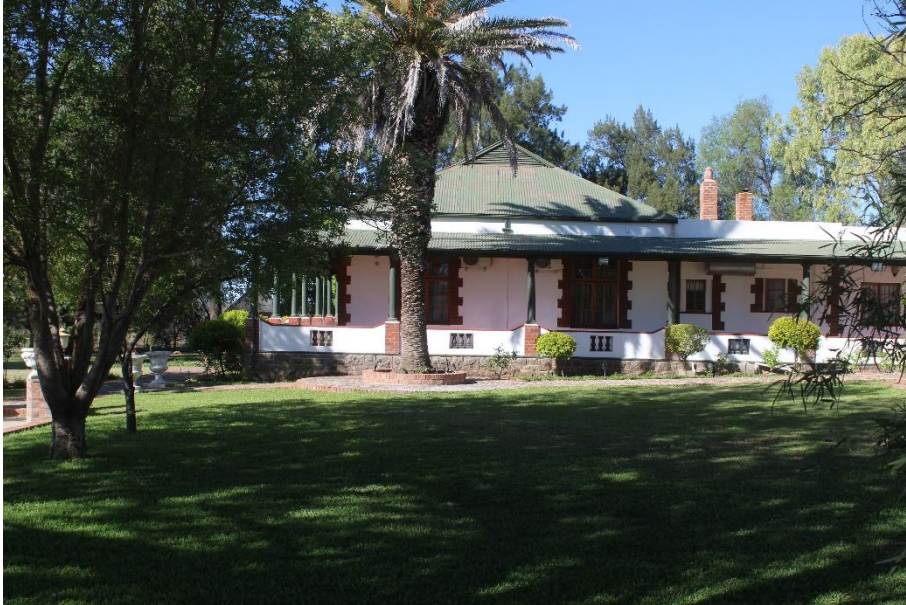
SITE NO	COORDINATES		PERIOD
ATL01	28°25'12.74"S	24°14'26.98"E	19 th -20 th century

DESCRIPTION: The principal dwelling house at the farmstead has a hipped roof and veranda on two sides. There are two chimneys. The façade represented by the two veranda sides has ornate finishes. Date of construction inscribed on the cornerstone is 1936.

HERITAGE SIGNIFICANCE	An important example of a farmhouse
MITIGATION	100 m servitude to protect the grave.

The principal dwelling house at the farmstead is a remarkable monument. It has a hipped roof and veranda on two sides. There are two chimneys. The façade represented by the two veranda sides has ornate finishes. The date of construction inscribed on the cornerstone is 1936. The building will not be affected by mining operations. There are other buildings at the farmstead which are not architecturally important.

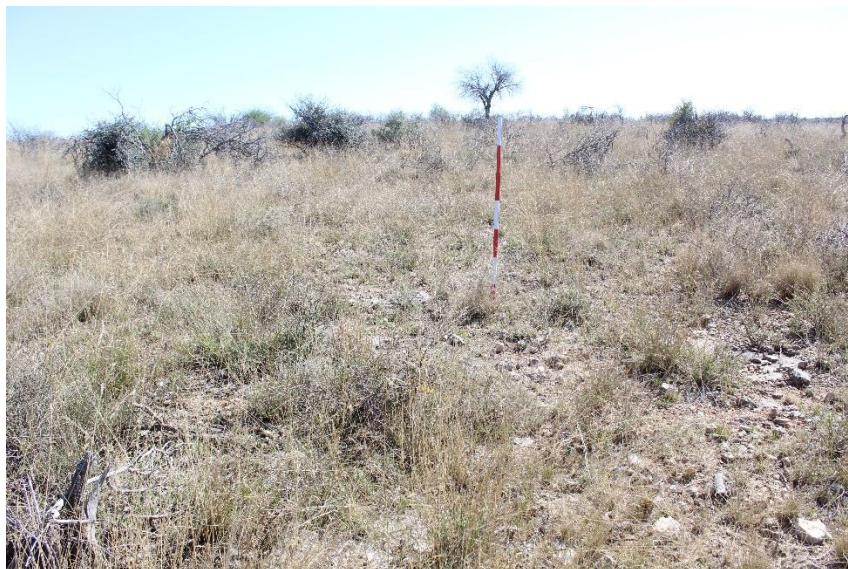
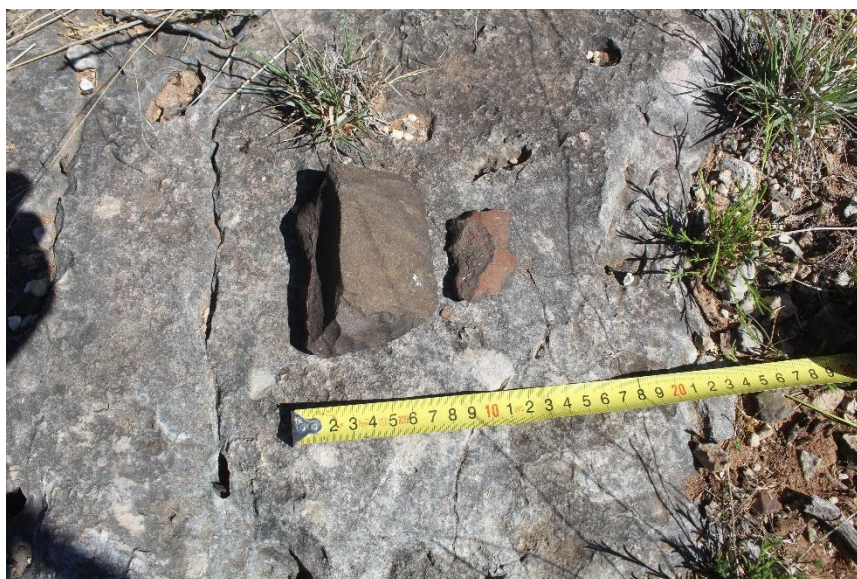
SITE NO	COORDINATES		PERIOD
ATL02	28°24'52.90"S	24°14'9.06"E	MSA/LSA

DESCRIPTION: On the veld above the floodplain, a cleaver and a scraper.

HERITAGE SIGNIFICANCE	Evidence of hunter-gatherer activities during the MSA/LSA
MITIGATION	No further action required

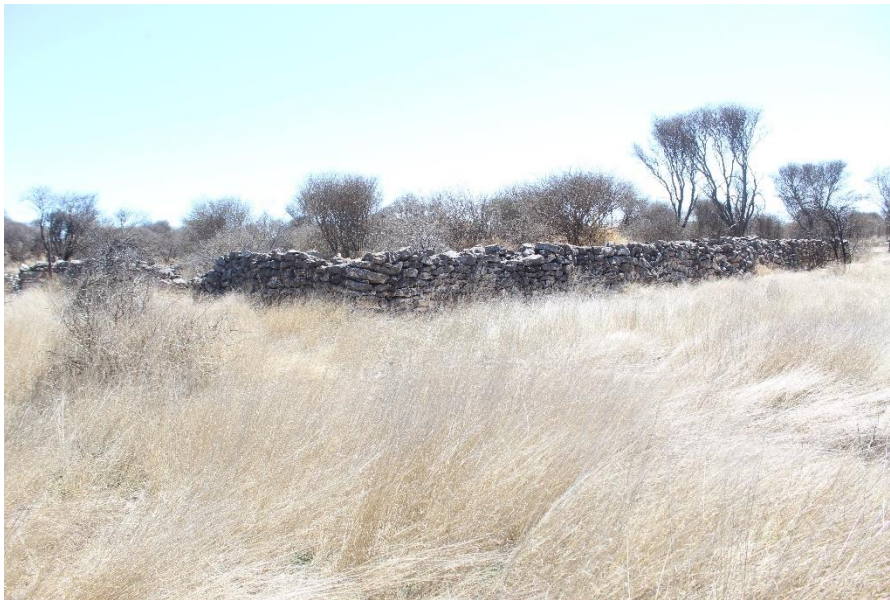
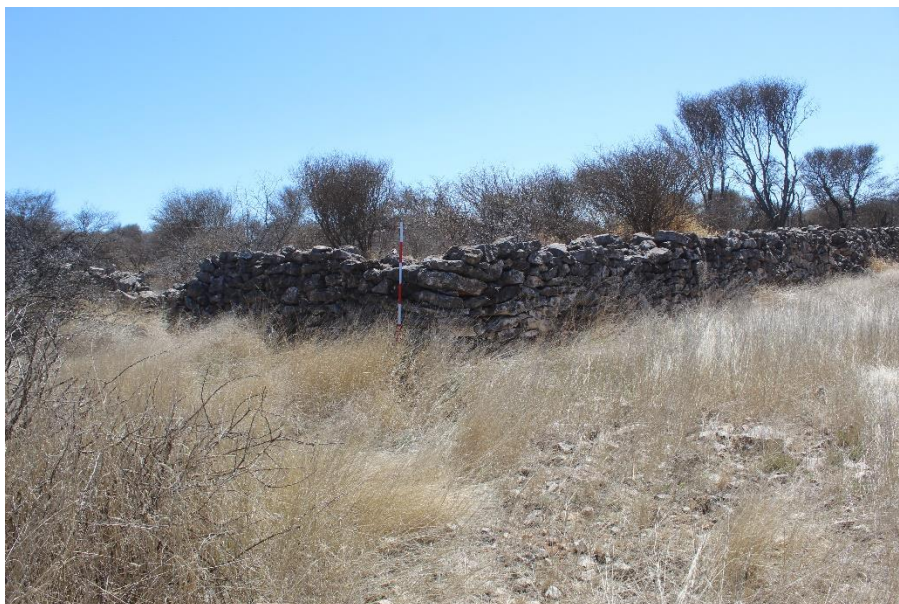
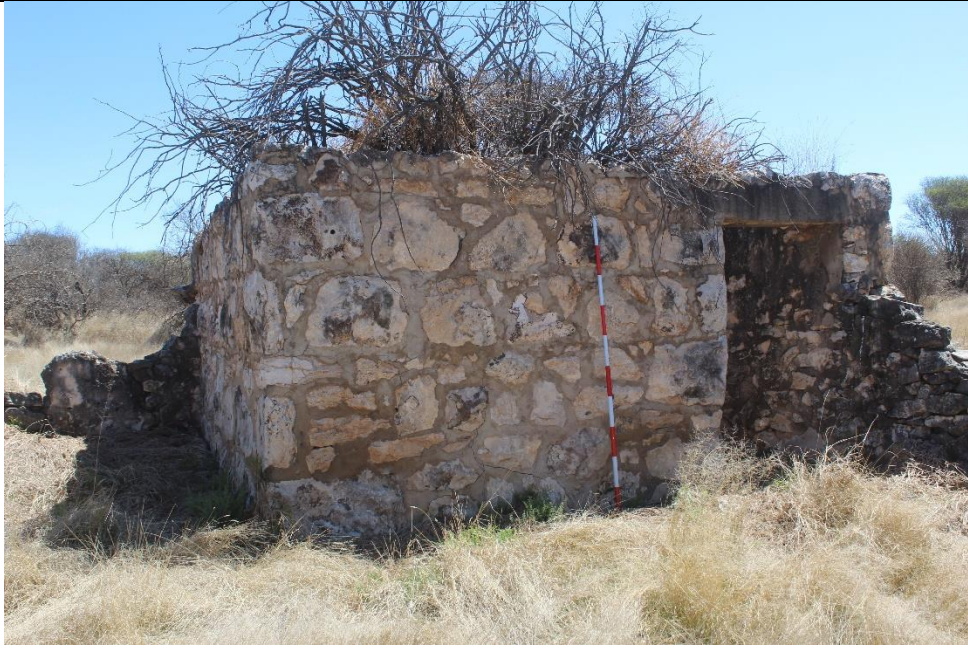
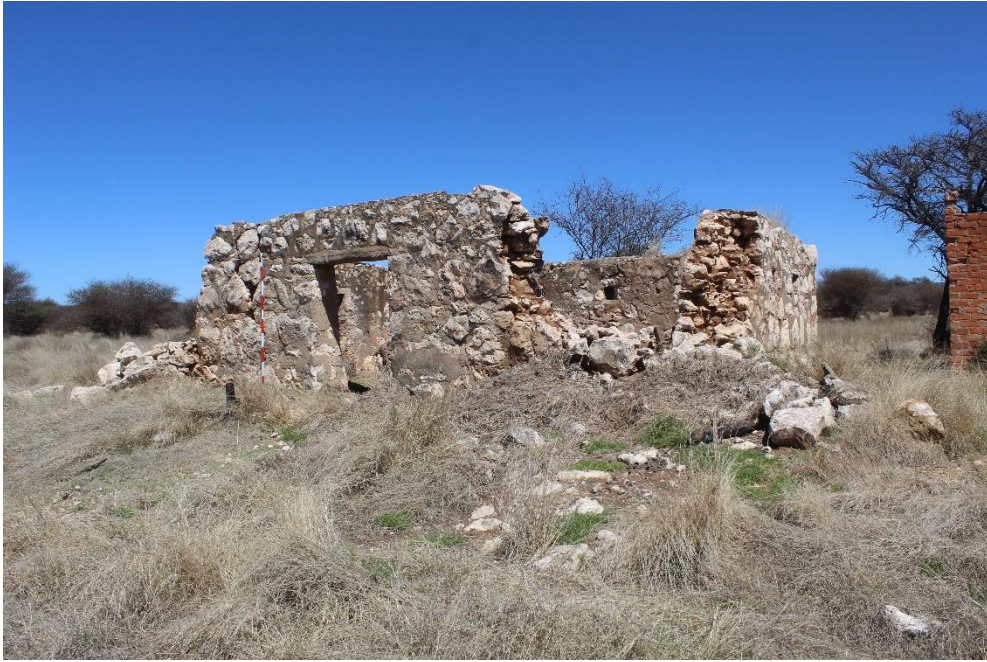
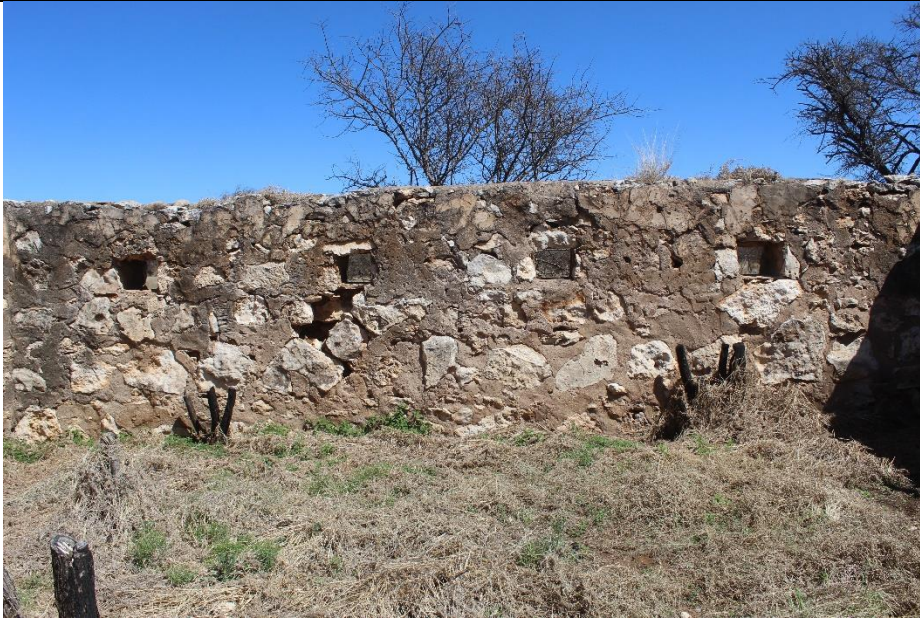
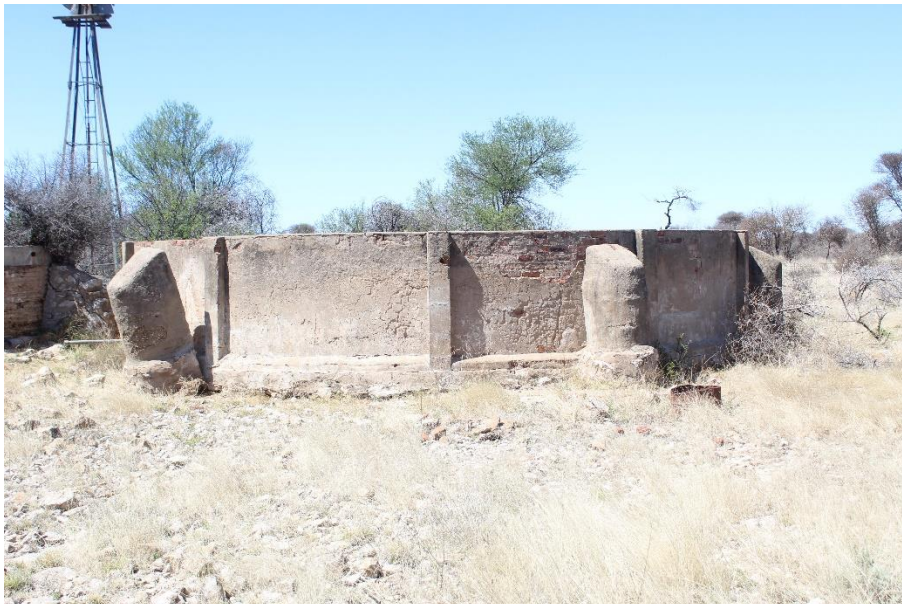
SITE NO	COORDINATES		PERIOD
ATL03	28°24'2.00"S	24°11'46.24"E	19 th -20 th century

DESCRIPTION: Old buildings dating to the 19th century. A square cattle enclosure of drystone masonry measuring 30 m x 30 m. Calcrete blocks were used. Inside the enclosure at the NW corner, there is a square building measuring 5 m x 5m, which was likely to have been used for penning calves or sheep. An old building, which appears to have been a dwelling, built of calcrete blocks and mortar, measuring 60 m x 6 m. On the south wall, there are 4 square loopholes that appear to have been for ventilation. A water tank built of clay farm bricks with cement plaster.

HERITAGE SIGNIFICANCE	Important in the history of the development of commercial farming in South Africa.
MITIGATION	A 50 m radius must be reserved around the buildings

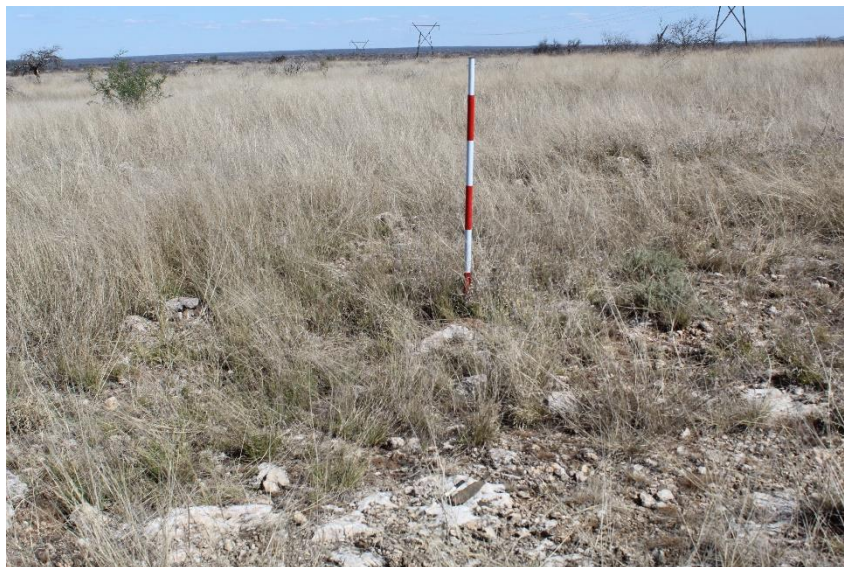
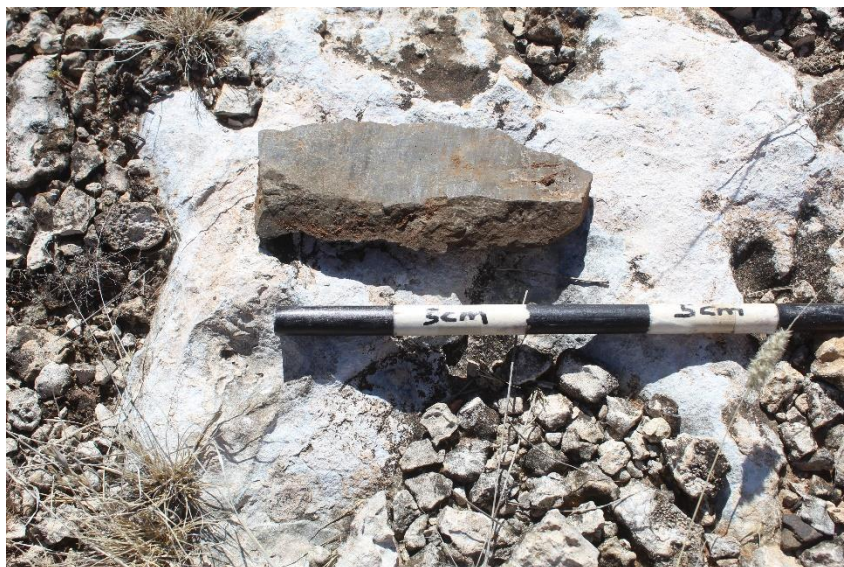
SITE NO	COORDINATES		PERIOD
ATL04	28°25'12.20"S	28°25'12.20"S	MSA/LSA

DESCRIPTION: On the veld above the floodplain. A blade 15 cm long blade.

HERITAGE SIGNIFICANCE	Evidence of hunter-gatherer activities during the MSA/LSA
MITIGATION	No further action required

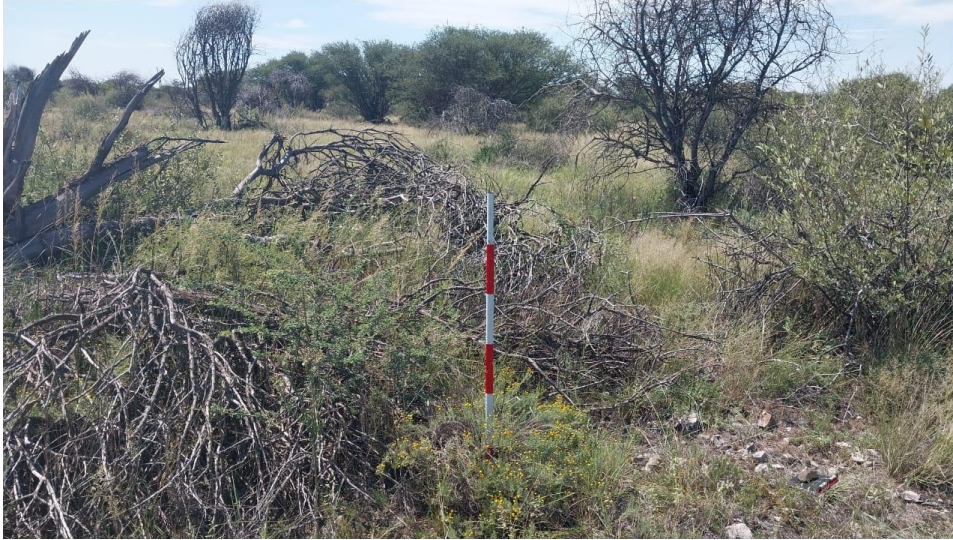
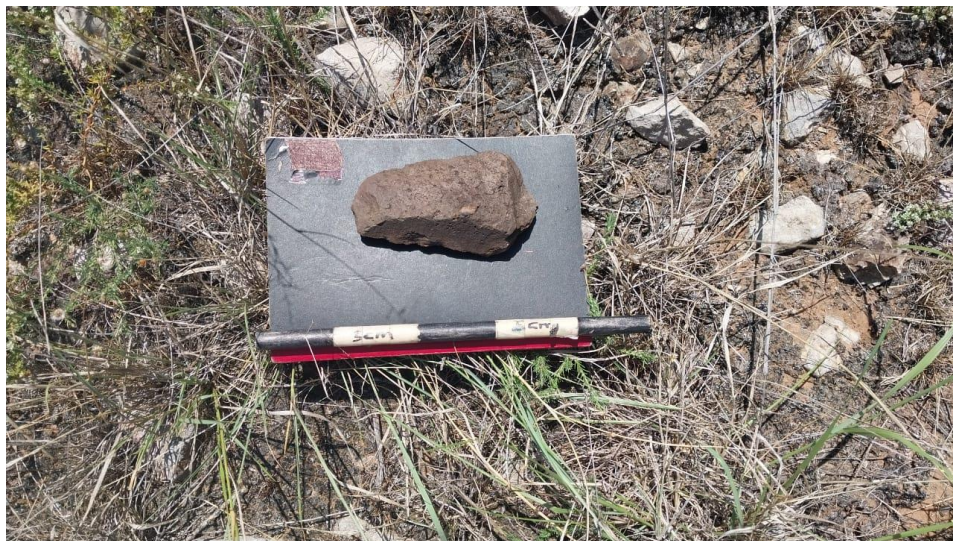
SITE NO	COORDINATES		PERIOD
ATL06	28°23'56.20"S	24°13'24.80"E	MSA/LSA

DESCRIPTION: Flat terrain, calcrete waste and hardpan, a blade found.

HERITAGE SIGNIFICANCE	Evidence of hunter-gatherer activities during the MSA/LSA
MITIGATION	No further action required

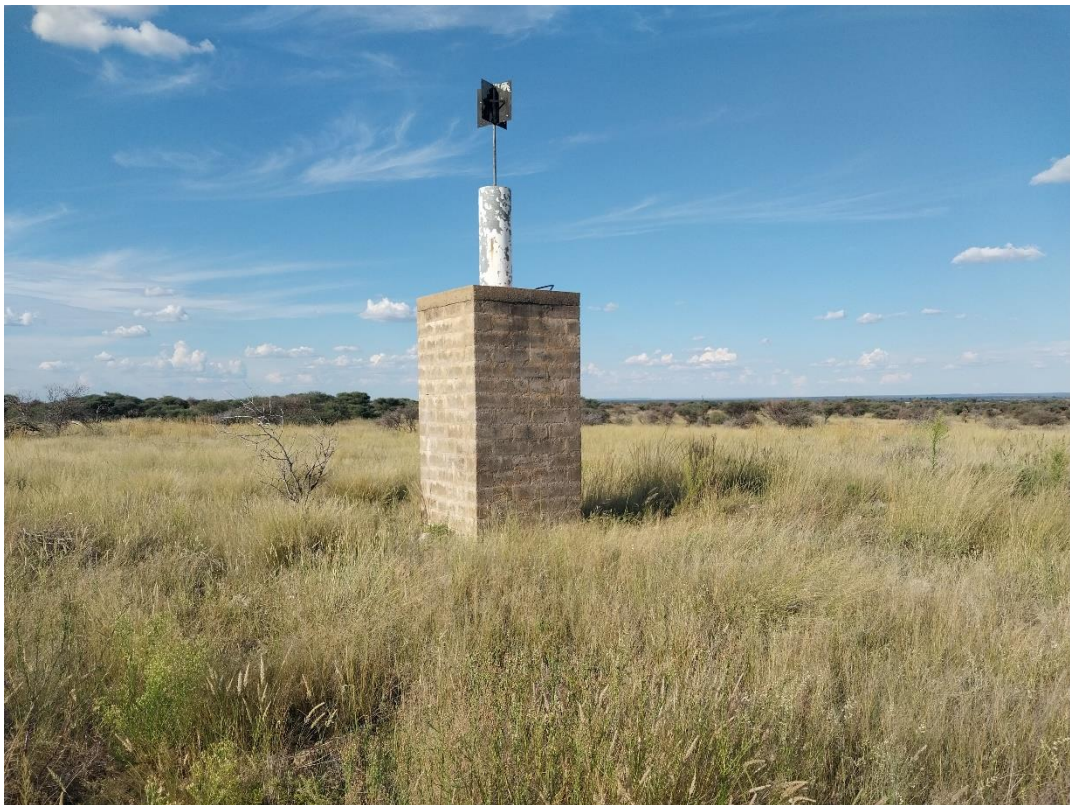
SITE NO	COORDINATES		PERIOD
ATL08	28°24'55.50"S	24°13'9.70"E	20 th century

DESCRIPTION: Trigonometrical Survey Beacon, elevated location, 1058 m AMSL			
HERITAGE SIGNIFICANCE	Evidence of hunter-gatherer activities during the MSA/LSA		
MITIGATION	No further action required

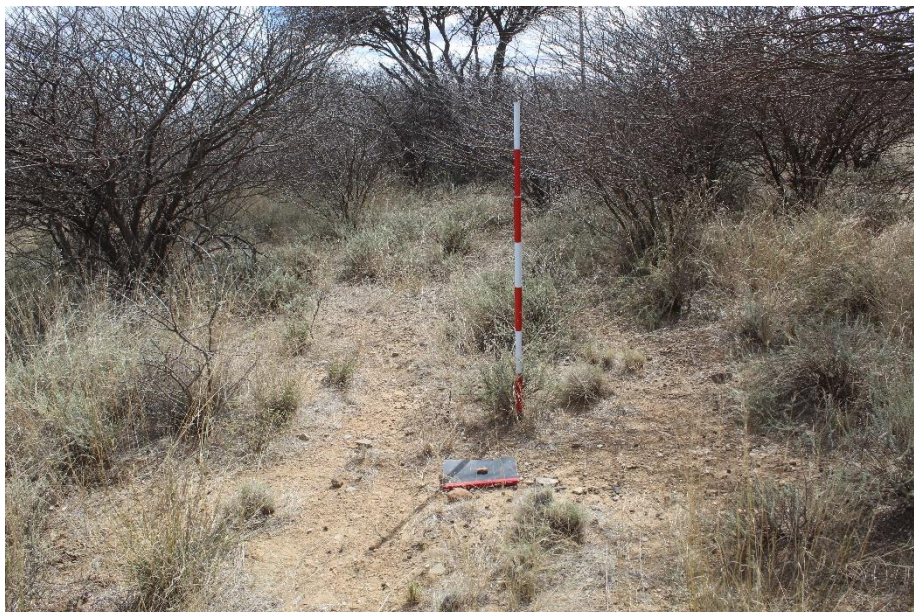
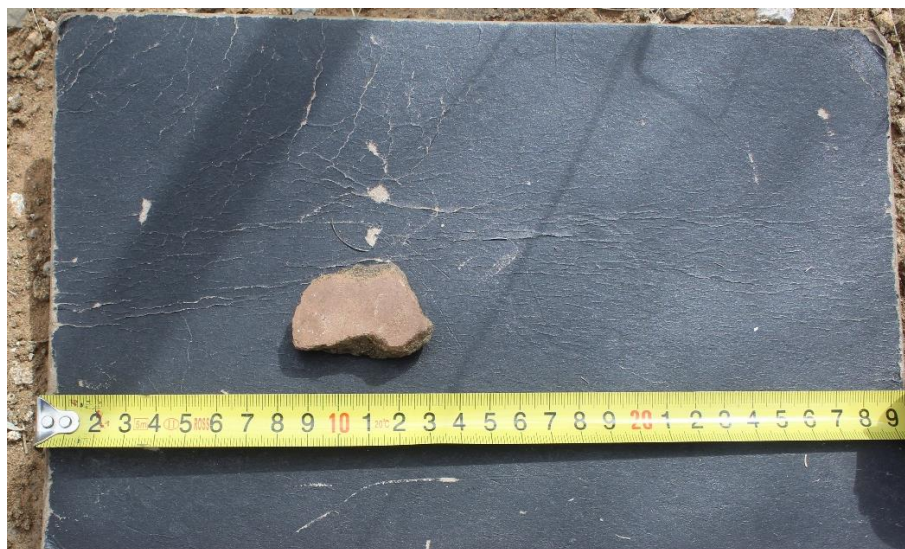
SITE NO	COORDINATES		PERIOD
DBD02	28°49'54.70"S	24° 3'6.80"E	MSA/LSA

DESCRIPTION: On the veld, but a short distance from the east bank of the Vaal River. One potsherd.

HERITAGE SIGNIFICANCE	Represents the transition to the Iron Age
MITIGATION	No further action required

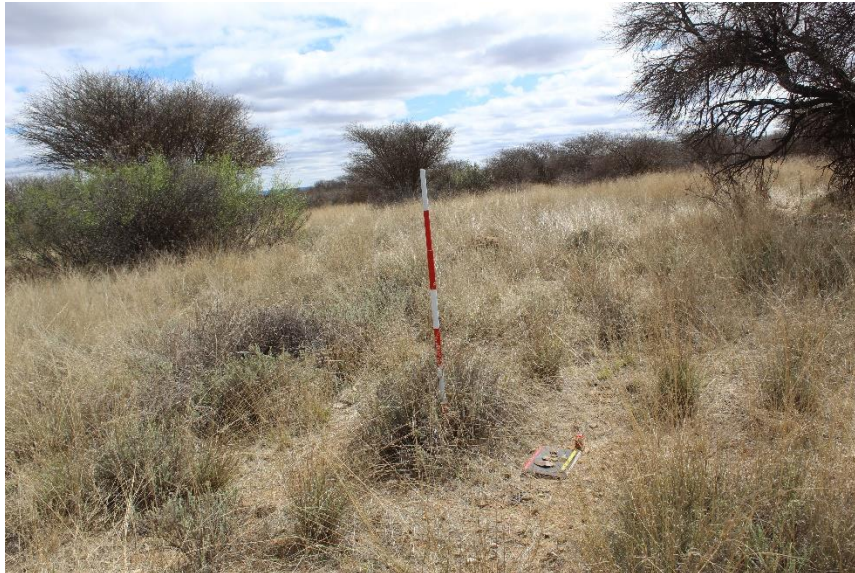
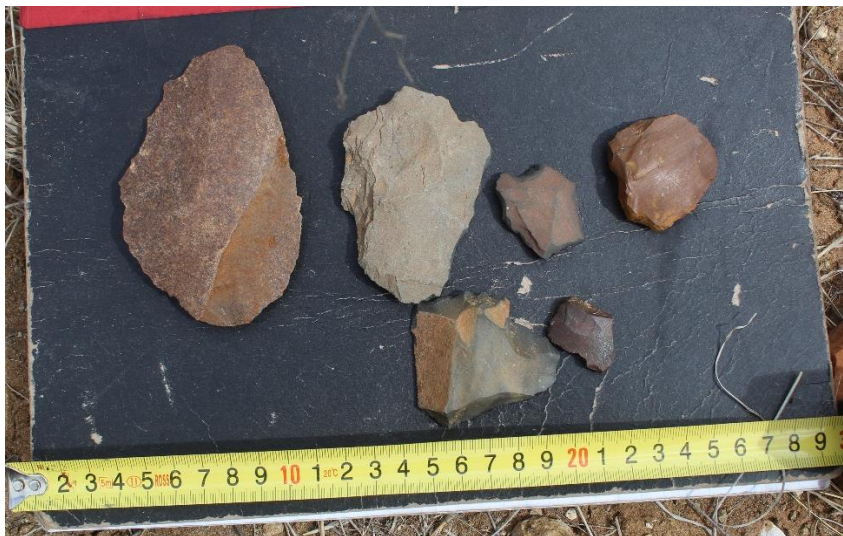
SITE NO	COORDINATES		PERIOD
DBD03	28°49'56.70"S	28°49'56.70"S	MSA/LSA

DESCRIPTION: On the veld, but a short distance from the east bank of the Vaal River. 6 lithics: 2 blades, 4 scrapers.

HERITAGE SIGNIFICANCE	Evidence of hunter-gatherer activities during the MSA/LSA
MITIGATION	No further action required

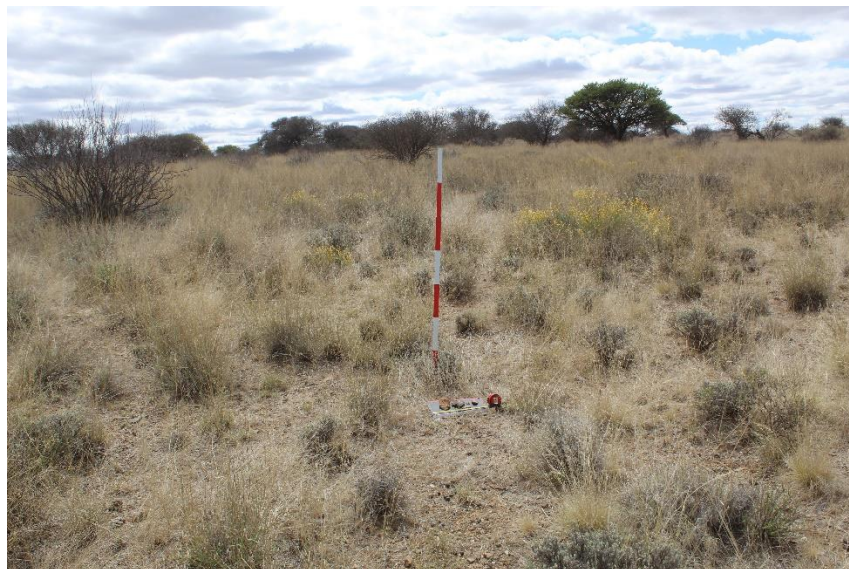
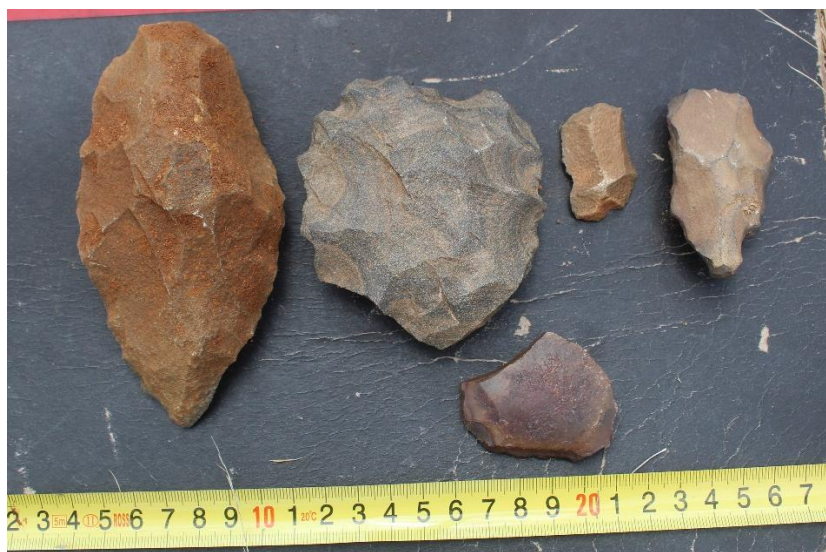
SITE NO	COORDINATES		PERIOD
DBD04	28°49'58.20"S	24° 3'8.00"E	MSA/LSA

DESCRIPTION: On the veld, but a short distance from the east bank of the Vaal River. 5 lithics: 1 handaxe, 1 blade, 1 scraper, 1 flake.

HERITAGE SIGNIFICANCE	Evidence of hunter-gatherer activities during the MSA/LSA
MITIGATION	No further action required

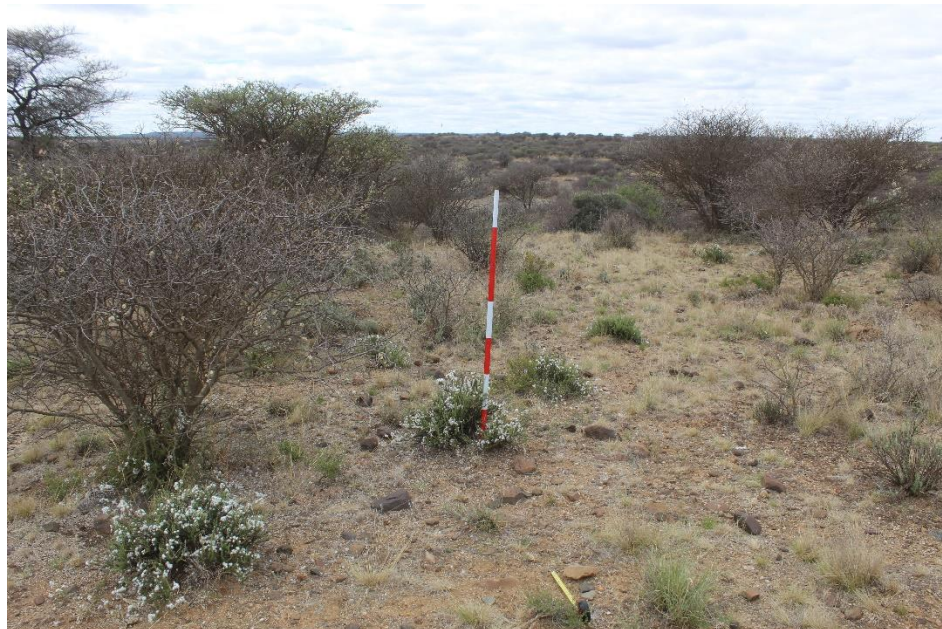
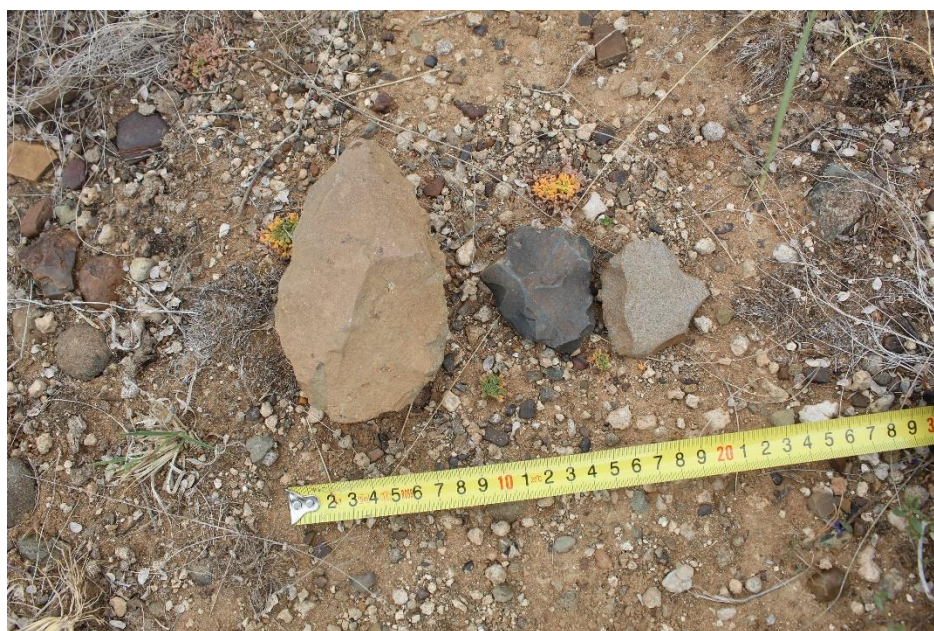
SITE NO	COORDINATES		PERIOD
DBD05	28°50'17.10"S	24° 1'51.14"E	MSA/LSA

DESCRIPTION: On the edge of a stream flowing west into the Vaal River. 1 handaxe, 2 scrapers.

HERITAGE SIGNIFICANCE	Evidence of hunter-gatherer activities during the MSA/LSA
MITIGATION	No further action required

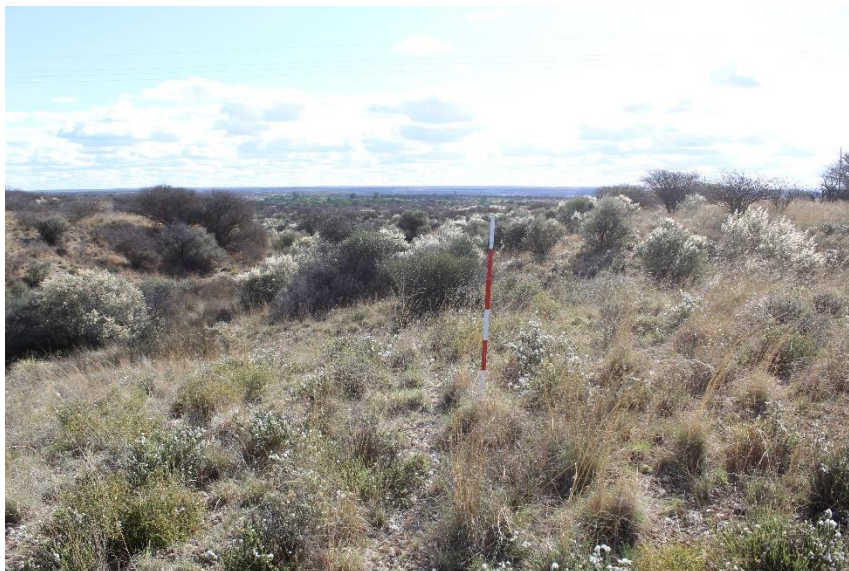
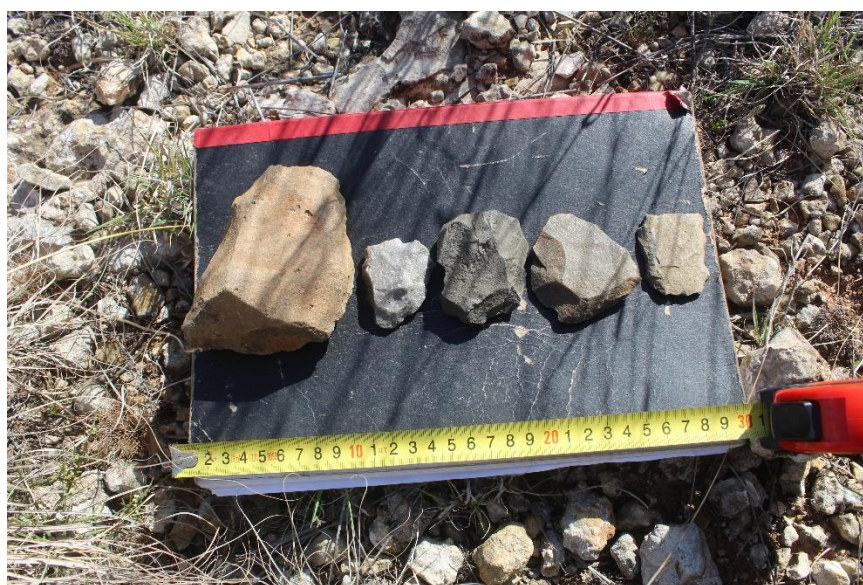
SITE NO	COORDINATES		PERIOD
DBD06	28°49'31.30"S	24° 3'11.20"E	MSA/LSA

DESCRIPTION: On the edge of a stream flowing west into the Vaal River. 1 cleaver, 4 scrapers.

HERITAGE SIGNIFICANCE	Evidence of hunter-gatherer activities during the MSA/LSA
MITIGATION	No further action required

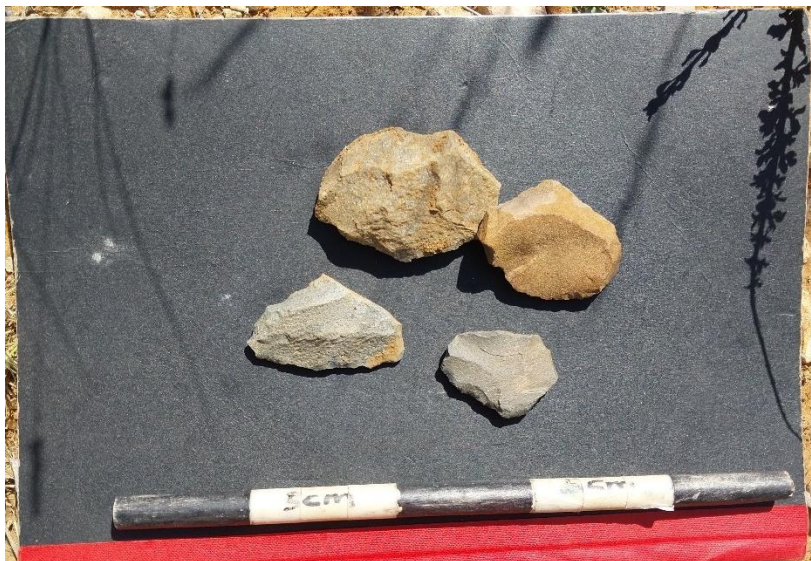
SITE NO	COORDINATES		PERIOD
DBD07	28°49'18.80"S	24° 3'9.40"E	MSA/LSA

DESCRIPTION: On the shoulder of the valley, overlooking the Vaal River. 4 lithics: 1 blade, 3 scrapers.

HERITAGE SIGNIFICANCE	Evidence of hunter-gatherer activities during the MSA/LSA
MITIGATION	No further action required

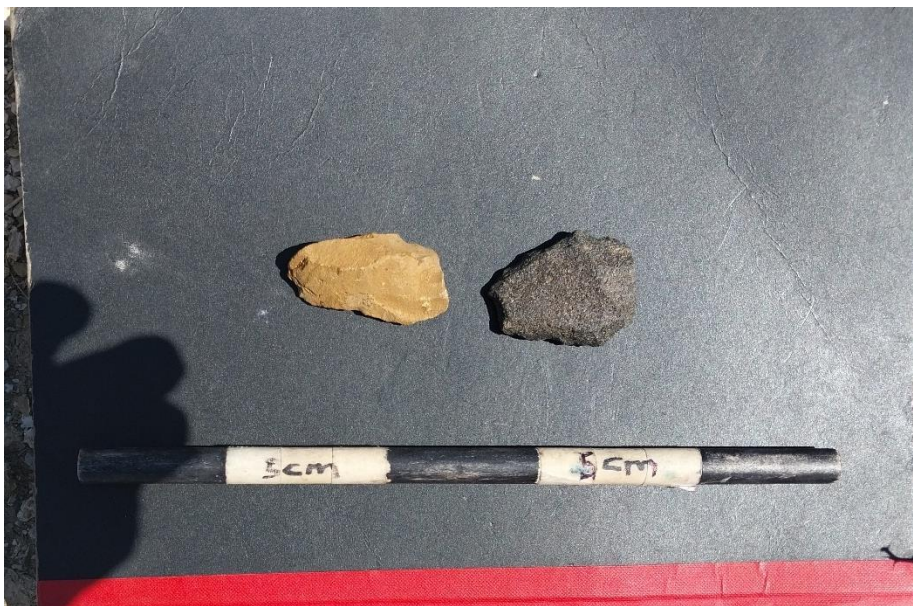
SITE NO	COORDINATES		PERIOD
DBD08	28°49'14.40"S	24° 3'5.50"E	MSA/LSA

DESCRIPTION: Valley slope overlooking the Vaal River. Calcrete surface. 1 blade, 1 scraper.

HERITAGE SIGNIFICANCE Evidence of hunter-gatherer activities during the MSA/LSA

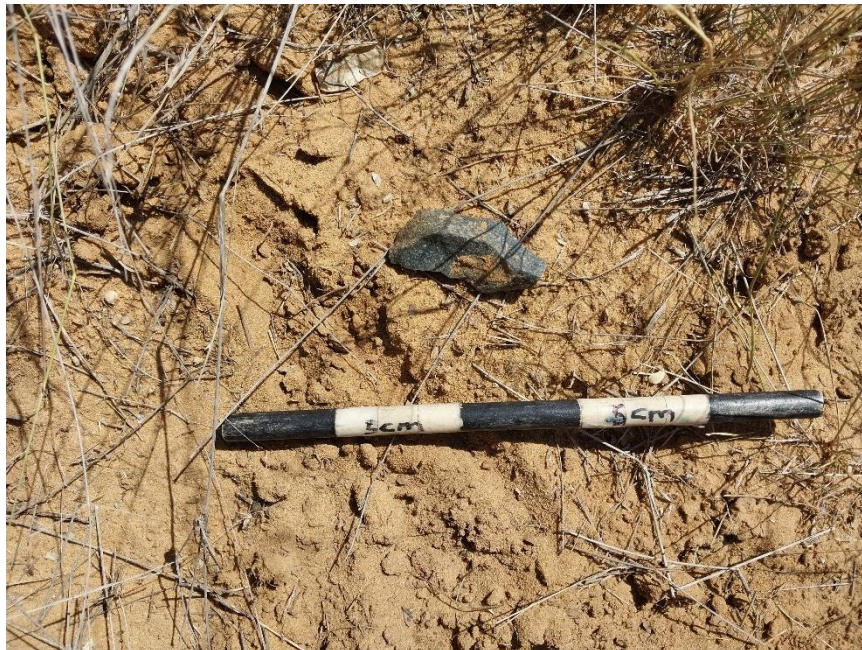
SITE NO	COORDINATES		PERIOD
DBD09	28°49'12.50"S	24° 3'3.80"E	MSA/LSA

DESCRIPTION: Sandy area on the edge of the Vaal River floodplain. 1 blade.

HERITAGE SIGNIFICANCE	Evidence of hunter-gatherer activities during the MSA/LSA
MITIGATION	No further action required

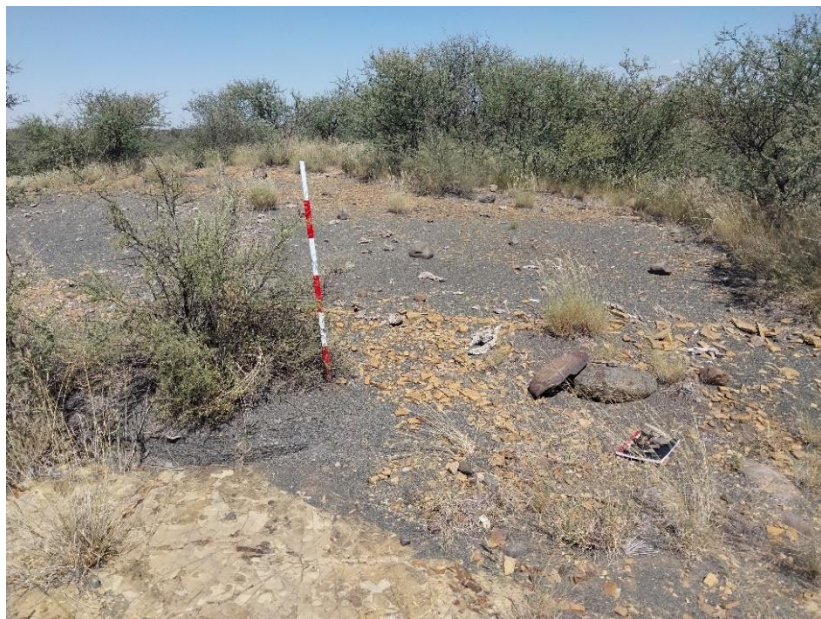
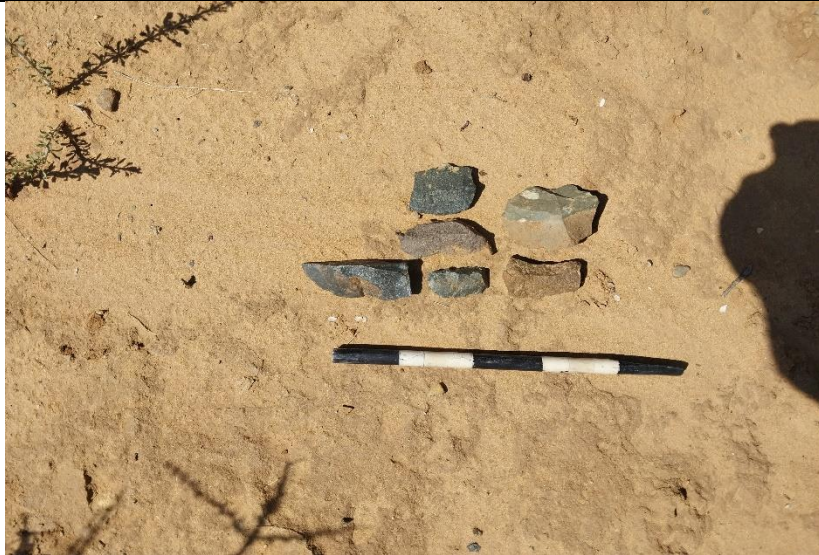
SITE NO	COORDINATES		PERIOD
DBD10	28°49'13.80"S	24° 2'55.40"E	MSA/LSA

DESCRIPTION: On the shoulder of a stream valley, stream running west into the Vaal River.
6 lithics: 5 blades, 1 scraper.

HERITAGE SIGNIFICANCE	Evidence of hunter-gatherer activities during the MSA/LSA
MITIGATION	No further action required

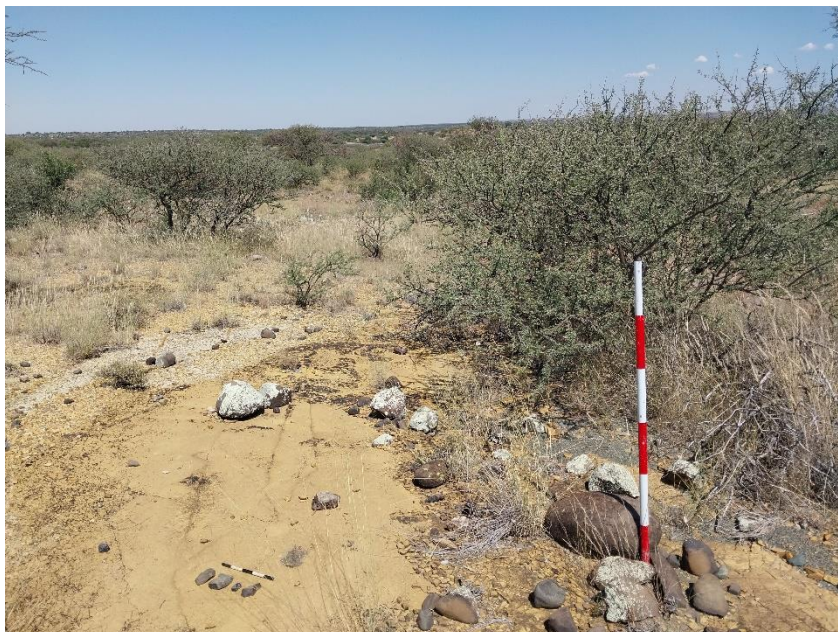
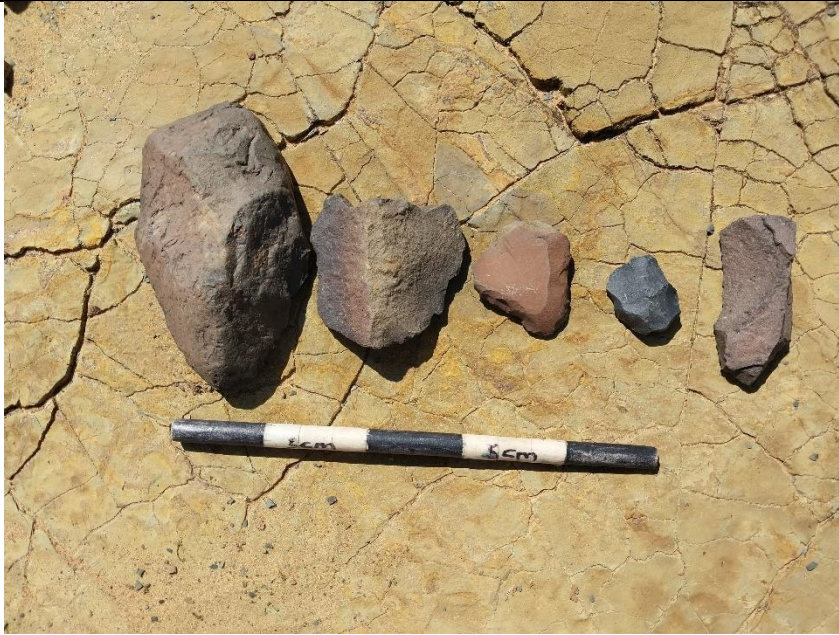
SITE NO	COORDINATES		PERIOD
DBD11	28°49'17.90"S	24° 2'56.90"E	MSA/LSA

DESCRIPTION: Near a shale bed on the edge of the Vaal River floodplain. 5 lithics: 1 handaxe, 3 scrapers, 1 blade.

HERITAGE SIGNIFICANCE	Evidence of hunter-gatherer activities during the MSA/LSA
MITIGATION	No further action required

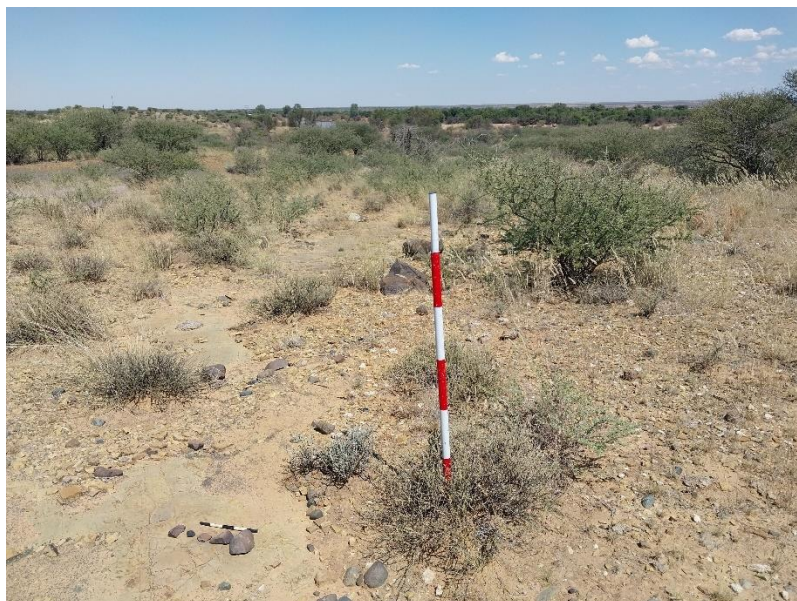
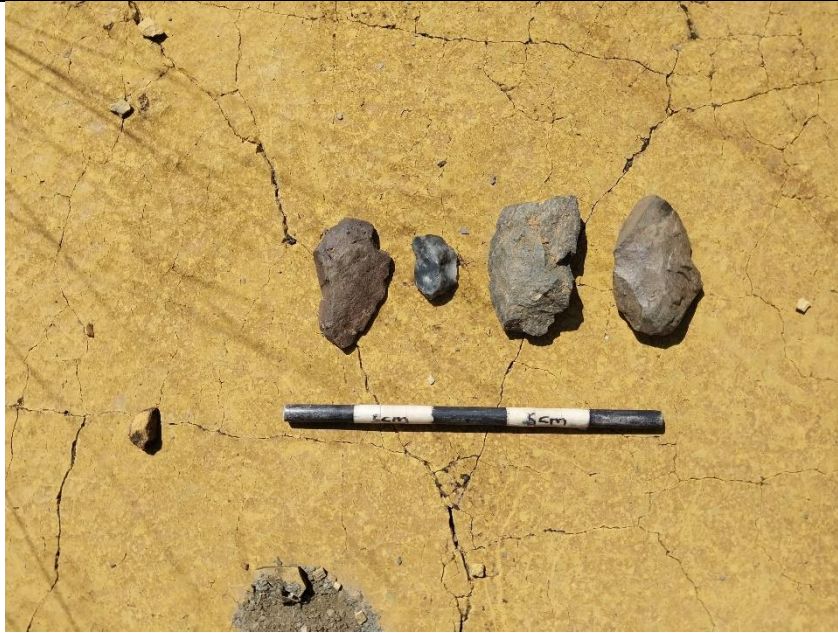
SITE NO	COORDINATES		PERIOD
DBD12	28°49'19.20"S	24° 3'4.30"E	MSA/LSA

DESCRIPTION: Near a shale bed on the edge of the Vaal River floodplain. 4 lithics: 3 blades, 1 scraper.

HERITAGE SIGNIFICANCE	Evidence of hunter-gatherer activities during the MSA/LSA
MITIGATION	No further action required

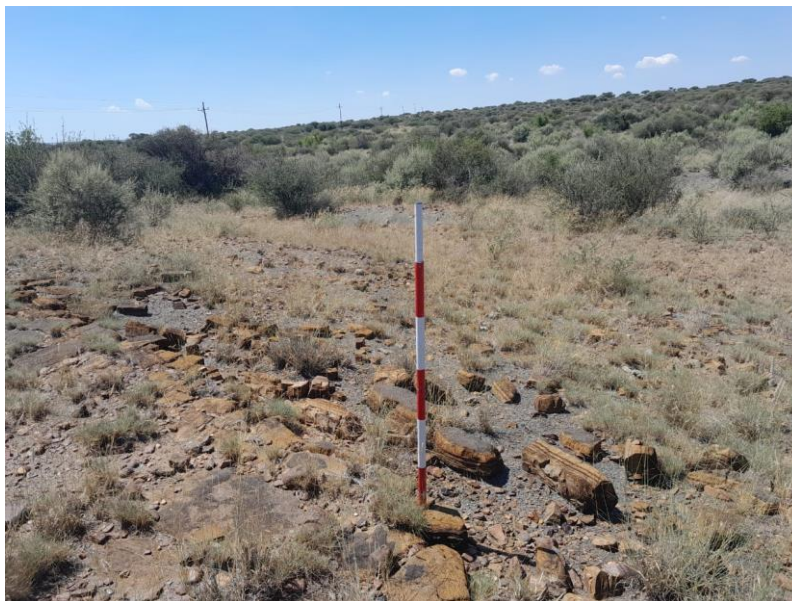
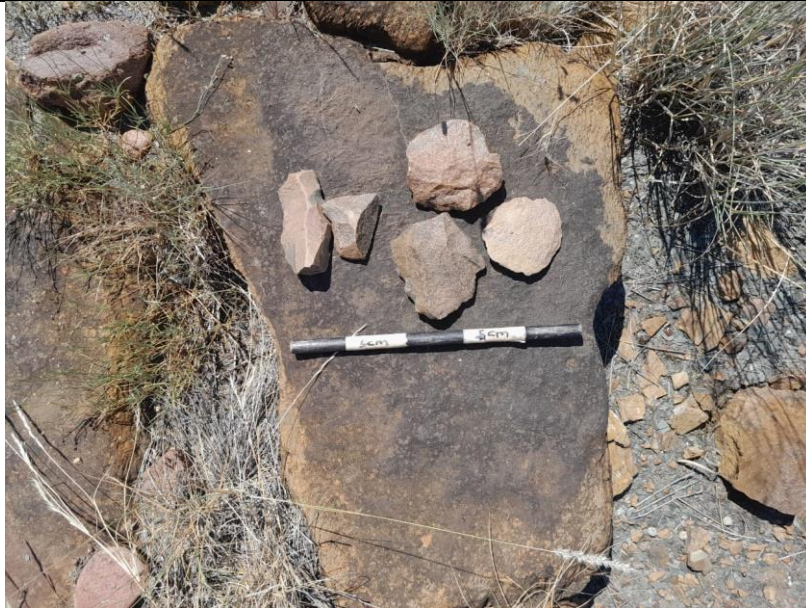
SITE NO	COORDINATES		PERIOD
DBD13	28°50'11.70"S	24° 1'54.60"E	MSA/LSA

DESCRIPTION: On the edge of a stream running north into the Vaal River. 5 lithics: 2 blades, 3 scrapers.

HERITAGE SIGNIFICANCE	Evidence of hunter-gatherer activities during the MSA/LSA
MITIGATION	No further action required

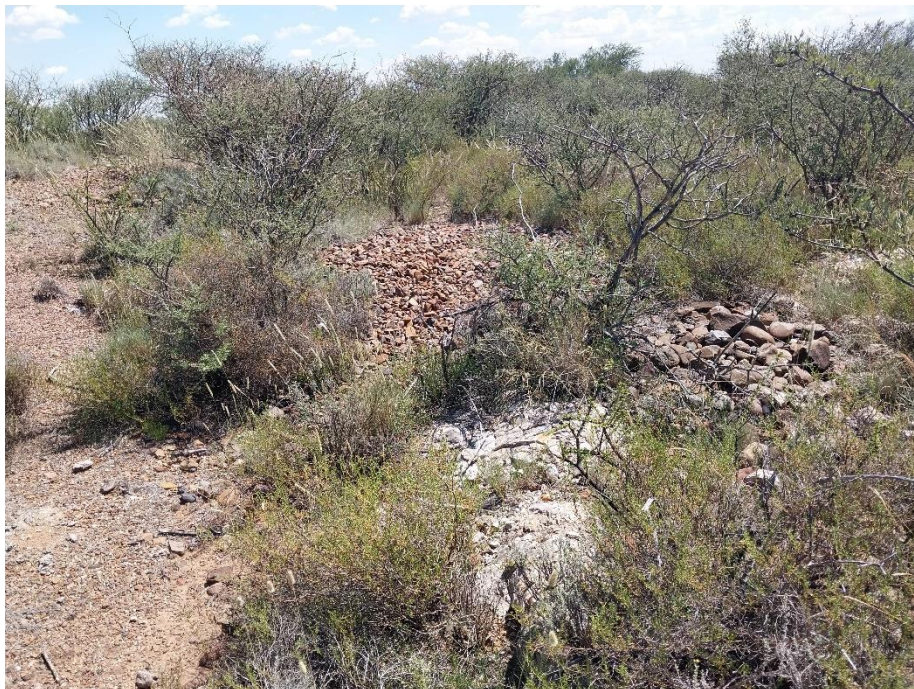
SITE NO	COORDINATES		PERIOD
DBD14	28°50'26.80"S	24° 1'59.30"E	MSA/LSA

DESCRIPTION: On the plain above the Vaal River valley. Old workings evidenced by pile of stone discard from the processing.

HERITAGE SIGNIFICANCE	Evidence of hunter-gatherer activities during the MSA/LSA
MITIGATION	No further action required
