Heritage Impact Assessment (including Palaeontological Desktop Assessment) for a Mining Right Application on Portion 2 (At Last) of Farm No 232 near Delportshoop, and Portion 2, 3, 4, 5 and 6 of the Farm De Bad 155 near Schmidtsdrift, Northern Cape Province

(UPDATED)

(A)HSA Archaeological and Heritage Services Africa (Pty) Ltd

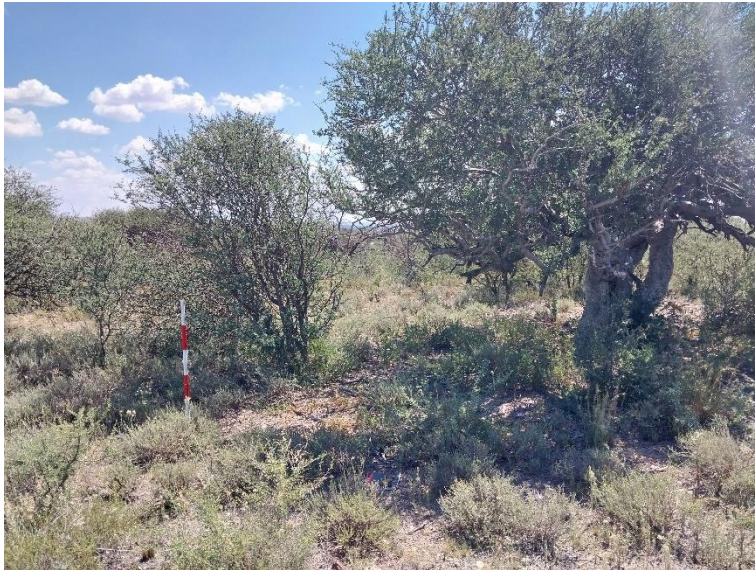
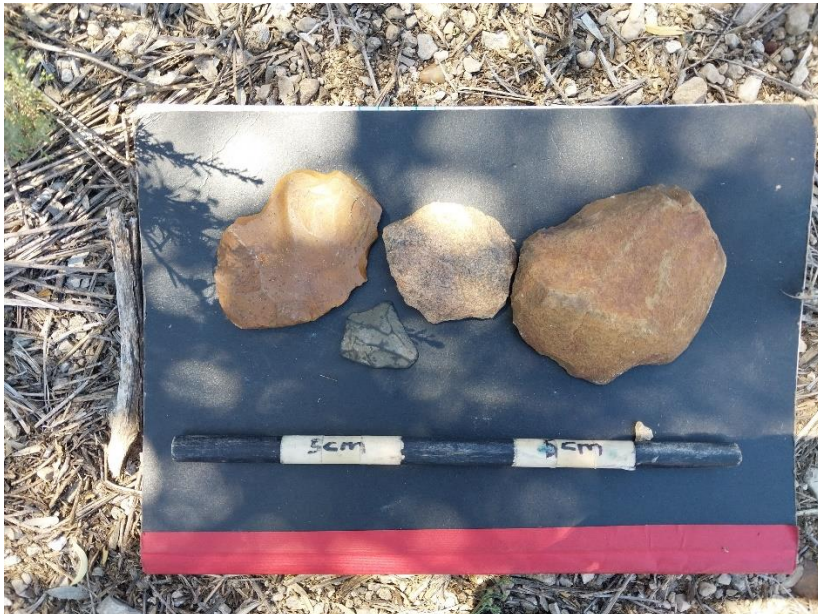
SITE NO	COORDINATES		PERIOD
DBD15	28°50'25.90"S	24° 1'58.00"	MSA/LSA

DESCRIPTION: On the plain above the Vaal River valley. 4 scrapers.

HERITAGE SIGNIFICANCE	Evidence of hunter-gatherer activities during the MSA/LSA
MITIGATION	No further action required

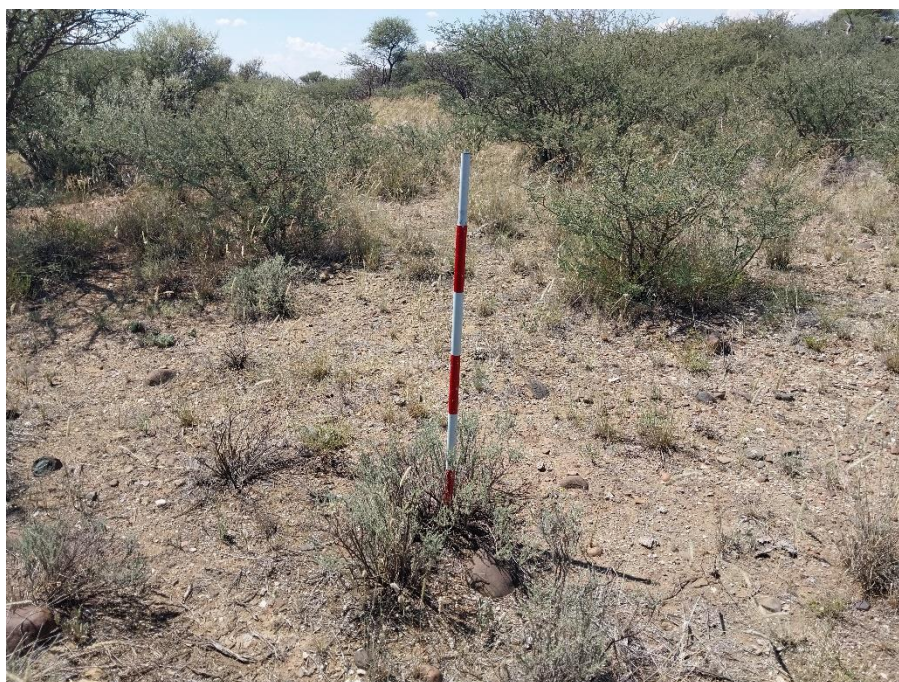
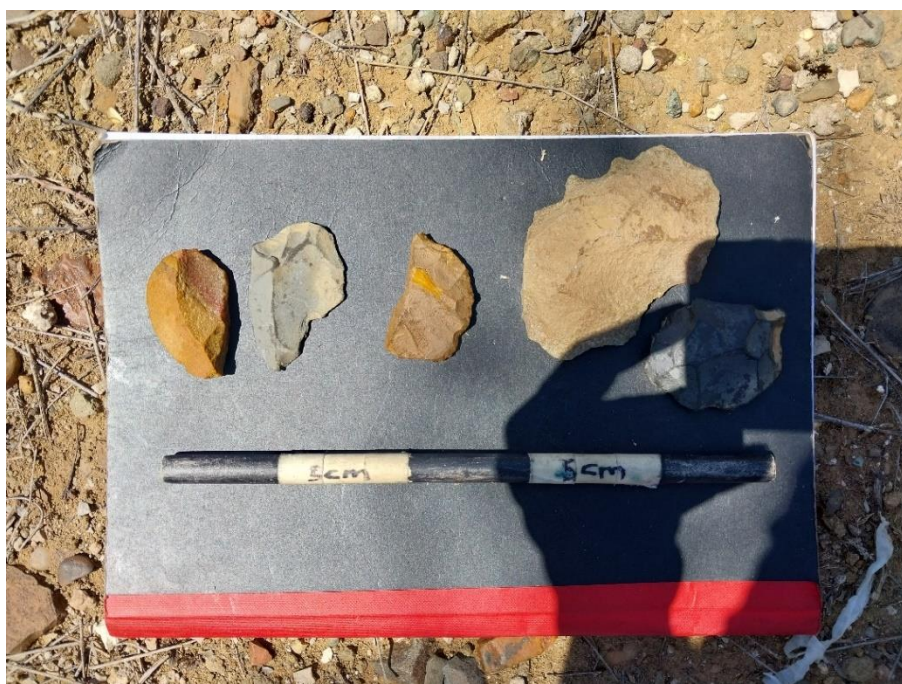
SITE NO	COORDINATES		PERIOD
DBD16	28°50'19.10"S	24° 2'2.30"E	MSA/LSA

DESCRIPTION: Close to the shoulders of the Vaal River valley. 5 lithics: 2 blades, 3 scrapers.

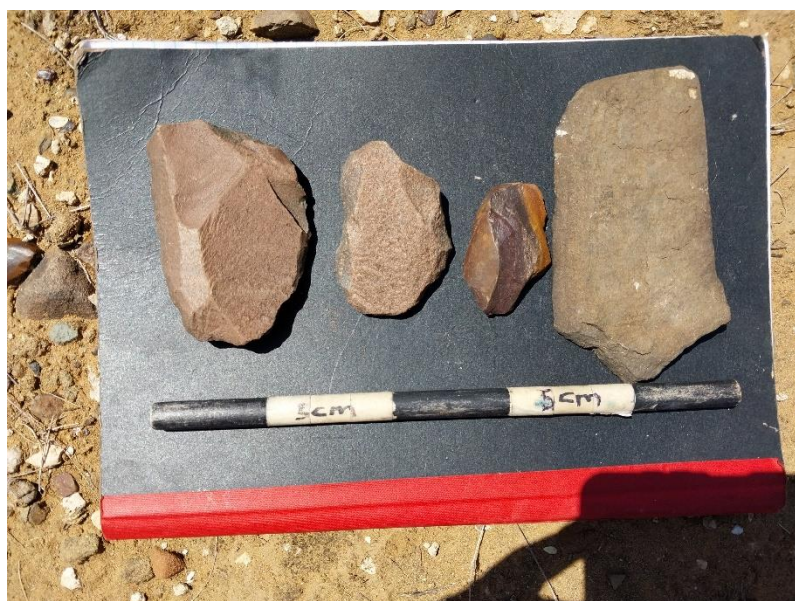
SITE NO	COORDINATES		PERIOD
DBD17	28°50'18.50"S	24° 2'0.40"E	MSA/LSA

DESCRIPTION: Close to the shoulders of the Vaal River valley. 5 lithics: 2 blades, 3 scrapers. 2 scrapers, 2 blades.

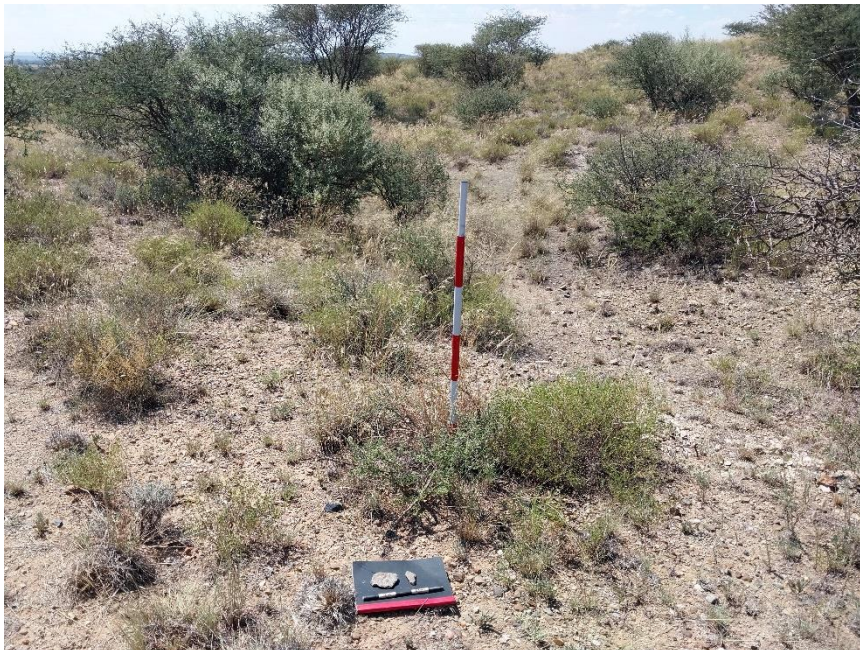
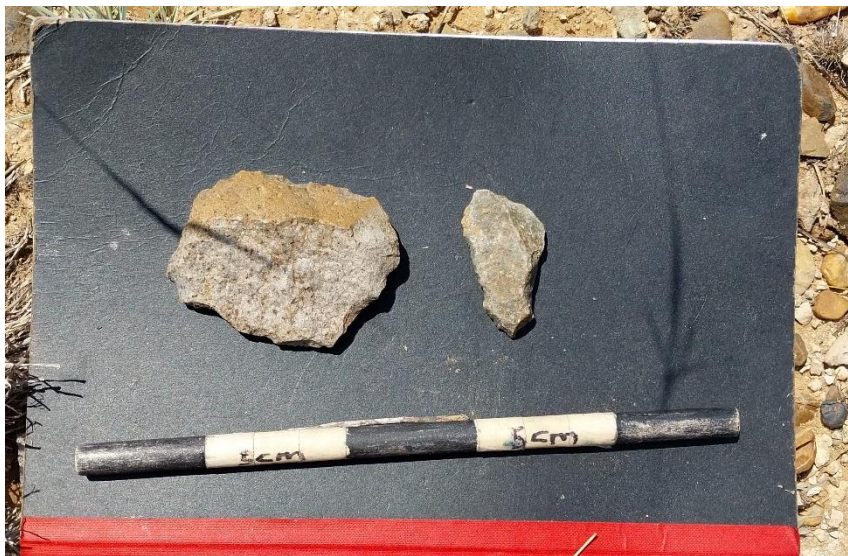
SITE NO	COORDINATES		PERIOD
DBD18	28°50'16.40"S	24° 2'11.60"E	MSA/LSA

DESCRIPTION: On the edge of a stream running into the Vaal River. 1 blade, 1 scraper.

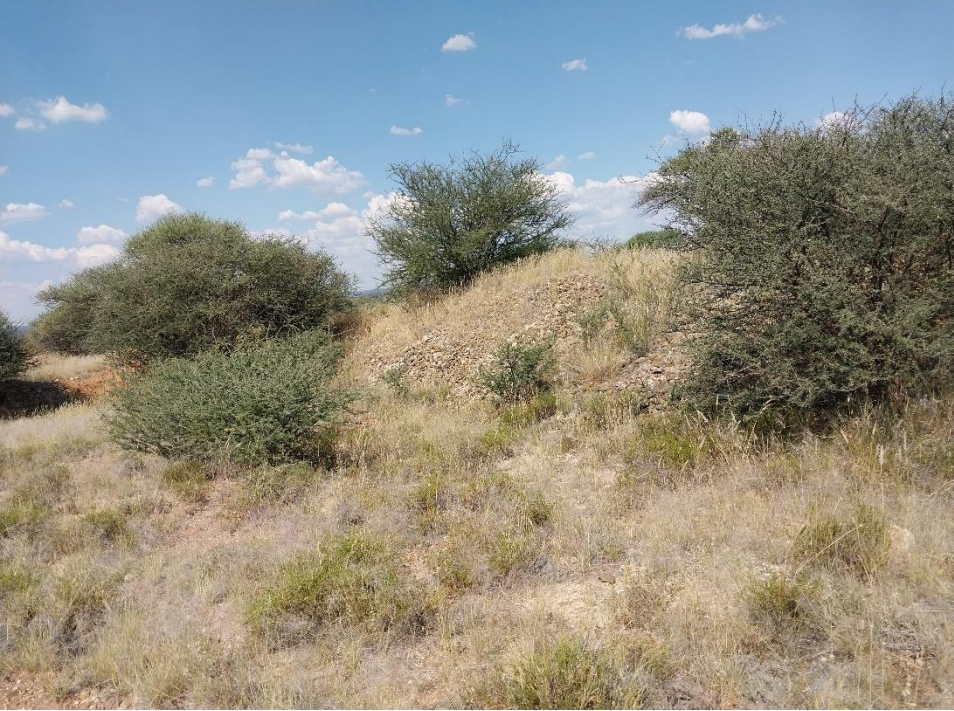
SITE NO	COORDINATES		PERIOD
DBD19	28°50'7.90"S	24° 1'16.50"E	MSA/LSA

<p>DESCRIPTION: Old workings. Pile of stone discard from a screening process.</p>			
HERITAGE SIGNIFICANCE		Evidence of hunter-gatherer activities during the MSA/LSA	
MITIGATION		No further action required

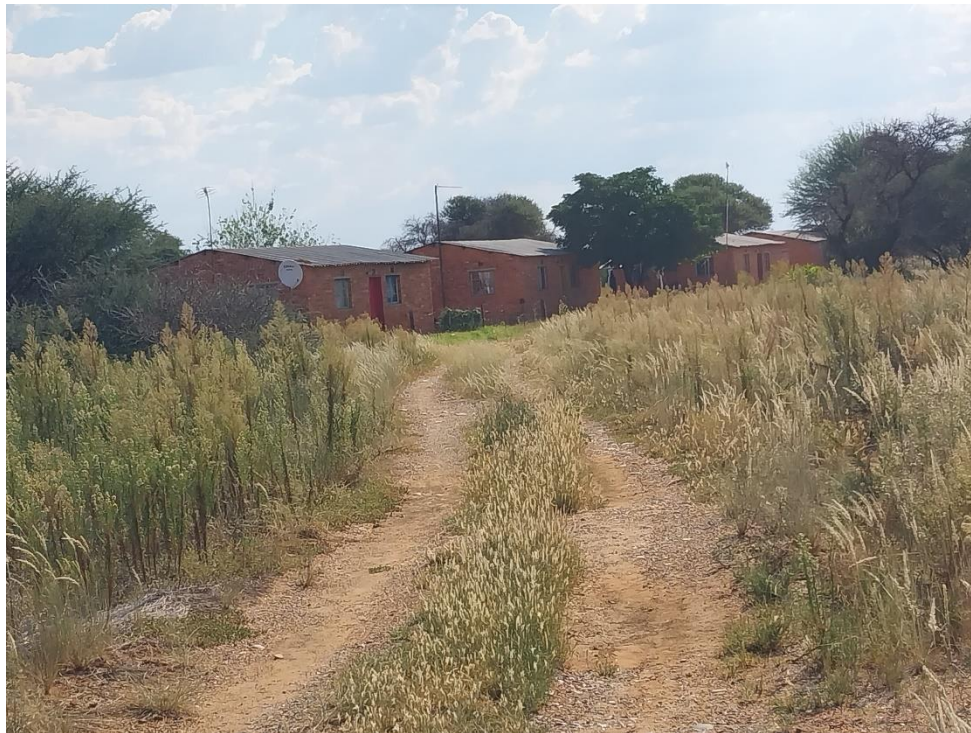
SITE NO	COORDINATES		PERIOD
DBD21	28°50'13.97"S	24° 1'2.68"E	MSA/LSA

DESCRIPTION: Workers' houses located near the Vaal River.

There is a cluster of simple un-plastered (brick face) houses for farm workers located in the prospecting area. The houses are considered of low heritage significance. A cairn field located near the irrigated fields is not a burial ground, but piles of stones cleared when the fields were first prepared (DBD22).

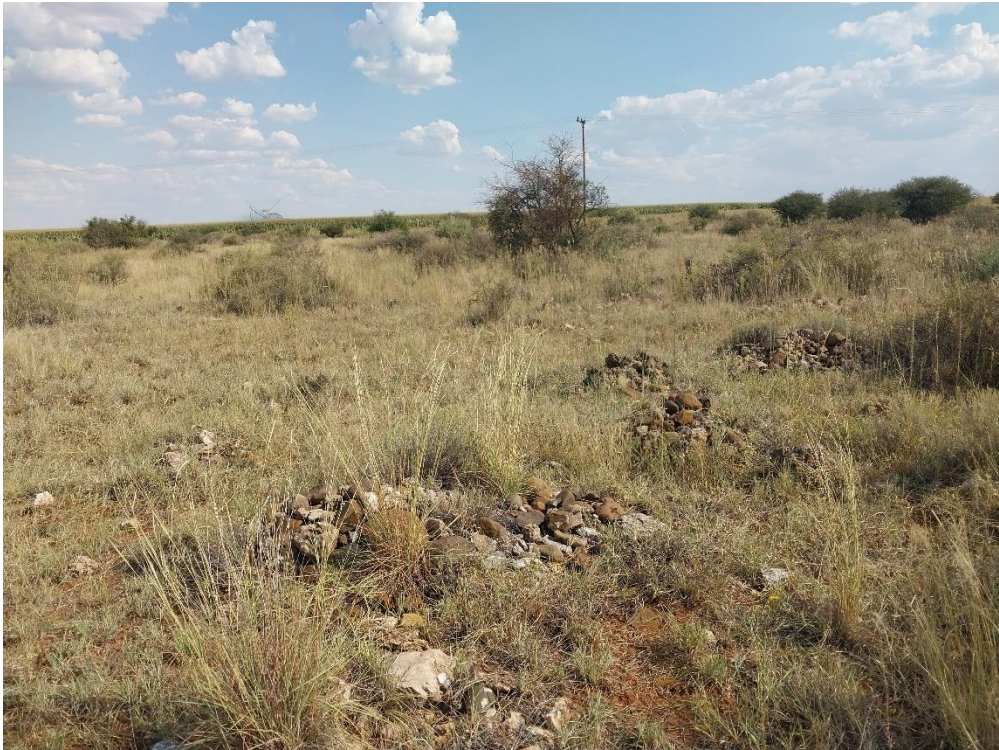
SITE NO	COORDINATES		PERIOD
DBD22	28°50'27.40"S	24° 1'17.20"E	MSA/LSA

<p>DESCRIPTION: Close to circular irrigation fields. The cairns appear to be stones cleared when the fields were first prepared.</p>			
HERITAGE SIGNIFICANCE	Evidence of hunter-gatherer activities during the MSA/LSA		
MITIGATION	No further action required
