BASIC ASSESSMENT REPORT:

**THE UPGRADING OF THE
RIMER'S WATER TREATMENT
(PURIFICATION) WORKS,
BARBERTON**

Report prepared for: Umjindi Local Municipality

Report dated: June 2015 (draft)

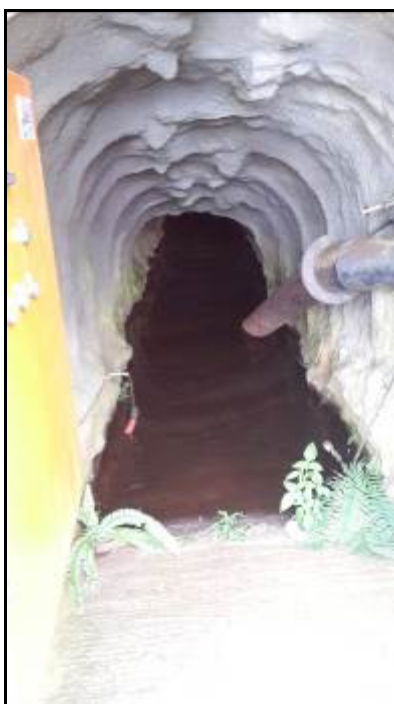
Photo 3.1: View of Saddleback Tunnel (close to outfall) (taken from Kotze, 2015)

Water from the Lomati Dam flows through the Saddleback Tunnel (Photo 3.1) and is released into the Rimer's Creek Weir located upstream of the Works (Photo 3.2). From the diversion weir (Photo 3.3), water is diverted via a 300mm diameter steel gravity supply pipeline (Photo 3.4) to the Works.

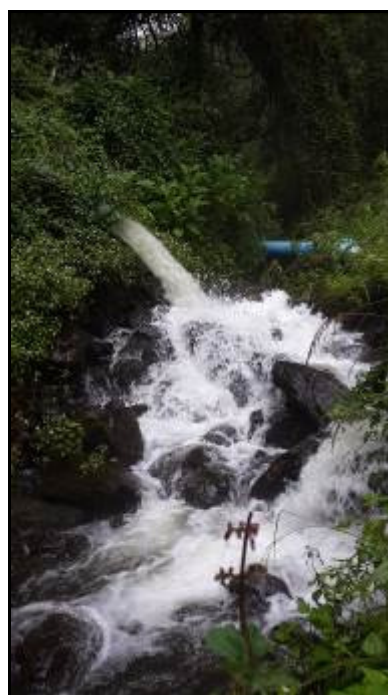
Photo 3.2: View of Lomati water transfer site (taken from Kotze, 2015)

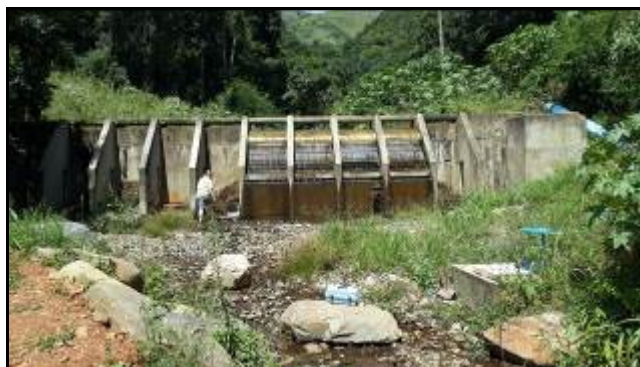
Photo 3.3: View of diversion weir (taken from Kotze, 2015)

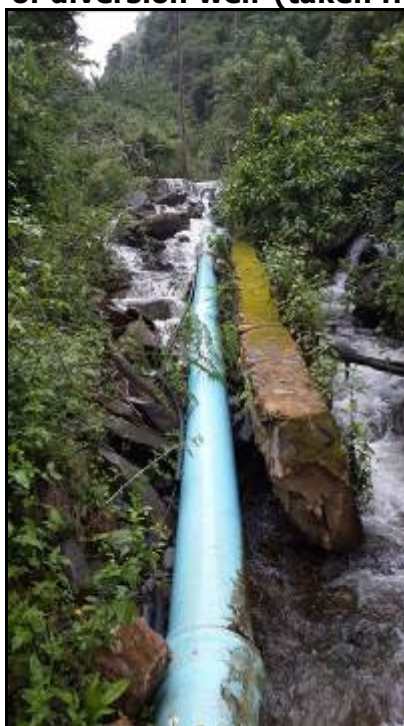
Photo 3.4: View of pipeline (taken from Kotze, 2015)

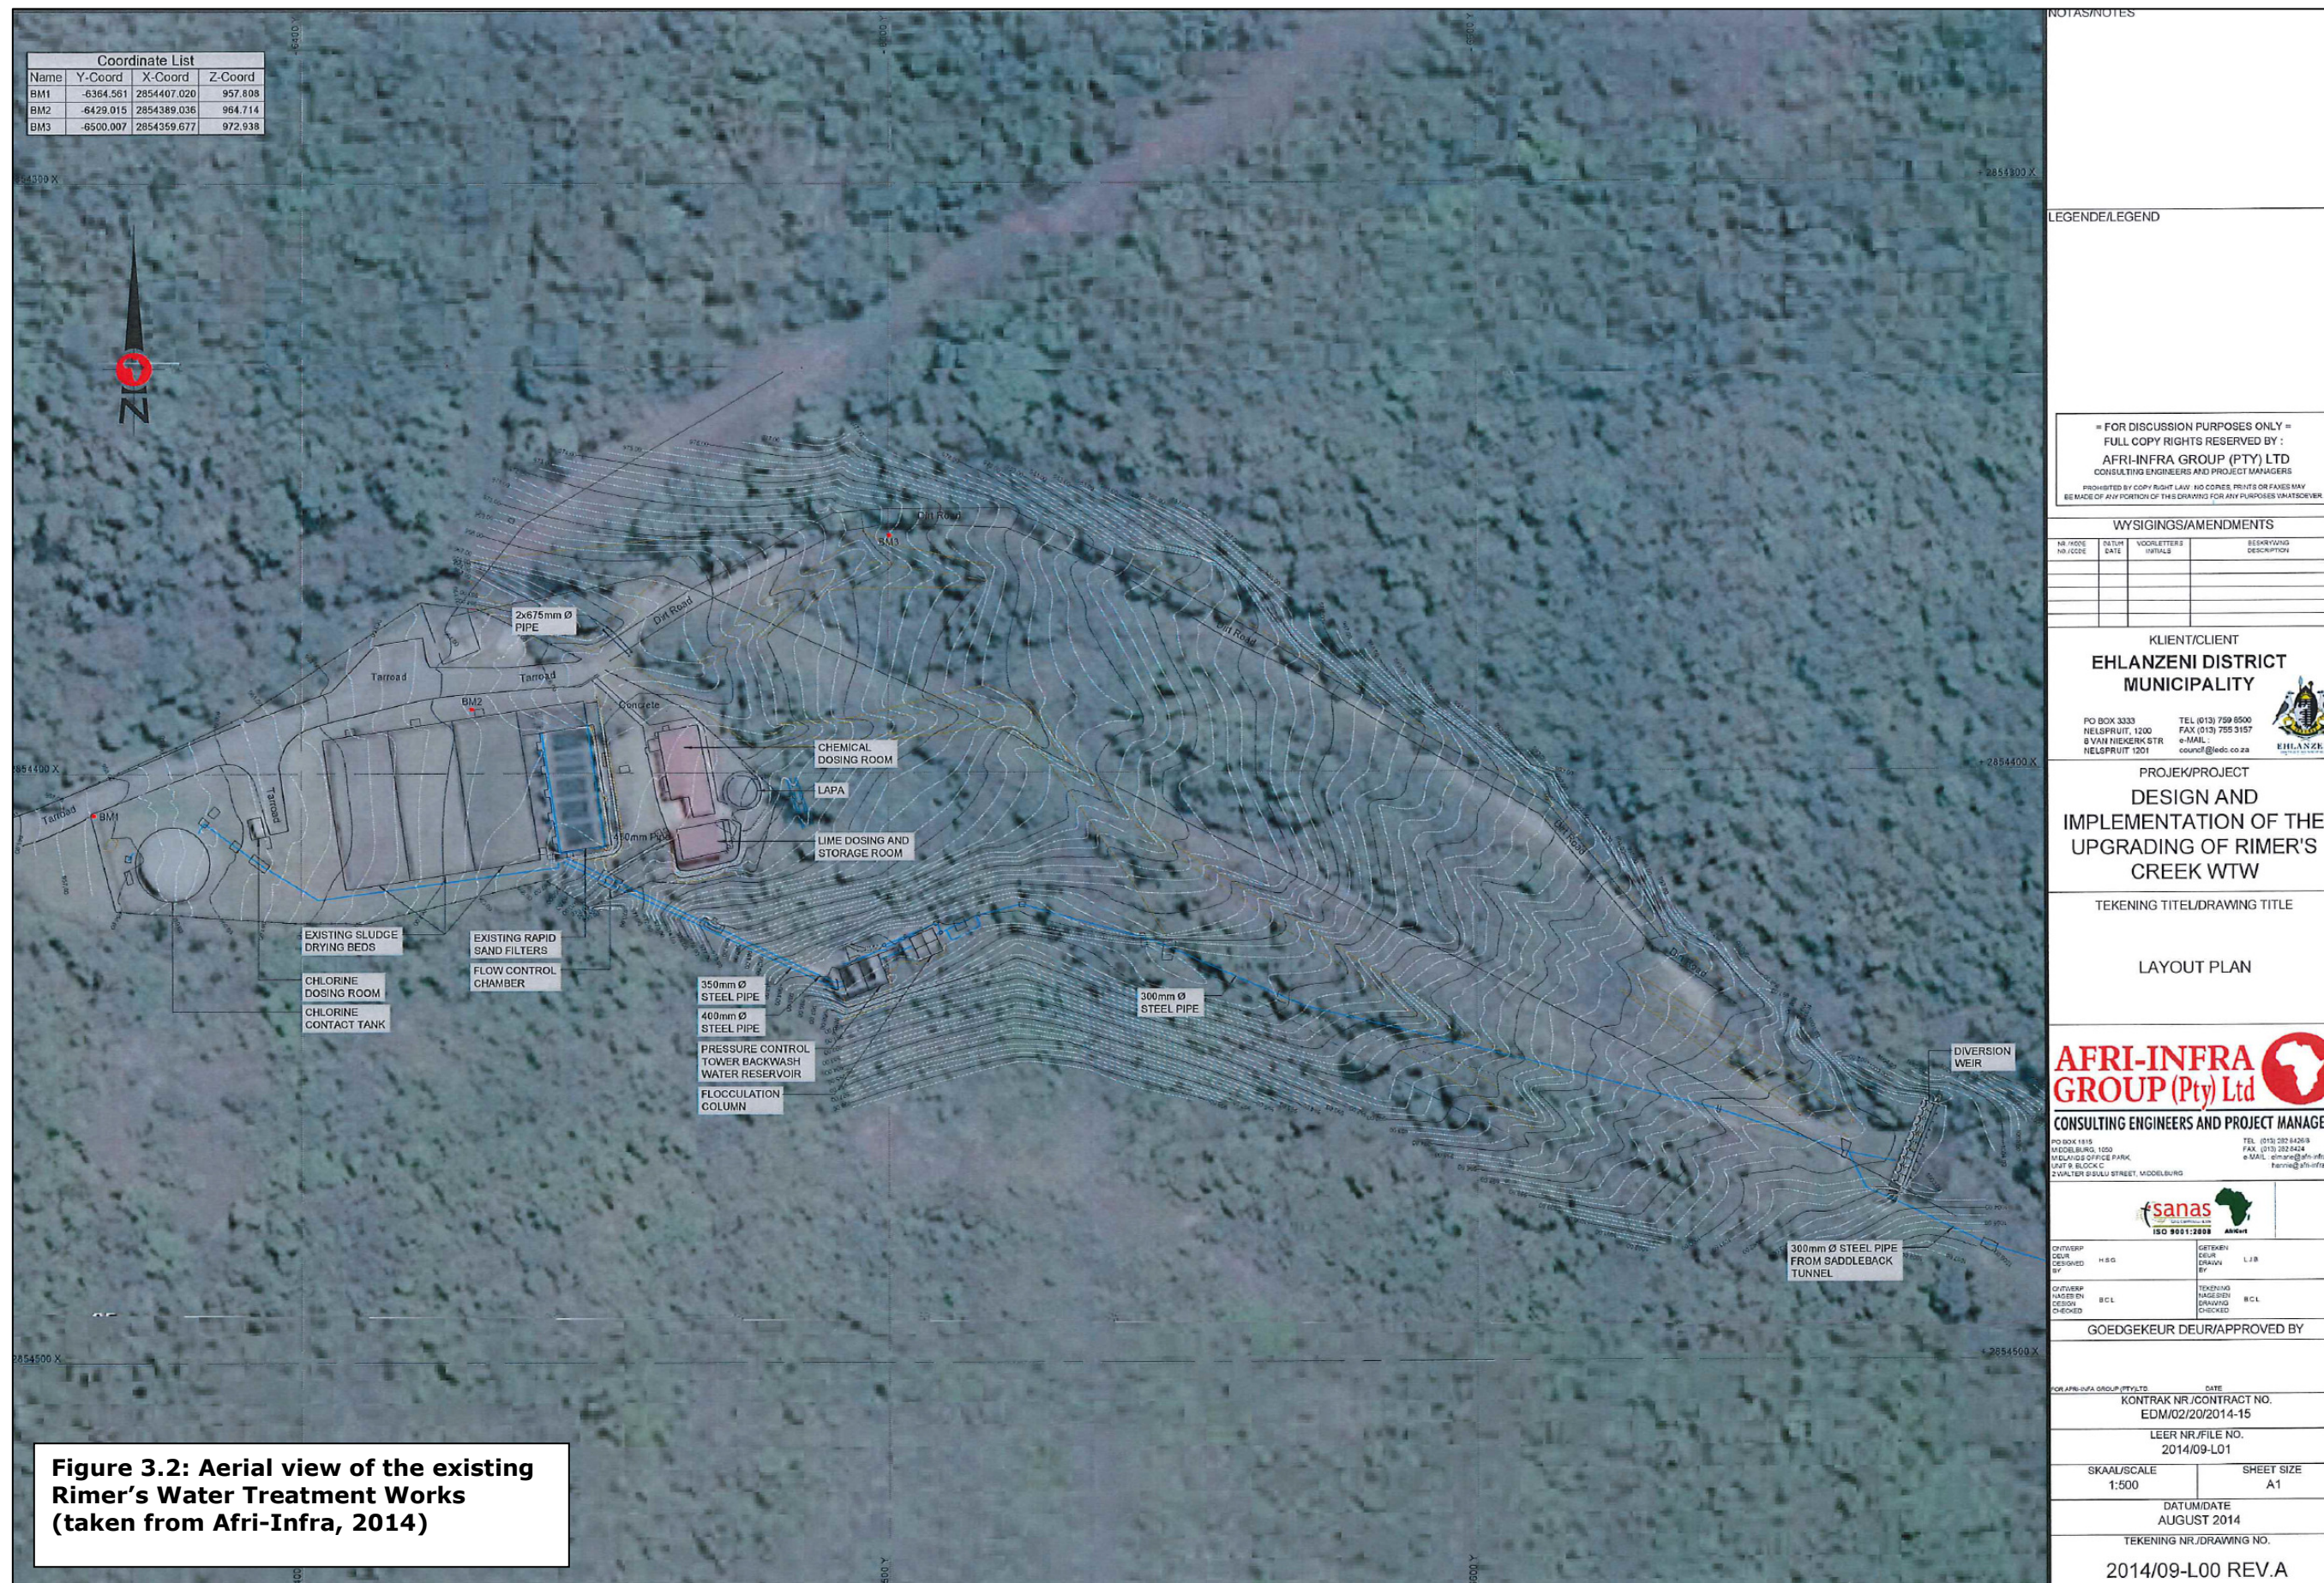
Figure 3.2: Aerial view of the existing Rimer's Water Treatment Works (taken from Afri-Infra, 2014)

Figure 3.1 provides the layout of the existing Rimer's Water Treatment Works while Figure 3.2 provides an aerial view thereof.

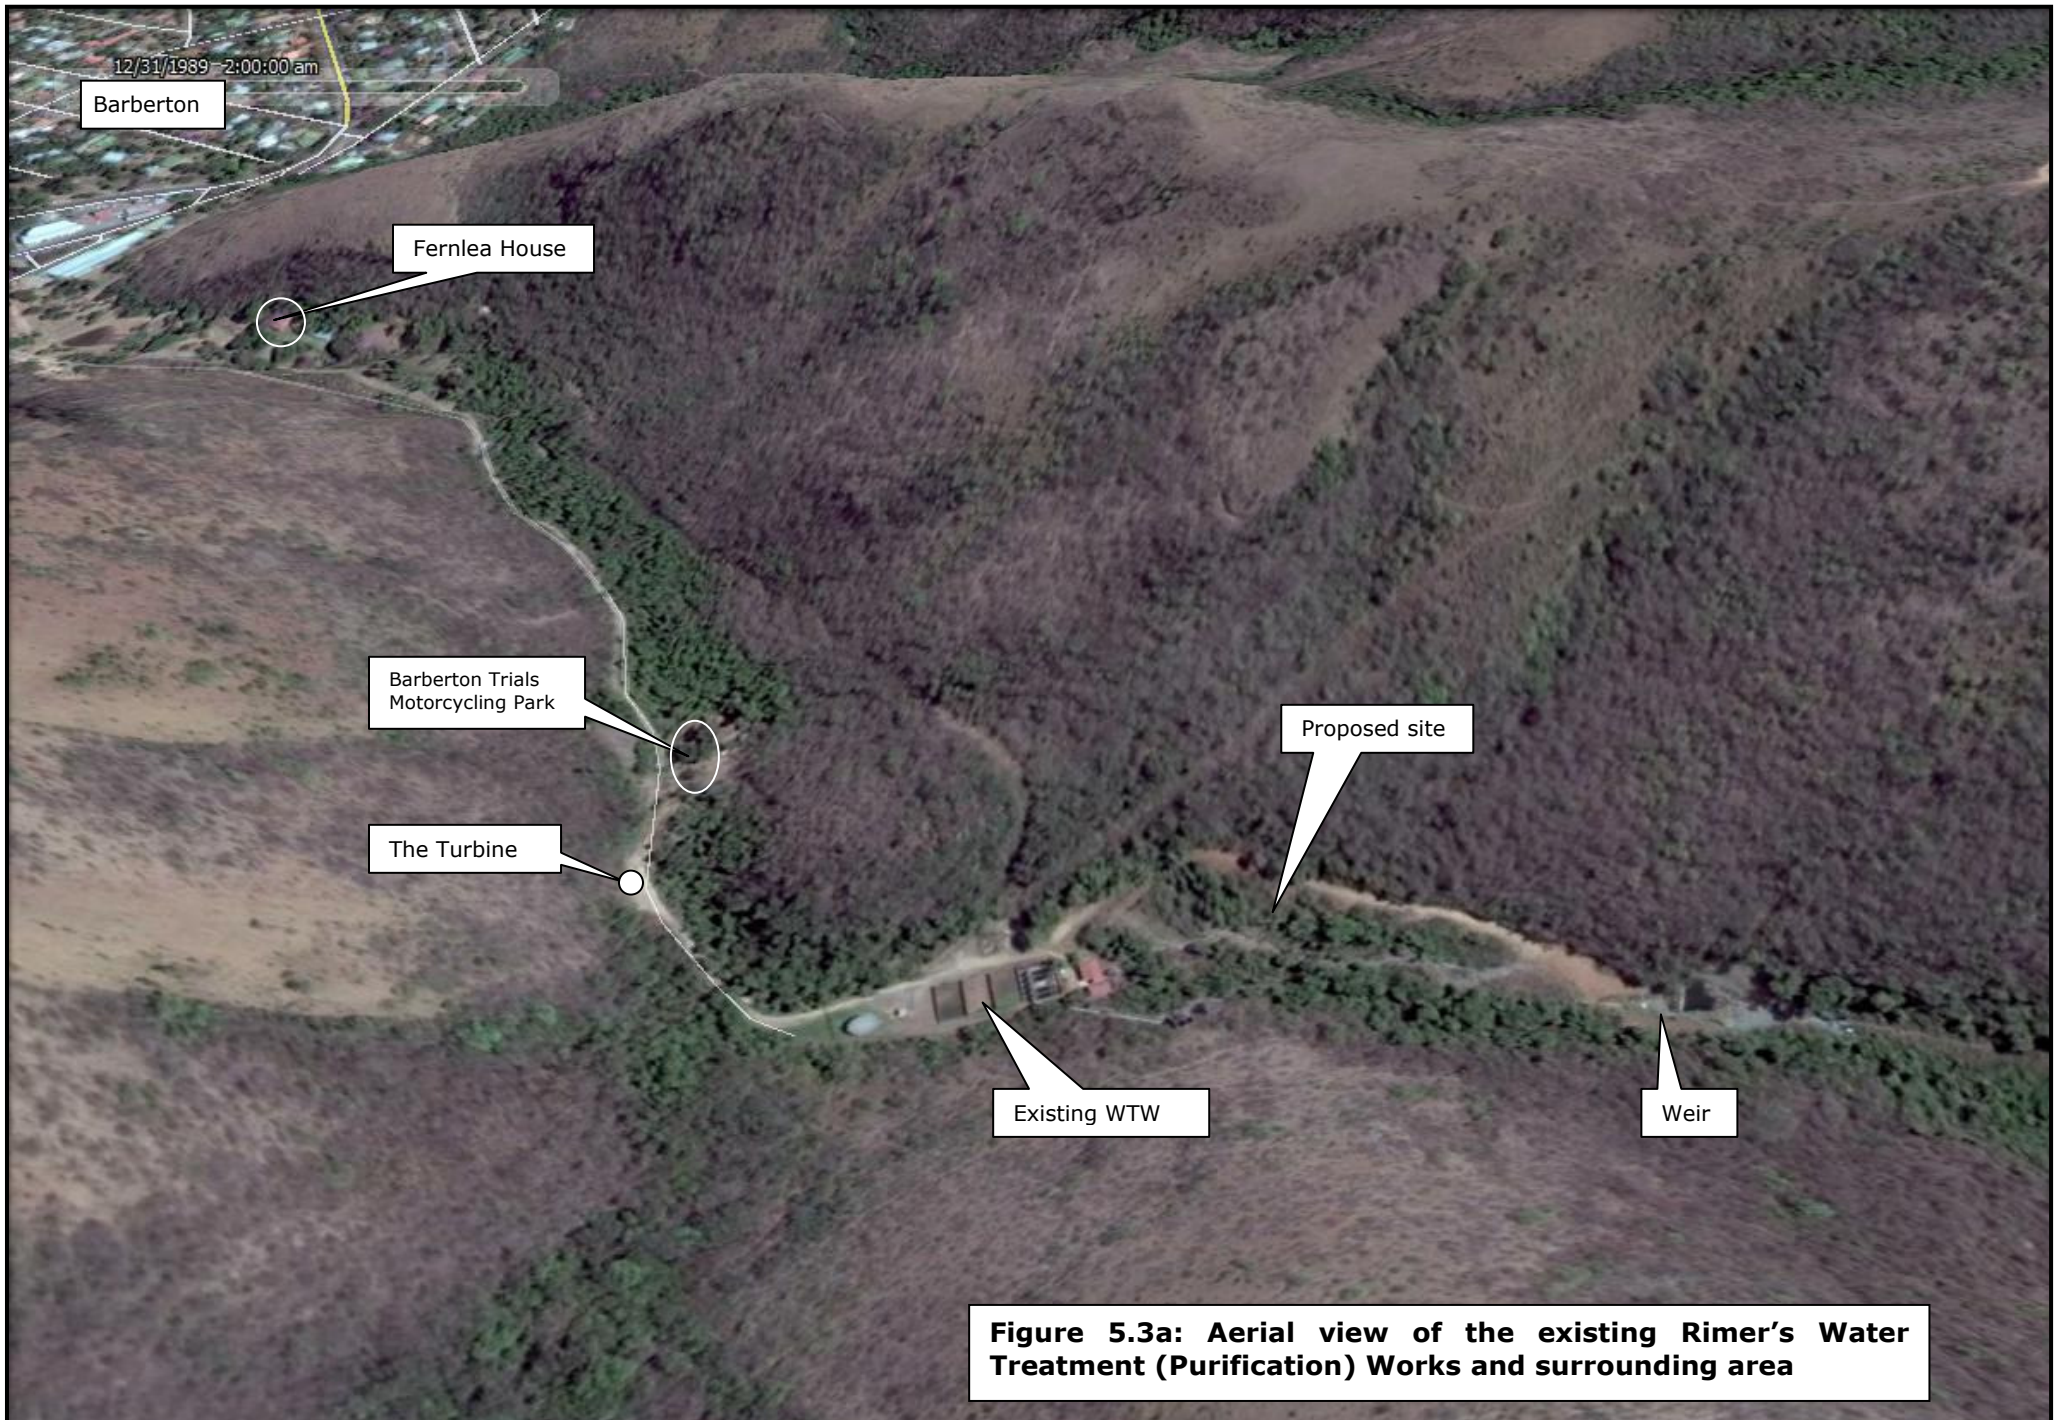
Figure 5.3a: Aerial view of the existing Rimer's Water Treatment (Purification) Works and surrounding area

As indicated in Figure 5.2, the surrounding land use is nature conservation (i.e. Barberton Private Nature Reserve). However, the said area is also used for activities other than nature conservation. The Barberton Trials Motorcycling Park (Photo 5.1) is located downstream of the site as indicated in Figure 5.3a.

Two heritage sites, The Turbine and Fernlea House, are located downstream of the site as indicated in Figure 5.3a. Further details regarding these sites are provided in Section 5.14 of this report.

Fernlea House (a wood and iron house built in the early 1890's for Mrs. Emily Fernandes) is located about 1 km towards the northwest of the WTW (Figure 5.3a and Photo 5.4). Today this building houses an exhibition mainly about Rimer's Creek and the restoration of the house. It is unlikely that Fernlea House will be directly impacted upon in terms of the proposed development.

The Gilbert Gikes and Gordon Turbine (referred to as the Turbine) is situated about 720 metres from Fernlea House (Figure 5.3a) and was installed in 1931 to purify the town's water. This turbine was manufactured in Kendal, Cumbria, England. In 1986 the turbine was donated to the museum and reinstalled in its original building (Photo 5.5).

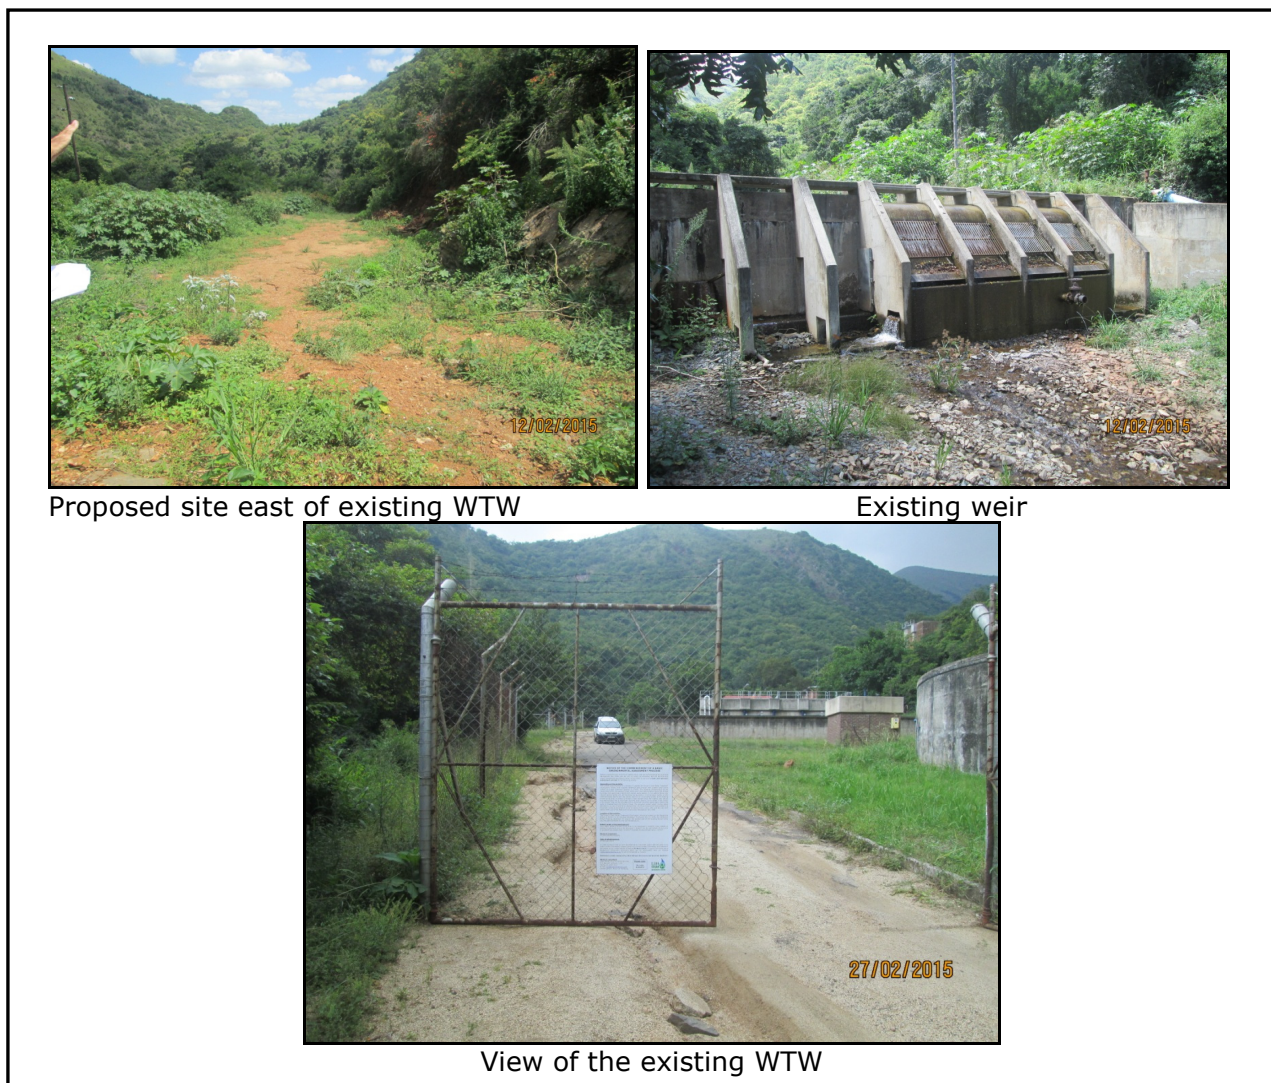
Figure 5.3b: Photographic view of the site

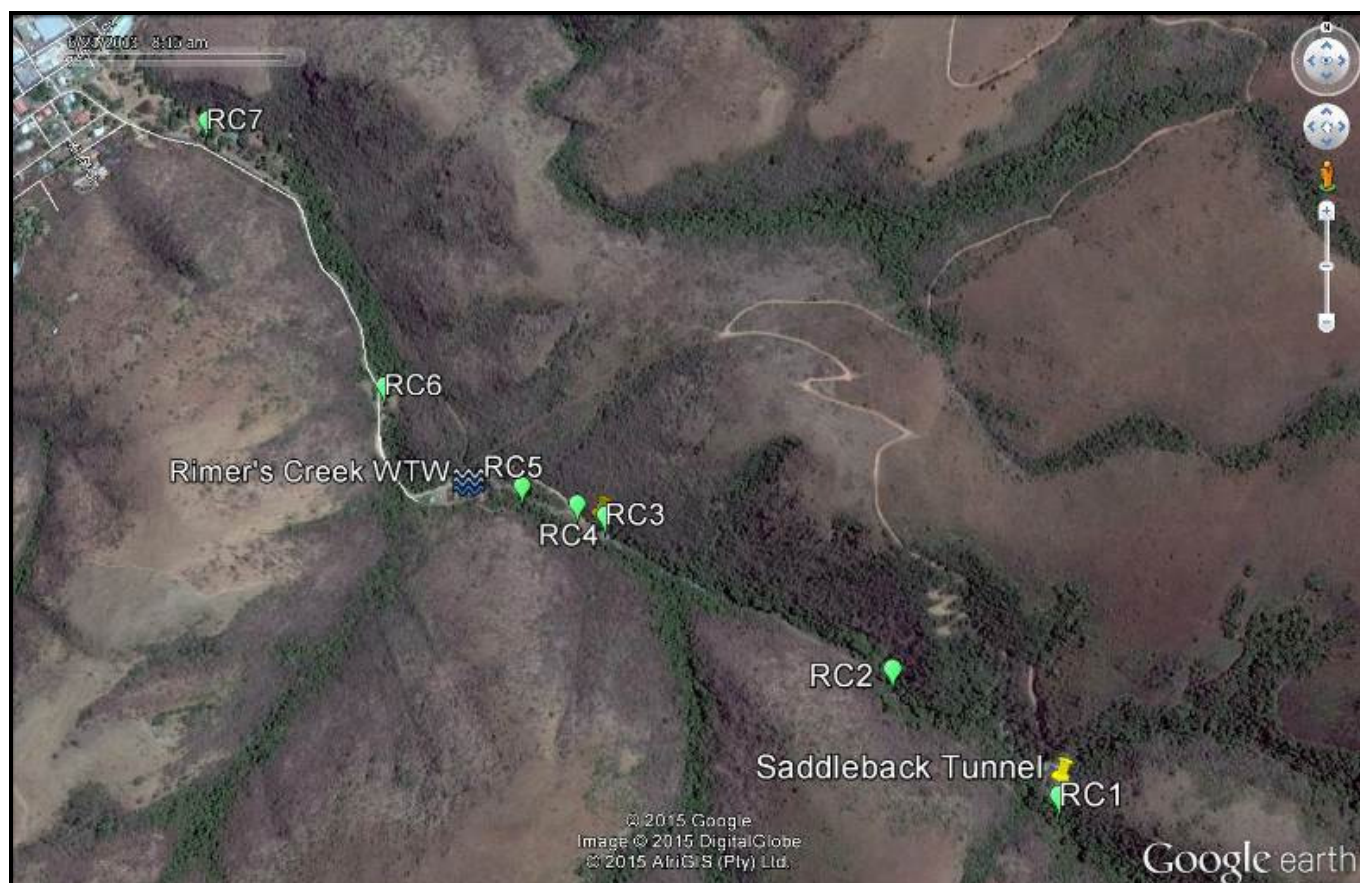
Within each reach, aquatic sampling points as indicated in Table 5.14 and Figure 5.13 were identified.

Figure 5.13: Four reaches and aquatic sampling points
