FINAL BASIC ASSESSMENT REPORT:

**THE DEVELOPMENT OF A
NEIGHBOURHOOD SHOPPING CENTRE
ON ERF 1051
(ZONED PUBLIC OPEN SPACE),
ROCKDALE, MIDDELBURG**

Report dated: September 2020 (final)

Report number: BA 2020/02

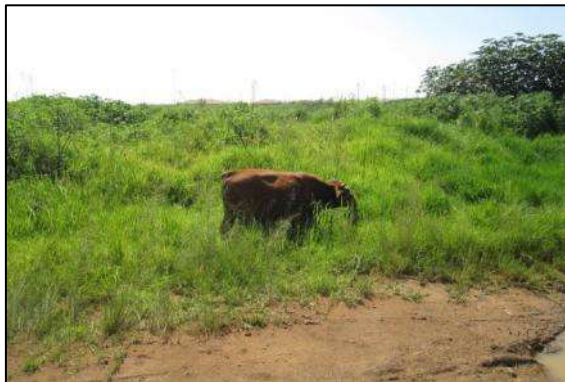
Photo 5.2: Cattle grazing on site

The site is currently used by the surrounding residents for the dumping of building rubble, garden and domestic waste (Photo 5.3) as well as grazing (cattle; Photo 5.2).

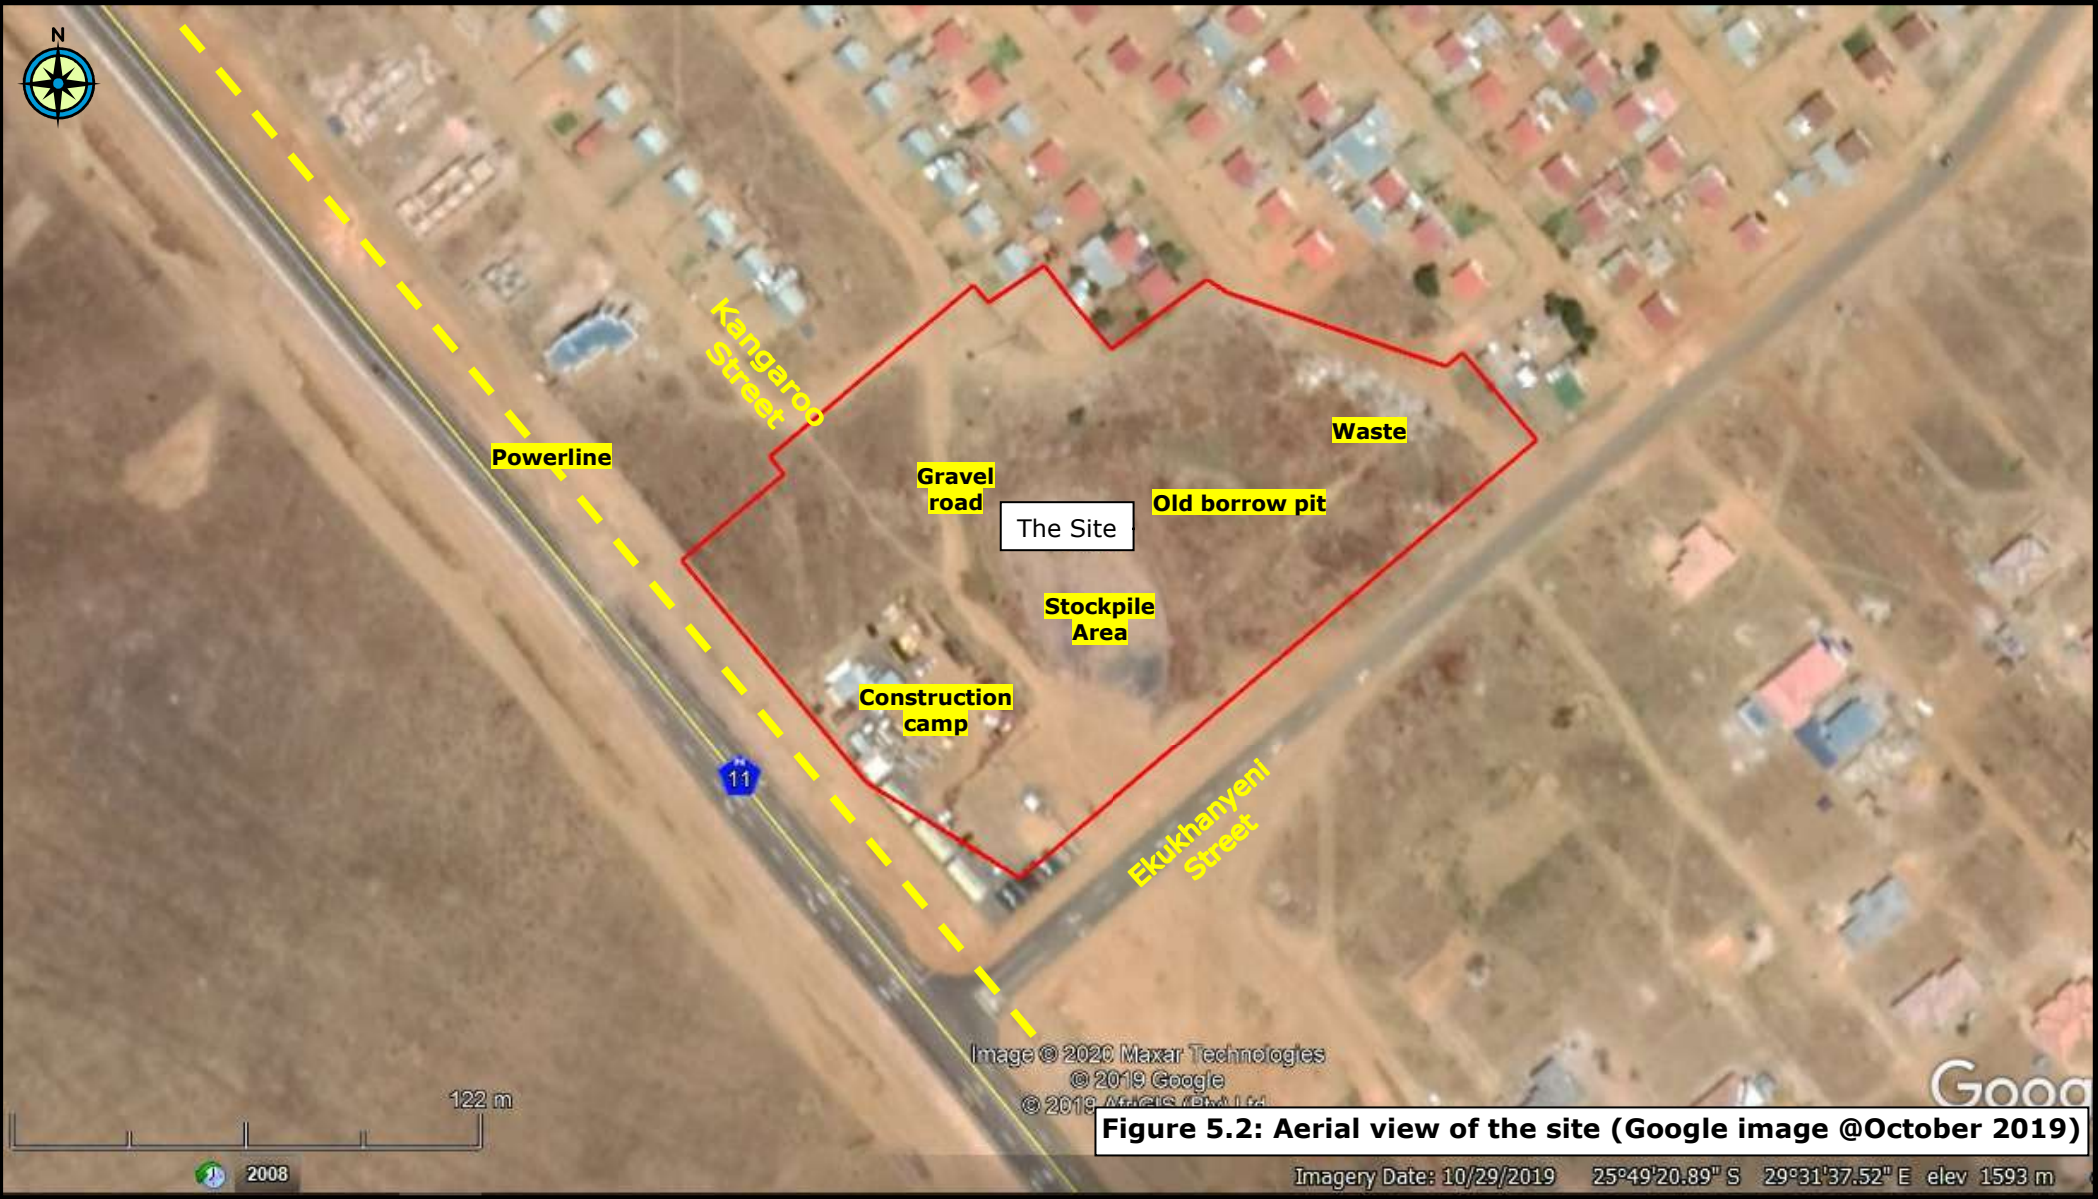
Figure 5.2: Aerial view of the site (Google image @October 2019)

An informal gravel road extends through the western portion of the site connecting Ekukhanyeni and Kangaroo Streets (Photo 5.6). As indicated in Figure 5.2, the site is abutted by roads, which form part of the Rockdale internal road network.

The proposed neighbourhood shopping centre will be located within an already built up area (Figure 5.2 and 5.3). The proposed height of the buildings will be restricted to two storeys as indicated in Section 3.1.3. It is therefore not expected that the proposed neighbourhood shopping centre will impact on any aviation paths. The sensitivity rating for the Civil Aviation Theme should therefore be **Low**.

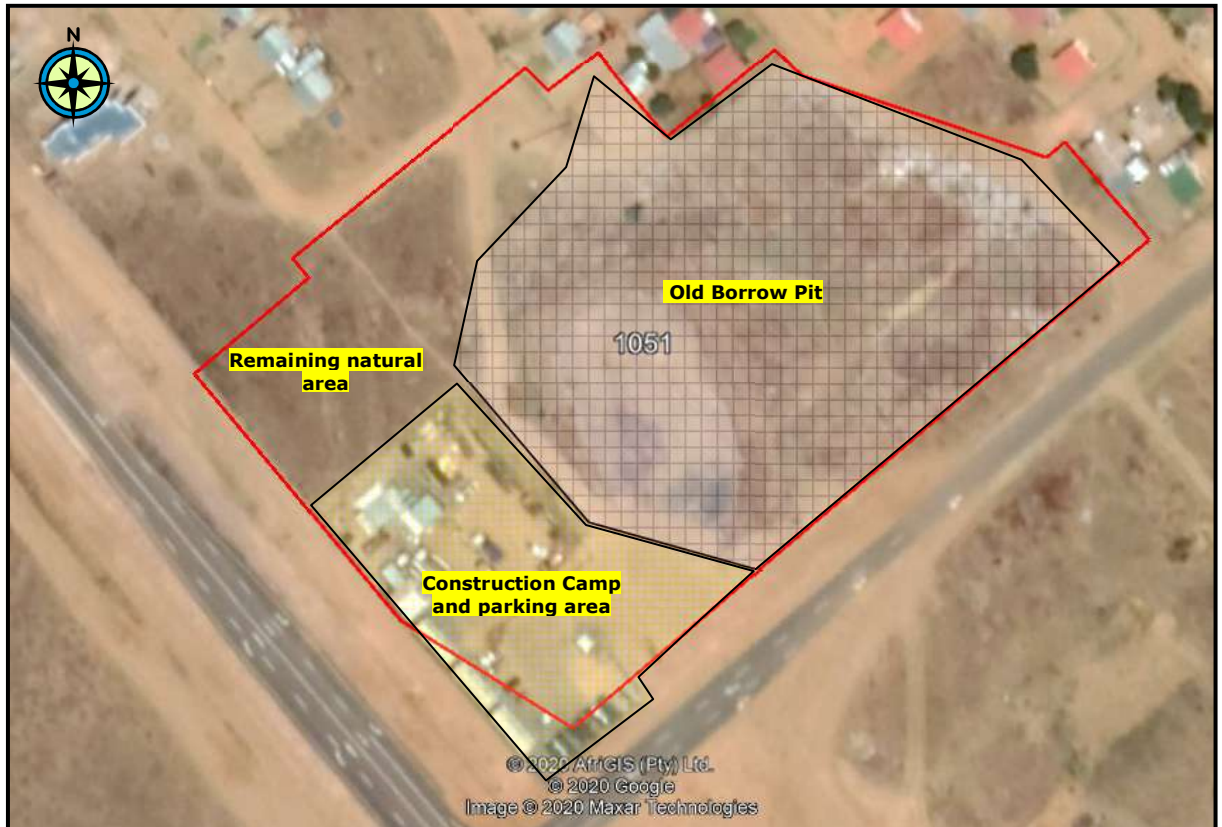
Figure 5.6: Aerial view indicating the extent of historical disturbance on site.

Figure 5.6 provides an aerial view of the site and a preliminary indication of the extent of the original borrow pit. The geology of a large portion (approximately 60%; 1.2ha) of the site was thus impacted by the excavation of the borrow pit. The geology of the remaining 40% (0.4ha) was not impacted (Figure 5.6).

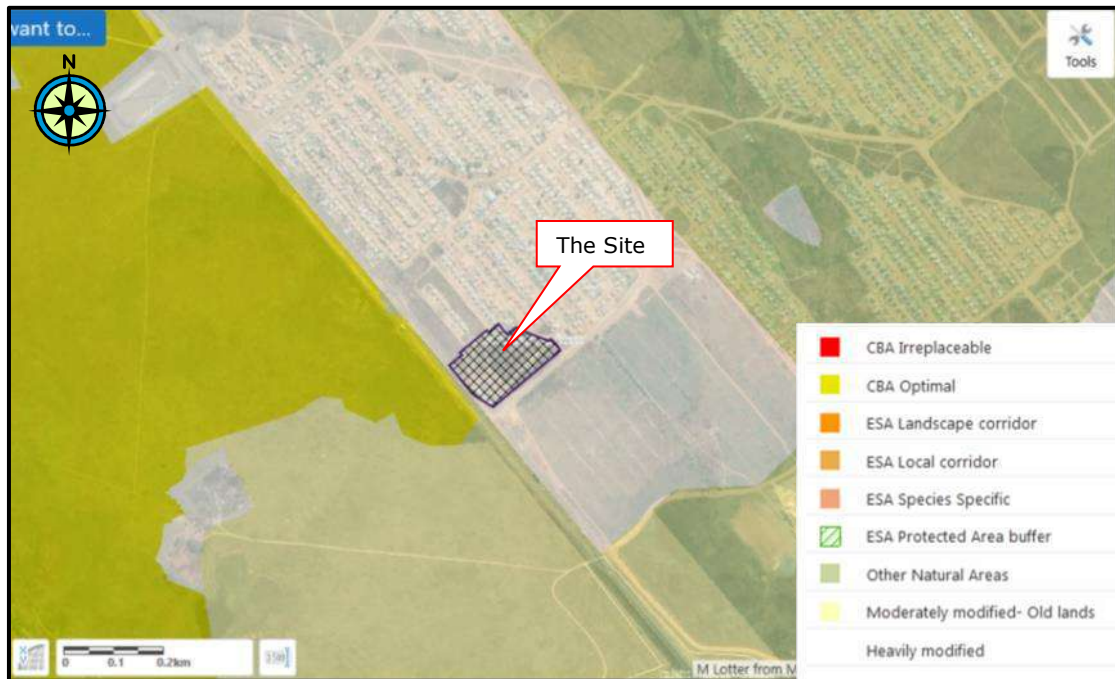
Figure 5.15: Terrestrial biodiversity assessment of the Mpumalanga Biodiversity Sector Plan, 2013

According to the MBSP (2013), the site is classified as '**Heavily Modified**' (Figure 5.15). No Critical Biodiversity Areas, Ecological Support Areas or Ecological Corridors are present on site (Figure 5.15 and 5.17). The closest Critical Biodiversity Area (CBA: Optimal) is located to the west of the site, i.e. on the other side of the N11 national road (Figure 5.15).

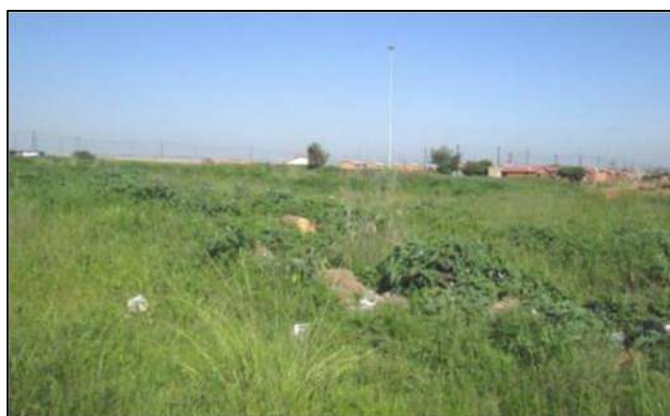
Photo 5.9: A view of the vegetation indicative of disturbance within the old borrow pit area

The Initial Site Sensitivity Investigation conducted by AdiEnvironmental (5 December 2019, 31 January and 14 February 2020) confirmed that the majority of the site comprises an old borrow pit ($\pm 60\%$; 1.2ha of the site; Figure 5.6), which was never rehabilitated. It is now used by the surrounding community for the dumping of building rubble, garden and domestic waste (Photo 5.8). The old borrow pit area (Figure 5.16) consists mainly of plant species indicative of disturbance (Photo 5.9) as indicated in Table 5.1. A number of weeds and alien invasive species were recorded (Table 5.1).

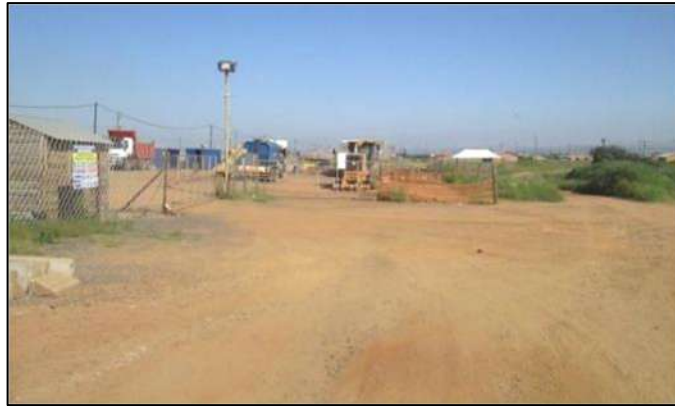
Photo 5.10: Area where vegetation was completely removed

The vegetation over $\pm 20\%$ of the site (0.4ha) was cleared for the construction camp and parking area (Photo 5.10 and Figure 5.16). In addition, vegetation was also cleared within the borrow pit for the storage of construction material and the construction of gravel roads (Figure 5.16).

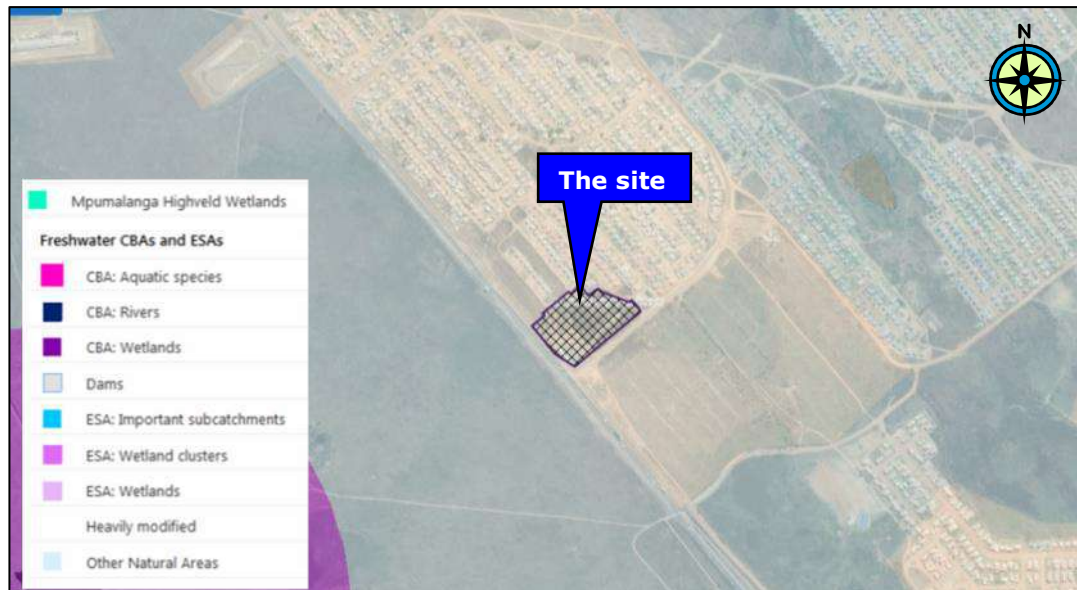
Figure 5.17: Freshwater biodiversity assessment of the Mpumalanga Biodiversity Sector Plan, 2013

No Critical Biodiversity Areas (CBA's) for aquatic species or Ecological Support Areas (ESA's) for fish are present on or near the site (Figure 5.17).

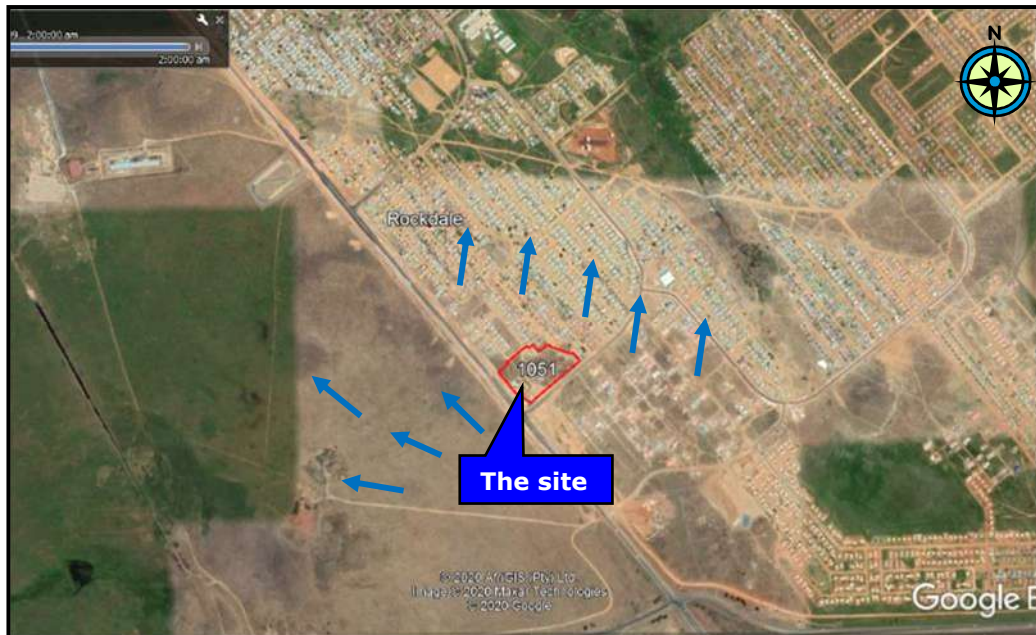
Figure 5.18: Surface flow direction

Surface water from the western portion of the site (construction camp and cleared area) flows in a north easterly direction towards the gravel road and construction material storage area where it ponds (Photo 5.14).

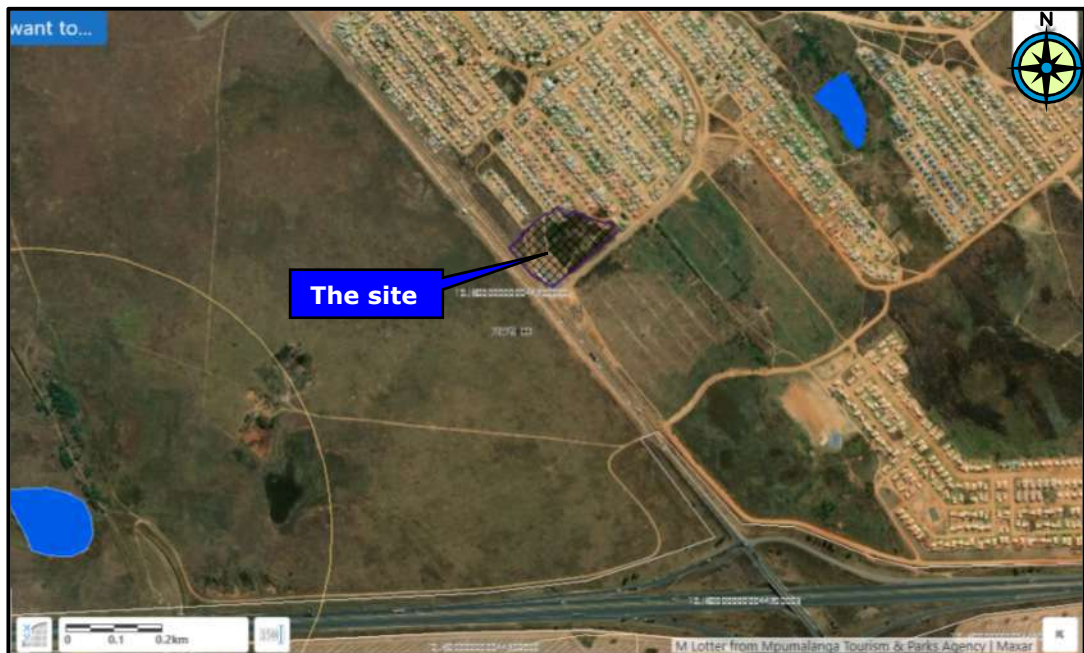
Figure 5.19: NFEPA wetlands and wetland clusters located near the site (taken from MBSP, 2013)

No NFEPA wetlands are indicated to be present on site or in close proximity of the site (Figure 5.19). The closest NFEPA wetlands/wetland clusters are present approximately 560m north east and 500m south west of the site (Figure 5.19).

No rivers, streams or other surface water environments are present on or near the site (Figure 5.19). The closest river/stream is an unnamed tributary of the

Klein Olifants River located ± 560 m northeast of site (Figure 5.1). The area between the site and the unnamed tributary is built up (Figure 5.19).

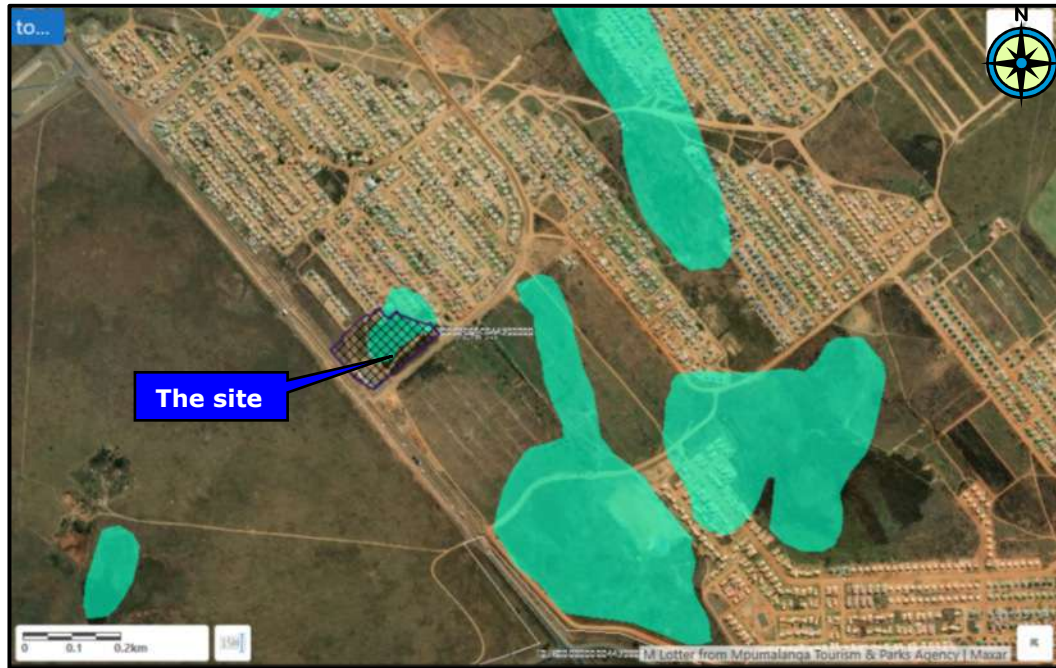
Figure 5.20: Mpumalanga Highveld Wetlands (taken from MBSP, 2013)

The Mpumalanga Highveld Wetlands dataset (MBSP, 2013) indicates that a wetland is present on site (Figure 5.20). Wetlands are also indicated south east, north east and south west of the site (Figure 5.20).

In order to confirm the presence of a wetland on site, a wetland delineation study was undertaken by Stephen Burton of Sivest (hereafter referred to as Burton, 2018). A copy of the report is provided in Appendix 5. The said report should be consulted with regards to the methodology used in this assessment and limitations of the study.

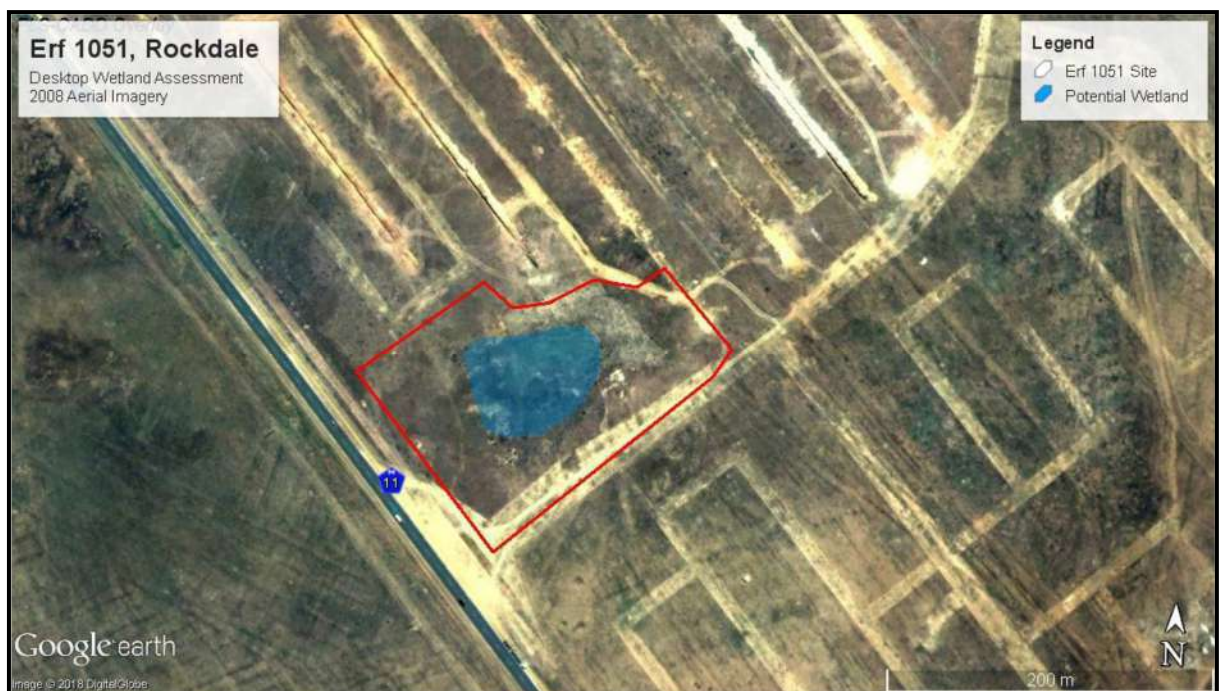
Figure 5.21: 2008 Aerial view indicating the possible presence of a wetland (taken from Burton, 2018)

According to Burton (2018), historical imagery of the site shows a potential depression wetland in the centre of site, which was probably fed by storm water from the N11 national road (Figure 5.21).

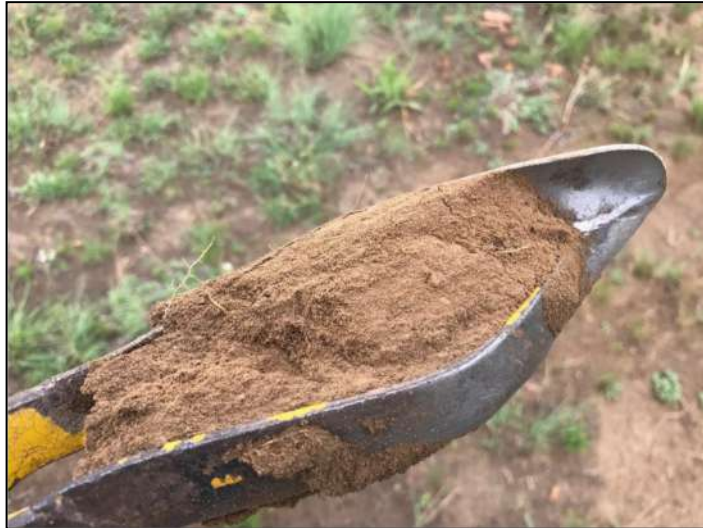
Photo 5.15: Soil from a depth of 40-50 cm showing no wetland indicators (taken from Burton, 2018)

Based on the findings of the soil sampling, Burton (2018) indicated no wetland soils (Photo 5.15) present on site. In addition, no wetland vegetation was recorded on site.

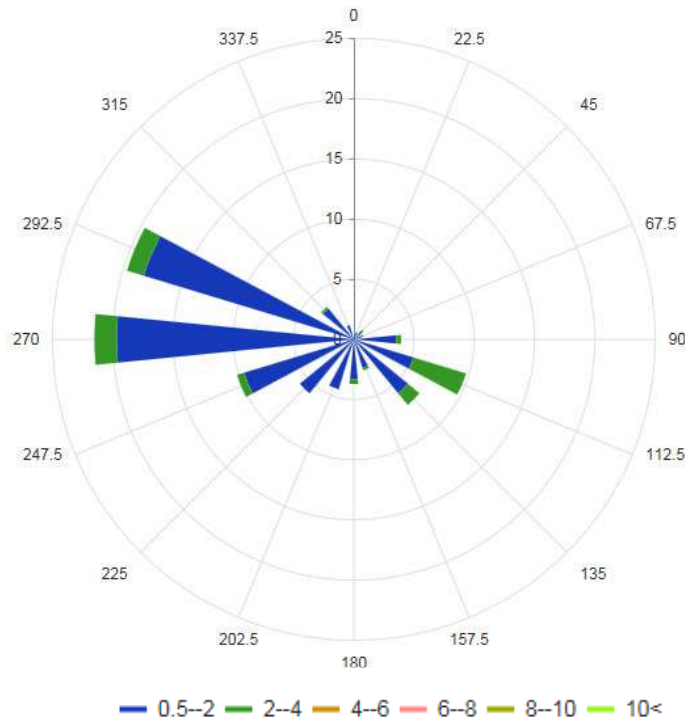
Figure 5.22 Dominant wind directions - January 2019 to January 2020 (taken from South African Air Quality Information System – SAAQIS, 2020)

Wind roses summarise the occurrence of winds at a location, representing their strength, direction and frequency. Figure 5.22 provides the wind rose for 1 January 2019 to 1 January 2020 for the Middelburg Station. As is evident from Figure 5.22, winds in the area are relatively stable with the dominant wind directions being north westerly and south easterly winds.

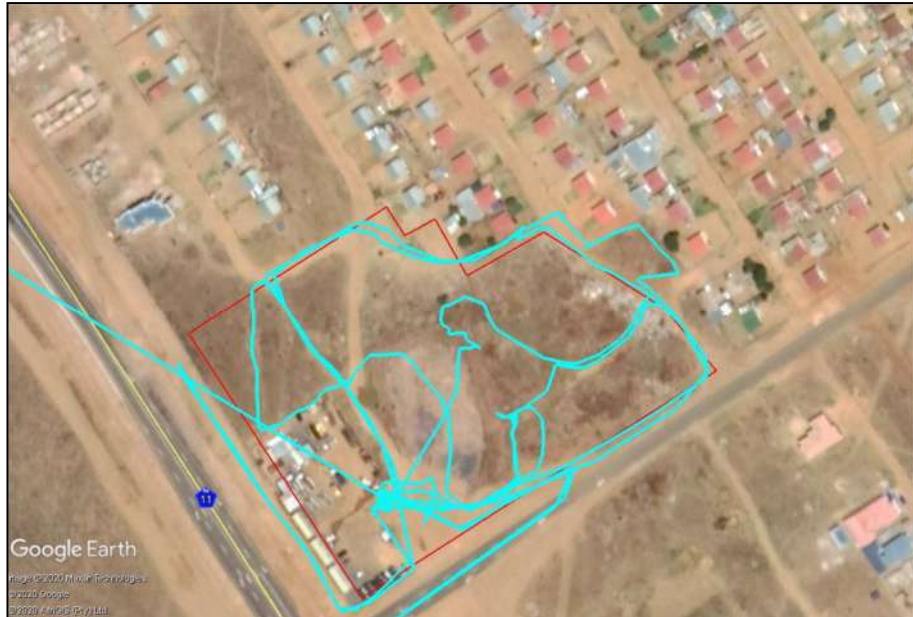
Figure 5.23: Track route of the Heritage survey (taken from Van Vollenhoven, 2020)

Figure 5.23 provides the track route of the site visit of 26 February 2020 during which Van Vollenhoven (2020) identified nothing of heritage importance on the proposed site.

In view of the entire site being highly disturbed as a result of the old borrow pit and associated activities, Van Vollenhoven (2020) recommended that the development be exempted from doing a Phase 1 Heritage Impact Assessment since the chances of finding any heritage related features are deemed extremely slim.

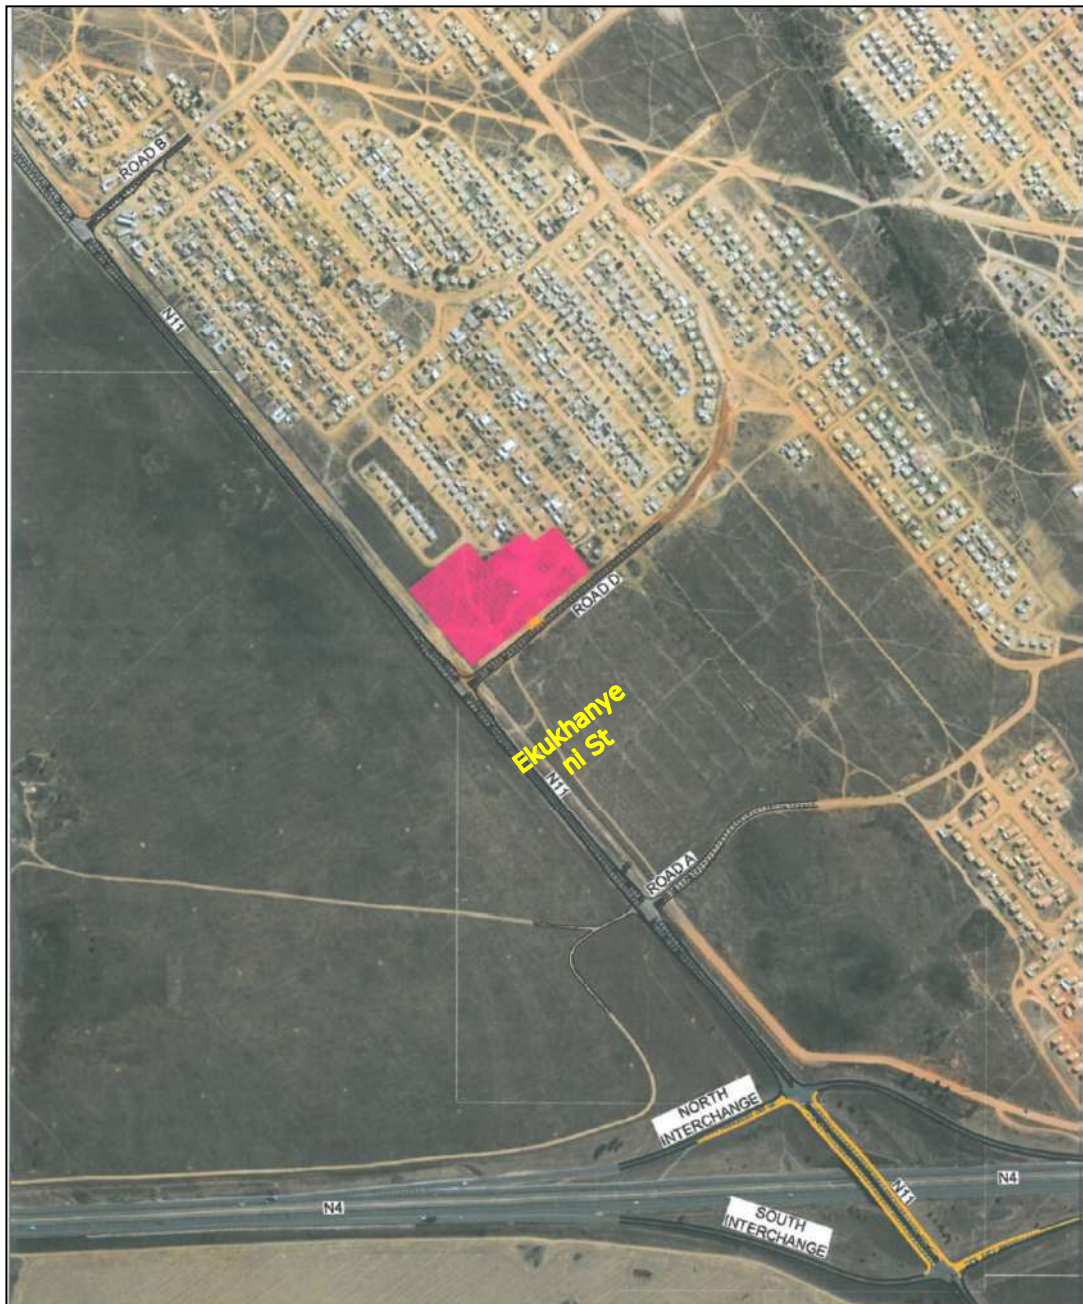
Figure 5.25: Location of intersections counted (taken from Roberts, 2019)

Roads A, B and D (Table 5.5; Figure 5.25) are Class 4 roads (i.e. district distributors) and link the N11 to the residential streets of Rockdale. These roads are typically constructed as two lane single carriageway roads with turning lanes where required (Roberts, 2019).

MAIN ROAD/STREET	CROSS STREET (Figure 5.25)	CONTROL
N4 terminals	N11	Priority on side streets
N11	Road A	Priority on the side street
N11	Road B	Priority on the side street
N11	Road D	Priority on the side street

Table 5.5 provides an indication of the existing road network and classification in the area surrounding the proposed development site. Figure 5.25 provides the location of the various roads in relation to the proposed development site.
