**DRAFT BASIC ASSESSMENT
REPORT FOR THE PROPOSED
DEVELOPMENT OF SU CASA
PRIVATE BURIAL ESTATE AND
ASSOCIATED ACTIVITIES ON
PORTION 10 OF FARM
DOORNRUG 302 IN EMALAHLENI
LOCAL MUNICIPALITY,
MPUMALANGA PROVINCE**

FEBRUARY 2023

1/3/1/16/1N-345

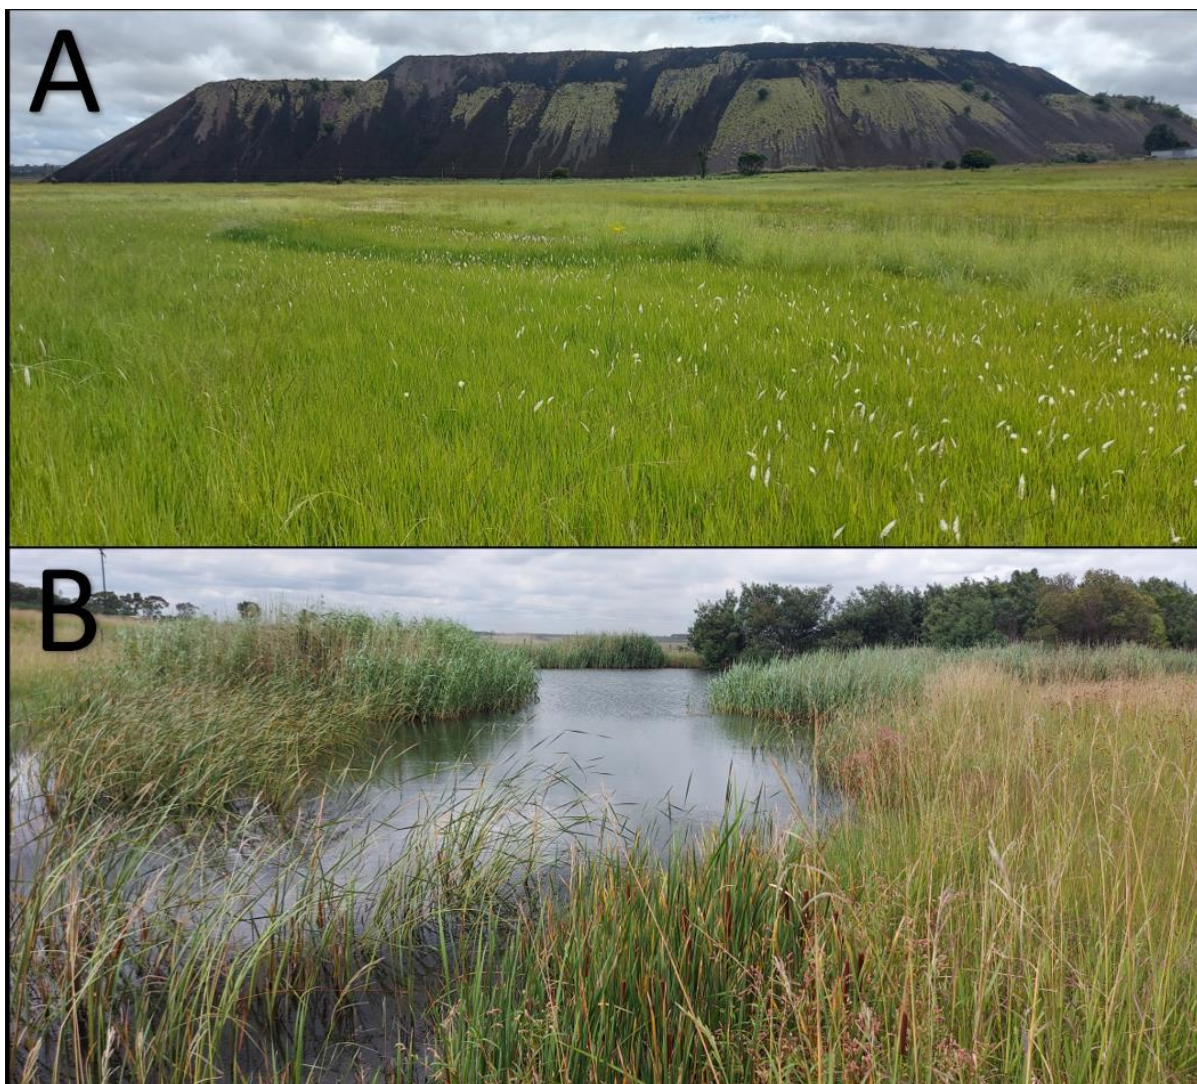
Figure 11: Examples of the different HGM units delineated within the project area. A) Unchanneled valley bottom at HGM 1, B) Dam located within the Unchannelled valley bottom at HGM 1.

Two HGM units both unchannelled valley bottom has been identified within the 500 m regulated area (see Figure 10 and Figure 11). In addition, multiple drainage features were identified within the 500 m regulated area. These drainage feature although not classified as wetland areas still require conservation while the proposed activity takes place. These drainage systems have been excluded from the functional assessment. Some recommendations have been made to conserve the integrity of the drainage features.

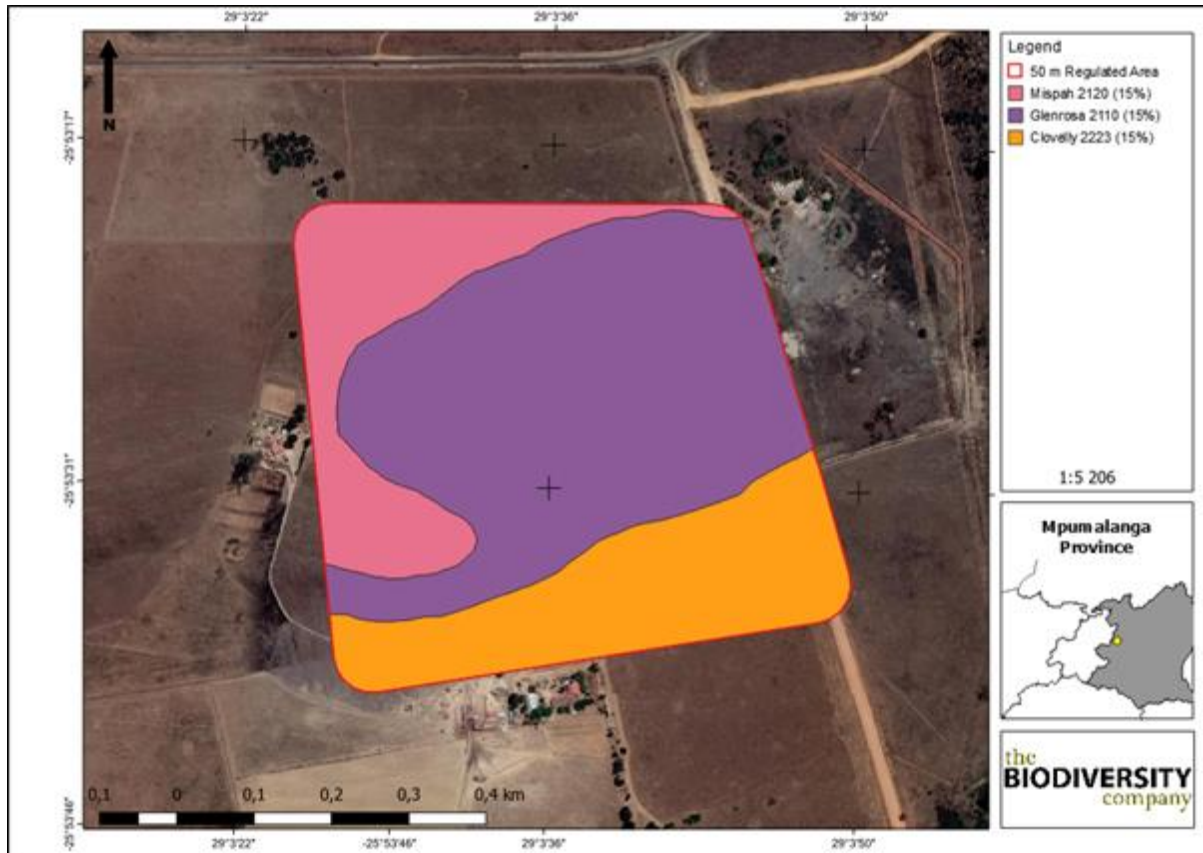
Figure 34: Soil forms delineated within the 50 m regulated area

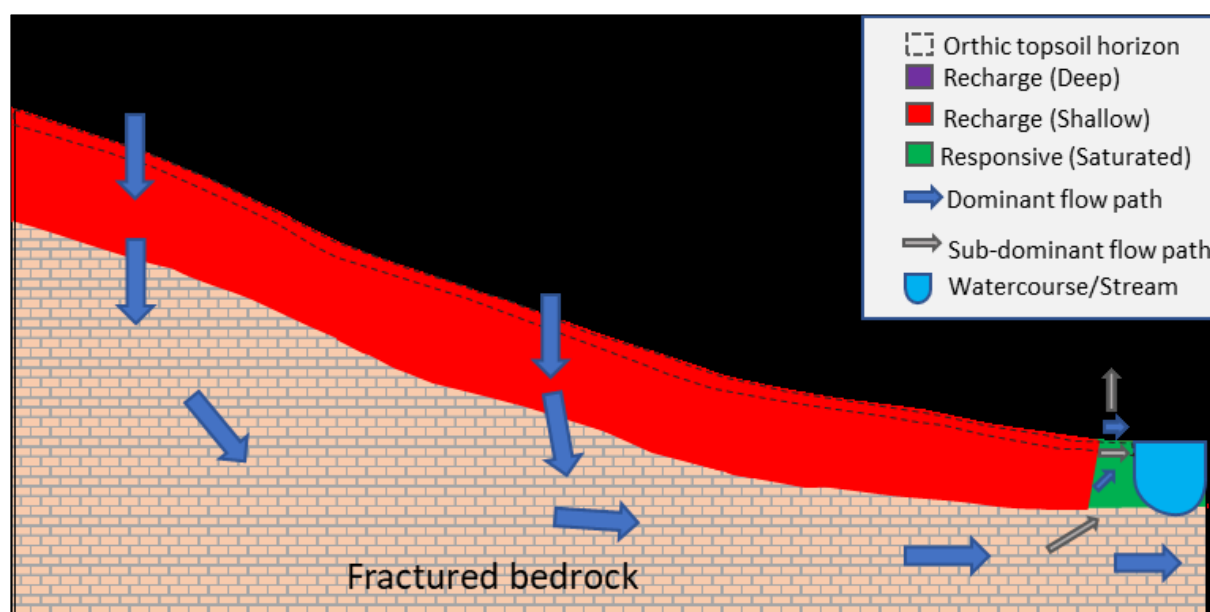
Figure 3442: Hillslope hydrology of the second of two distinct hydropedological patterns prior to cemetery construction.

The shallow Glenrosa and Mispah soil forms identified on-site are characterised with well drained profiles. The Glenrosa soil forms consist of an orthic topsoil profiles which include the presence of a fractured lithic horizon at the rock interface. The Mispah soil forms are characterised with orthic topsoil profiles merging into a fractured substratum. These profiles are characterised by extremely high Ks rates, including the lower lithic horizon.

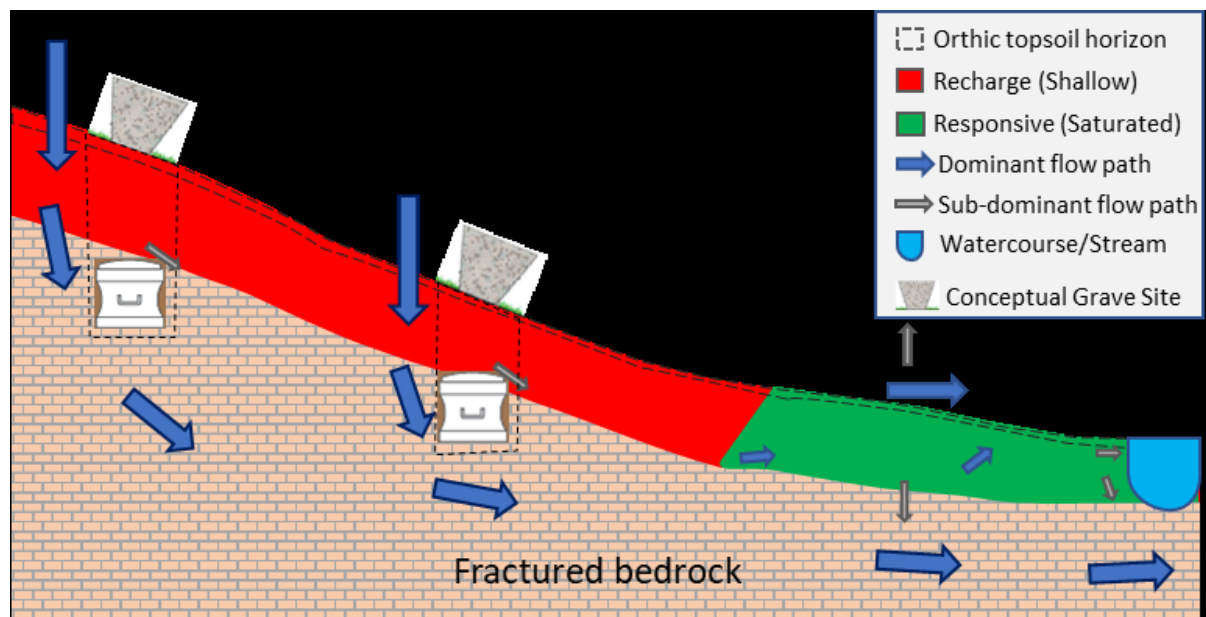
Figure 35: Hillslope hydrology of one of two distinct hydropedological patterns after the establishment of the burial estate and associated infrastructure.

The proposed Su Casa Burial Estate and associated infrastructure components will have very little impact on the hydropedology of the relevant hillslopes, regardless of the position of the grave sites (crest, mid-slope or valley bottom). For recharge soils (which are dominant), recharge won't be affected at all given the fact that infiltration will only be impeded for the width of the grave site, which has been deemed insignificant given the size of the catchments as the dominant flow paths will remain vertical recharging groundwater stores (see Figure 34; Figure 35; for a conceptual example of interferences via the proposed grave sites).

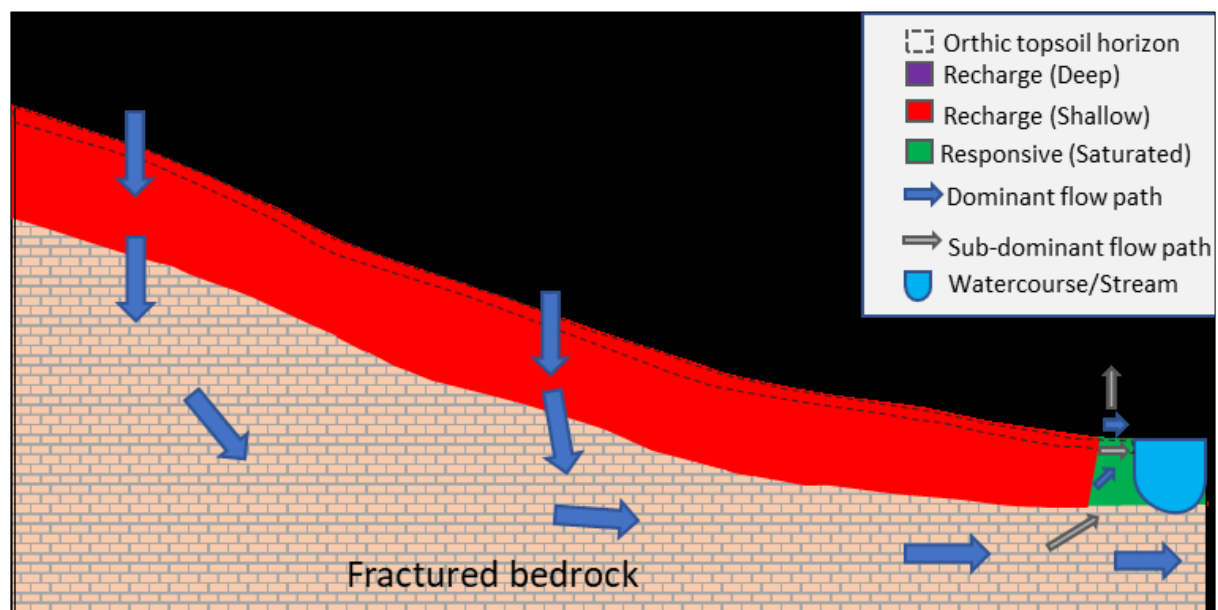
Figure 9076: Hillslope hydrology of the second of two distinct hydrogeological patterns prior to cemetery construction.

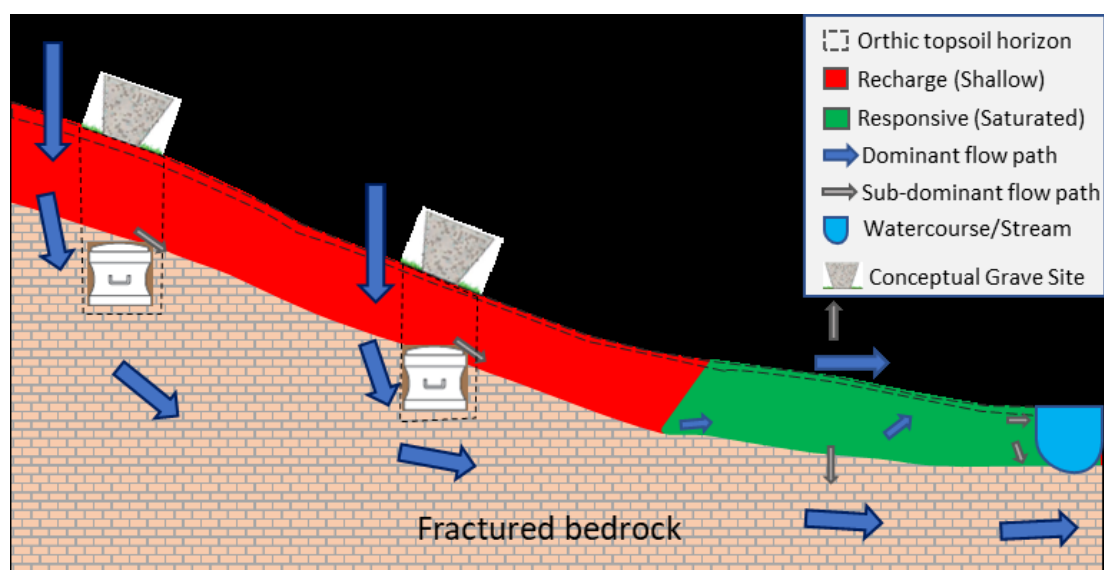
Figure 91: Hillslope hydrology of one of two distinct hydropedological patterns after the establishment of the burial estate and associated infrastructure.
