**FINAL BASIC ASSESSMENT  
REPORT AND WATER USE  
LICENCE APPLICATION PROCESS  
FOR THE PROPOSED  
DEVELOPMENT OF SU CASA  
PRIVATE BURIAL ESTATE AND  
ASSOCIATED ACTIVITIES ON  
PORTION 10 OF FARM  
DOORNRUG 302 IN EMALAHLENI  
LOCAL MUNICIPALITY,  
MPUMALANGA PROVINCE**

**APRIL 2023**

1/3/1/16/1N-345

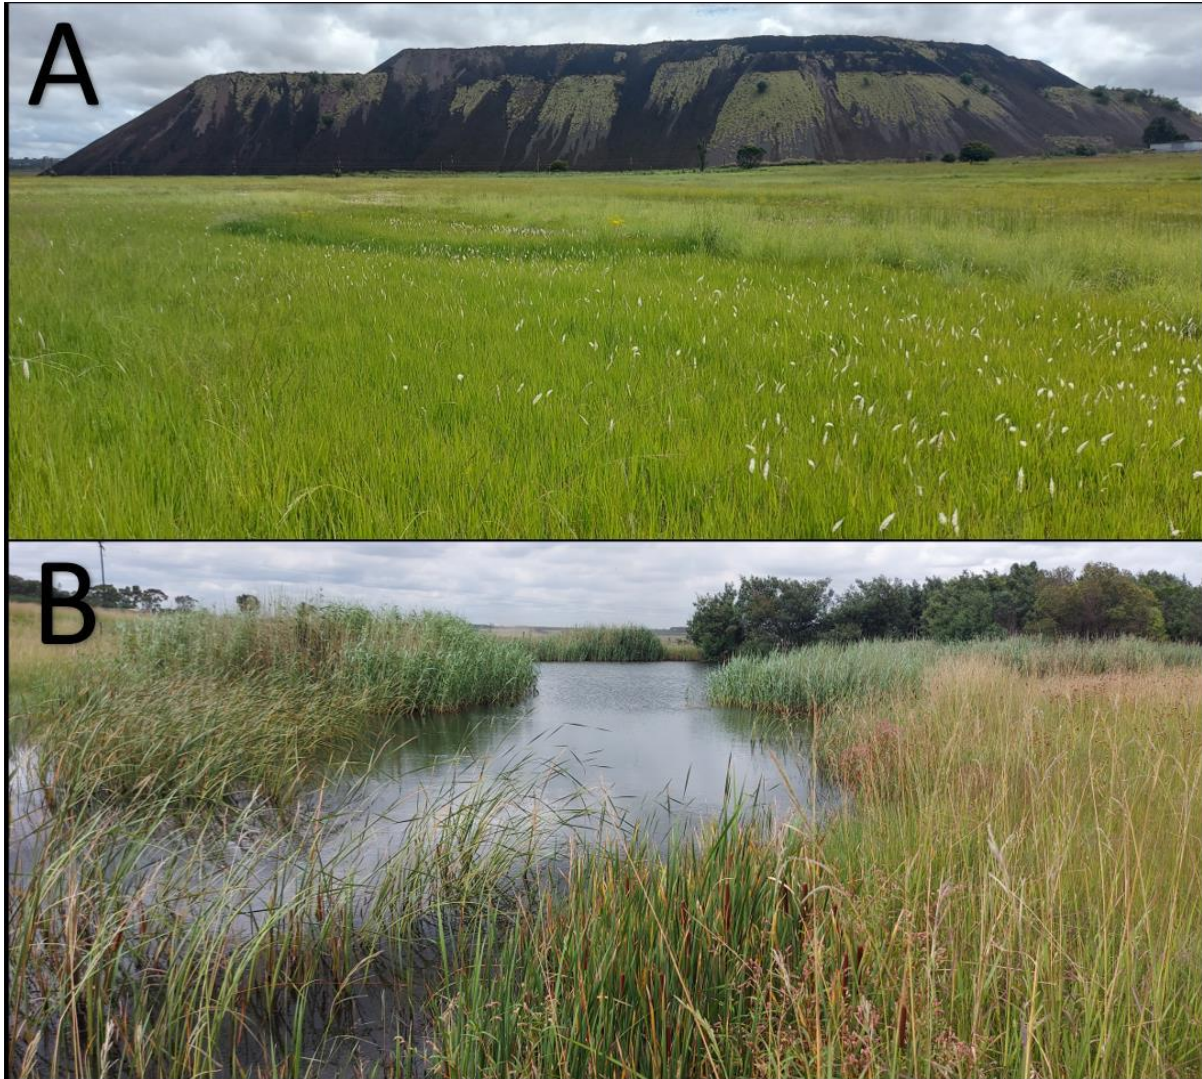
Figure 8-6 : Examples of the different HGM units delineated within the project area. A) Unchanneled valley bottom at HGM 1, B) Dam located within the Unchannelled valley bottom at HGM 1.

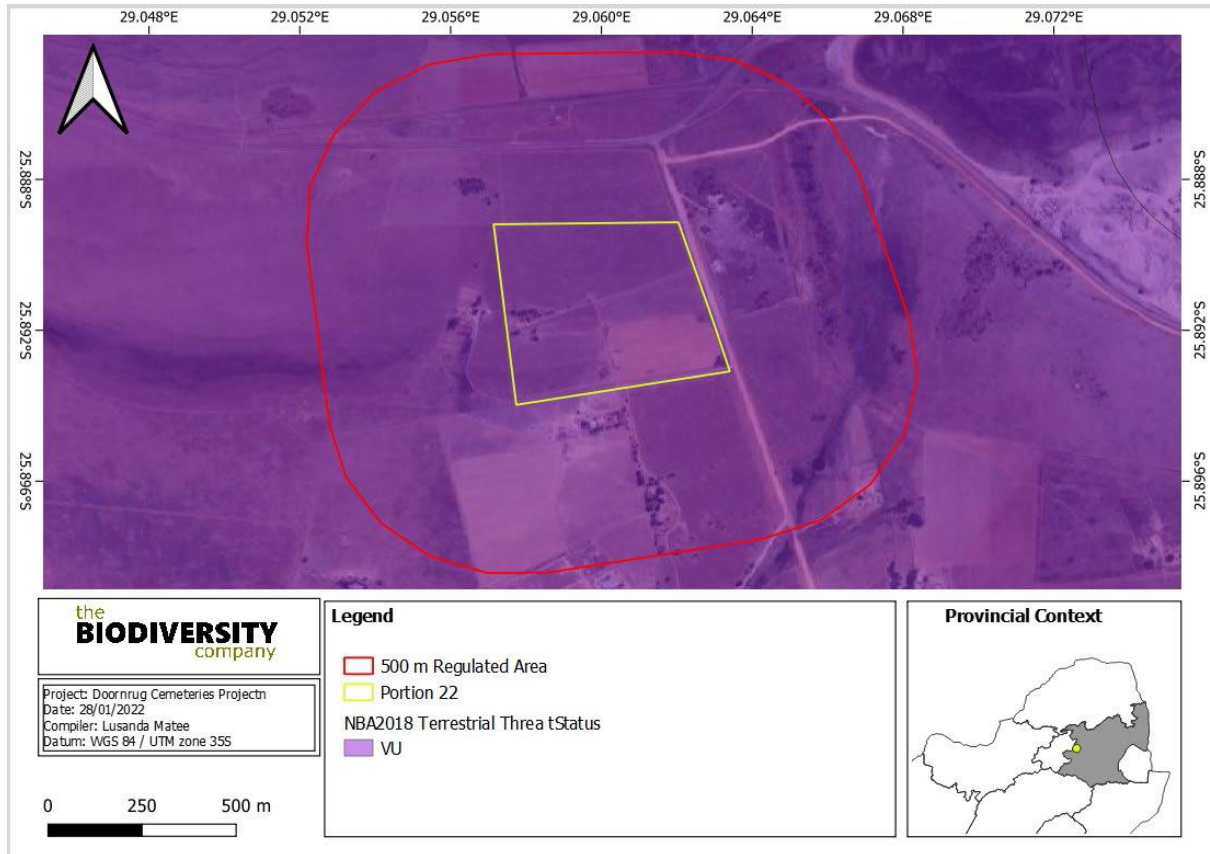
Figure 8-8 : Map illustrating the ecosystem threat status associated with the proposed project area

The Ecosystem Threat Status is an indicator of an ecosystem’s wellbeing, based on the level of change in structure, function or composition. Ecosystem types are categorised as Critically Endangered (CR), Endangered (EN), Vulnerable (VU), Near Threatened (NT) or Least Concern (LC), based on the proportion of the original extent of each ecosystem type that remains in good ecological condition. According to the spatial dataset, the proposed development overlaps with a VU ecosystem (Figure 12).

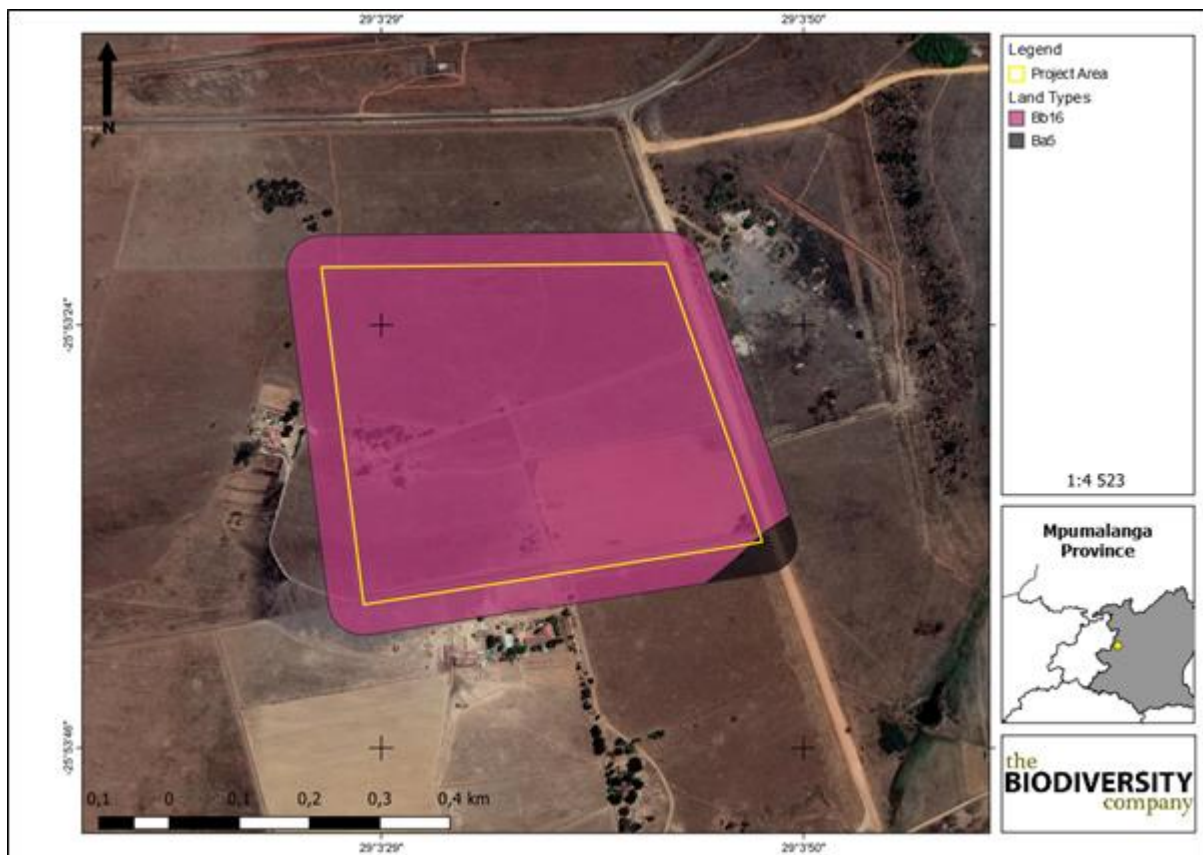
According to the land type database (Land Type Survey Staff, 1972 - 2006), the project area is characterised by the Ba5 land type as well as the Bb16 land type which is illustrated in Figure 23. The Ba and Bb land types consists of duplex and marginalitic soils which tend to be dystrophic or mesotrophic. The subsoils consists of widespread red soils and according to Mucina & Rutherford (2006), Glenrosa as well as Mispah soil forms tend to dominate these areas. These soil forms are predominantly formed on rocky ridges.

Figure 8-19 : The land types associated with the project area

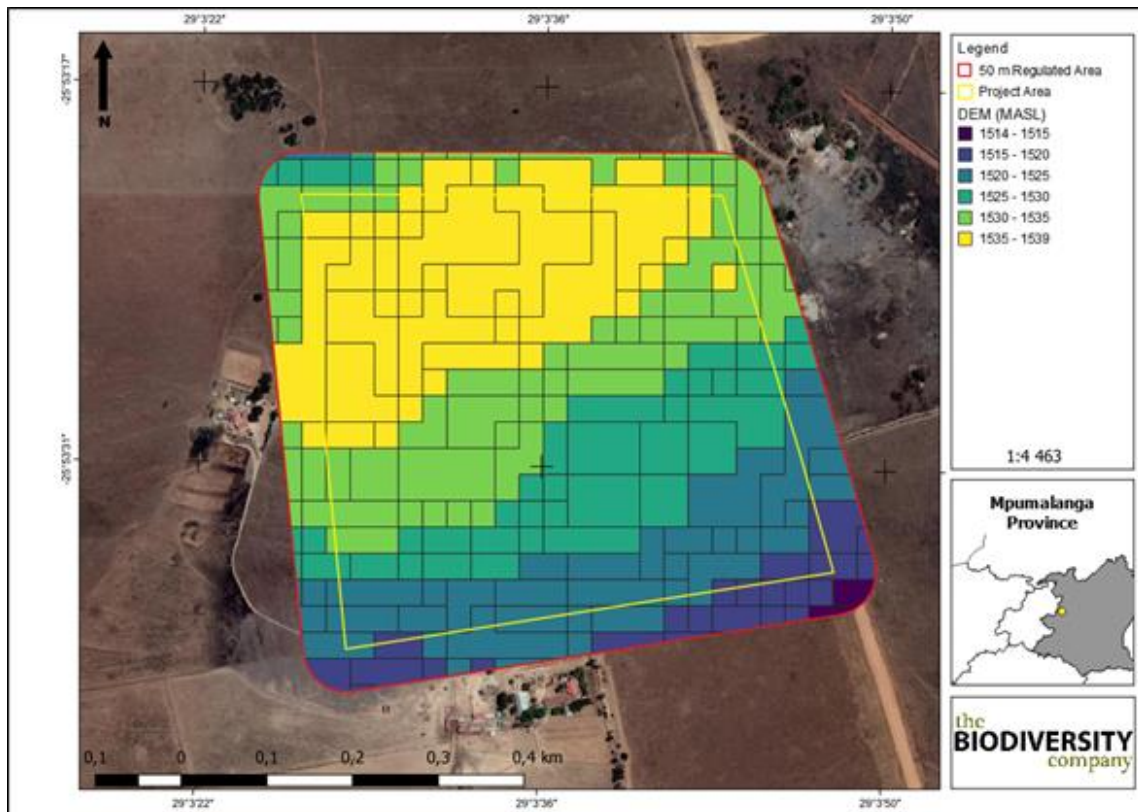
Figure 8-23 : Digital Elevation Model of the regulated area (metres above sea level)

The slope percentage of the project area has been calculated and is illustrated in Figure 8-11. The majority of the regulated area is characterised by a slope percentage between 0% and 5%. A smaller part of the regulated area is characterised by a slope percentage between 5% and 10%, with some smaller patches within the project area characterised by a slope percentage up to 15. This illustration indicates a non-uniform topography with gentle to steep slopes being present. The Digital Elevation Model (DEM) of the project area (Figure 8-23) indicates an elevation of 1 514 to 1 539 Metres Above Sea Level (MASL).

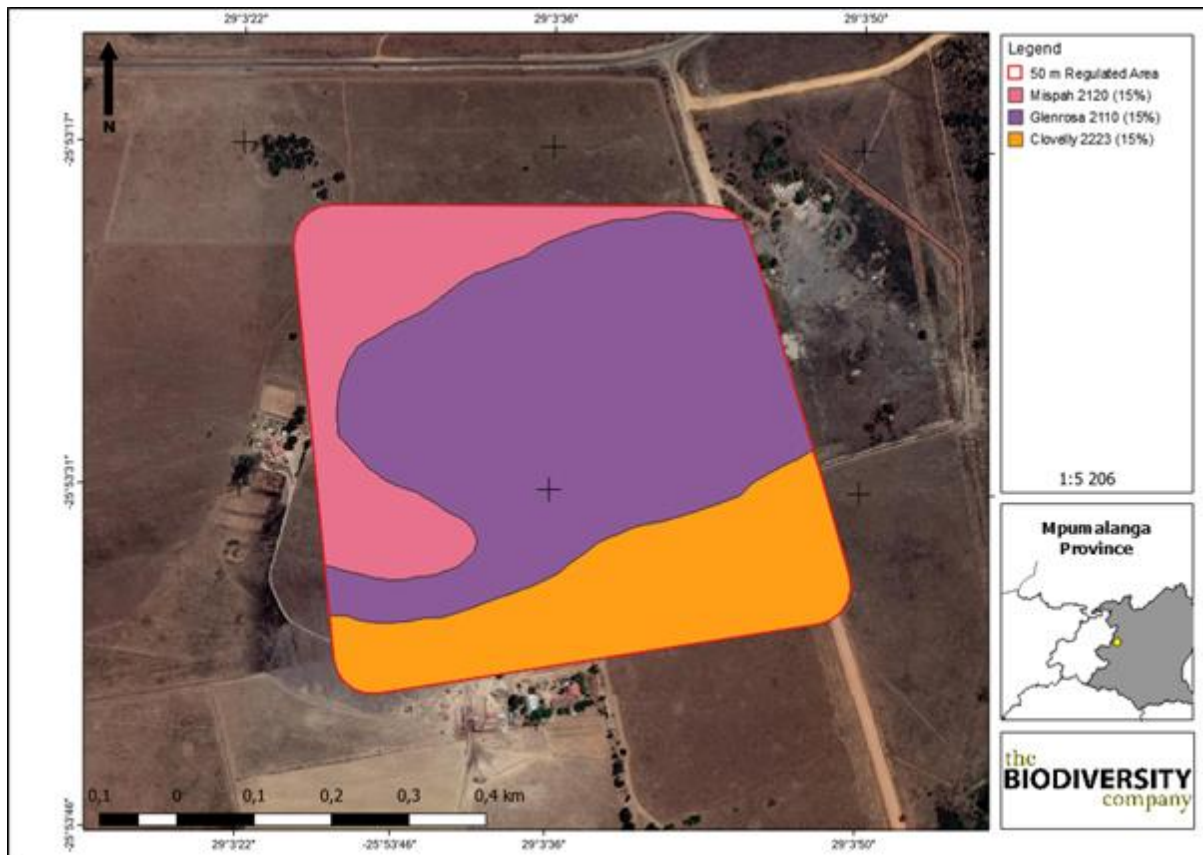
Three soil forms were identified within the 50 m regulated area namely Mispah, Glenrosa and Clovelly. Of these soil forms, the Clovelly soil form is most sensitive.

Figure 8-24 : Soil forms delineated within the 50 m regulated area

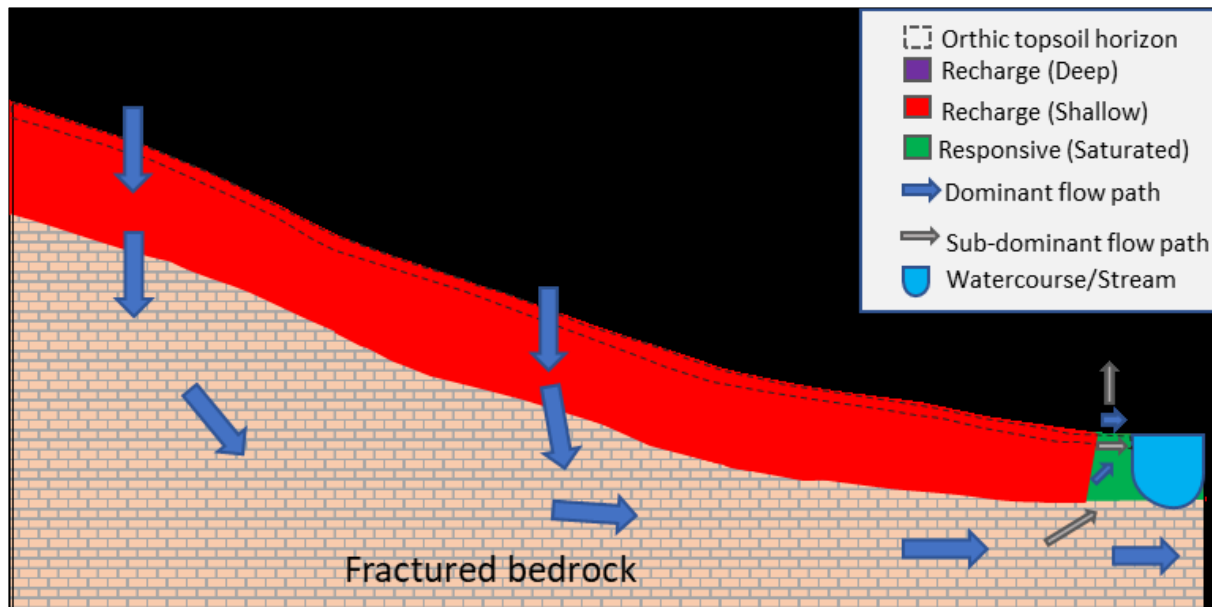
Figure 8-30 : Hillslope hydrology of the second of two distinct hydropedological patterns prior to cemetery construction.

The shallow Glenrosa and Mispah soil forms identified on-site are characterised with well drained profiles. The Glenrosa soil forms consist of an orthic topsoil profiles which include the presence of a fractured lithic horizon at the rock interface. The Mispah soil forms are characterised with orthic topsoil profiles merging into a fractured substratum. These profiles are characterised by extremely high Ks rates, including the lower lithic horizon.

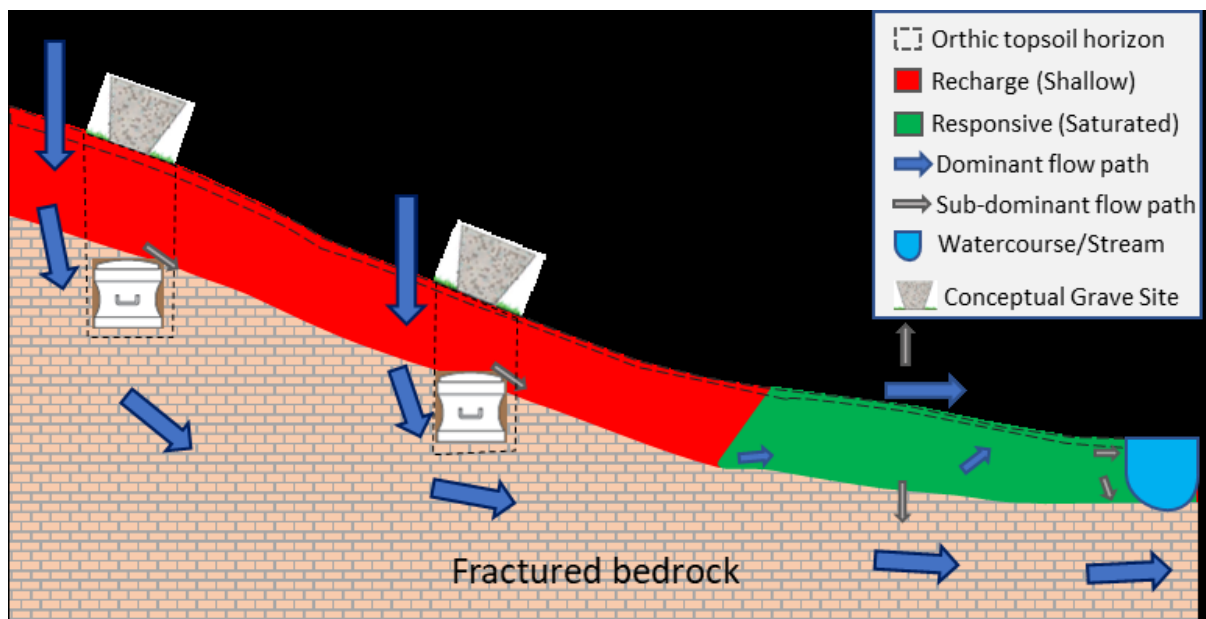
The proposed Su Casa Burial Estate and associated infrastructure components will have very little impact on the hydrogeology of the relevant hillslopes, regardless of the position of the grave sites (crest, mid-slope or valley bottom). For recharge soils (which are dominant), recharge won't be affected at all given the fact that infiltration will only be impeded for the width of the grave site, which has been deemed insignificant given the size of the catchments as the dominant flow paths will remain vertical recharging groundwater stores (see Figure 34; Figure 35; for a conceptual example of interferences via the proposed grave sites).

Figure 8-31 : Hillslope hydrology of one of two distinct hydrogeological patterns after the establishment of the burial estate and associated infrastructure.

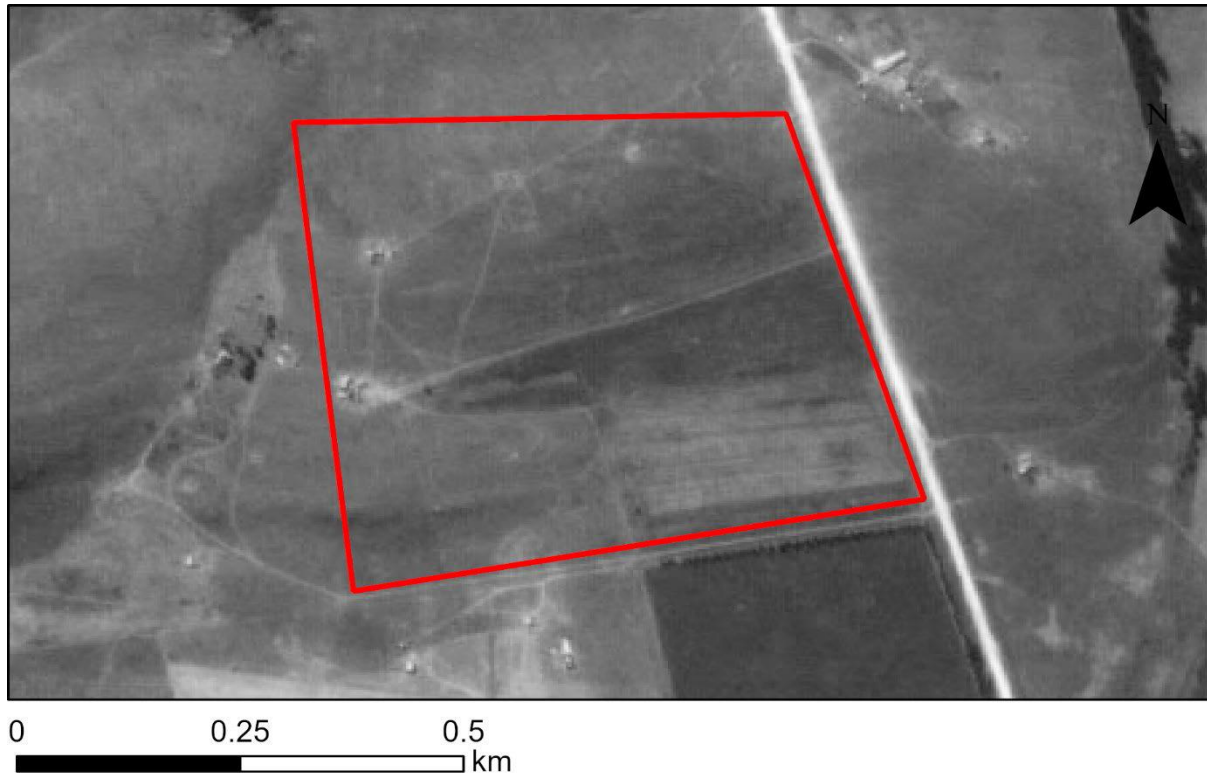
Figure 8-35 : Aerial imagery from 1979. Expansion of UP-DRB-2529-01 on western boundary visible with footpaths linking it with UP-DRB-2529-06 and UP-DRB-2529-07 in the northern half of the project area.

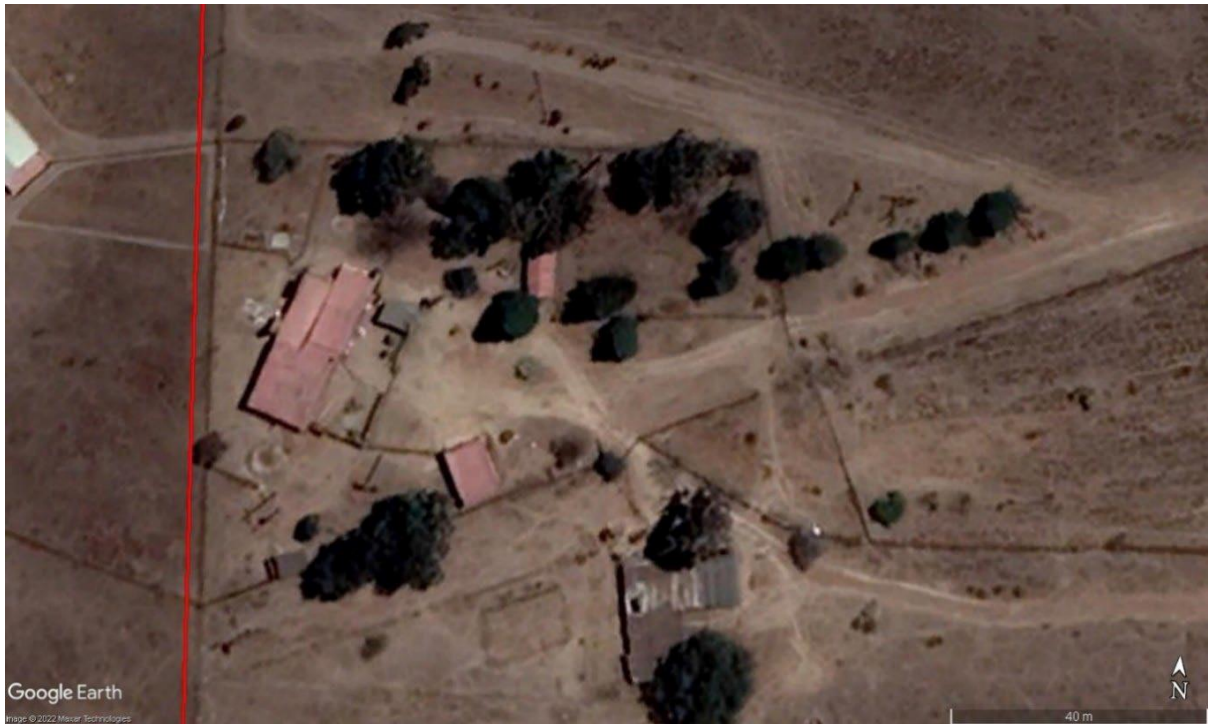
Figure 8-36 : UP-DR UP-DRB-2529-01 on Google Earth image from 2022.

UP-DRB-2529-01 represent an extant house and outbuildings. A portion of the building may potentially be older than 60 years since historical images from 1962 indicates a single square building where the current house is located. It does not appear on earlier images from 1943. The northeast orientation of the building and the clearly visible wall joints indicates that the original structure likely corresponds to the southeast portion of the current house. Extensive expansions and alterations have been made to the original structure in subsequent years that have severely altered the original building severely diminishing its heritage value.

There are several outbuildings around the house. These include a stonewalled chicken coop/storeroom and brick garage. Aerial images and field inspection of building materials indicate that these are all less than 60 years old.

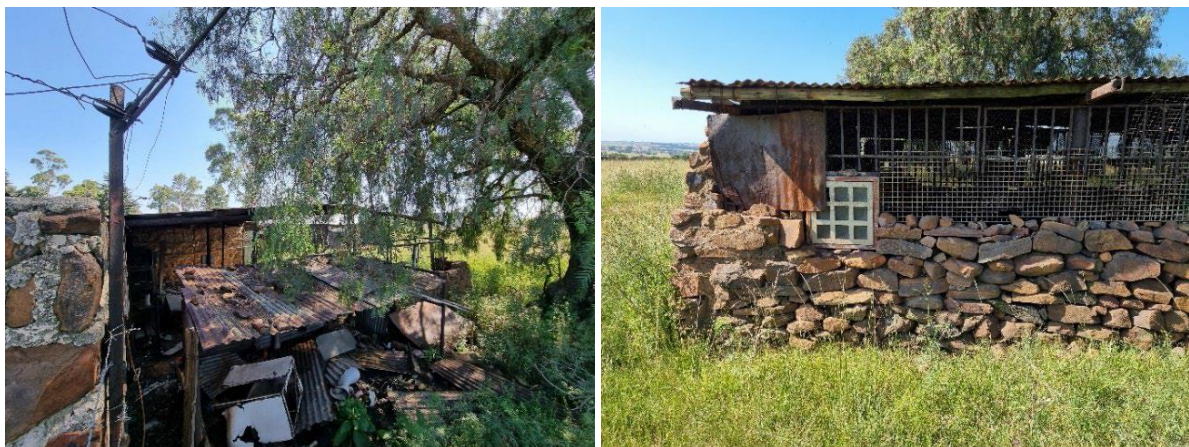
Figure 8-38 : Farm outbuilding. Likely storeroom and livestock pen/chicken coop. Southwest corner of outbuilding, right north facing wall.

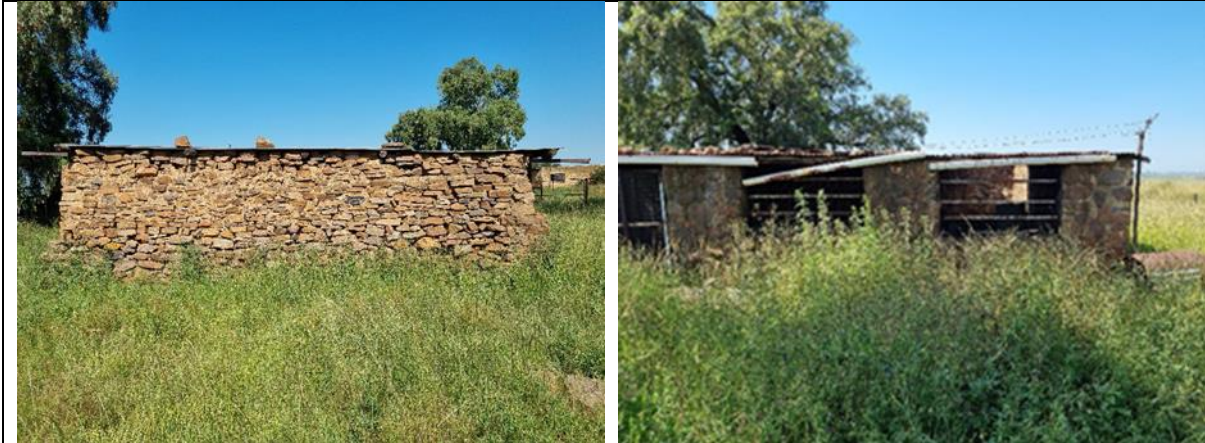
Figure 8-39: Likely storeroom and livestock/pen/chicken coop. South facing wall (left) and northwest corner (right).

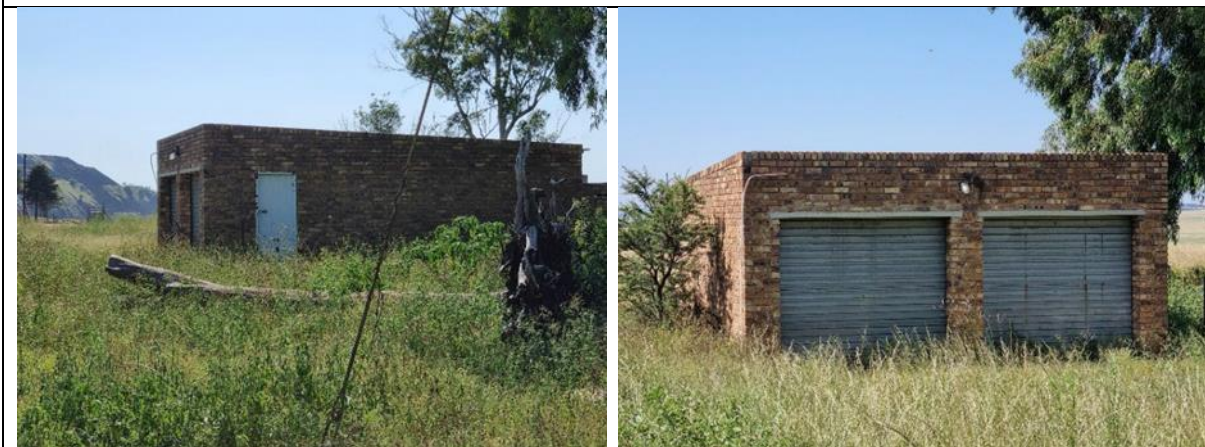
Figure 8-40 : Late 20<sup>th</sup> century brick structure with metal roller doors.

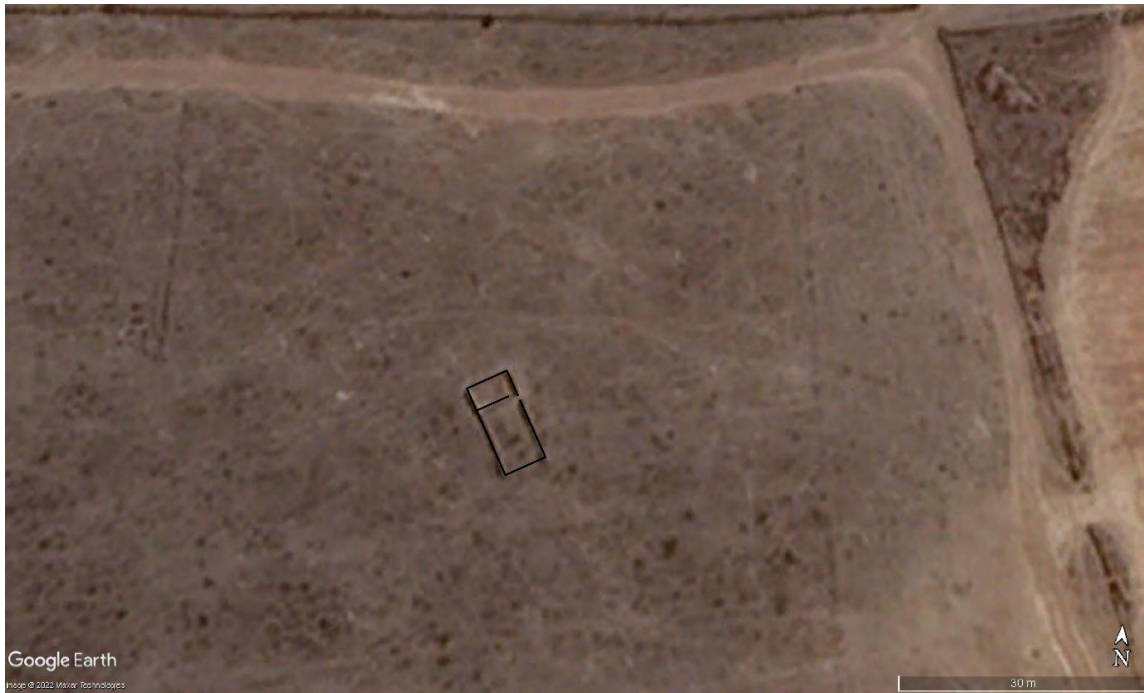
Figure 8-41 : UP-DRB-2529-02 outlines on Google Earth imagery.

Site UP-DRB-2529-02 is the remains of a two roomed rectangular structure roughly orientated in a northwest-southeast direction. The walls are dry stacked local stone, built up to a height of approximately 60cm. Wall abutting joints indicate that the structure was built in two phases. The first was the construction a 3mx5m northern room, and later, a 9mx5m southern room was added. There is a single entrance to structure which leads directly into the southern room with the doorway to the northern room immediately on the right. The interior of the northern room was covered with a cement plaster and a cement cap was placed on the top course of the wall. No cement reinforcing or plaster were observed at the southern room. It is possible that the walls supported a superstructure of material that has either perished or had been removed.

Determining the age is however difficult since it does not appear on early aerial images and no material culture was present to provide a relative date. The earliest aerial images where the site is clearly visible is dated 2005, but at this stage it is already in a ruined state. It is likely that this structure served as living quarters for farm labourers in the 20th century. Its absence on the 1962 and 1979 images implies that it was erected after these dates, and therefore less than 60 years old.

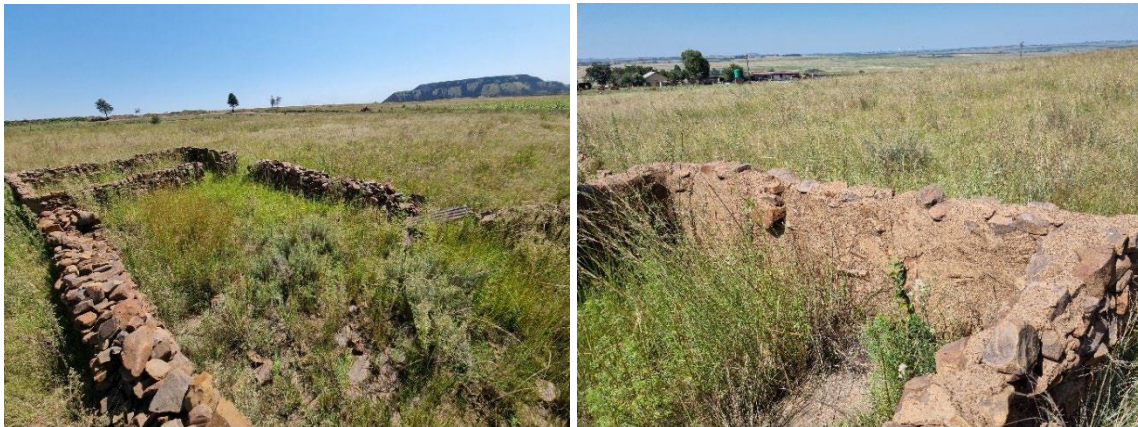
Figure 8-42 : UP-DRB-2529-02, (left) looking east over both rooms, and north (right) with cement plaster visible on inside of northern room.

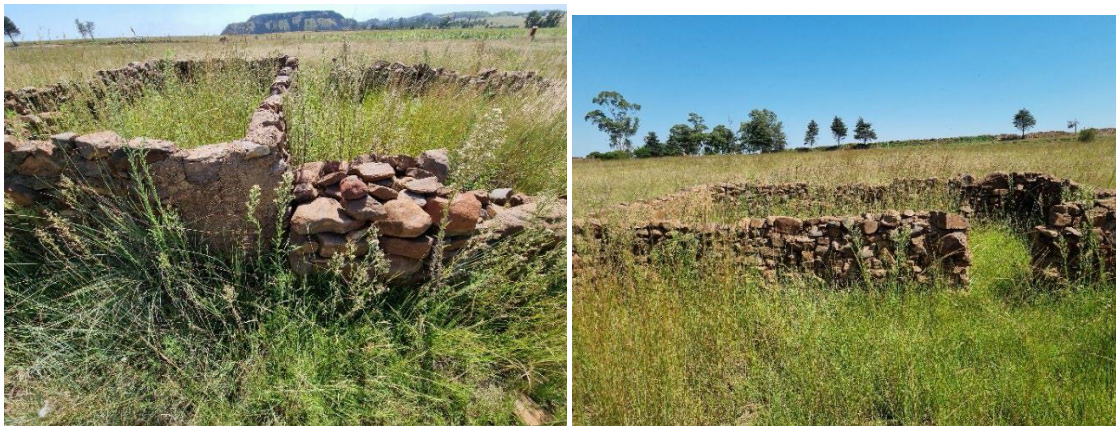
Figure 8-43 : UP-DRB-2529-02 (left) showing the joint of the two rooms along the west facing wall, and (right) the main entrance on the east facing wall.

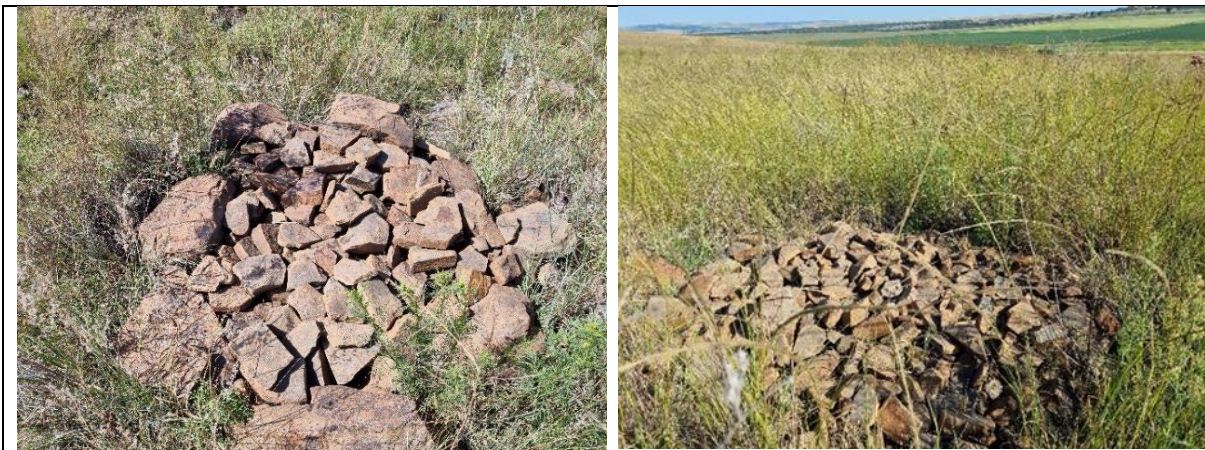
Figure 8-44 : Stones features, UP-DRB-2529-03 (left) and UP-DRB-2529-04 (right), of unknown use and function, but likely related to 20th century farming activities.

Two circular stone mounds were identified whose use/function is unknown. UP-DRB-2529-03 is approximately 60cm in diameter and formed by an outer ring of large stones and filled with smaller stones. UP-DRB-2529-04 is an approximately 1m wide pile of stones (~10-20cm range). No material culture was associated with the features, however, given the absence of prehistoric remains in the immediate vicinity, these most likely relate to 20th century activities.

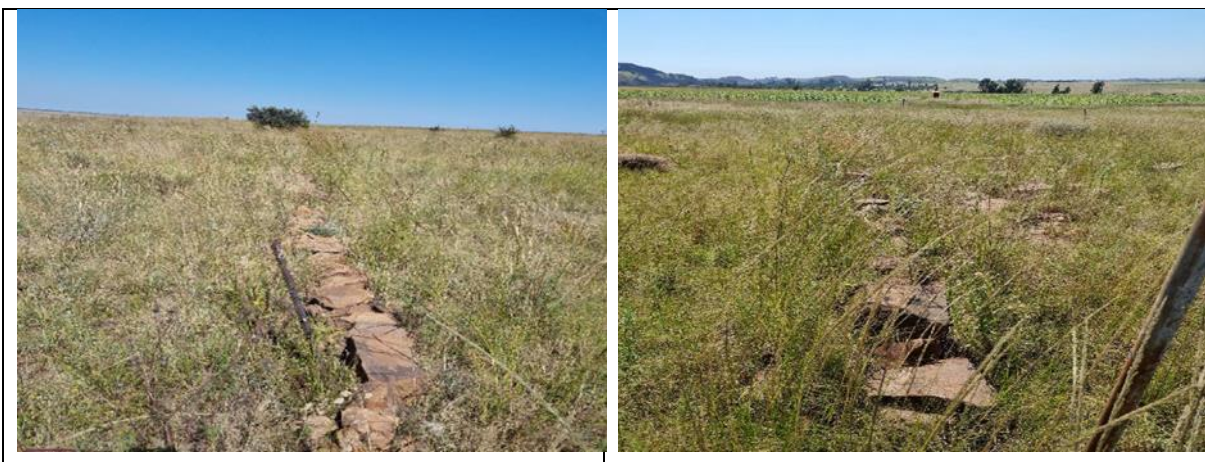
Figure 8-45: Examples of stone field boundary sections (UP-DRB-2529-05)

In the southwestern section of the project area there are linear stone walls that demarcate old field boundaries. In places metal fence poles are and fencing wire is trapped in the stones. Some of these are faintly visible on aerial photos from 1979, and the absence of the other walls show that the majority may be more recent than this date.

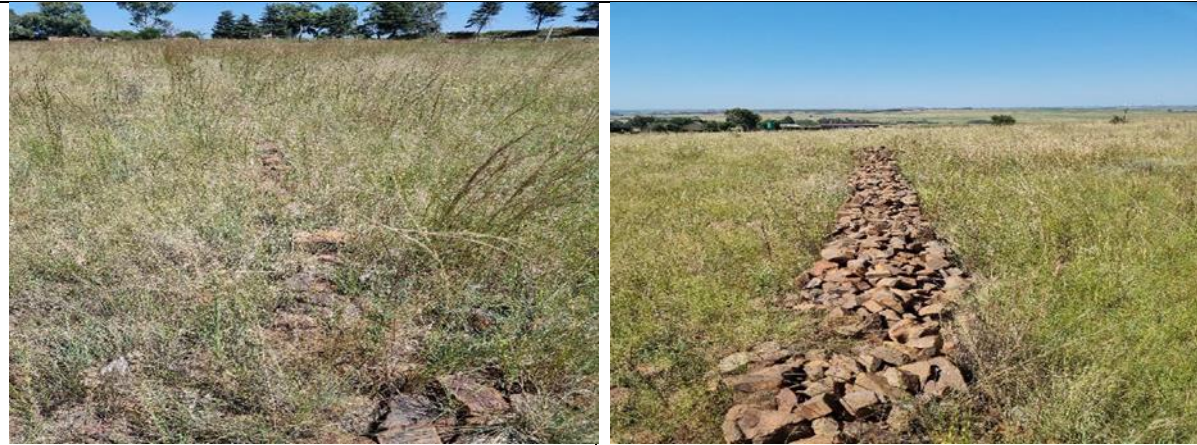
Figure 8-46: Examples of stone field boundary sections (UP-DRB-2529-05)

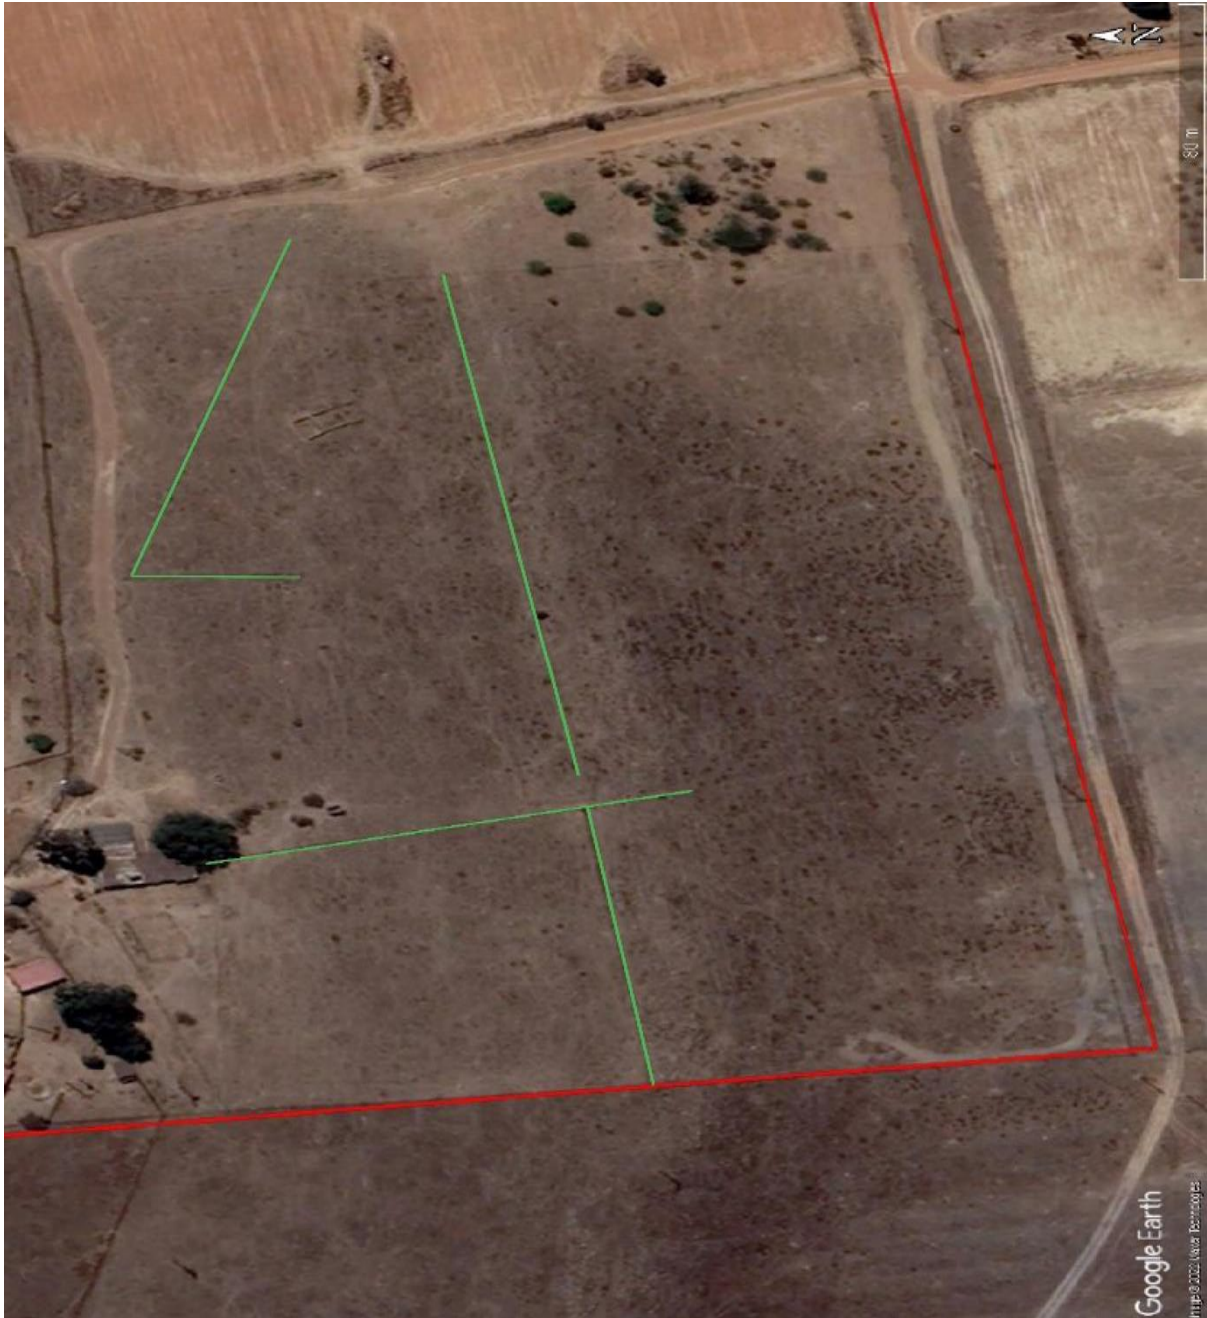
Figure 8-47 : Linear field boundary walls (UP-DRB-2529-05) in green. Project area in red.

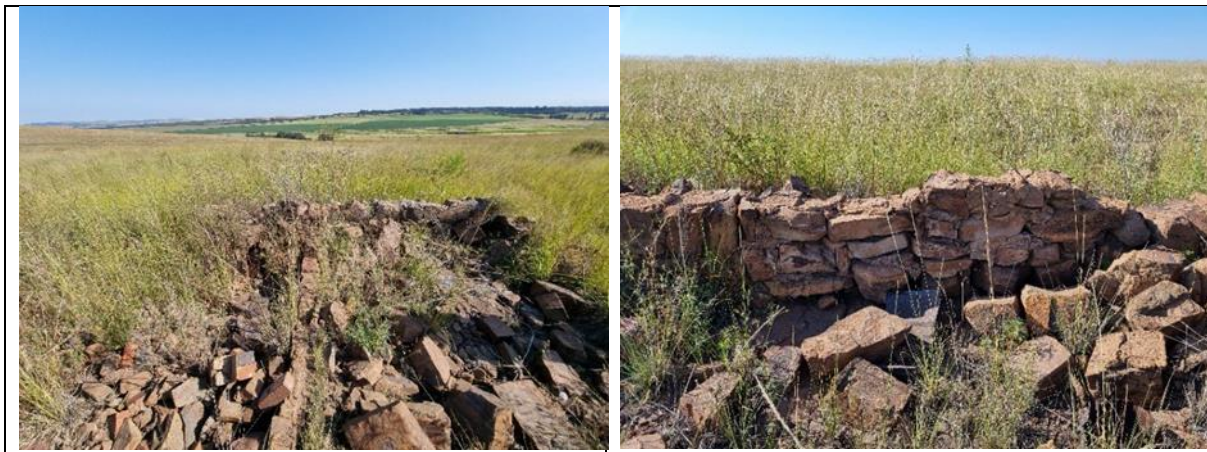
Figure 8-48: UP-DRB-2529-06 looking north (left) and east.

were rectangular shape. Both were constructed from a combination of natural stone, brick, and cement mortar. The original walls seem to be around 60-80cm high. Fragments of plaster on some bricks indicates that the inside of these structures were plastered with cement and painted white. A few pieces of structural metal such as corrugated sheeting indicate that these may also have been used in the original building. Green glass bottle fragments on UP-DRB-2529-06 were the only material culture identified.

The earliest images where these features are visible are from 1979. In these historical images, there are clear footpaths connecting both to one another and to southwest to the main farmhouse complex northeast to the main road. These pathways suggest that these were likely the remains of farm labourer housing. Given their absence on earlier images, they likely date to the 1970s.

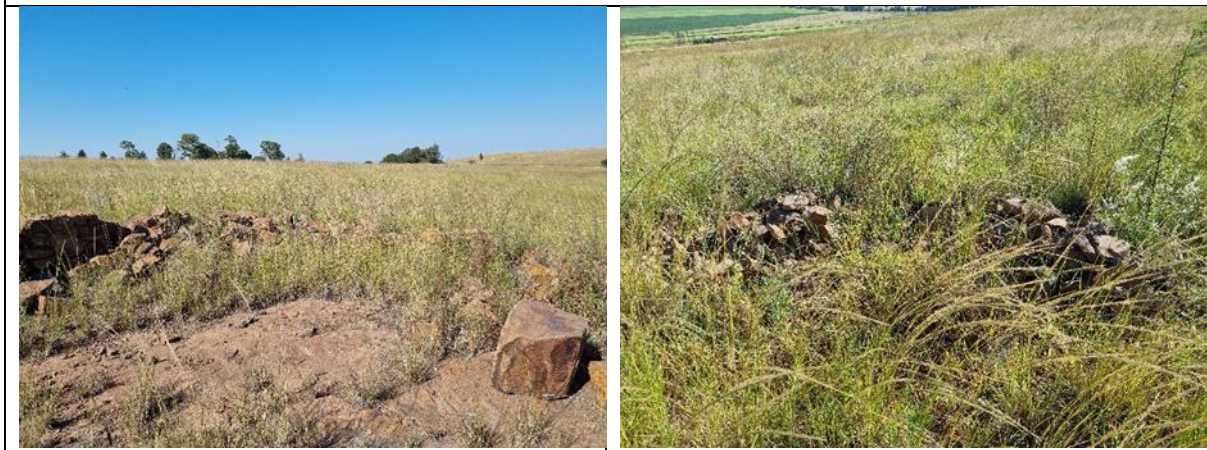
Figure 8-49: View of UP-DRB-2529-07 looking south (left) and looking east (right).

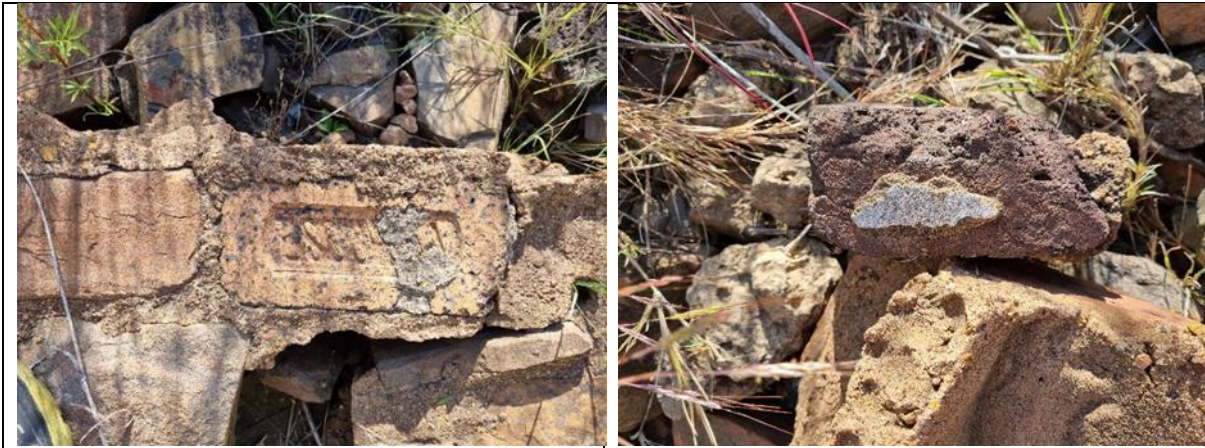
Figure 8-50 : Stone structures indicating the use of local stone, brick, cement and metal.

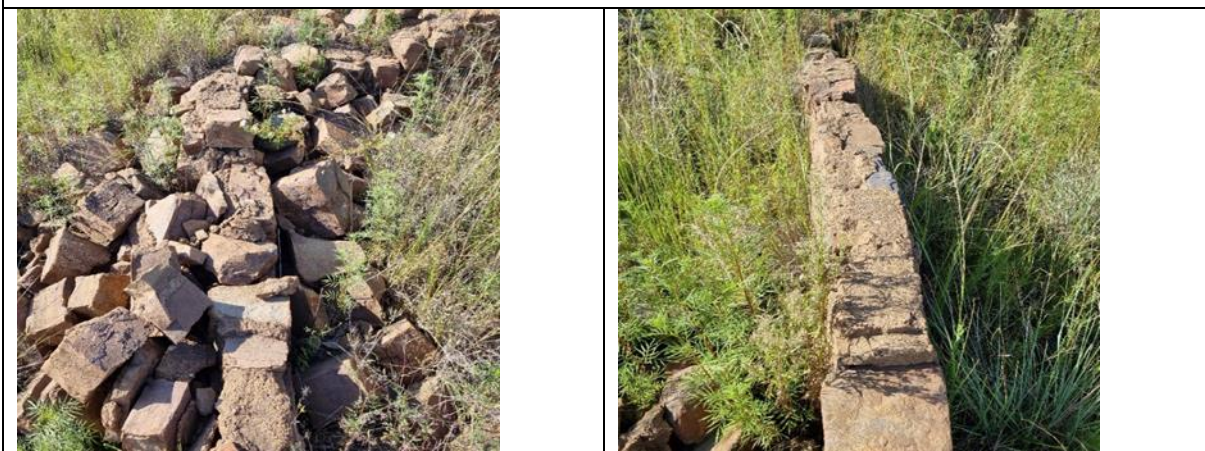
Figure 8-51 : Collapsed free standing brick and cement walls. UP-DRB-2529-06 (left) and UP-DRB-2529-07 (right).

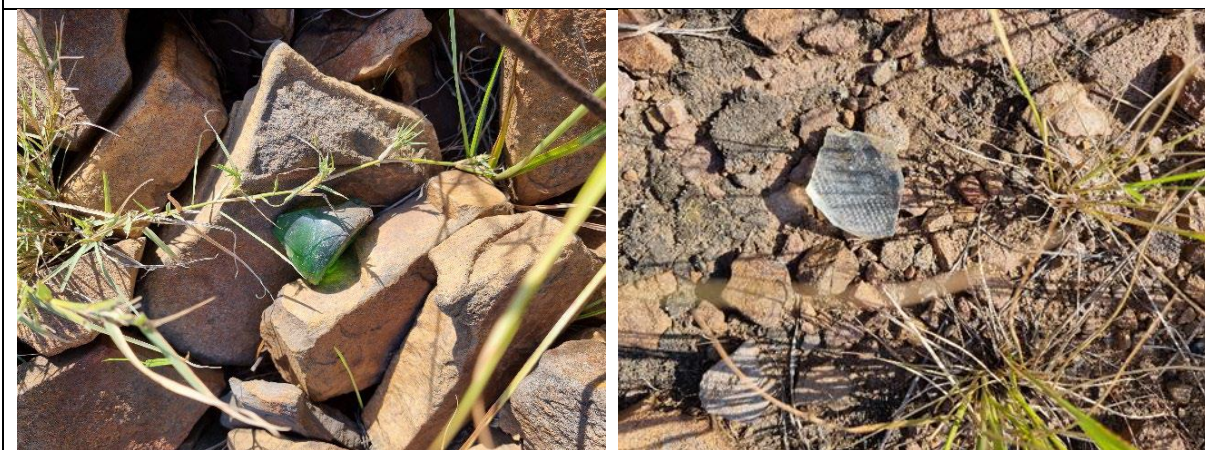
Figure 8-52 : Glass bottle fragments on UP-DRB-2529-06.

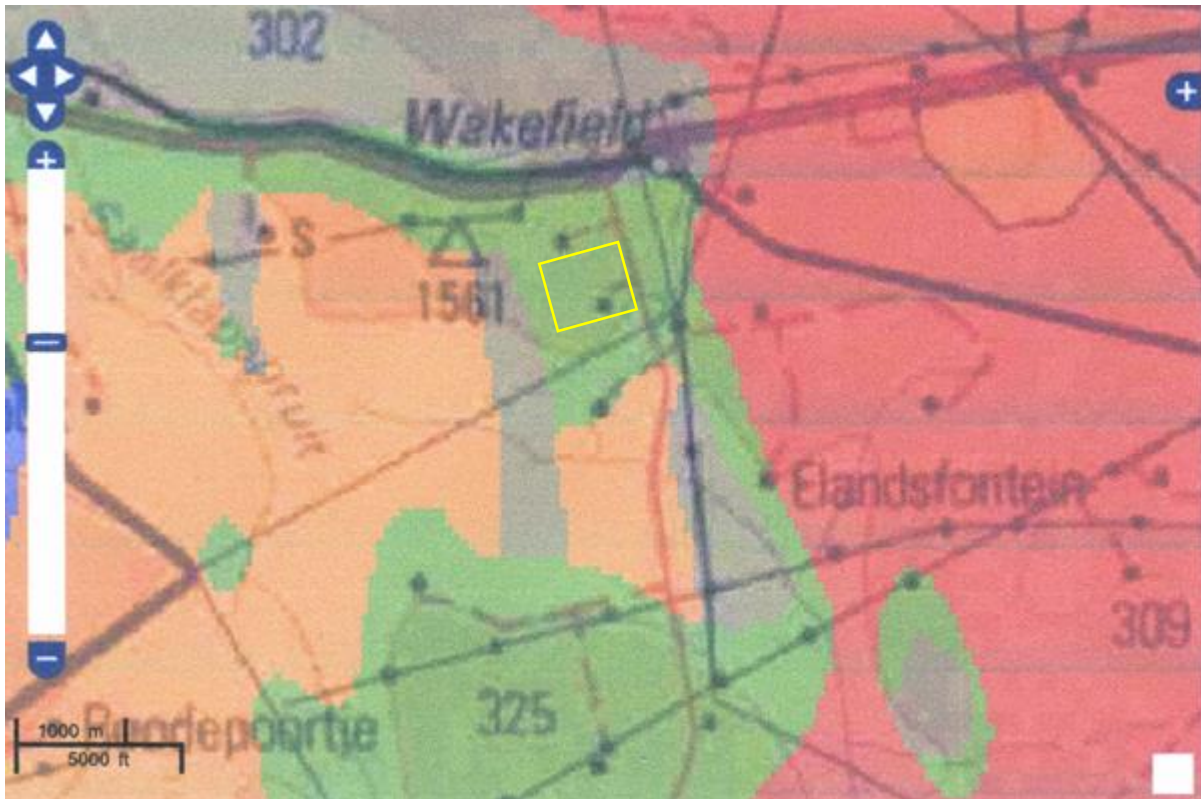
Figure 8-55 : SAHRIS palaeosensitivity map for the site for the proposed cemetery shown within the yellow rectangle. Background colours indicate the following degrees of sensitivity: red = very highly sensitive; orange/yellow = high; green = moderate; blue = low; grey = insignificant/zero.

According to the Palaeontological Impact Assessment Report, based on the nature of the project, surface activities may impact upon the fossil heritage if preserved in the development footprint. The geological structures suggest that the rocks are either much too old to contain fossils or are the correct age but wrong lithology. Furthermore, the material to be excavated is soil and this does not preserve fossils.
