**FINAL BASIC ASSESSMENT  
REPORT AND WATER USE  
LICENCE APPLICATION PROCESS  
FOR THE PROPOSED  
DEVELOPMENT OF SU CASA  
PRIVATE BURIAL ESTATE AND  
ASSOCIATED ACTIVITIES ON  
PORTION 10 OF FARM  
DOORNRUG 302 IN EMALAHLENI  
LOCAL MUNICIPALITY,  
MPUMALANGA PROVINCE**

**APRIL 2023**

1/3/1/16/1N-345

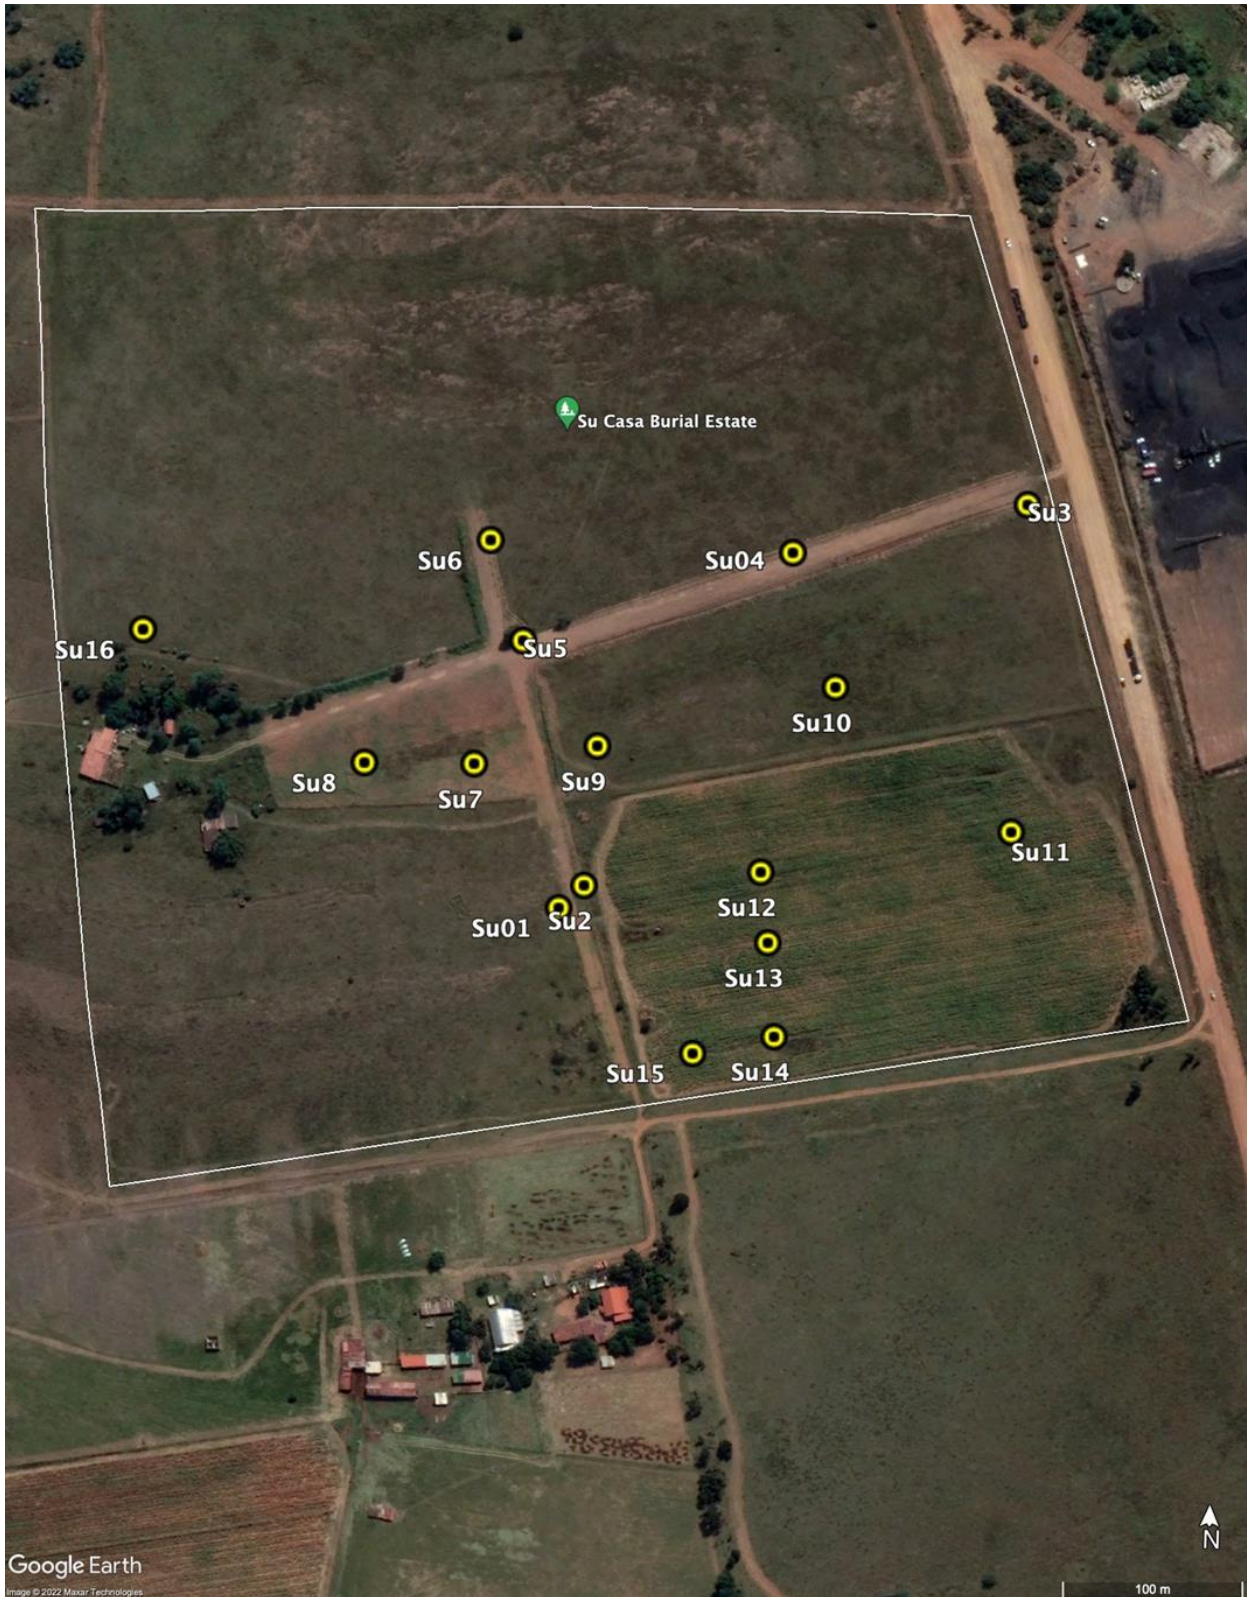
Figure 8-56: Site layout and test pit positions. Portion 22 Doornrug 302-JS Emalahleni

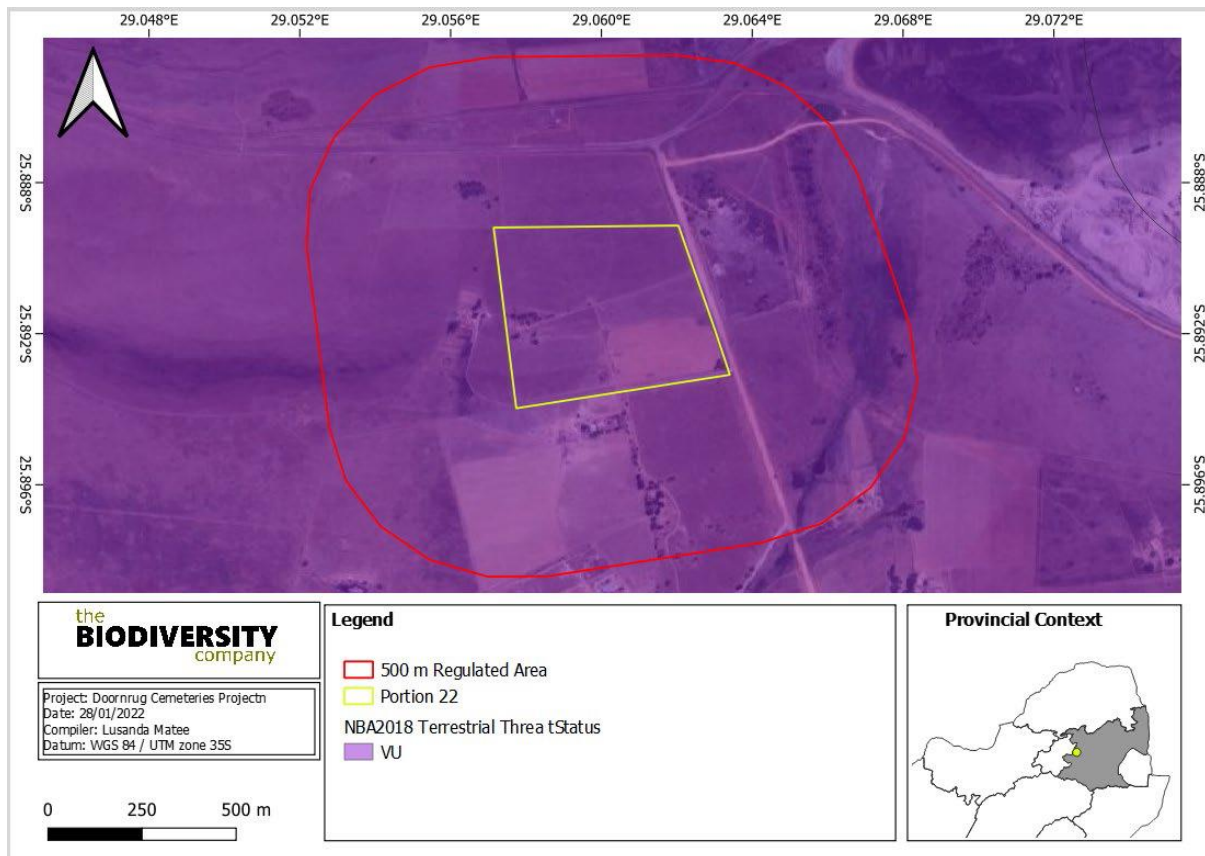
Figure 10.4-9 : Map illustrating the ecosystem threat status associated with the proposed project area

The Ecosystem Threat Status is an indicator of an ecosystem’s wellbeing, based on the level of change in structure, function or composition. Ecosystem types are categorised as Critically Endangered (CR), Endangered (EN), Vulnerable (VU), Near Threatened (NT) or Least Concern (LC), based on the proportion of the original extent of each ecosystem type that remains in good ecological condition. According to the spatial dataset, the proposed development overlaps with a VU ecosystem (Figure 12).

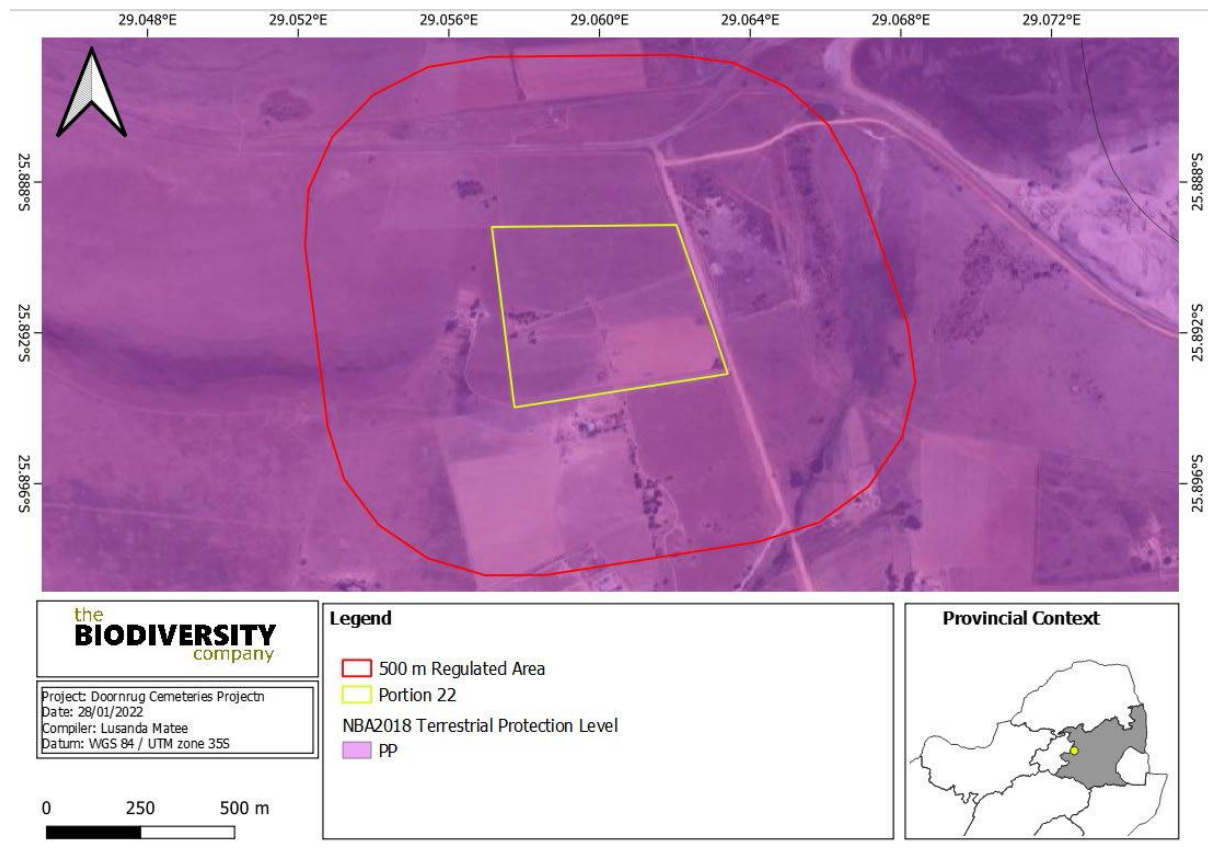
Figure 10.4-10 : Map illustrating the ecosystem protection level associated with the proposed project area

Indicator of the extent to which ecosystems are adequately protected or under-protected. Ecosystem types are categorised as Well Protected (WP), Moderately Protected (MP), Poorly Protected (PP), or Not Protected (NP), based on the proportion of the biodiversity target for each ecosystem type that is included within one or more protected areas. Not Protected, Poorly Protected or Moderately Protected ecosystem types are collectively referred to as under-protected ecosystems. The proposed development overlaps with a PP ecosystem (Figure 13).

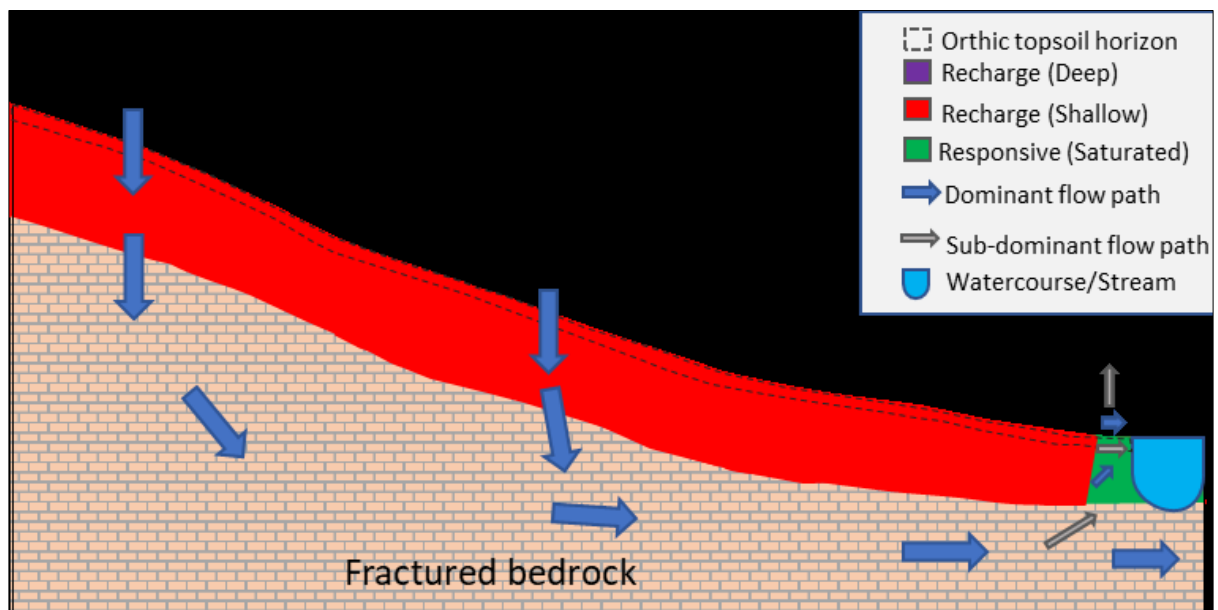
Figure 10.4-30 : Hillslope hydrology of the second of two distinct hydrogeological patterns prior to cemetery construction.

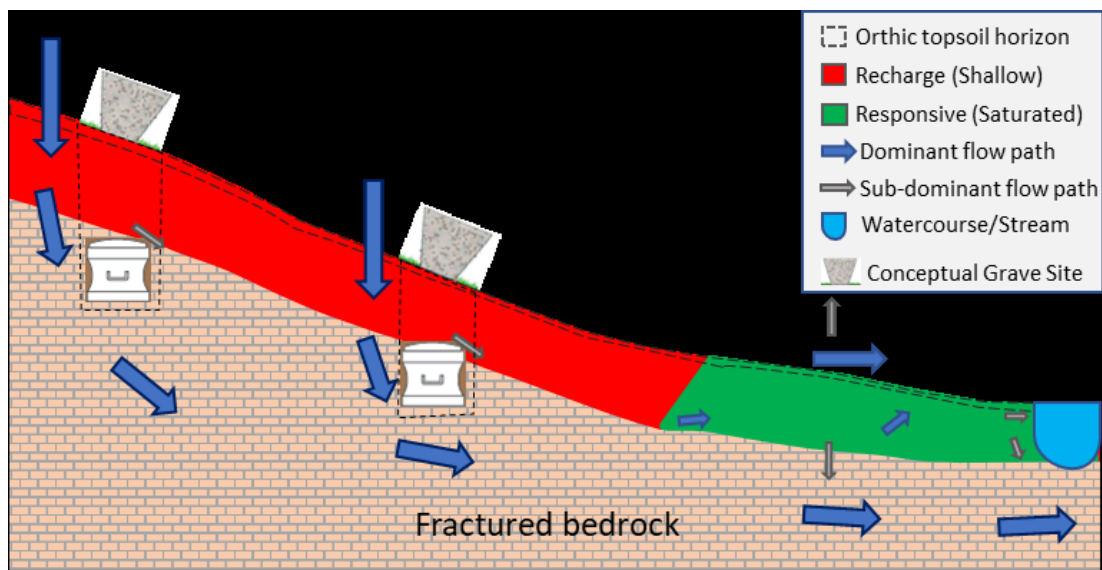
Figure 10.4-31 : Hillslope hydrology of one of two distinct hydrogeological patterns after the establishment of the burial estate and associated infrastructure.

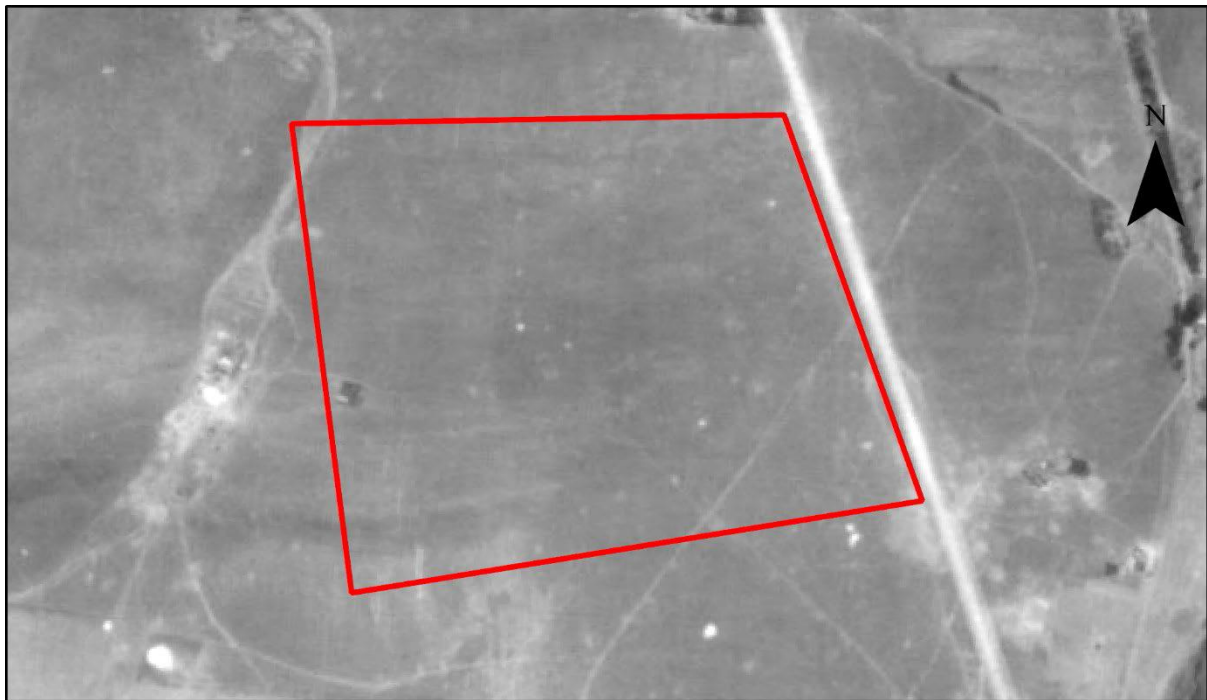
0 0.25 0.5  
km

Figure 10.4-34 : Aerial imagery from 1962. Relatively pristine landscape with a single structure visible in on western boundary where UP-DRB-2529-01 is located.

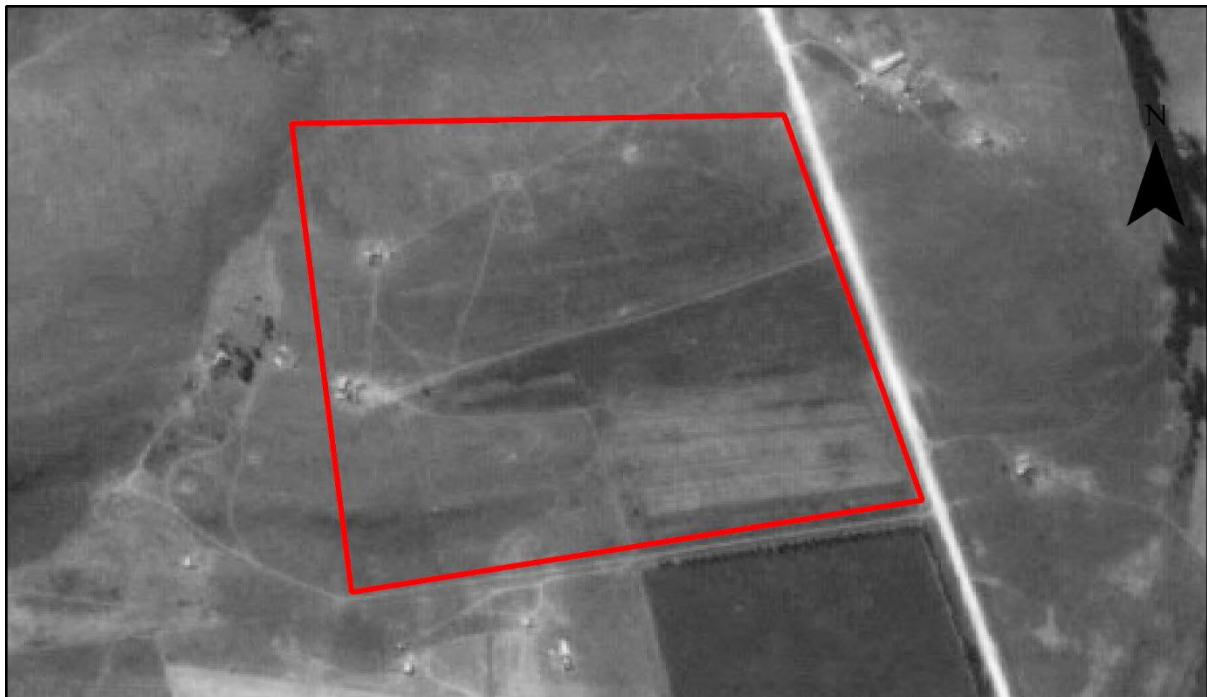
0 0.25 0.5  
km

Figure 10.4-35 : Aerial imagery from 1979. Expansion of UP-DRB-2529-01 on western boundary visible with footpaths linking it with UP-DRB-2529-06 and UP-DRB-2529-07 in the northern half of the project area.

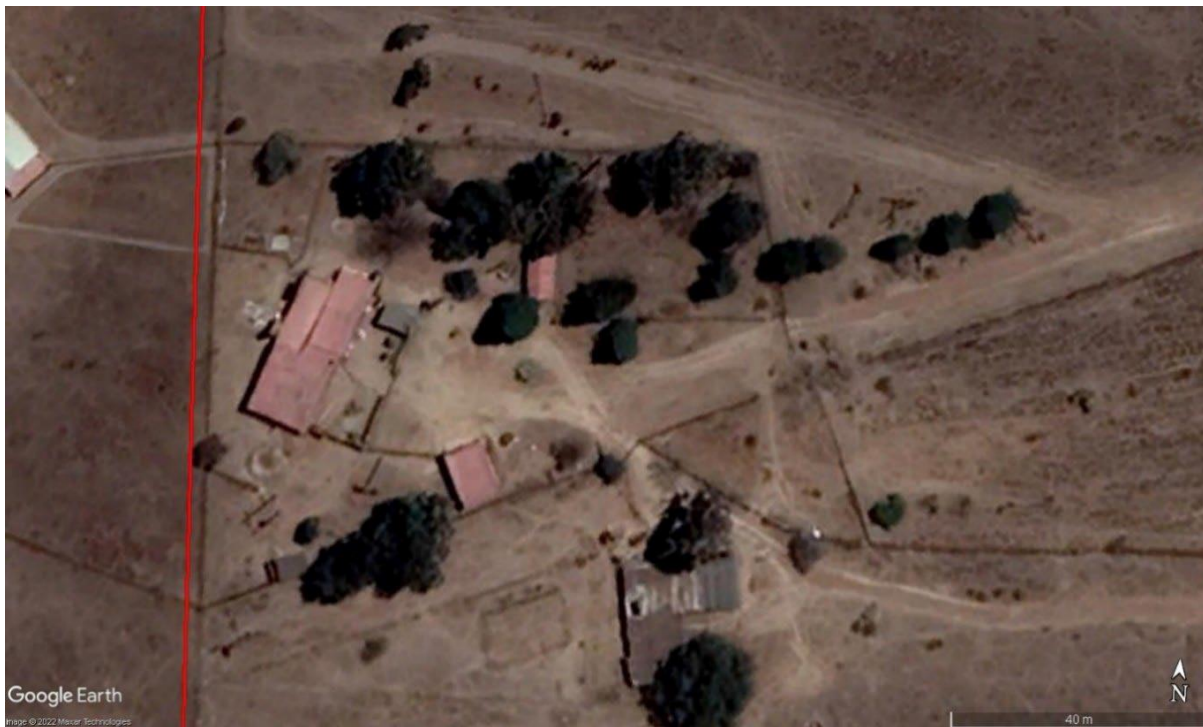
Figure 10.4-36 : UP-DR UP-DRB-2529-01 on Google Earth image from 2022.

UP-DRB-2529-01 represent an extant house and outbuildings. A portion of the building may potentially be older than 60 years since historical images from 1962 indicates a single square building where the current house is located. It does not appear on earlier images from 1943. The northeast orientation of the building and the clearly visible wall joints indicates that the original structure likely corresponds to the southeast portion of the current house. Extensive expansions and alterations have been made to the original structure in subsequent years that have severely altered the original building severely diminishing its heritage value.

There are several outbuildings around the house. These include a stonewalled chicken coop/storeroom and brick garage. Aerial images and field inspection of building materials indicate that these are all less than 60 years old.

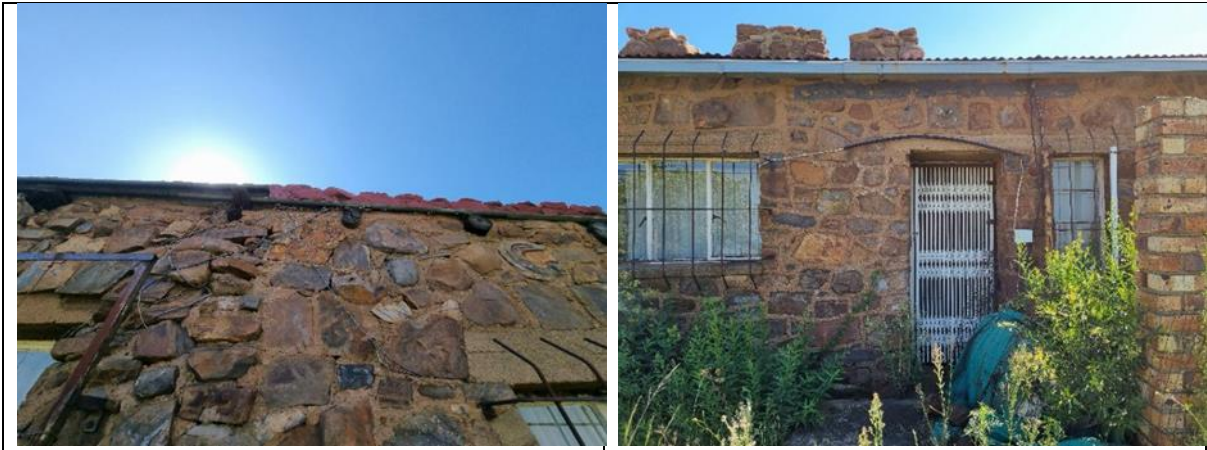
Figure 10.4-37 : Farm outbuilding. Likely livestock pen/chicken coop. Left, south facing wall; Right west facing wall.

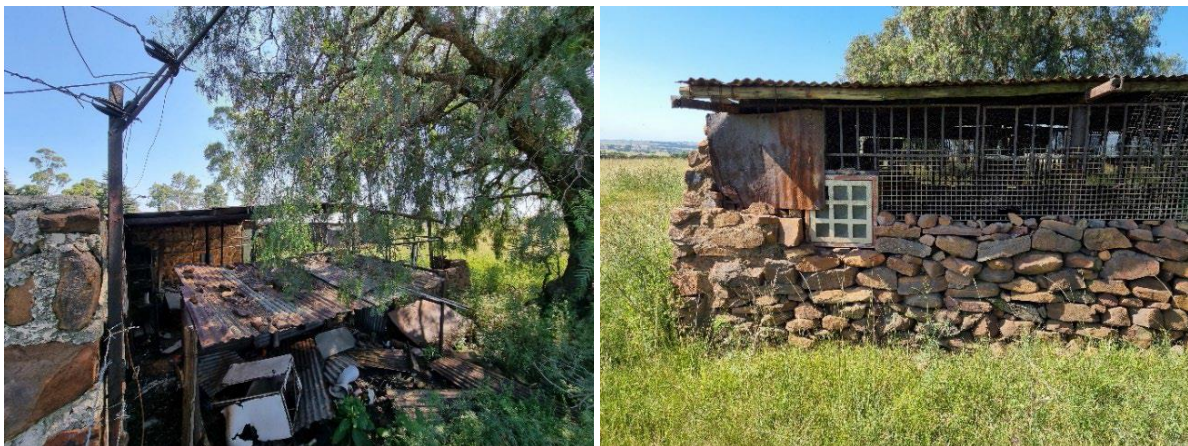
Figure 10.4-38 : Farm outbuilding. Likely storeroom and livestock pen/chicken coop. Southwest corner of outbuilding, right north facing wall.

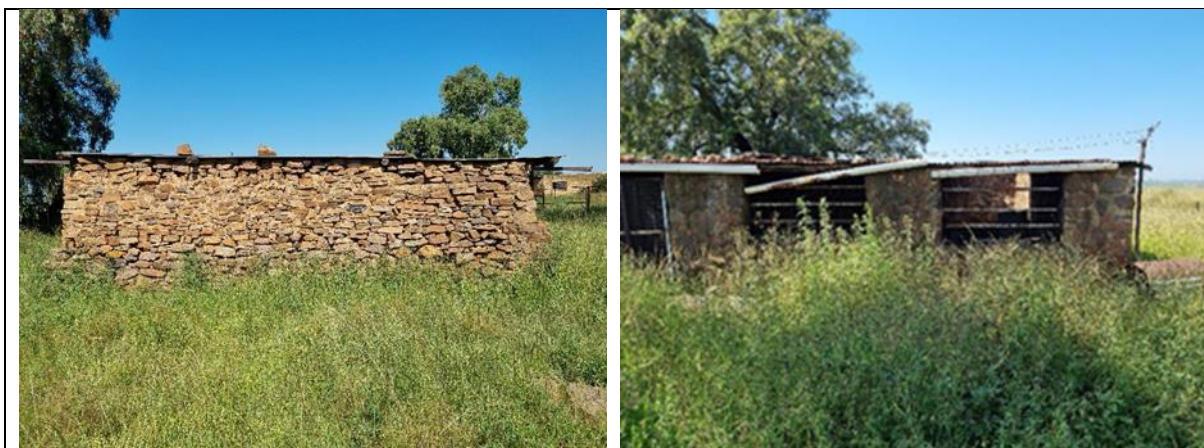
Figure 10.4-39: Likely storeroom and livestock/pen/chicken coop. South facing wall (left) and northwest corner (right).

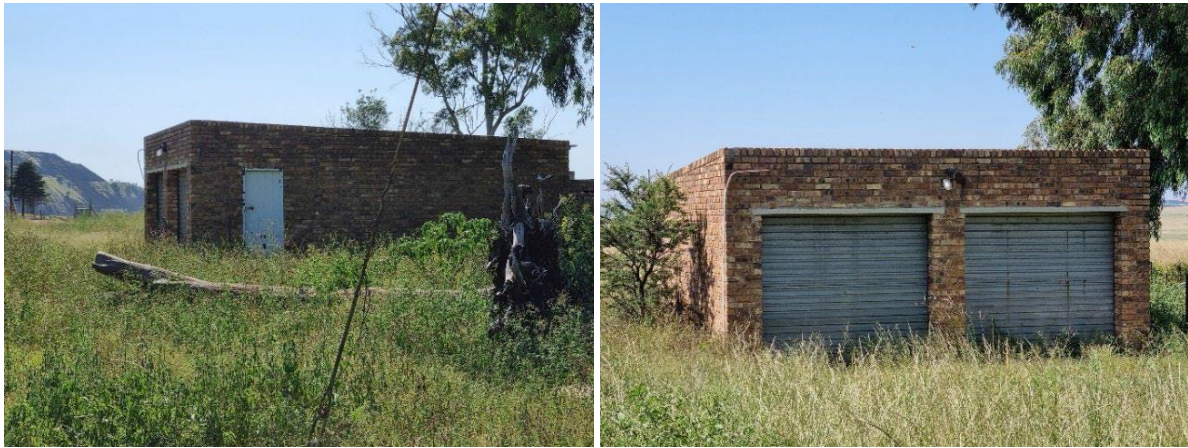
Figure 10.4-40 : Late 20<sup>th</sup> century brick structure with metal roller doors.

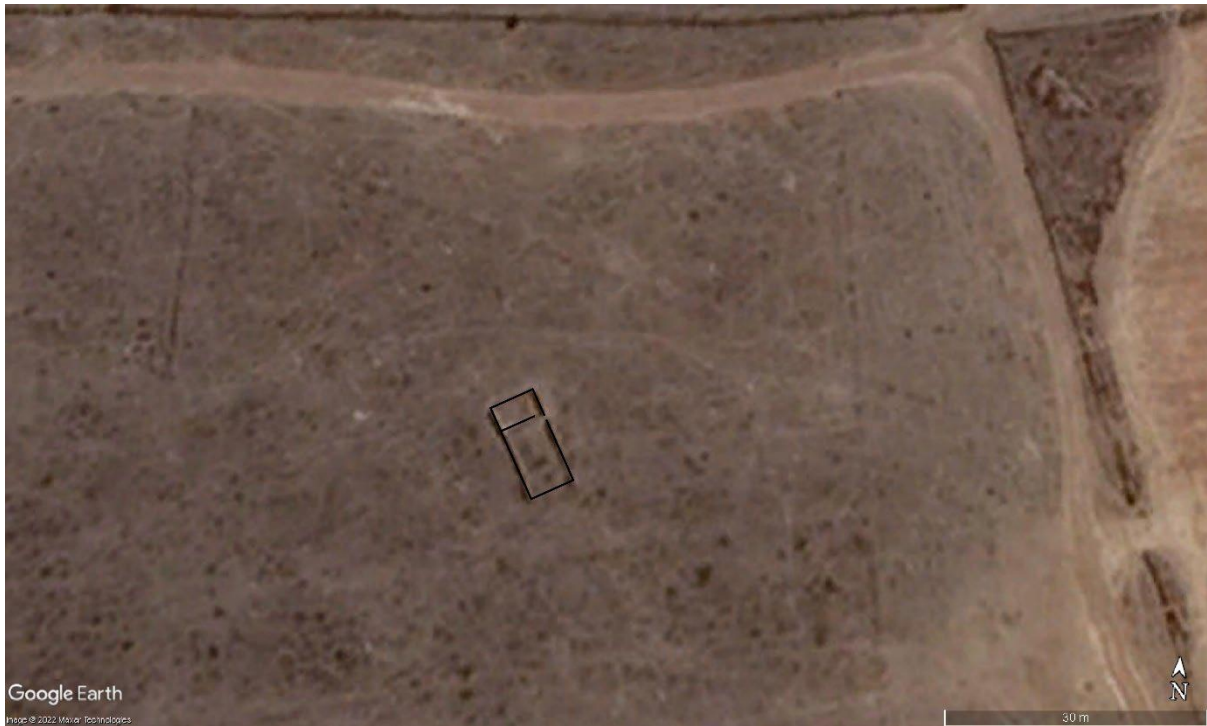
Figure 10.4-41 : UP-DRB-2529-02 outlines on Google Earth imagery.

Site UP-DRB-2529-02 is the remains of a two roomed rectangular structure roughly orientated in a northwest-southeast direction. The walls are dry stacked local stone, built up to a height of approximately 60cm. Wall abutting joints indicate that the structure was built in two phases. The first was the construction a 3mx5m northern room, and later, a 9mx5m southern room was added. There is a single entrance to structure which leads directly into the southern room with the doorway to the northern room immediately on the right. The interior of the northern room was covered with a cement plaster and a cement cap was placed on the top course of the wall. No cement reinforcing or plaster were observed at the southern room. It is possible that the walls supported a superstructure of material that has either perished or had been removed.

Determining the age is however difficult since it does not appear on early aerial images and no material culture was present to provide a relative date. The earliest aerial images where the site is clearly visible is dated 2005, but at this stage it is already in a ruined state. It is likely that this structure served as living quarters for farm labourers in the 20th century. Its absence on the 1962 and 1979 images implies that it was erected after these dates, and therefore less than 60 years old.

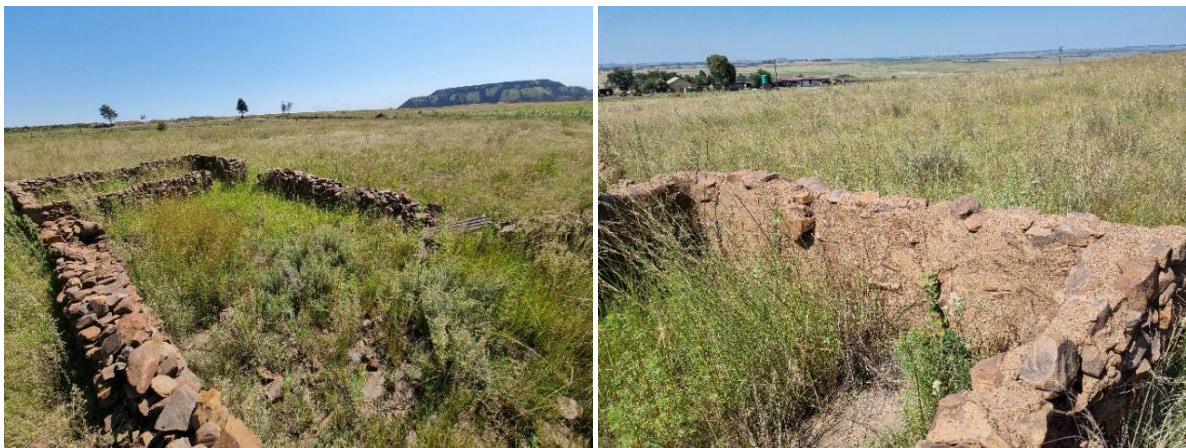
Figure 10.4-42 : UP-DRB-2529-02, (left) looking east over both rooms, and north (right) with cement plaster visible on inside of northern room.

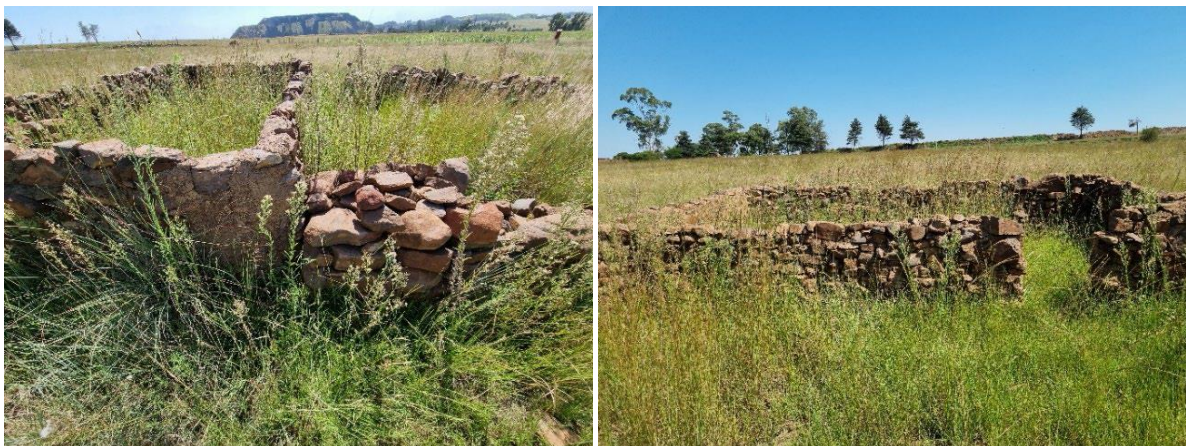
Figure 10.4-43 : UP-DRB-2529-02 (left) showing the joint of the two rooms along the west facing wall, and (right) the main entrance on the east facing wall.

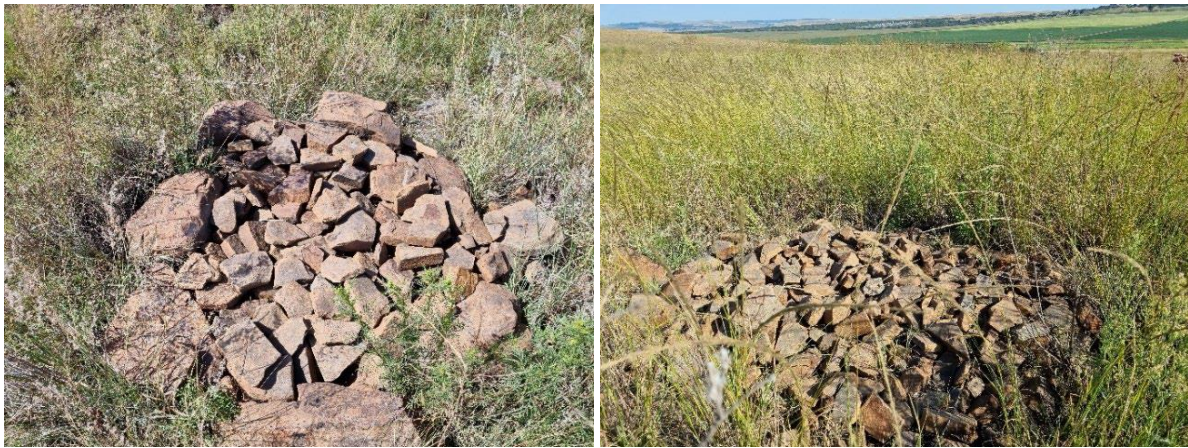
Figure 10.4-44 : Stones features, UP-DRB-2529-03 (left) and UP-DRB-2529-04 (right), of unknown use and function, but likely related to 20<sup>th</sup> century farming activities.

Two circular stone mounds were identified whose use/function is unknown. UP-DRB-2529-03 is approximately 60cm in diameter and formed by an outer ring of large stones and filled with smaller stones. UP-DRB-2529-04 is an approximately 1m wide pile of stones (~10-20cm range). No material culture was associated with the features, however, given the absence of prehistoric remains in the immediate vicinity, these most likely relate to 20th century activities.

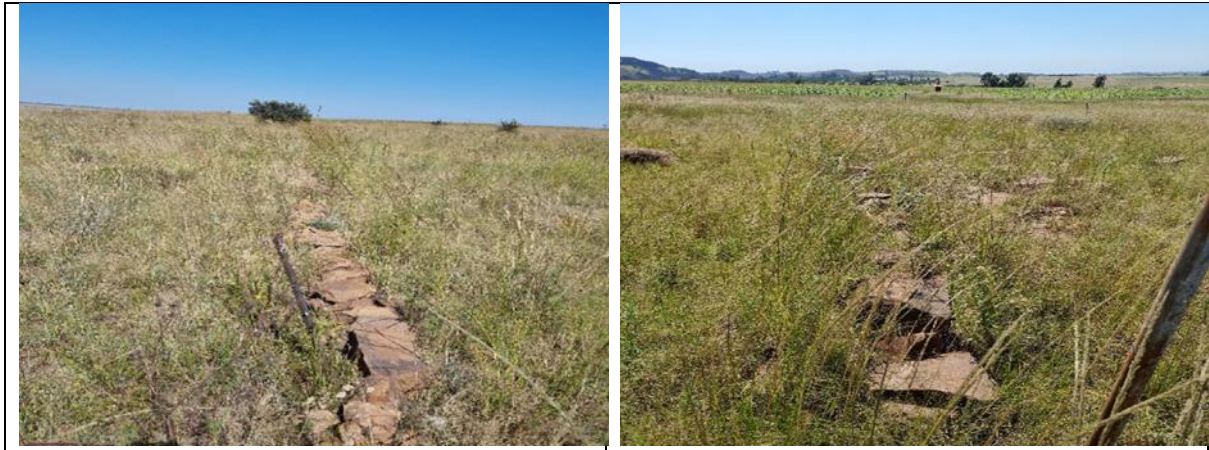
Figure 10.4-45 : Examples of stone field boundary sections (UP-DRB-2529-05)

In the southwestern section of the project area there are linear stone walls that demarcate old field boundaries. In places metal fence poles are and fencing wire is trapped in the stones. Some of these are faintly visible on aerial photos from 1979, and the absence of the other walls show that the majority may be more recent than this date.

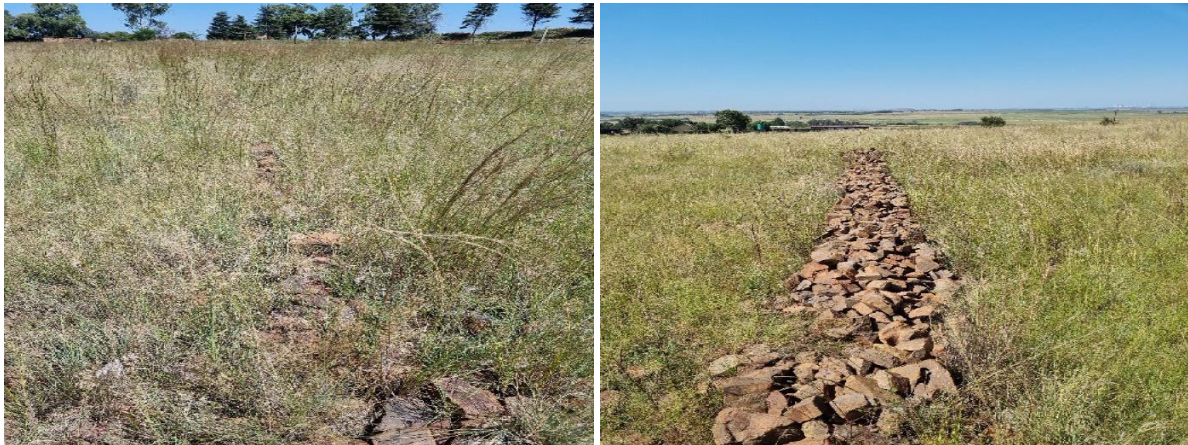
Figure 10.4-46 : Examples of stone field boundary sections (UP-DRB-2529-05)

Name of the report	Recommendations
	<ul style="list-style-type: none"> <li>• UP-DRB-2529-05 are the remains of 20th century linear field boundary walls less than 60 years old. These walls carry no significance (1). It was adequately recorded and documented in the Phase I Heritage Assessment. No further mitigation steps are required.</li> </ul> <p>Investigation of the Project Area identified seven sites. These however respectively carry no (category 1 – no mitigation) and low (category 2a - recording) heritage significance. These ratings mean that no further mitigation is needed and that the proposed cemetery can continue from a heritage point of view.</p>
<p>Palaeontological Impact Assessment</p>	<p><b>Chance Find Protocol</b></p> <p>Monitoring Programme for Palaeontology – to commence once the excavations begin.</p> <ul style="list-style-type: none"> <li>• The following procedure is only required if fossils are seen on the surface and when excavations commence.</li> <li>• When excavations begin the rocks and must be given a cursory inspection by the environmental officer or designated person. Any fossiliferous material (plants, insects, bone, coal) should be put aside in a suitably protected place. This way the project activities will not be interrupted.</li> <li>• Photographs of similar fossils must be provided to the developer to assist in recognizing the fossil plants, vertebrates, invertebrates or trace fossils in the shales and mudstones (for example see Figure 115). This information will be built into the EMP's training and awareness plan and procedures.</li> <li>• Photographs of the putative fossils can be sent to the palaeontologist for a preliminary assessment.</li> <li>• If there is any possible fossil material found by the developer/environmental officer then the qualified palaeontologist sub-contracted for this project, should visit the site to inspect the selected material and check the dumps where feasible.</li> </ul>

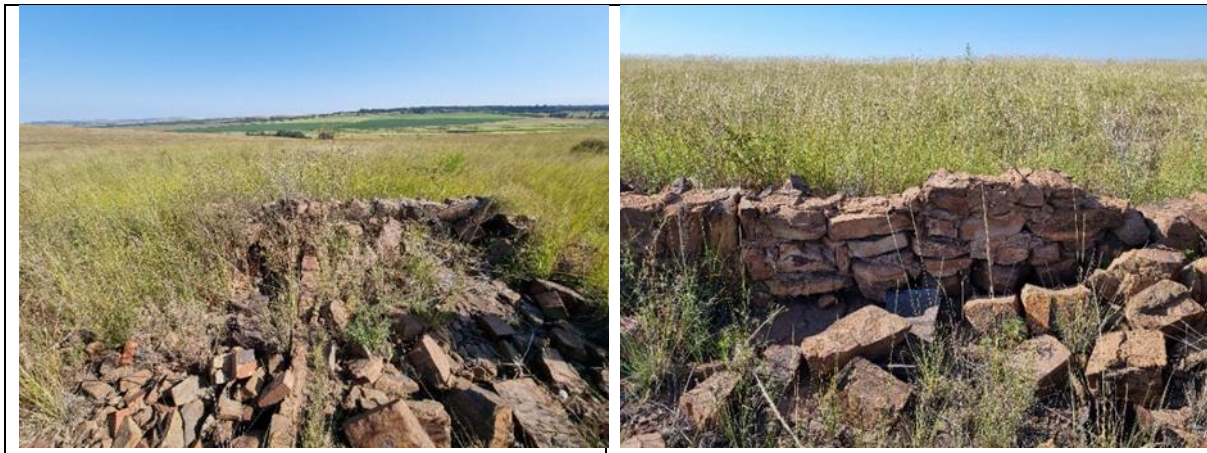
Figure 10.4-48 : UP-DRB-2529-06 looking north (left) and east.

were rectangular shape. Both were constructed from a combination of natural stone, brick, and cement mortar. The original walls seem to be around 60-80cm high. Fragments of plaster on some bricks indicates that the inside of these structures were plastered with cement and painted white. A few pieces of structural metal such as corrugated sheeting indicate that these may also have been used in the original building. Green glass bottle fragments on UP-DRB-2529-06 were the only material culture identified.

The earliest images where these features are visible are from 1979. In these historical images, there are clear footpaths connecting both to one another and to southwest to the main farmhouse complex northeast to the main road. These pathways suggest that these were likely the remains of farm labourer housing. Given their absence on earlier images, they likely date to the 1970s.

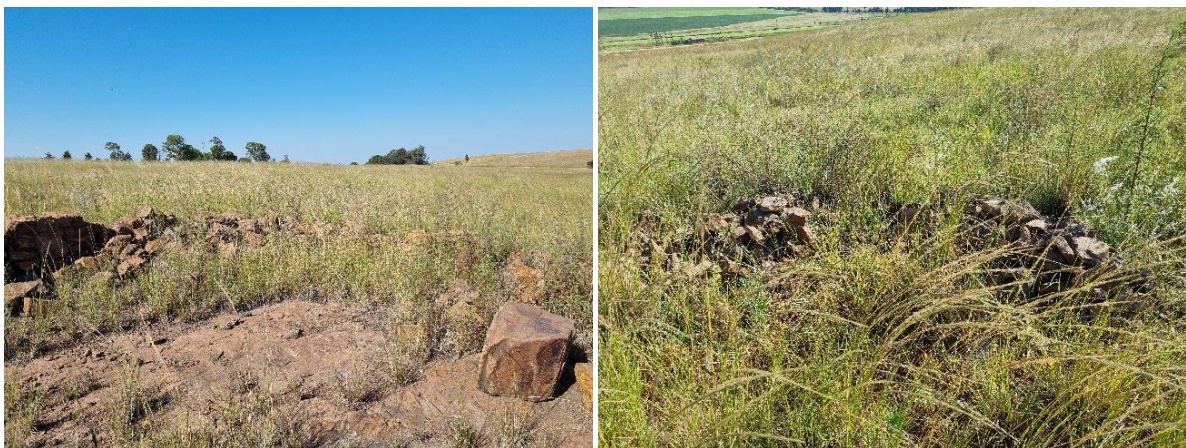
Figure 10.4-49 : View of UP-DRB-2529-07 looking south (left) and looking east (right)

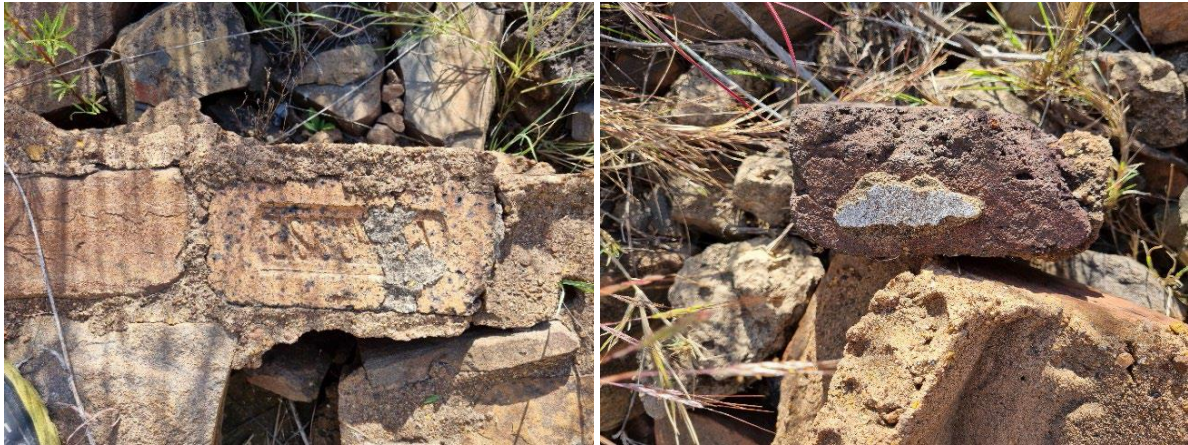
Figure 10.4-50 : Stone structures indicating the use of local stone, brick, cement and metal.

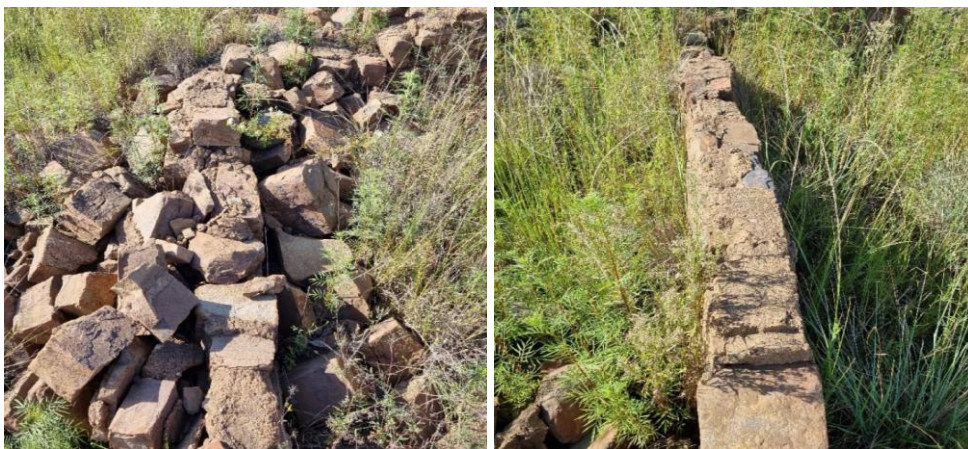
Figure 10.4-51 : Collapsed free standing brick and cement walls. UP-DRB-2529-06 (left) and UP-DRB-2529-07 (right).

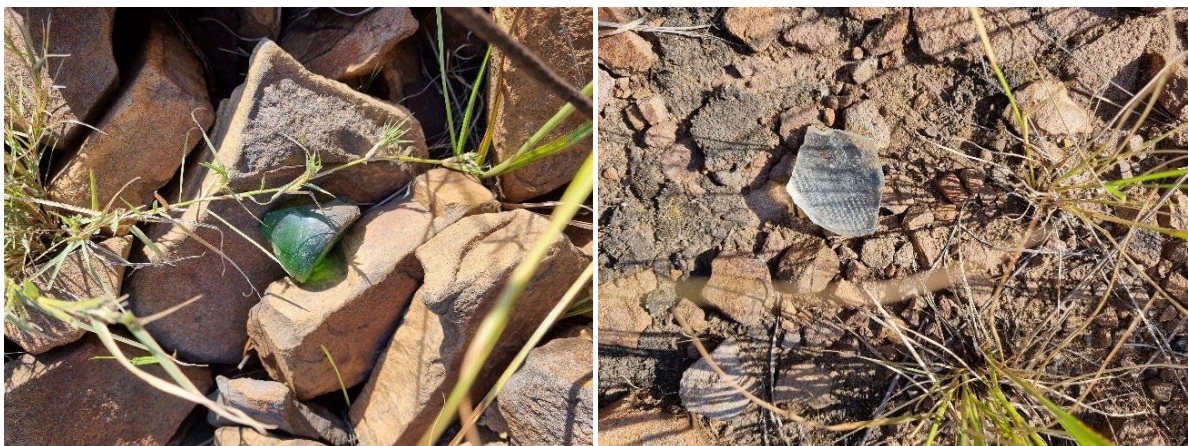
Figure 10.4-52 : Glass bottle fragments on UP-DRB-2529-06.

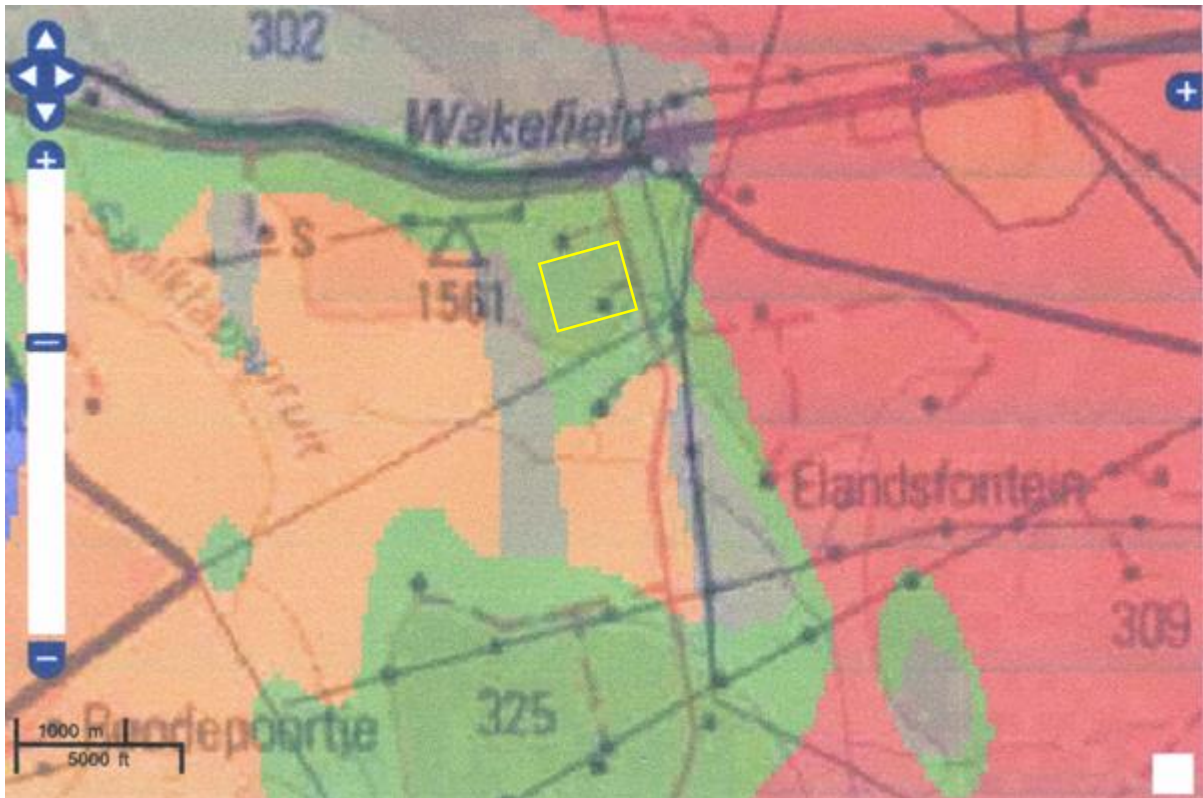
Figure 10.4-55 : SAHRIS palaeosensitivity map for the site for the proposed cemetery shown within the yellow rectangle. Background colours indicate the following degrees of sensitivity: red = very highly sensitive; orange/yellow = high; green = moderate; blue = low; grey = insignificant/zero.

According to the Palaeontological Impact Assessment Report, based on the nature of the project, surface activities may impact upon the fossil heritage if preserved in the development footprint. The geological structures suggest that the rocks are either much too old to contain fossils or are the correct age but wrong lithology. Furthermore, the material to be excavated is soil and this does not preserve fossils.

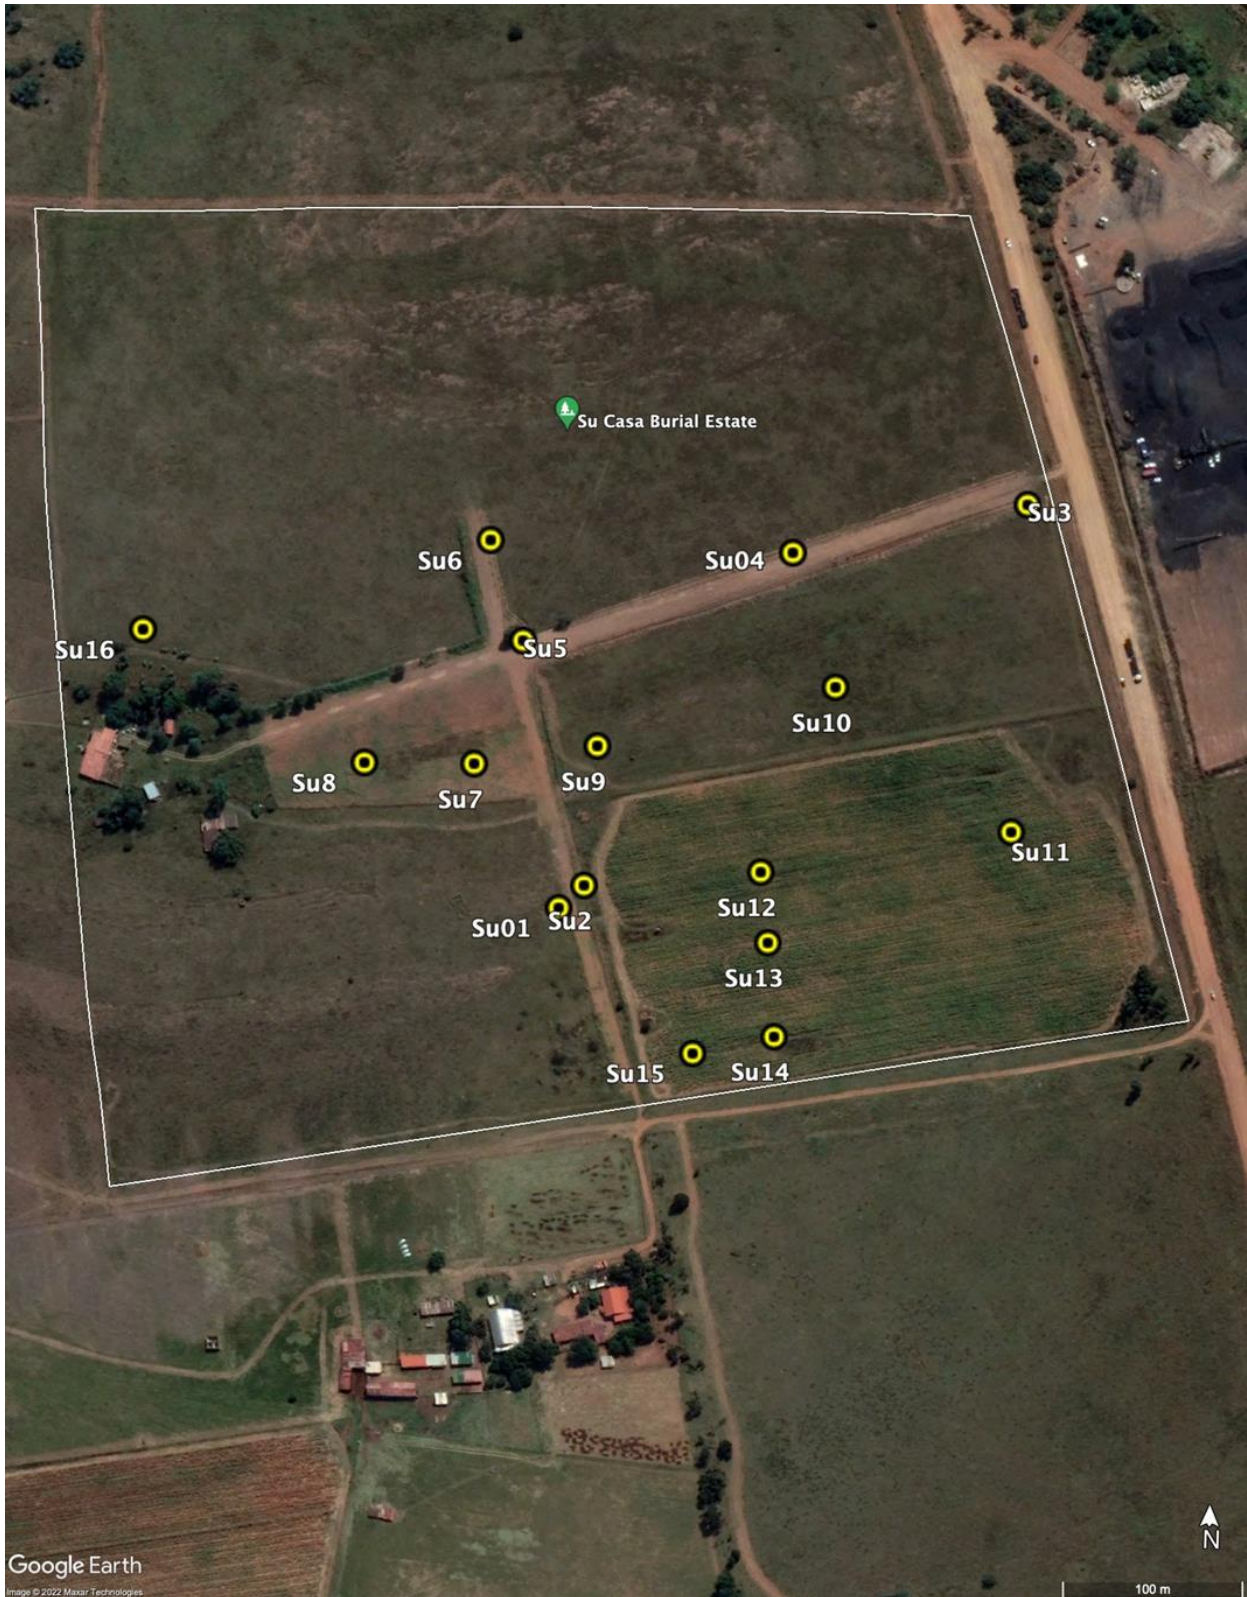
Figure 10.4-56: Site layout and test pit positions. Portion 22 Doornrug 302-JS Emalahleni
