**FINAL BASIC ASSESSMENT  
REPORT AND WATER USE  
LICENCE APPLICATION PROCESS  
FOR THE PROPOSED  
DEVELOPMENT OF SU CASA  
PRIVATE BURIAL ESTATE AND  
ASSOCIATED ACTIVITIES ON  
PORTION 10 OF FARM  
DOORNRUG 302 IN EMALAHLENI  
LOCAL MUNICIPALITY,  
MPUMALANGA PROVINCE**

**APRIL 2023**

1/3/1/16/1N-345

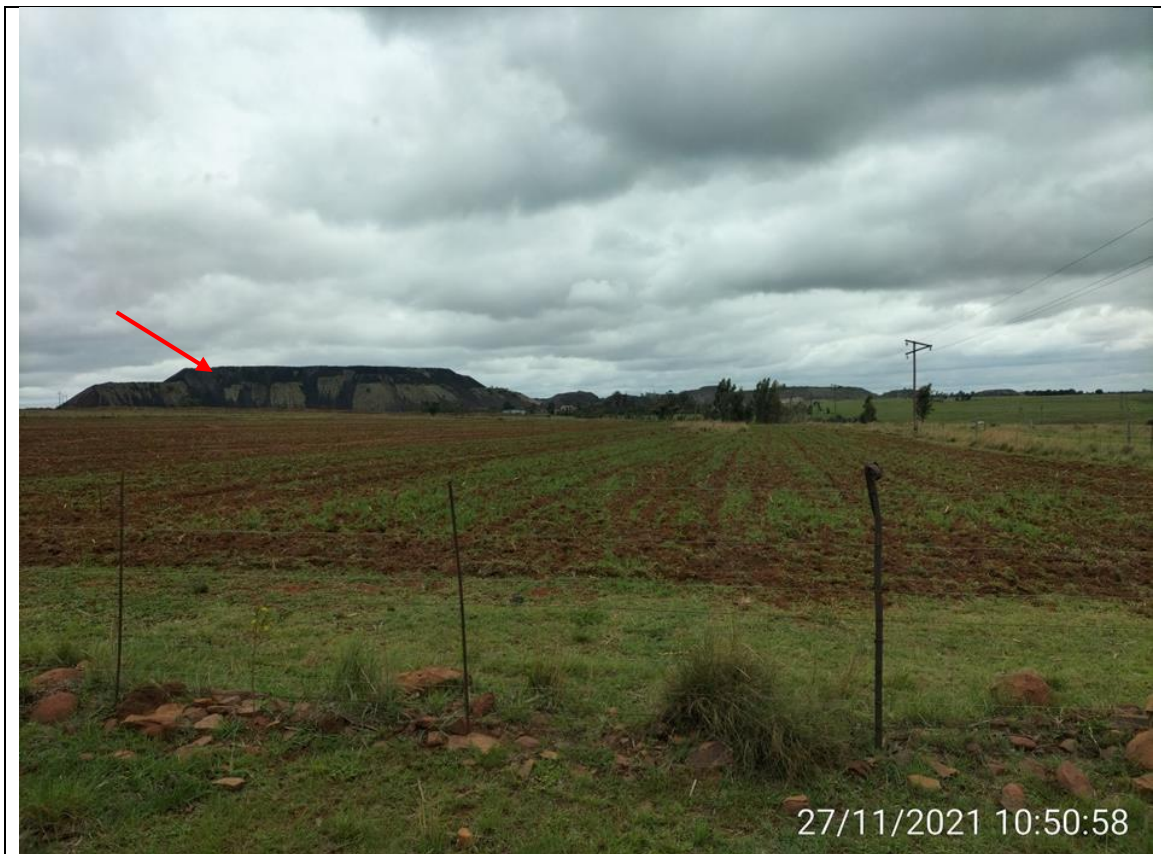
The proposed site is located near a mine dump which is causing visual impact in the surrounding. The cemetery site may also cause negative visual impact, but the impact will be Low as the area is currently negatively impacted by the dump. Refer to the Figure below.

Figure 12.2-1: Mine dump near the proposed site

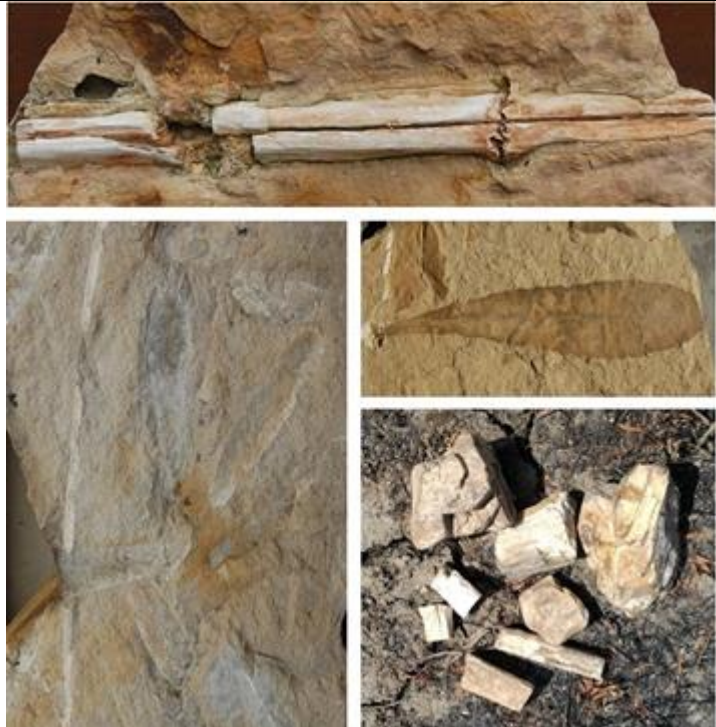
<p><b>Figure 14-1: Photographs of fossil plants of the early Glossopteris flora that occur in the Dwyka Group sediments in north western South Africa.</b></p>	
Hydropedology	The proposed Su Casa Burial Estate and associated infrastructure components will have very little impact on the hydropedology of the relevant hillslopes, regardless of the position of the grave sites (crest, mid-slope or valley bottom). For recharge soils (which are dominant), recharge won't be affected at all given the fact that infiltration will only be impeded	Included in Section 11 of this report and the EMPr attached as Appendix F.

Table 14-1 : Summary of the Findings of the Specialist Reports		
Name of the report	Findings and recommendation	Section of the report where the information is included
	<ul style="list-style-type: none"> <li>• If there is any possible fossil material found by the developer/environmental officer then the qualified palaeontologist sub-contracted for this project, should visit the site to inspect the selected material and check the dumps where feasible.</li> <li>• Fossil plants or vertebrates that are considered to be of good quality or scientific interest by the palaeontologist must be removed, catalogued and housed in a suitable institution where they can be made available for further study. Before the fossils are removed from the site a SAHRA permit must be obtained. Annual reports must be submitted to SAHRA as required by the relevant permits.</li> <li>• If no good fossil material is recovered then no site inspections by the palaeontologist will be necessary. A final report by the palaeontologist must be sent to SAHRA once the project has been completed and only if there are fossils.</li> <li>• If no fossils are found and the excavations have finished then no further monitoring is required.</li> </ul> <p>Examples of fossils from the Dwyka Group.</p>

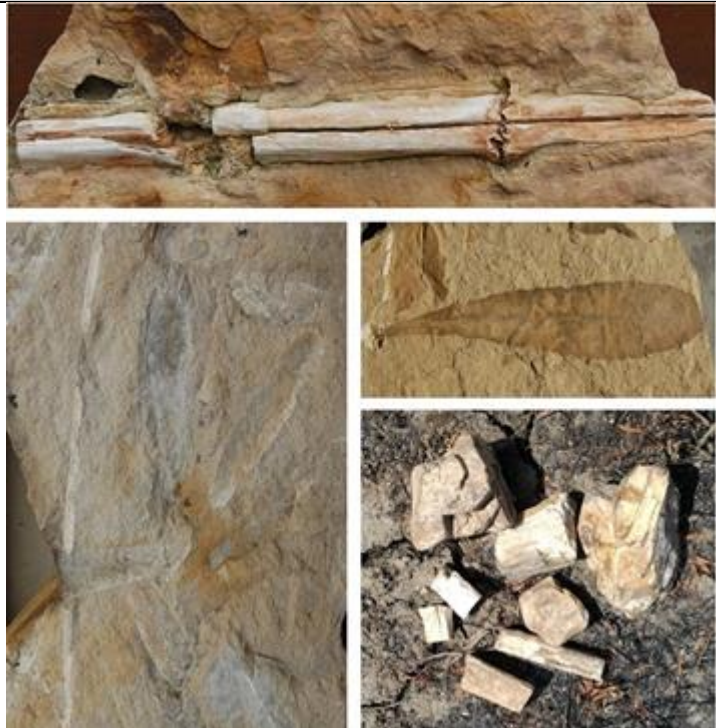
<p data-bbox="465 991 1984 1027">Figure 115: Photographs of fossil plants of the early Glossopteris flora that occur in the Dwyka Group sediments in north western South Africa.</p>
Hydropedology	<p data-bbox="465 1098 904 1129"><b>Surface Water Monitoring Programme</b></p> <p data-bbox="465 1198 2047 1334">The limits prescribed in this monitoring programme are stipulated in the Target Water Quality Range (TWQR) for aquatic ecosystems (DWAF, 1996). This prescribed monitoring programme should be conducted in conjunction with other aspects of riverine monitoring in the form of aquatic biomonitoring which addresses macroinvertebrate and ichthyofauna assemblages on a bi-yearly basis. The surface water monitoring programme will require monthly</p>

Name of the report	Recommendations
	<ul style="list-style-type: none"><li data-bbox="472 252 2047 384">• Fossil plants or vertebrates that are considered to be of good quality or scientific interest by the palaeontologist must be removed, catalogued and housed in a suitable institution where they can be made available for further study. Before the fossils are removed from the site a SAHRA permit must be obtained. Annual reports must be submitted to SAHRA as required by the relevant permits.</li><li data-bbox="472 405 2047 488">• If no good fossil material is recovered then no site inspections by the palaeontologist will be necessary. A final report by the palaeontologist must be sent to SAHRA once the project has been completed and only if there are fossils.</li><li data-bbox="472 509 1518 539">• If no fossils are found and the excavations have finished then no further monitoring is required.</li></ul> <p data-bbox="472 608 927 638">Examples of fossils from the Dwyka Group.</p>
