# Wetland Delineation and Assessment for the Proposed Exxaro Matla Coal Mine Stooping Project, Mpumalanga Province

**Reference: 687/2011**

**PROJECT:** **Wetland Delineation and Assessment for the  
Proposed Exxaro Matla Coal Mine Stooing Project,  
Mpumalanga Province**

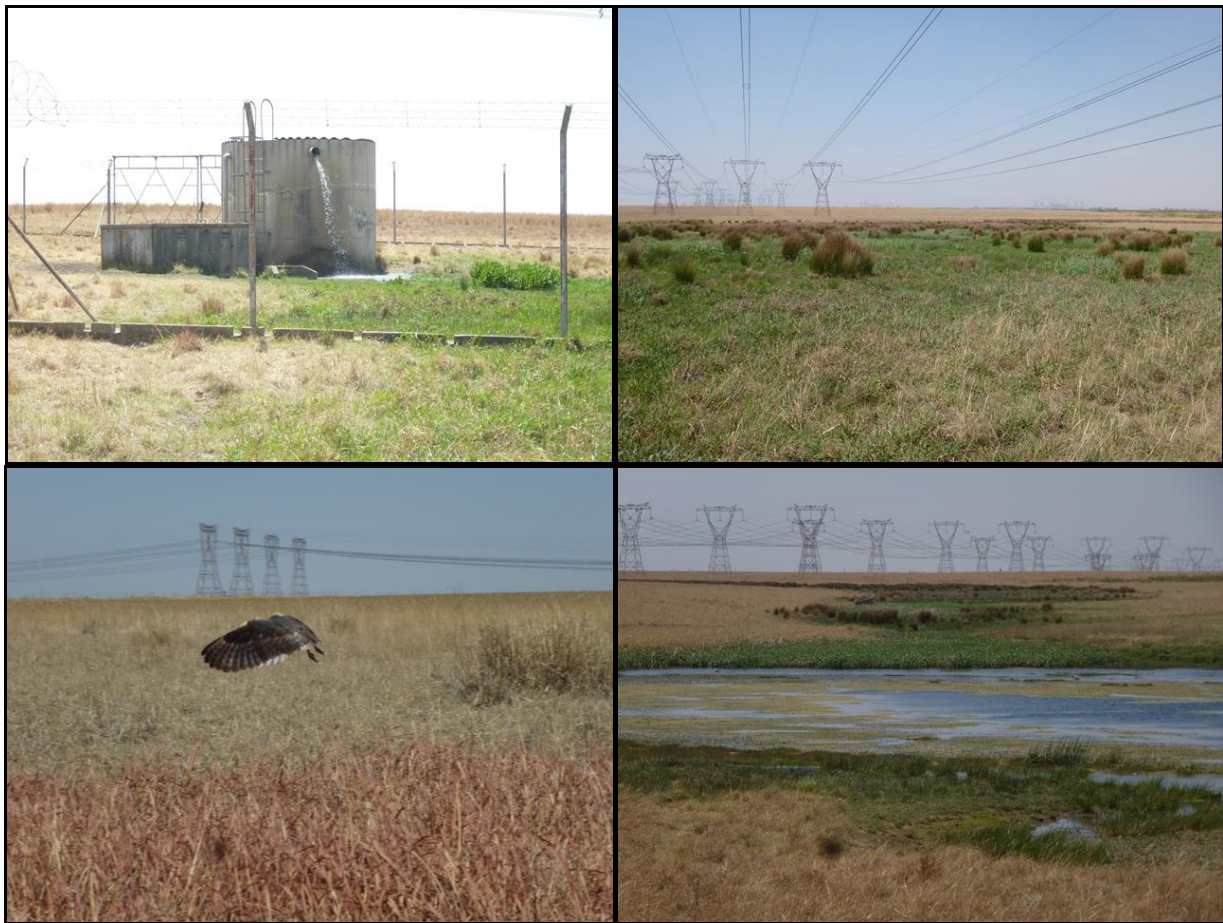
**Figure 11. Photographs of the wetlands within the Block B and C area (clockwise from top left): water discharge point; wetland habitat below discharge point; wetland below discharge point feeding into farm dam; African Grass Owl observed within the north eastern hillslope seepage wetland.**

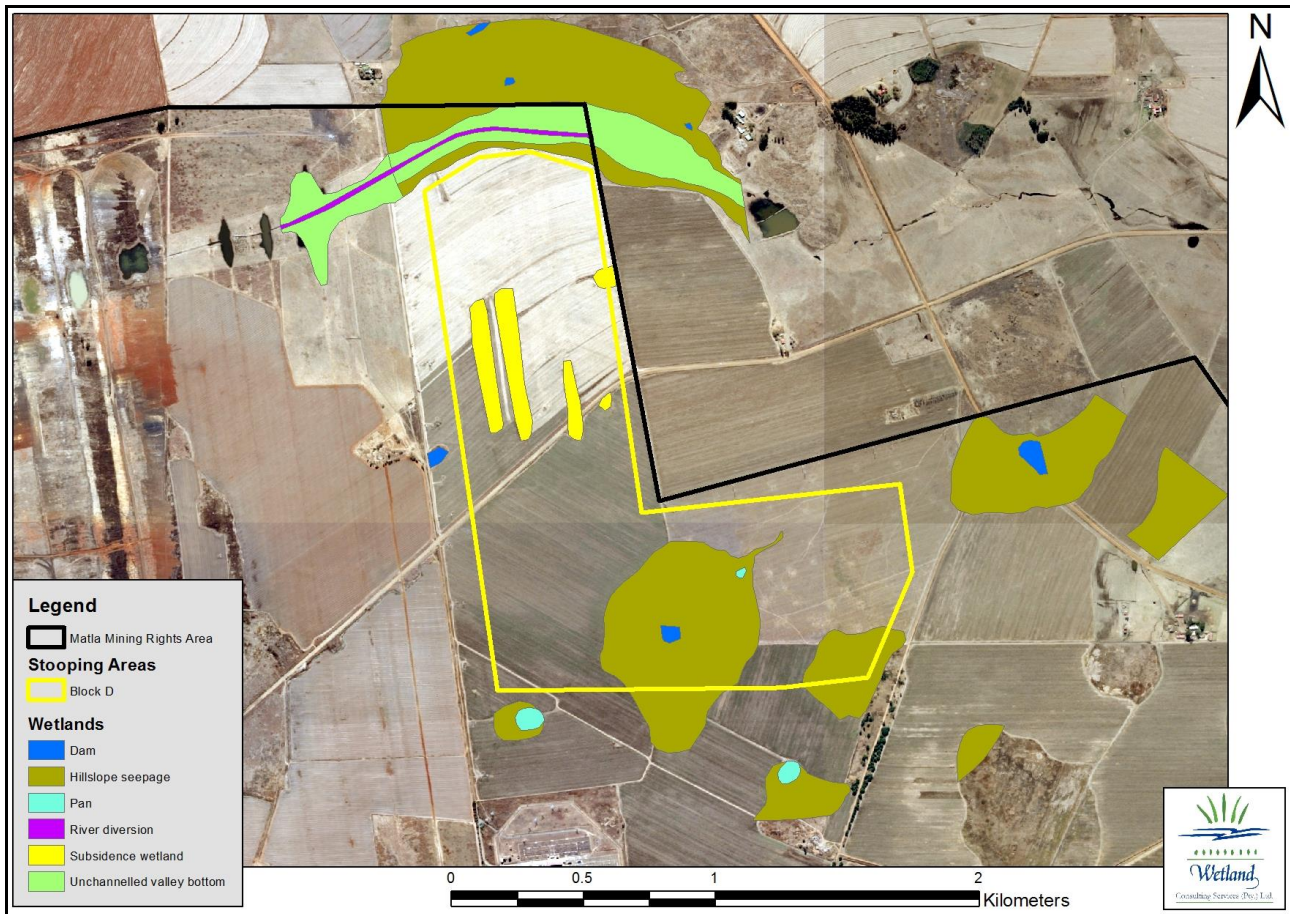
Within the southern portions of Block D, several large seemingly isolated hillslope seepage wetlands occur. These have for the most part been cultivated at some stage, with portions still currently under cultivation. Planted pastures also occur within the wetlands.

**Figure 12. Map of the delineated wetland areas within the Block D area.**

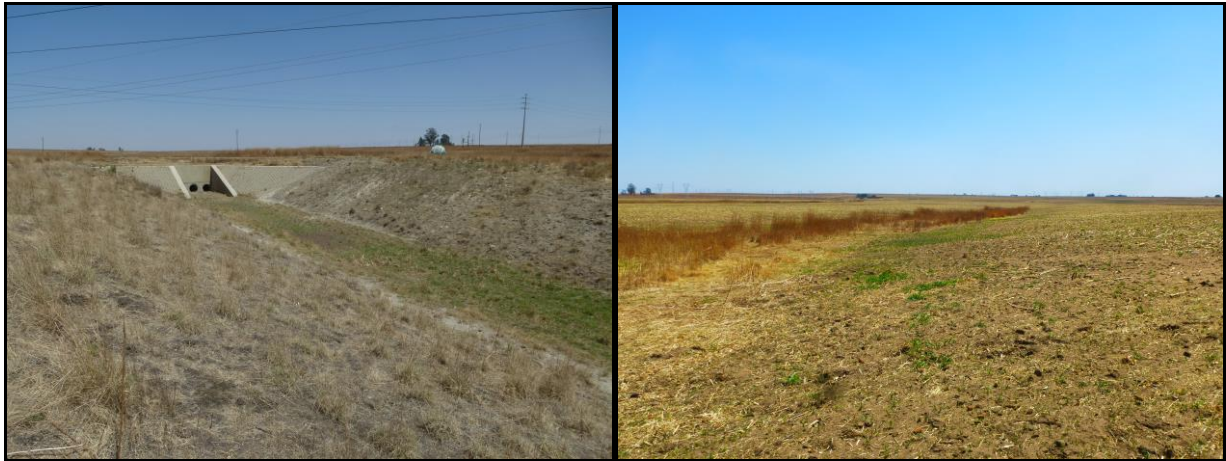
**Figure 13. Photographs of the wetlands within the Block D area (clockwise from top left): Excavated channel and subsided area.**

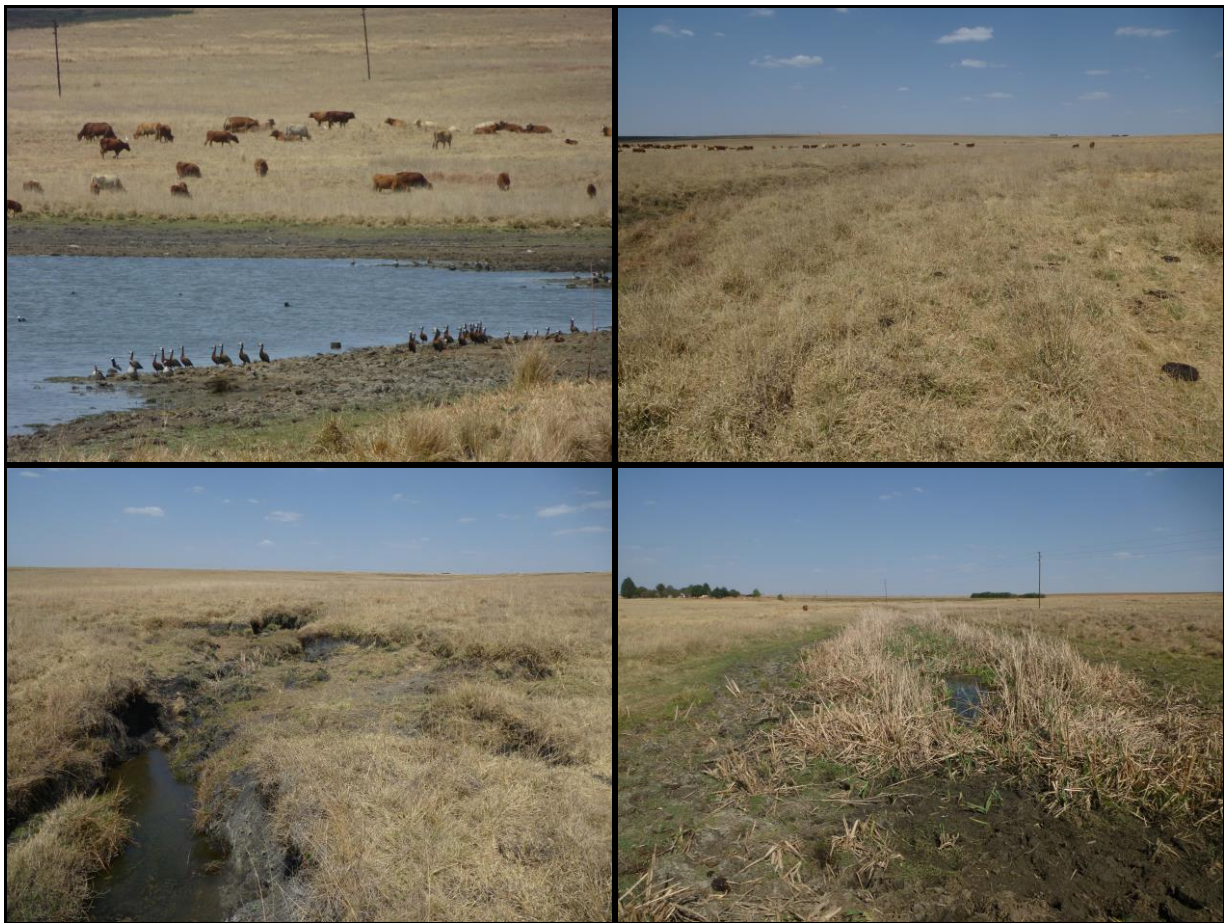
Figure 15. Photographs of the wetlands within the Block E area (clockwise from top left): Upper reach of farm dam; view upstream of the farm dam; channelled valley bottom downstream of the farm dam – note straight channel; and erosion upstream of the farm dam associated with cattle trampling – note black clay soils.

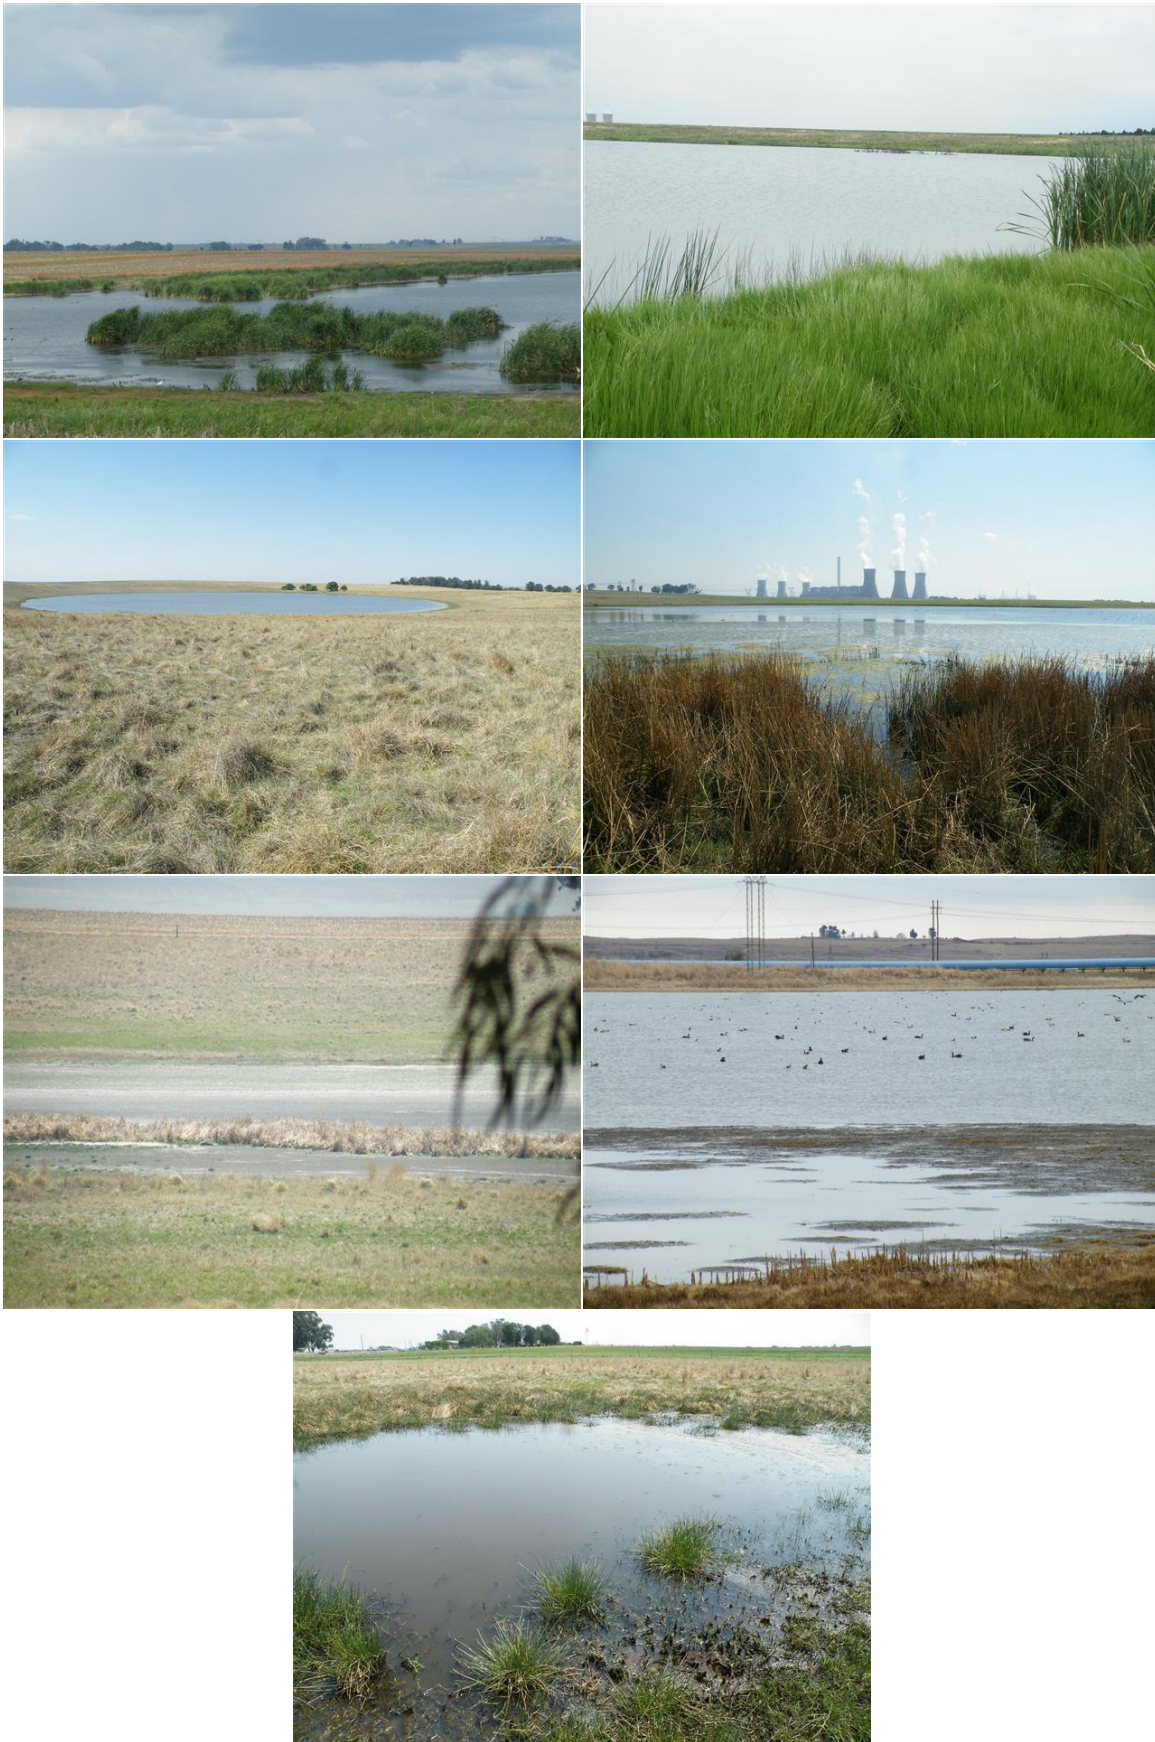
**Figure 31. Photographs of pans sampled at Matla. Fltr: P1 and 2, P4 and 7, Grootpan and P10, P 12.**

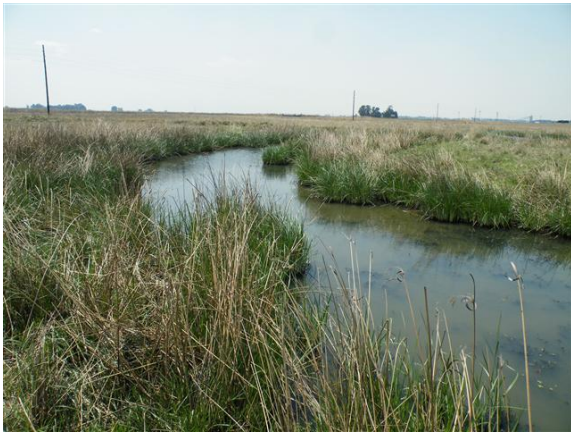
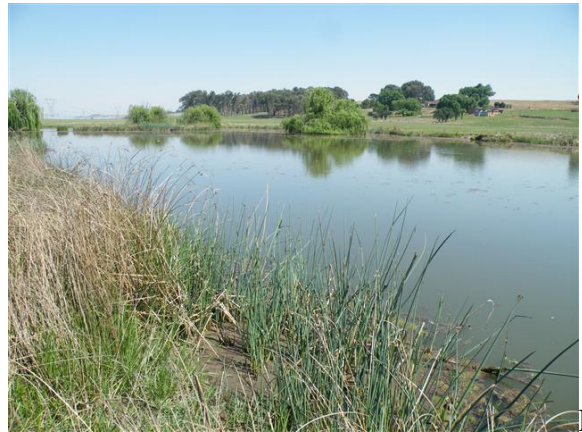
**Figure 32. Photographs of aquatic sampling sites within the Rietspruit Catchment (sites R2 and R3)**

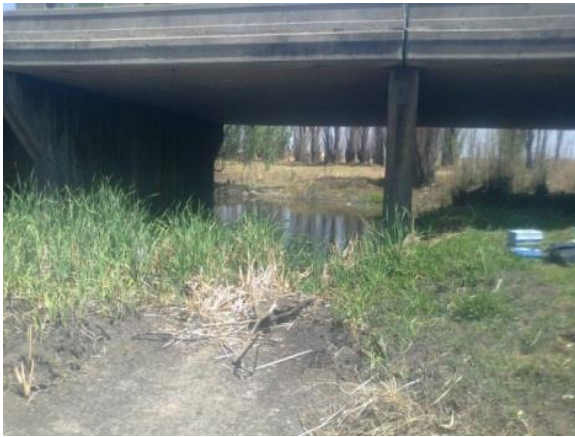
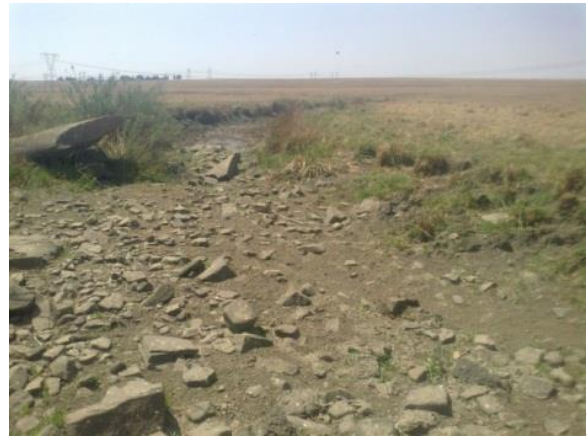
**Figure 33. Photographs looking downstream and upstream of the aquatic sampling site within the Kromdraaispruit Catchment (K1)**

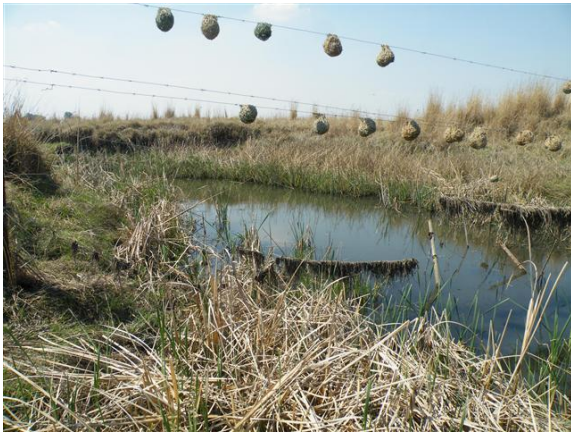
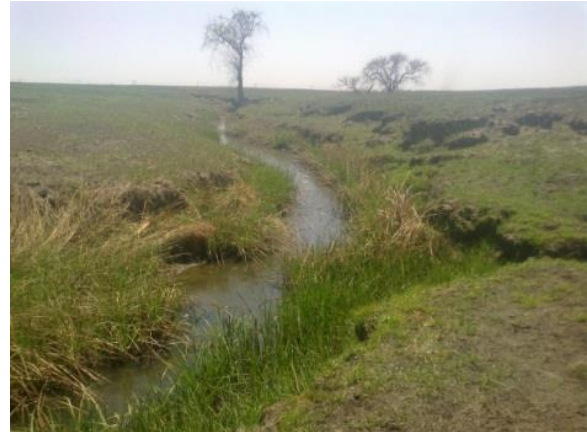
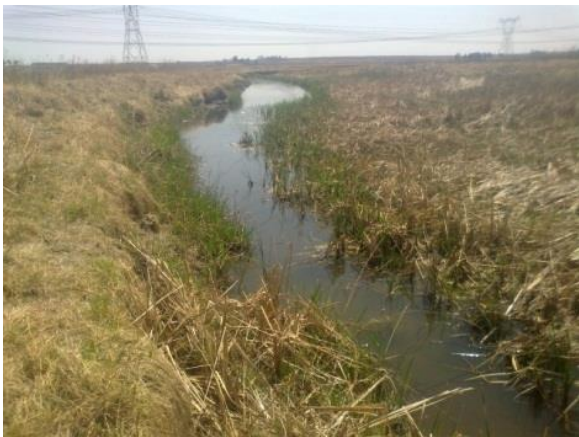
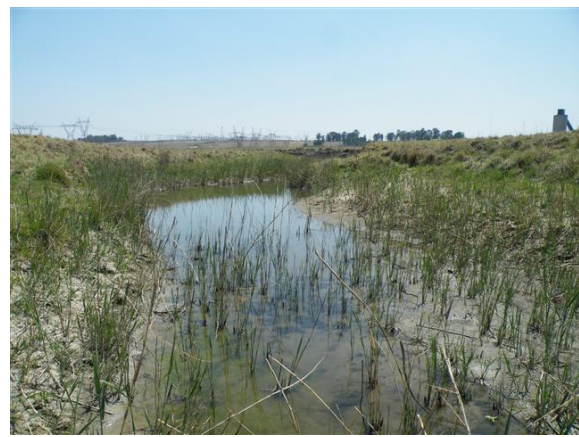
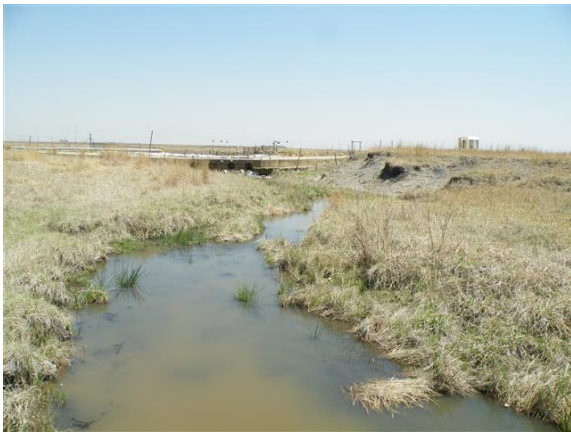
**Figure 34. Photographs of aquatic sites sampled within the Blesbokspruit catchment for the Matla Colliery Mining EIA: Site B1, BDiv and B2A are upstream, within (the original watercourse) and immediately downstream of the diversion. Site B3 is immediately upstream of the Rietspruit confluence. Site B2 is a tributary that joins the original watercourse downstream of BDiv.**

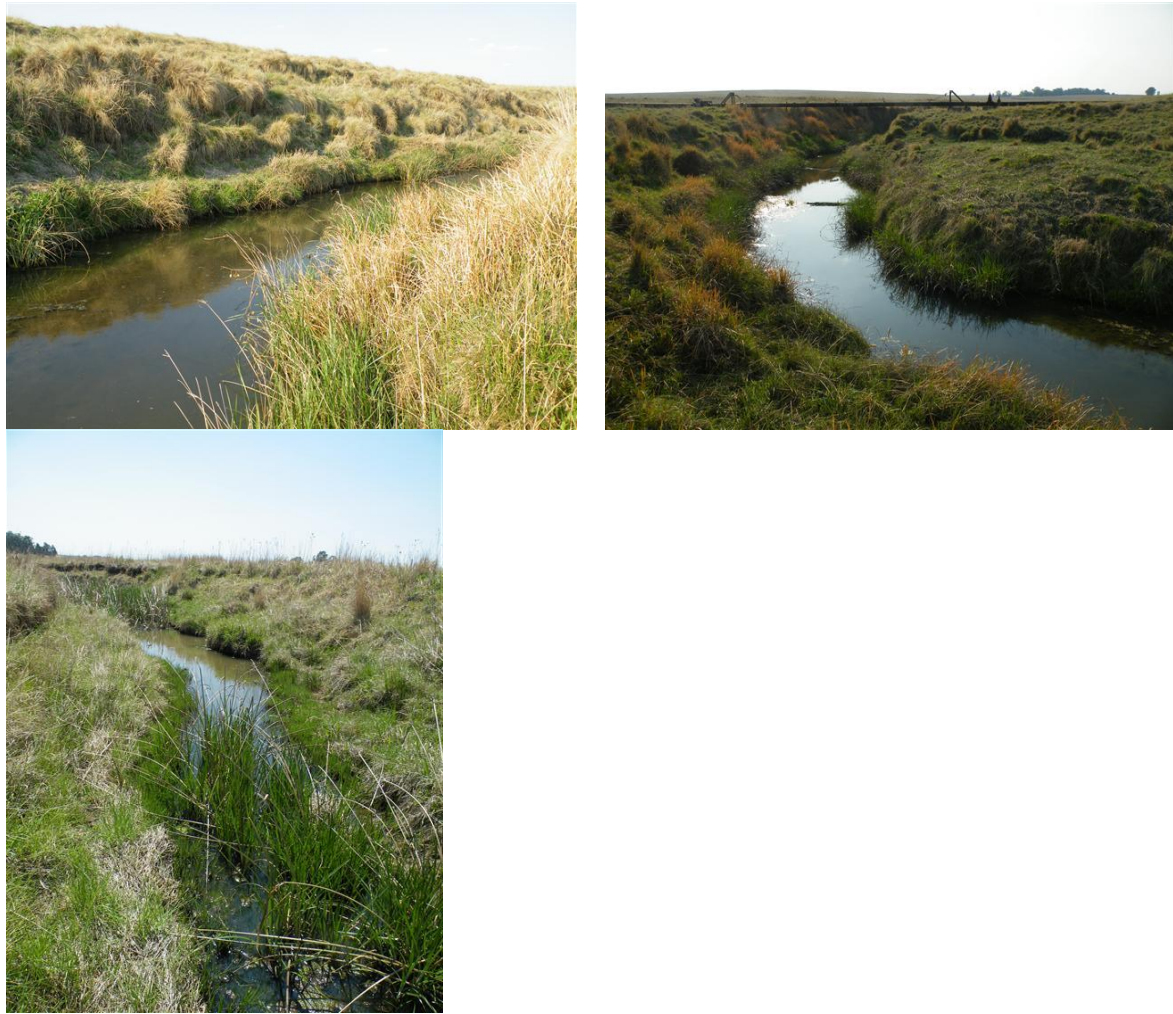
**Figure 35. Photographs of D1 and D2 (Dwars-in-die-Wegspruit) (top) and the Steelpoort tributary at site M4 (bottom).**
