PROPOSED UPGRADE OF NATIONAL ROUTE R574

(KM 0,0 to KM 38,8)

BIODIVERSITY ASSESSMENT

Terrestrial Ecological Assessment (Fauna and Flora) and Aquatic (Wetland) Ecological Assessment for the Proposed Upgrade of the Existing National Route R574 from Groblersdal (KM 0,0) to Morwaneng (KM 38,8) situated in the Elias Motsoaledi Local Municipality of the Sekhukhune District Municipality, Limpopo Province

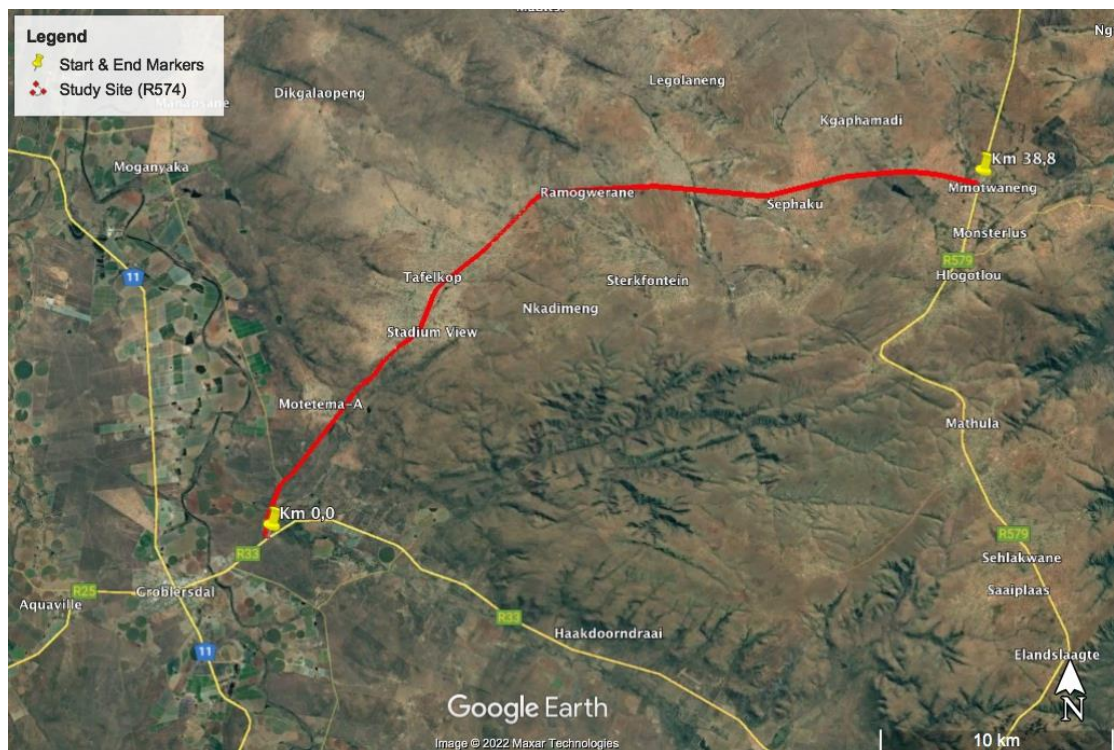
Figure 3: Study Site Location (Google Earth)

The study site includes the actual road, road shoulder and road reserve. The road reserve is an area usually less than 50m in width each side of the edge of the asphalt (Figure 1, Figure 2, Figure 3).

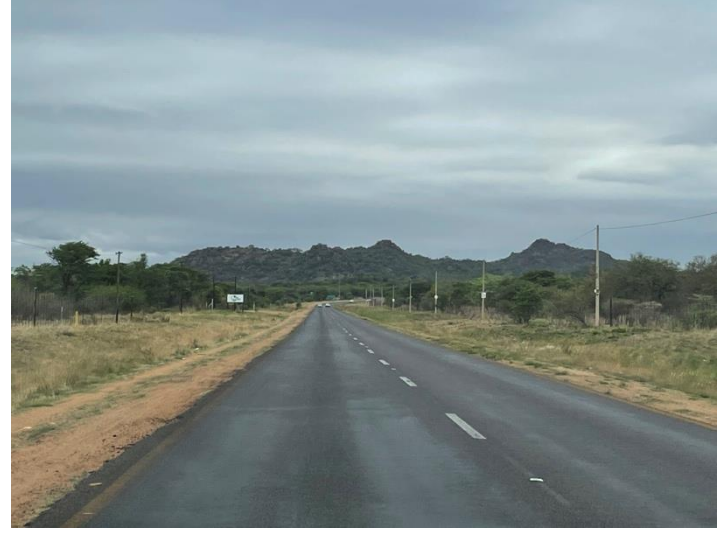
<p>R574 showing some grasses within the road reserve with trees in picture growing outside of the study site on open farmlands</p>

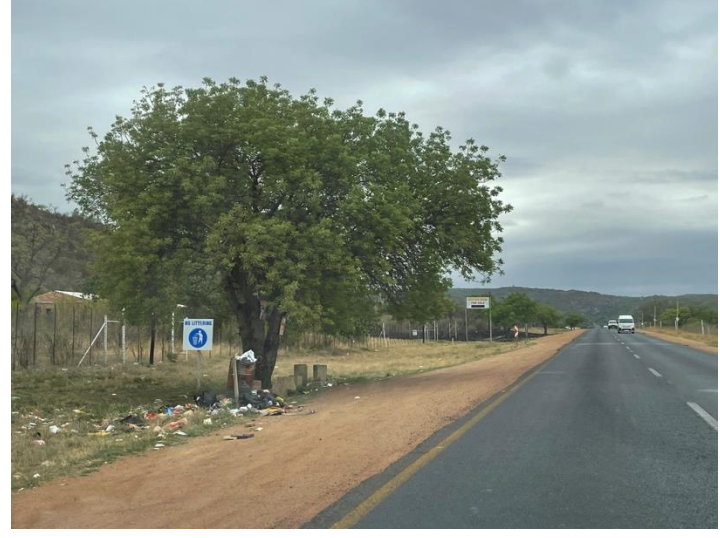
<p>Marula tree (protected tree) growing in the road reserve. There are a few scattered marula trees along the study site.</p>

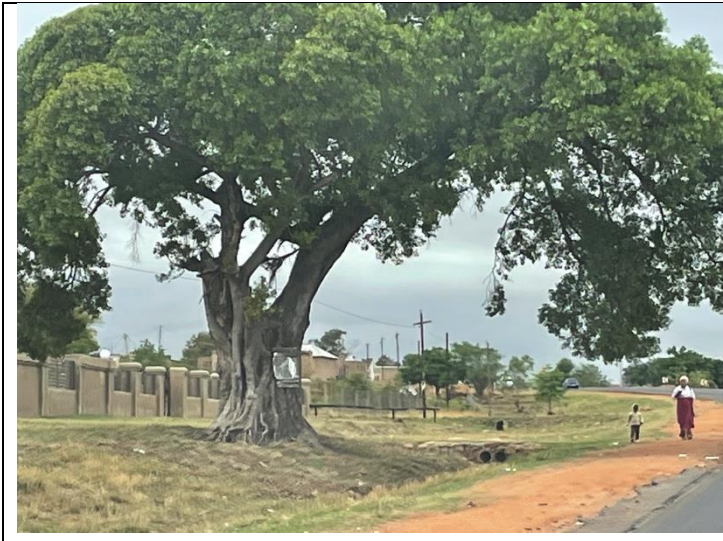
<p>Large fig tree in the road reserve. Although not a protected tree there are a few such trees that should be avoided if possible.</p>

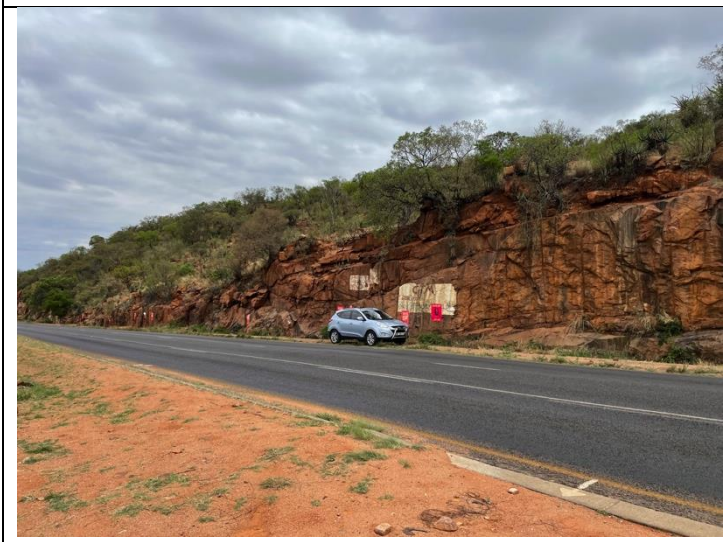
<p>The area of the proposed cutting where the road needs to be broadened. This is probably the most sensitive area (along with watercourse crossings) in the study area.</p>

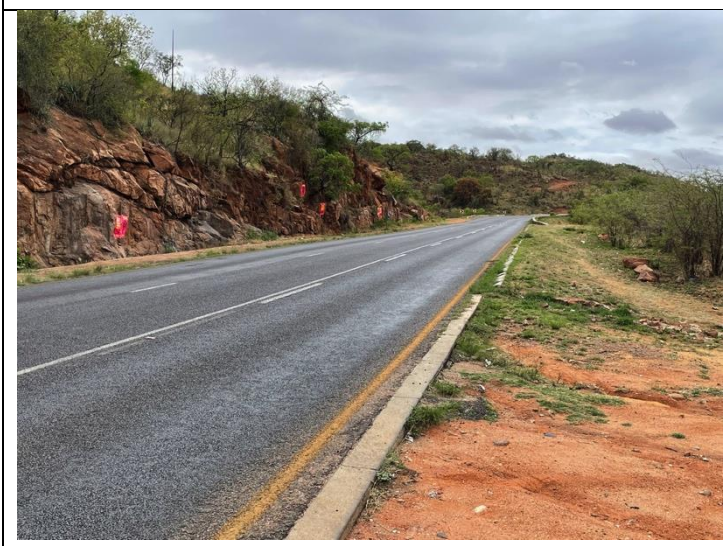
<p>Another view of the rocky hill, which is earmarked to be cut to broaden the road.</p>

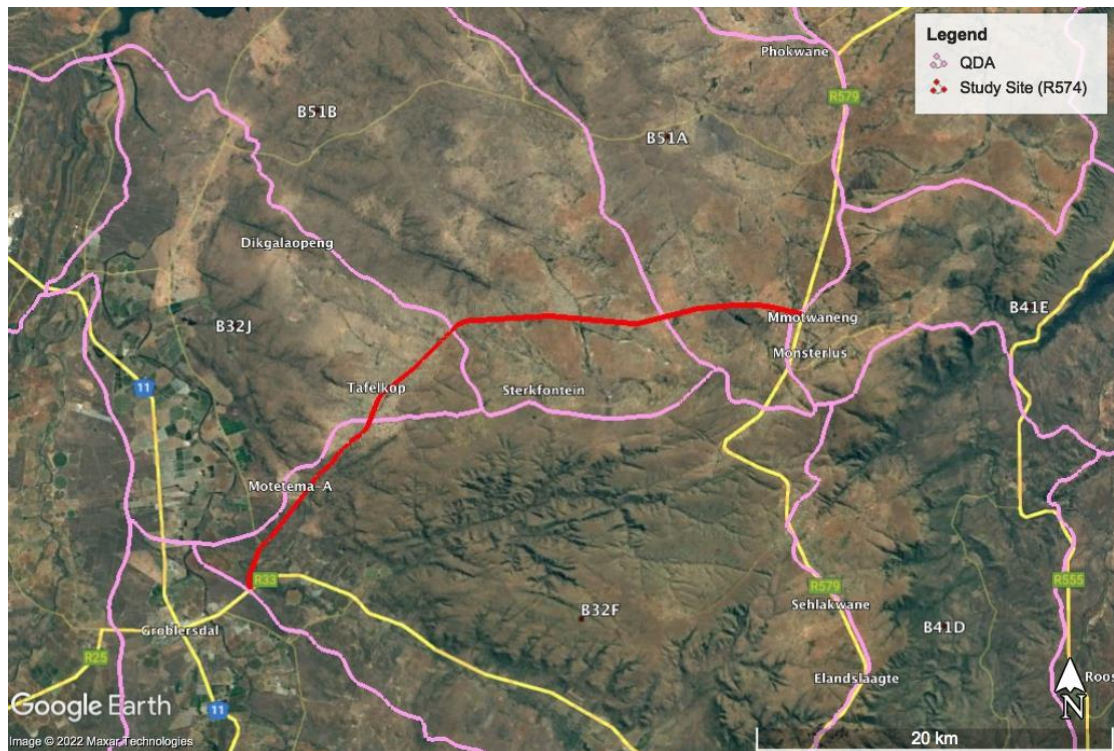
Figure 15: Quaternary Drainage Areas (QDAs)

The study area is situated within the Primary Drainage Area (PDA) of **B** and in the Quaternary Drainage Areas (QDAs) of **B32F, B32J, B51A & B51B** (Figure 15). A summary of the catchment areas is shown in Table 17, below.

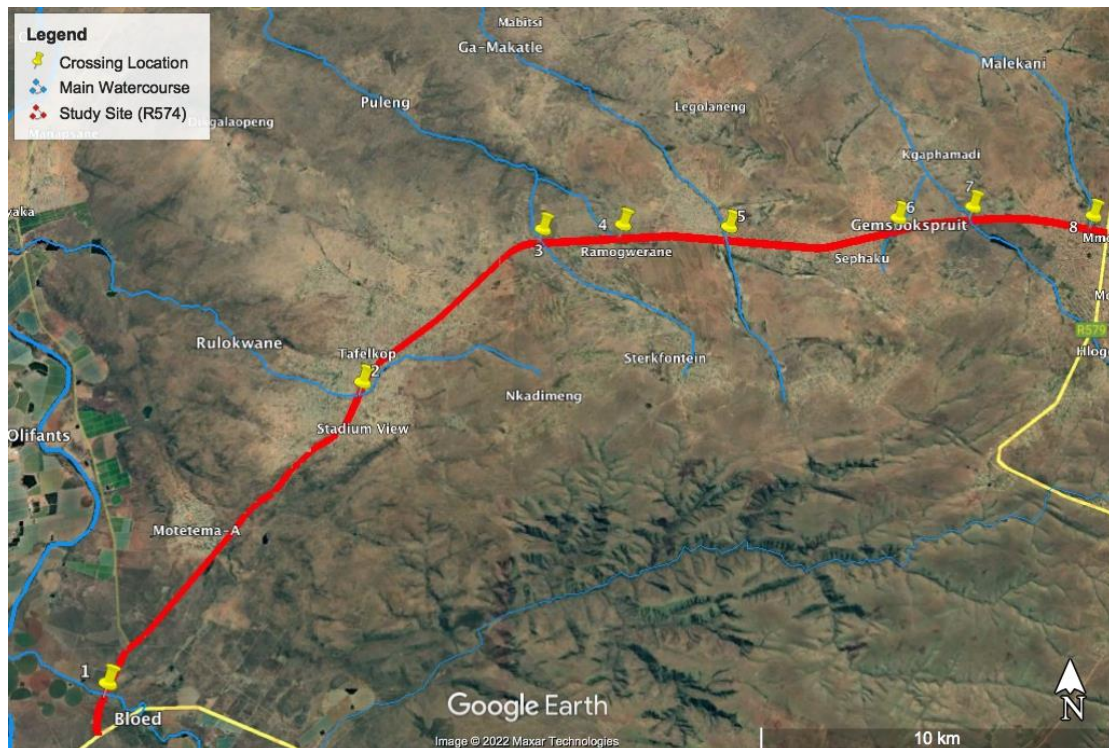
Figure 17: Main Watercourses

There are eight main watercourses (rivers or streams) that the study site (R574) crosses over. Starting from KM 0,0, near Groblersdal these are: Bloed, Rulokwane, Puleng, Puleng tributary, Ga-Makatlle, Gemsbokspruit tributary, Gemsbokspruit and Malekani (Figure 17). The positions of these watercourse crossings are shown below in Table 18 and Figure 17.

No	River / Stream	GPS Location	Present Structures
1	Bloed	25°8'17.60"S; 29°26'15.96"E	Bridge
2	Rulokwane	25°3'29.81"S; 29°30'20.35"E	Box Culverts
3	Puleng	25°0'44.63"S; 29°33'38.96"E	Box Culverts
4	Puleng Tributary	25°0'39.50"S; 29°35'11.60"E	Box Culverts
5	Ga-Makatlle	25°0'41.76"S; 29°37'14.07"E	Bridge
6	Gemsbokspruit Tributary	25°0'31.63"S; 29°40'30.79"E	Box Culverts
7	Gemsbokspruit	25°0'18.76"S; 29°41'58.95"E	Pipe Culverts
8	Malekani	25°0'28.75"S; 29°44'17.42"E	Box Culvert

In general the watercourses in the study area (those that are crossed) are all small, mostly semi-perennial / intermittent streams and seasonal drainage lines. The crossings are also small and narrow with only two actual bridges crossings over the Bloed River and Ga-Makatlé River. The streams have no distinctive riparian zones or vegetation, except for the Bloed River, which only has a narrow zone of a few metres wide. Table 19, below, shows the existing watercourse crossings in the study site (R574). The only wetlands present in the study site are valley bottom or floodplain wetlands associated with the eight small rivers and streams already mentioned. There are no large or distinctive ‘stand alone’ wetlands in the study area such as pans, valley bottom wetlands without mainstream channels, etc. The national wetland map (Map 5, 2018) only shows one valley bottom wetland associated with the Gemsbokspruit (Figure 18).

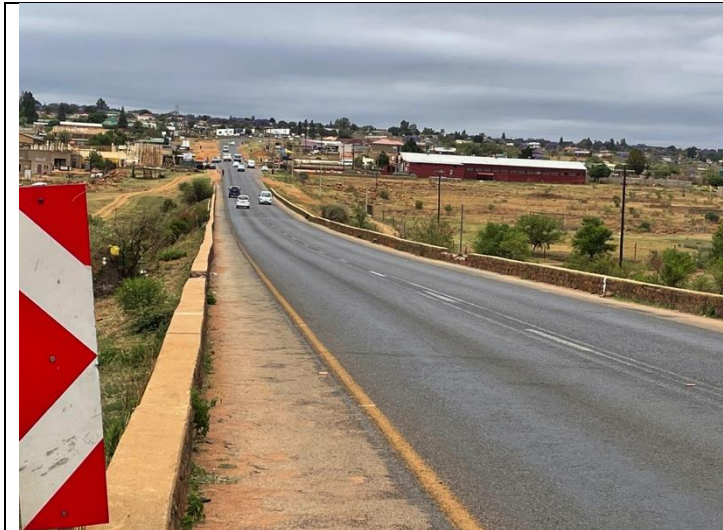
<p>Crossing at the Rulokwane. The watercourse is small with pipe culverts under the road.</p>

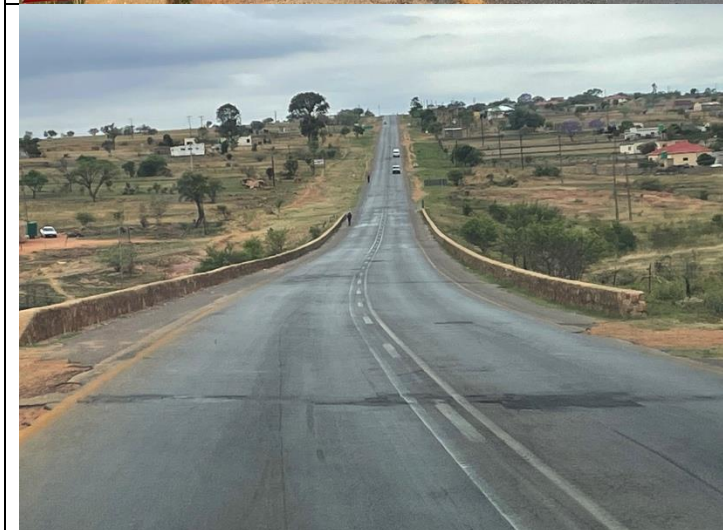
<p>Puleng with small side barriers and no bridge, only cement box culverts under the road. A few thorn trees can be seen on the edge of the stream near the road, but no riparian zone is present.</p>

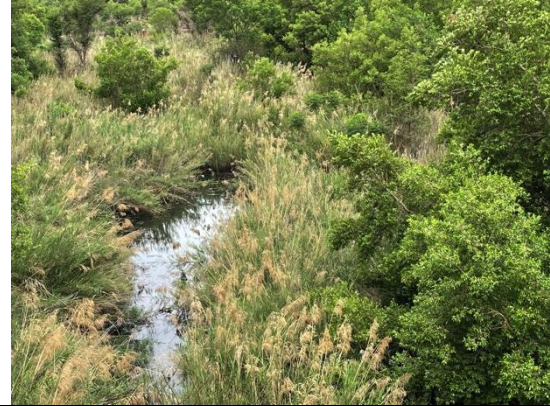
<p>Bloed River upstream of crossing</p>	<p>Bloed River downstream of crossing</p>

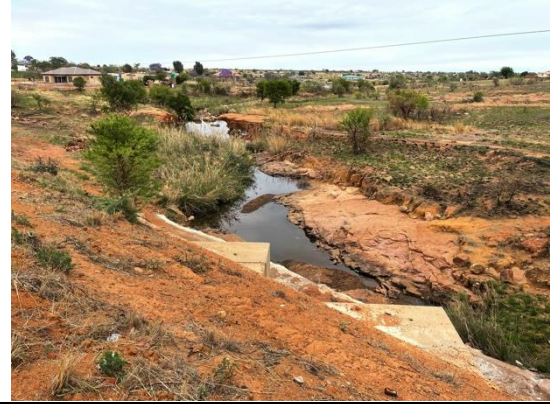
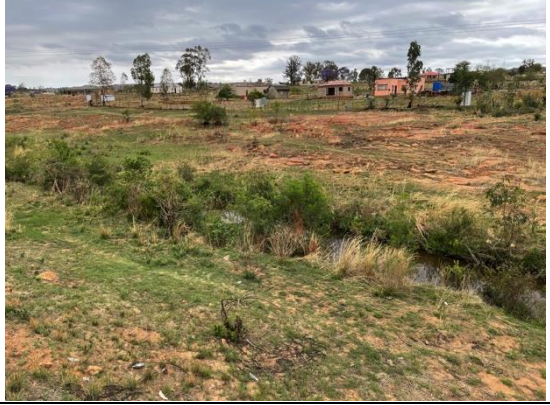
<p>Rulokwane showing no water flow and culverts under road</p>	<p>Rulokwane downstream</p>

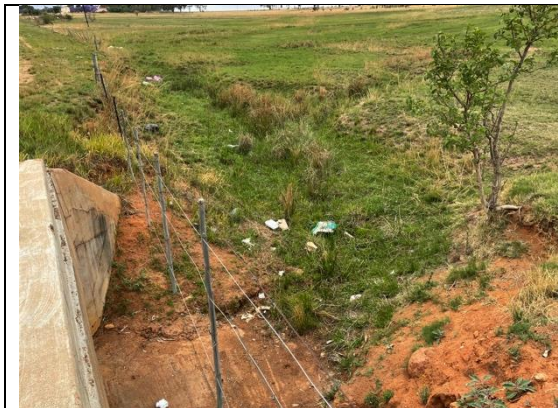
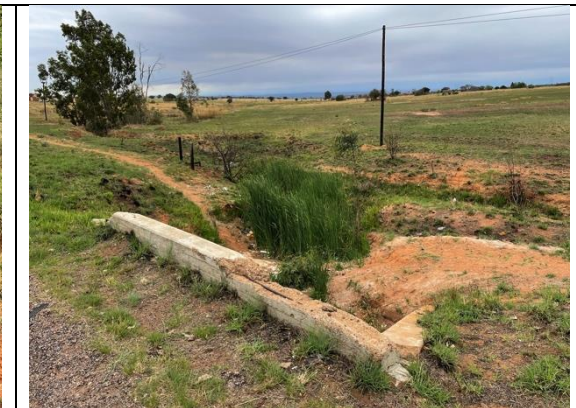
<p>Puleng upstram showing narrow channel some scattered shrubs along the streambanks and box culverts under the road. Erosion is also fairly evident along the stream banks</p>	<p>Puleng downstream showing no distinctive riparian zone except for a few small shrubs along the narrow stream channel</p>

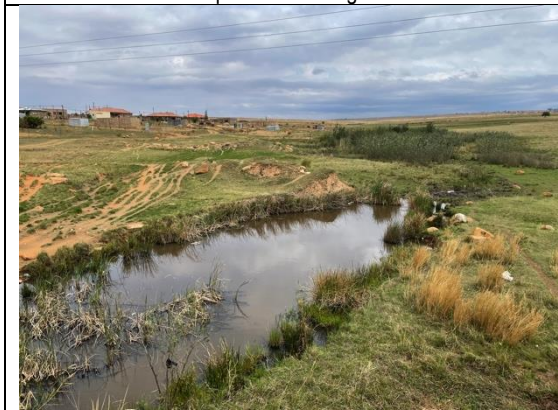
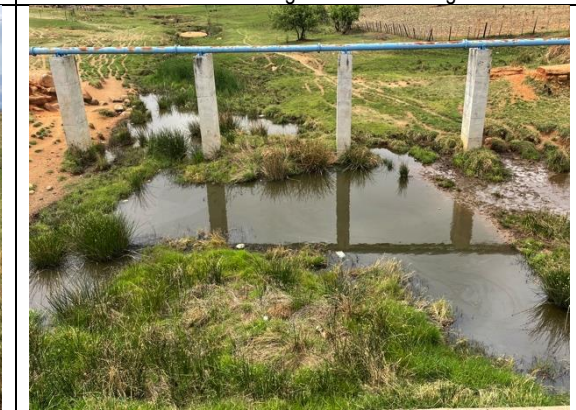
<p>Ga-Makatle upstream</p>	<p>Ga-Makatle downstream</p>

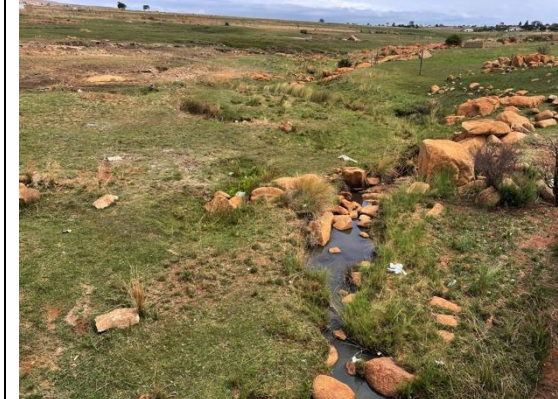
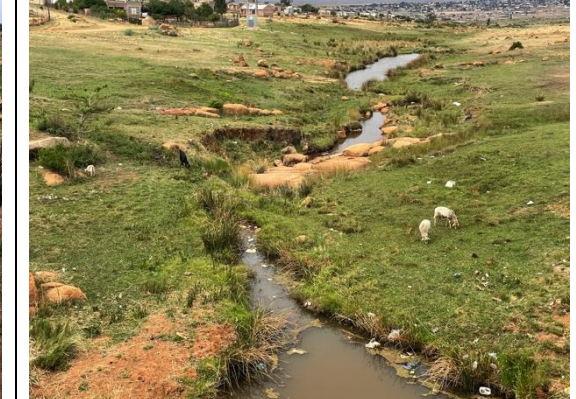
<p>Gemsbokspruit Tributary upstream is a narrow and small drainage line / small stream with no riparian vegetation</p>	<p>Gemsbokspruit Tributary downstream</p>

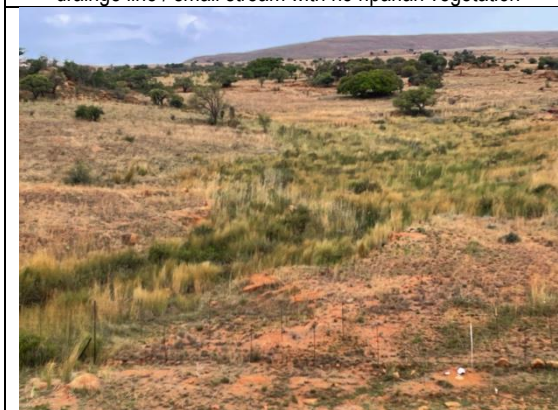
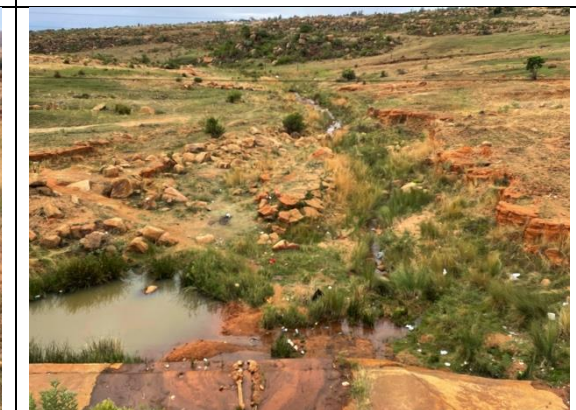
<p>Gemsbokspruit upstream. The area is picture is part of the Mahtrombi Nature Reserve</p>	<p>Gemsbokspruit downstream</p>

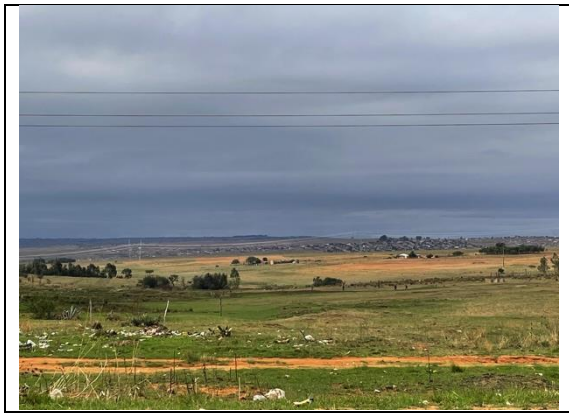
<p>Malekani downstream. The stream originates in the area of the road crossing and there is no upstream channel or watercourse. There is only a stormwater culvert under the road for channelled surface run-off from various directions and areas.</p>

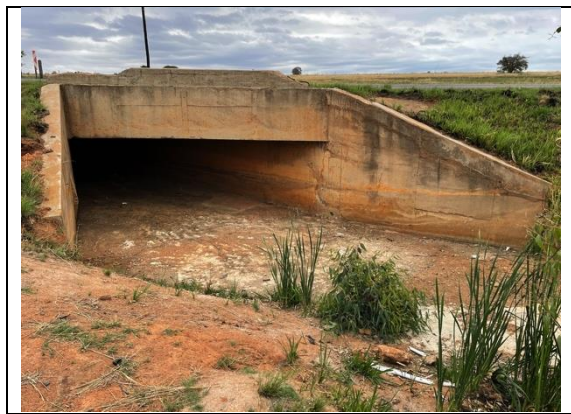
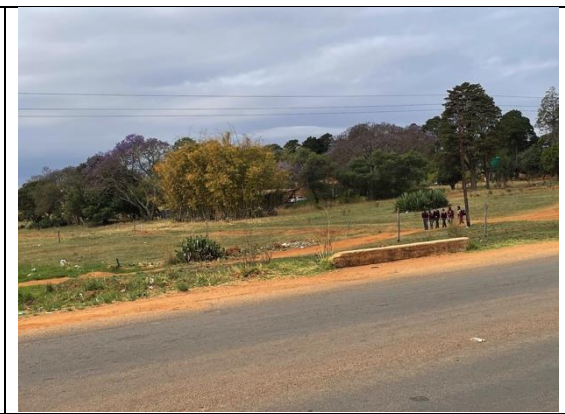
<p>Box culvert at the Puleng Tributary</p>	<p>Culvert at Malekani showing that in this area it is literally a stormwater culvert drain under the road in this area.</p>

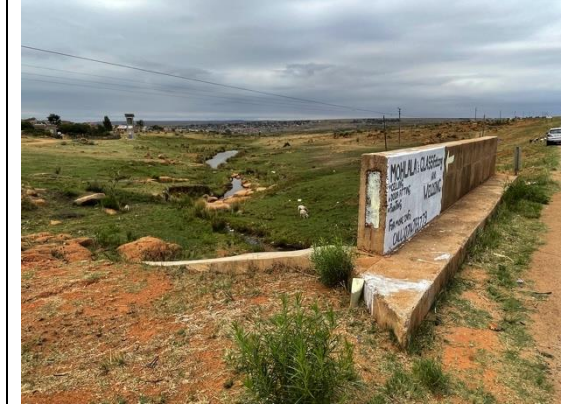
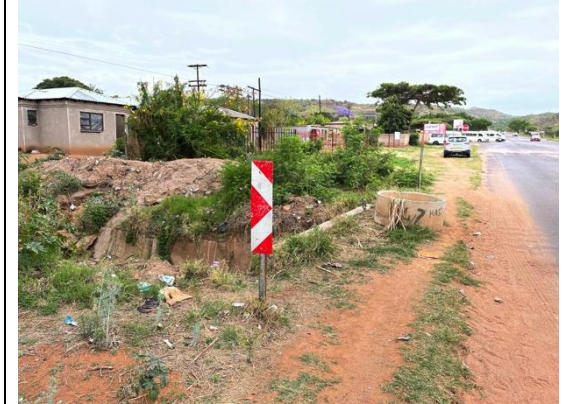
<p>Small wall / barrier on box culvert at Gemsbokspruit Tributary crossing</p>	<p>Stormwater open drain in village area of R574.</p>
