**Dalmanutha Wind Energy Facility
Geotechnical Desktop Assessment**
WSP Africa

21500715-352637-3

2 June 2022

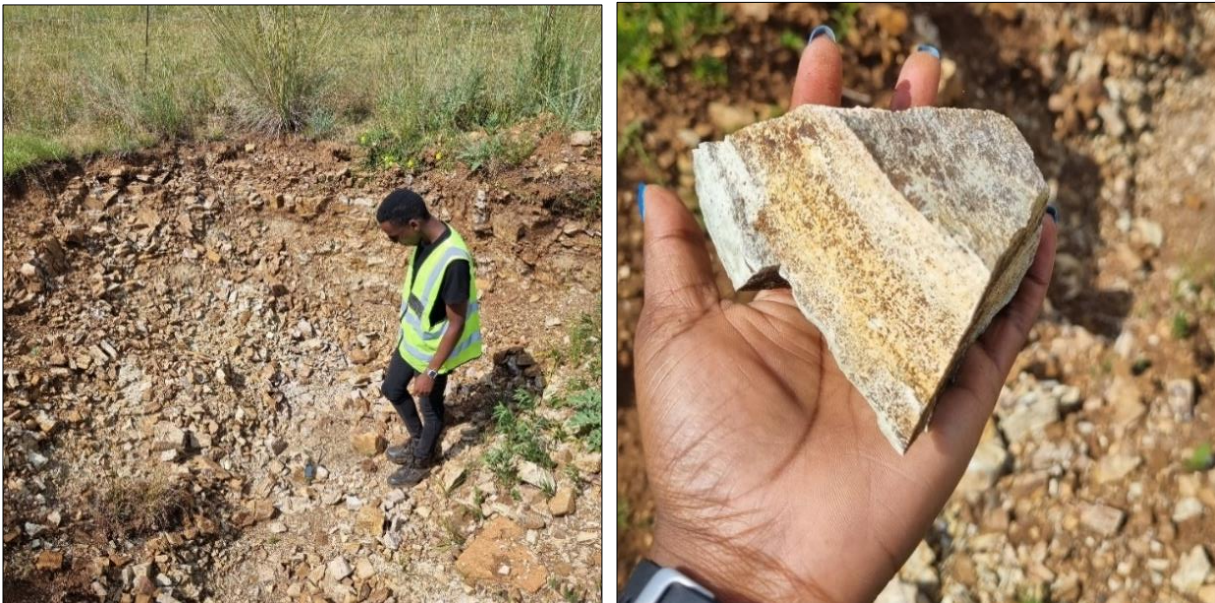
On site, shale of the Vryheid Formation was observed in a small borrow pit situated close to WTG37. The profile in the pit comprised a thin layer of transported and residual soil underlain by shale as illustrated in Figure 9.

Figure 9: Small Vryheid Shale Borrow Pit Observed on Site Close to WTG37 on the Northern Portion

Vryheid shale generally weathers to a clayey residual soil which is often compressible and potentially expansive. Expansive soils are those materials that exhibit volume change with a change in moisture content. These materials “shrink” when the moisture content decreases and “heave” or “expand” when the moisture content increases. Where the residual shale profile is thinly developed, it is recommended that the material should be stripped. Where thickly developed, the structural design needs to take cognizance of the potential expansiveness.

Some shale breaks down rapidly after exposure to the elements with micro-cracks developing as a result of moisture loss or stress relief. Mudrocks such as shale, are generally not considered suitable for use as construction materials. This is due to their potential expansiveness, excessive absorption of water, poor engineering performance and lack of durability. However, some shale material is considered suitable for use as selected layers in road construction (wearing course for gravel roads). However, the durability and potential expansiveness should be ascertained beforehand.

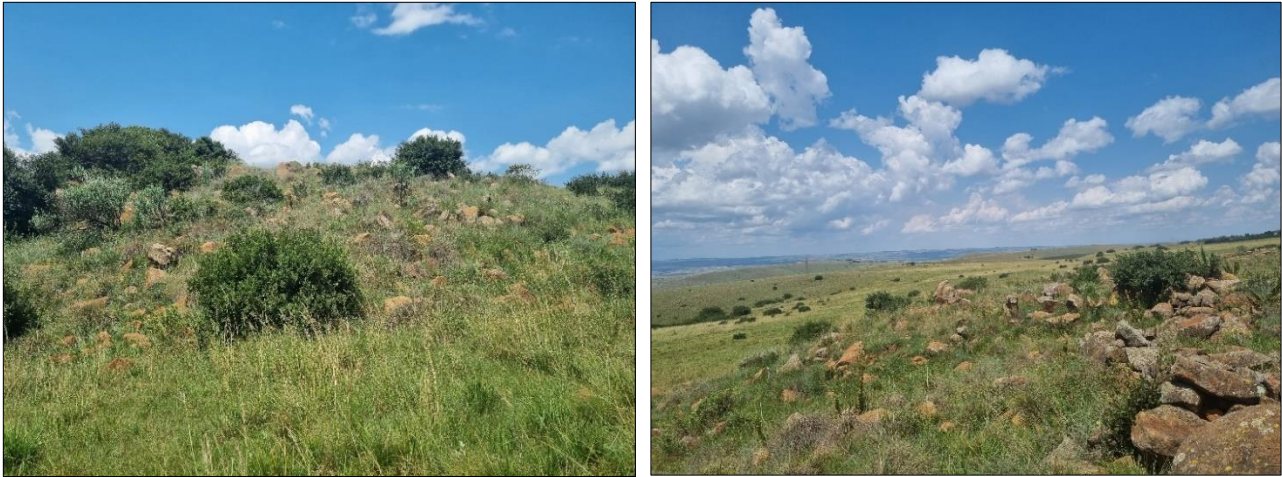
Diabase was not observed in outcrop across the site during the site reconnaissance. A hill with diabase boulders was observed approximately 0.35m south-west of WTG49, Figure 10. According to the published geological map, WTG54 is underlain by diabase. According to the Google Earth image, diabase boulders may be present in the area of WTG54.

Figure 10: Diabase Hill with Boulders, Located Close to WTG49, Side Profile (Left) and Top (Right)

Residual clay is generally compressible and potentially expansive in the “medium to high” range. Where a turbine straddles residual diabase and a different soil type, the turbine should be moved to avoid differential settlement or designed accordingly.

Diabase rock, cobbles, boulders, gravel and sand are generally durable and are suitable for a variety of purposes. It is commonly quarried and used as a construction material such as for concrete aggregate and road construction material.

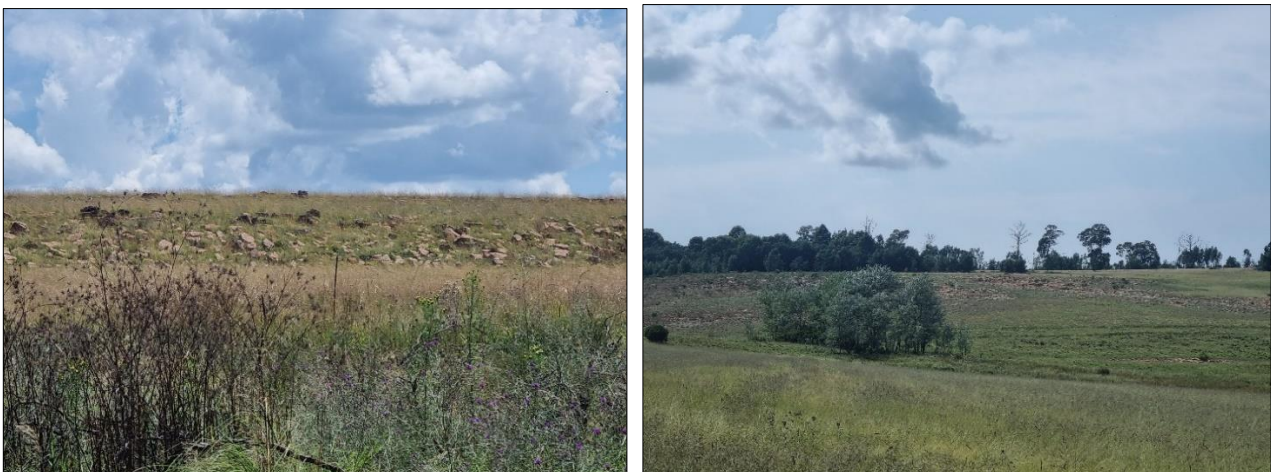
Quartzite outcrop was observed on surface across the center of the WEF on the flat hilltop. The sides of the slopes are characterized by quartzite boulders as shown in Figure 11 and Figure 12. The quartzite encountered is cream white, moderately weathered, medium to coarse grained, medium hard to hard rock. Where present, residual soils are likely to be thinly developed.

Figure 11: Quartzite on Surface, Photo Taken Facing WTG45 (Left) and Facing WTG16 (Right)

Although not observed on site, the residual soil tends to comprise loose silty sand or clayey sand with a thickness of less than 2m. The residual quartzitic clayey/silty sand may be potentially collapsible.

Soils with a collapsible structure experience additional settlement when subjected to an inundation of some kind. This occurs without an increase in loading and may occur many years after construction. Soil improvement, by means of compaction with the addition of water to -1% to +2% of optimum moisture content might be required where the residual soil is thickly developed. This is, however, not expected as rock is expected to be encountered within the 3m excavation required for the turbine bases.

Quartzite is often quarried and used as concrete aggregate and in road pavement layers.

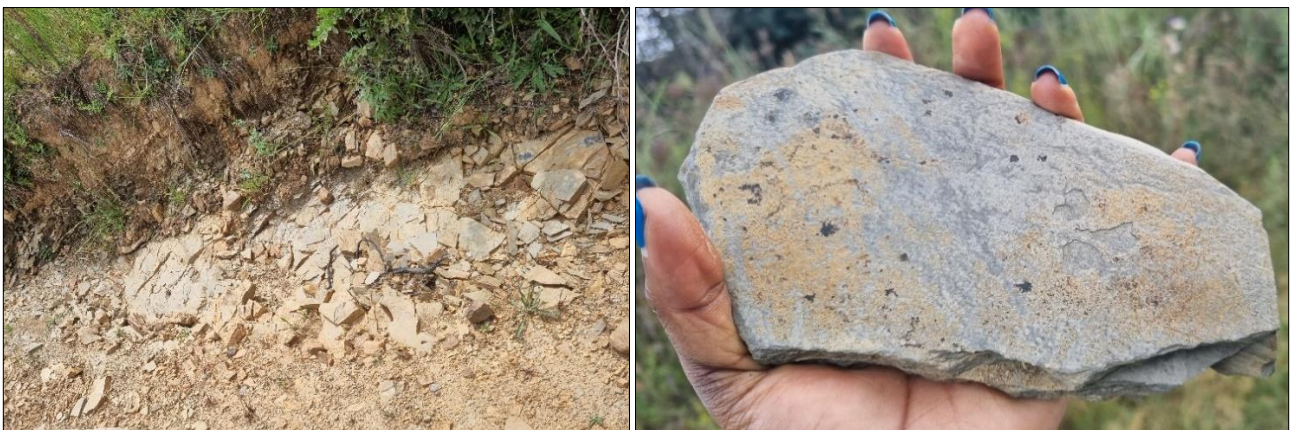
Figure 13: Silverton Shale

Silverton shale underlies the majority of the eastern side of the site. Shale outcrop was encountered on a road near to WTG25 (Figure 13). The rock is light grey, moderately weathered, fine grained, thinly laminated, with light yellow silty sand infill along the bedding planes, soft rock shale. The rock was overlain by a thin (0.30m) layer of residual shale profiled as slightly moist, light brown to beige, soft, intact, sandy silt. A slightly moist, light greyish brown, loose, silty sand topsoil blanketed the area.

The residual profile is generally thinly developed above the Silverton shale, less than 2m thick, and is expected to comprise a clay/silt material. The residual clay is generally potentially expansive and compressible.

Areas of subsurface or surface shale are present throughout the site and give rise to restricted drainage. Where a shallow water table is proven during the detailed investigation or the flat areas on top of the slopes, water ponding must be prevented to avoid the oversaturation of the residual soils. Residual shale soils are impermeable, which will lead to water ponding in and around the foundation. This can lead to differential settlement of the turbine foundations, hence, stormwater management in the area is imperative.
