# **AQUATIC BIODIVERSITY AND IMPACT ASSESSMENT FOR THE PROPOSED IGOLIDE WIND ENERGY FACILITY, GAUTENG**

Aquatic Ecology Report

**PROJECT NO. 41104282**

**DATE: OCTOBER 2023**

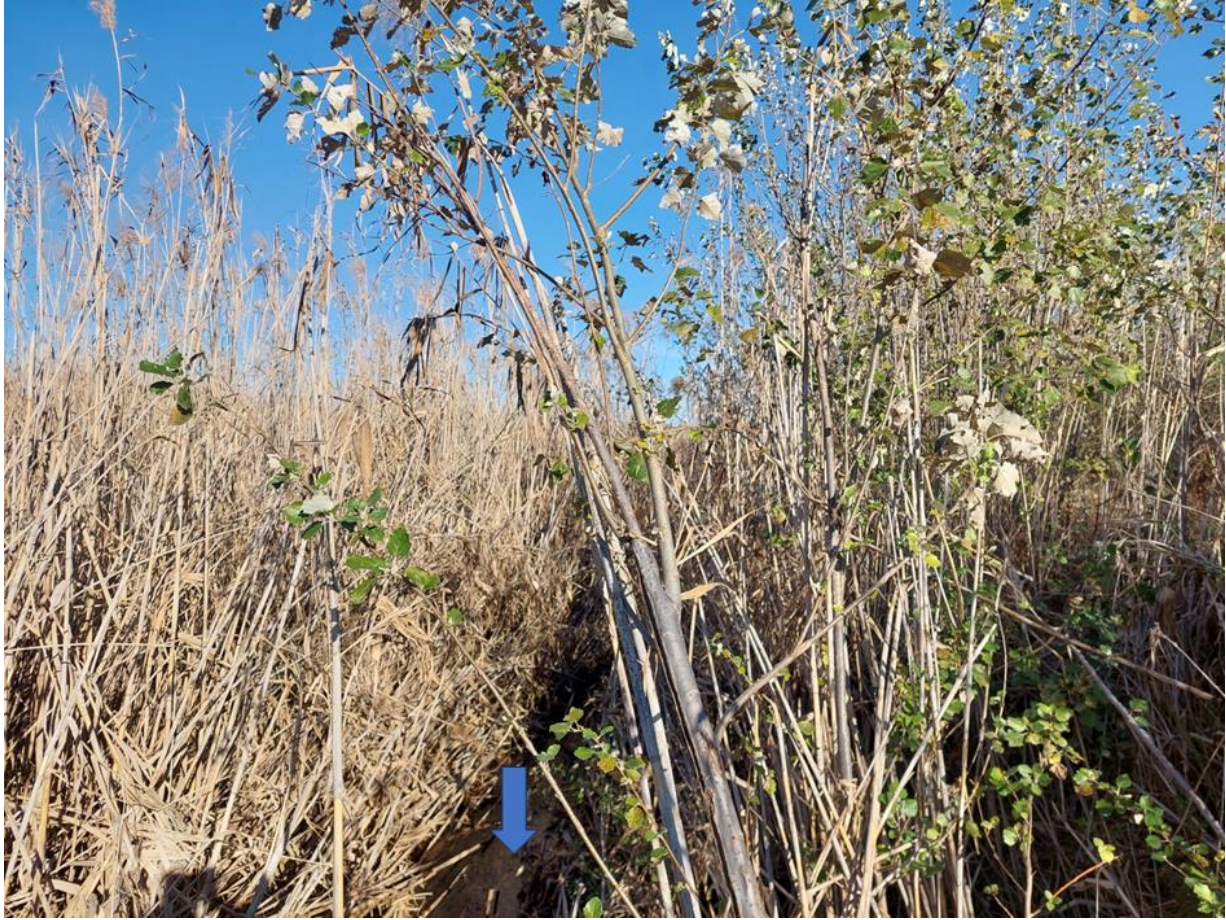
The assessed Loopspruit upstream site is located within a narrow and shallow (approximately 1 m wide and deep) system dominated by reeds and the invasive (category 2 NEMBA) White Poplar trees (Figure 1-3), thus the sampling effort was hindered. Results obtained for this site should be interpreted with caution.

**Figure 1-3 - Narrow channel (blue arrow) of the Loopspuit upstream site dominated by reeds and Poplar trees.**

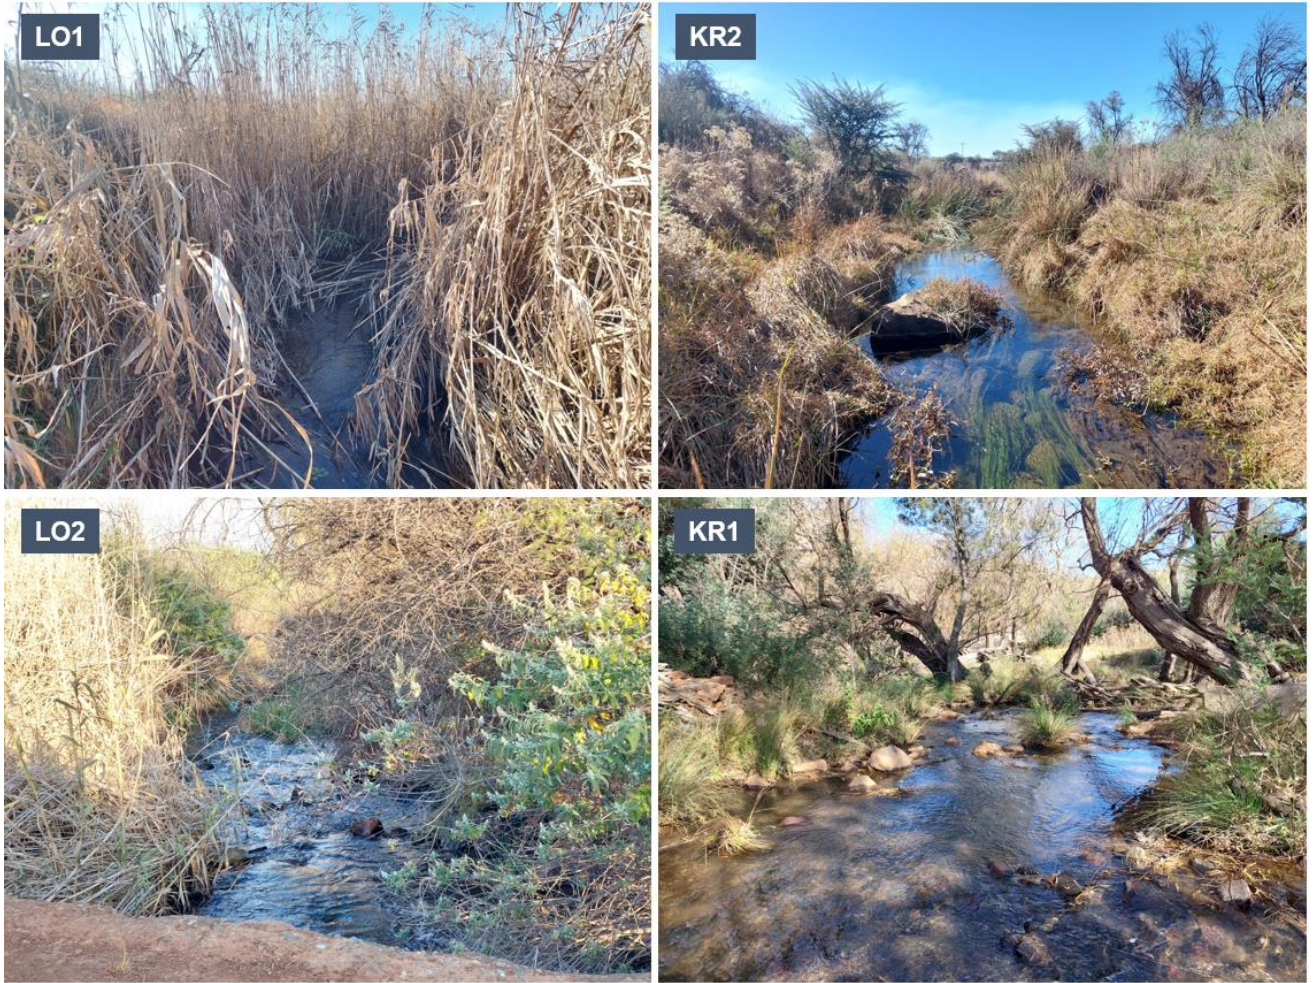
The assessed Loopspruit and Kraalkopspruit reaches are predominantly characterised by narrow and shallow streams with the hydrological regime largely influenced by the presence of impoundments along the river systems. Each of the assessed sites were in flow at the time of the survey. The Loopspruit upstream site (LO1) and the Kraalkopspruit downstream site (KR2) were characterised by a gentle slope dominated by a sandy stream bed, thus the flow velocity was slow-to-moderate. The Loopspruit downstream site (LO2) and the Kraalkopspruit upstream site (KR1) were characterised by rocky stream beds with moderate-to-fast flows resulting in riffles (Figure 4-1). These features are characteristic of rivers which lie within the upper foothills longitudinal zone (Class D; Rowntree et al., 2000).

**Figure 4-1 - Photos showing flow conditions at time of the survey. Slow-to-moderate flow velocity (Top) and moderate-to-fast (Bottom)**

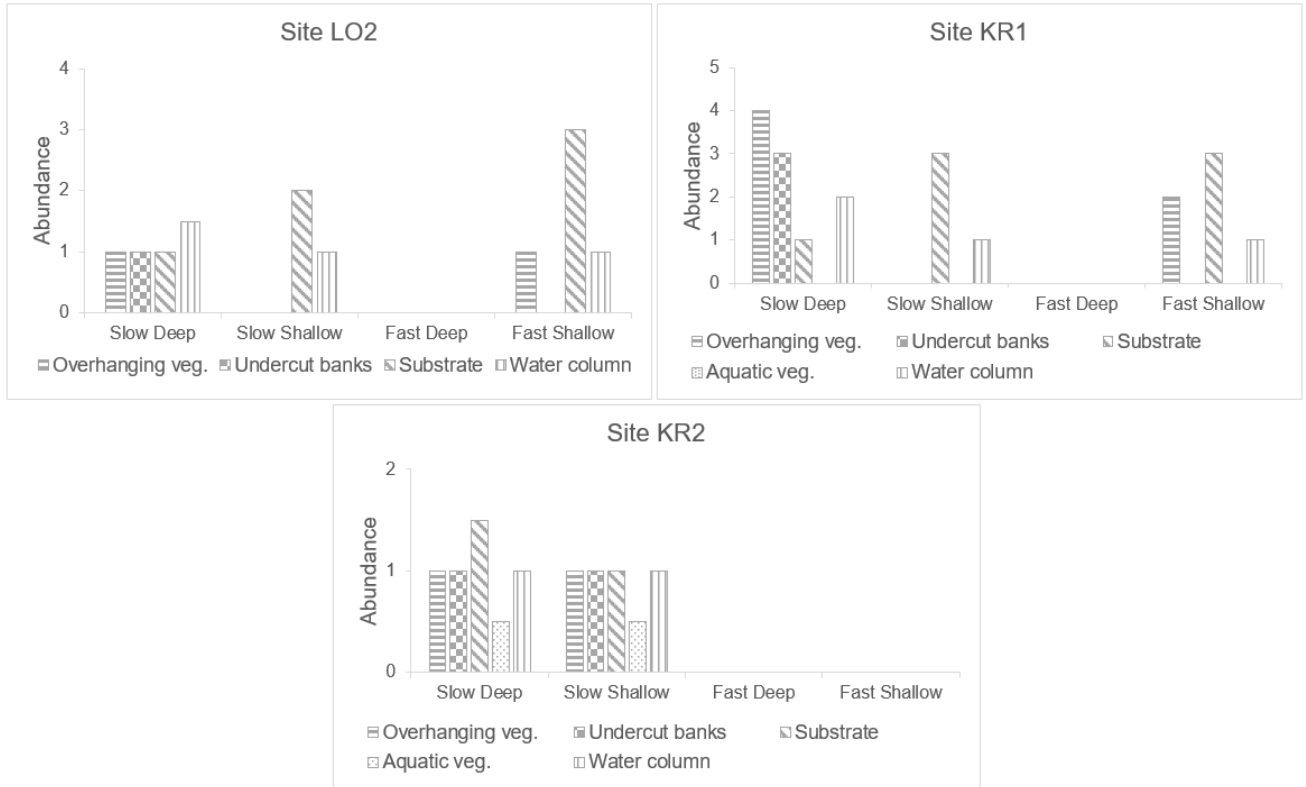
**Figure 4-3 – Fish habitat metric group abundances**

The sampled fish habitat potential was rated between 0 to 5 (1 = rare; 2 = sparse; 3 = common; 4 = abundant; 5 = very abundant) at each of the monitoring sites (Figure 5-9). These ratings were considered in the determination of the expected frequency of occurrence (FROC) for each fish species.

Overall, the fish habitat cover types at the assessed sites were predominantly substrate and overhanging vegetation within the slow-shallow and fast-shallow velocity-depth classes. Therefore, the expected fish species recorded were largely those with a preference for these habitat types.
