**DESKTOP VISUAL IMPACT ASSESSMENT SCREENING FOR THE PROPOSED WASTE WATER
TREATMENT WORKS, ROBBEN ISLAND, WESTERN CAPE, SOUTH AFRICA**

Report Name:	DESKTOP VISUAL IMPACT ASSESSMENT SCREENING FOR THE PROPOSED WASTE WATER TREATMENT WORKS, ROBBEN ISLAND, WESTERN CAPE, SOUTH AFRICA
VIA Specialists:	<p>LOGIS 531A Witogie Street, Die Wilgers, Pretoria Contact Person: Lourens du Plessis Tel: 082 922 9019 Email: lourens@logis.co.za</p>
Report prepared by:	<p>This report was prepared by Peter Velcich on behalf of LOGIS. Contact Person: Peter Velcich Tel: 082 4420220 Email: peter@nuleafsa.co.za Expertise: Peter Velcich is a <i>Professional Landscape Architect</i> registered with The South African Council for Landscape Architectural Profession (SACLAP), and specialises in Environmental management and Visual Impact Assessments (VIA).</p>
Report reviewed by:	<p>Contact Person: Lourens Plessis Tel: 082 922 9019 Email: lourens@logis.co.za Expertise: Lourens du Plessis (t/a LOGIS) is a <i>Professional Geographical Information Sciences (GISc) Practitioner</i> registered with The South African Geomatics Council (SAGC), and specialises in Environmental GIS and Visual Impact Assessments (VIA).</p> <p

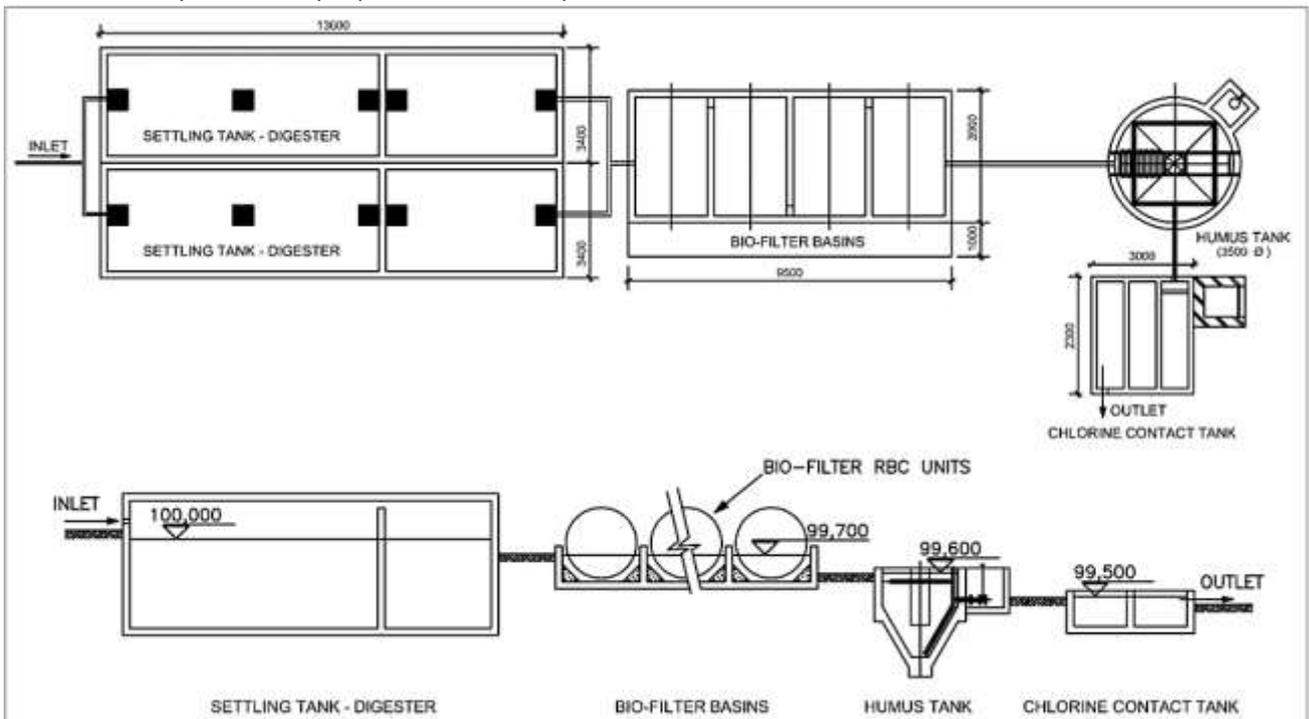
Figure 1: Schematic layout of the main components of the WWTW

The Applicant is proposing the development of a Wastewater Treatment Plant on Robben Island, Table Bay, Cape Town. The Waste Water Treatment Works (WWTW) will have a treatment capacity of 108,000 m³ per annum with all the effluent generated on the island discharged via a marine outfall into the coastal environment after treatment. The design allows for a maximum discharge volume of 300m³ per day. The WWTW covers a total footprint area of approximately 1070m².

The primary components of the WWTW includes:

- **An Inlet Structure**
Raw sewage will flow through a simple civil concrete inlet structure upstream of the primary settling tank with a hand rake screen which provides a facility to remove un-organic objects from the sewage.
- **Primary Settling Tank (Anaerobic and Anoxic Reactor)**
After screening, raw sewage will flow into a septic tank.
- **Rotating Biological Contactors (Aerobic Reactor)**
From the septic tank, the sewage will gravitate to the covered Rotating Biological Contactors (RBCs) within the aerobic reactor.
- **Secondary Settling Tank (Humus Tank)**

From the RBC, sewage will gravitate to the secondary settling tank or humus tank.

- **Disinfection**
The effluent from the secondary settling tank will gravitate to the chlorine contact channel where it will be dosed with a disinfectant.
- **Rising Main for Final Effluent Reuse**
A 75 mm diameter by 1.4 km welded HDPE rising main (existing underground pipe) to convey the treated effluent from the existing sewage collector sump at the proposed WWTW site to the connection point near the desalination plant, using the existing sewer pump.

Treated effluent will gravitate to the existing sewage collector sump at the proposed WWTW site from where it will be pumped along the existing outfall sewer pipeline to discharge through a diffuser 465m offshore.

A schematic layout of the proposed WWTW is presented below.

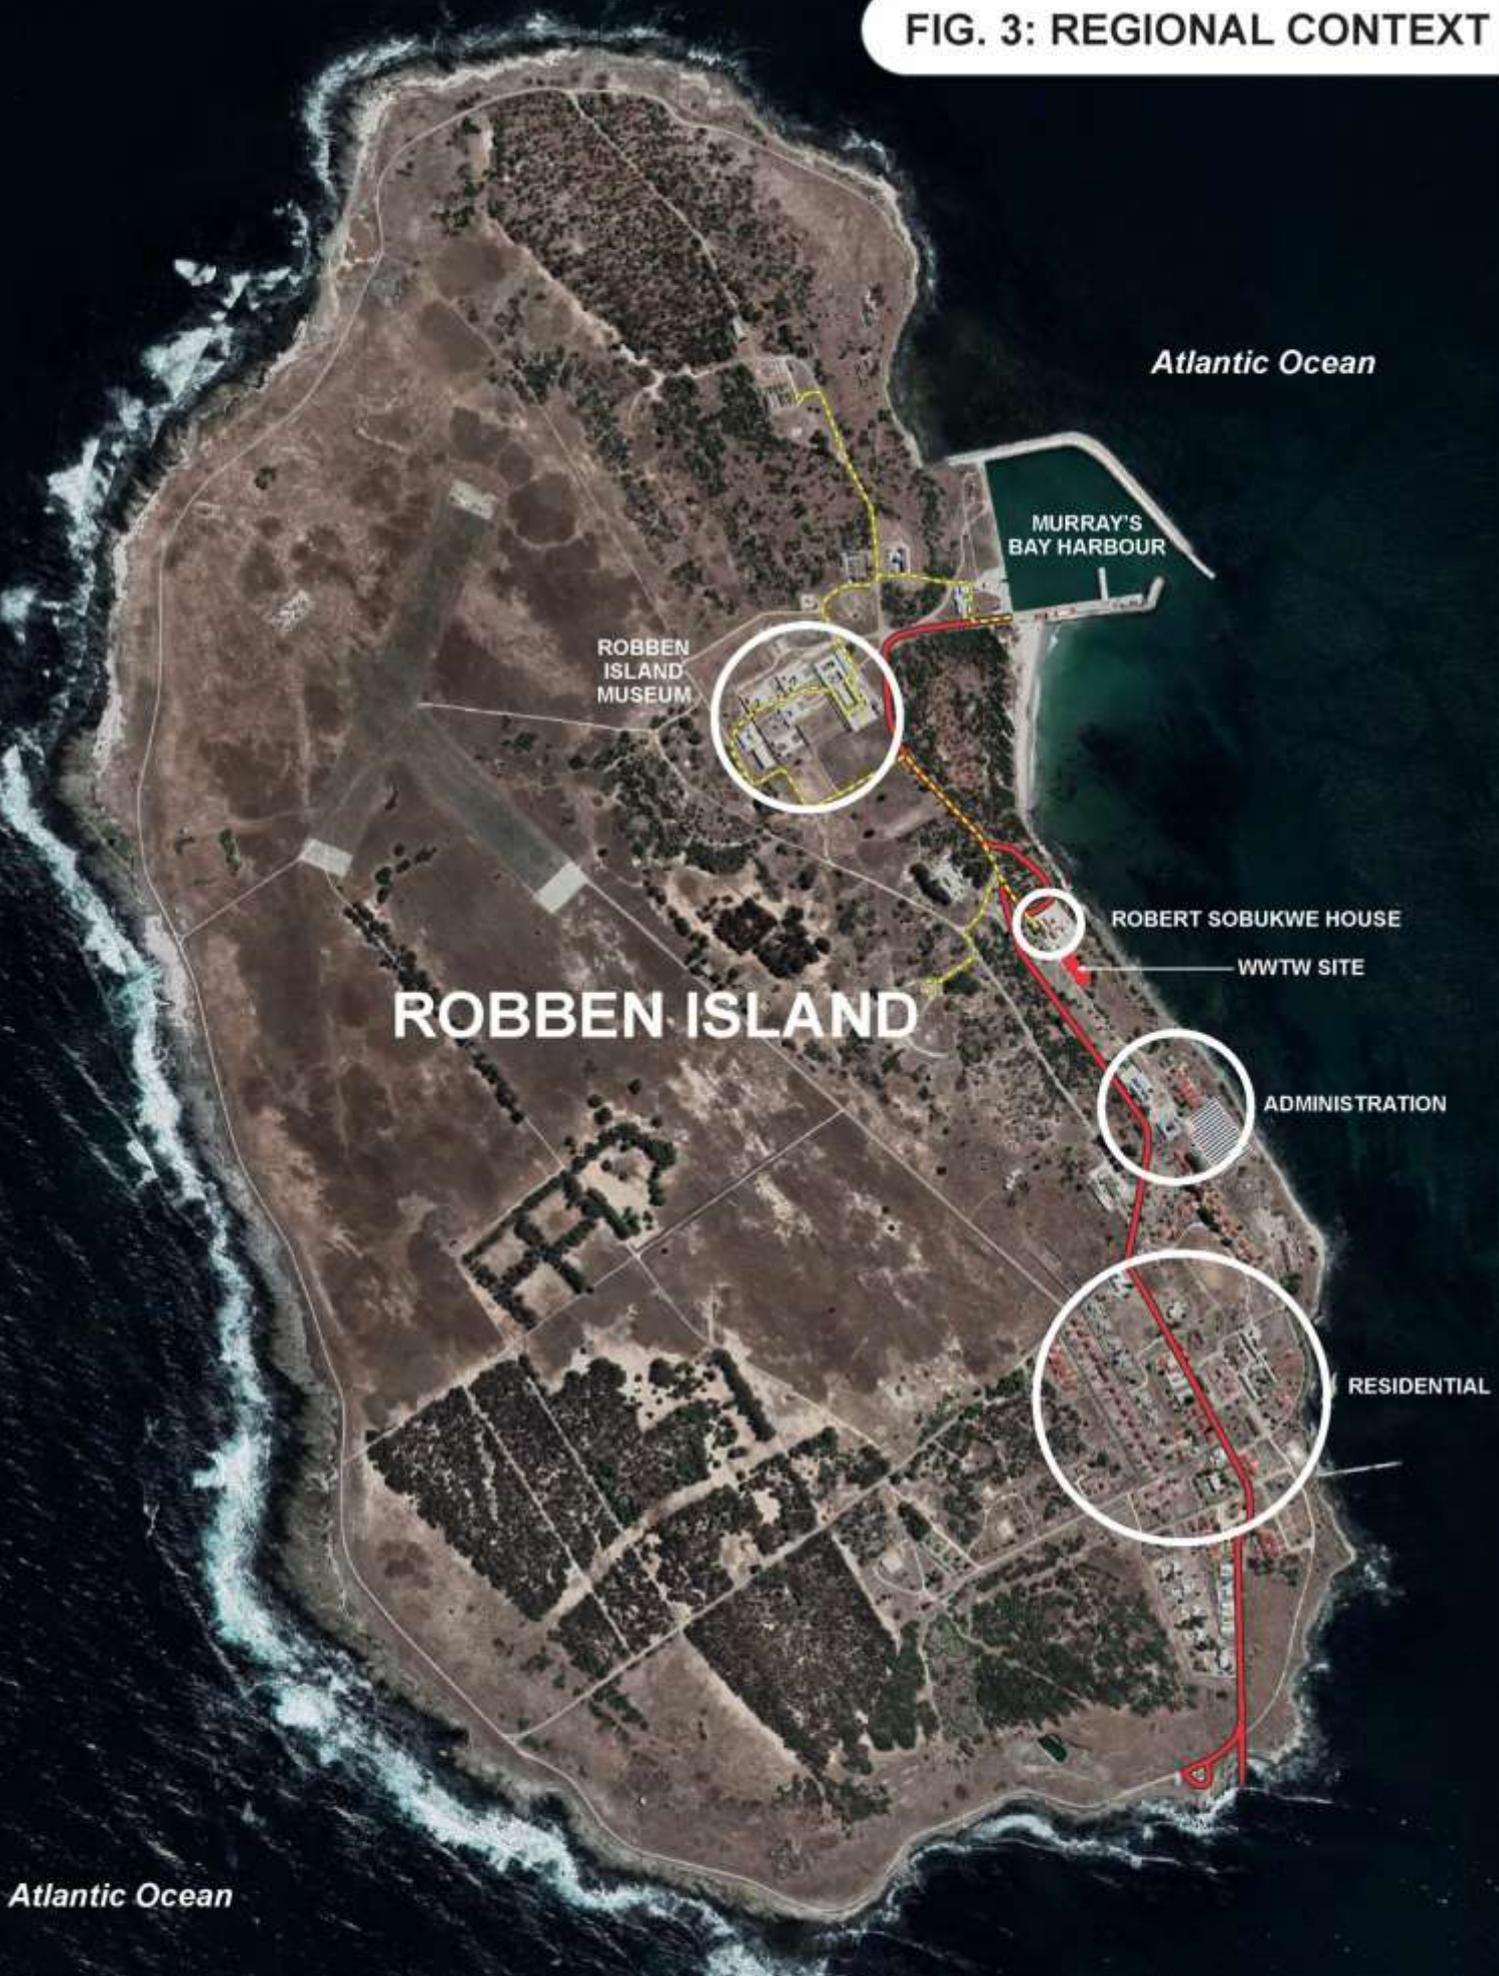
FIG. 3: REGIONAL CONTEXT

Robben Island is a UNESCO World Heritage site and is frequented by local and international tourists. The site is located on the eastern side of the island, immediately south of Robert Sobukwe House, approximately 70m from the eastern shoreline of the island, and at an elevation of 6m. See Figure 3.

A main tourist road (Murray Bay Road) runs north-south, 45m to the west of the site, linking Murray's Bay Harbour in the north to Robert Sobukwe House and the Church of the Good Shepherd in the south. This road is used extensively by bus tours taking visiting tourists around the island. A visitor Walking Tour route passes close by the site, but not within view of the site (see Figure 3).

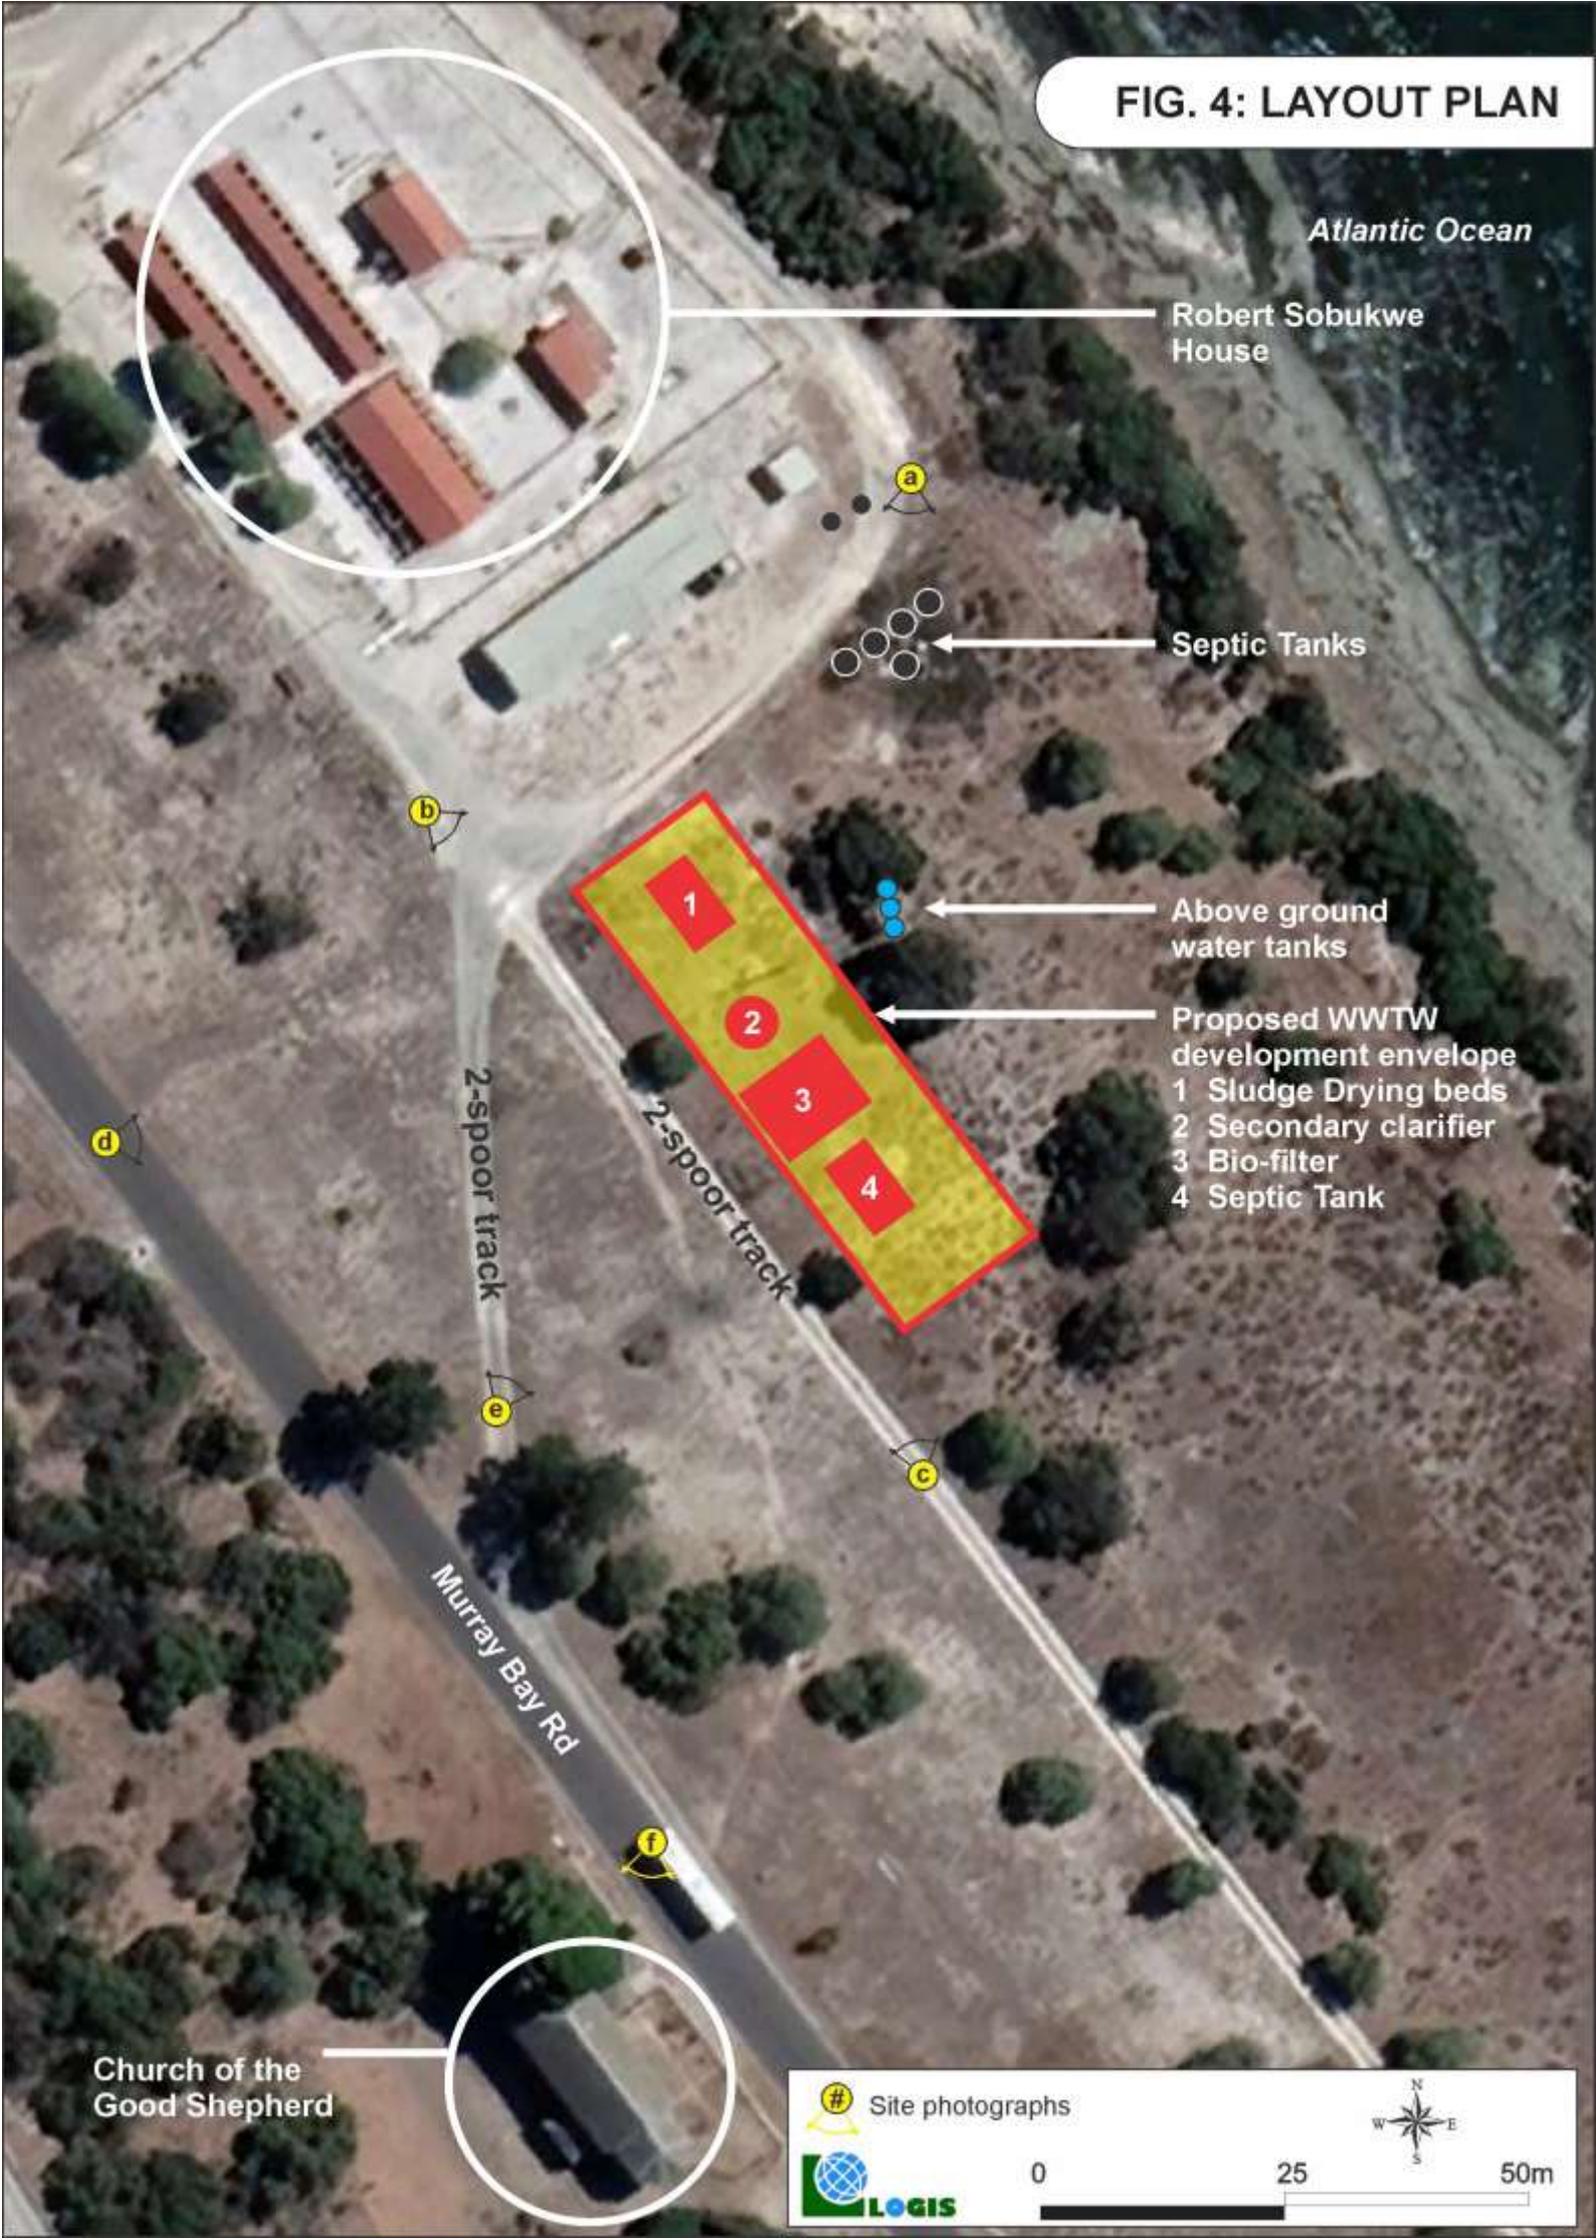
FIG. 4: LAYOUT PLAN

The site and immediate environs is heavily disturbed, with alien invasive plant species, and anthropogenic disturbance, including old water tanks, septic tank manholes, electrical boxes, disused telephone line poles, and informal 2-spoor tracks. The latter appear to be short-cut links that have developed over time.

Proposed WWTW development envelope
1 Sludge Drying beds
2 Secondary clarifier
3 Bio-filter
4 Septic Tank

See Figures 4, 5, 6, 7.

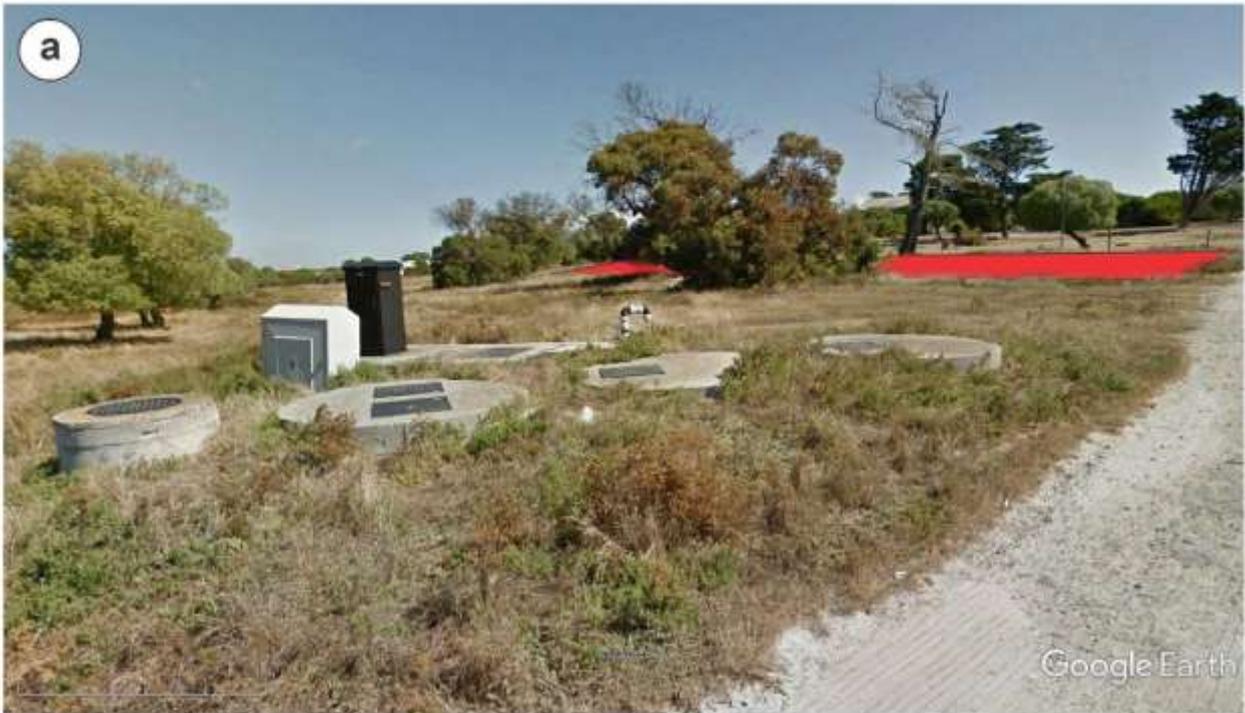
Figure 5: Site photographs from points (a) and (b).

View from point (a) looking south with the existing septic tanks in the foreground. The approximate development envelope is illustrated in red.

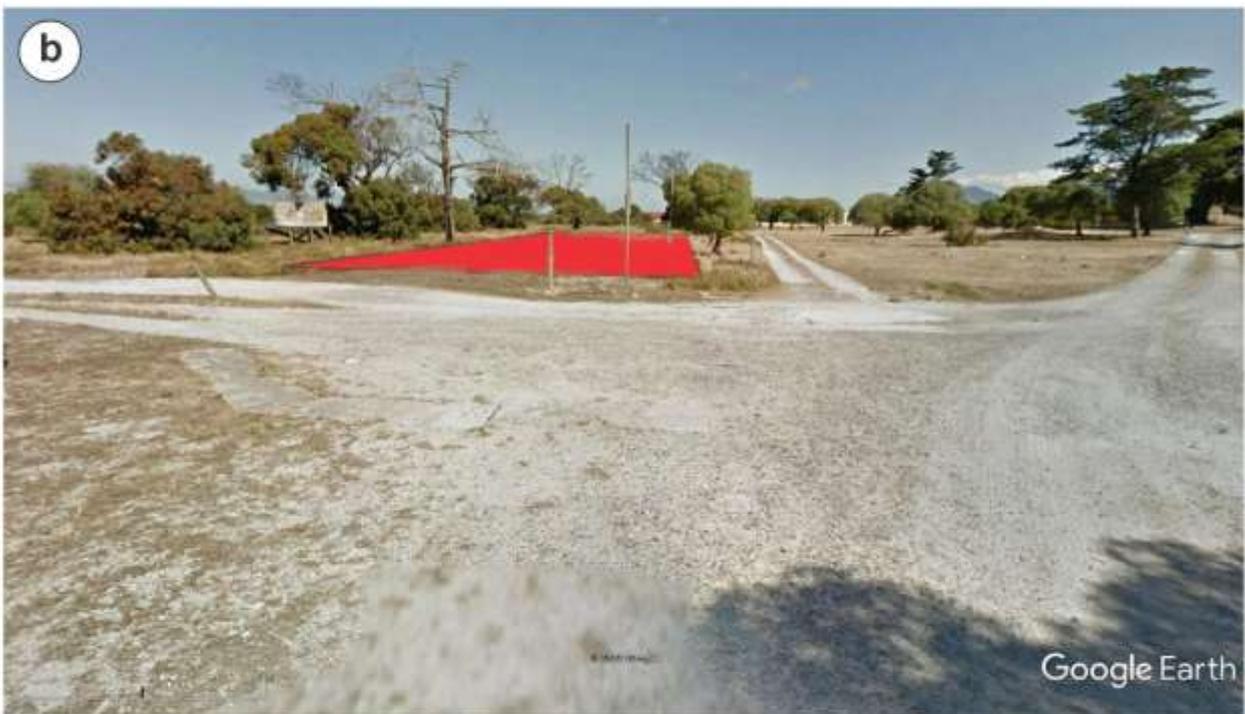
View from point (b) looking south-east . The approximate development envelope is illustrated in red.

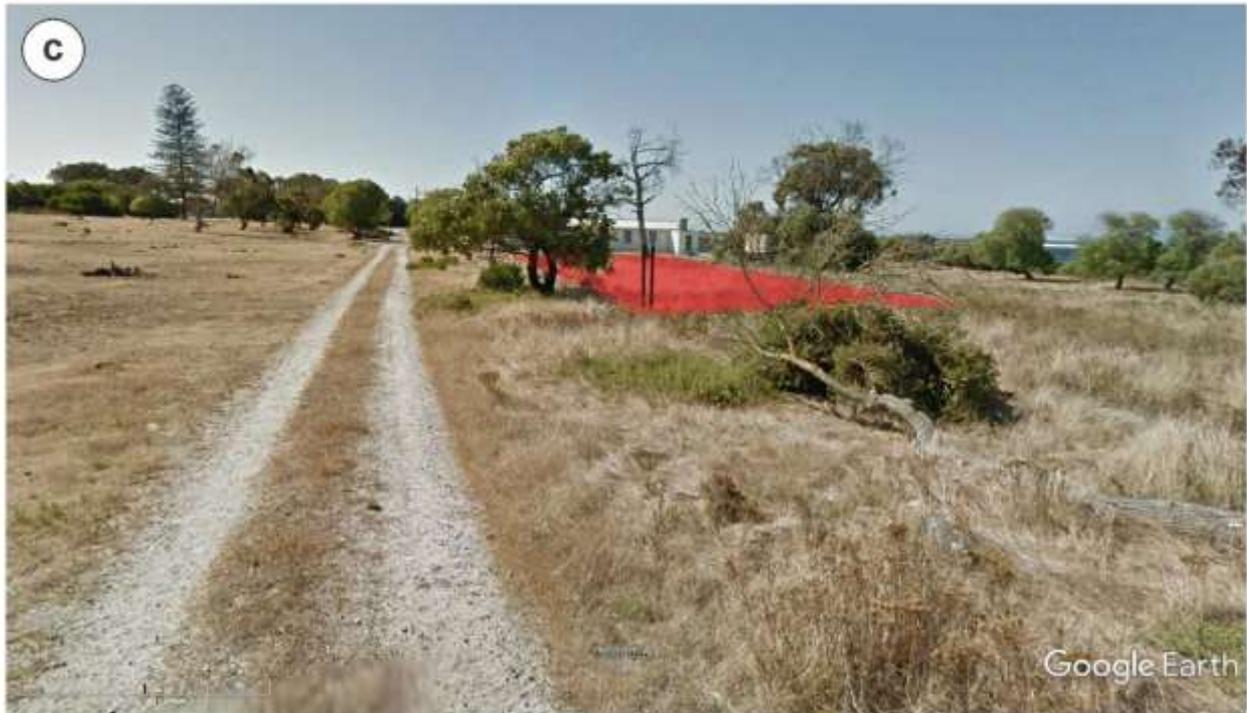
Figure 6: Site photographs from points (c) and (d).

View from point (c) looking north. The approximate development envelope is illustrated in red.

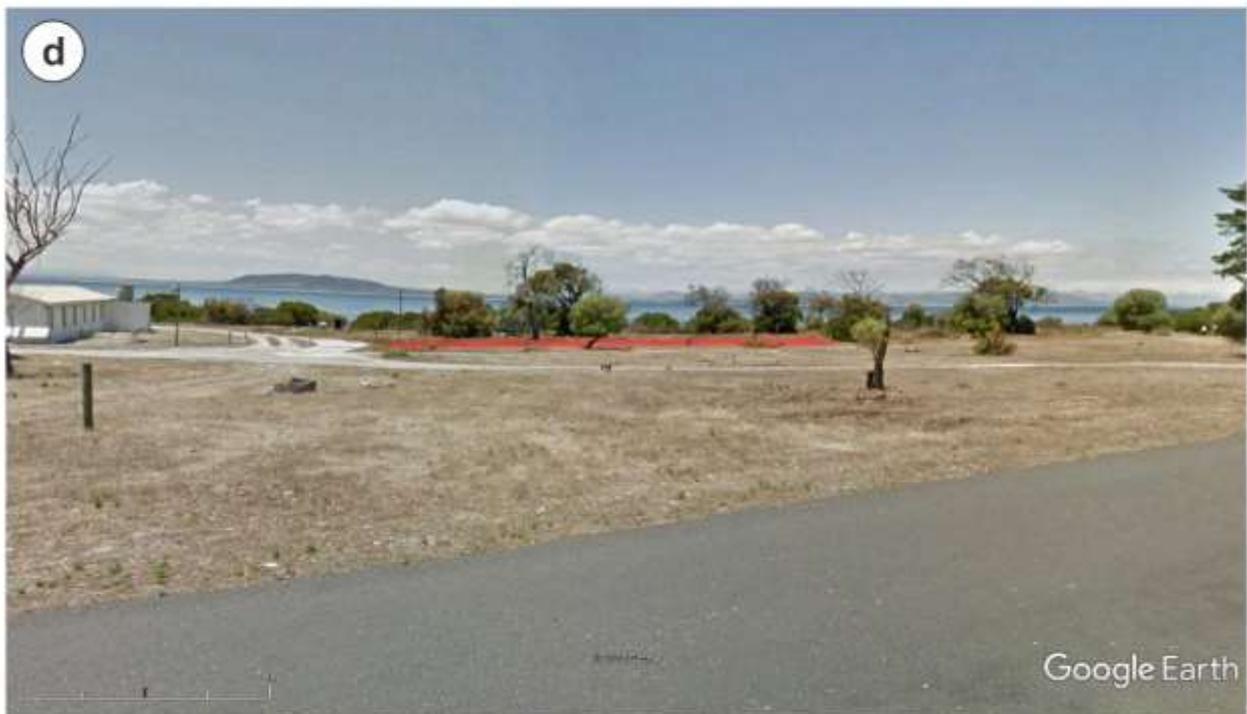
View from point (d) looking east. The approximate development envelope is illustrated in red.

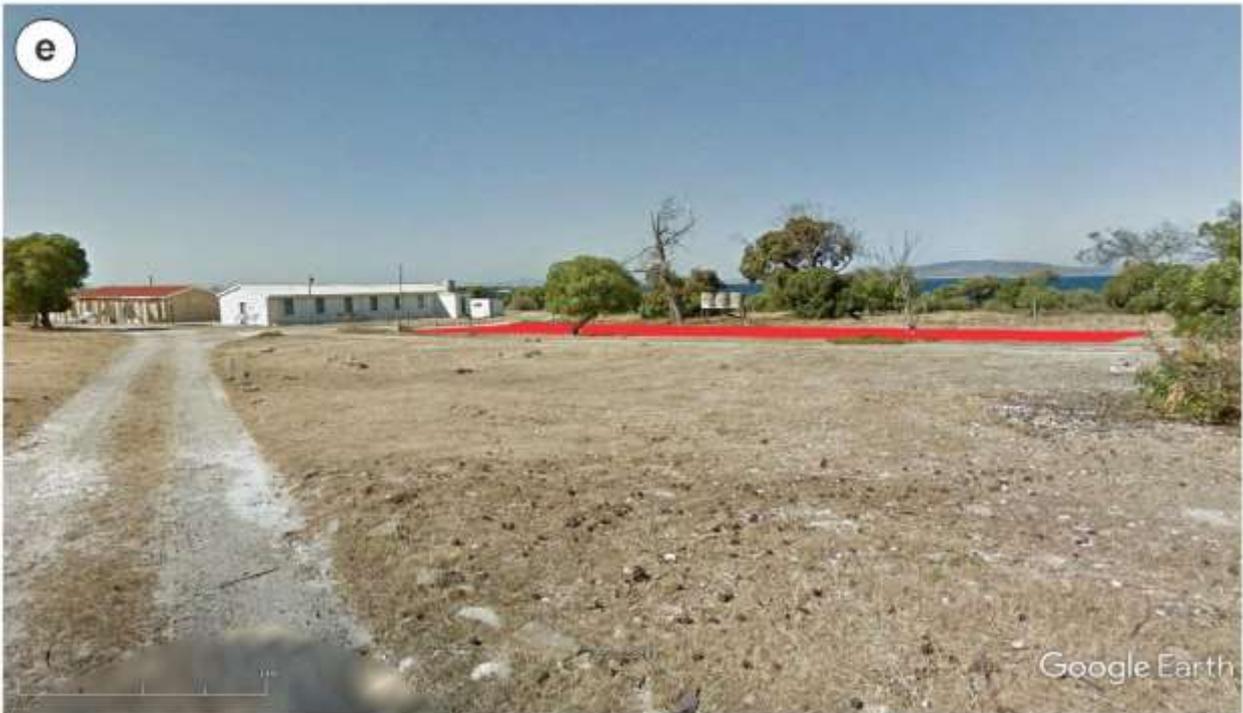
Figure 7: Site photographs from points (e) and (f).

View of Robert Sobukwe House from point (e). The approximate development envelope is illustrated in red.

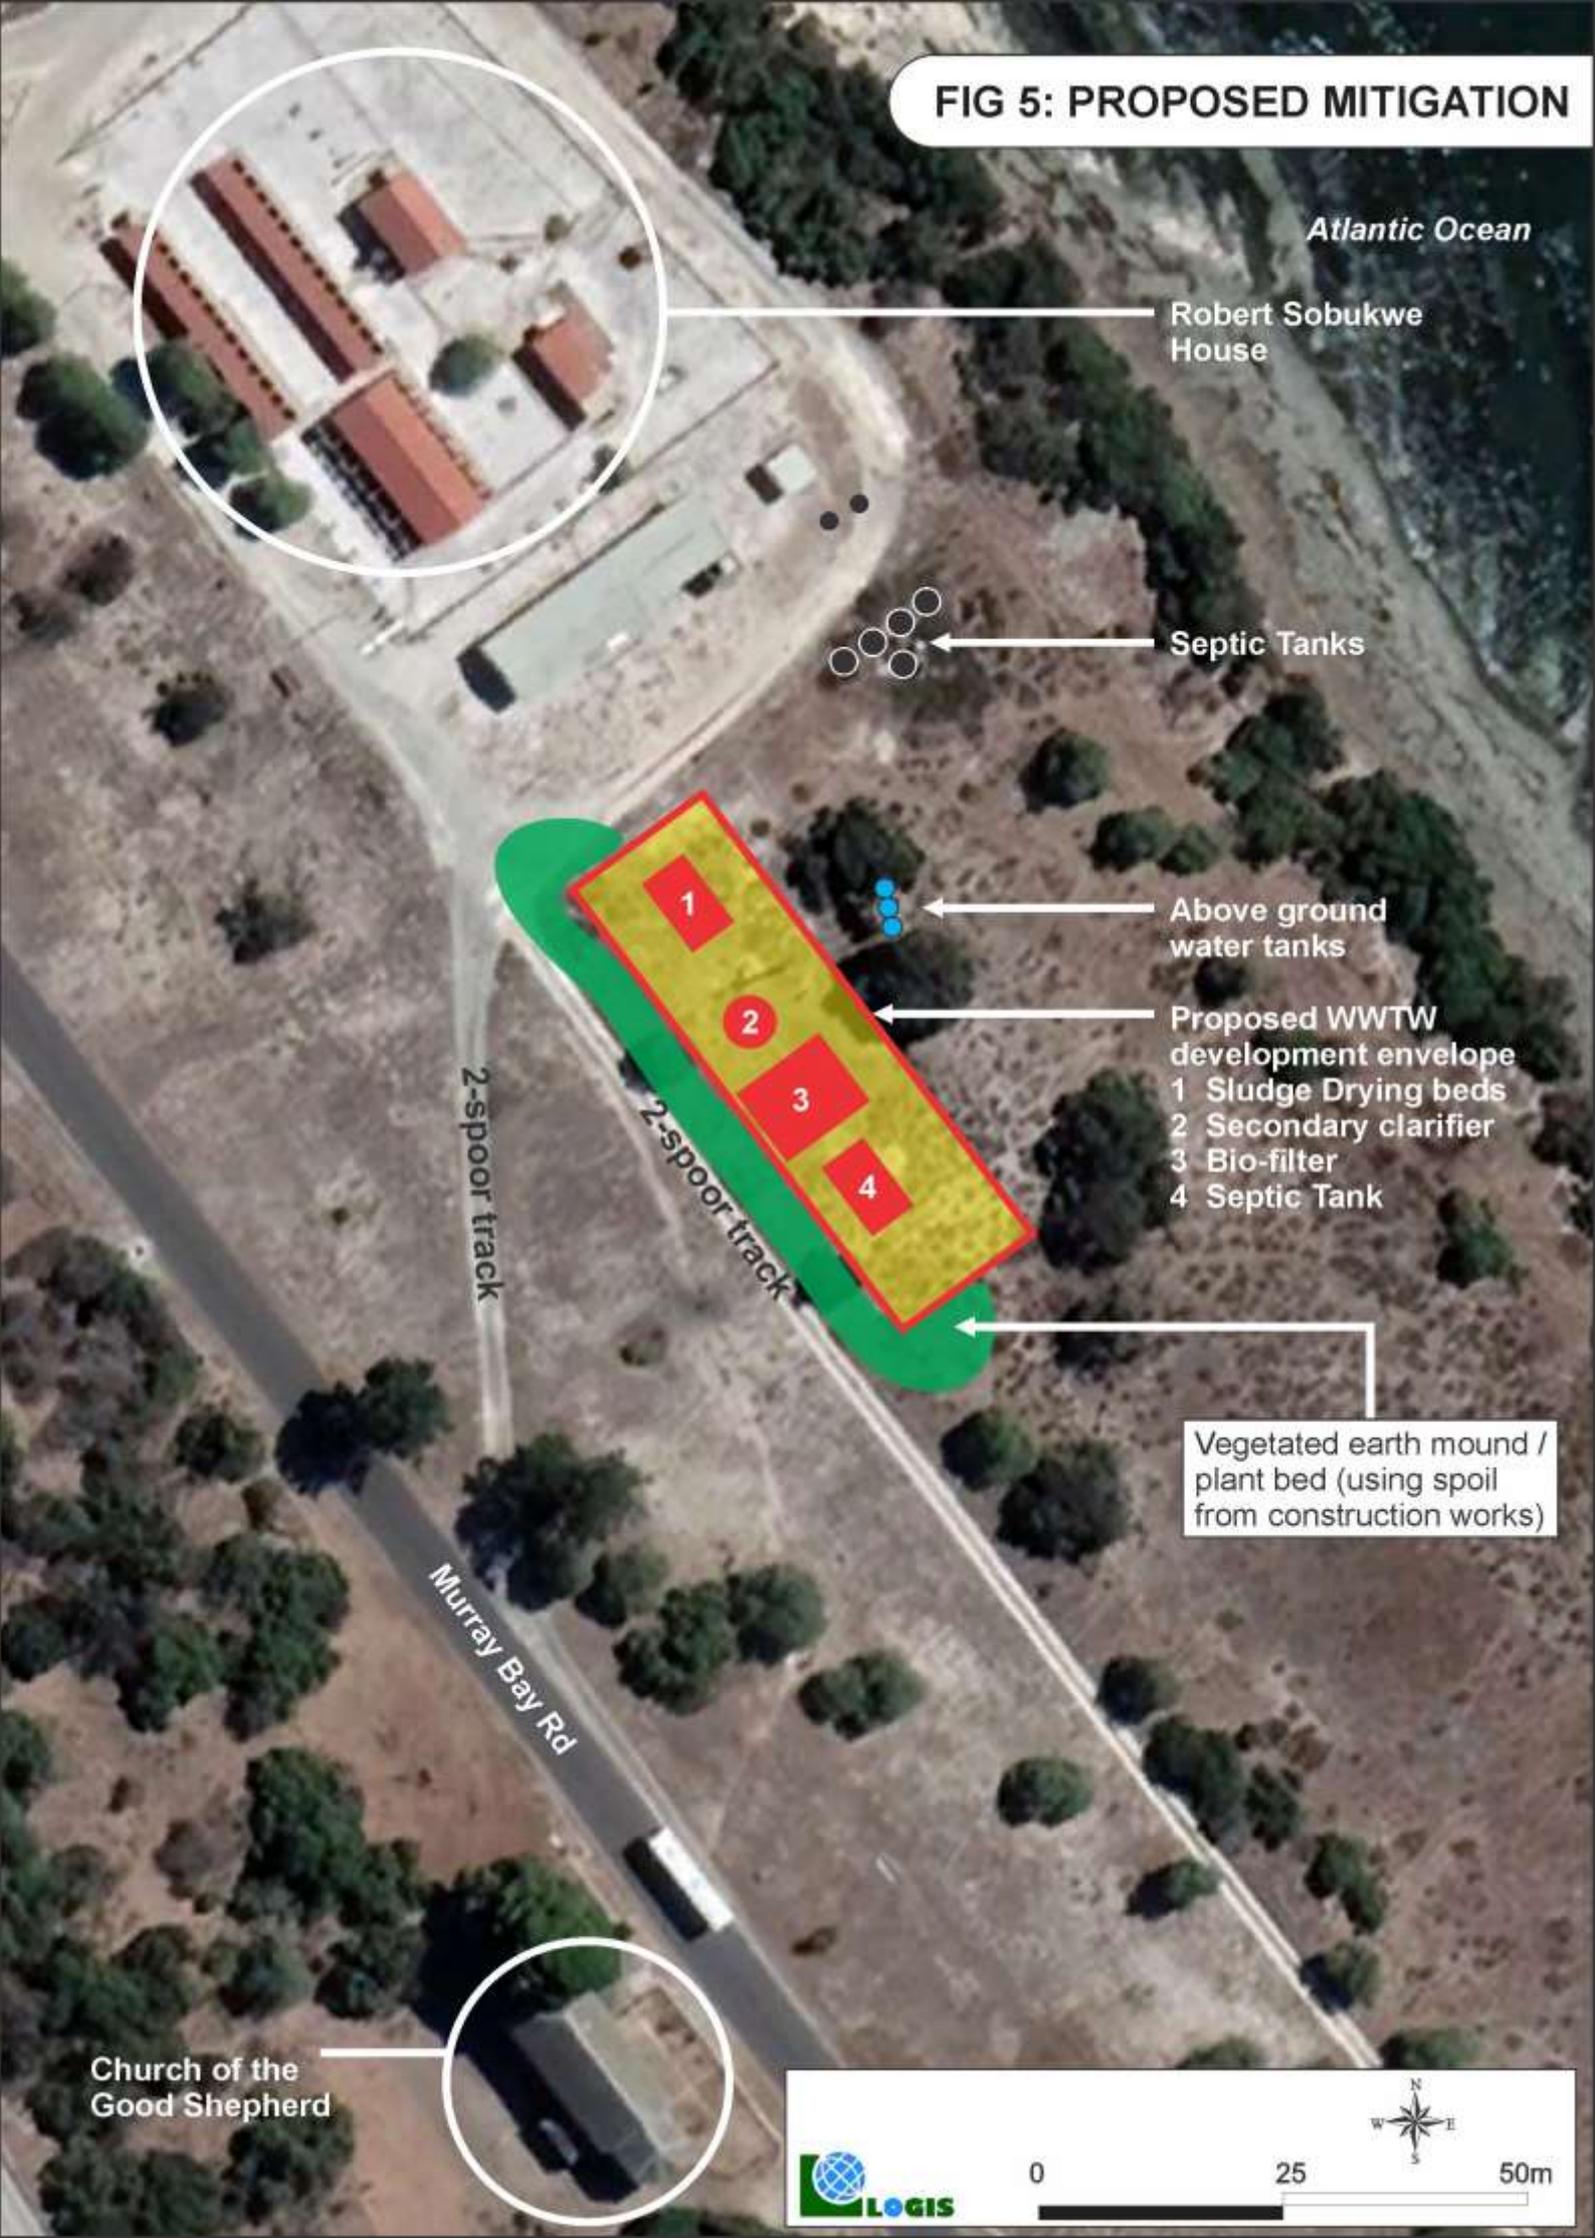
FIG 5: PROPOSED MITIGATION

Various generic mitigation procedures have been described above, but it is submitted that the most effective way to ameliorate the impact and would be by using all spoil material salvaged from the construction works to create a planted earth mound along the western, southern and northern perimeter of the development envelope. This mound should be organically designed to resemble a natural topographic feature ('dune

shaped') and planted with hardy indigenous vegetation. At a planted height of 1.5m, the planted earth mound will effectively screen any view of the WWTW from the aforementioned sensitive receptors. A local botanist should be consulted for advice on an appropriate indigenous planting palette.

It is further recommended that the general site be cleared of other disused and derelict structures, such as telephone poles which litter the area. These mitigation measures are graphically presented on Figure 5 overleaf.

Vegetated earth mound / plant bed (using spoil from construction works)
