# IGOLIDE WIND ENERGY FACILITY

Geotechnical Desktop Study

**REPORT (REV0) CONFIDENTIAL**

**PROJECT NO. 41104282**

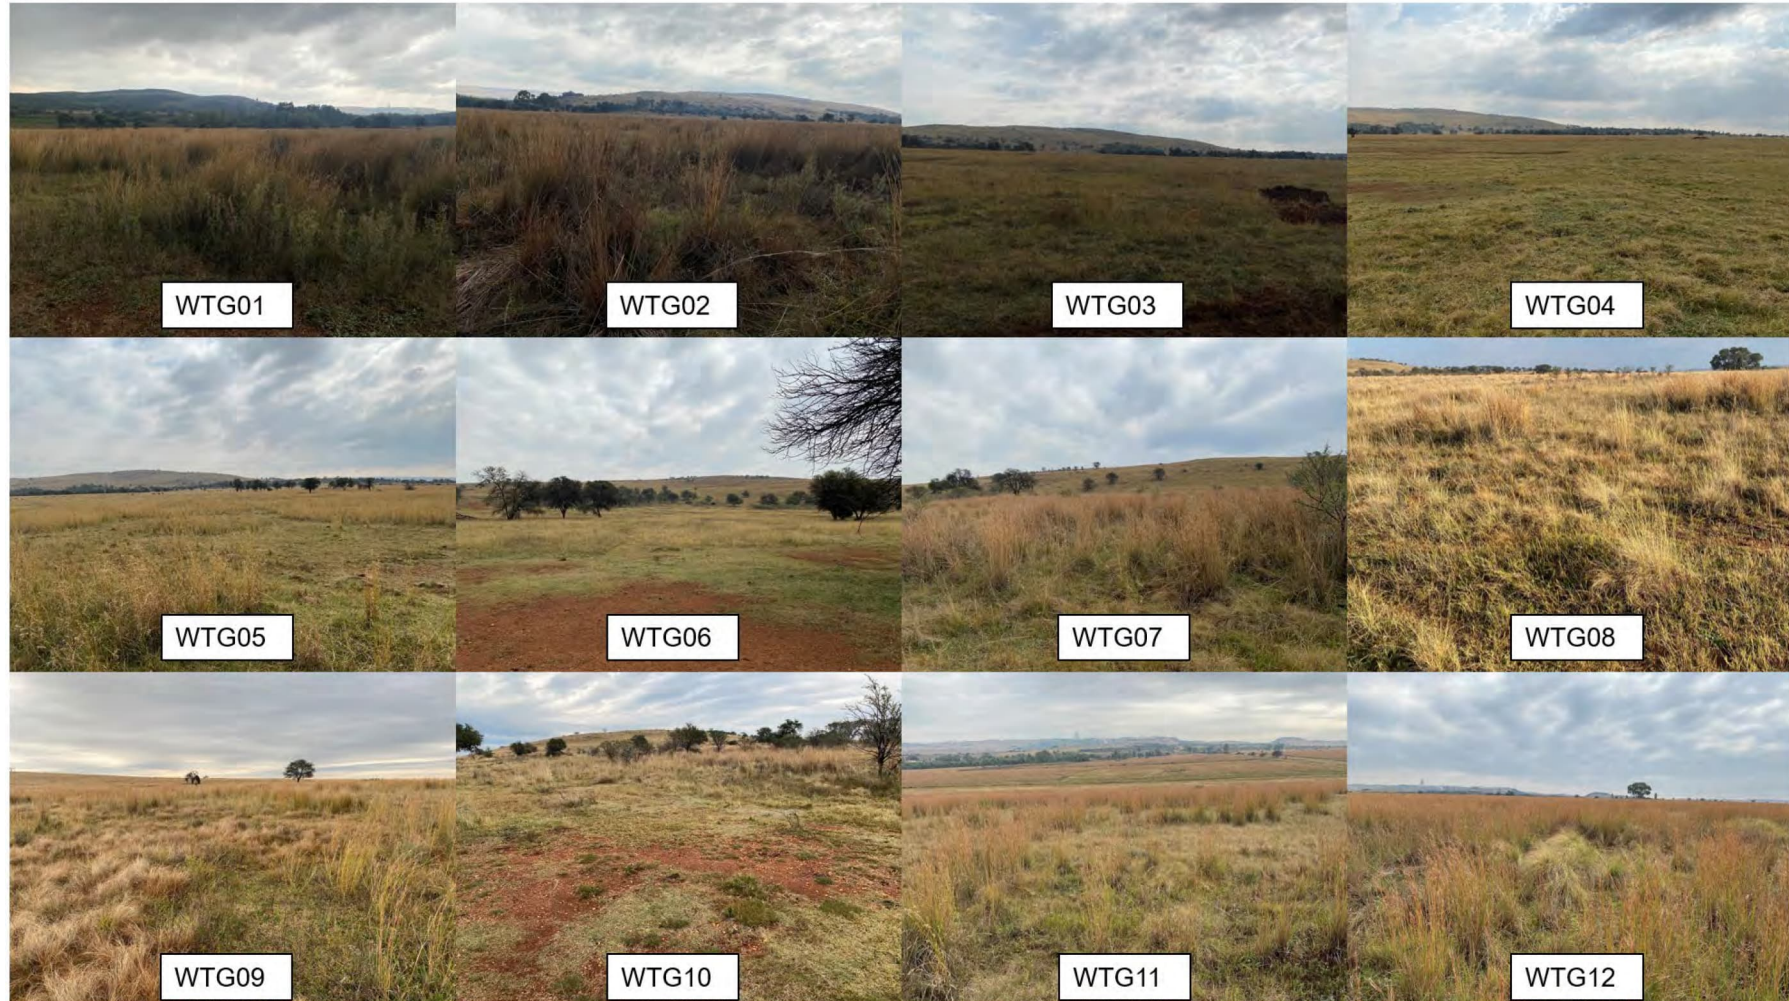
Figure 2-2 – Terrain at the turbine positions

The site is situated on a game farm characterised by short grass and trees. Some game animals were observed during the site reconnaissance. There are gravel roads on the farm that lead directly to all the wind turbine positions.

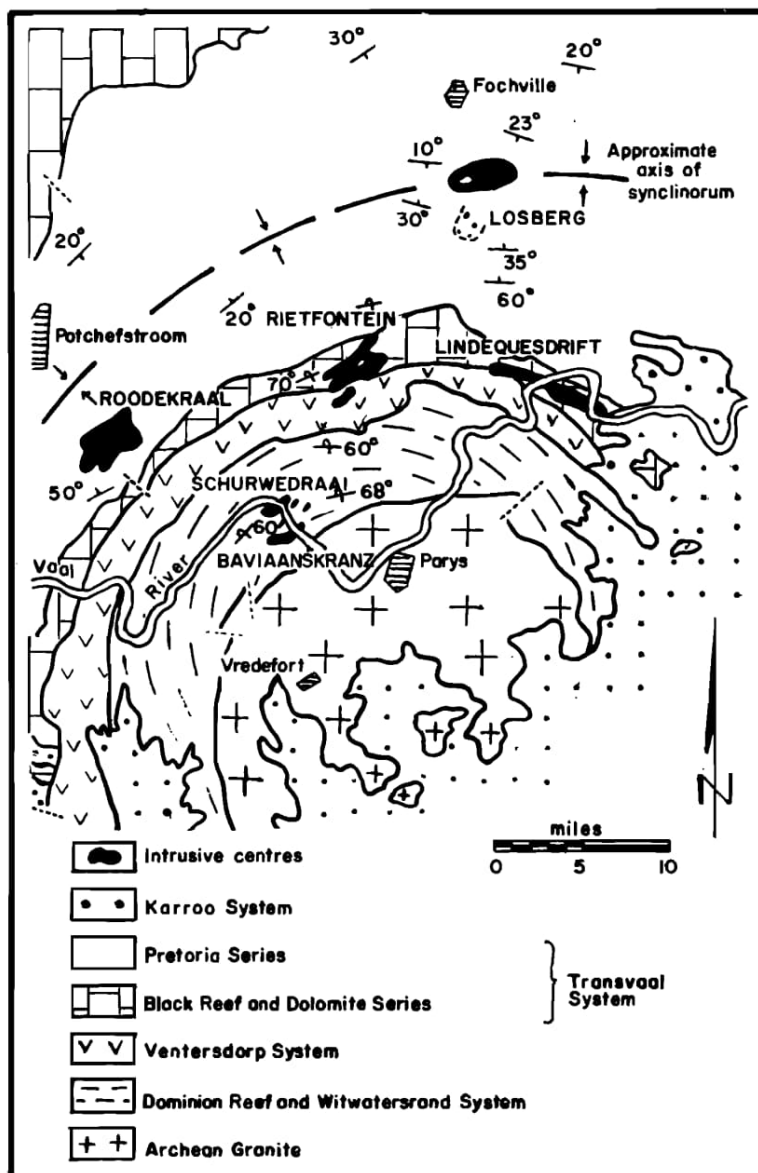
**Figure 3-2 - Geology north of the Vredefort Dome**

Supergroup	Group	Formation	Lithology	Map Symbol
Transvaal	Pretoria	Strubenkop Shale	Ferruginous Shale, Quartzite	Vs
		Hekpoort Andesite	Andesite, Agglomerate, Tuff	Vh
		Timeball Hill	Ferruginous shale, Hornfels, Ferruginous Quartzite	Vt

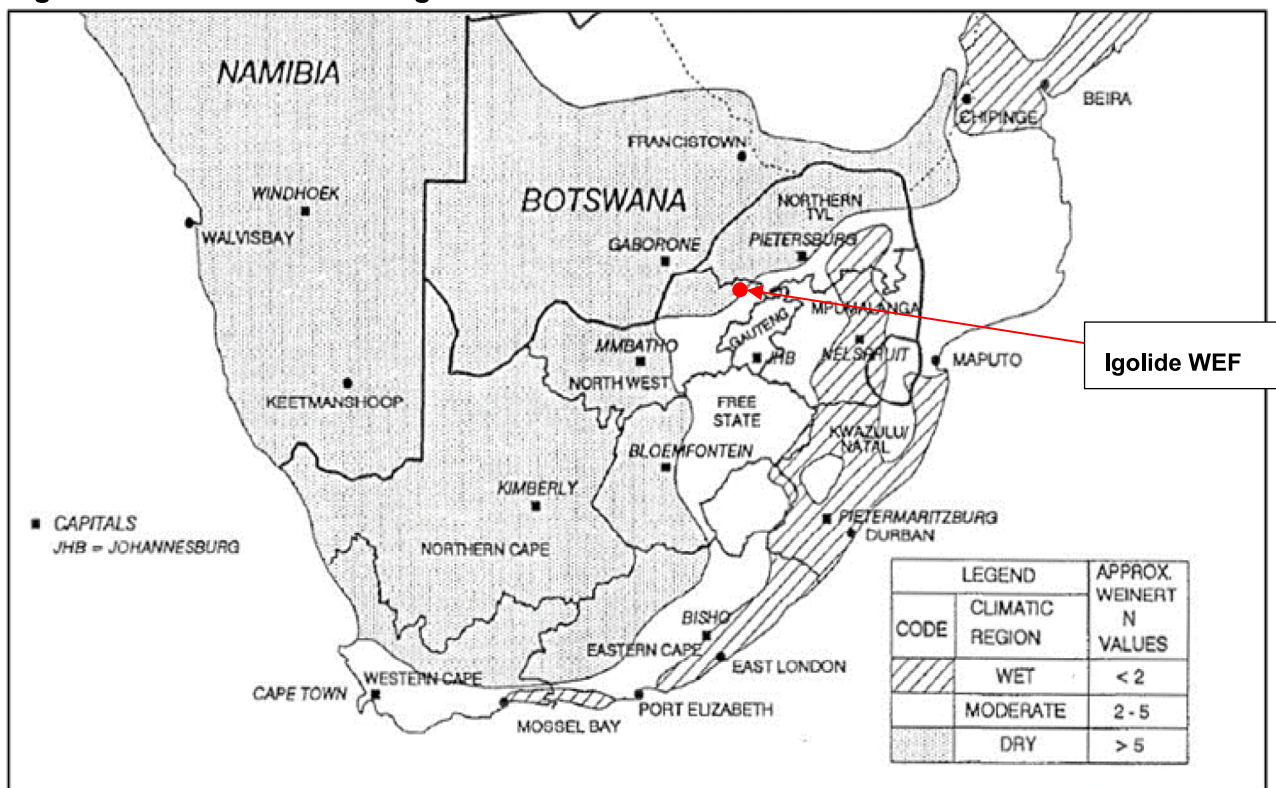
**Figure 4-1 - Macro climatic regions of South Africa**

The study area falls within the temperate highland sub-tropical region of South Africa where the N value is between 2 and 5 as illustrated in Figure 4-1. This indicates that moderate climatic conditions occur on the site and that the rock and soil are, therefore, expected to be subject to, predominantly, chemical disintegration.

The type and rate of rock weathering, and hence the soil profile, is determined by the climate of an area. Weinert (1980) developed an N-value system, which is used to derive the type of weathering likely to occur in an area based on macro-climatic conditions including evaporation and rainfall.

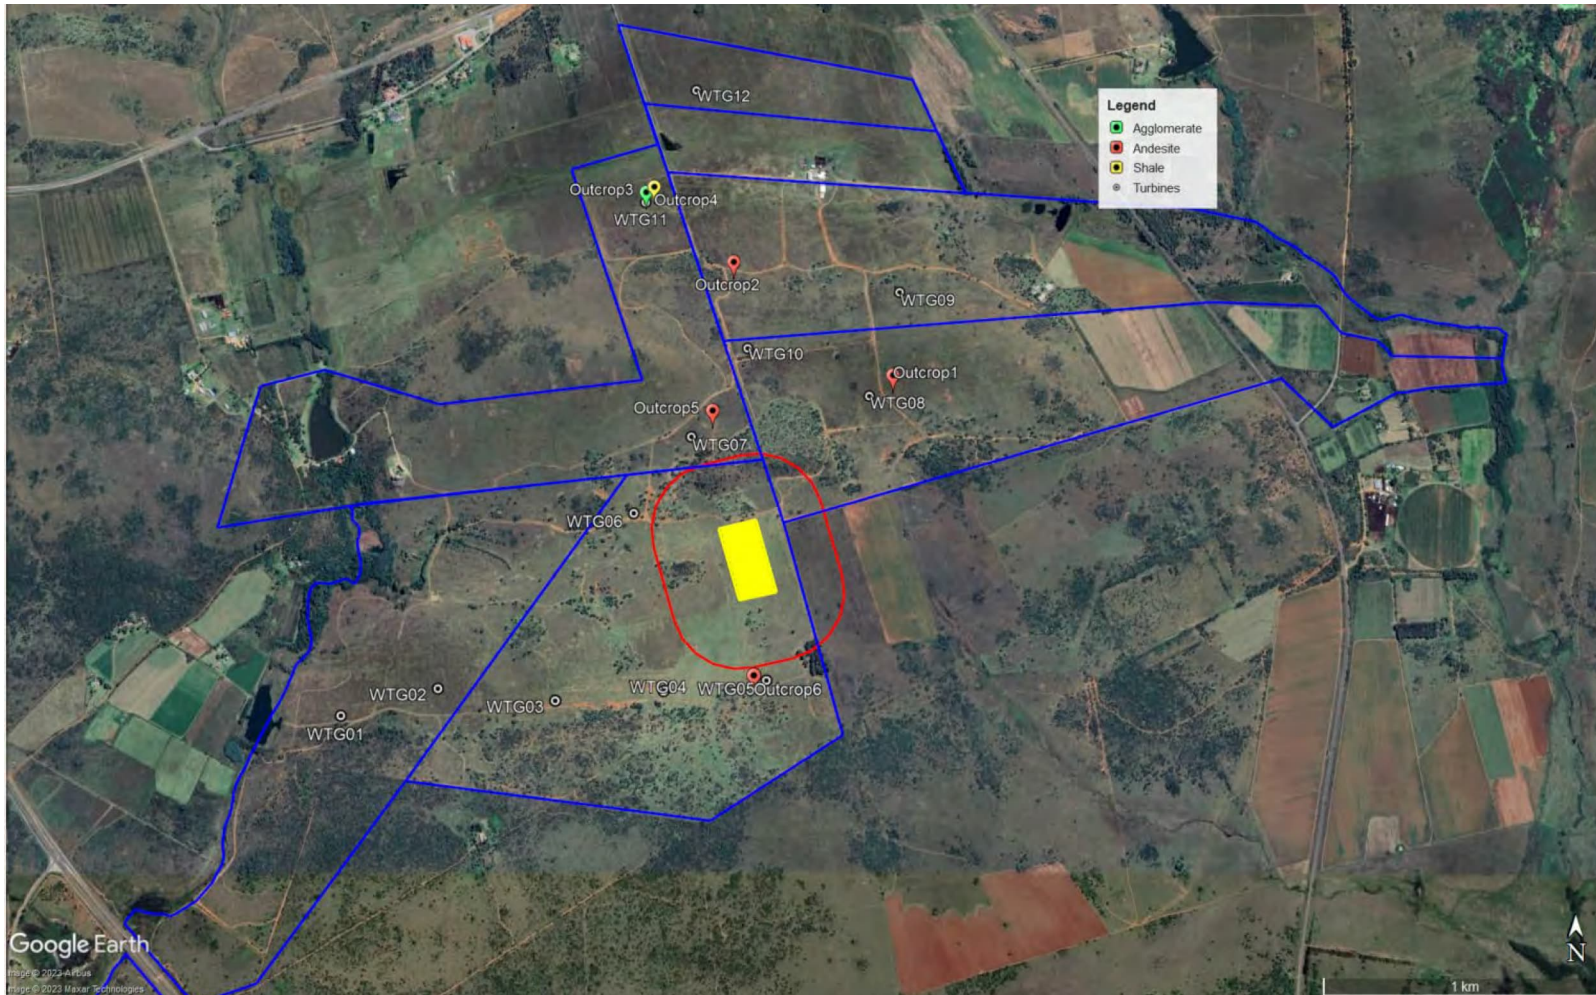
Figure 4-2 - Outcrop locations on site

Figure 4-2 shows the positions of the outcrops observed on site. The geological formations underlying each turbine position is indicated in Table 4-1 while Table 4-2 describes the formation and rock type of the outcrops observed on site.

A majority of the site, and thus a majority of the turbine positions, are underlain by the Hekpoort Andesite Formation. This was evident during the site reconnaissance with several andesite and agglomerate outcrops observed across the site

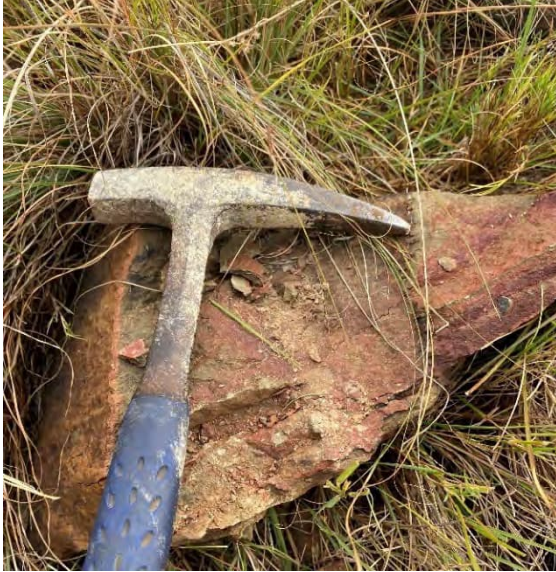
**Figure 4-3 - Shale rock encountered on site.**

The shale of the Pretoria Group, including that of the Stubenkop Shale and Timeball Hill Formations, commonly weathers into relatively shallow residual profiles of less than 2 to 4m in thickness. The residual soil generally comprises clayey silt to silty clay which is generally compressible and occasionally expansive. Notwithstanding this, a shale rock outcrop is present approximately 3m from the proposed position of WTG11. The shale is olive green weathered red, highly weathered, very fine grained, intensely bedded, slightly fractured, soft rock and can be seen in Figure 4-3.

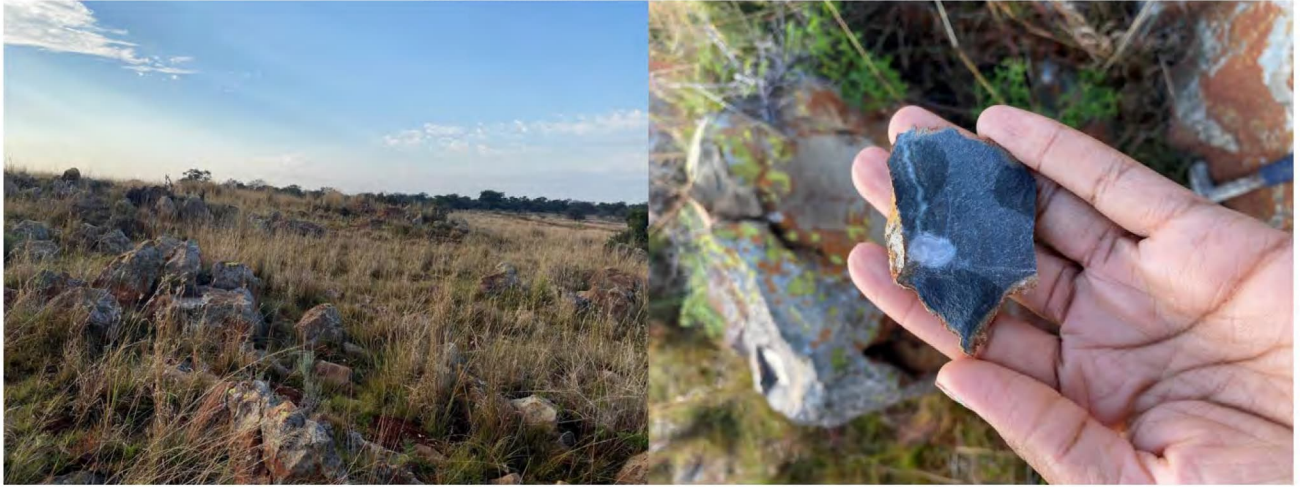
**Figure 4-4 - Andesite outcrop and typical andesite**

Andesite rock and agglomerate rock were observed as outcrops on site with some present in close proximity to WTG06, WTG07 and WTG08. The andesite and agglomerate is shown in Figure 4-4 and Figure 4-5, respectively, and were described as follows:-:

- Dark grey weathered red and light grey, slightly weathered, fine grained, slightly fractured, hard rock **andesite** with 10mm to 12mm diameter amygdale crystals.
- Dark grey weathered red, slightly to moderately weathered, medium to fine grained, moderately to highly fractured, medium hard rock **agglomerate** with 2m to 40mm diameter, opaque white to greyish white, subrounded, hard rock calcite fragments in rock matrix.

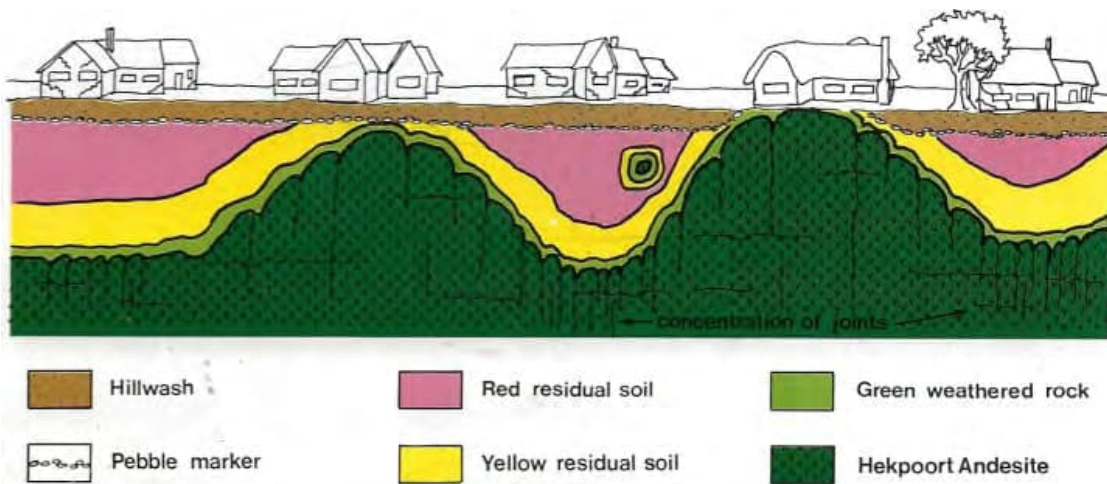
**Figure 4-6 - Variability of depth of decomposition in the Hekpoort andesite.**

As stated by Brink ABA (1979) “*an interesting feature of the Hekpoort andesite is the extreme variability in depth and in degree of decomposition across relatively short distances.*”. This is as illustrated in . Therefore although outcrops are present, a more thickly developed profile may be present within a very short distance. It is therefore of significant importance, that the depth of the residual profile directly below the turbine foundation positions be investigated and determined prior to design and construction.

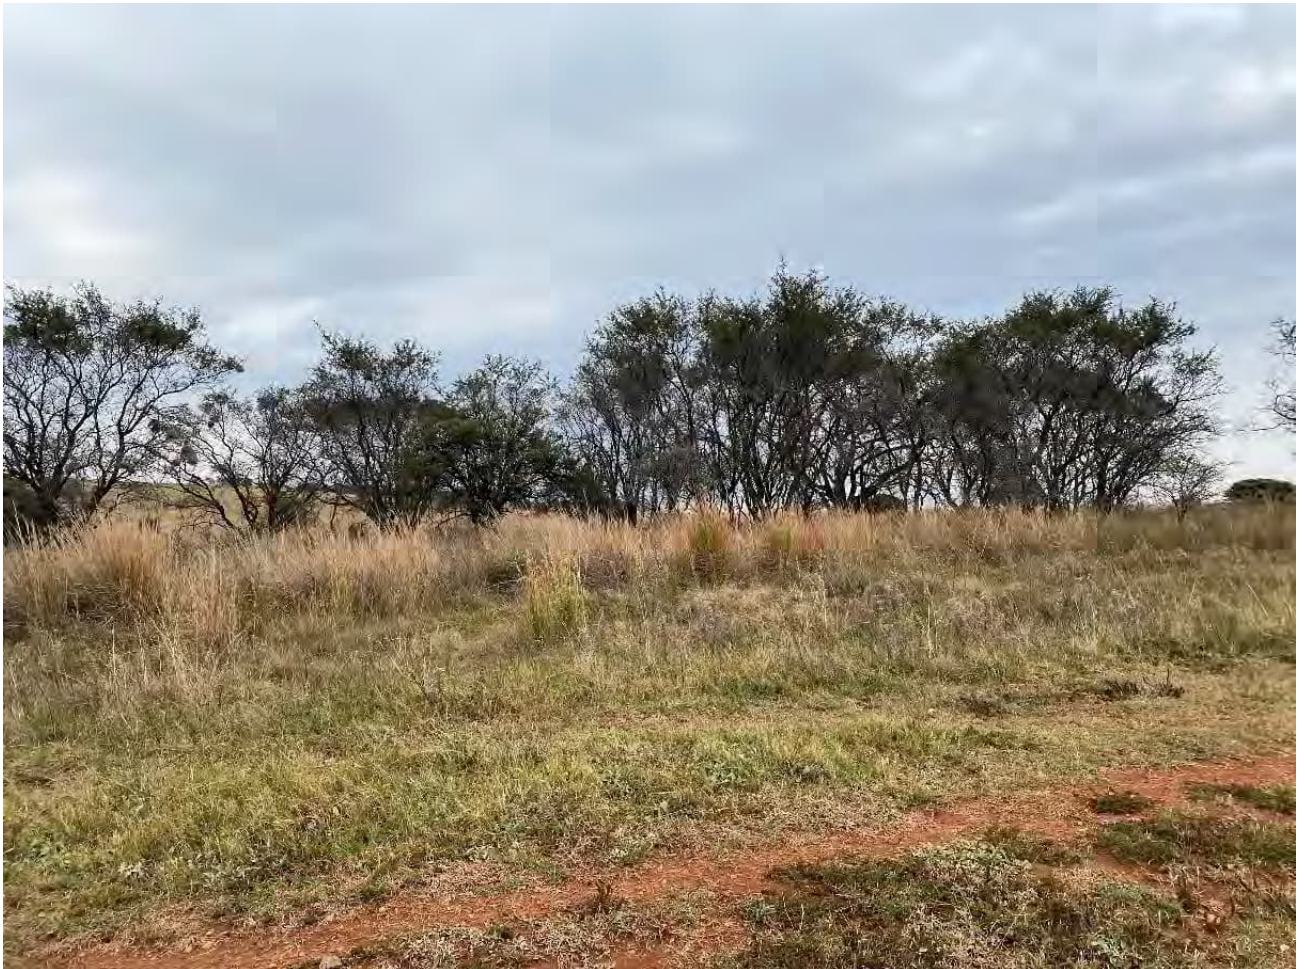
**Figure 5-1 - Vegetation on site**

The slope on site, as well as the soil structure will influence the amount of erosion that occurs on site. The undulating gradient makes the probability of erosion likely although this is reduced by the presence of tall grass and trees, as shown in Figure 5-1, that cover large portions of the site. Construction might increase the likelihood of erosion due to the disturbance of natural vegetation. This should be mitigated by revegetation after construction.

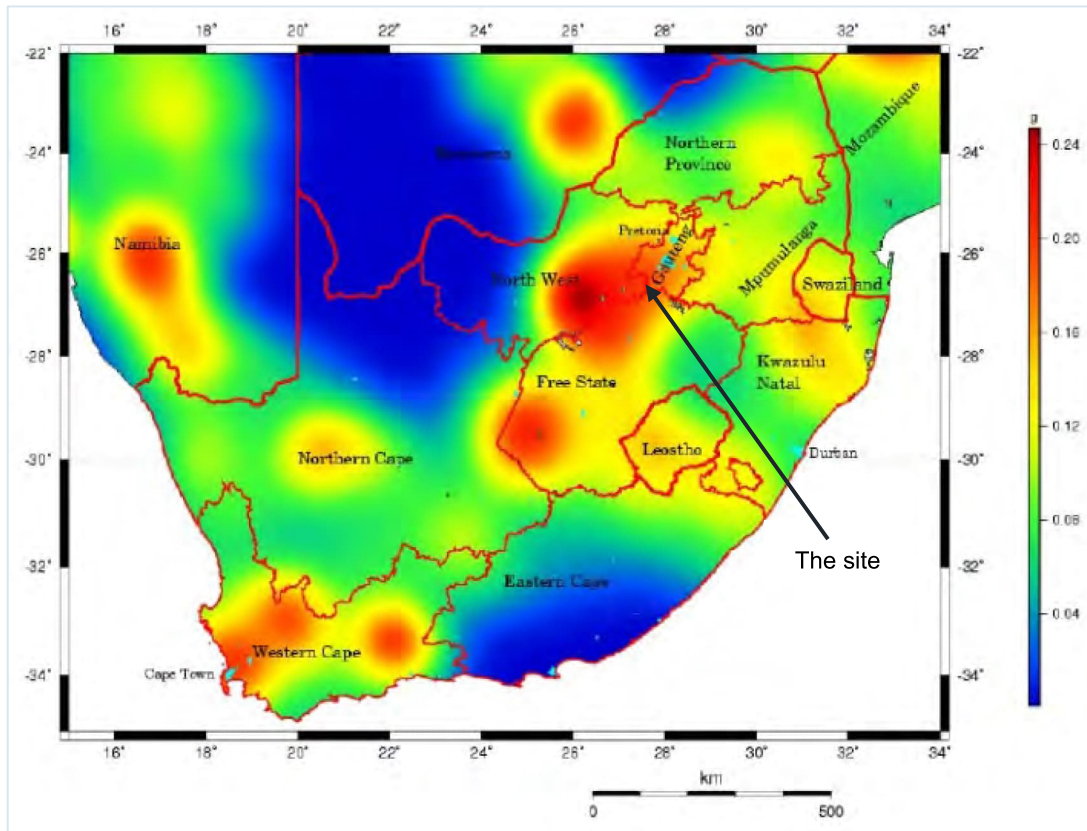
**Figure 5-2 - Probabilistic seismic hazard map of South Africa**

According to the Seismic Hazard Map of South Africa (Council for Geoscience report No. 2003-0053.), the peak ground acceleration is between 0.16g and 0.20g for the site. The peak ground acceleration may be described as the maximum acceleration of the ground shaking during an earthquake, which has a 10% probability of being exceeded in a 50-year period as per Figure 5-2.

SANS 10160-4 2017 should be consulted to ensure structural design of the proposed WEF meets the minimum requirements for buildings in this seismic zone.

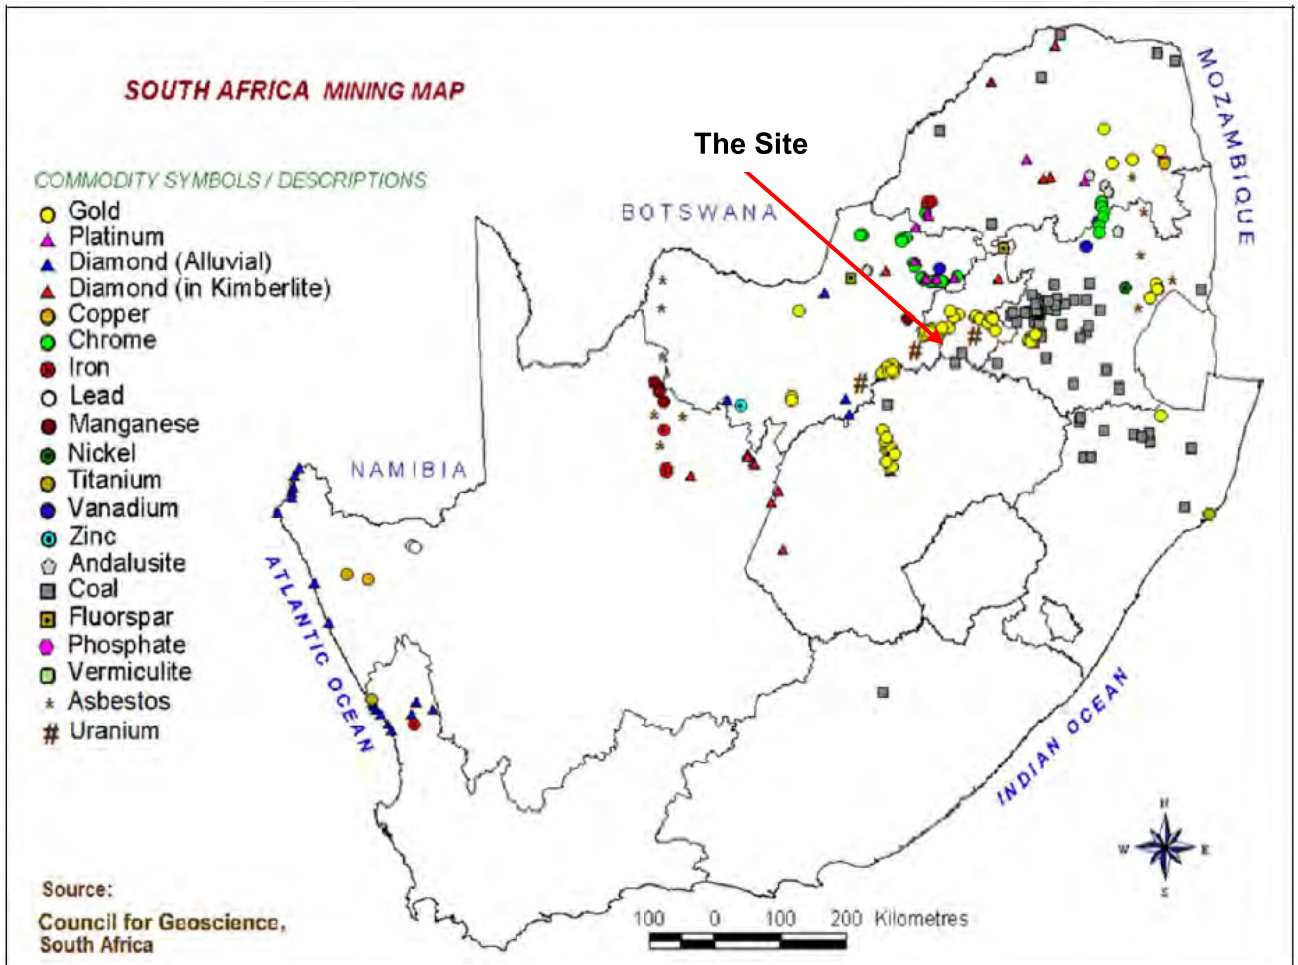
Figure 5-4 - Map indicating mining areas in South Africa

Subsidence at surface in undermined areas is caused by the collapse and failure of the underground mining voids relatively close to the surface (Heath and Engelbrecht, 2011). The extent of mining activity in South Africa is shown in Figure 5-4, It can be seen from this figure that the site is located in an area with a significant number of gold mines.

The extent of any undermining below the site should be assessed, in detail, prior to development as the possibility of surface subsidence cannot be discounted should the site be undermined. .
