STORMWATER MANAGEMENT PLAN FOR THE PROPOSED KOMATI SOLAR PV, BESS, AND ASSOCIATED INFRASTRUCTURE

PROJECT NO. 41103965

DATE: MAY 2023

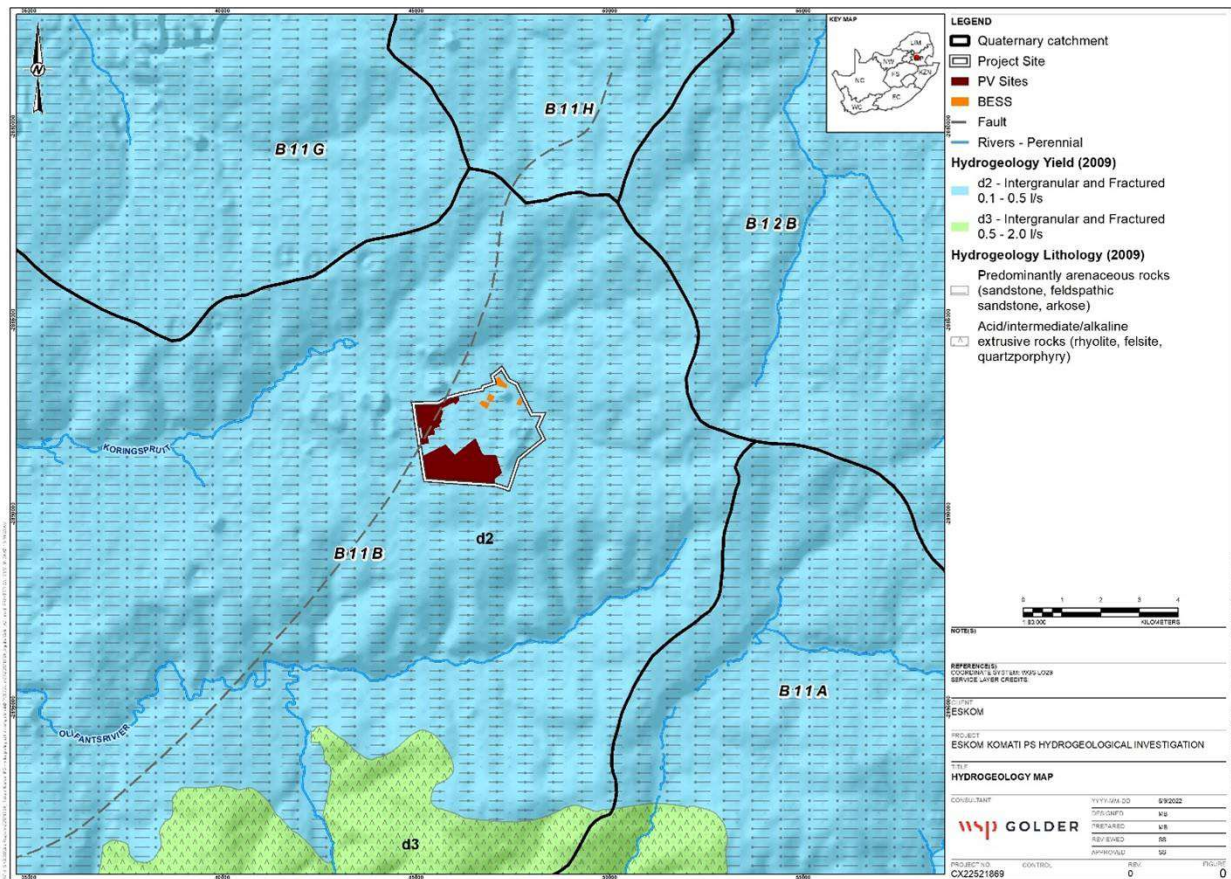
The inclusion of a hydrogeology map (Figure 3-1) in this stormwater management report is crucial for understanding the underlying geological conditions and their influence on stormwater runoff and infiltration. This map provides valuable information about the subsurface characteristics, such as soil types, permeability, and groundwater flow patterns, which are essential for designing effective stormwater management strategies. By incorporating the hydrogeology map into our analysis, we can identify areas prone to flooding, determine suitable locations for infiltration systems or detention basins, and make informed decisions regarding stormwater conveyance and retention. The hydrogeology map serves as a valuable tool for ensuring the efficient and sustainable management of stormwater in the project area.

Figure 3-1 - Hydrogeology Map

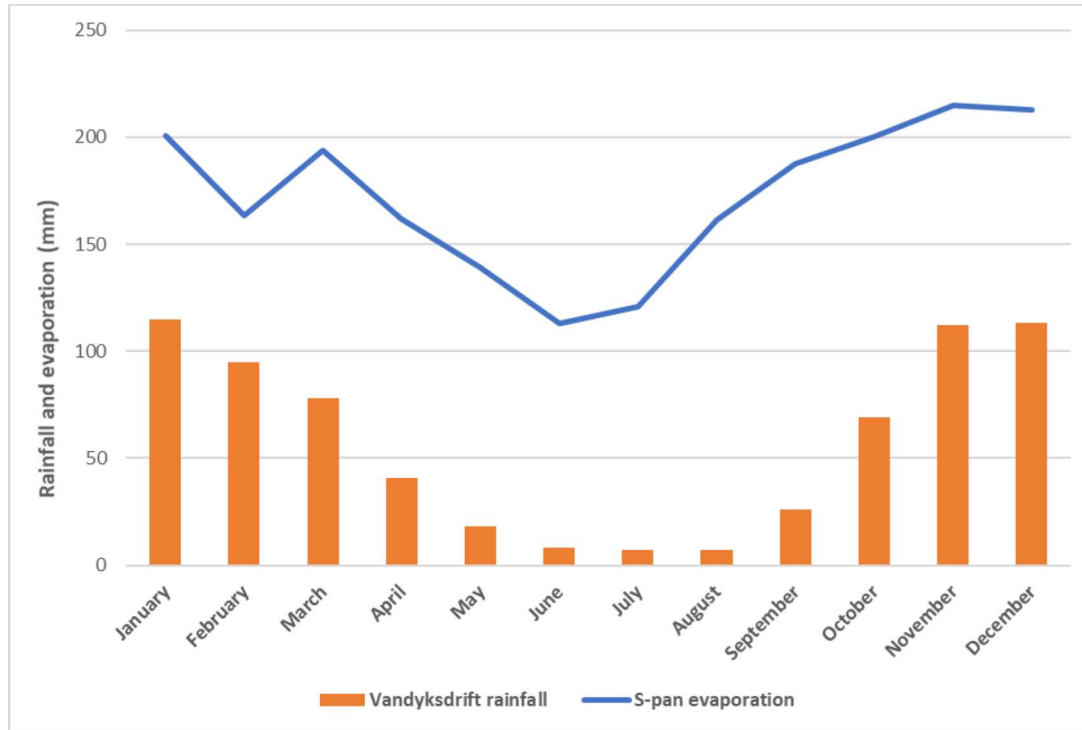
In comparison to the rainfall (see Figure 3-2) the evaporation is always higher than the rainfall over the course of the year. This indicates that most of the precipitation is evaporated. The evaporation varies throughout the year, with the highest evaporation in the area observed in the months of October to March and the lowest evaporation occurring during the months of October to March.

Figure 3-2 - Rainfall and evaporation comparison

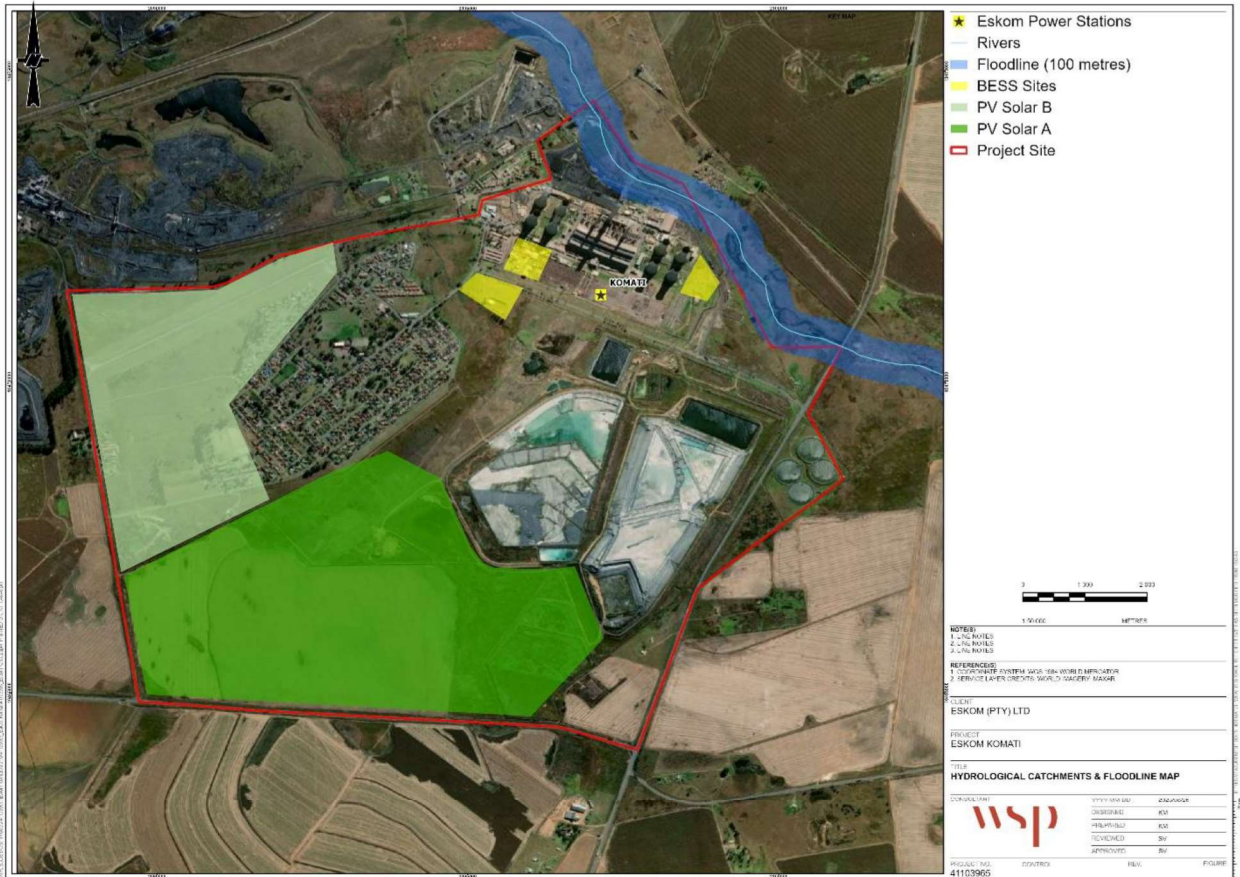
The delineated catchments are as shown in Figure 4-1 below.

Figure 4-1 - Hydrological Catchments and Floodline Map

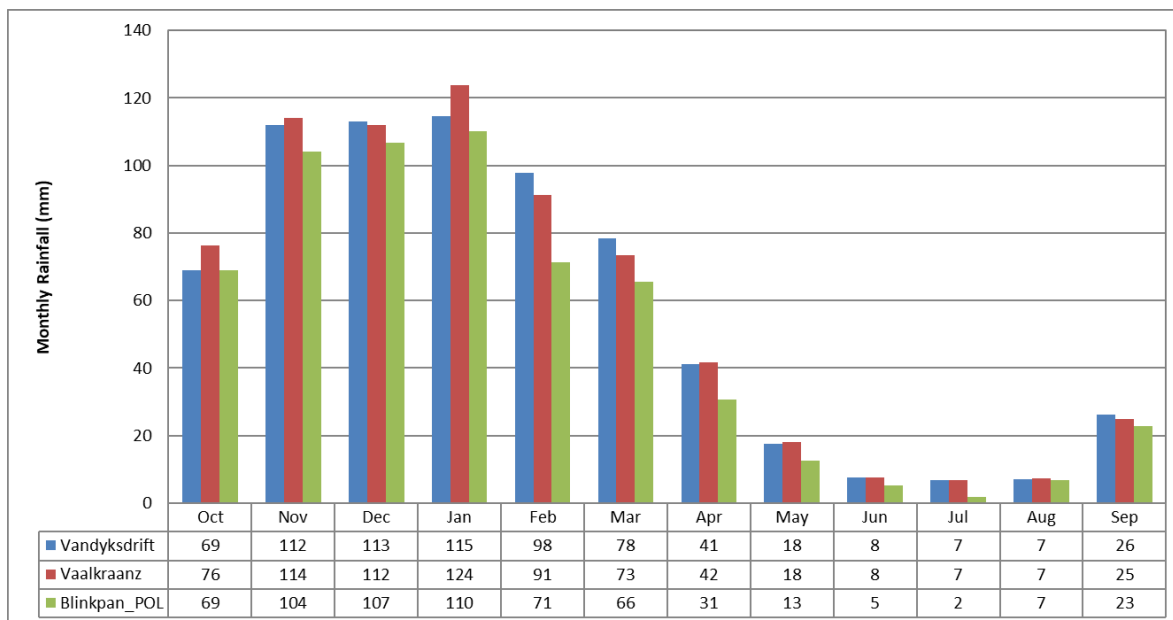
The average monthly plot was used to compare the rainfall records as shown in Figure 3. The rainfall records cover the same time periods, and the average monthly rainfall depths for the different stations have a similar pattern. During the wet season, the highest average rainfall was recorded in the month of January. The driest month on average was recorded in the month of July.

Figure 3: Average monthly rainfall for the stations

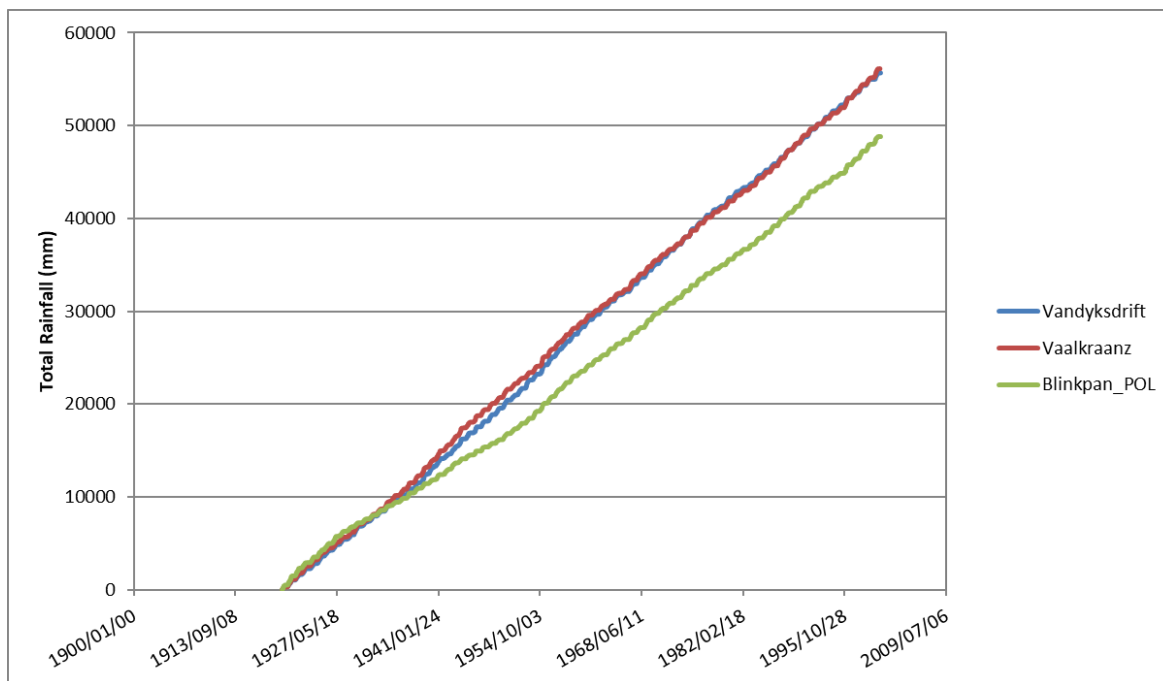
The Vandyksdrift, Vaalkraanz and Blinkpan (POL) rainfall stations show a similar increasing trend as observed in Figure 4. The trends are consistent throughout, with no significant changes in slope. Figure 4 shows the total cumulative rainfall over time.

Figure 4: Cumulative rainfall for the stations analyzed

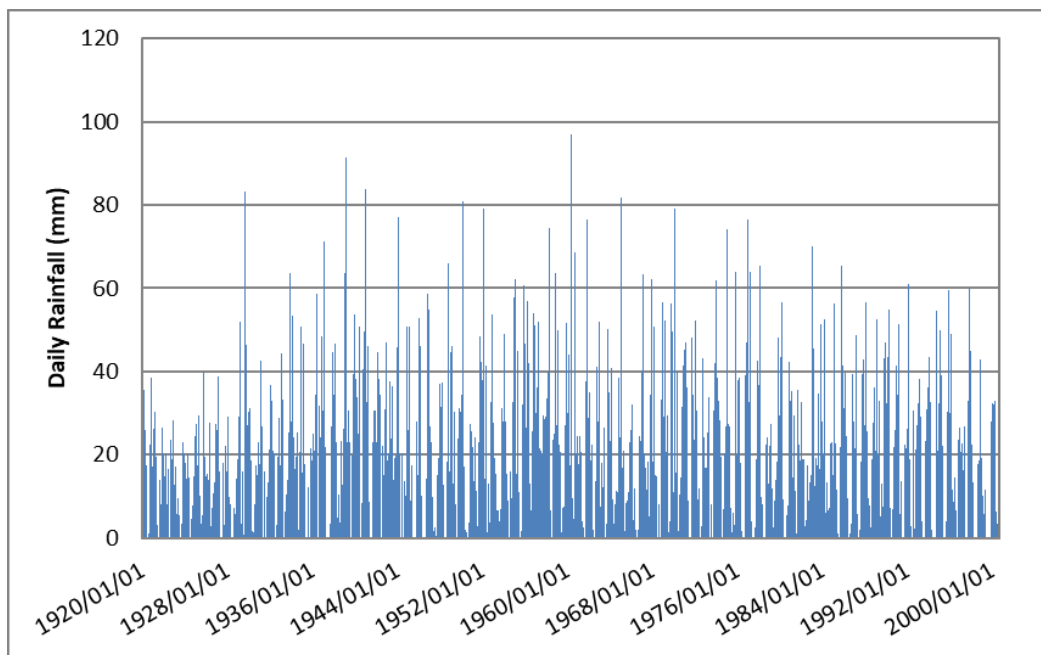
Vandyksdrift rainfall station is situated approximately 12 km from the site with 80-years of recorded data. It has the highest reliability (less patched data) of the analysed stations. The maximum recorded 24-hour rainfall depth is 97 mm, recorded on the 26th of April 1960, as shown in Figure 5. Figure 6 shows the annual rainfall depths. The mean annual precipitation for the station is 693 mm.

Figure 5: Vandyksdrift weather station daily rainfall

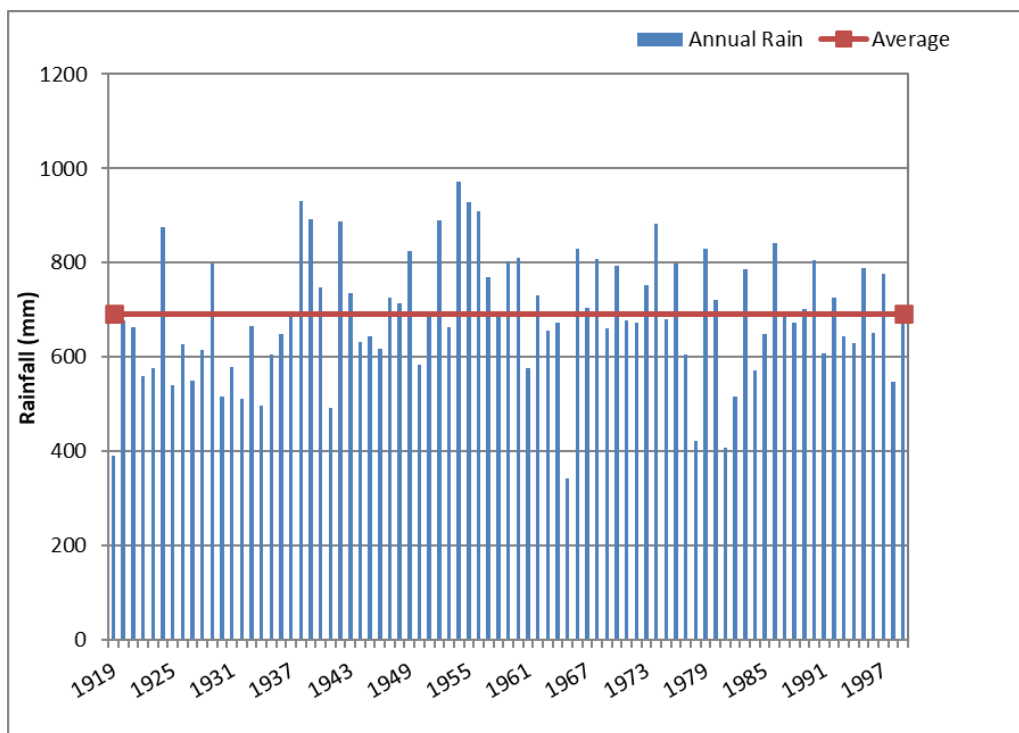
Figure 6: Vandyksdrift weather station annual rainfall readings and mean annual precipitation (MAP)

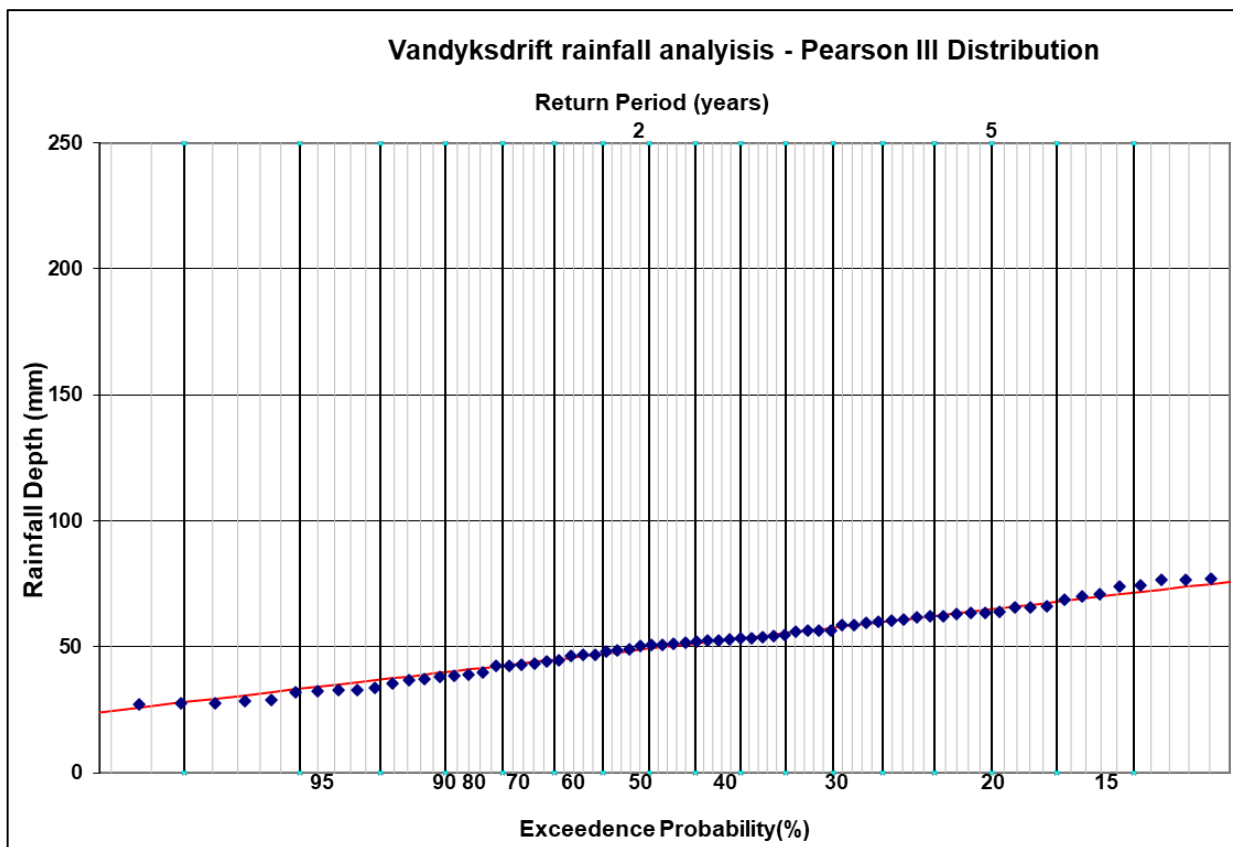
to be the Pearson III distribution (see Figure 5), this was used to estimate the 24-hour storm rainfall depths associated with the various recurrence intervals as summarised in Table 2.

Figure 5 : Vandyksdrift Pearson III distribution

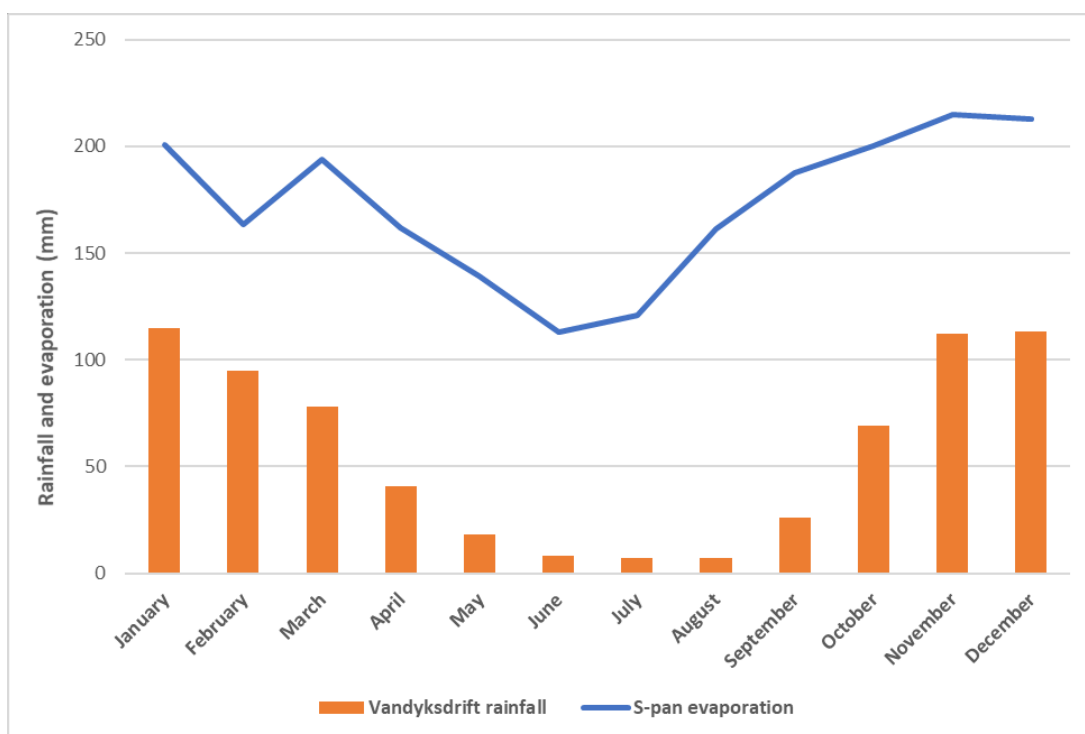
Figure 7: Rainfall and evaporation comparison

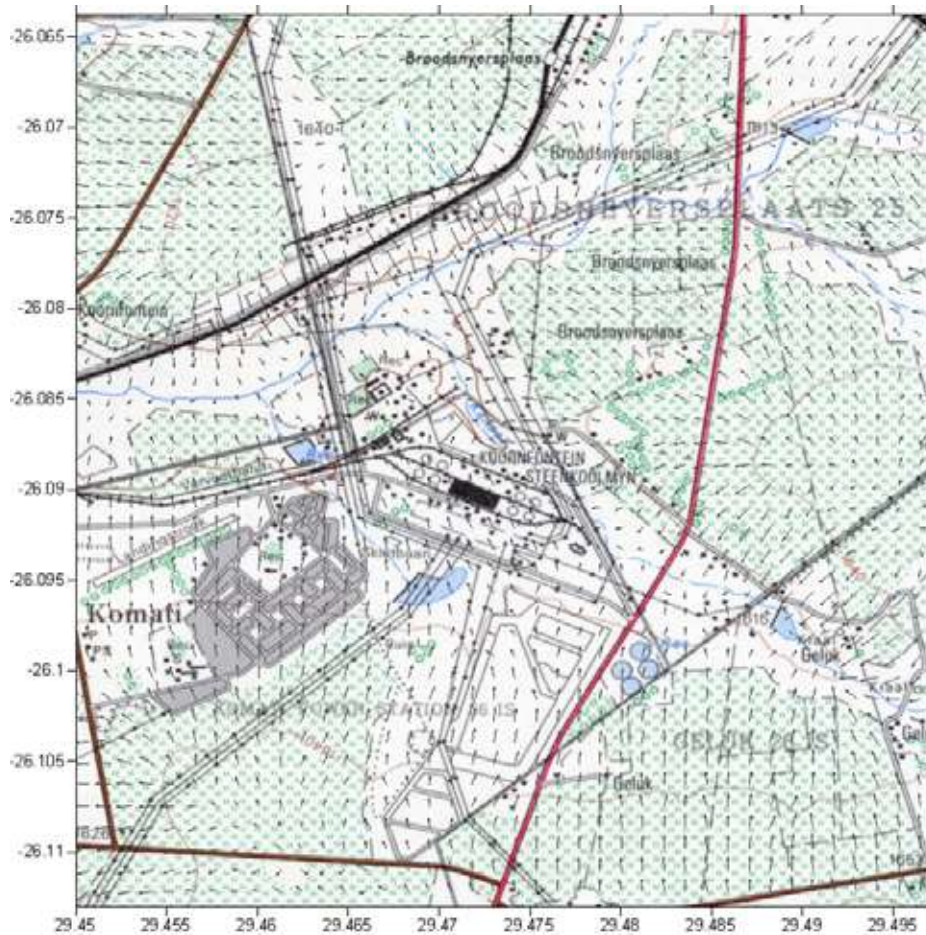
Figure 2. Surface drainage indicating flow directions

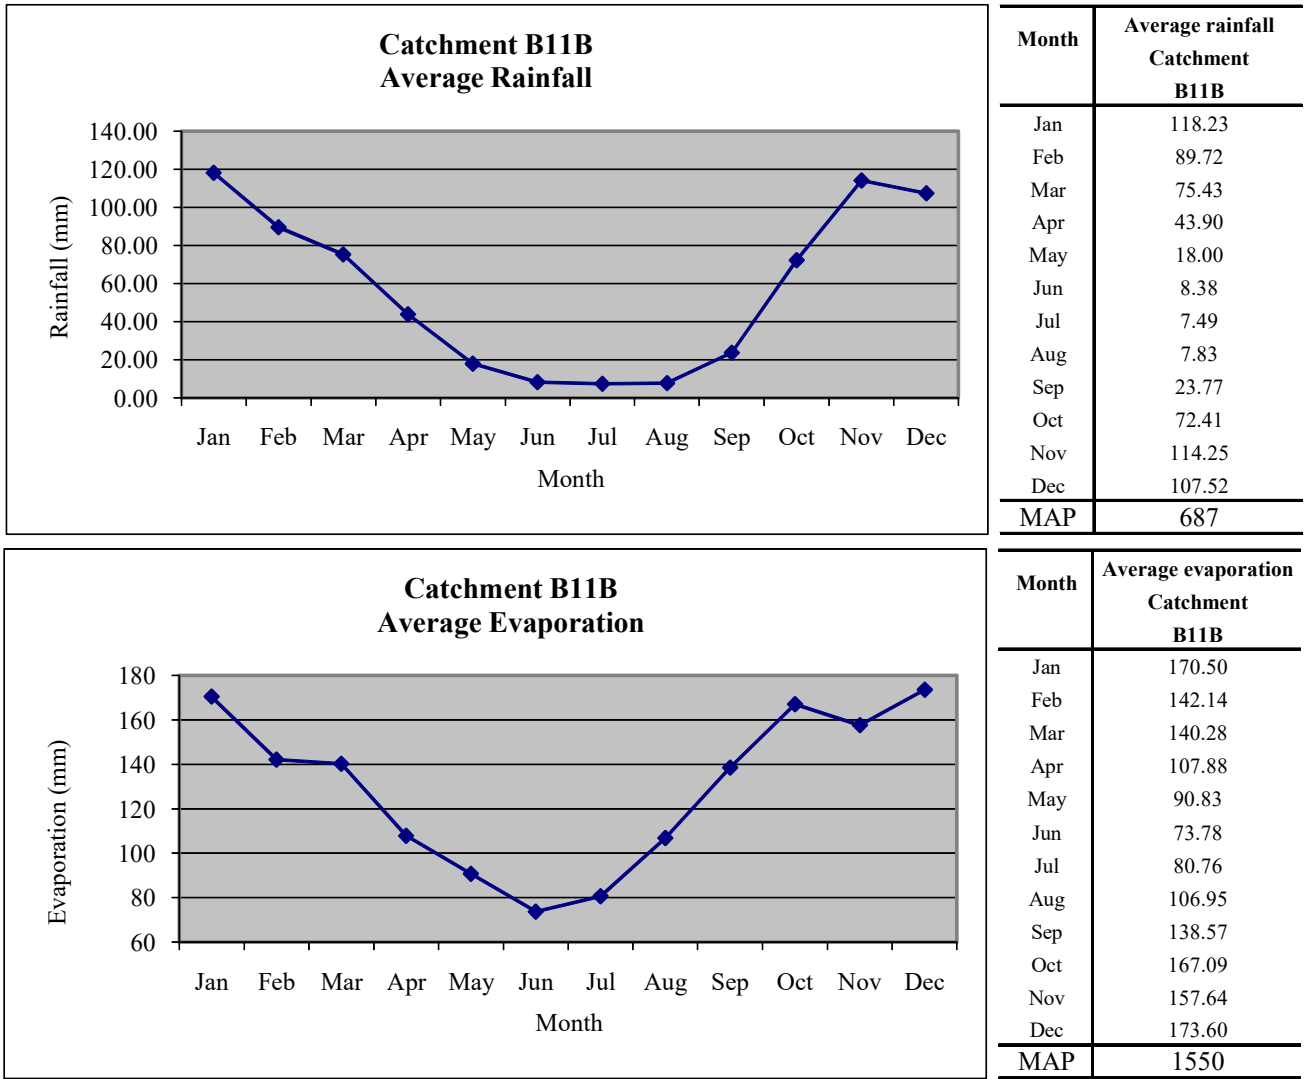
The average monthly rainfall and evaporation for catchment B11B is summarised and displayed graphically in Figure 3.

Figure 3. Average rainfall and evaporation for Quaternary sub-catchment B11B

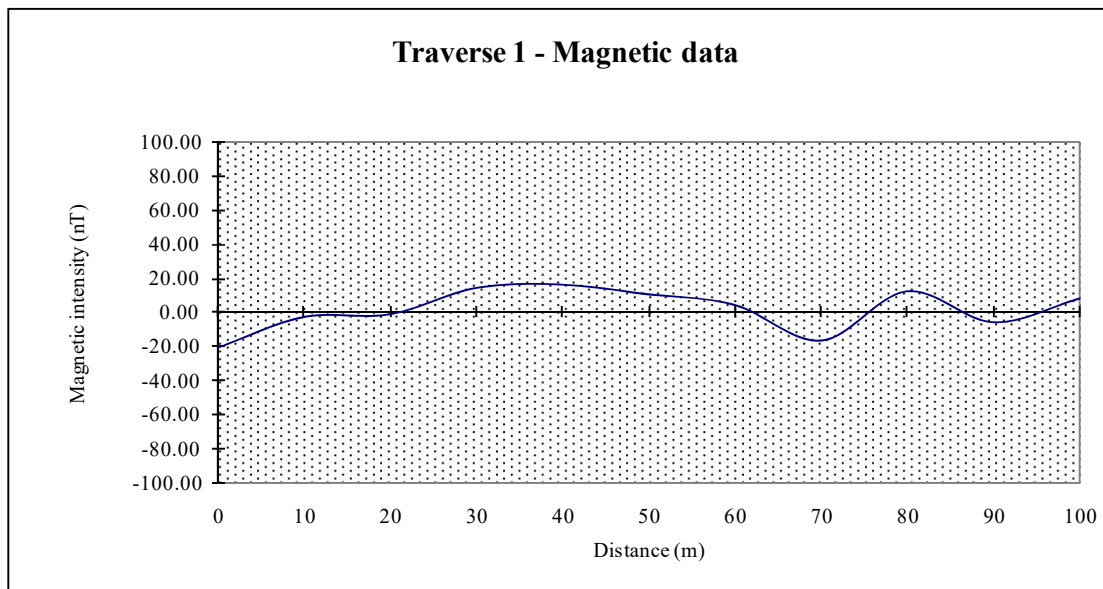
Figure 4. S-N magnetic profile of Traverse 1.

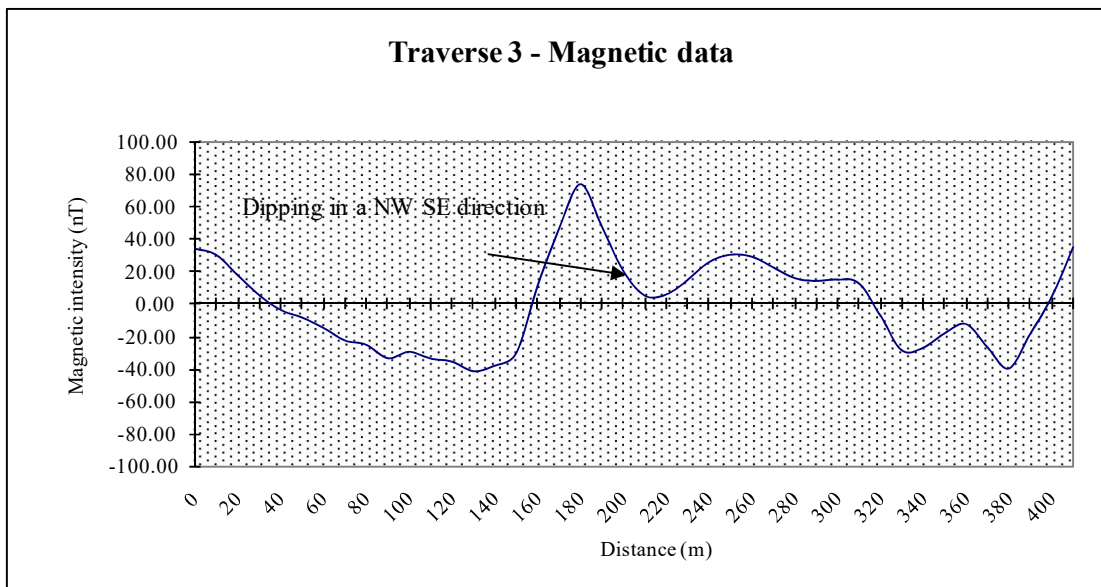
An anomaly was recorded on Traverse 3 indicating the possible presence of a dolerite sill with a dip in a northwest southeast direction.

Figure 6. SW-NE magnetic profile of Traverse 3.

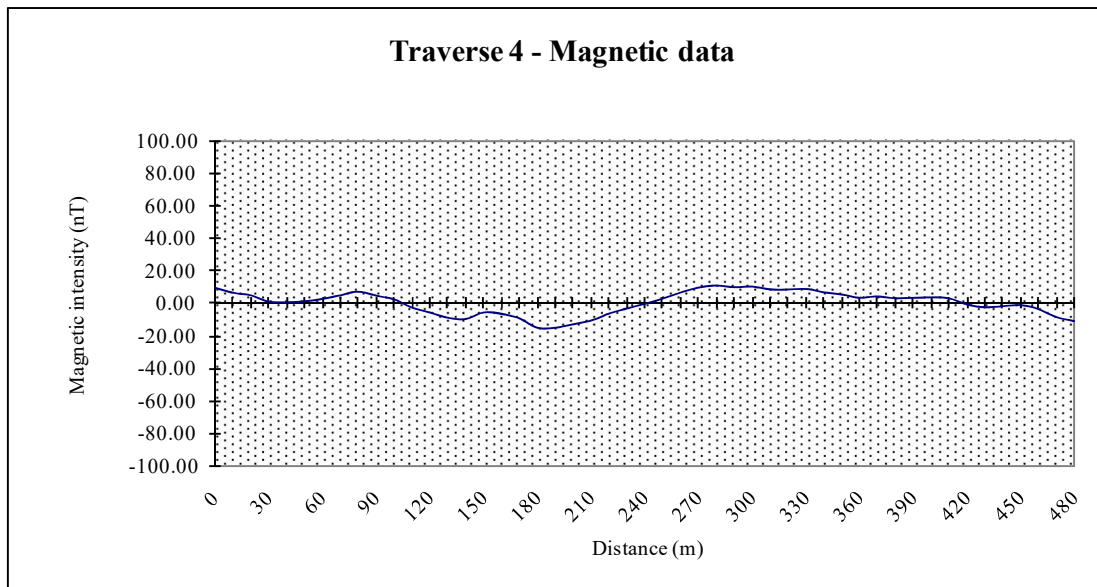
Data was recorded on one traverses south of the Ash Dam with an approximate west/east strike (Traverses 4). No magnetic anomalies of any significance were recorded on traverse 4.

Figure 7. W-E magnetic profile of Traverse 4.

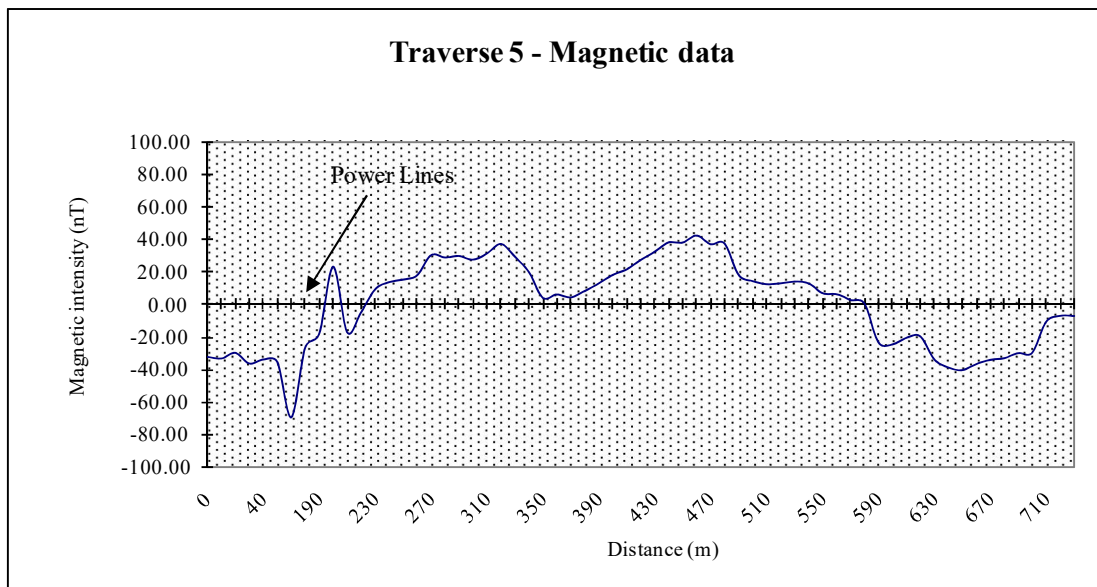
Anomalies were recorded on two of the traverses namely, Traverses 5 and 9. These anomalies are due to the presence of power lines. No magnetic anomalies of any significance were recorded on the other traverses on the eastern side of the Ash Dam.

Figure 8. SW-NE magnetic profile of Traverse 5.

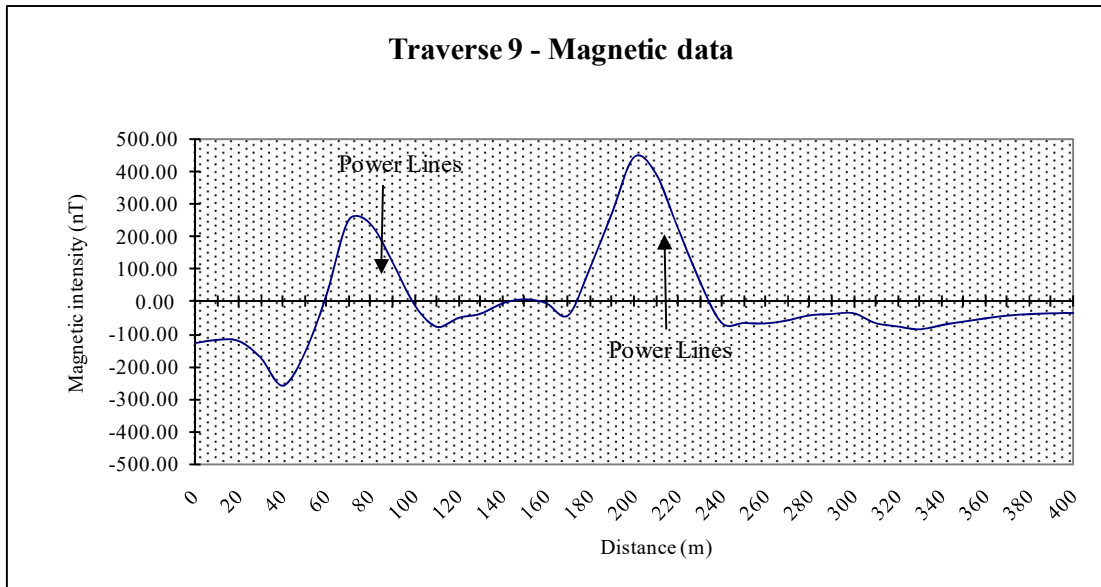
Figure 12. SE-NE magnetic profile of Traverse 9.

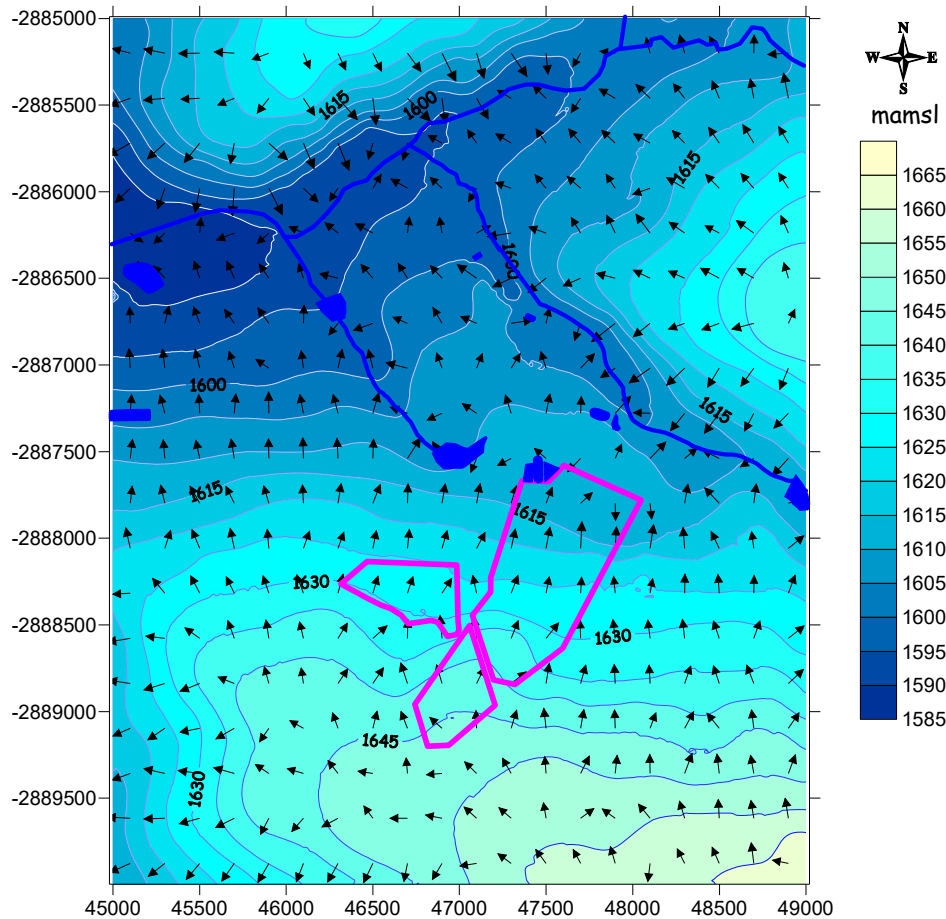
Figure 13. Simulated Pre-Operational Phase groundwater levels and flow directions (Bayesian Interpolation)

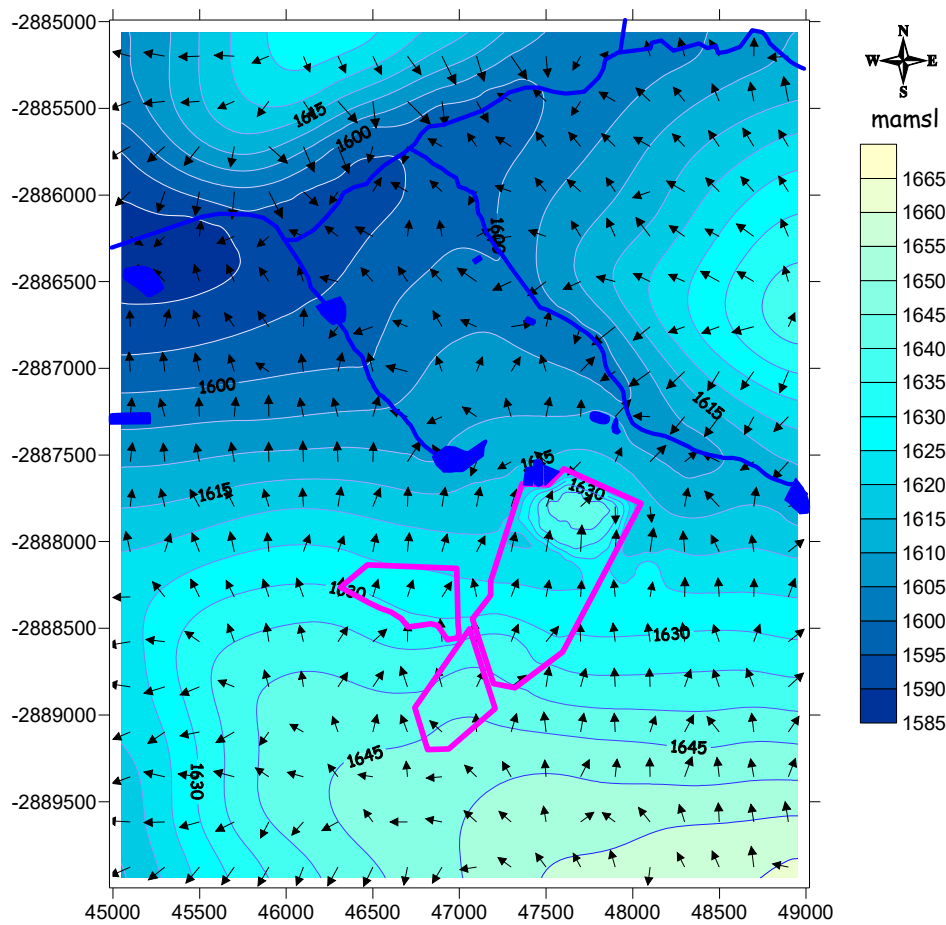
Figure 14. Simulated current (2008) groundwater levels and flow directions (Modelled Water Table)

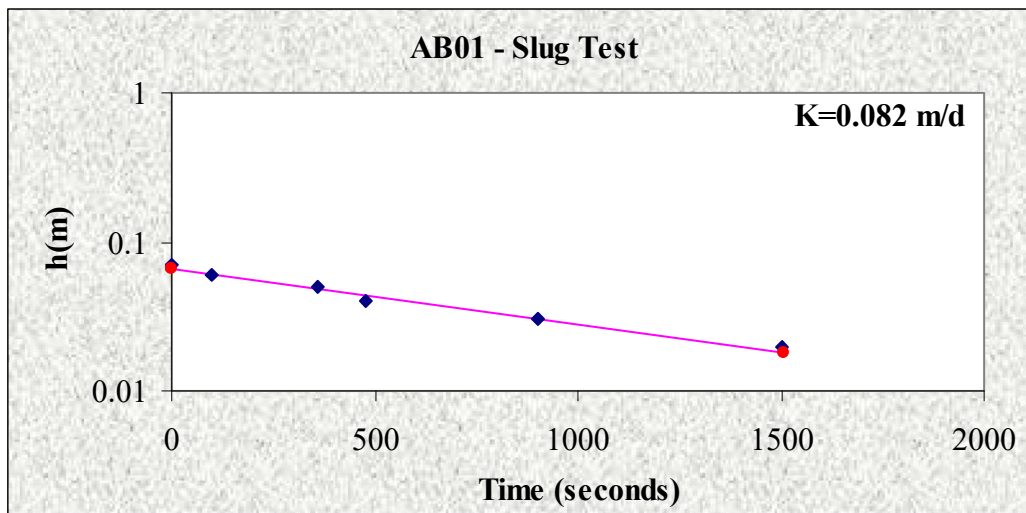
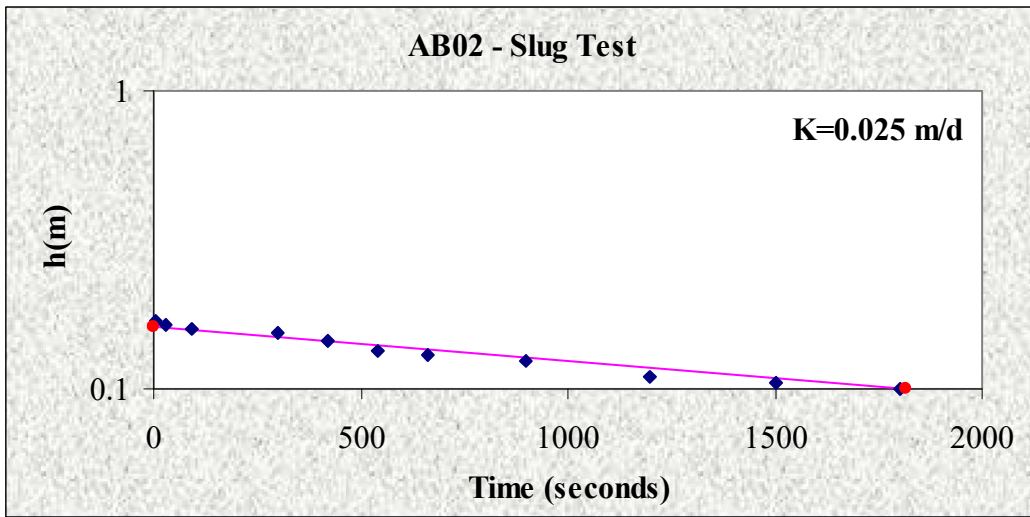
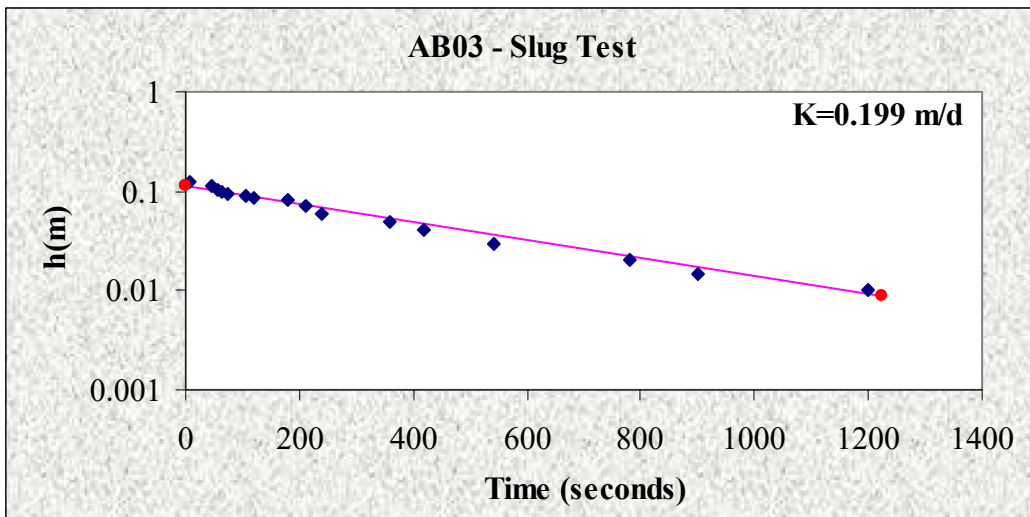
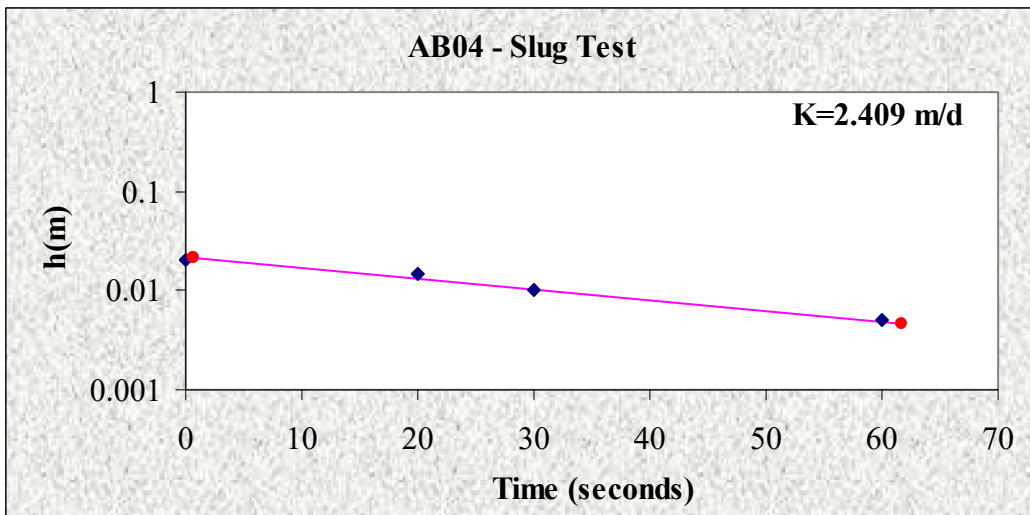
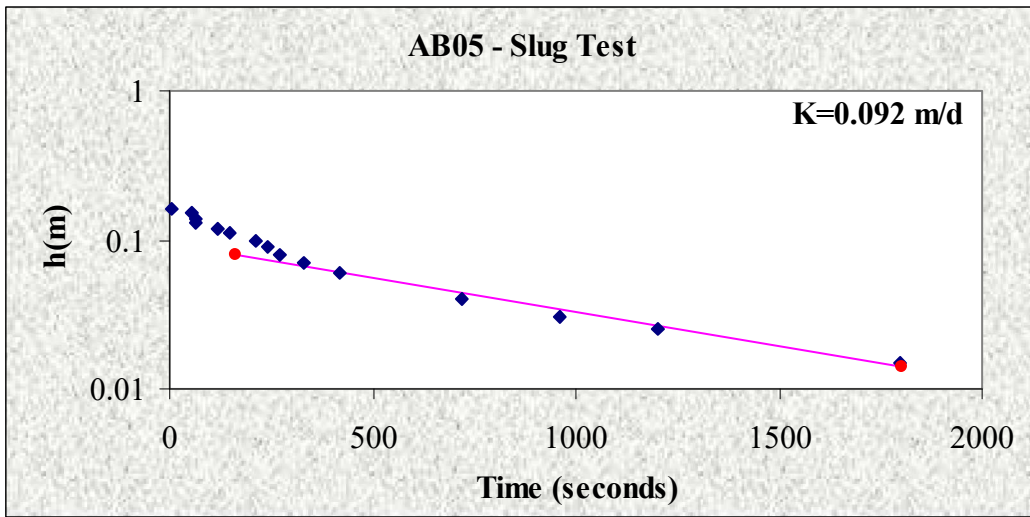
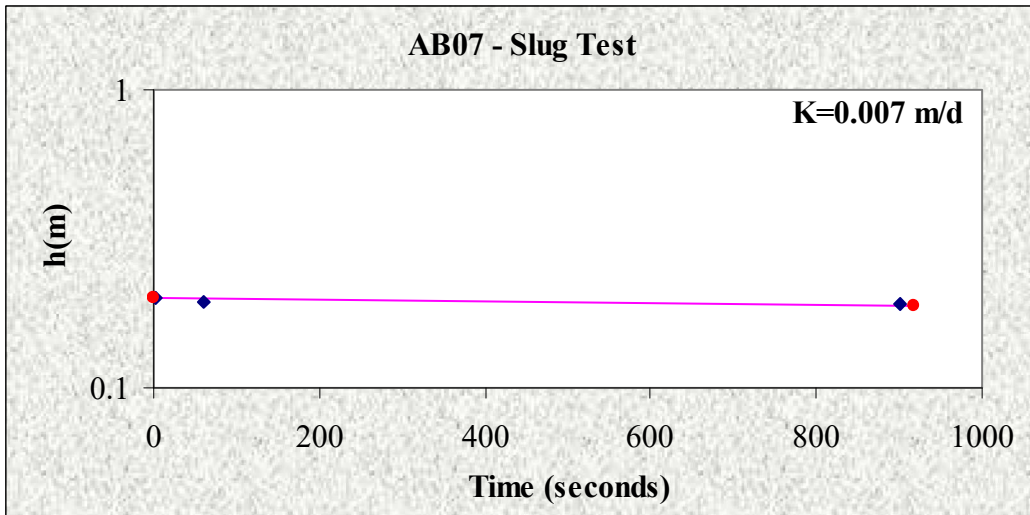
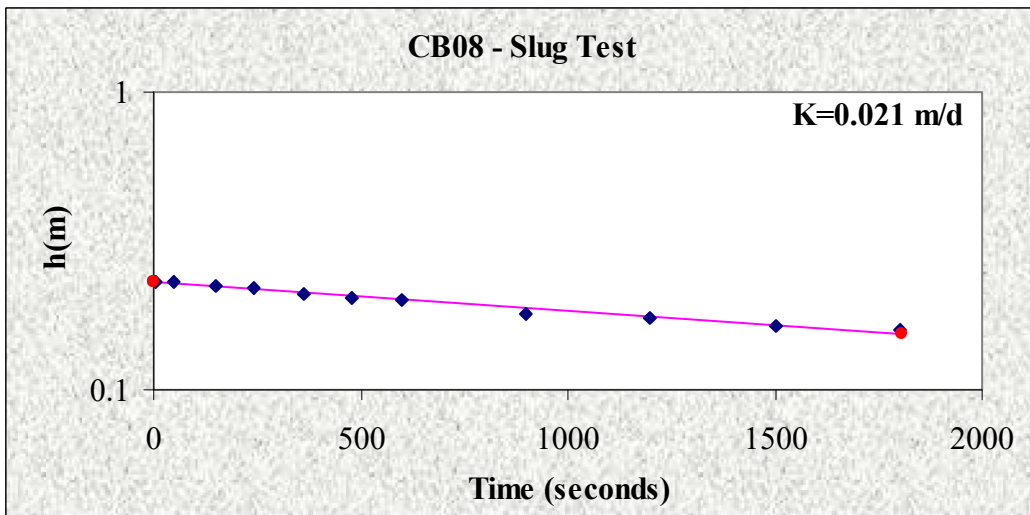
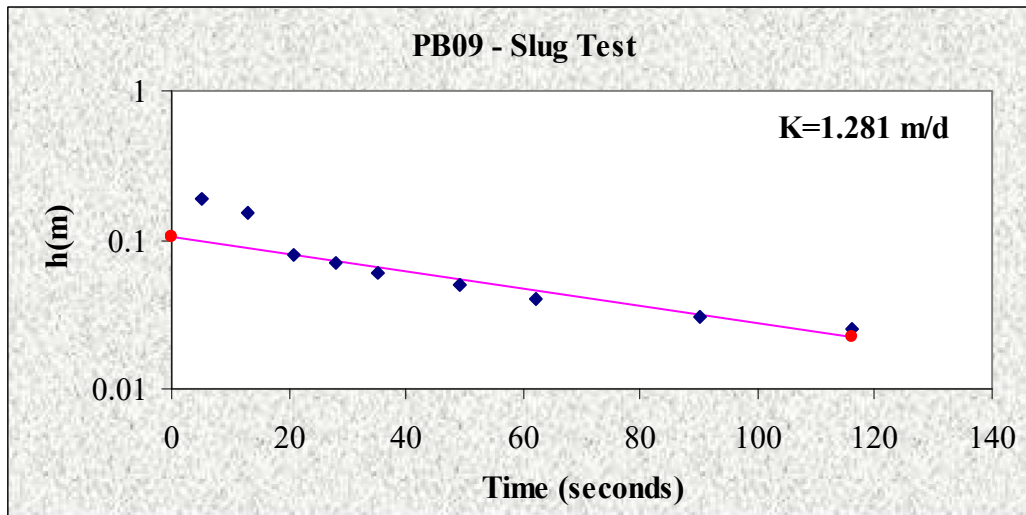
The Bouwer-Rice method was used to analyses the permeability tests performed on the Power Station boreholes. The results of the tests are presented in Figure 15 to Figure 22.

These observations suggest that the rocks on and in the vicinity of Komati Power Station generally have low permeabilities and hydraulic conductivities. The presence of preferential pathways, such as fractured zones, might be present in the region and may cause marked increases in the hydraulic conductivities. Migration of groundwater and/or contaminants can be expected to be high along such pathways. Permeability tests were not performed during this investigation on boreholes located on the neighbouring farms due to the presence of equipment in the boreholes.

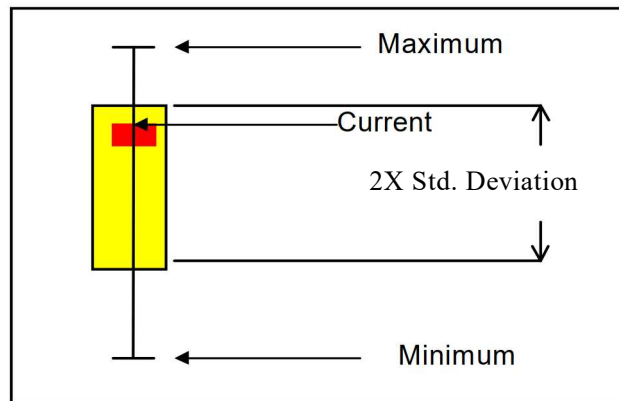
A diagram of an MMAC plot is shown in the Figure 23 and serves to explain the meaning of each element in the presentation. Instead of only an average value, twice the standard deviation, given as one value above and one value below the average is supplied. The standard deviation allows an idea of the usual range of values measured for the particular constituent at the particular site. A small standard deviation indicates a stable sample, while a large value represents a high variation in values. The maximum and minimum values ever recorded at the site are indicated in these plots by horizontal lines.

Figure 23. Maximum, Minimum, Average and Current Plot (MMAC)

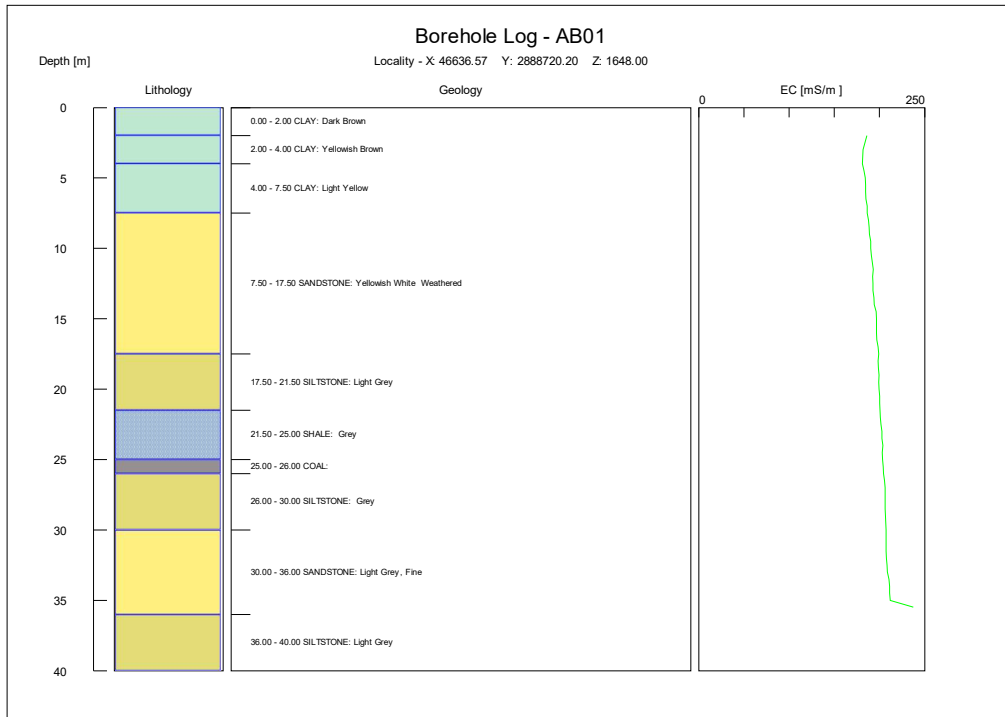
This borehole is currently sampled at a depth of 15 mbgl. The EC values remain within a very narrow range along the length of the borehole. No preferential pathways for groundwater migration and contaminant migration can be identified. It is recommended that sampling be continued at this depth.

Figure 24. Monitoring borehole AB01.

It should be noted that AB01 was drilled to a depth of 40 metres but has since silted up to a depth of around 35.5 metres.

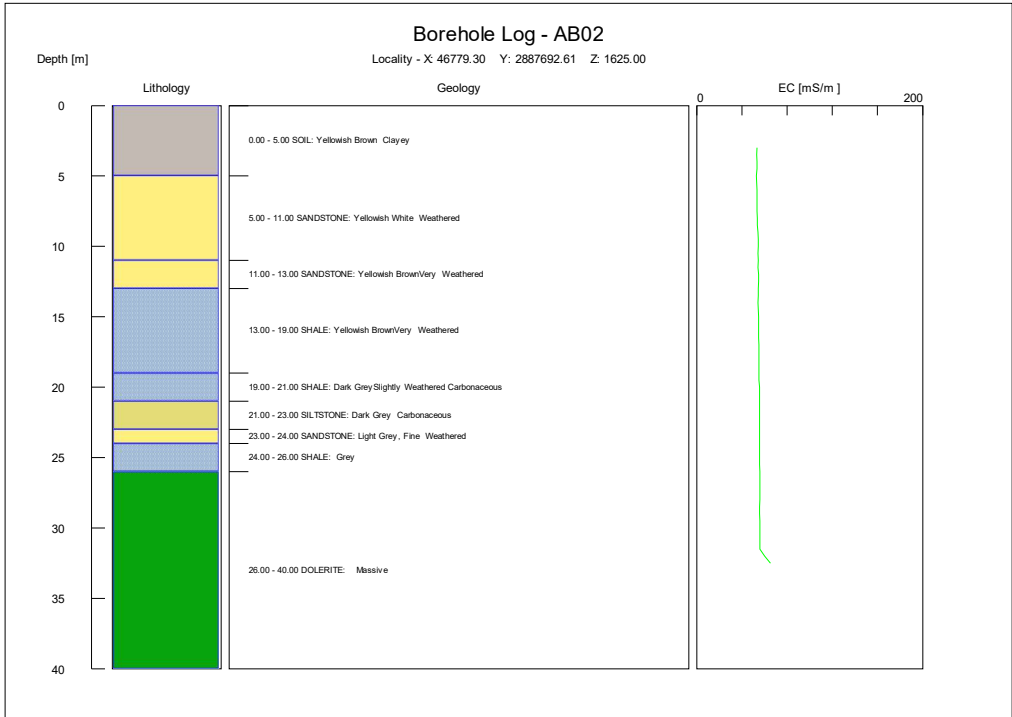
It should be noted that AB02 was drilled to a depth of 40 metres but has since silted up to a depth of around 32.5 metres.

Figure 25. Monitoring borehole AB02.
