STORMWATER MANAGEMENT PLAN FOR THE PROPOSED KOMATI SOLAR PV, BESS, AND ASSOCIATED INFRASTRUCTURE

PROJECT NO. 41103965

DATE: MAY 2023

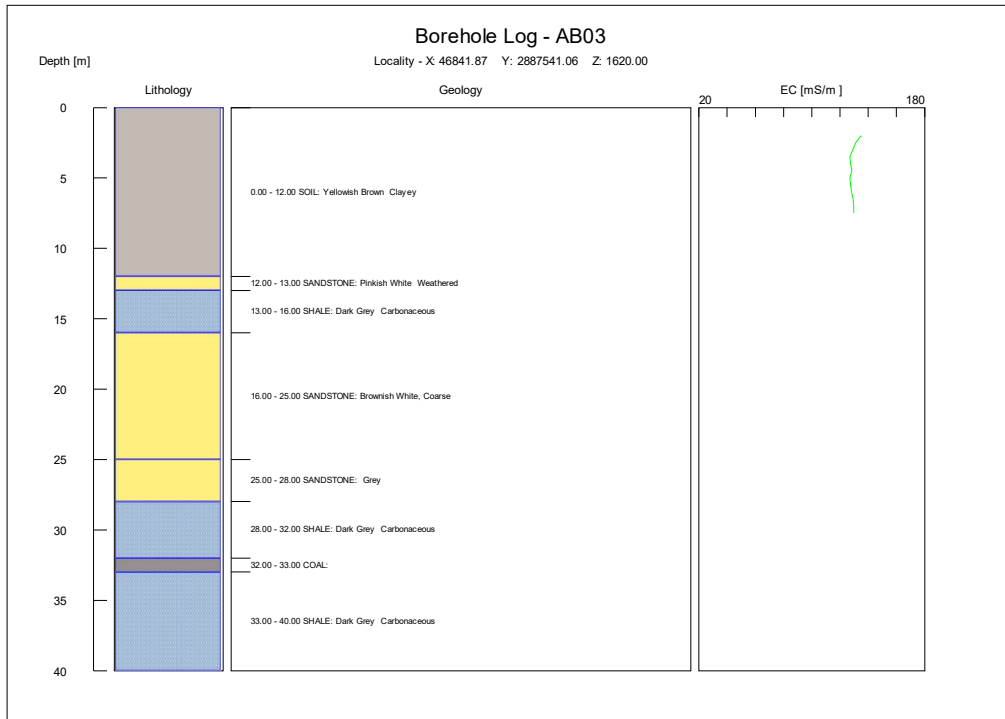
It should be noted that AB03 was drilled to a depth of 40 metres but has since collapsed or silted up to a depth of around 7.5 metres.

Figure 26. Monitoring borehole AB03.

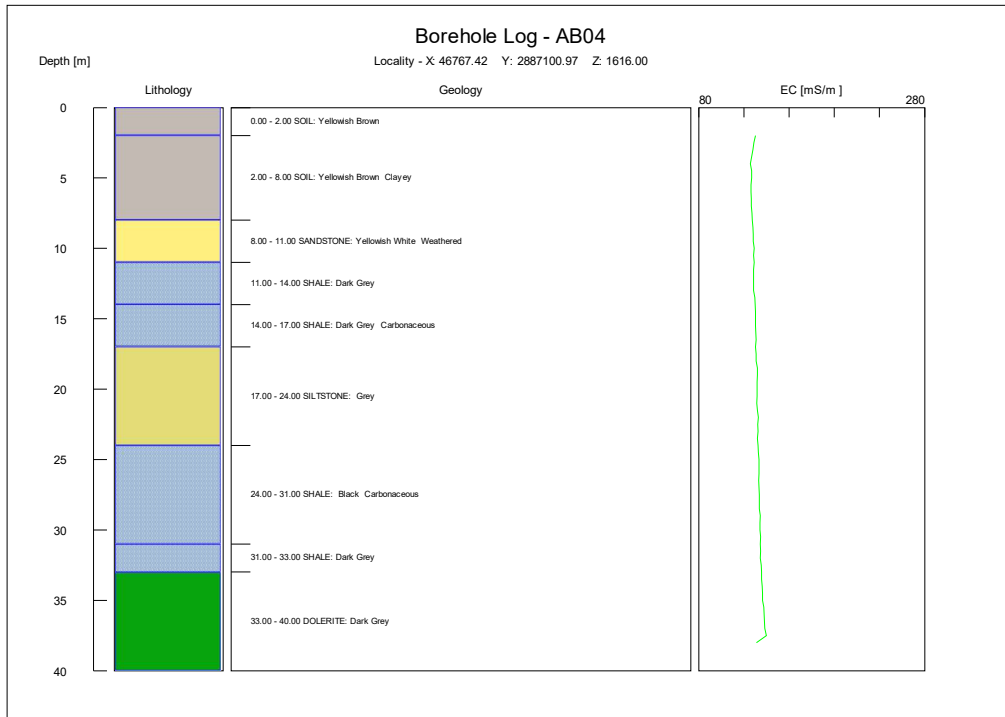
It should be noted that AB04 was drilled to a depth of 40 metres but has since silted up to a depth of around 38 metres.

Figure 27. Monitoring borehole AB04.

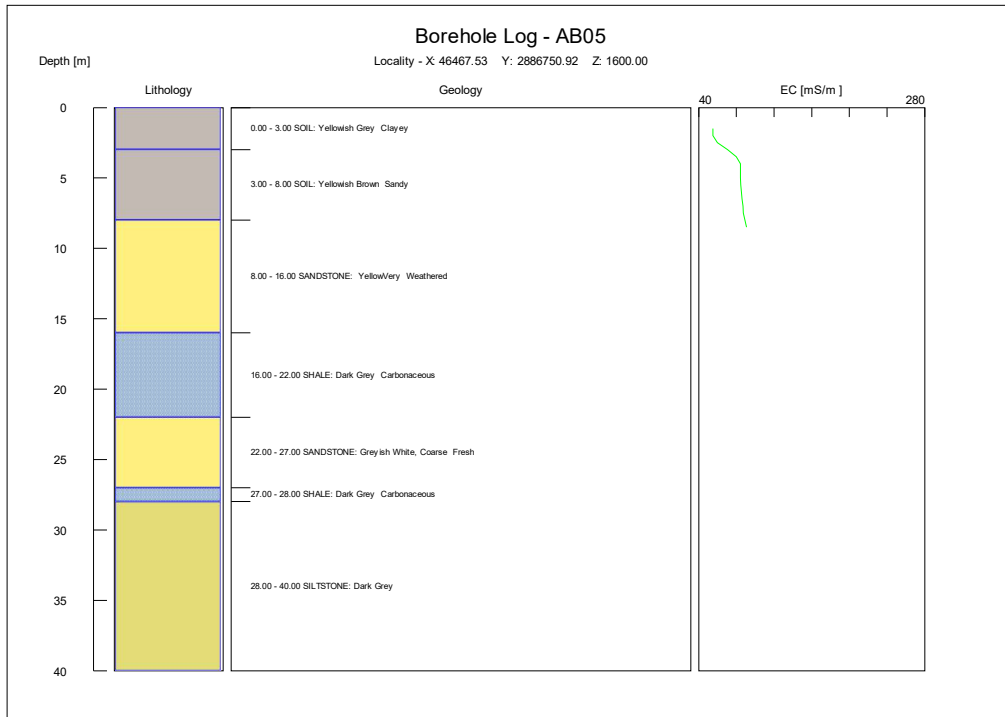
This borehole is currently sampled at a depth of 8.5 mbgl within a sandstone layer.

Figure 28. Monitoring borehole AB05.

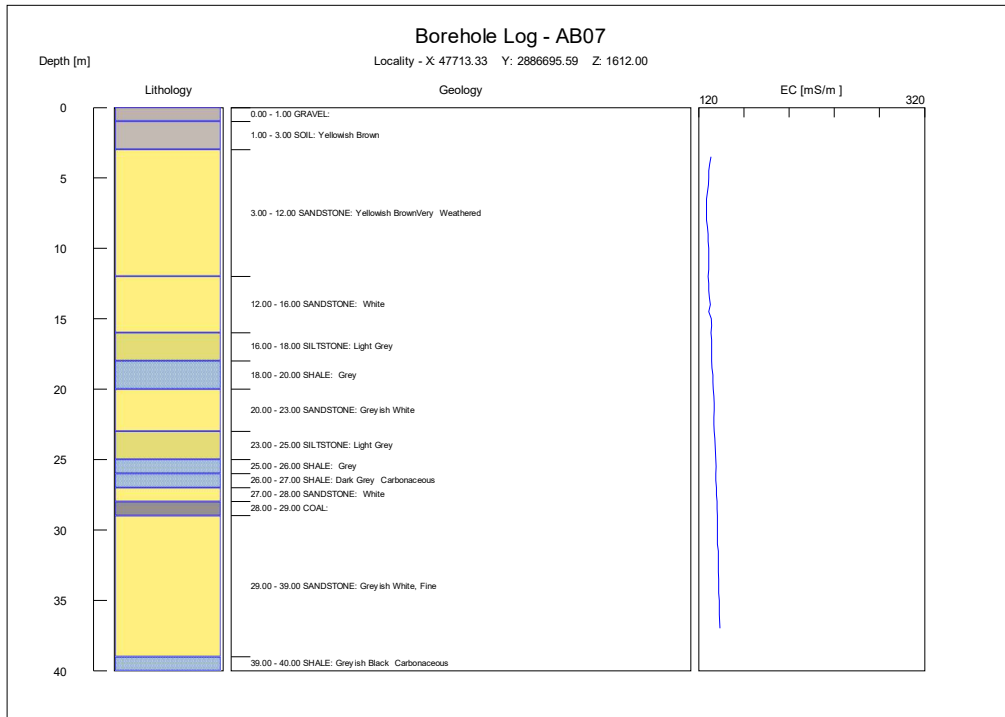
It should be noted that AB07 was drilled to a depth of 40 metres but has since silted up to a depth of around 37 metres.

Figure 29. Monitoring borehole AB07.
