**APPENDIX 1: W OG WRD GEOTECHNICAL INVESTIGATION REPORT**

**REPORT ON A GEOTECHNICAL INVESTIGATION  
FOR THE  
PROPOSED FAR WEST WASTE ROCK DUMP 2  
FOR THE THARISA MINE**

**SEPTEMBER 2021**

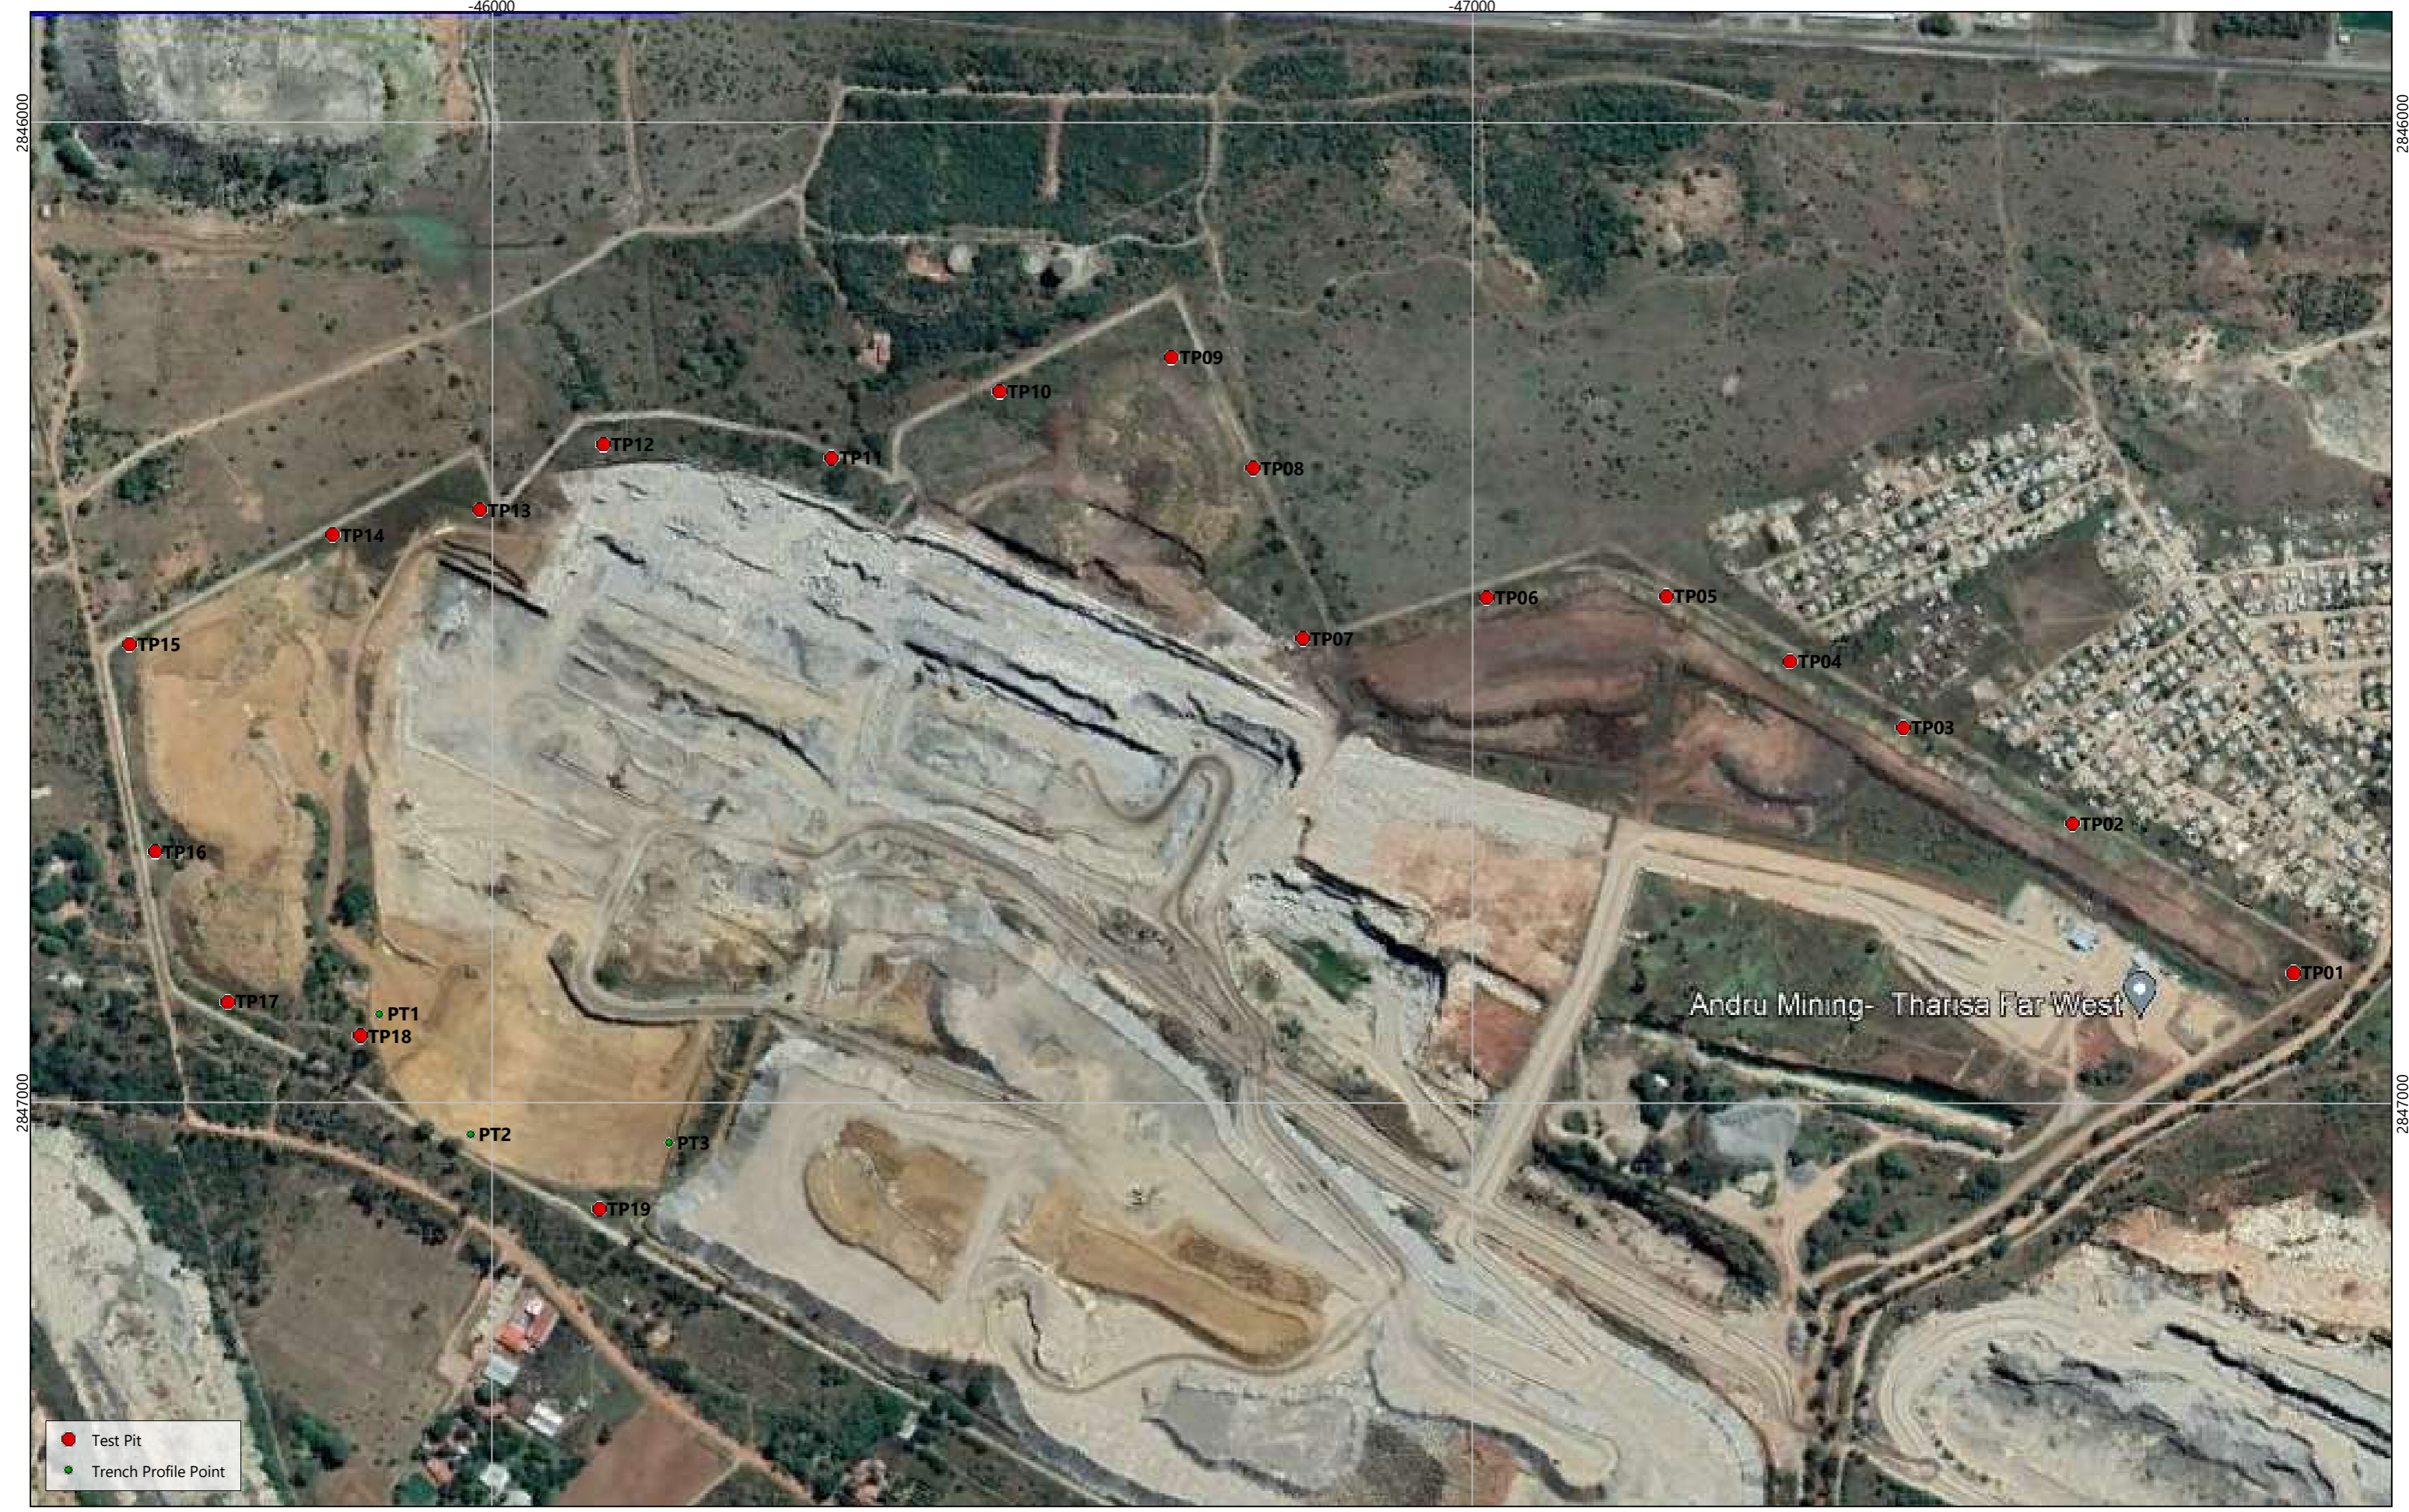
### SITE PLAN SHOWING POSITIONS OF TEST PITS

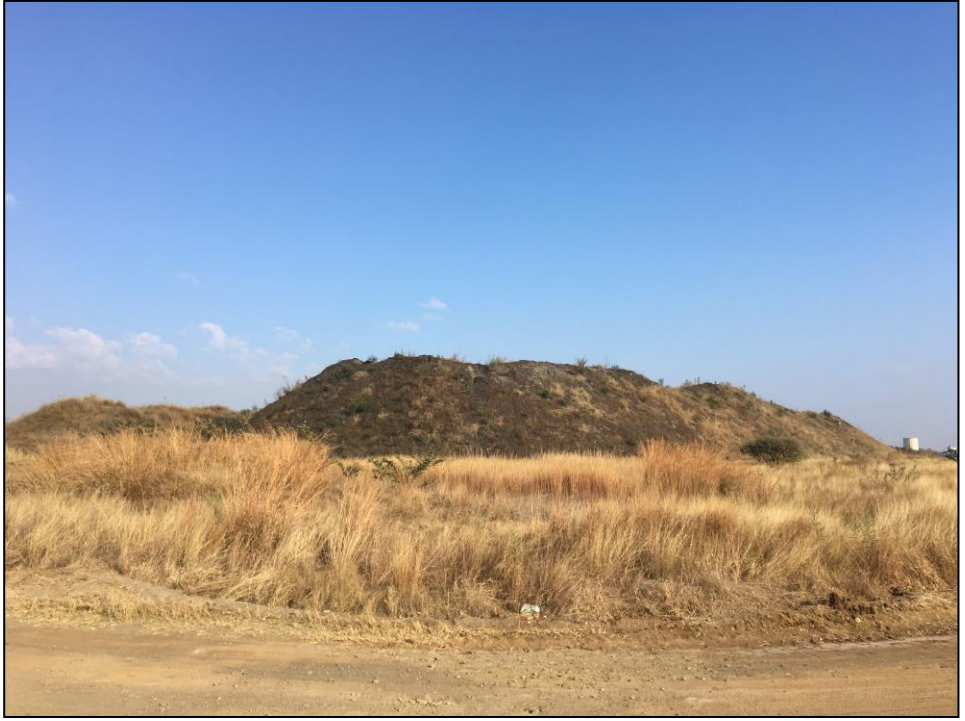
<b>PHOTOGRAPHIC RECORD</b>	
<b>SITE NAME: Tharisa FW WRD2</b>	
PHOTOGRAPH  <b>1</b>

<b>Comments: View of overburden/topsoil stockpile from near TP01 looking west</b>	
PHOTOGRAPH  <b>2</b>

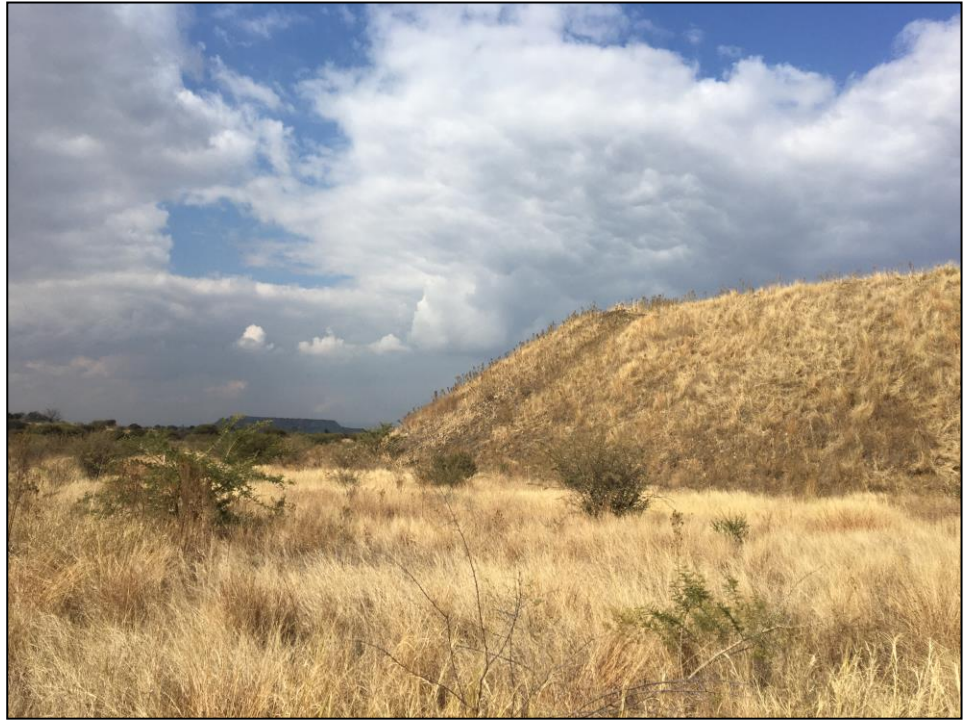
<b>Comments: View of overburden/topsoil stockpile in the vicinity of TP09 looking east</b>

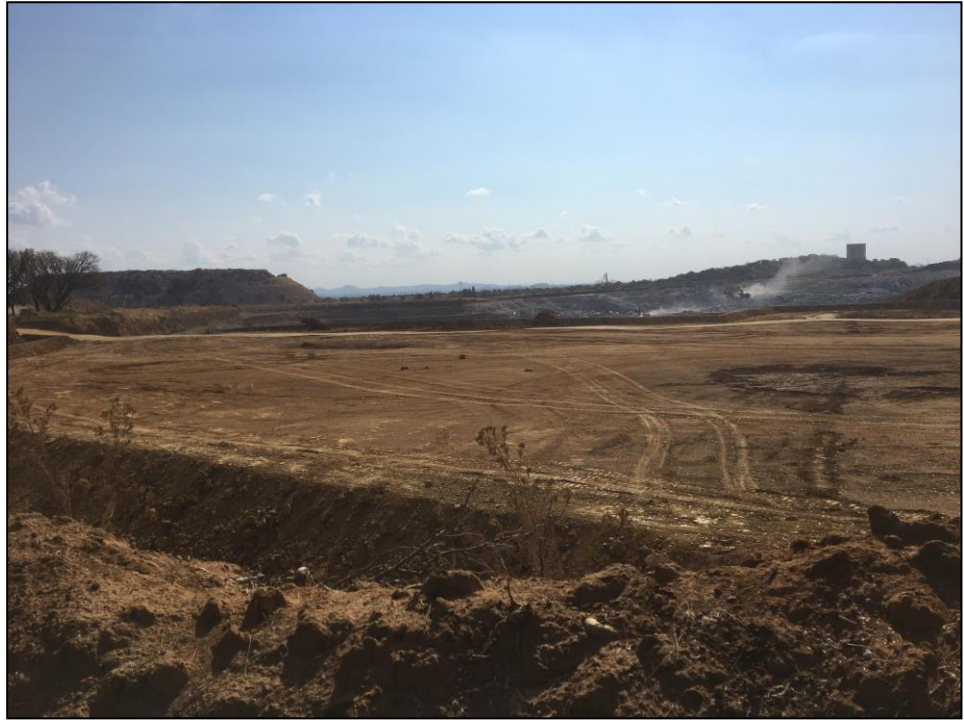
3

**Comments: View of mine pit from near PT2 looking north-west**

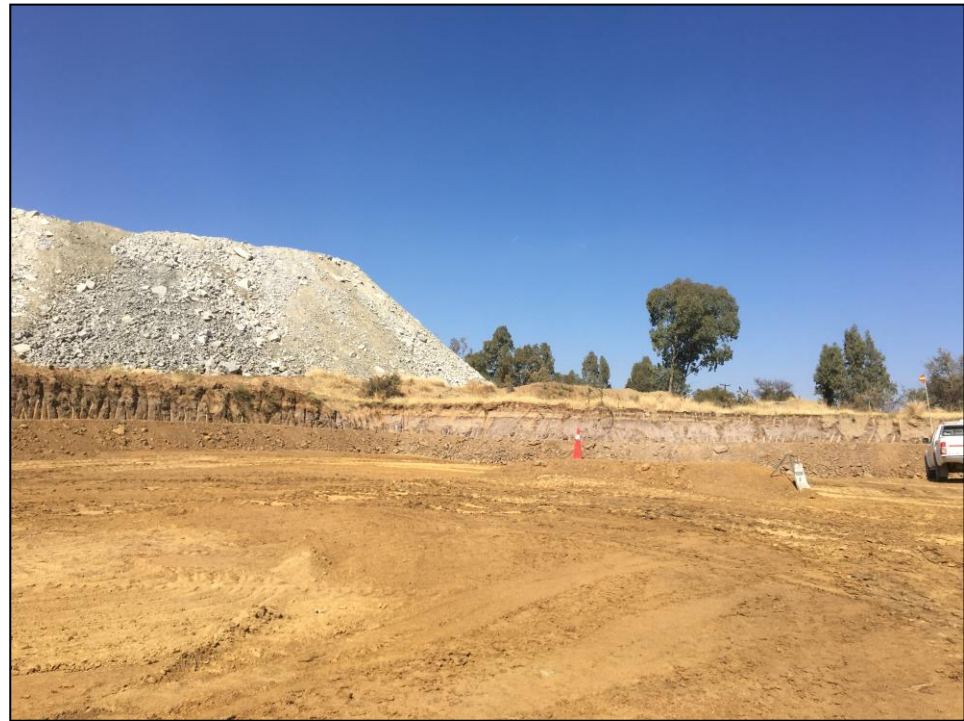
4

**Comments: View of excavation face near PT3 with waste rock dump in the background looking south-east**
