AQUATIC SITE SENSITIVITY VERIFICATION REPORT FOR THE PROPOSED NYALA SOLAR ENERGY FACILITY 3, NEAR NORTHAM, THABAZIMBI LOCAL MUNICIPALITY, LIMPOPO PROVINCE.

JUNE 2023

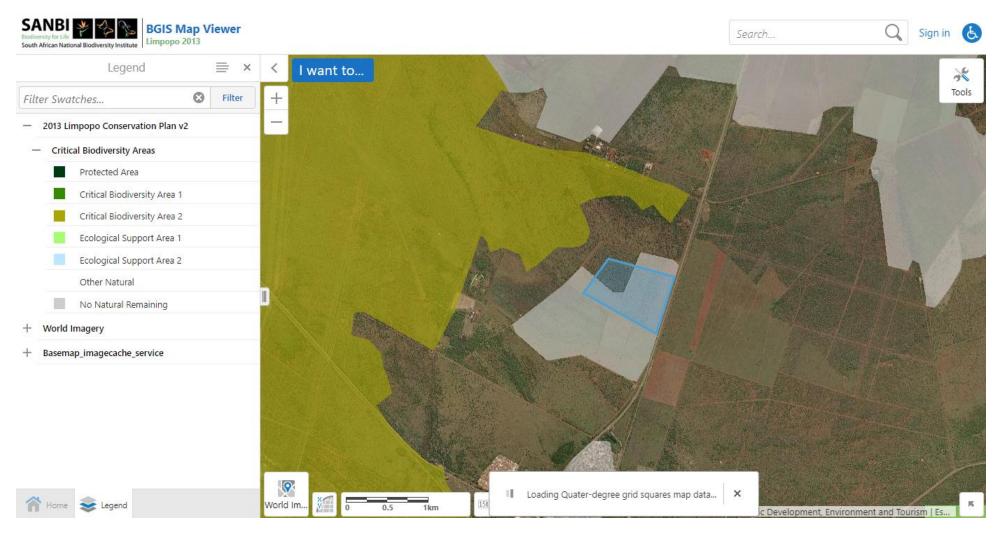
In the 2018 Limpopo Critical Biodiversity Areas mapping (Figure 7), a CBA2 is mapped along the Bierspruit to the west of the site. CBA2 sites (can be either terrestrial or aquatic) are more widespread or not threatened, with choices on where in the landscape targets for these features can be achieved. The proposed activities are also unlikely to impact the CBA landscape targets. Much of the site is mapped as still containing natural terrestrial areas and is addressed by the botanist for the project with no aquatic ecosystem concerns.

Figure 7. Limpopo Critical Biodiversity Areas map for the study site, where the blue polygon indicates the study boundaries (SANBI Biodiversity GIS, 2023)

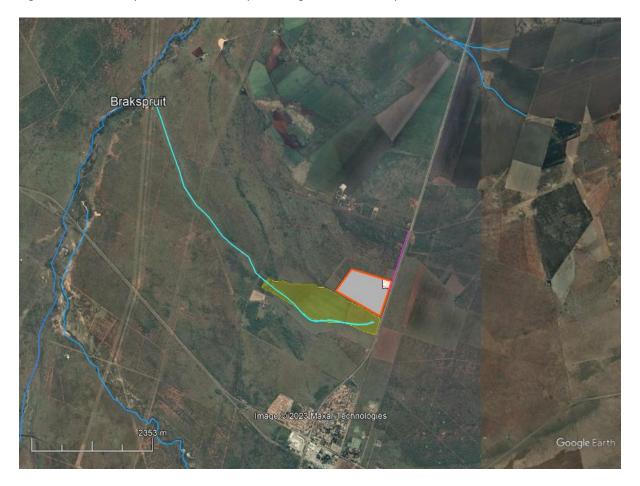
The initial desktop screening assessment undertaken by Flori Scientific Services in August 2022 indicated that no major watercourses or aquatic ecosystems were present in the general study area that would impact the project, with the potential exception of the 'wet' area to the south of the site. This assessment also confirmed that the National Wetland Map does not highlight/demarcate any major wetlands or watercourses in the study area. Figure 8 shows the aquatic constraints map resulting from the desktop assessment.

Figure 8. Google Earth image showing aquatic constraints mapped in the desktop assessment of the site with the yellow area indicating the potential wet area

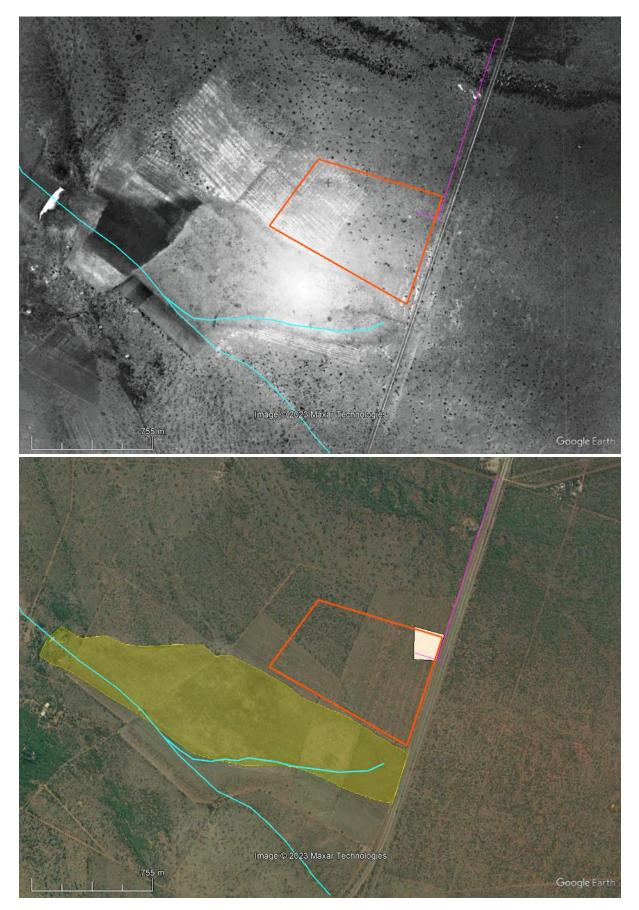
Past imagery of the site from 1948 and again in 2009 (Figure 9) indicates that there was definitely a minor drainage system with an associated unchanneled valley floor wetland present at the site. The wetland area has, however been targeted for cultivation even prior to 1948. During the site visit, no aquatic features of any significance were found within the proposed development site. There was however some indication of wetness visible in terms of the topography, soils and vegetation along the drainage feature and within the location of the valley bottom wetland. The drainage feature was however only marginal and not supportive of functional aquatic ecosystems. The area is visible on the aerial images as a wetland area is dominated by cultivated alien grasses and also did not display any distinctive wetland characteristics, having had a long history of modification. The soils however did comprise clay that is seasonally wet, indicating the presence of wetland habitat within this area. There were also areas where there was visible wetness within the site, but these were confirmed to be associated with the water supply infrastructure on the site.

Figure 9. Aerial image of the sites taken in 1948 (top) and a more recent Google Earth image from April 2009 (bottom)

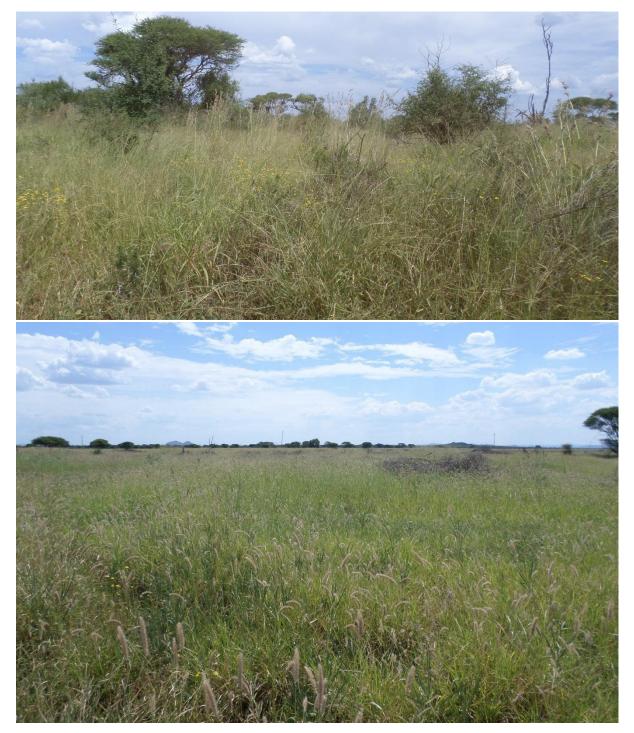
Figure 10. View of the area where there is a small drainage line south of the site where the wet area occurs (bottom)

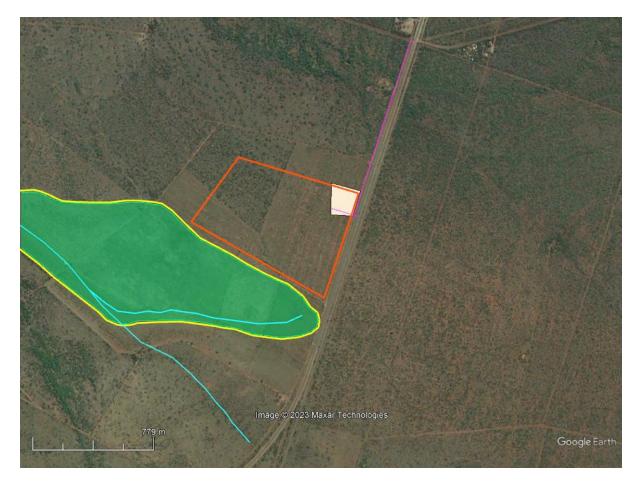
The aquatic constraints and sensitivity mapping are shown in Figures 11 and 12. In the aquatic sensitivity mapping, the only aquatic feature of any significance in the greater that is recommended to be avoided is the valley bottom wetland to the south of the site. the drainage feature within Site 1 is not deemed significant enough to comprise an aquatic constraint. It is recommended that a 10m buffer or setback area be provided for in the proposed layout for this site.

Figure 11. Mapped aquatic features within the project area (green polygon indicates the wetland area, with the blue line indicating the drainage feature that lies within the wetland), shown in Google Earth

Site management measures such as fire breaks and access roads could potentially be placed within the buffer but not in any of the proposed facilities. It is also recommended that, as mitigation, the wetland be allowed to return to a more natural state as part of the proposed development of the site, rather than the regular cultivation of this area.

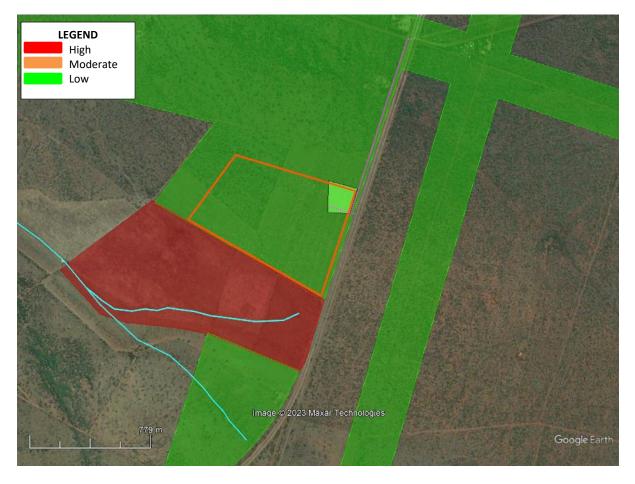
Figure 12. Mapped sensitivity of aquatic features within the project area, shown in Google Earth.

By implementing suitable buffers (10m) adjacent to the wetland and minimising the disturbance within the wetland, the impact of the proposed project activities would be low and unlikely to impact the integrity of the aquatic ecosystems. The recommended buffers are deemed adequate, irrespective of the proposed infrastructure. There is thus unlikely to be any potential aquatic ecosystem impacts associated with the proposed Nyala Solar Energy Facility 3 and this assessment largely concurs with the Screening Tool Mapping for Aquatic Combined Sensitivity except for the degraded wetland area adjacent to the site that is considered of high sensitivity.
