**AQUATIC SITE SENSITIVITY VERIFICATION REPORT FOR THE  
PROPOSED NDAU 1 SOLAR ENERGY FARM, NEAR POLOKWANE,  
IN THE LIMPOPO PROVINCE.**

JUNE 2023

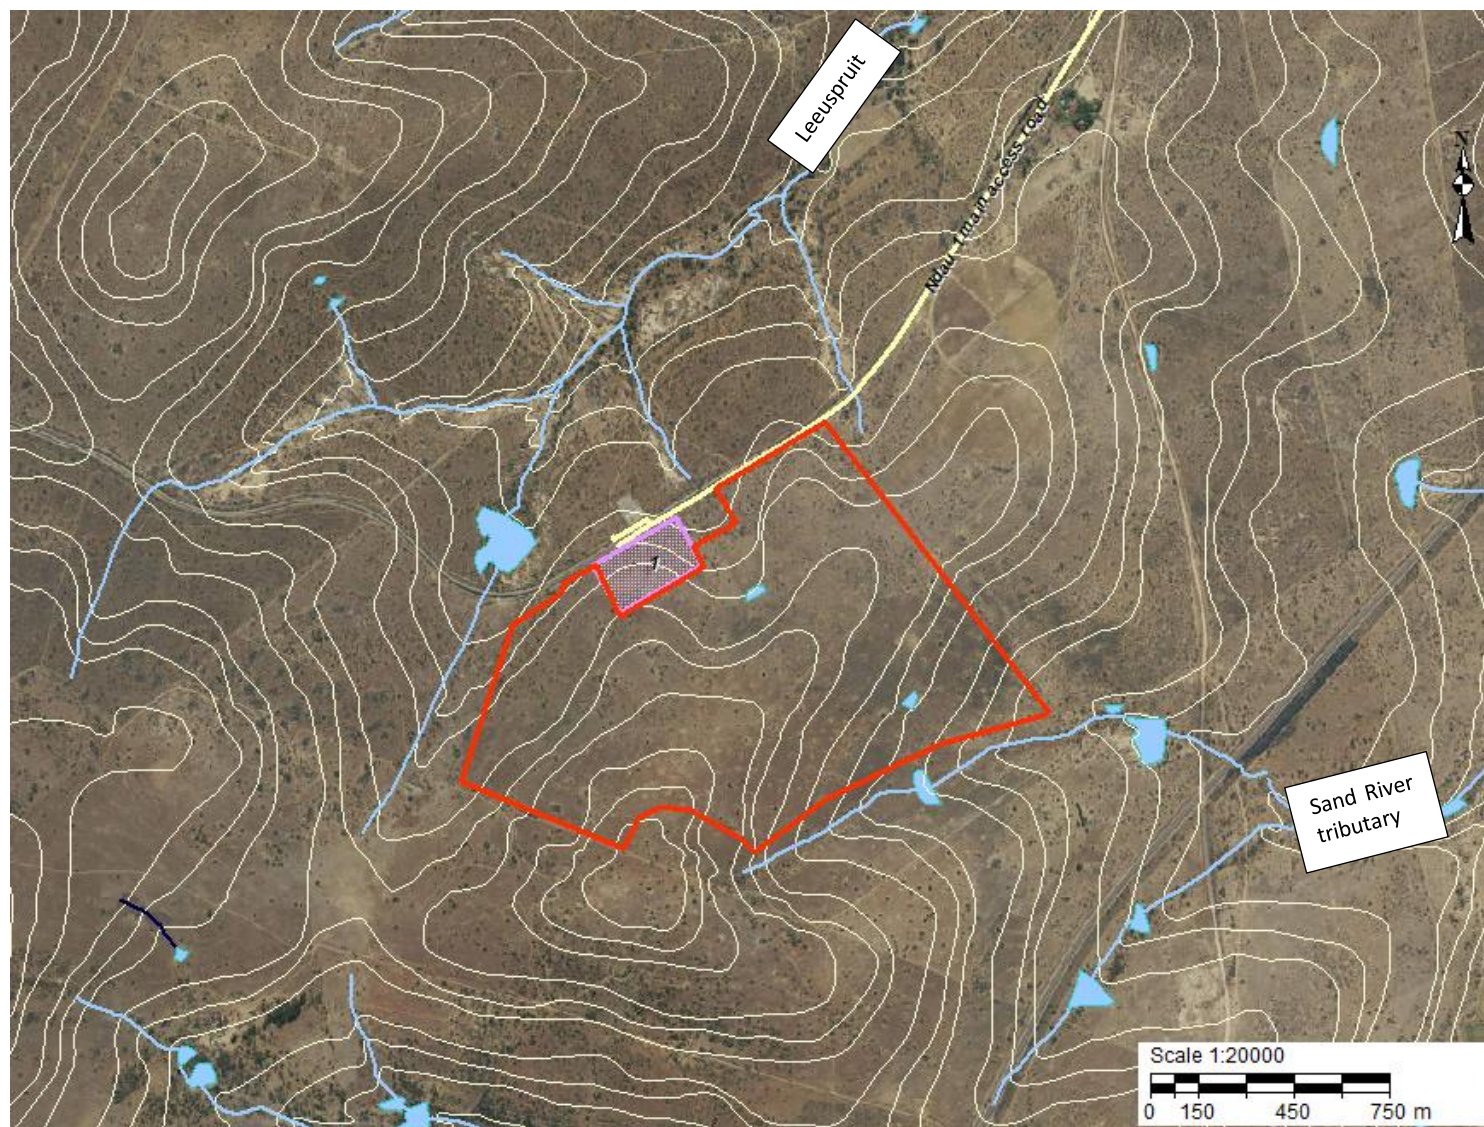
Figure 4. Rivers map for study site (red polygon represents the study boundaries) overlaid on a 2018 Orthophotograph of the area

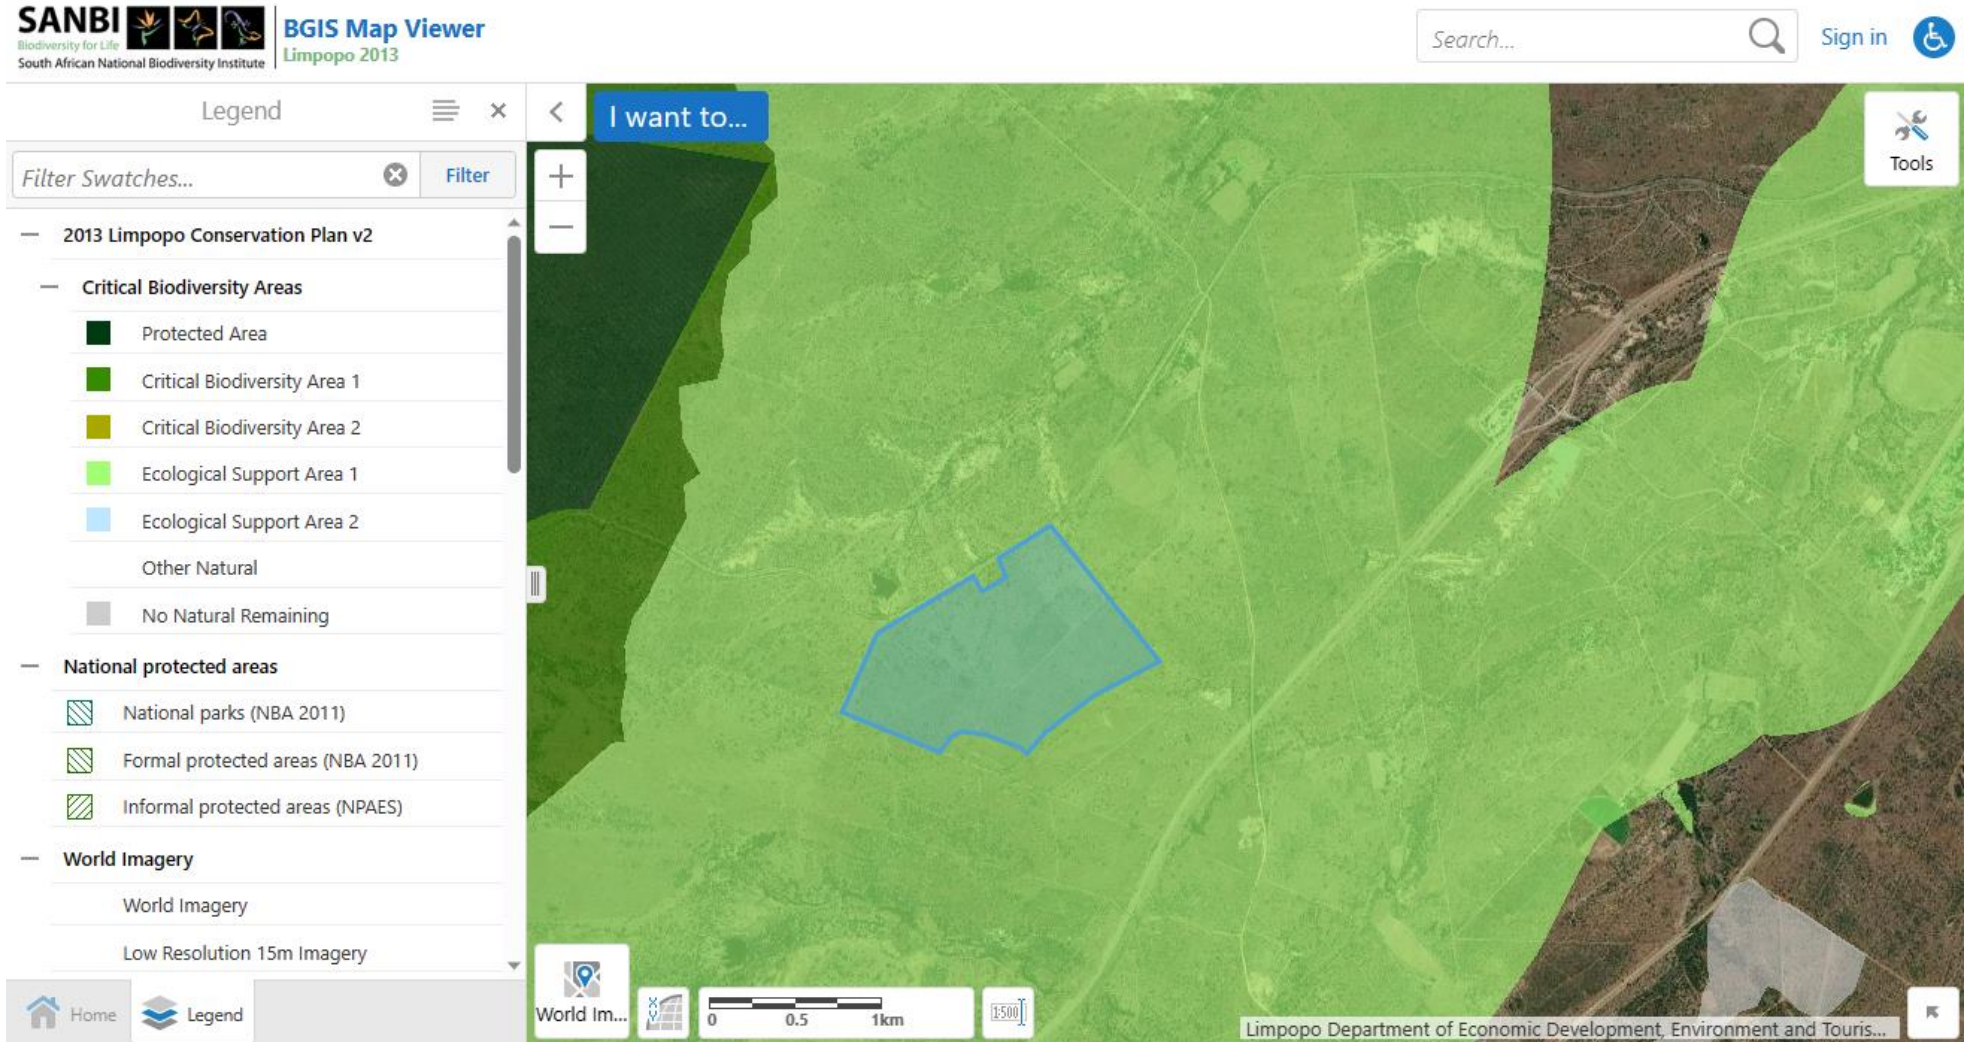
Figure 7. Limpopo Critical Biodiversity Areas map for the study site, where the red polygon indicates the study boundaries (SANBI Biodiversity GIS, 2023)

In the 2018 Limpopo Critical Biodiversity Areas mapping (Figure 7), the site is mapped as an ESA where it would be important to maintain ecological services in support of the adjacent CBA area. It would be important to maintain the river corridors and ensure no downstream impacts on the large Sand River system.

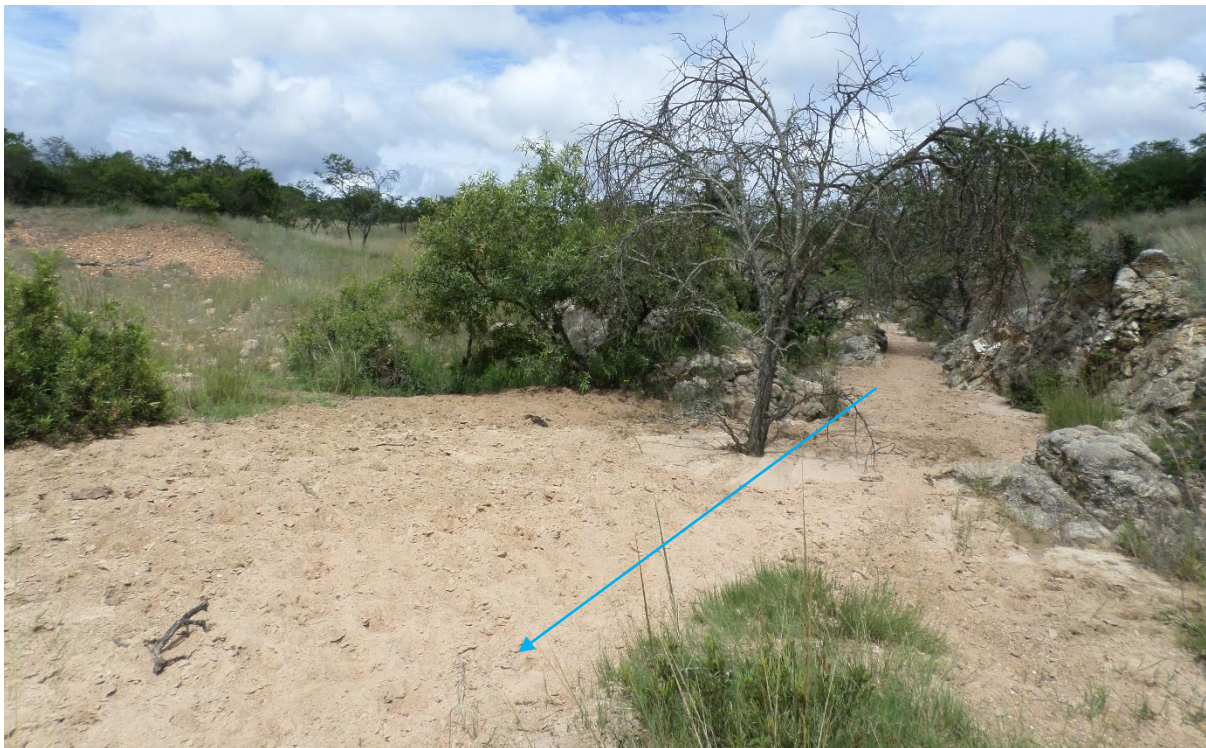
**Figure 10. View of the larger main channel of the Leeuspruit River that drains north of the site**

Site verification of the aquatic features determined the watercourses to be seasonal streams that have been significantly modified by the deep erosion that has taken place within the watercourse channels, as well as flow modification associated with the number of instream dams. In general, the eroded watercourse channels have resulted in the loss of the indigenous riparian vegetation, where in some places it has been replaced with alien plants. The watercourses as a result are in a moderately to largely modified condition instream and seriously modified in their riparian zones. While the smaller watercourses draining the valley sites are of low ecological importance, they are sensitive to disturbance and within the steeper slopes very sensitive to erosion which can impact on the aquatic ecological integrity of the watercourses as well as larger river system.

The larger streams on the valley floor are deemed to be of moderate importance. Although they may not provide valuable habitat for biota they do provide important corridors for the movement of biota, especially given that they connect the more important Sand River with higher-lying areas such as that within the Percy Fyfe Nature Reserve. These larger watercourses are also particularly sensitive to disturbance and changes to flow as well as erosion on the steeper slopes. As has been described for the smaller watercourses above, this can have quite a significant impact on the ecological integrity of the large aquatic ecosystems.
