Ecological Consolidation Report associated with the Matla Coal Mine

23 January 2017

Exxaro - Matla Coal

GCS Project Number: 16-1208

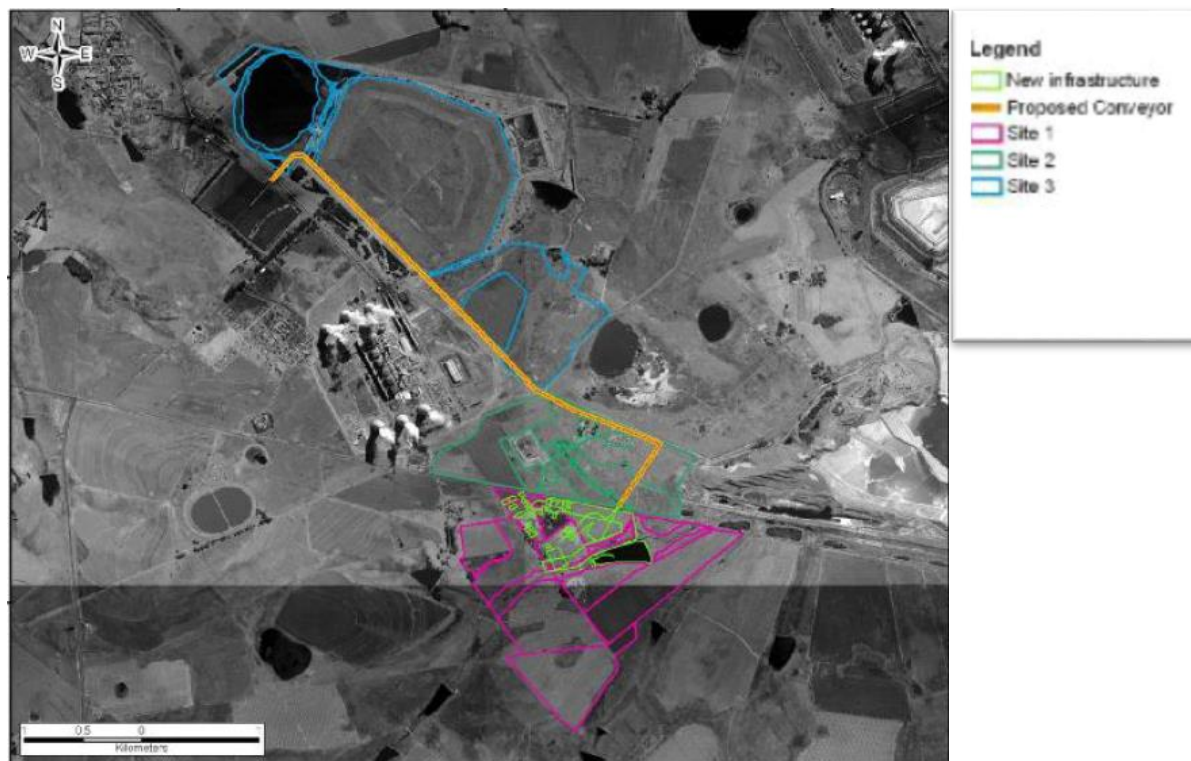
During the wetland assessment conducted by Golder Associates Report 10749, 2008 the wetlands (localities below) had a Present Ecological State C (Moderately Modified).

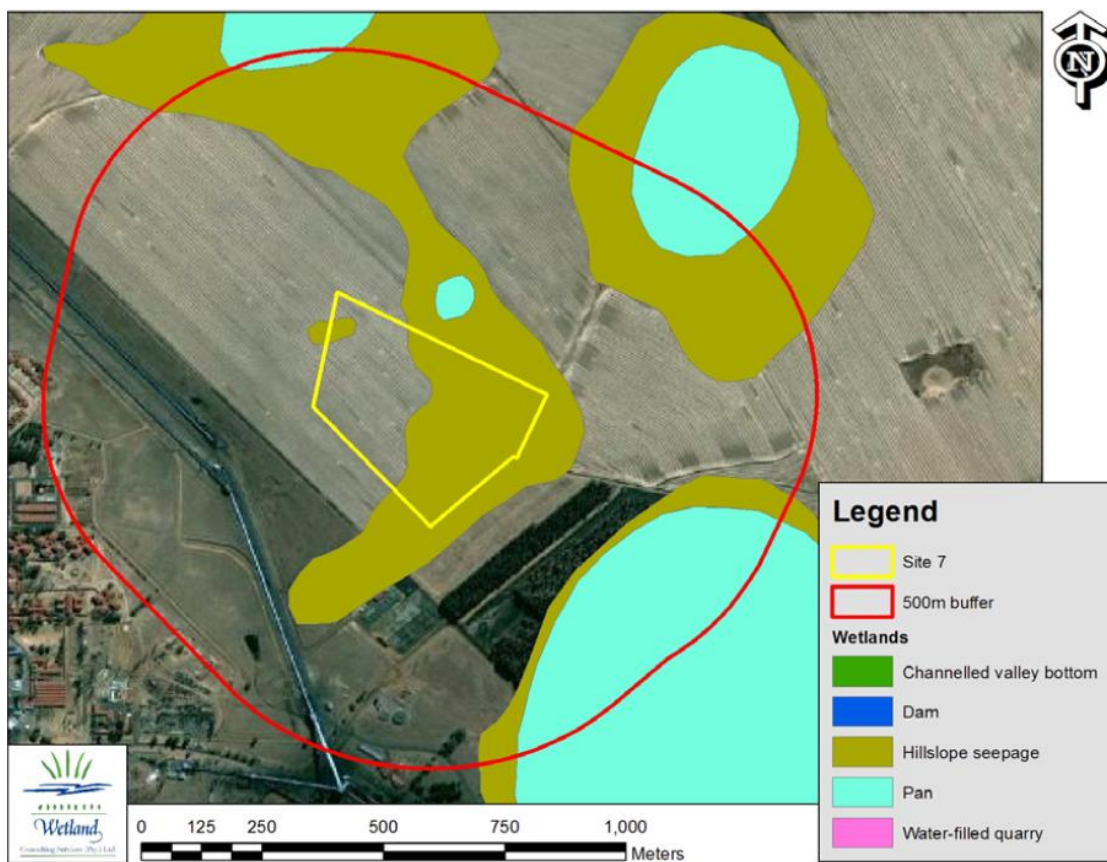
During the wetland assessment conducted by Wetland Consulting Services, 2011 for the proposed WWTW for the Matla Colliery (localities below)

The Present Ecological State (PES) of these wetlands ranged from largely modified (Ecological Class D) and seriously modified (Ecological Class E).
