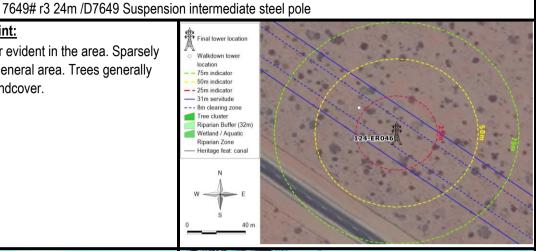
Open area with sparse tree cover evident in the area. Sparsely scattered protected trees in the general area. Trees generally moderate in size. Moderate groundcover.

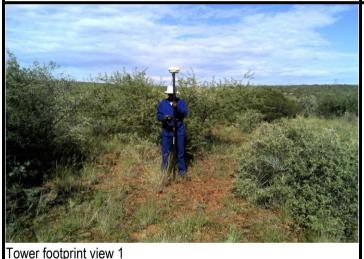
Open area with bush and moderate groundcover evident in the area. Moderate size trees located in servitude, will require pruning or removal.

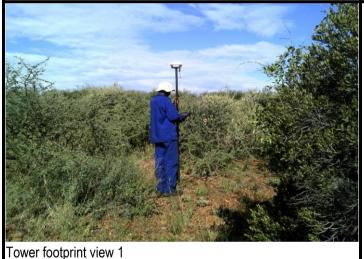
Open area with bush and moderate groundcover evident in the area. Moderate size trees located in servitude, will require pruning or removal.

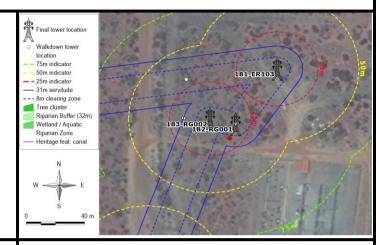
Open area with bush and moderate groundcover evident in the area. Moderate size trees located in servitude, will require pruning or removal.

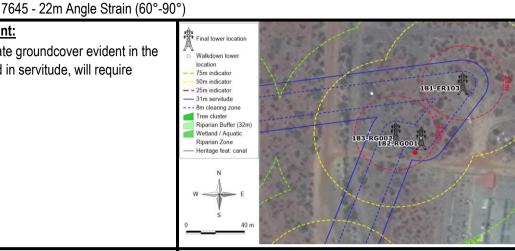
Open area with bush and moderate groundcover evident in the area. Moderate size trees located in servitude, will require pruning or removal.

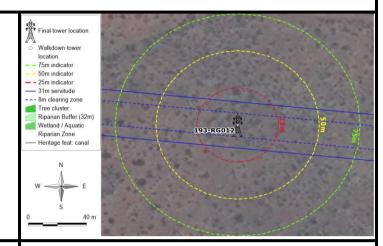
Aerial overview & tower footprint:

Open area with bush and moderate groundcover evident in the area. Moderate size trees located in servitude, will require pruning or removal.

Grave (HK5) identified 70m east of the proposed tower position. Recommend 20m No-Go buffer.
