**THE PROPOSED UPGRADE OF THE 66KV NETWORK IN THE  
KURUMAN AREA – HOTAZEL TO MOTHIBISTAT SUBSTATIONS,  
NORTHERN CAPE PROVINCE**

**Heritage Walkdown and Management Plan**

**Issue Date:** 21 June 2016  
**Revision No.:** 1  
**Client:** Zitholele Consulting (Pty) Ltd  
**Project Number:** 132HIA

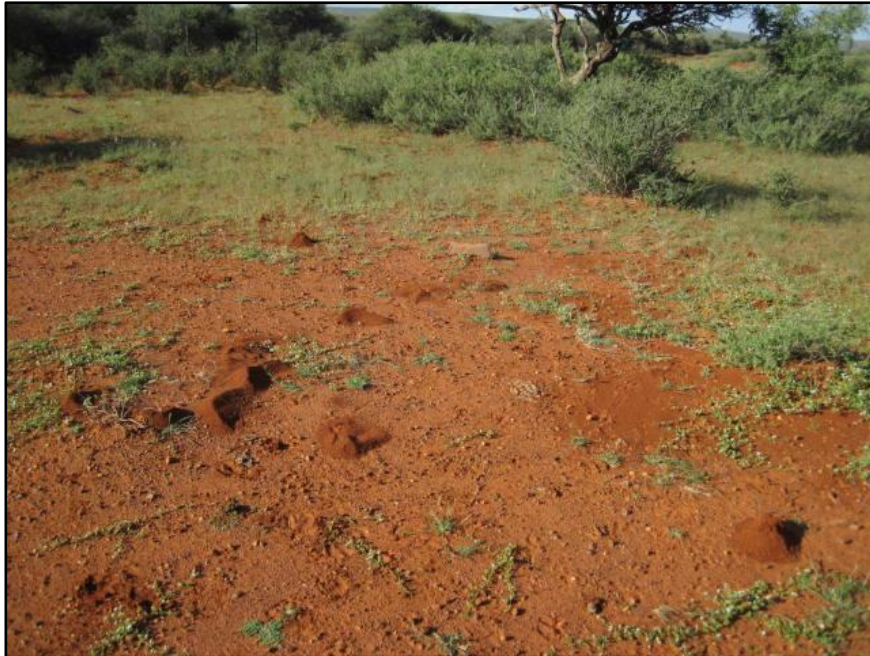
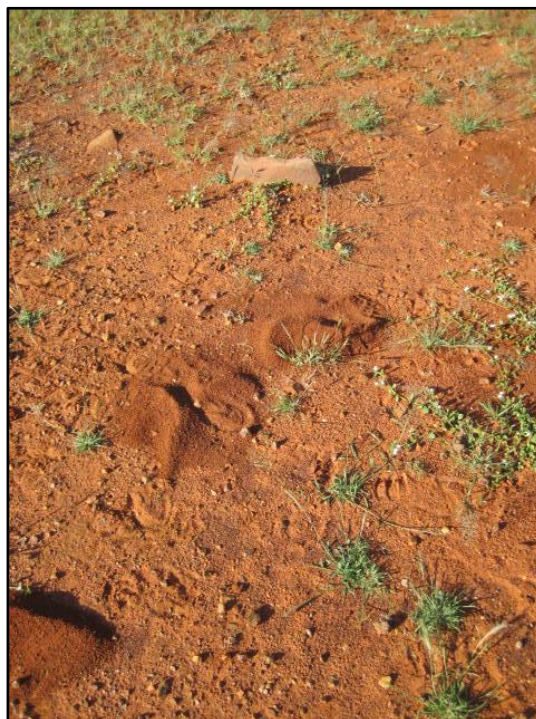
*Figure 9 – View of grave marker at HK1*

A single grave was identified at this location. The grave has a single rock as a headstone. This flat rock was placed upright in the soil and the grave is orientated from west to east. The grave is situated approximately 70m to the north of a farm worker's homestead. The farm worker, Daniel Kaogase, was questioned and he confirmed that the identified grave is indeed a grave. The grave does not have any inscriptions and Daniel did not know who was buried here or how old the grave is. He also pointed out two other locations with graves further to the east of this identified grave.

**Site size:** Approximately 2m x 2m in size.

**Grading:** The site is seen as having local heritage significance and rated as Grade 3B.

- ⊕ Demarcate the site as a no go area, with a 20 meter buffer.
- ⊕ The site must be monitored during construction

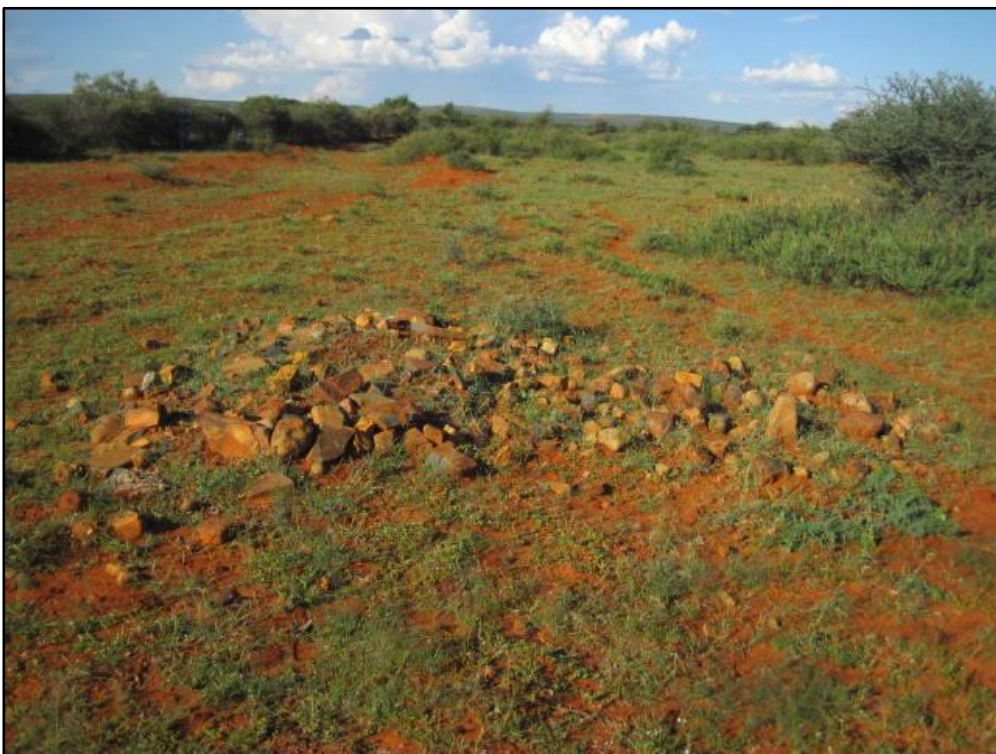
*Figure 10 – Graves at HK2*

Two graves were identified at this location. The graves were pointed out by an informant Daniel Kaogase, who stays nearby on the farm. The two graves were placed next to each other and were orientated from west to east. The graves have large oval shaped mounds of packed rock as dressings. The one grave also has an upright rock at the western end which serves as headstone. The graves have no inscriptions and it is not known who were buried here or how old the graves are. The informant also did not know who were buried or how old the graves are. The graves are approximately 40m further to the east from the identified grave at site HK 1.

**Site size:** Approximately 5m x 2m in size.

**Grading:** The site is seen as having local heritage significance and rated as Grade 3B.

- ⊕ Demarcate the site as a no go area, with a 20 meter buffer.
- ⊕ The site must be monitored during construction

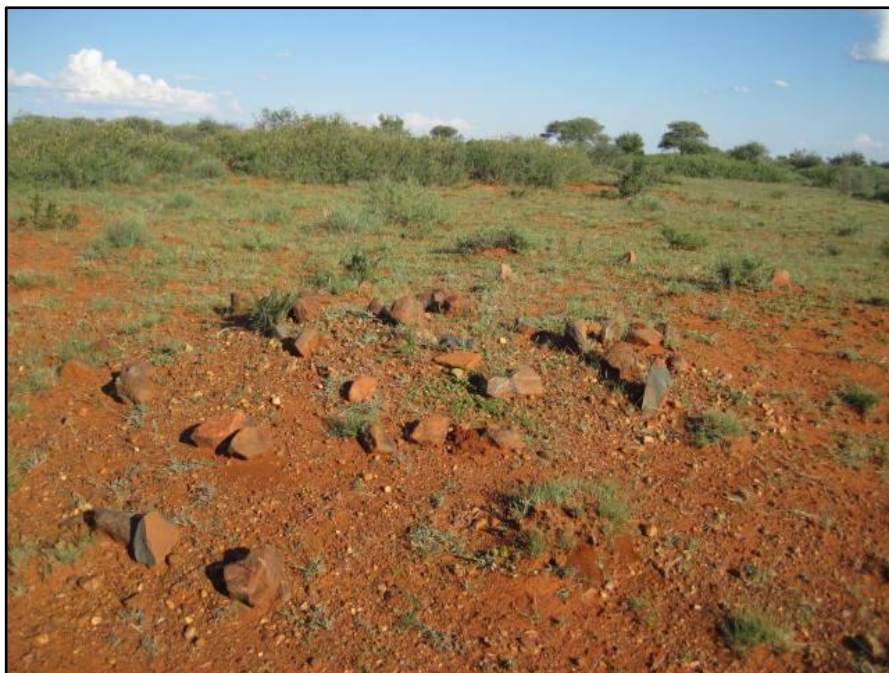
*Figure 11 – View of cemetery at HK3*

A single grave and two other possible graves were identified at this location. The graves were also pointed out by an informant Daniel Kaogase, who stays nearby on the farm. The three possible graves were placed next to each other and were orientated from west to east. The one grave has a large oval shaped outline of packed rocks as dressing. It also has an upright rock at the western end which serves as headstone. The one possible grave has an upright placed stone at the western as well as the eastern ends. No other rocks were packed as dressing. The second possible grave only has one upright placed rock which serves as headstone. The graves have no inscriptions and it is not known who were buried here or how old the graves are. The informant also did not know who were buried or how old the graves are. The graves are approximately 30m further to the east from the identified graves at site HK2.

**Site size:** Approximately 5m x 2m in size.

**Grading:** The site is seen as having local heritage significance and rated as Grade 3B.

- ⊕ Demarcate the site as a no go area, with a 20 meter buffer.
- ⊕ The site must be monitored during construction

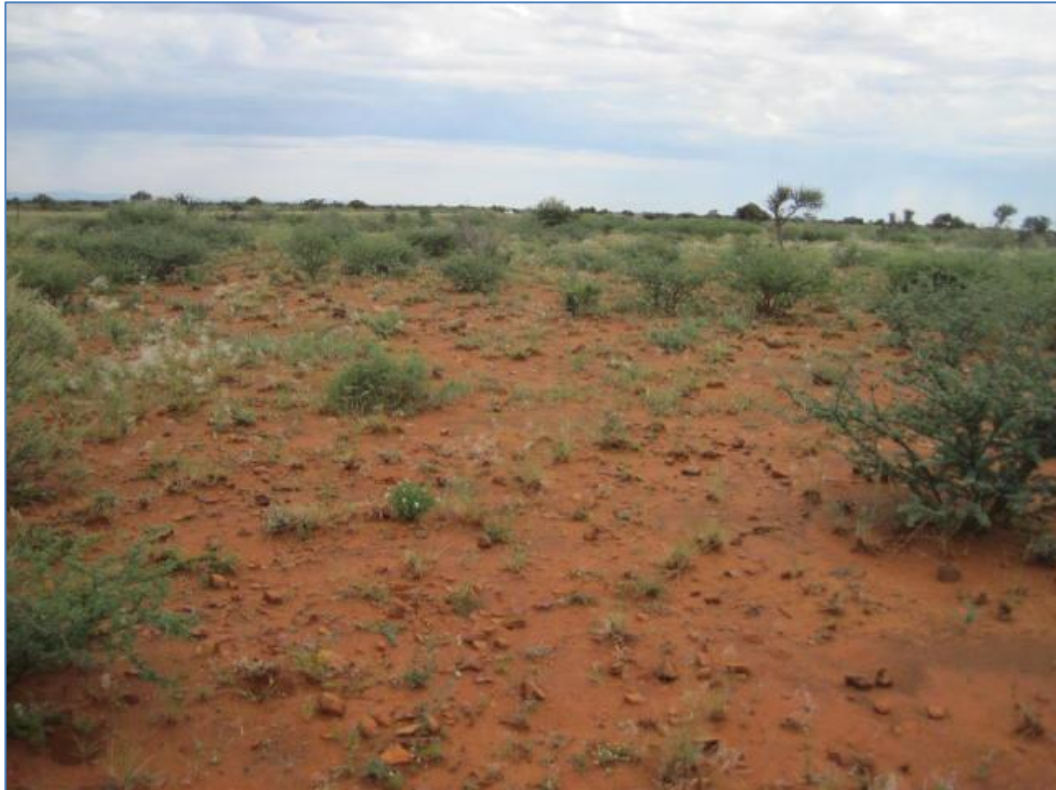
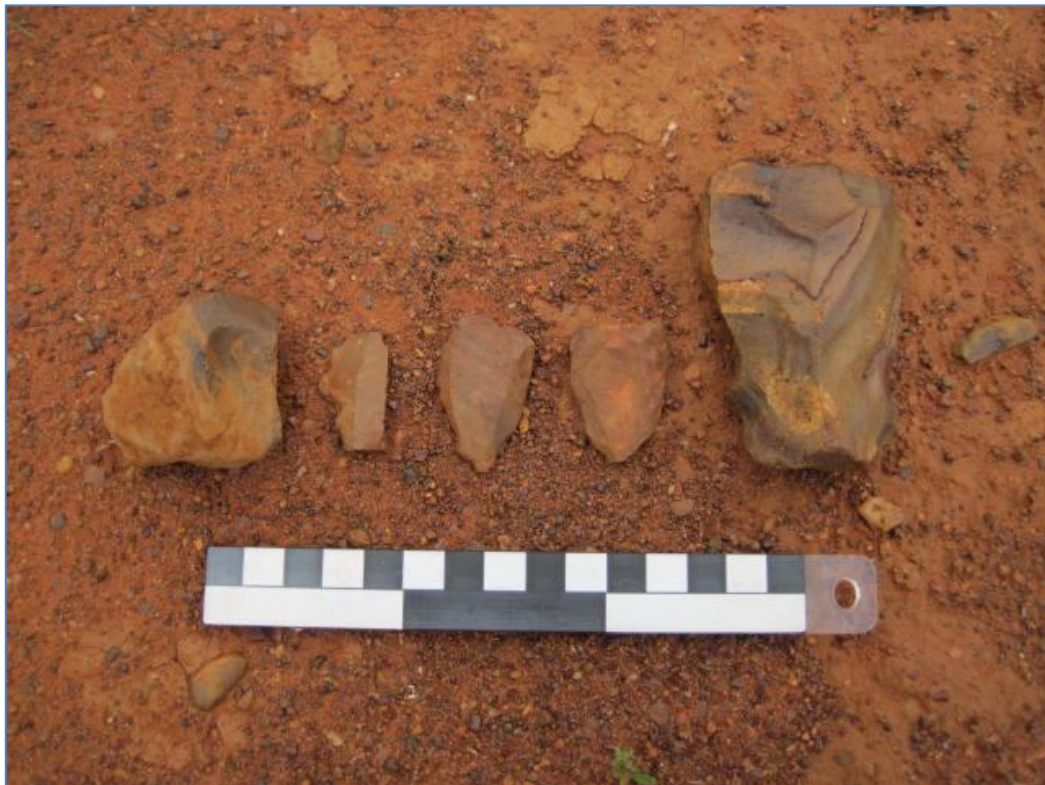
A low density scatter of stone tools was identified at this location ( $\pm$  2-5 artefacts in 10m x10m). The site is situated in a clearing with the artefacts being exposed by some measure of sheet erosion. The artefacts consist mainly of stone tools from the Late Stone Age and include mostly of LSA blades, scrapers. The artefacts are mainly made of weathered quartzite and are scattered over an area of approximately 30m in diameter.

**Site size:** Approximately 30m in diameter.

**Grading:** The site is seen as having local heritage significance and rated as Grade 3B.

*Figure 13 – View of site at HK4*

*Figure 14 – Lithics found at HK4*

- ⊕ Demarcate the site as a no go area, with a 20 meter buffer.
- ⊕ The site must be monitored during construction

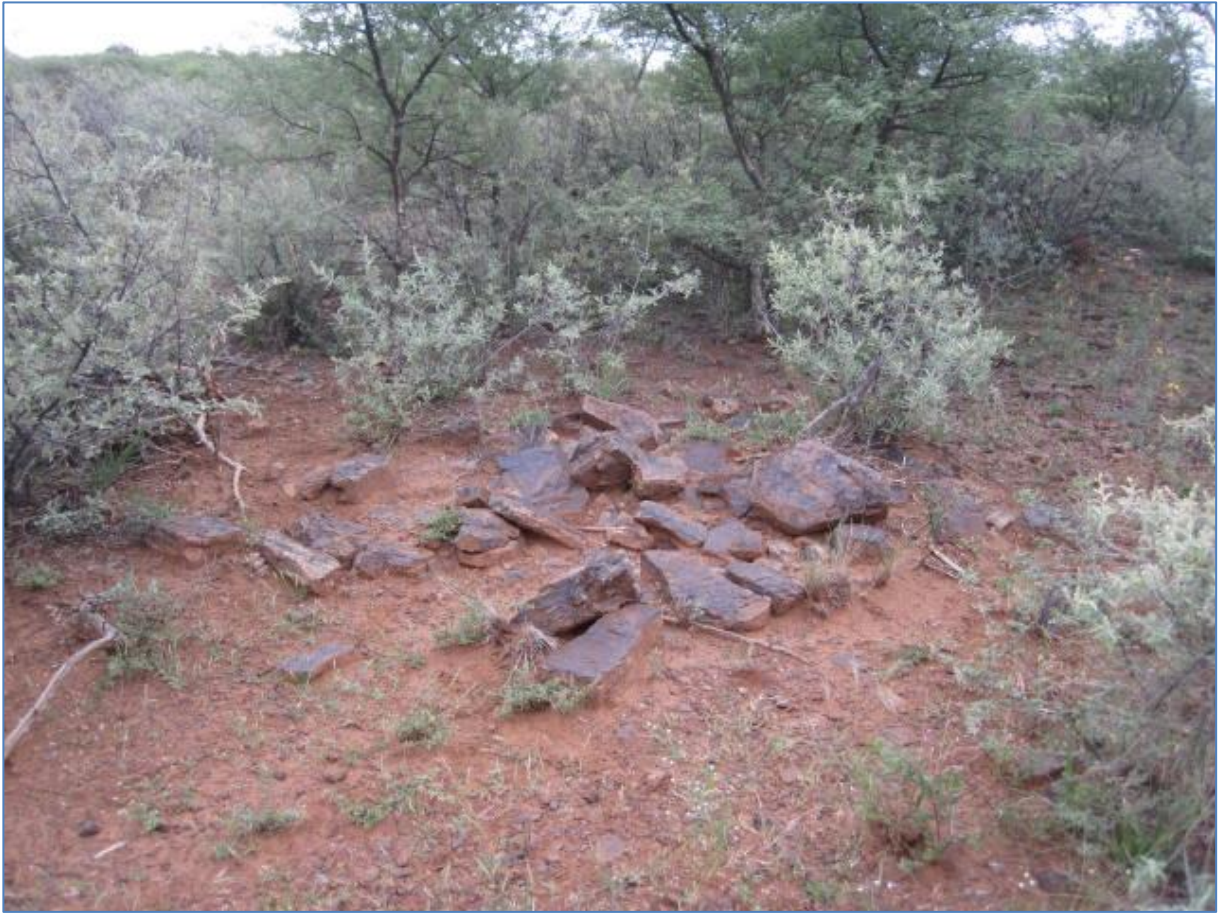
A single grave was identified at this location. The grave has a rectangular shaped mound of packed rocks which serves as dressing. The grave is orientated from west to east. No headstone or any inscription was identified. The grave does not have any inscriptions and it is not known who was buried here or how old the grave is.

**Site size:** Approximately 2m x 2m in size.

**Grading:** The site is seen as having local heritage significance and rated as Grade 3B.

*Figure 16 – Stone packed grave at HK5*

- ⊕ Demarcate the site as a no go area, with a 20 meter buffer.
- ⊕ The site must be monitored during construction

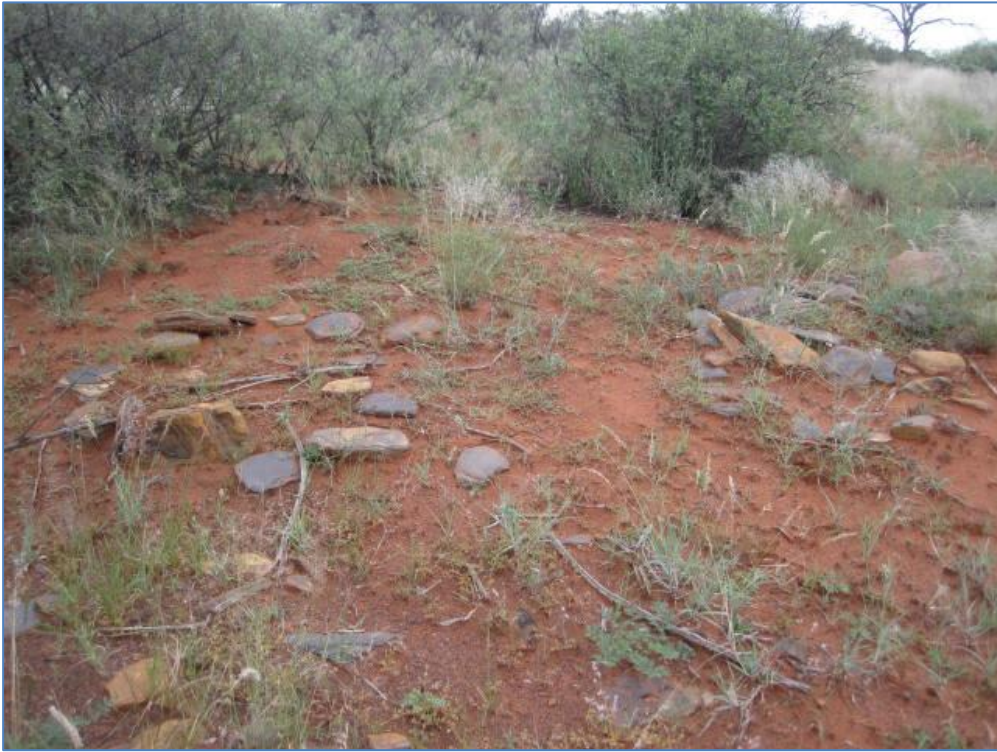
*Figure 18 – Graves at HK6*

Two graves were identified at this location. The graves were placed next to each other and were orientated from north to south. The graves have rectangular shaped outlines of packed rocks which serve as dressings. The graves also have upright placed rocks at the northern ends which serve as headstones. The graves do not have any inscriptions and it is not known who were buried here or how old the graves are.

**Site size:** Approximately 5m x 2m in size.

- ⊕ Demarcate the site as a no go area, with a 20 meter buffer.
- ⊕ The site must be monitored during construction

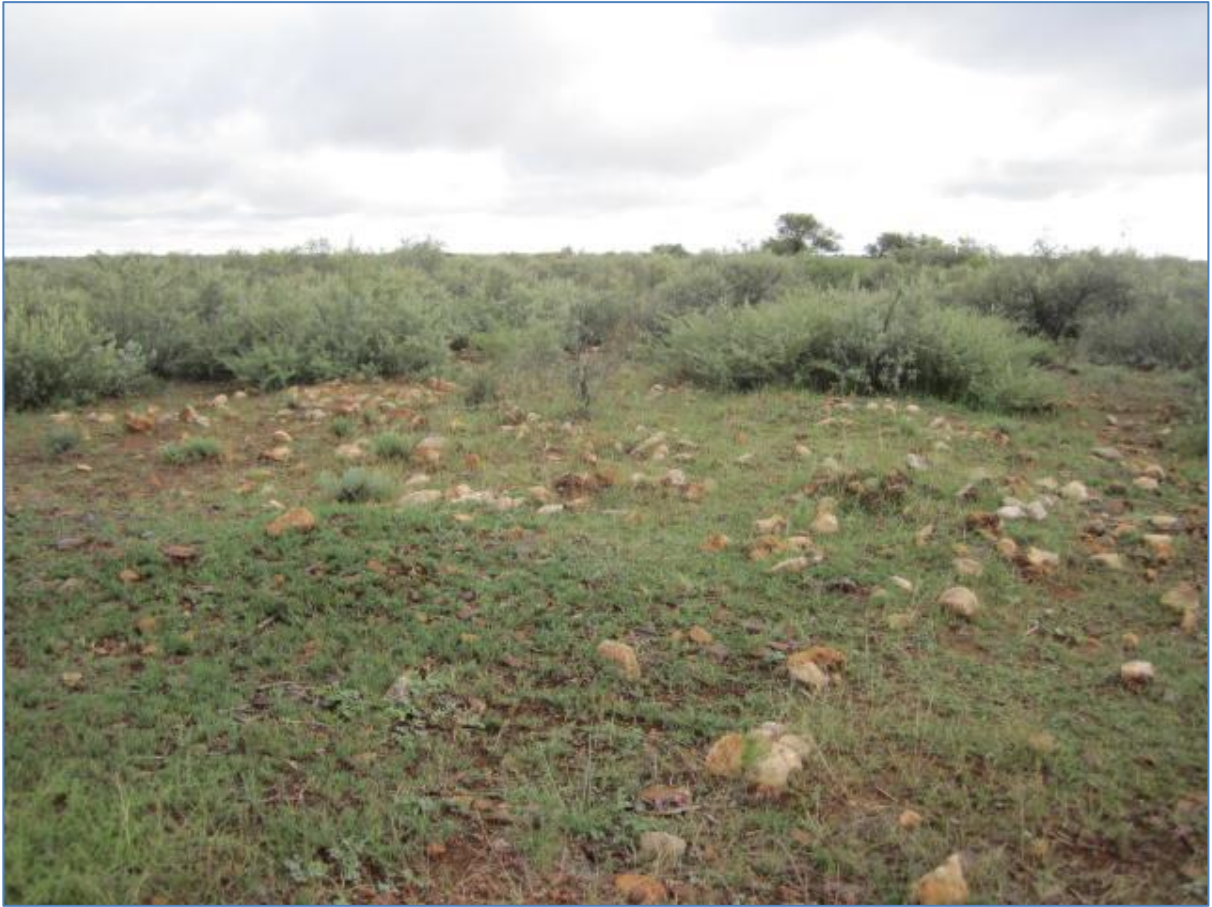
A small, informal cemetery with approximately 15 graves was identified at this location. Some of the grave's dressings have been damaged to an extent and the total number of graves is not clear at this stage. The graves were placed in three unequal lines next to each other and were orientated from west to east. The graves have rectangular and oval shaped mounds of rocks packed on them which serve as dressings. Some graves have upright rocks placed at the western ends to serve as headstones. The graves do not have any inscriptions and it is not known who were buried here or how old the graves are.

**Site size:** Approximately 20m x 20m in size.

*Figure 20 – Cemetery at HK7*

- ⊕ Demarcate the site as a no go area, with a 20 meter buffer.
- ⊕ The site must be monitored during construction

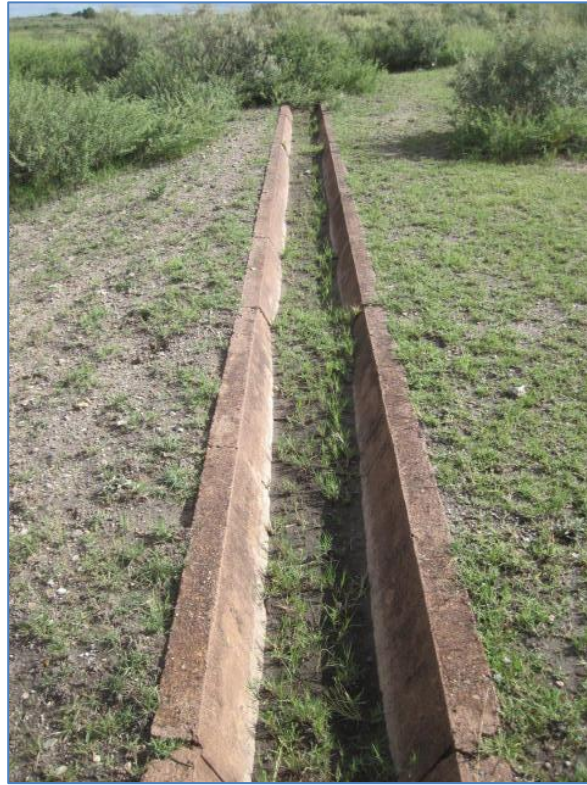
The remains of an unused canal and irrigation system were identified at this location. The canal system was cemented with little bridges crossing over the canal. The canal followed the flow of the Kuruman River, but is in an unused state for some time. The proposed power line follows the canal system for some extent. Some of the bridges across the canal have inscribed dates on them. Most of these inscriptions are very weathered, but one dated to 05/09/1946.

*Figure 22 – Concrete furrow*

- ⊕ Demarcate the site as a no go area, with a 20 meter buffer.
- ⊕ The site must be monitored during construction

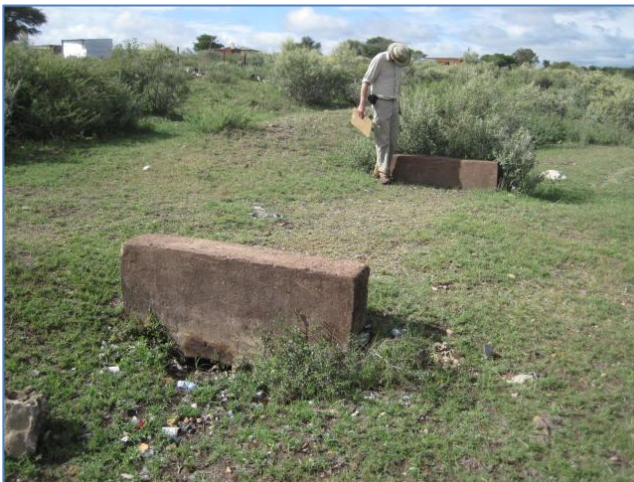
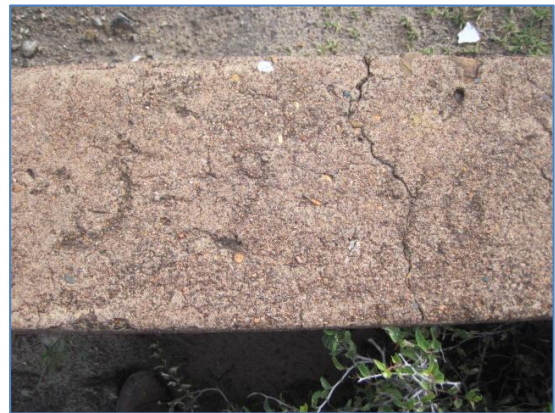
*Figure 23 – Small bridge with date of 1946*

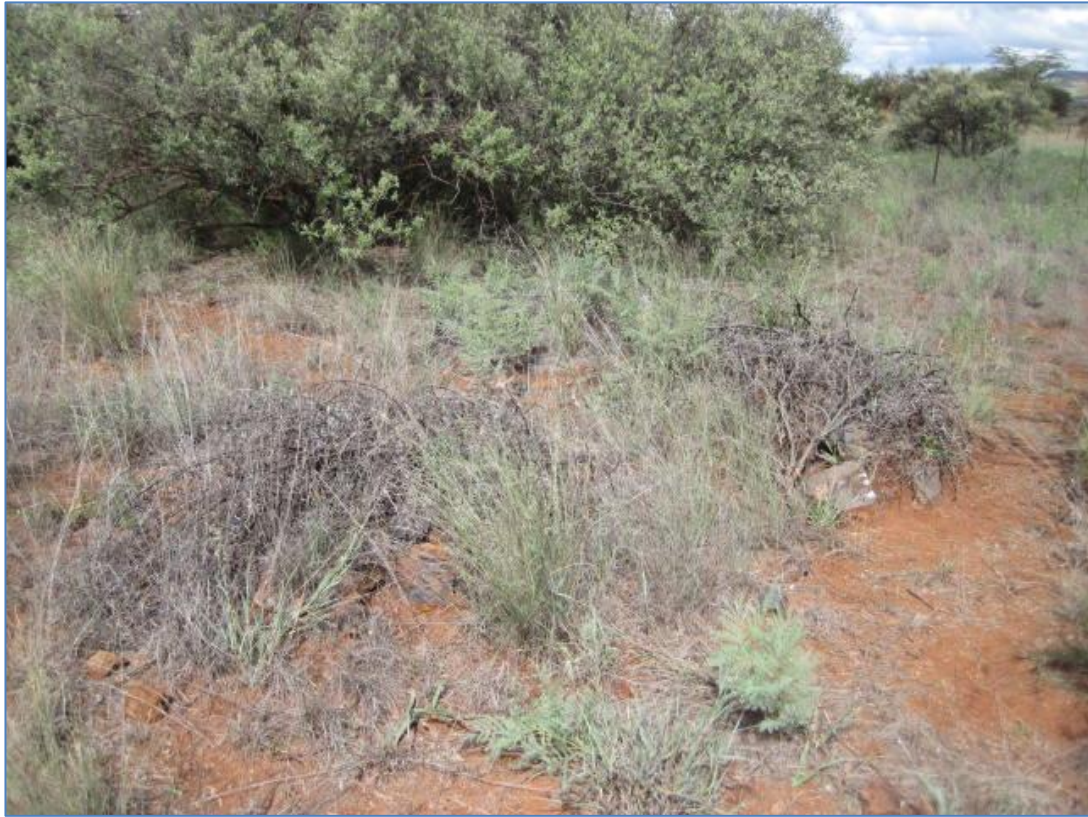
*Figure 25 – Graves at MV01*

The site consist of two stone packed graves aligned east-west. No formal headstone or inscription are present.

- ⊕ Demarcate the site as a no go area, with a 20 meter buffer.
- ⊕ The site must be monitored during construction
