# **SURFACE AND GROUNDWATER MONITORING PROGRAMME**

## **Rooipoort Developments (Pty) Ltd**

**November 2018**

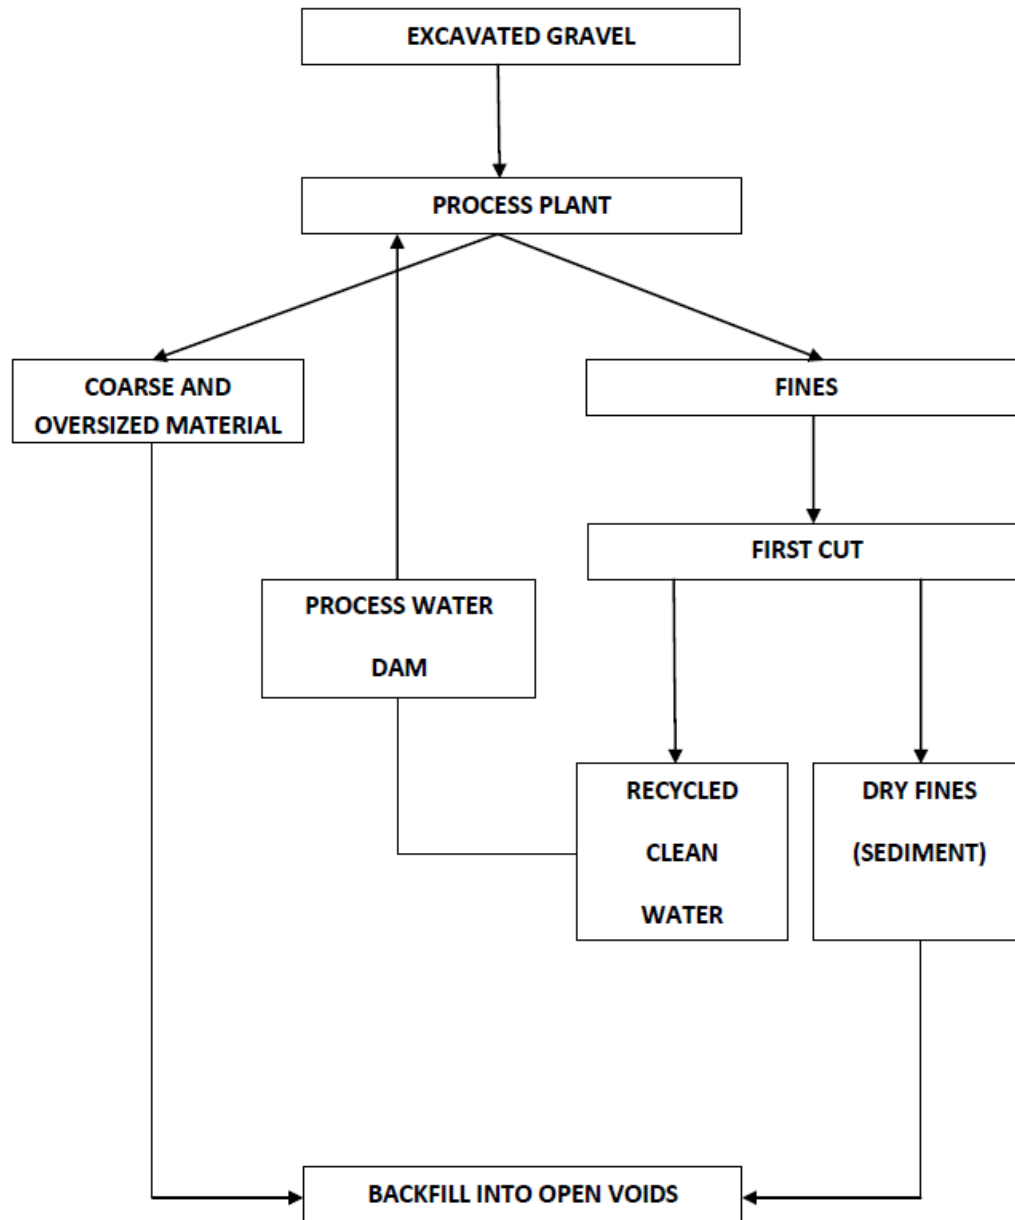
## OPERATIONAL DIAGRAM – PRODUCTS PRODUCED AND PATHWAYS

The figure above indicates the process and the products produced by the process. During the processing of the material, the grits and fine material will continuously be pumped to the First Cut on site. The First Cut was designed to allow the suspended fine material to settle in the first pond. Water will flow through a stone diversion between the two ponds. Clean water will be pumped from the second pond back to the PWD to be re-used in the process plant or for dust suppression. When the mining in the area is completed the First Cut will be left to dry and will be backfilled with oversized material, overburden and soil. The overburden and topsoil will be replaced to the voids to cover the backfilled dry fine gravel and plant gravels.

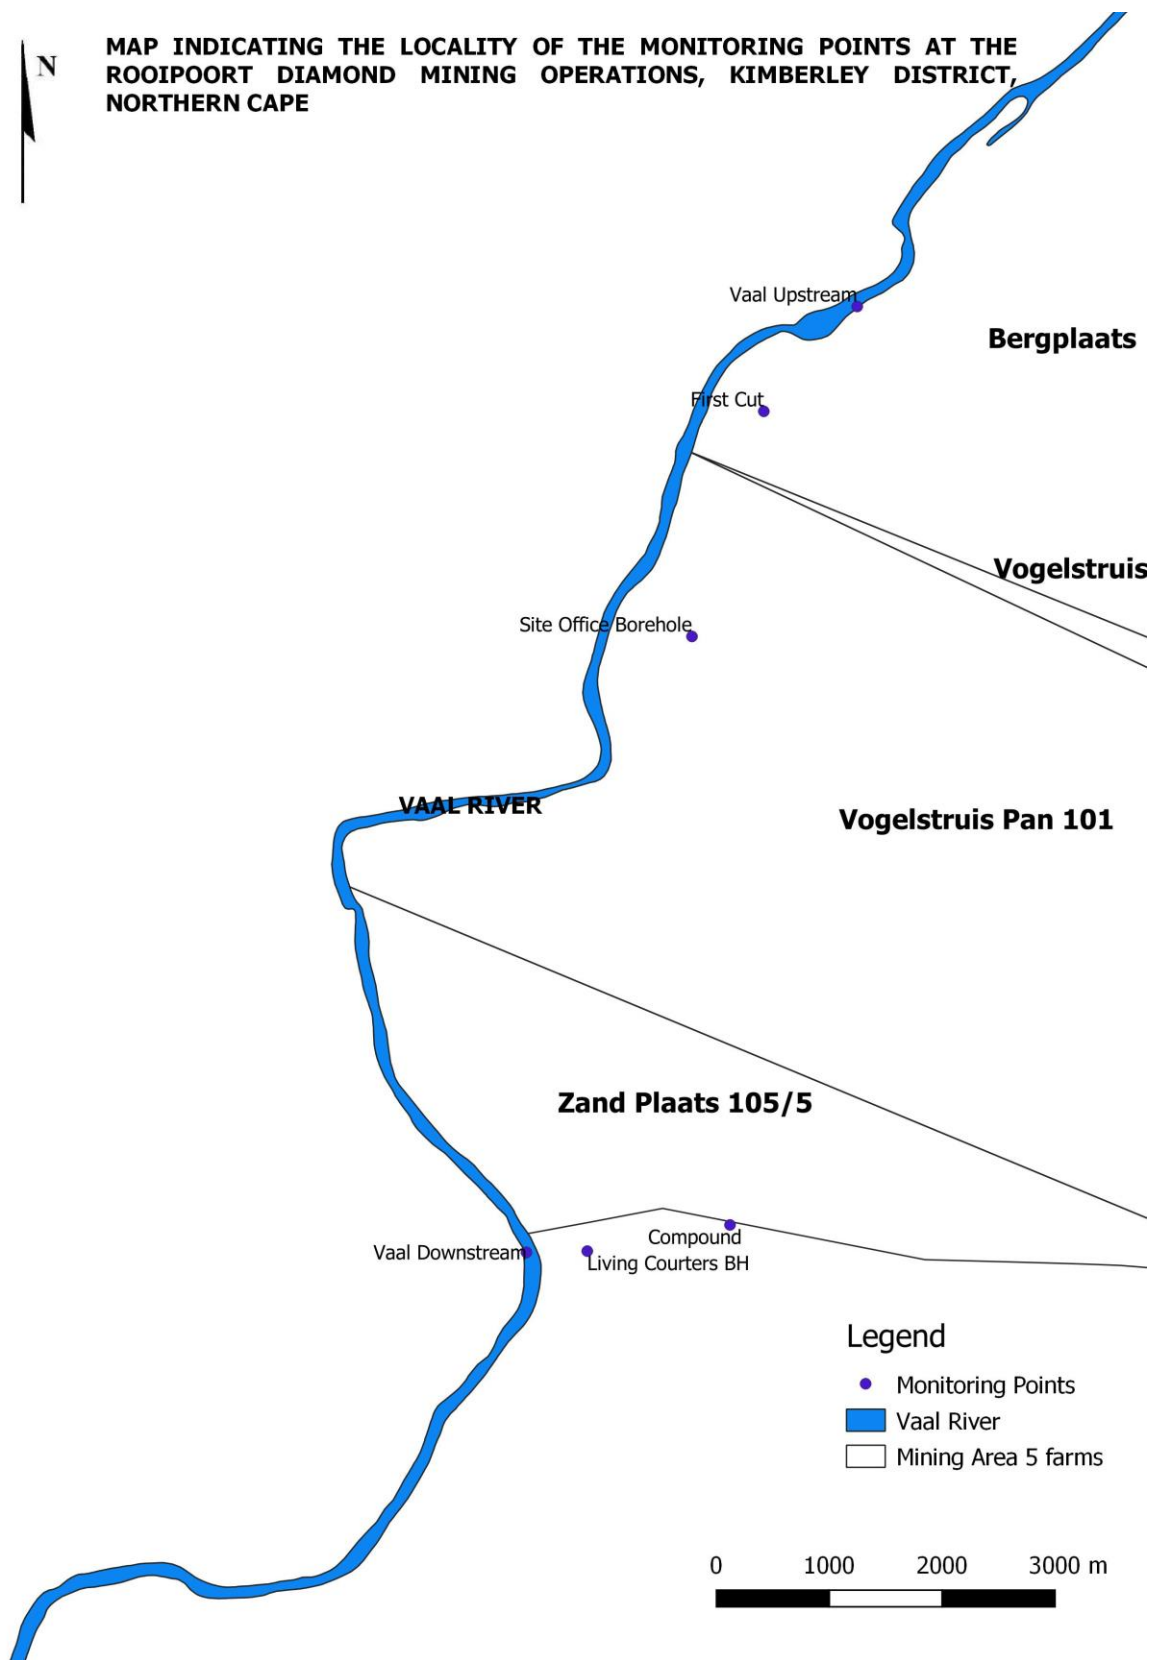
Figure 1: Map indicating the location of the sampling points

Point	Latitude	Longitude
Compound borehole	28° 42.072'	24° 5.605'
Living Courters Borehole	28° 42.215'	24° 4.829
Site office borehole	28° 38.857'	24° 5.399'
Upstream sample point	28° 37.054'	24° 6.299'
Downstream sample point	28° 42.222'	24° 4.498'
First Cut	28° 37.627'	24° 5.790'

Indication of sample points:

**Vaal Up:** Sample taken in the Vaal River upstream of the operation.

**SD:** Recovered water in the First Cut

**Vaal Down:** Sample taken in the Vaal River downstream of the operation.

**Compound:** Employees residents located outside the mining area

**LQ BH:** Borehole located at the supervisors living courters outside the mining area,

**Office BH:** This is the borehole at the site offices. Water is used for domestic purposes.
