PROPOSED CONSTRUCTION OF A 132KV POWER LINE AND ASSOCIATED INFRASTRUCTURE FOR THE EVACUATION OF POWER FROM THE PROPOSED KALKAAR CONCENTRATING SOLAR THERMAL POWER PROJECT ON THE REMAINDER OF PORTION 1 OF THE FARM KALKAAR 389 NEAR JACOBSDAL, FREE STATE AND NORTHERN CAPE PROVINCES

Heritage Impact Assessment

Issue Date: 19 January 2017

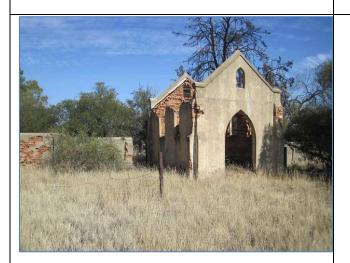
Figure 11 - View of chapel ruin

The site is rated as Grade 3A (Conservation; Mitigation not advised) the site is associated with the history of Kimberley and will have a strong link to some prominent figure of the diamond rush era. A distance of at least 50 m should be maintained from any development associated with the project.

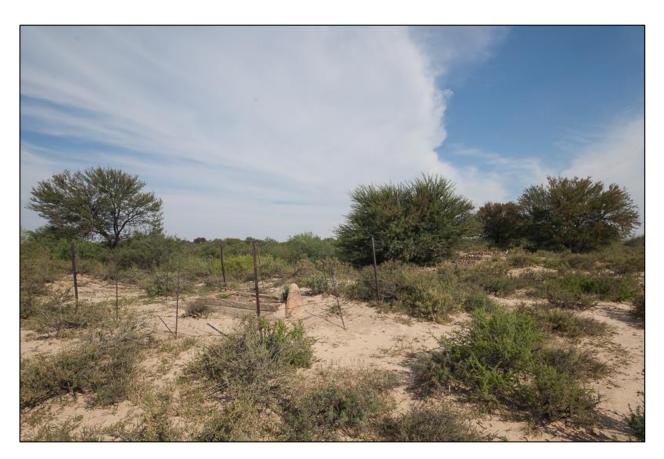
Figure 12 – Site BEZ 001 is a graveyard that is still in use. It is recommended that any development within 20 m of the graveyard be avoided

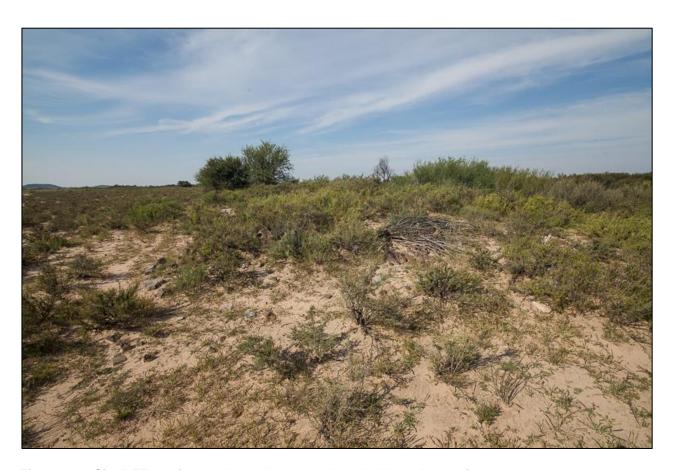
Figure 13 - Site BEZ 002 is a neglected graveyard, probably no longer in use

The process of grave relocation—negotiations with relatives, notifications, permits, identification of an acceptable alternative site for reburial, exhumation and reburial-- would need to be followed.

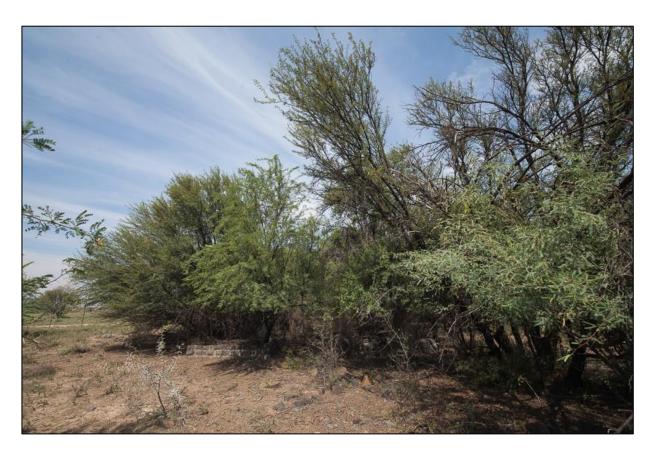
Figure 14 – Overgrown graveyard (Site KLP 001)

• The process of grave relocation—negotiations with relatives, notifications, permits, identification of an acceptable alternative site for reburial, exhumation and reburial-- would need to be followed.

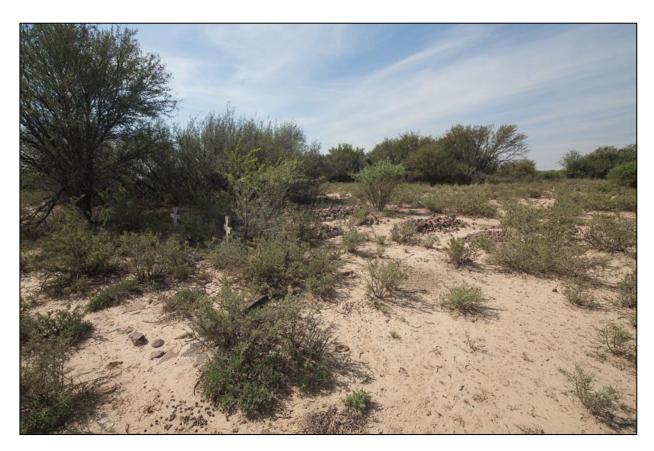
Figure 15 – Graveyard that is still in use (Site KLP 002). It is recommended that the graveyard be conserved and that no development take place closer than 20 m to the site

Mitigation is not advised, development should be limited to 20 m from the graveyard.

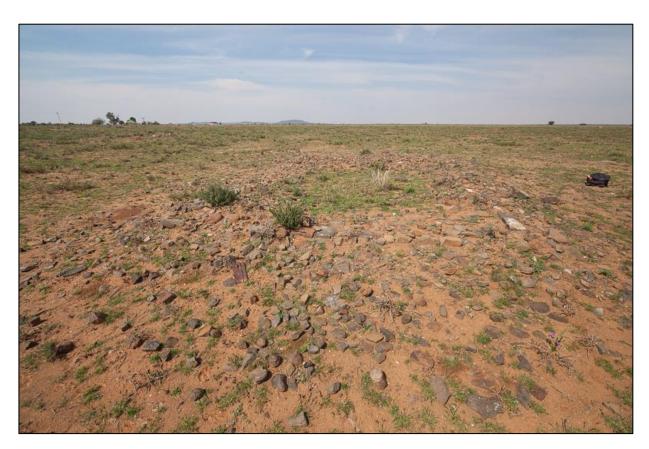
Figure 16 – The remains of a kraal built of stone (Site KLP 003)

The site should be recorded before destruction.

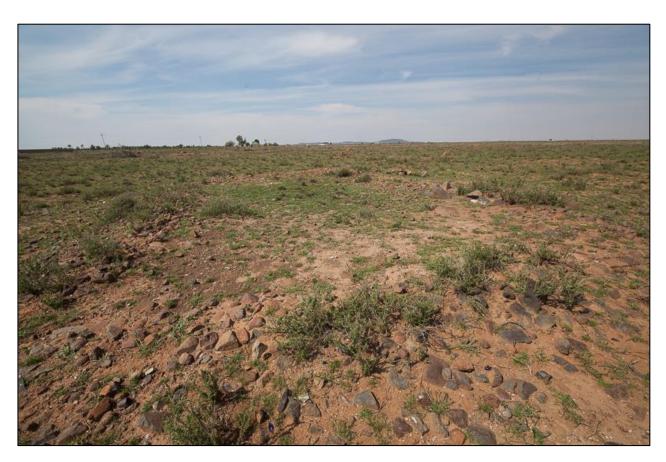
Figure 17 - Remains of a kraal (Site KLP 004)

The site should be recorded before destruction.

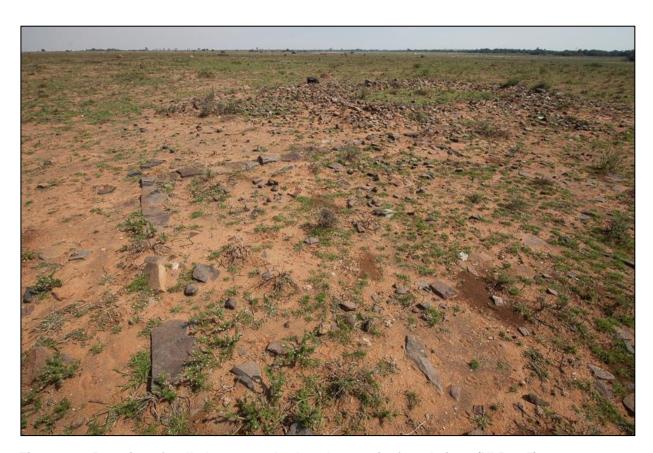
These are the remains of a walled building about 2 m by 2 m on Klipdrift No 20 Rem. Only the foundations remain.

Figure 18 – Remains of walled structure broken down to its foundations (KLP 005)

• The site should be recorded before destruction.

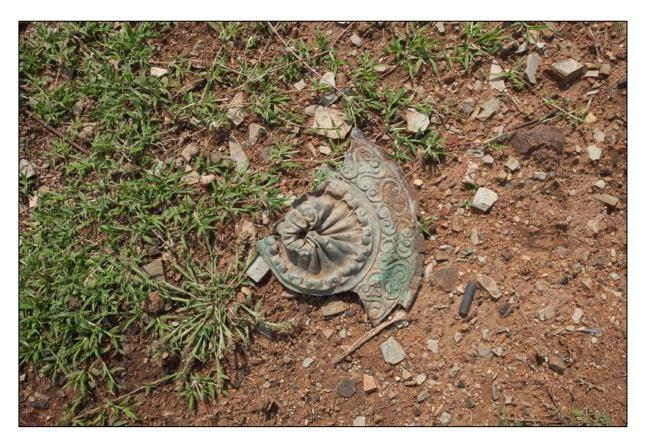
Figure 19 - Possible ceiling fixture found on ash heap on Rem of Klipdrift No 20 (KLP 006)

The site should be recorded before destruction.

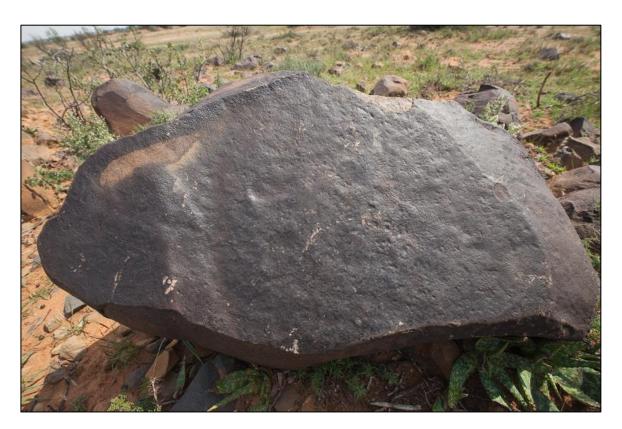
Figure 20 - Engraved dolerite boulder (Site KLP 007)

• Mitigation not advised. Development should be limited to 20 m from the engraved boulder.

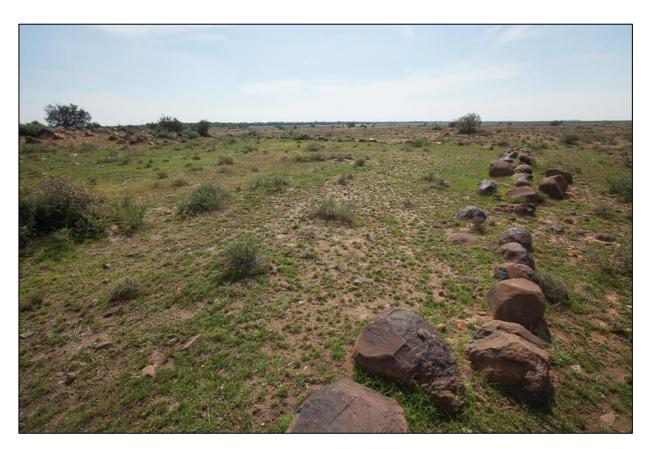
The site is rated as Grade 4B (medium significance).

Figure 21 – Outline of a rectangular kraal structure (KLP 008)

- It is advised that the alignment of the OHL be kept at least 50 meters away from this site. If not possible the following mitigation will be required:
- The site should be recorded before destruction.

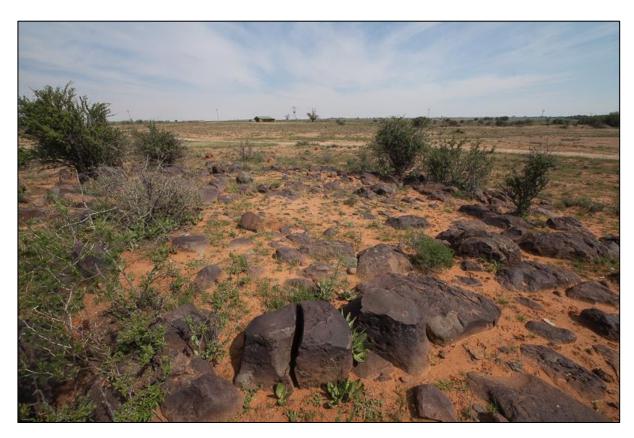
The site is rated as Grade 4B (medium significance).

Figure 22 – Circular enclosure on low rise (KLP 009)

- It is advised that the alignment of the OHL be kept at least 50 meters away from this site. If not possible the following mitigation will be required:
- The site should be recorded before destruction.

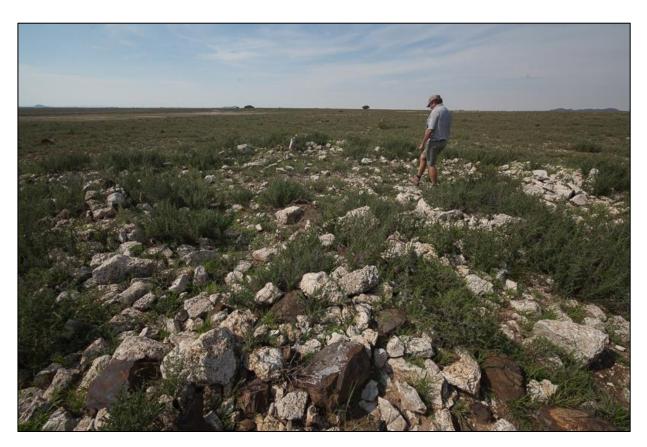
The site is rated as Grade 4A (high/medium significance, mitigation required).

Figure 23 – Possible kraals built of locally sourced, roughly dressed stone (KLP 010)

- It is advised that the alignment of the OHL be kept at least 50 meters away from this site. If not possible the following mitigation will be required:
- Research needs to be done into the historical significance of the kraals and the other structures that comprise the homestead.
- The homestead should be mapped, laser-scanned and photographed. The documentation should be archived where it is accessible to the public.

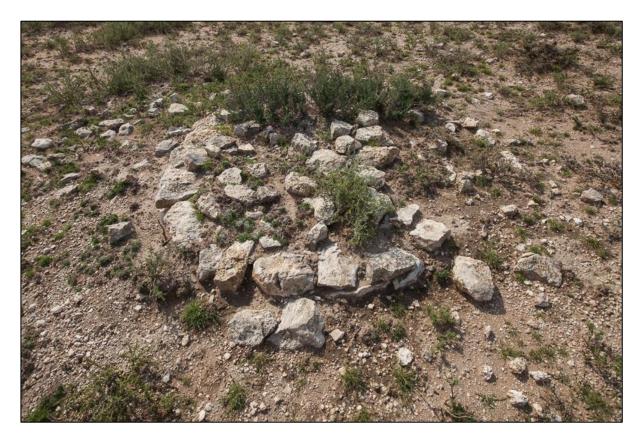
The structure is rated 4A (high/medium significance, mitigation required).

Figure 24 – Circular structure of stones (KLP 011)

- It is advised that the alignment of the OHL be kept at least 50 meters away from this site. If not possible the following mitigation will be required:
- Research needs to be done into the historical significance of this circular structure and the other structures that comprise the homestead.
- The homestead should be mapped, laser-scanned and photographed. The documentation should be archived where it is accessible to the public.

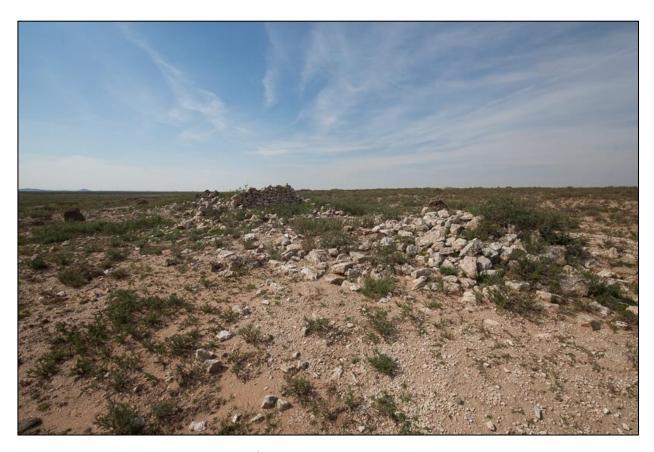
The structure is rated 4A (high/medium significance, mitigation required).

Figure 25 – Ruined house possibly 19th century, built of local stone (KLP 012)

- It is advised that the alignment of the OHL be kept at least 50 meters away from this site. If not possible the following mitigation will be required:
- Research needs to be done into the historical significance of this house and the other structures that comprise the homestead.
- The homestead should be mapped, laser-scanned and photographed. The documentation should be archived where it is accessible to the public.

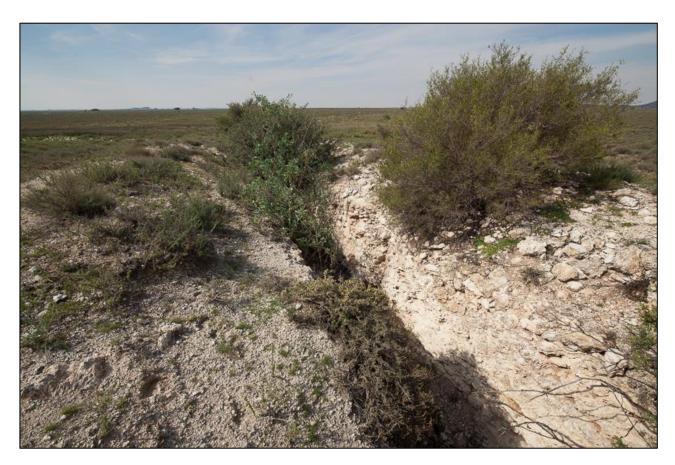
Figure 26 – Spring that has been dug open (KLP 013). It is probably part of the nearby homestead (KLP 010-012)

- It is advised that the alignment of the OHL be kept at least 50 meters away from this site. If not possible the following mitigation will be required:
- Research needs to be done into the historical significance of this house and the other structures that comprise the homestead.
- The homestead should be mapped, laser-scanned and photographed. The documentation should be archived where it is accessible to the public.

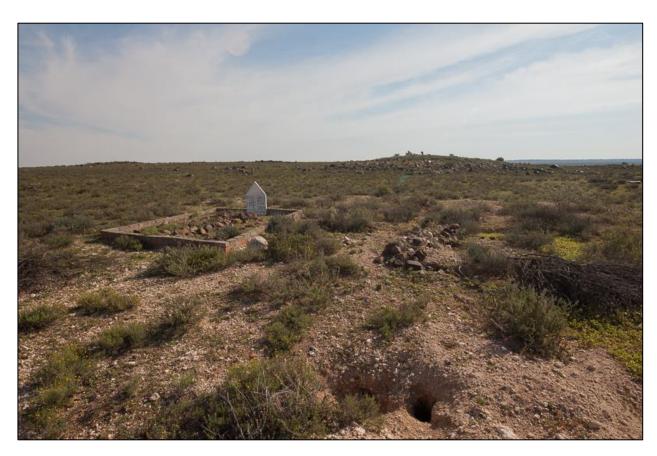
The site is rated as Grade 4A (high/medium significance). Mitigation would therefore be required if the powerlines or associated structures or roads encroach closer than 20 m upon the graveyard.

Figure 27 - Graves on Judex No 240 (JDX 001)

- It is advised that the alignment of the OHL be kept at least 50 meters away from this site. If not possible the following mitigation will be required:
- The process of grave relocation—negotiations with relatives, notifications, permits, identification of an acceptable alternative site for reburial, exhumation and reburial-- would need to be followed.

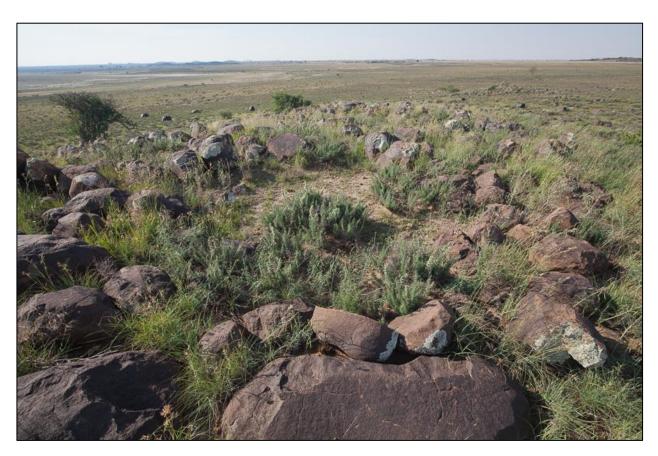
The site is rated as Grade 4B (medium significance).

Figure 28 - Circular enclosure of dolerite hilltop (JDX 002)

- It is advised that the alignment of the OHL be kept at least 50 meters away from this site. If not possible the following mitigation will be required:
- The site should be recorded before destruction.
