PROPOSED CONSTRUCTION OF A 132KV POWER LINE AND ASSOCIATED INFRASTRUCTURE FOR THE EVACUATION OF POWER FROM THE PROPOSED KALKAAR CONCENTRATING SOLAR THERMAL POWER PROJECT ON THE REMAINDER OF PORTION 1 OF THE FARM KALKAAR 389 NEAR JACOBSDAL, FREE STATE AND NORTHERN CAPE PROVINCES

Heritage Impact Assessment

Issue Date: 25 November 2016
Revision No.: 3
Project No.: 13620

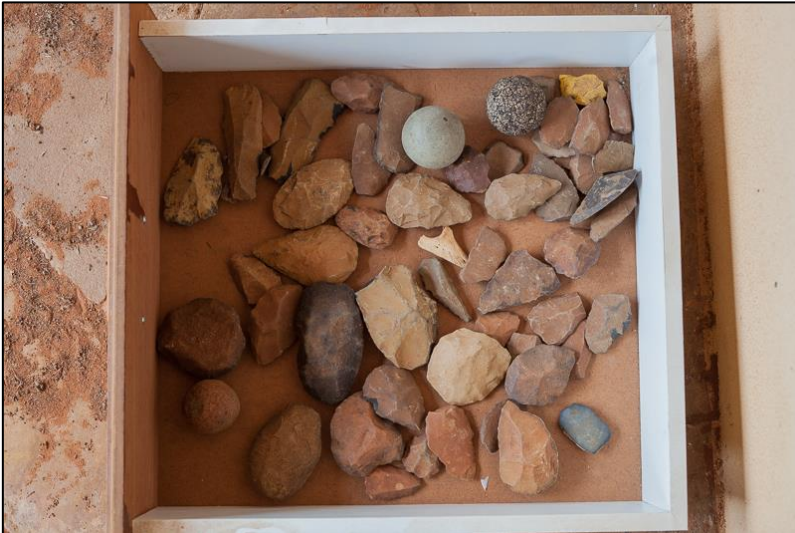
Figure 5 – Drawer full of Early and Middle Stone Age stone artefacts collected on the farm Rooifontein No 211 (Ptn 1) over the years by Mr J. Reichert and family

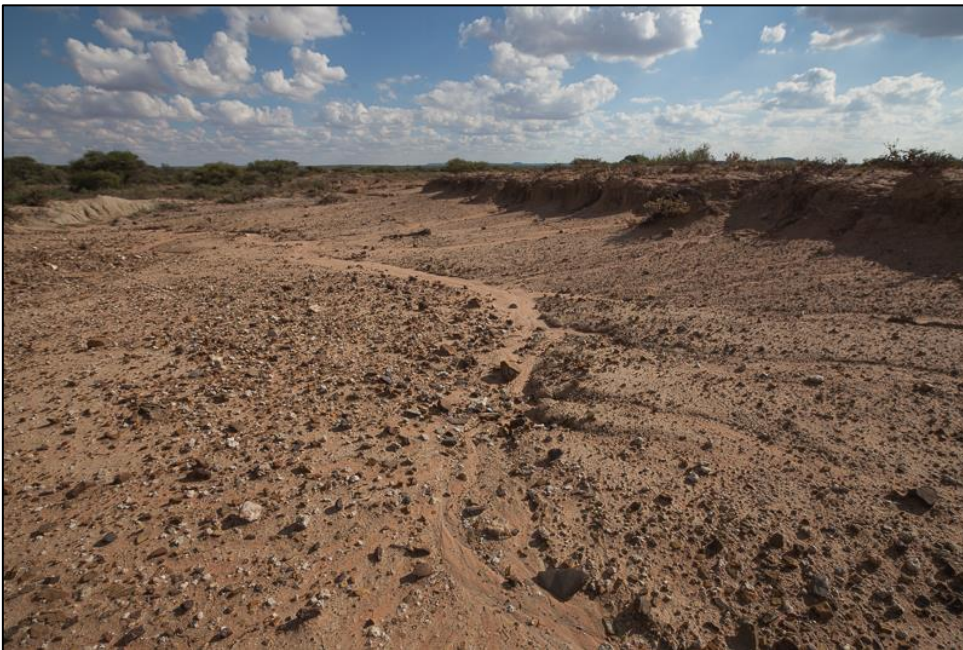
Figure 6 – Eroded area on Chavonne No 364 that has a large scatter of Middle Stone Age artefacts. The area is just outside the 500 m wide Corridor 1 Jacobsdal Link

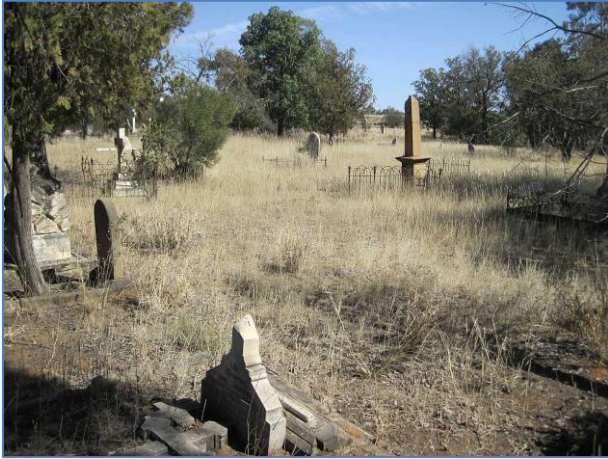
The site was accessed with the help of security of the De Beers mining company. The resource consists of the remains of the historic Jewish cemetery dating from the late 1800s to early 1900s. The cemetery is about 6 hectares in size. It is no longer in use and not maintained.

A small ruin that was most probably a small chapel or sinagoge is also present on the site. The site does have a berm around the southern and western sections.

Figure 7 – General view of the cemetery

Figure 8 – General view of the cemetery

Figure 9 – View of chapel ruin

The site is rated as Grade 3A (Conservation; Mitigation not advised) the site is associated with the history of Kimberley and will have a strong link to some prominent figure of the diamond rush era. A distance of at least 50 m should be maintained from any development associated with the project.

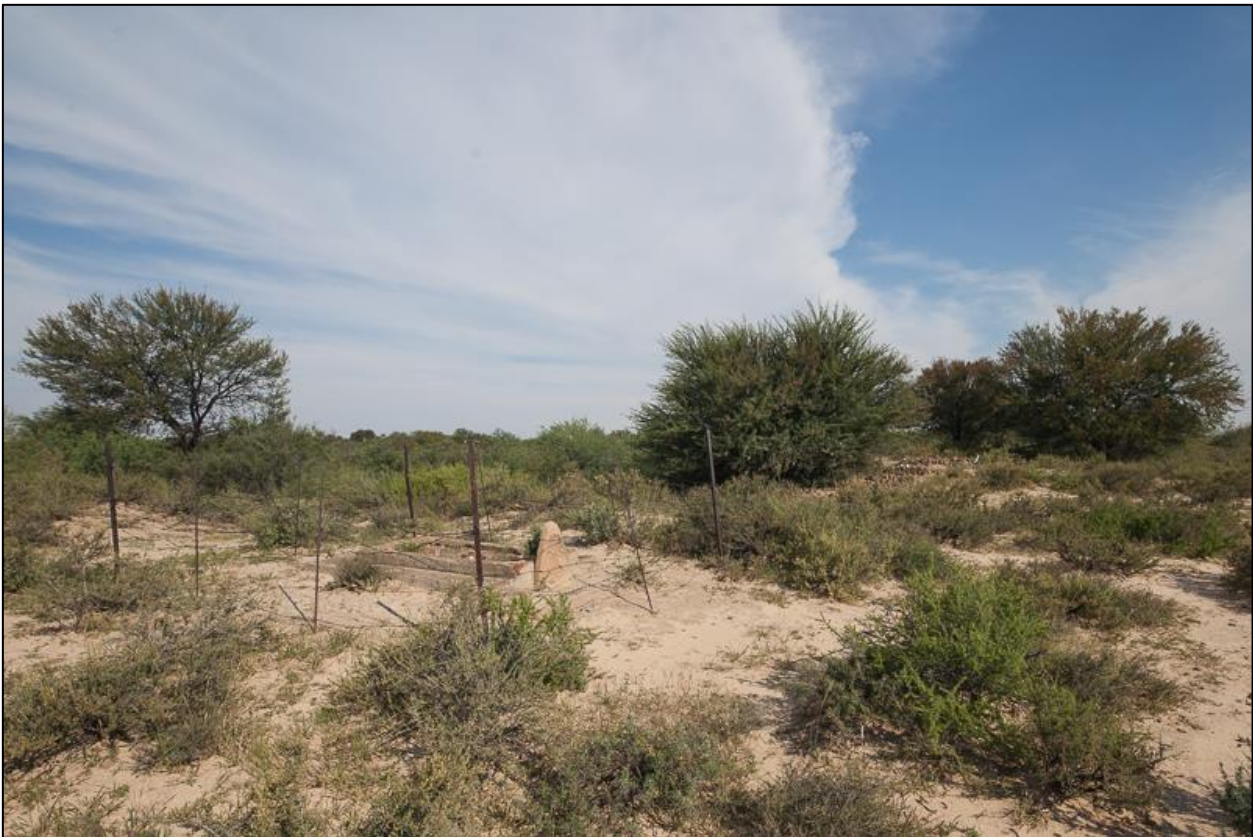
Figure 10 – Site BEZ 001 is a graveyard that is still in use. It is recommended that any development within 20 m of the graveyard be avoided

- Mitigation is not advised. Development should be limited to 20 m from the graveyard.

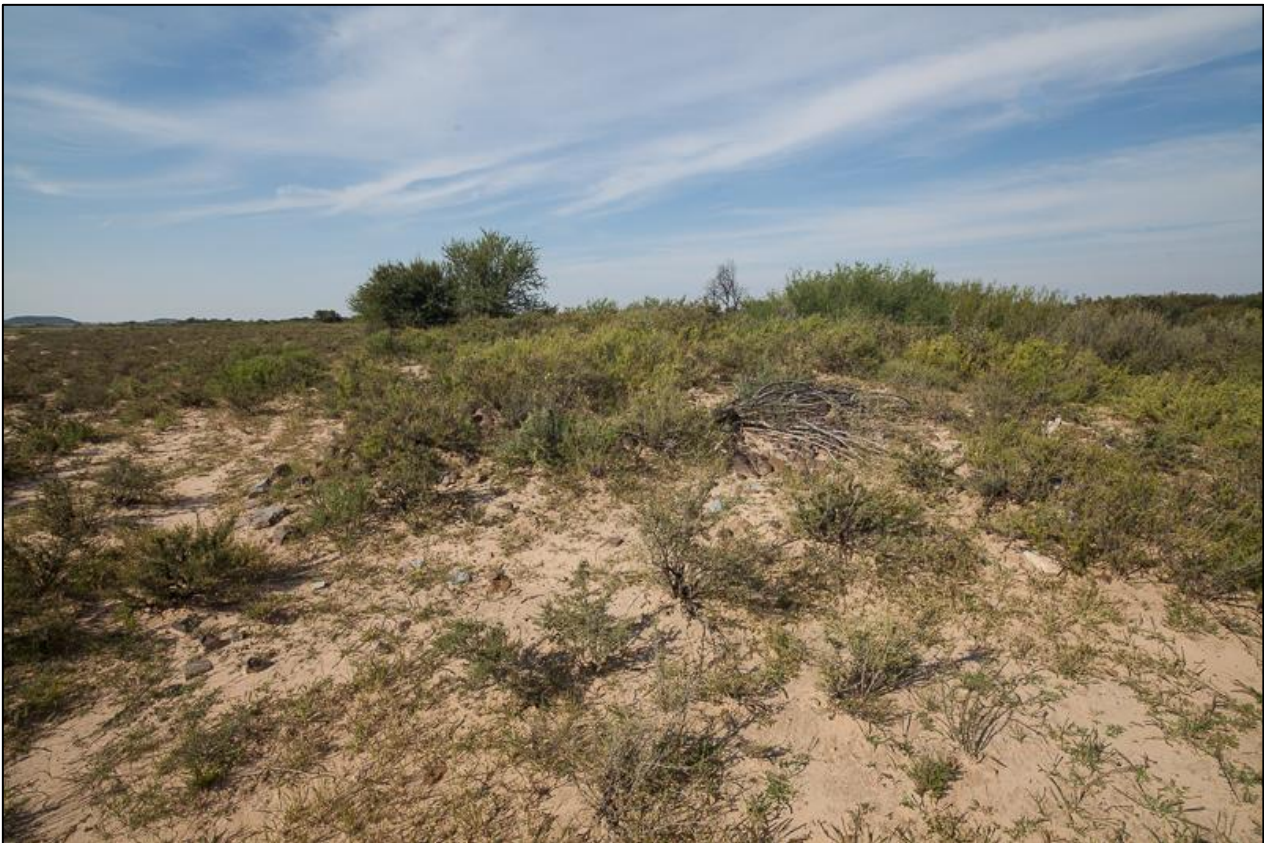
Figure 11 – Site BEZ 002 is a neglected graveyard, probably no longer in use

- The process of grave relocation—negotiations with relatives, notifications, permits, identification of an acceptable alternative site for reburial, exhumation and reburial-- would need to be followed.

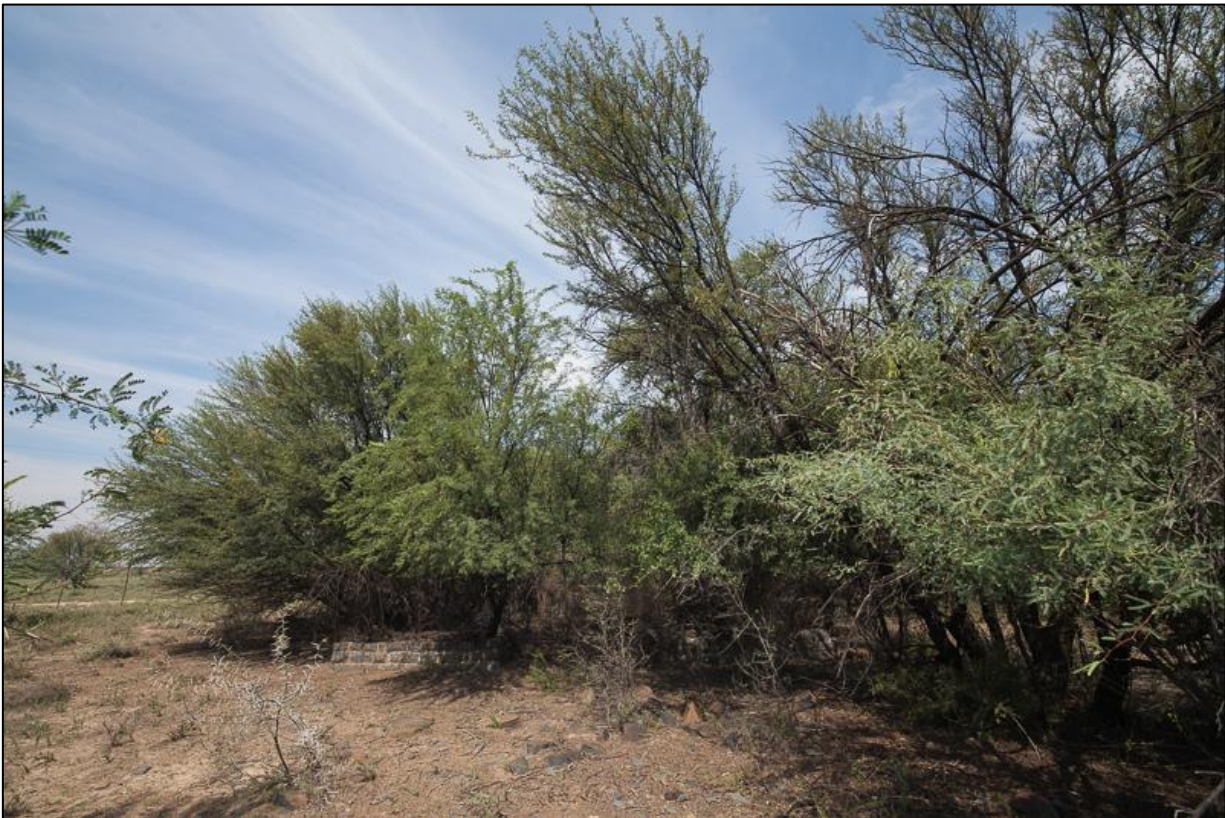
Figure 12 – Overgrown graveyard (Site KLP 001)

- The process of grave relocation—negotiations with relatives, notifications, permits, identification of an acceptable alternative site for reburial, exhumation and reburial-- would need to be followed.

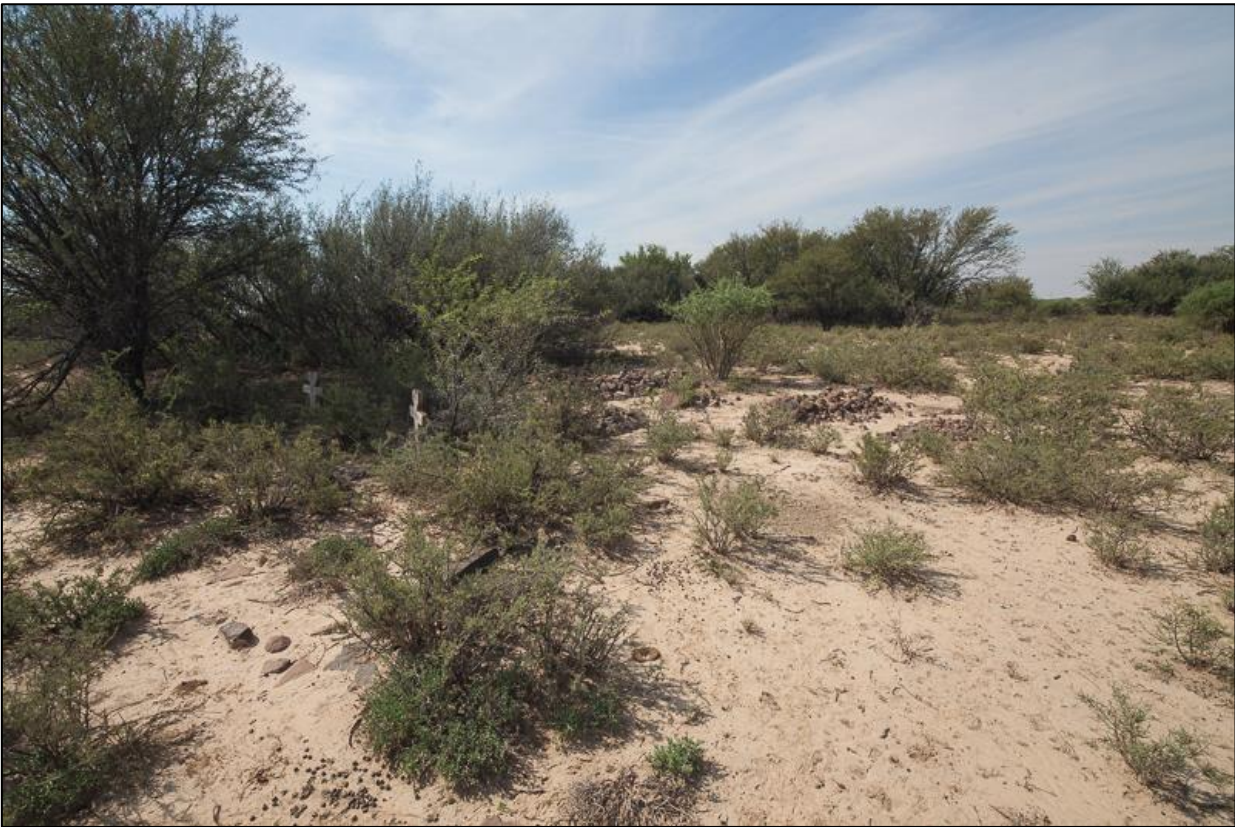
Figure 13 – Graveyard that is still in use (Site KLP 002). It is recommended that the graveyard be conserved and that no development take place closer than 20 m to the site

- Mitigation is not advised, development should be limited to 20 m from the graveyard.

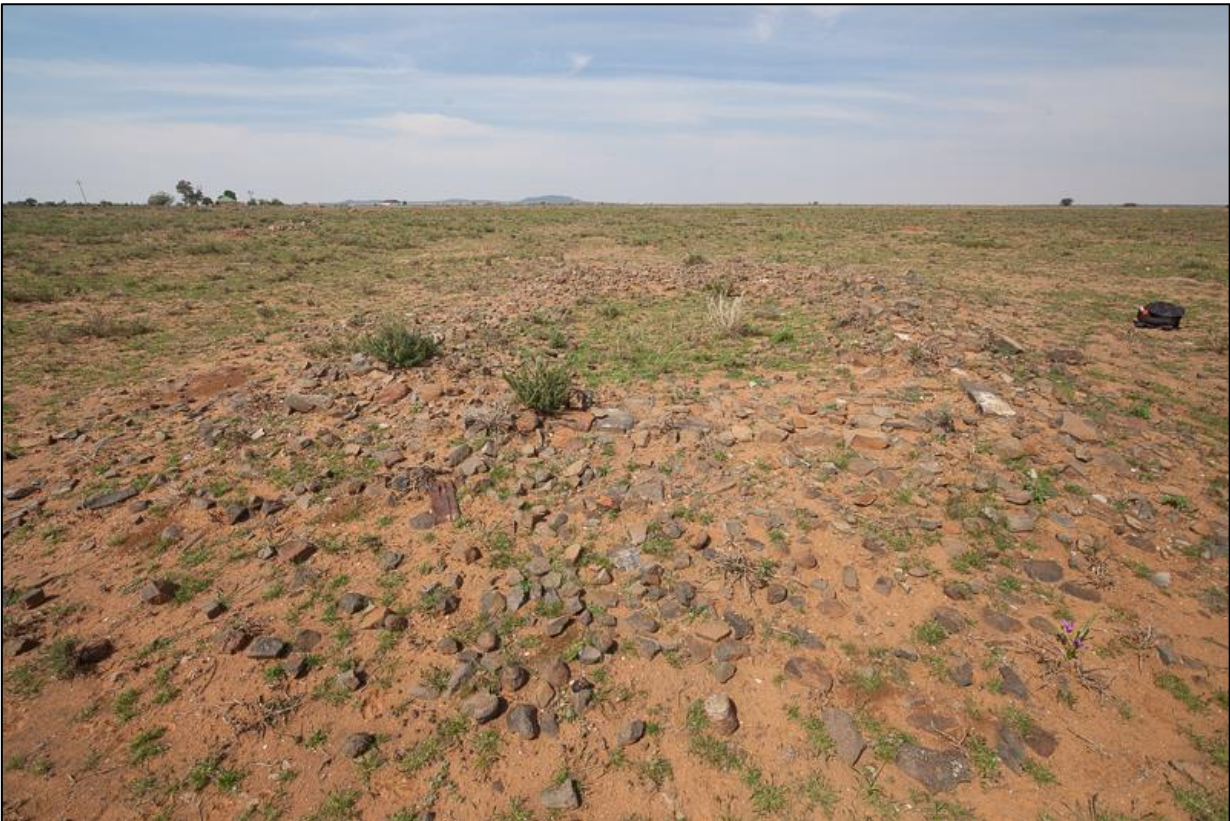
Figure 14 – The remains of a kraal built of stone (Site KLP 003)

- The site should be recorded before destruction.

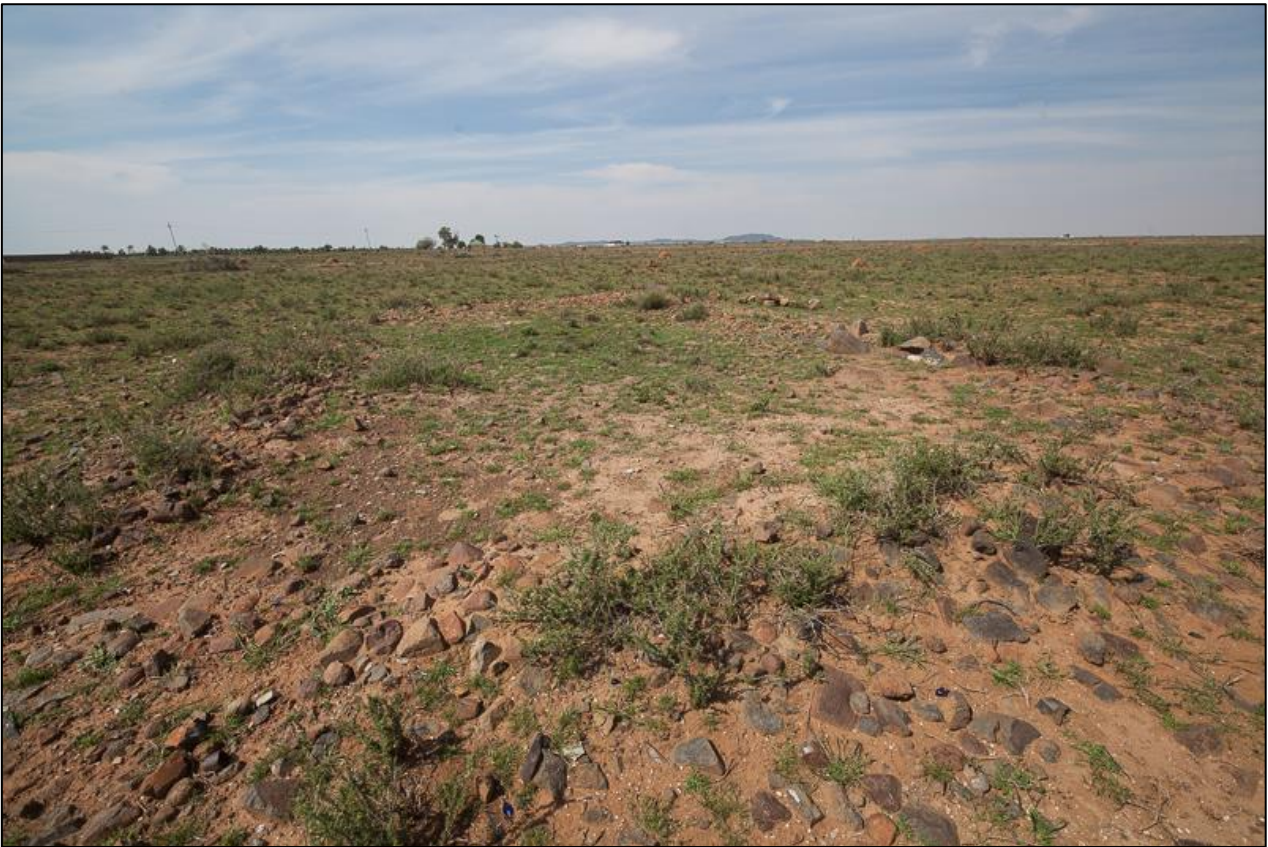
Figure 15 – Remains of a kraal (Site KLP 004)

- The site should be recorded before destruction.

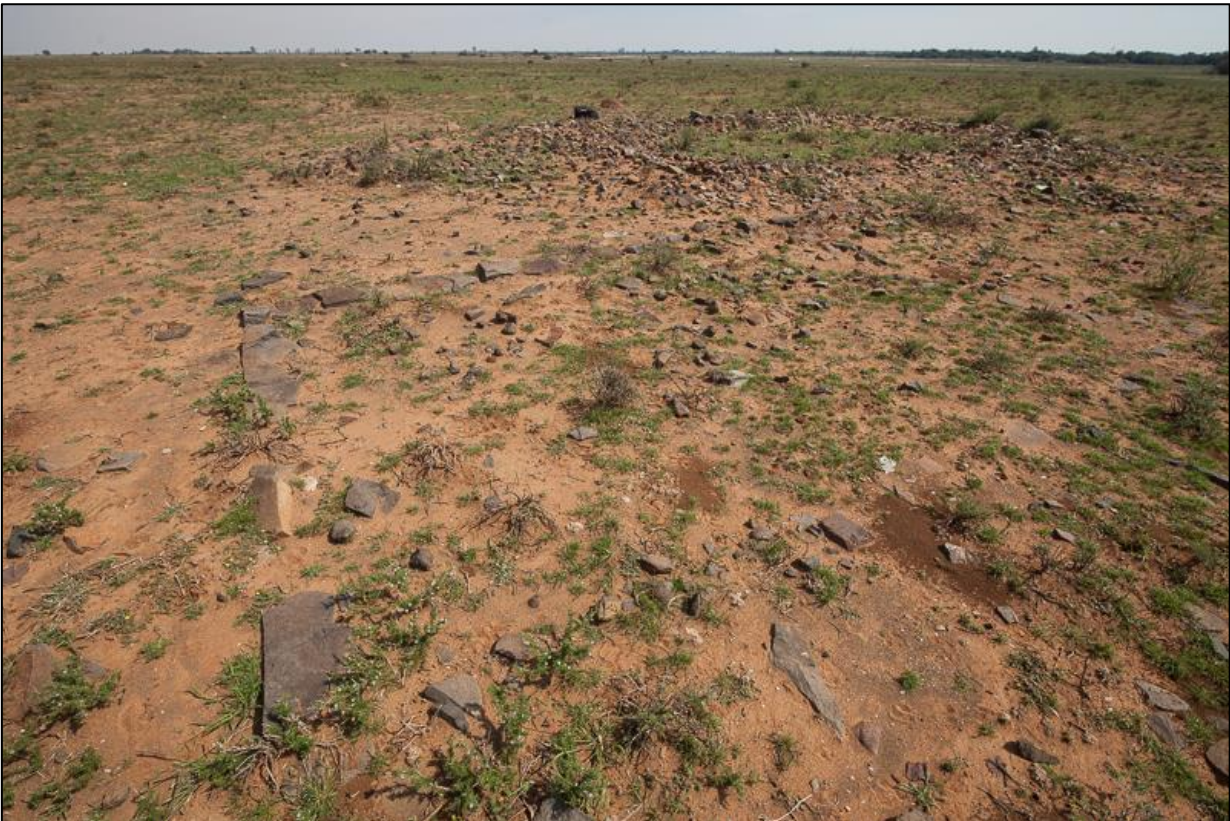
These are the remains of a walled building about 2 m by 2 m on Klipdrift No 20 Rem. Only the foundations remain.

Figure 16 – Remains of walled structure broken down to its foundations (KLP 005)

- The site should be recorded before destruction.

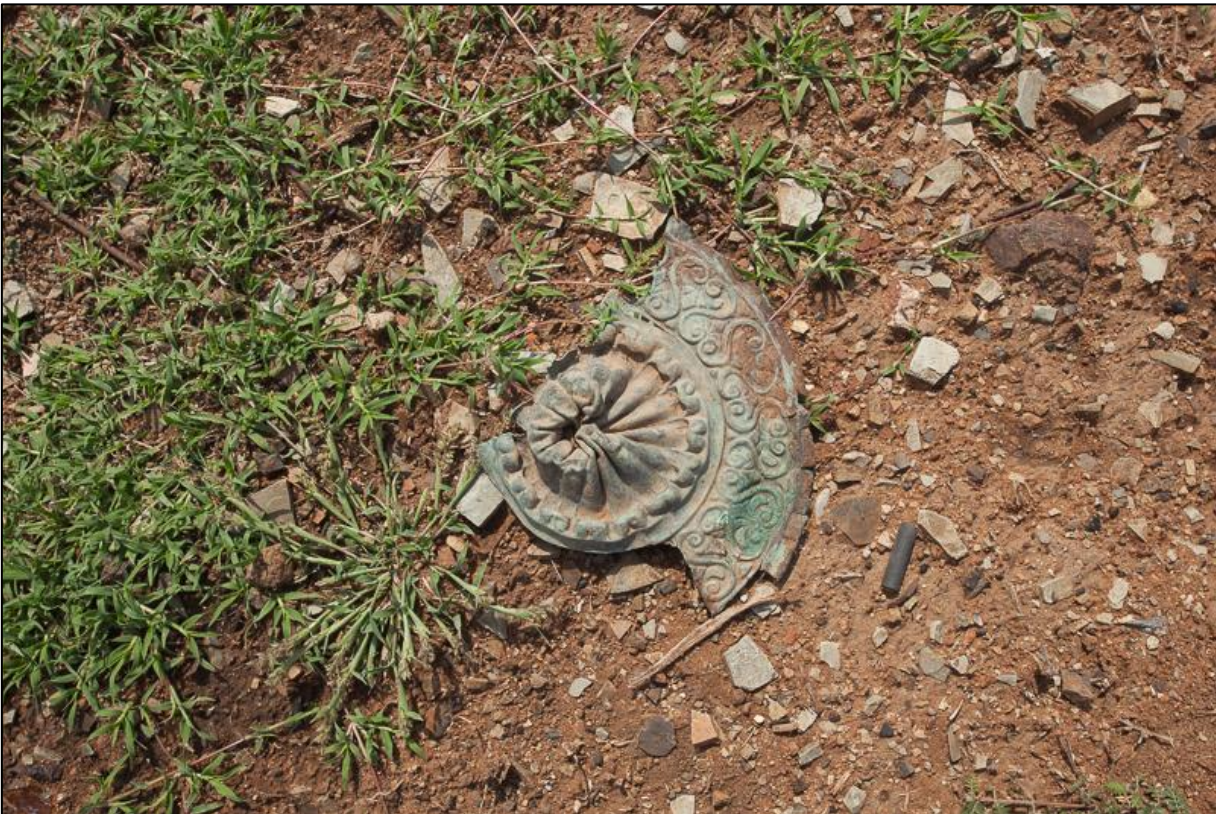
Figure 17 – Possible ceiling fixture found on ash heap on Rem of Klipdrift No 20 (KLP 006)

- The site should be recorded before destruction.

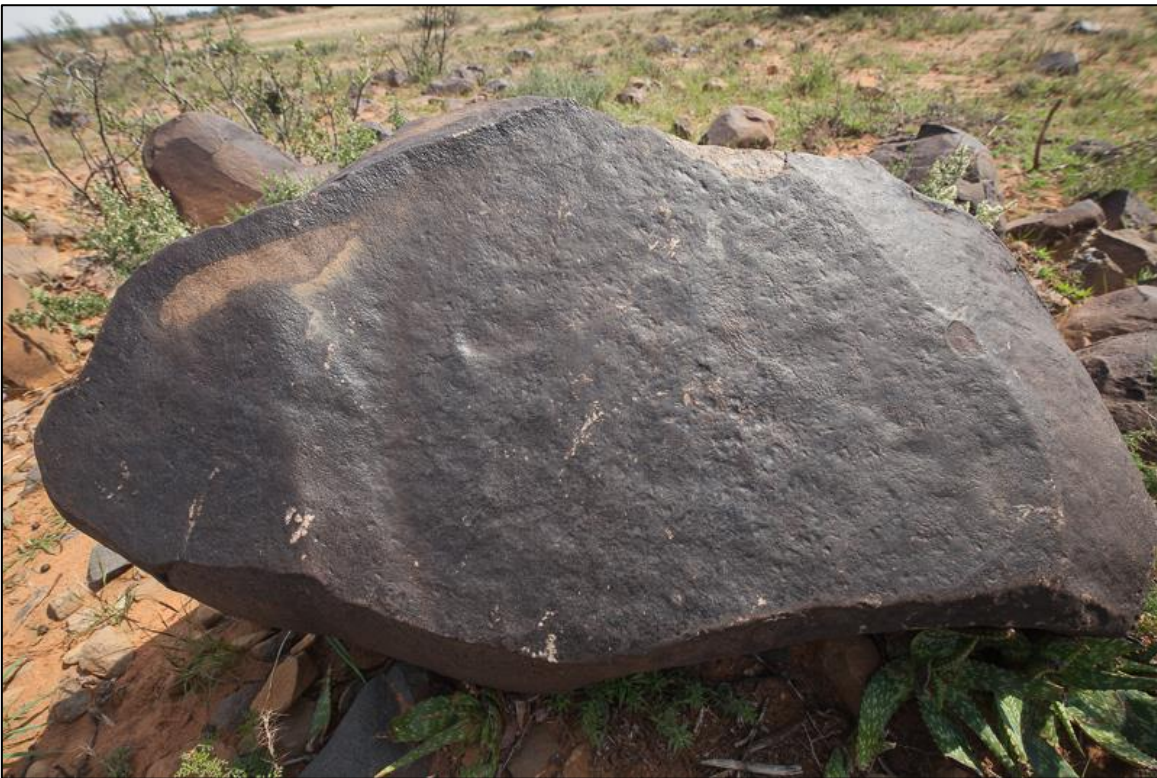
Figure 18 – Engraved dolerite boulder (Site KLP 007)

- Mitigation not advised. Development should be limited to 20 m from the engraved boulder.

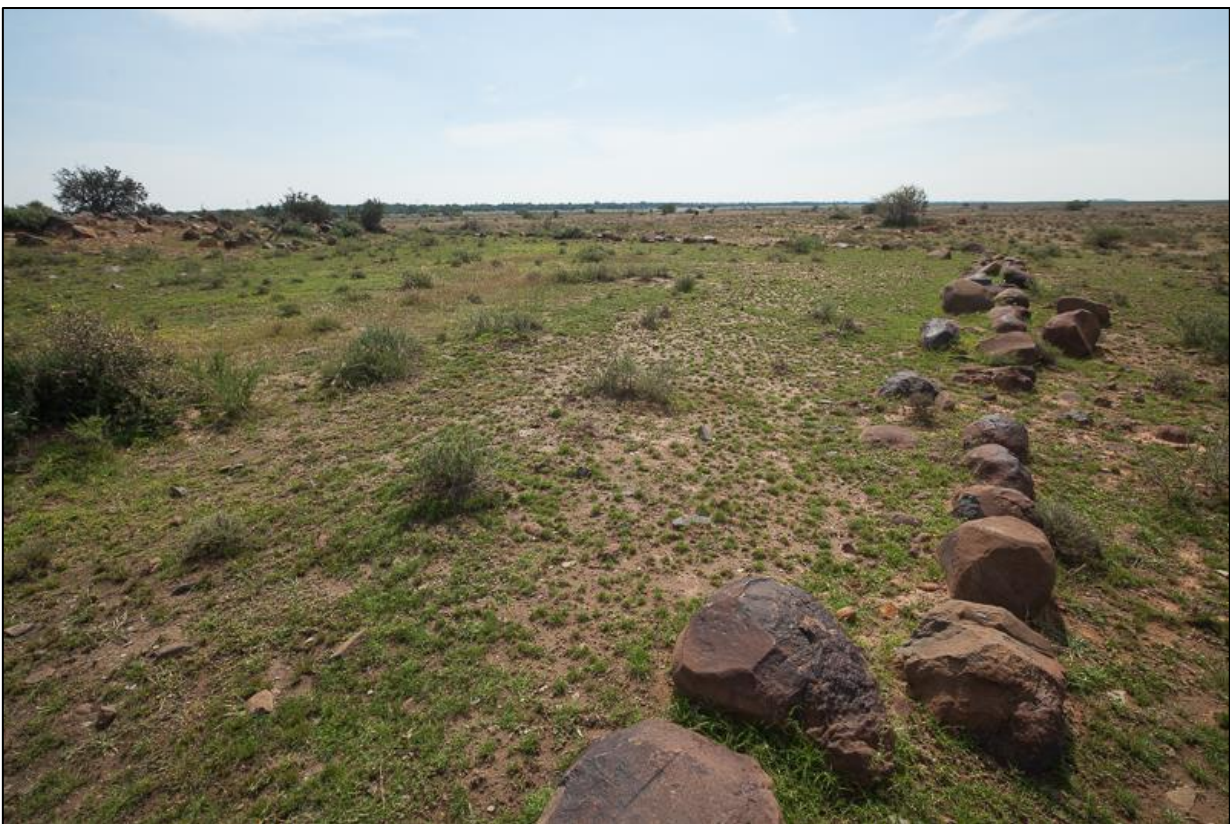
Figure 19 – Outline of a rectangular kraal structure (KLP 008)

- It is advised that the alignment of the OHL be kept at least 50 meters away from this site. If not possible the following mitigation will be required:
- The site should be recorded before destruction.

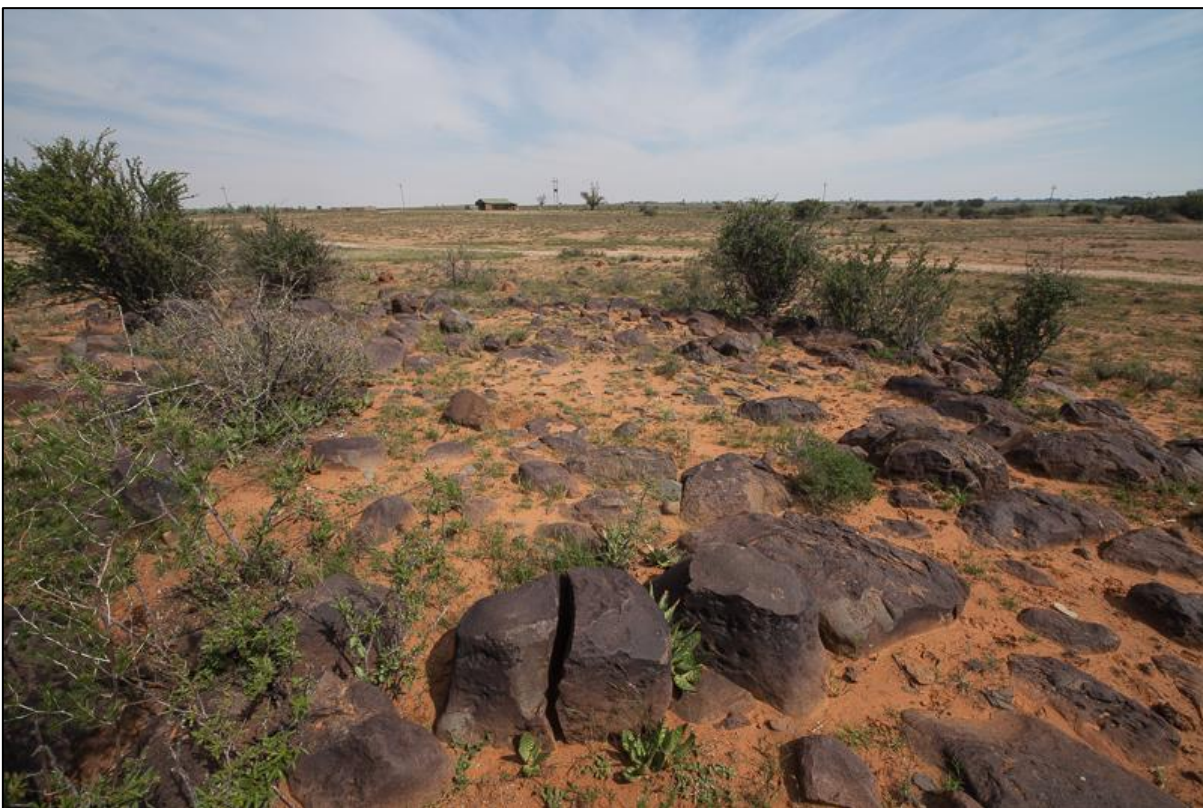
Figure 20 – Circular enclosure on low rise (KLP 009)

- It is advised that the alignment of the OHL be kept at least 50 meters away from this site. If not possible the following mitigation will be required:
- The site should be recorded before destruction.

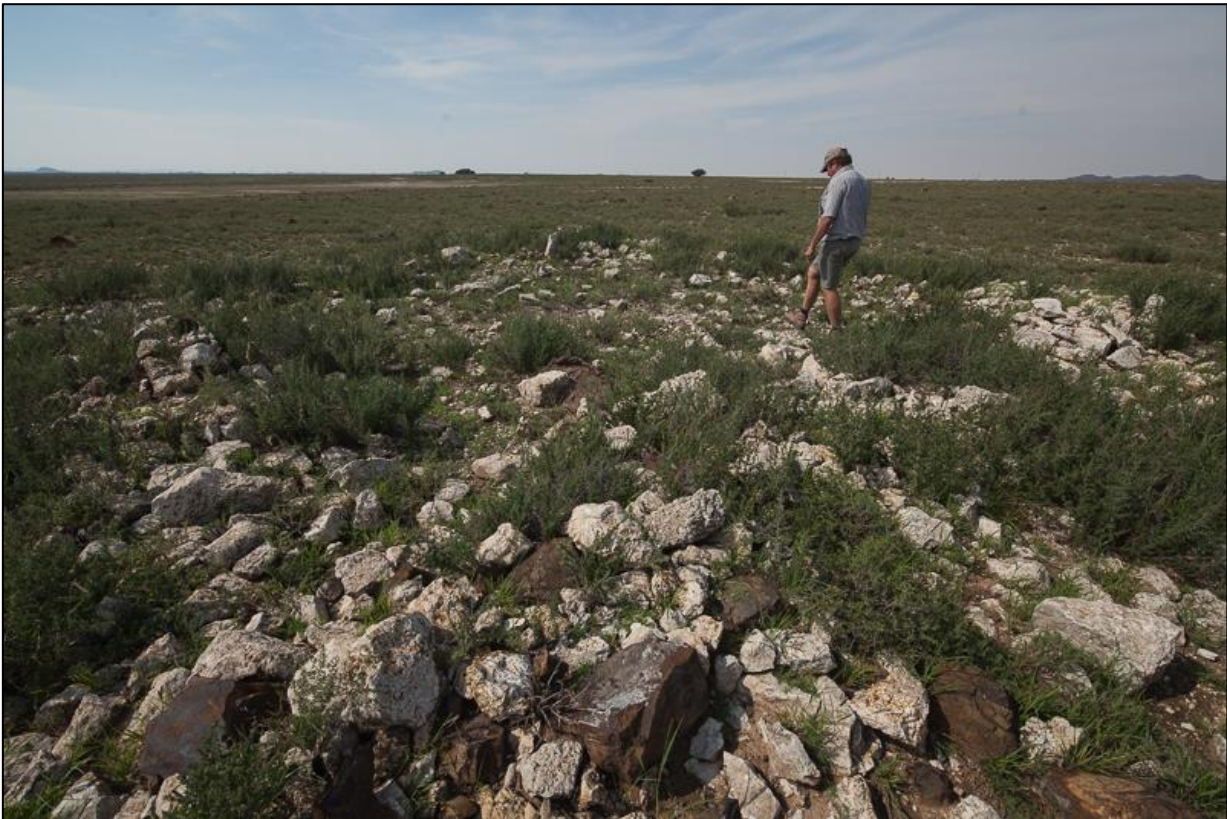
Figure 21 – Possible kraals built of locally sourced, roughly dressed stone (KLP 010)

- It is advised that the alignment of the OHL be kept at least 50 meters away from this site. If not possible the following mitigation will be required:
- Research needs to be done into the historical significance of the kraals and the other structures that comprise the homestead.
- The homestead should be mapped, laser-scanned and photographed. The documentation should be archived where it is accessible to the public.

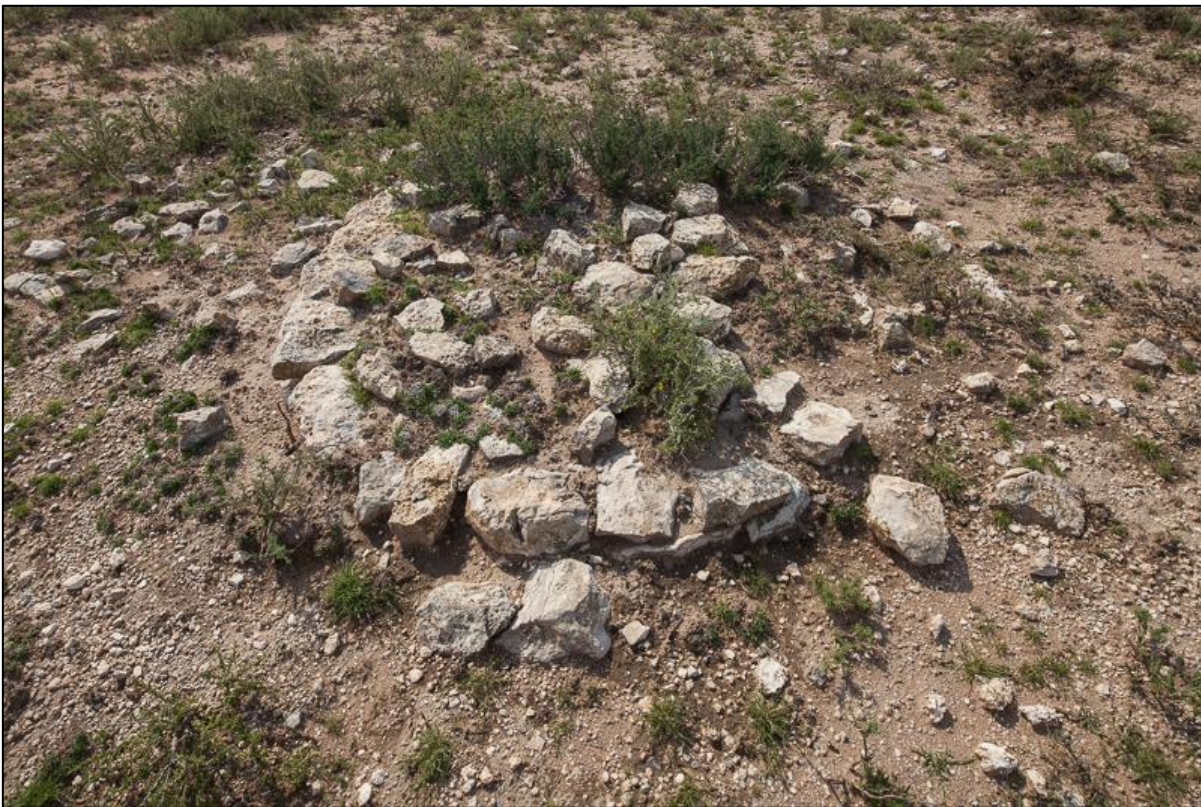
Figure 22 – Circular structure of stones (KLP 011)

- It is advised that the alignment of the OHL be kept at least 50 meters away from this site. If not possible the following mitigation will be required:
- Research needs to be done into the historical significance of this circular structure and the other structures that comprise the homestead.
- The homestead should be mapped, laser-scanned and photographed. The documentation should be archived where it is accessible to the public.

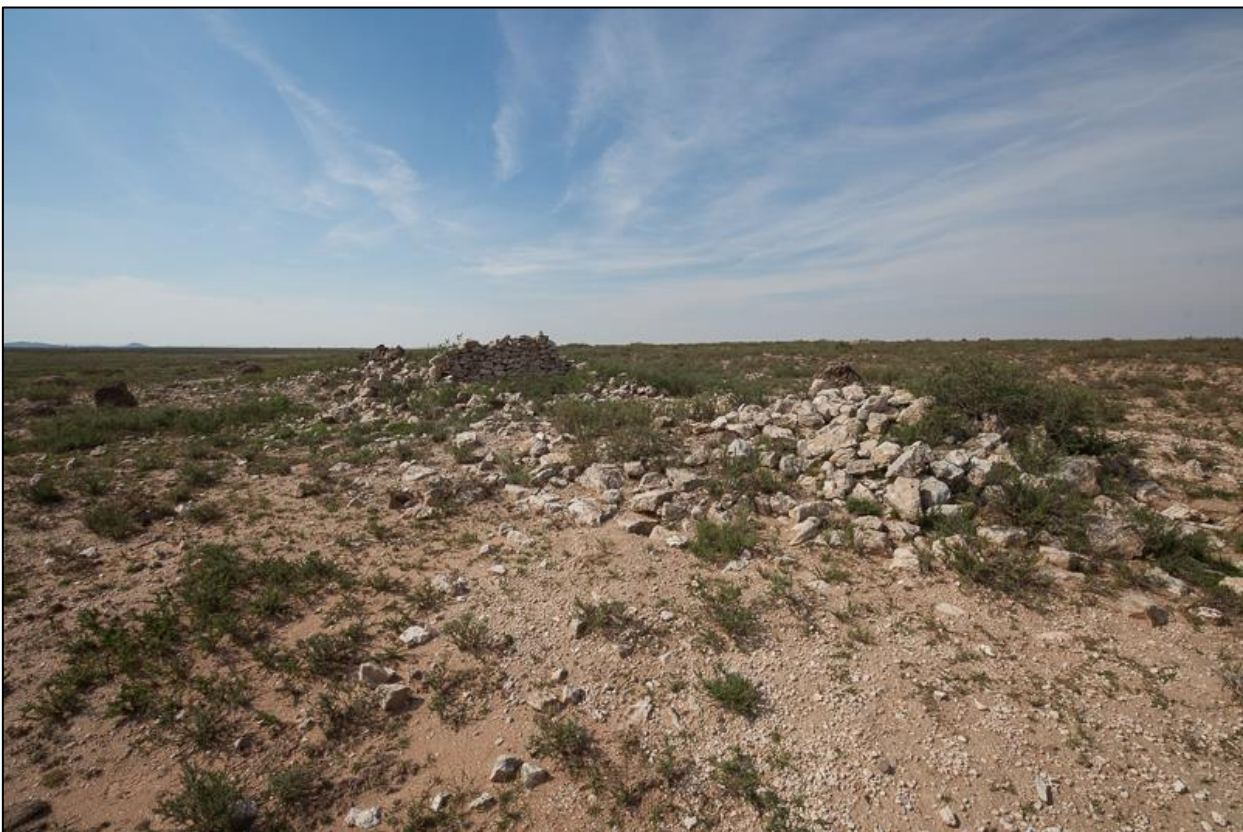
Figure 23 – Ruined house possibly 19th century, built of local stone (KLP 012)

- It is advised that the alignment of the OHL be kept at least 50 meters away from this site. If not possible the following mitigation will be required:
- Research needs to be done into the historical significance of this house and the other structures that comprise the homestead.
- The homestead should be mapped, laser-scanned and photographed. The documentation should be archived where it is accessible to the public.

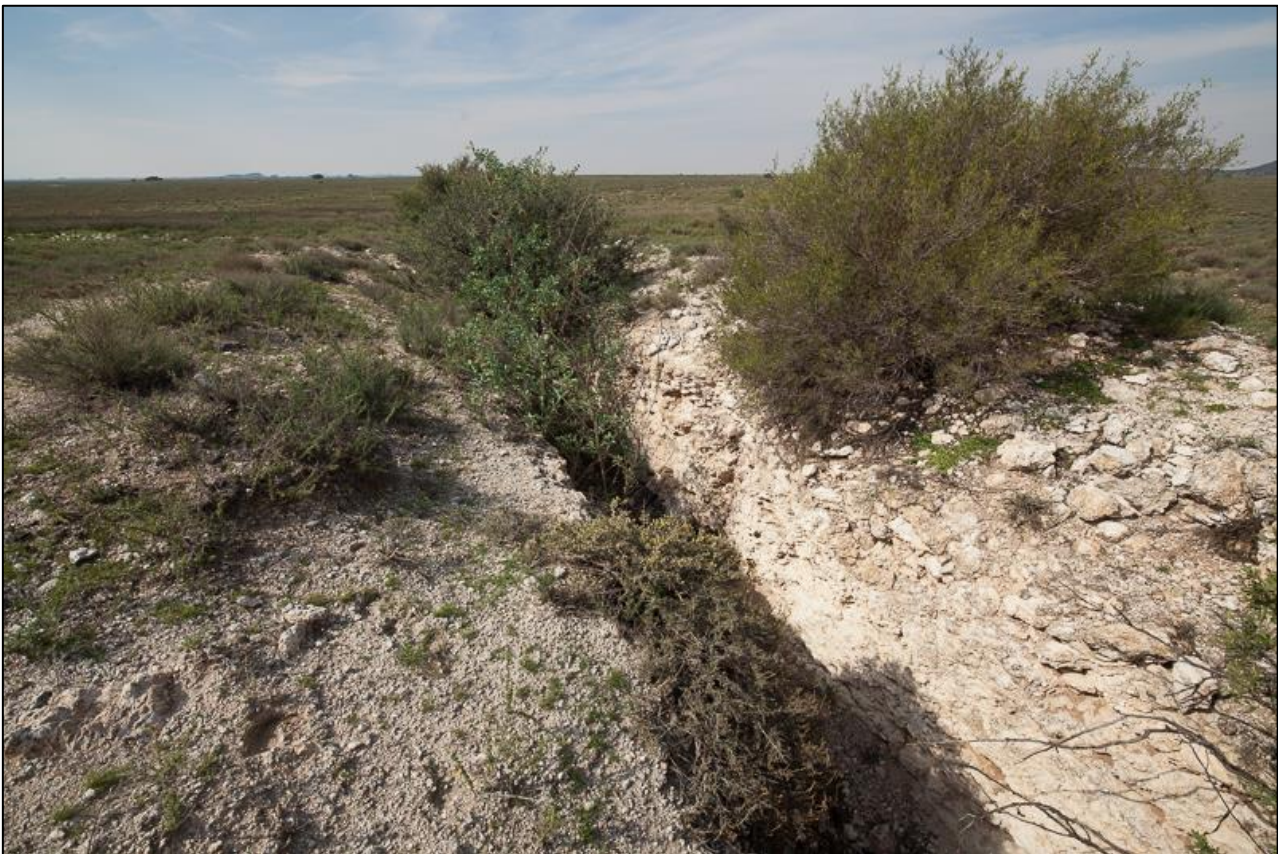
Figure 24 – Spring that has been dug open (KLP 013). It is probably part of the nearby homestead (KLP 010-012)

- It is advised that the alignment of the OHL be kept at least 50 meters away from this site. If not possible the following mitigation will be required:
- Research needs to be done into the historical significance of this house and the other structures that comprise the homestead.
- The homestead should be mapped, laser-scanned and photographed. The documentation should be archived where it is accessible to the public.

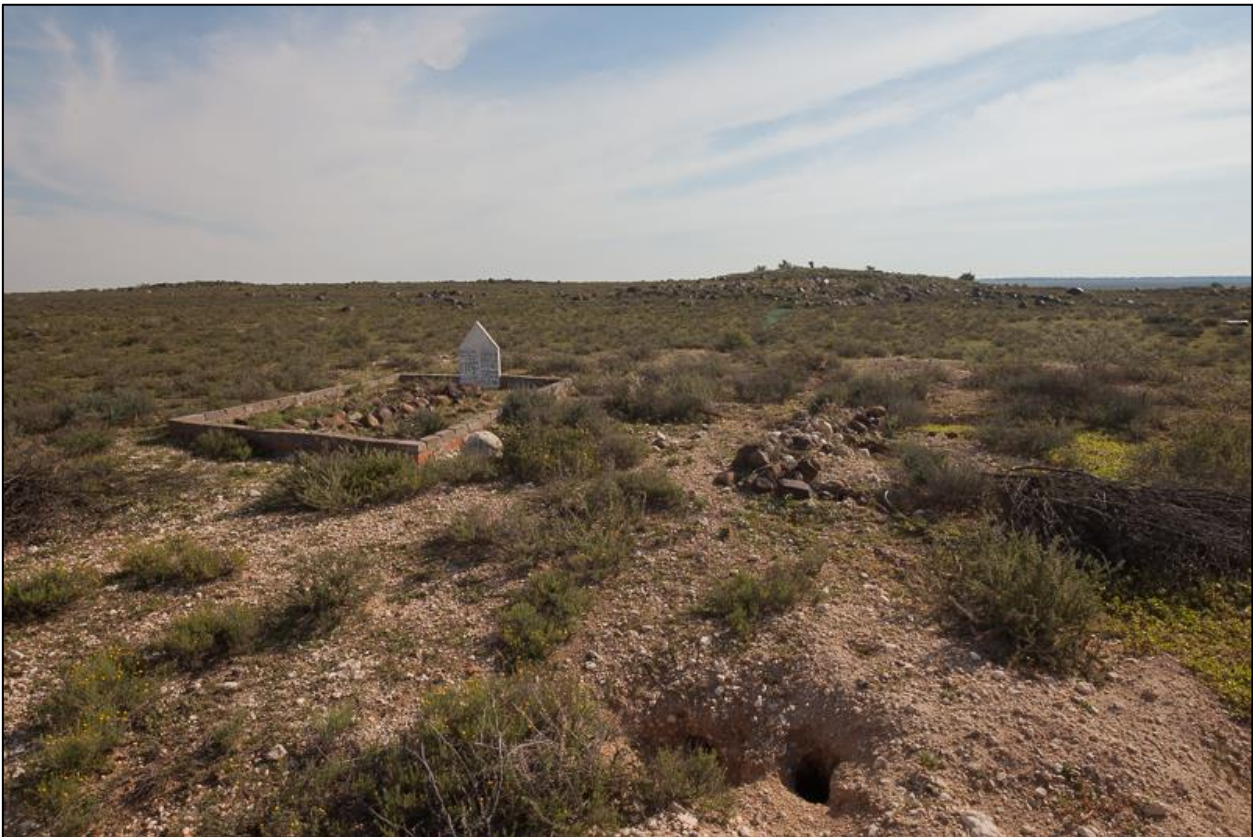
Figure 25 – Graves on Judex No 240 (JDX 001)

- It is advised that the alignment of the OHL be kept at least 50 meters away from this site. If not possible the following mitigation will be required:
- The process of grave relocation—negotiations with relatives, notifications, permits, identification of an acceptable alternative site for reburial, exhumation and reburial-- would need to be followed.

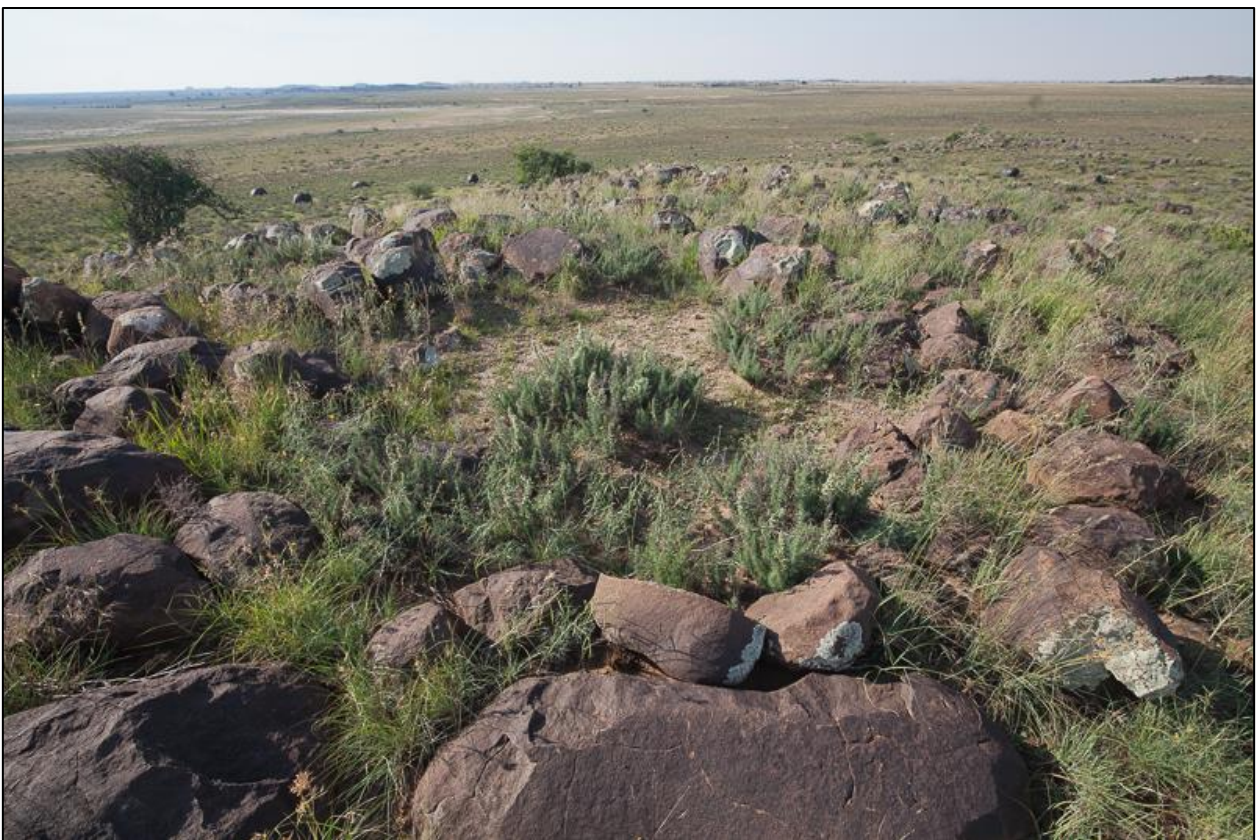
Figure 26 – Circular enclosure of dolerite hilltop (JDX 002)

- It is advised that the alignment of the OHL be kept at least 50 meters away from this site. If not possible the following mitigation will be required:
- The site should be recorded before destruction.

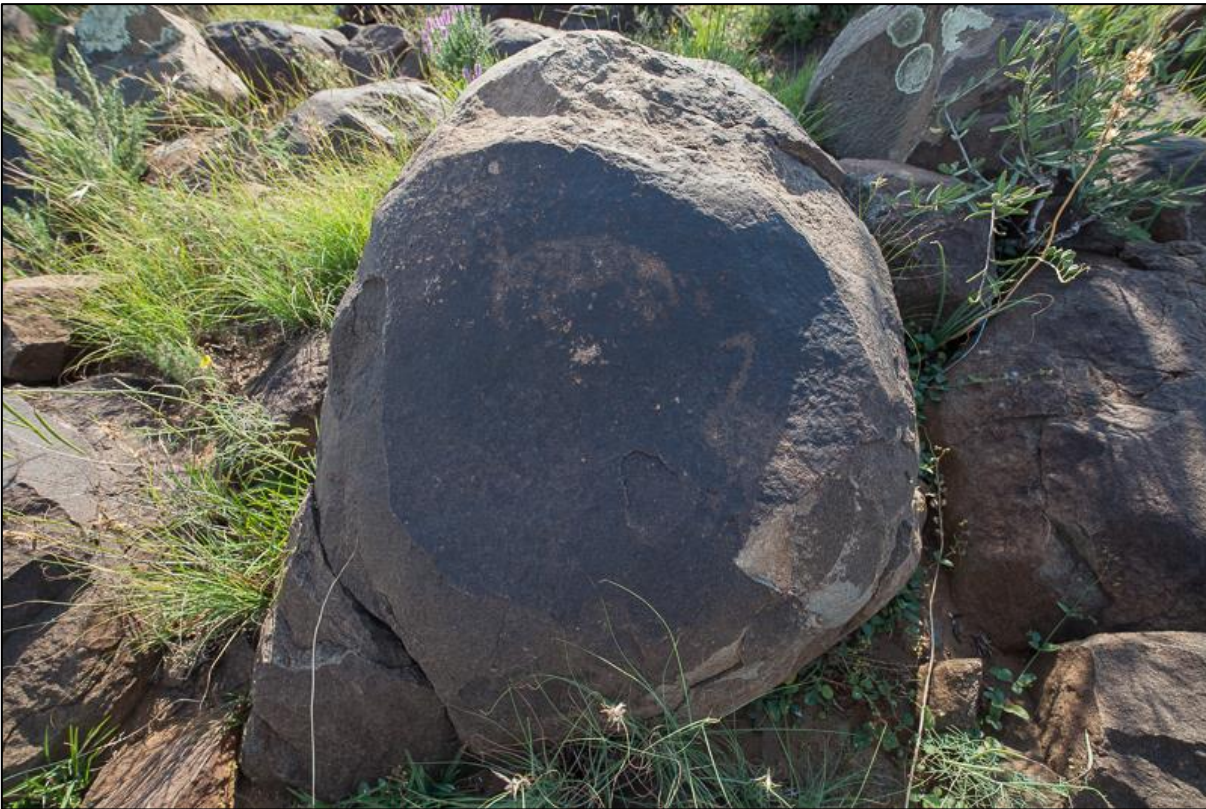
Figure 27 – Two scraped engravings: an ostrich at right. Unknown animal at left (JDX 003)

- Mitigation not advised. Development should be restricted to 20 m from the engraved boulder.

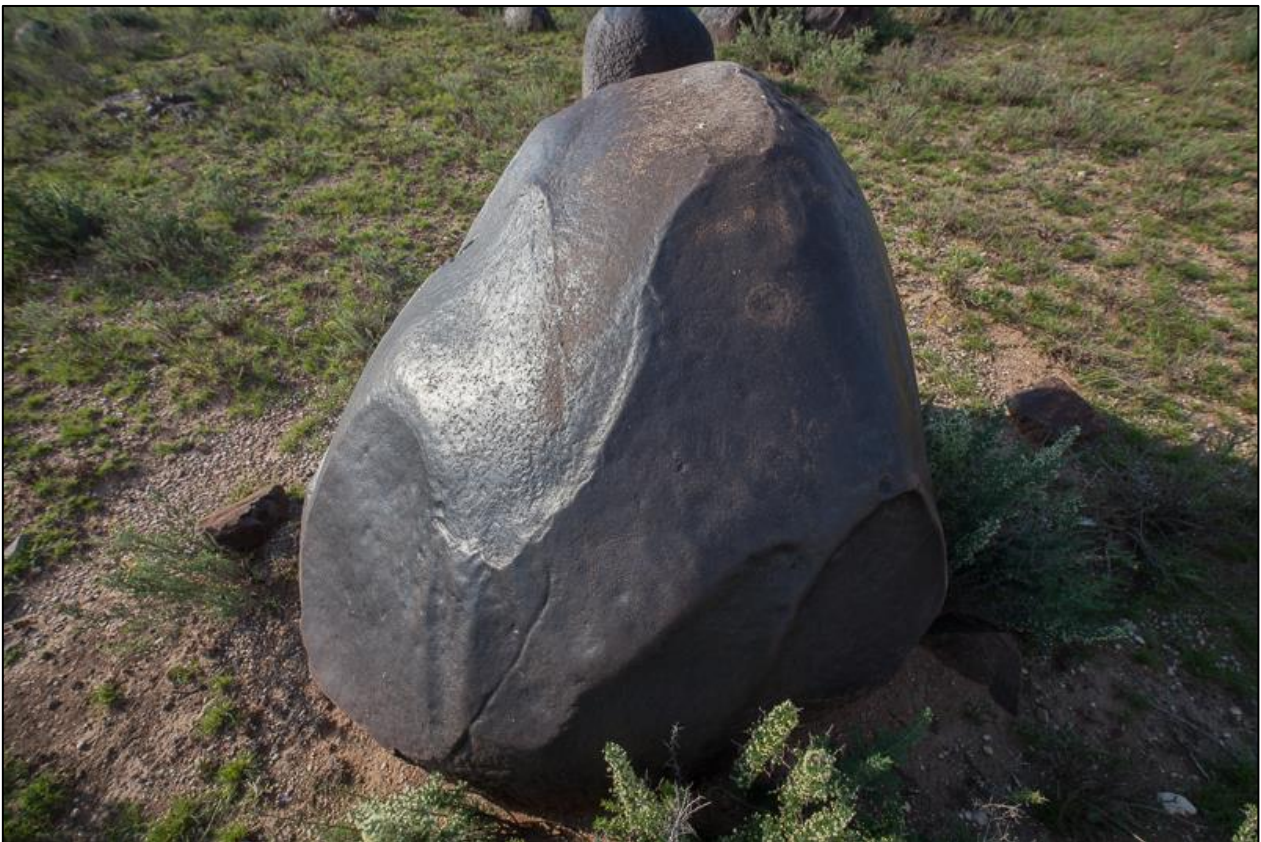
Figure 28 -- Engraved dolerite boulder with at least five circular motifs and a pecked right-facing four-legged animal with horns (JDX 004)

- Mitigation not advised. Development should be restricted to 20 m from the engraved boulder.
