PROPOSED CONSTRUCTION OF A 132KV POWER LINE AND ASSOCIATED INFRASTRUCTURE FOR THE EVACUATION OF POWER FROM THE PROPOSED KALKAAR CONCENTRATING SOLAR THERMAL POWER PROJECT ON THE REMAINDER OF PORTION 1 OF THE FARM KALKAAR 389 NEAR JACOBSDAL, FREE STATE AND NORTHERN CAPE PROVINCES

Heritage Impact Assessment

Issue Date: 25 November 2016
Revision No.: 3
Project No.: 13620

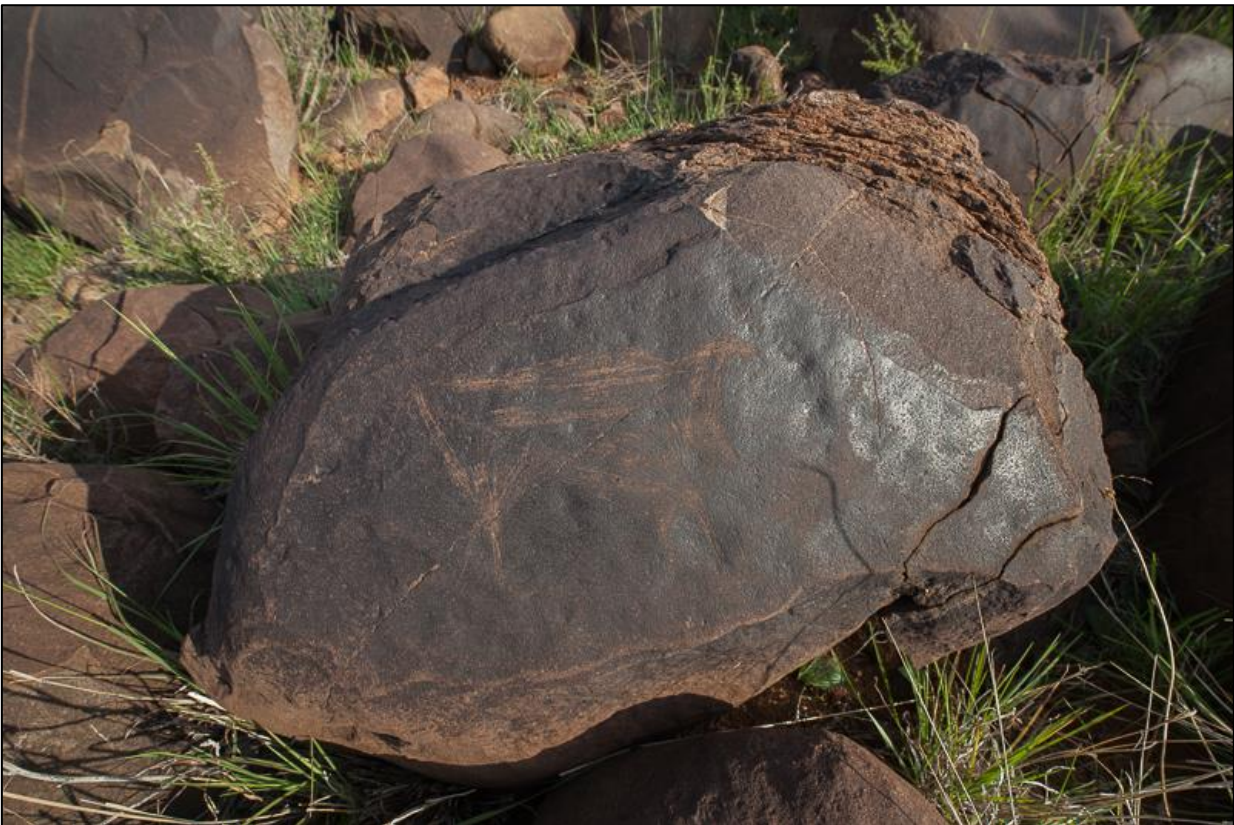
Figure 29 -- Scraped engraving of a right-facing eland (JDX 005)

- Mitigation not advised. Development should be restricted to 20 m from the engraved boulder.

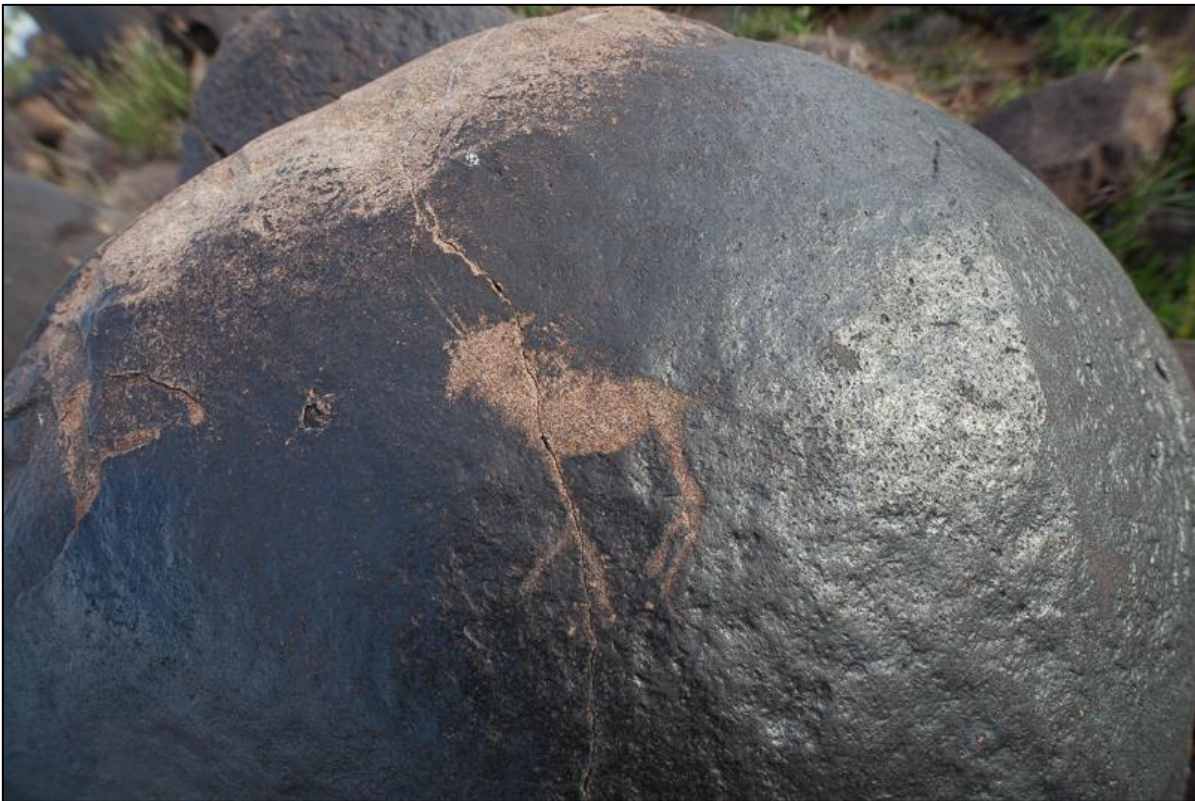
Figure 30 – Engraving of a possible antelope with curious and unrealistically splayed hooves (JDX 006)

- Mitigation not advised. Development should be restricted to 20 m from the engraved boulder.

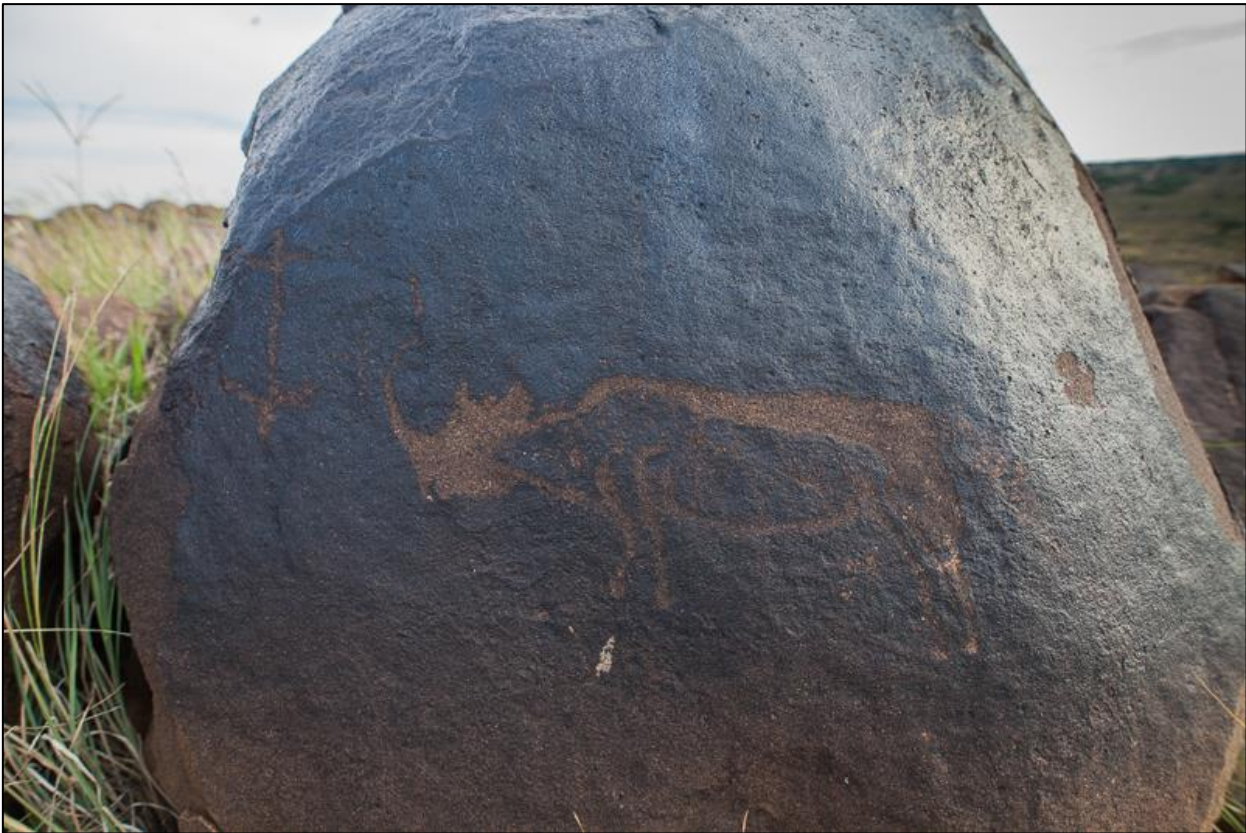
Figure 31 – Engraving of a rhinoceros (JDX 007)

- Mitigation not advised. Development should be restricted to 20 m from the engraved boulder.

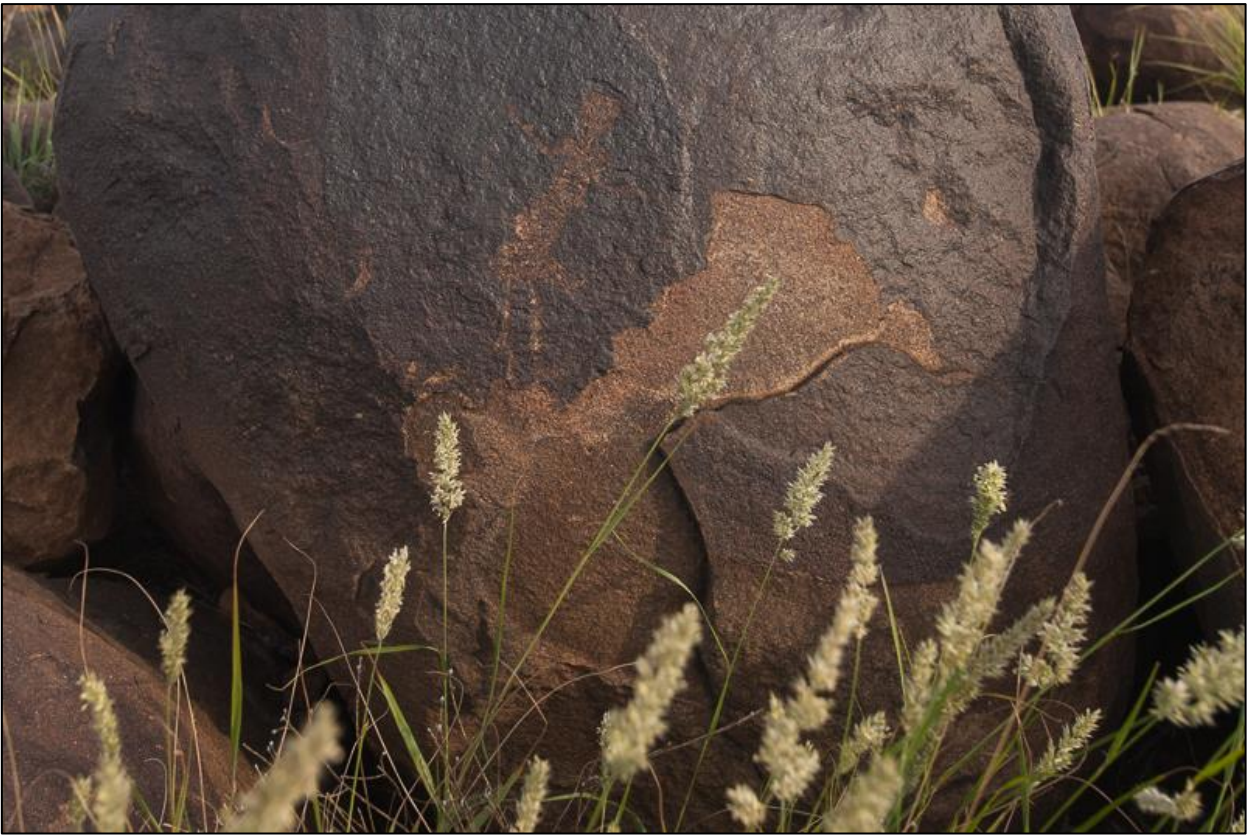
Figure 32 – Scraped engraving of dancing anthropomorph (JDX 008)

- Mitigation not advised. Development should be restricted to 20 m from the engraved boulder.

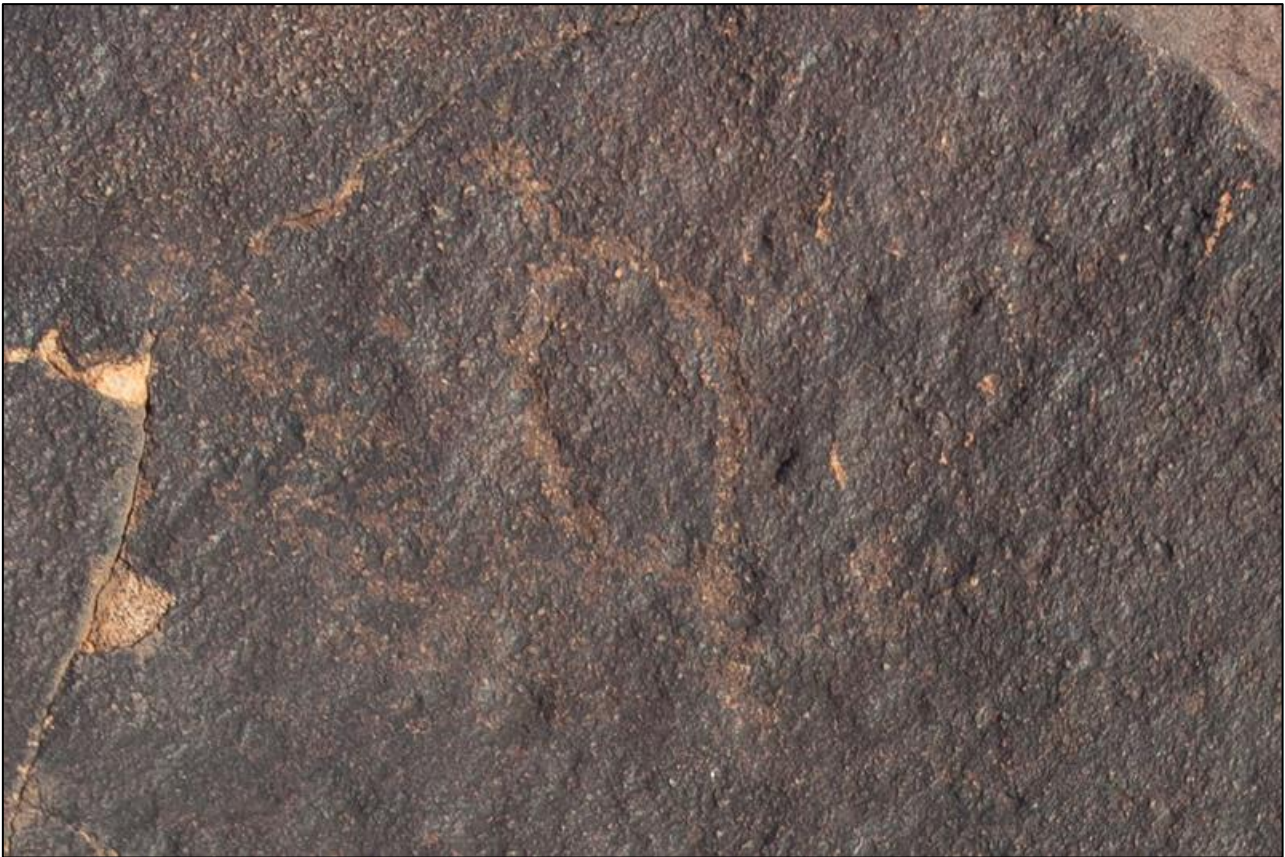
Figure 33 – Engraving of an elliptical shape with two short, straight lines at either end (JDX 009)

- Mitigation not advised. Development should be restricted to 20 m from the engraved boulder.

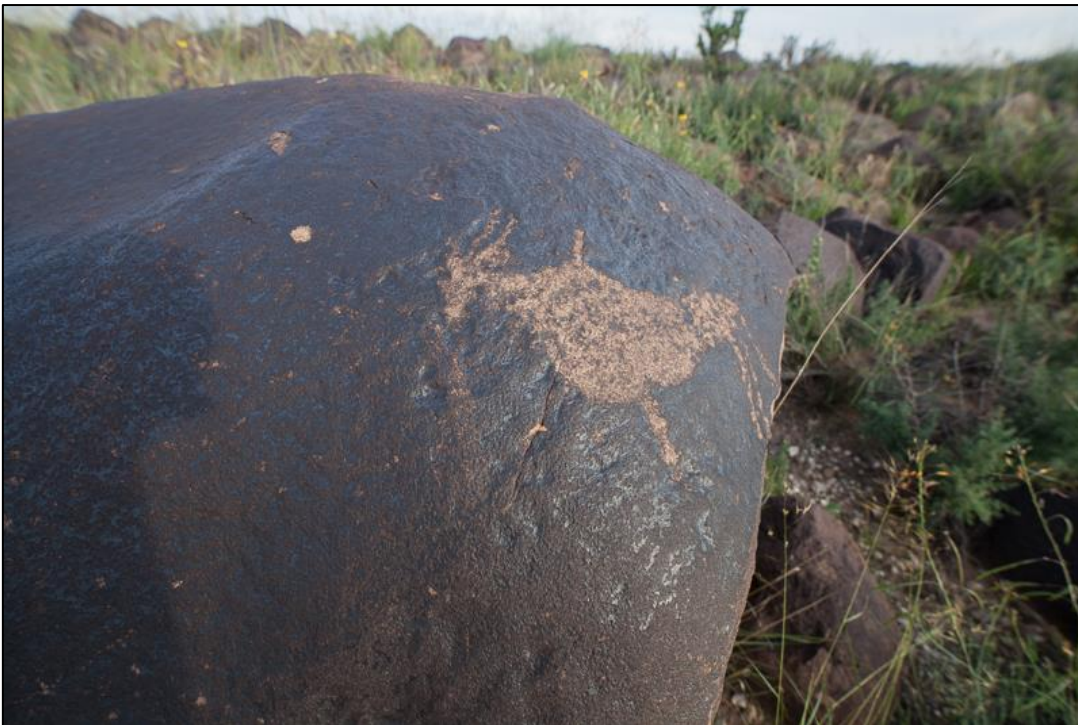
Figure 34 – Engraving of an eland (JDX 011)

- Mitigation not advised. Development should be restricted to 20 m from the engraved boulder.

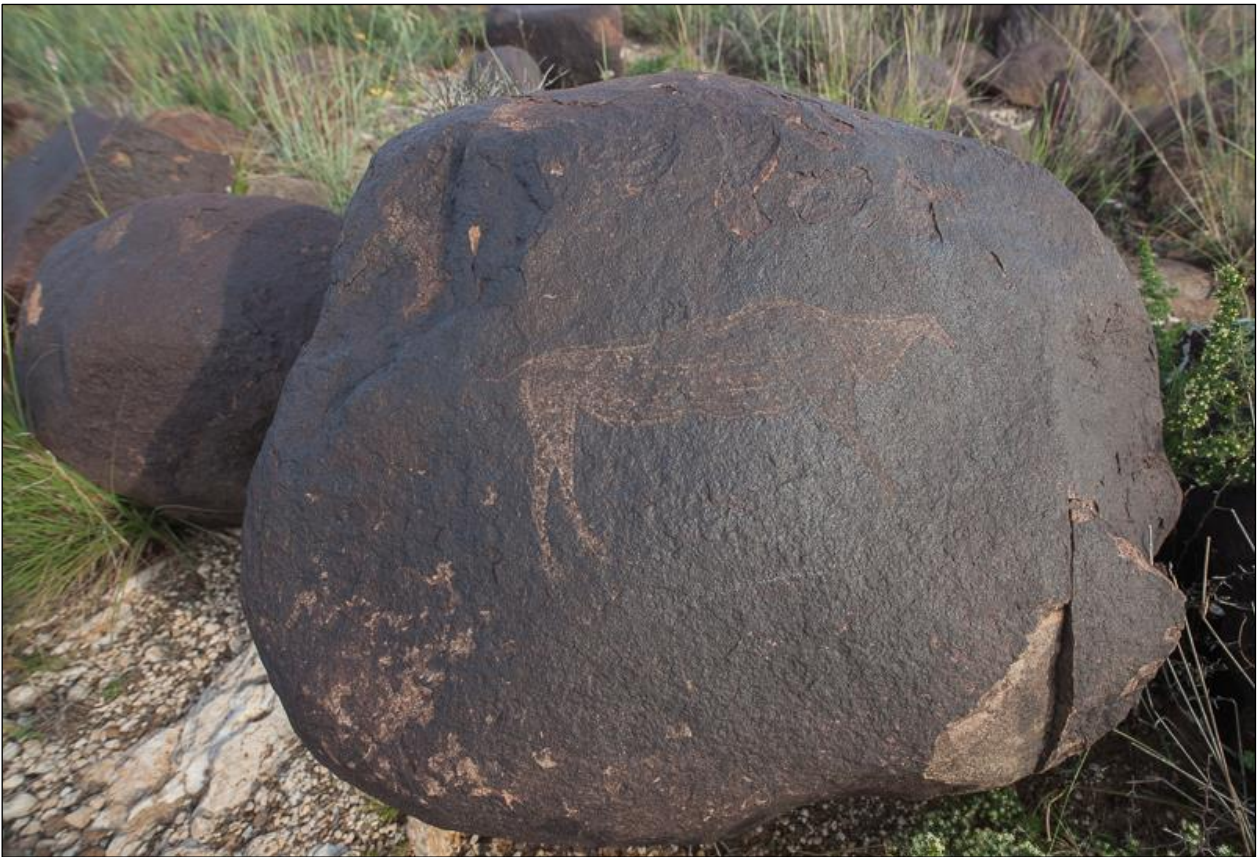
Figure 35 – Engraving of an eland (JDX 012)

- Mitigation not advised. Development should be restricted to 20 m from the engraved boulder.
