# EIA REF. NO.: DM/0004/2018

## DRAFT BASIC ASSESSMENT REPORT

PROPOSED INANDA GLEBE SEWER RETICULATION PROJECT,  
LOCATED WITHIN THE ETHEKWINI MUNICIPALITY, KWAZULU-  
NATAL

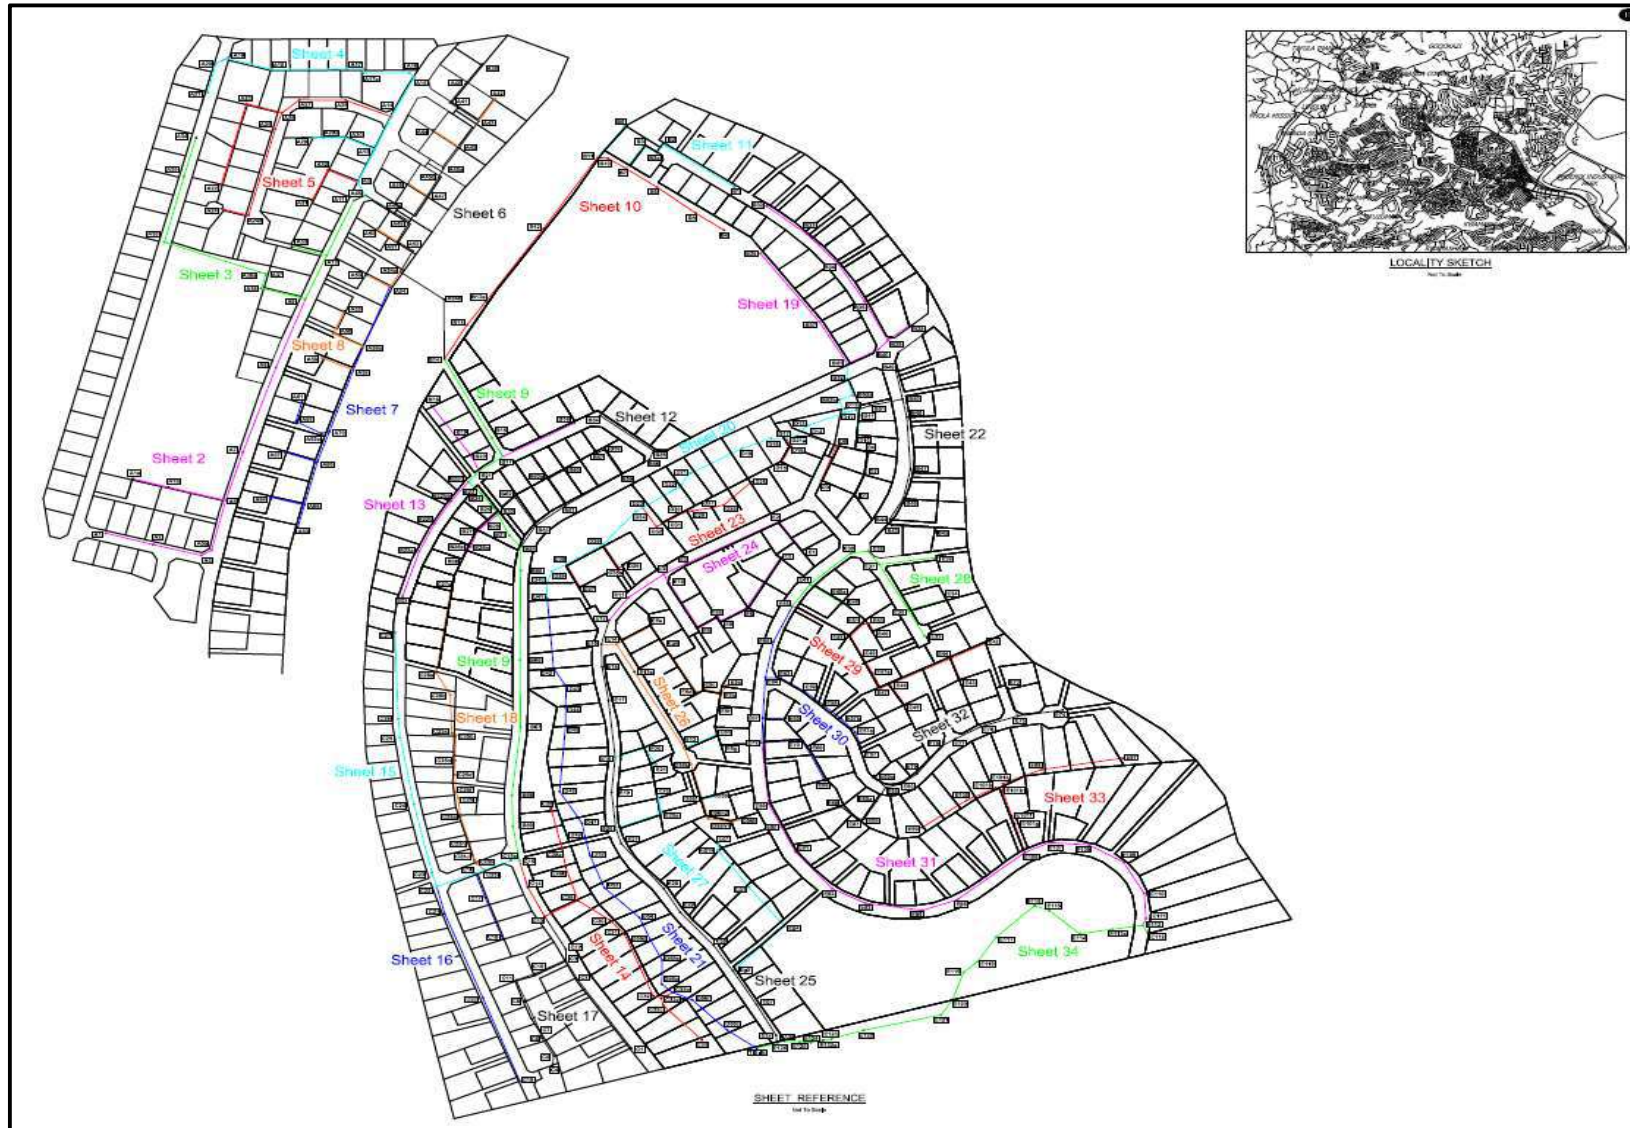
Refer to Figure 1 below which indicates the preferred layout alternative. An A3 copy of the layout plan can be reviewed under Appendix C.

**Figure 1: Preferred Layout Alternative for the proposed sewage reticulation**

The proposed project consists of pipelines under one flow condition – low pressure for gravity flow. The reticulation will consist of HDuPVC 160mmØ pipes which will be utilised for gravity flows. There are two stream crossings which will be undertaken by encasing the pipe with concrete.

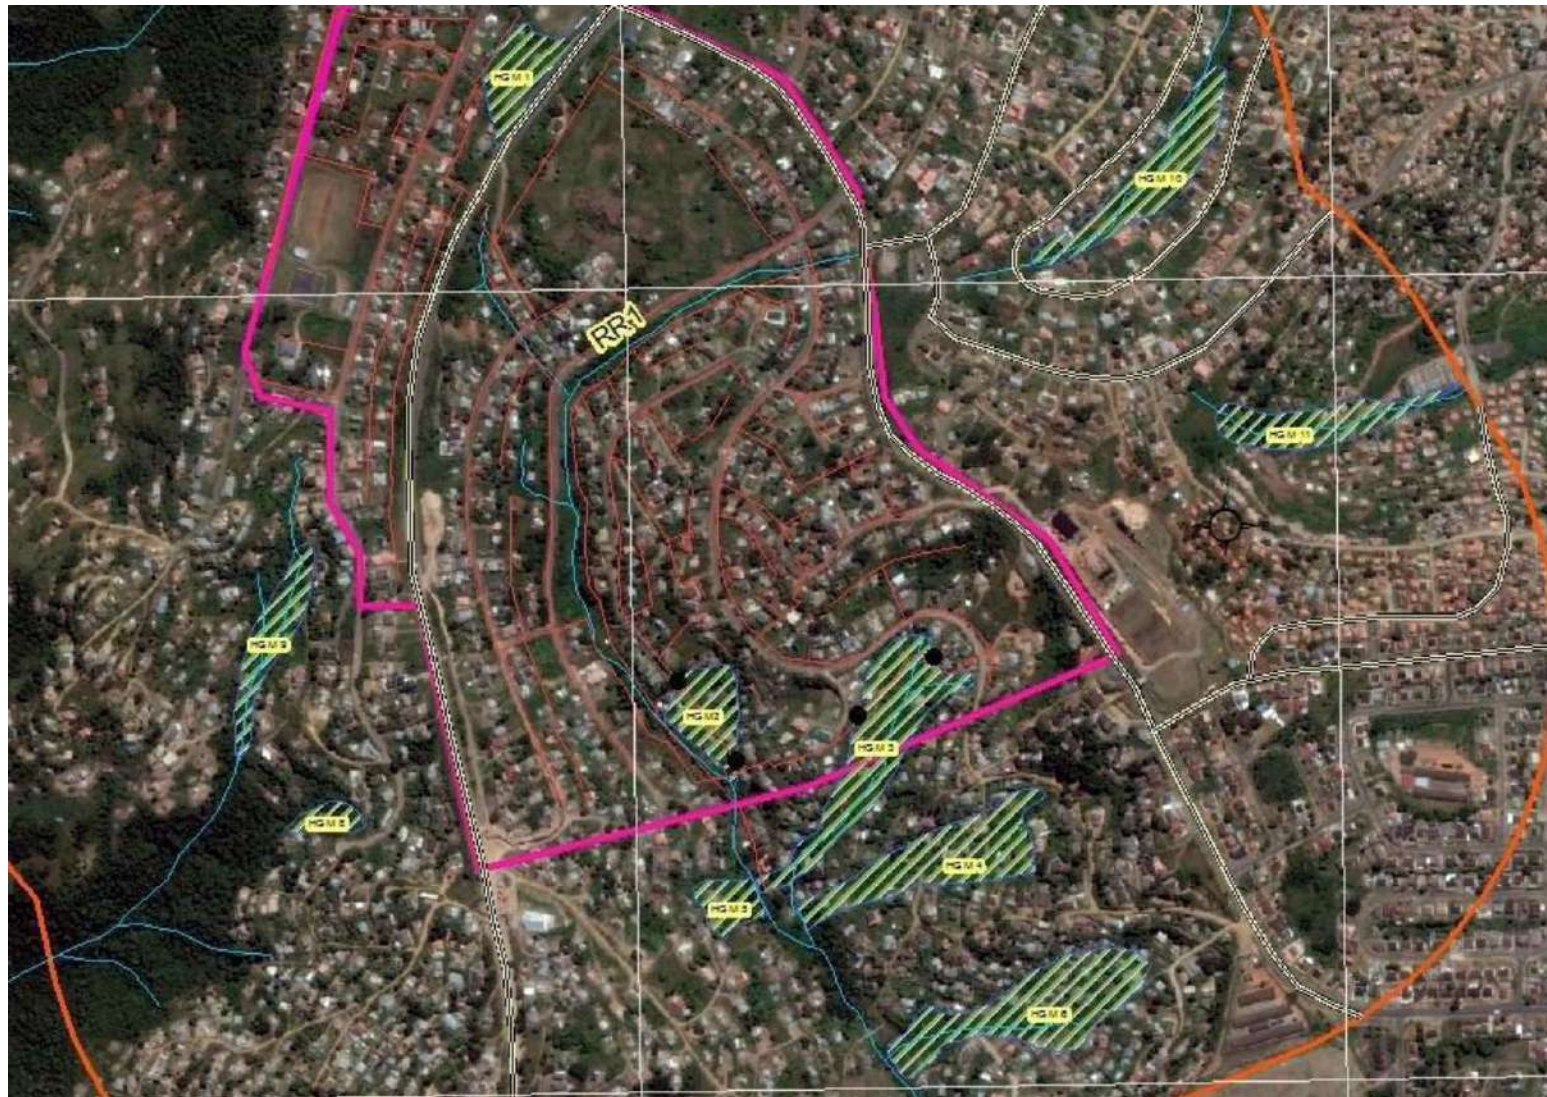
FIGURE 4.1: The HGM units and river riparian habitat found within the surrounding 500m buffer of the Inanda Glebe sewer reticulation project

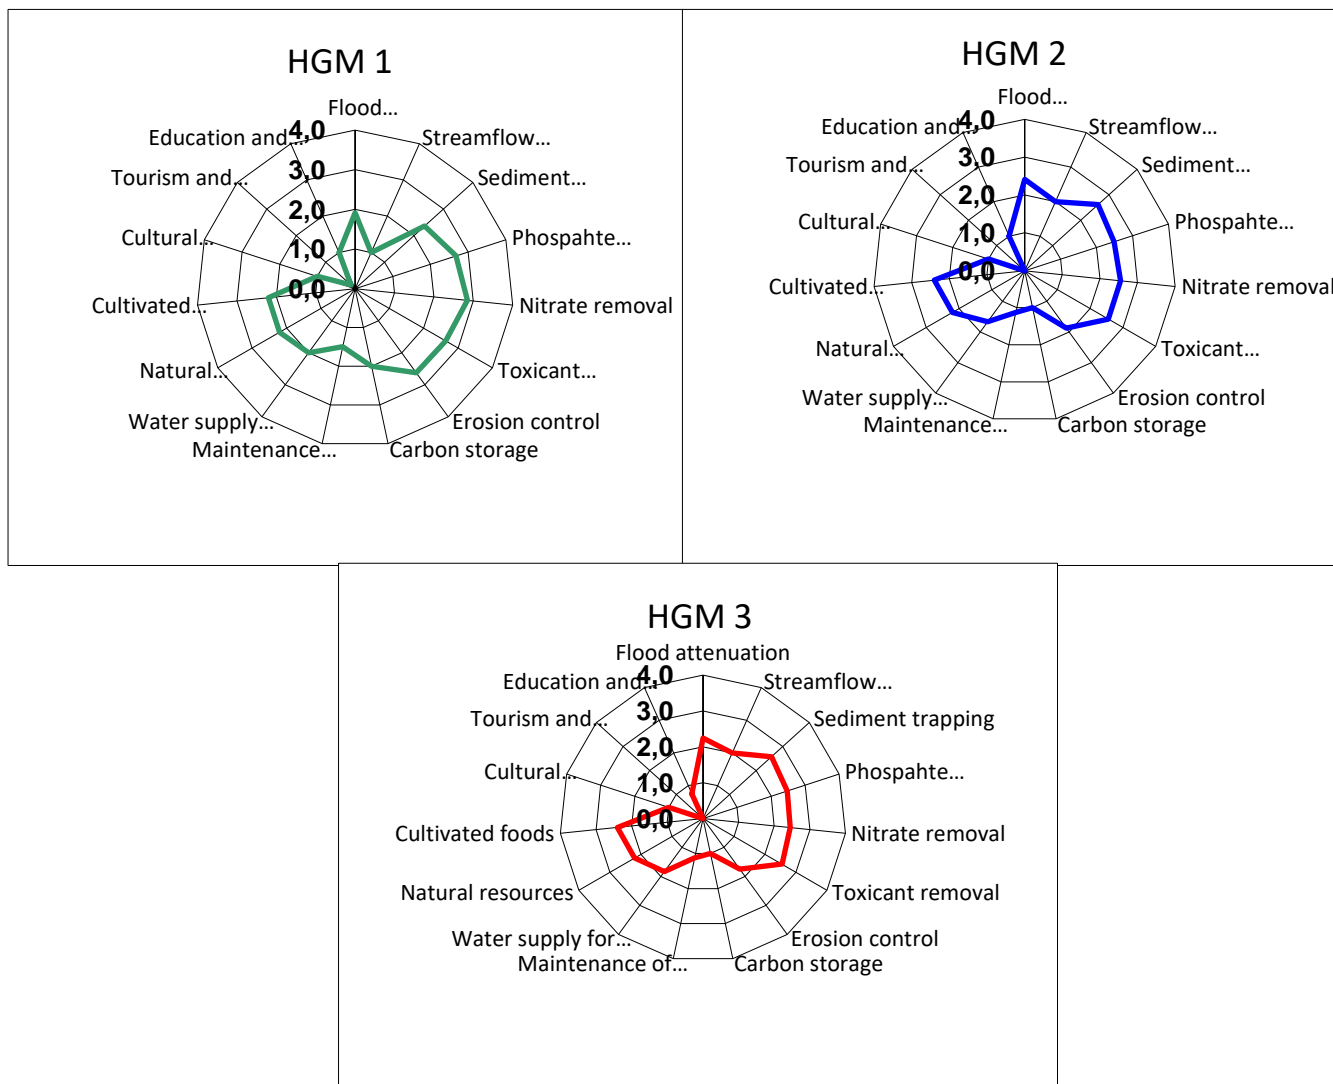
A WET-EcoServices Level 2 assessment was conducted and assessed the indirect “ecological goods and services” provided by HGM’s 1, 2 and 3 which are potentially affected by the proposed sewer reticulation and the maintenance of this new reticulation in the future. The tool provided information on the importance of a HGM unit which delivered different ecosystem services in relation to a number of different categories (Kotze *et al.*, 2009). Figure 4.2 illustrates the ecosystem services scores:

**FIGURE 4.4: WET-EcoServices for HGM's 1, 2 and 3.**

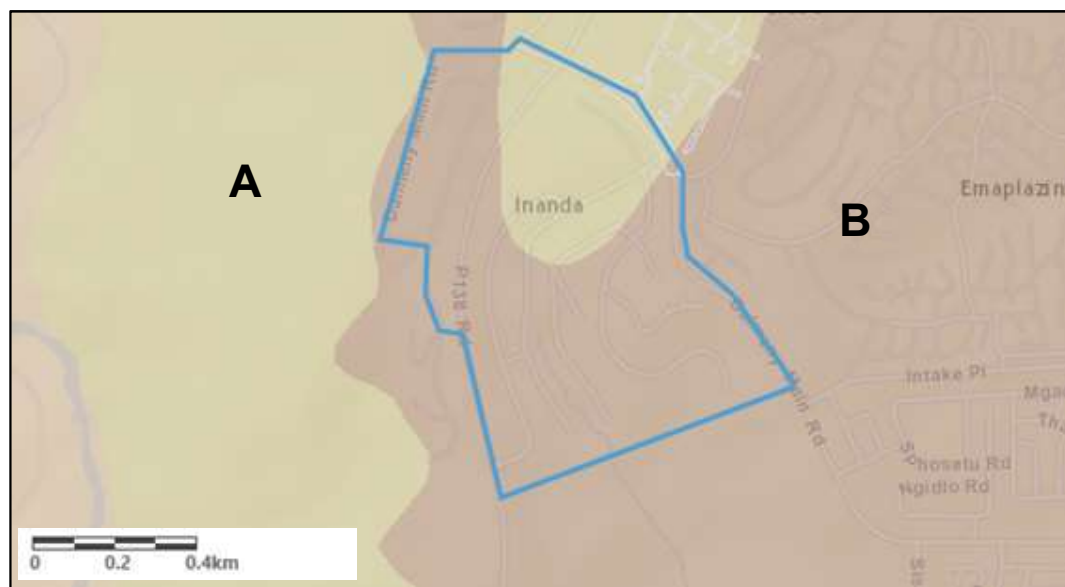
The soils found along the proposed development are characterised the presence of two soil type. The first, referred to as “A” in **Figure 2** is classified as Lithosols, which consist of shallow soils on hard or weathering rock. The second type, referred to as “B” is comprised of soils that are imperfectly drained which are often shallow with plinthic horizon.

**Figure 2 – General Soil Types within the Study Area (SANBI, 1996)**

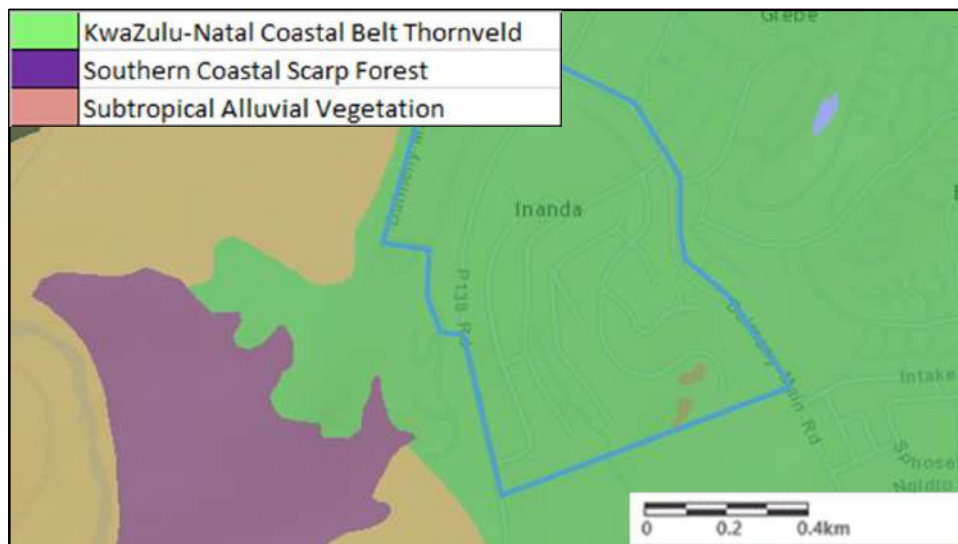
According to **Figure 4** the naturally occurring vegetation of the area is KwaZulu-Natal Coastal Belt Thornveld, with the occurrence of subtropical alluvial vegetation found within the wetland area. Nearby This vegetation type is listed as endangered and is said to be the dominant vegetation of the entire area. In a broader geographical context, there is also a substantial amount of Southern Coastal Scarp Forest, which has not extended into the study area.

**Figure 4 - Vegetation Map of the Area (SANBI, 2014)**

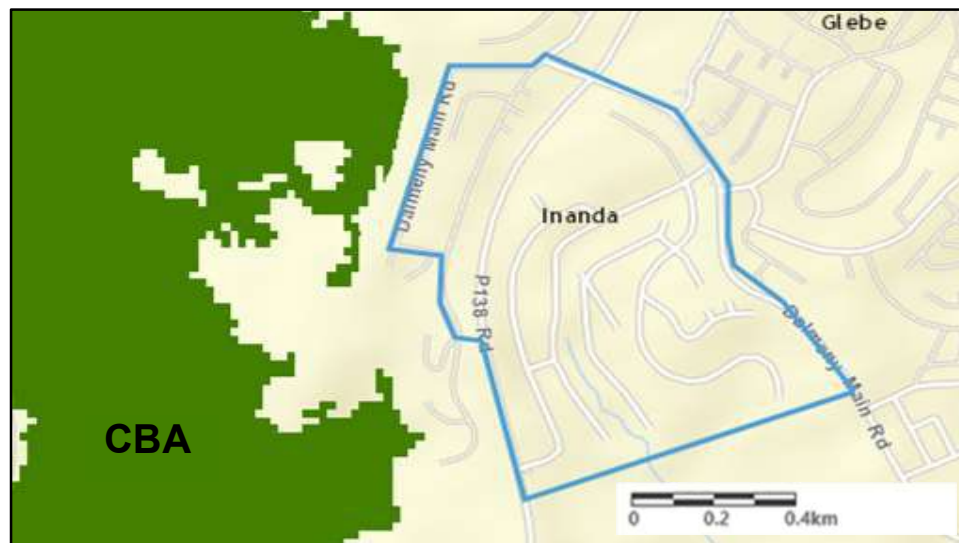
In general terms, CBA units demonstrate features confined to specific niche habitats such as forest (Eastern Scarp Forest), which does not extend into this study area. Furthermore, it is apparent that no ecological support areas or corridors are found within, or nearby the development area.

**Figure 5 – Critical Biodiversity Areas (Irreplaceable) in the Study Area (eKZNW 2016)**

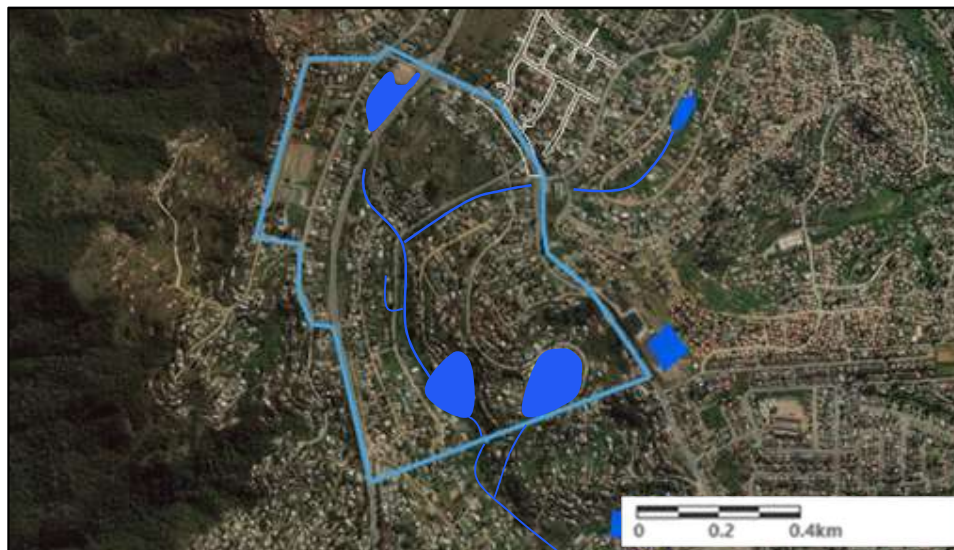
**Figure 6 – Protect Areas and Wetlands in the Study Area SANBI, 2016)**

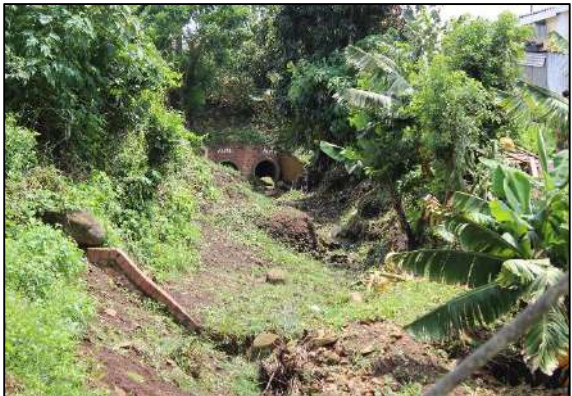
<p>In this snapshot, the current state of the habitat near one of the drainage lines that feeds into the Gobhogobho River is demonstrated. All natural vegetation appears to be cleared and replaced by cultivated crops (<i>Musa hybrid</i>) and exotics such as <i>Melia azedarach</i> and <i>Solanum mauritianum</i>.</p>

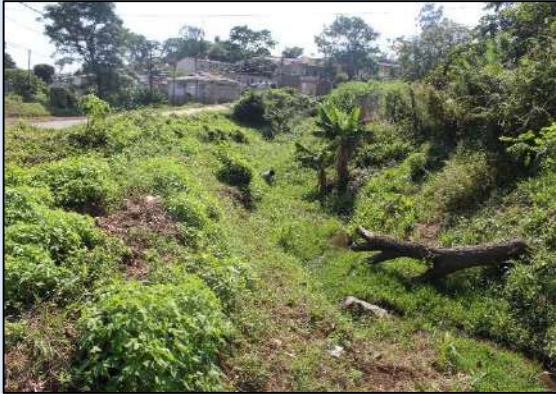
(3)

This photo gives an example of vegetation that can be found along the riparian area (Gobhogobho River) that cuts through the middle of the proposed develop area. In this particular photo, there was one indigenous species (*Typha capensis*) found which is seen to be a very common species to the river environment. Other vegetation is of an exotic nature, majority of which are alien invasive plant species (*Lantana camara*, *Canna Indica* and *Melia azedarach*).

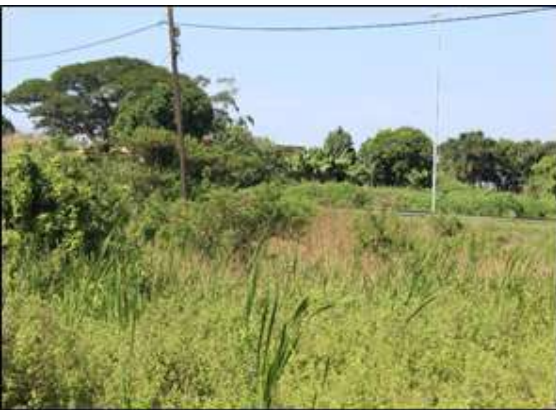
(4)

In photograph 4, the first wetland affected by the proposed development can be seen. Here, unlike the other two wetlands, some natural vegetation still remains. However, the dominant natural vegetation is *Typha capensis* and sedges, which are very common and often dominate these environments and can become weeds. This wetland lacked evidence of lilies or other natural hydrophilic species which otherwise would be expected in a wetland. What can also be seen in this snapshot is a single *Acacia sieberana* and an large expanse young *Chromolaena odorata*.

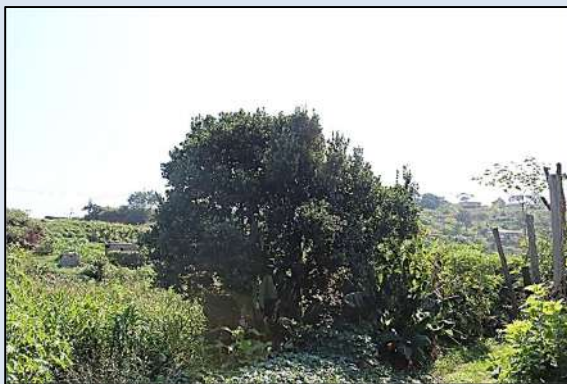
(5)

In this snapshot the second wetland can be seen. In the background, residential houses can be seen encroaching on this already disturbed area. In the middle of the photo, a single *Syzigium cordatum* can be seen on the boundary of this wetland. Alongside this species, *Canna indica*, *Morus nigra*, *Solanum mauritianum* and *Schinus terebinthifolius* can be found in high numbers.

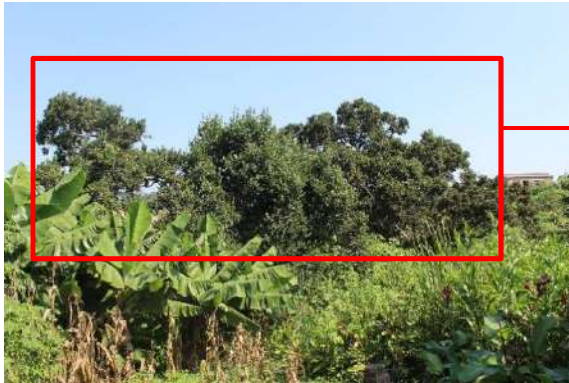
(6)

Although densely populated by exotic species, there was specific area inhabited by more than six mature species of *Syzygium cordatum*. A tree found commonly in forest margins and riverine thickets and should be conserved as far as possible during development.

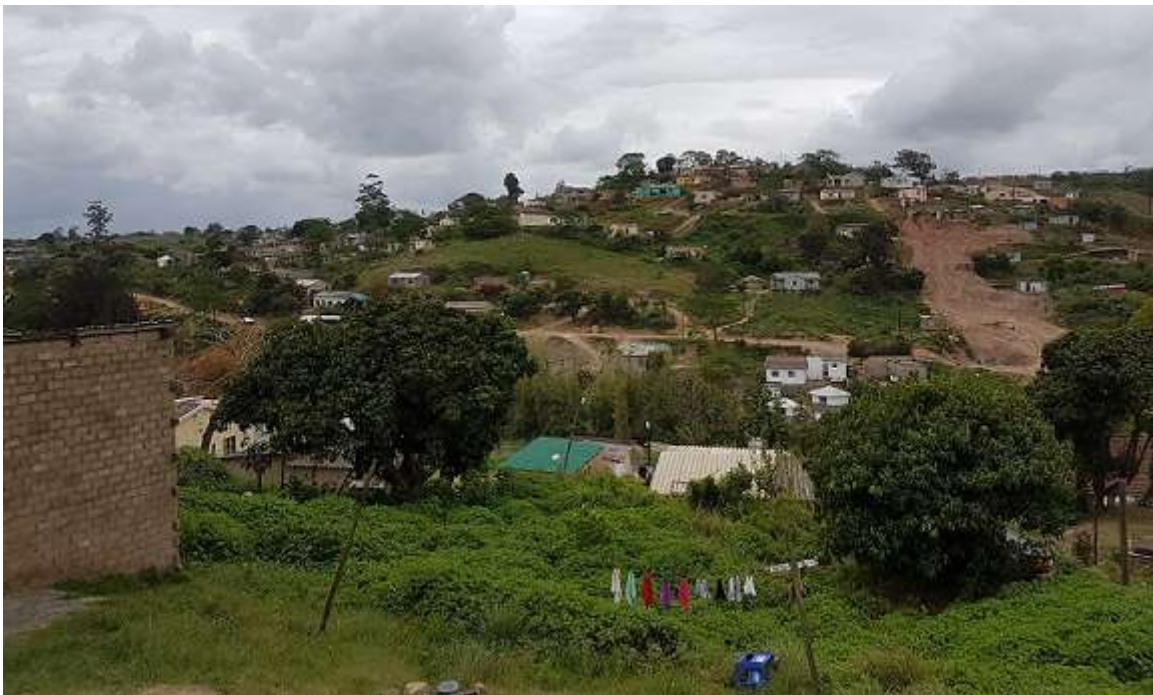
The general site conditions encountered on site are broadly represented in Figure 2 below.

**Figure 2 : Photograph of the southeastern portion of the site, taken from DCP32 facing east, showing gently to moderate steep slopes above gently sloping natural drainage line and typical local housing present throughout the developed site area.**
