S24G REPORT

S24G APPLICATION FOR THE UNLAWFUL STORAGE OF DANGEROUS GOODS BY PREMIER FMCG LOCATED AT 341 SYDNEY ROAD, CONGELA, DURBAN, ETHEKWINI MUNICIPALITY, KWAZULU-NATAL.

August 2022

S24G APPLICATION REPORT IN TERMS OF A BASIC ASSESSMENT PROCESS

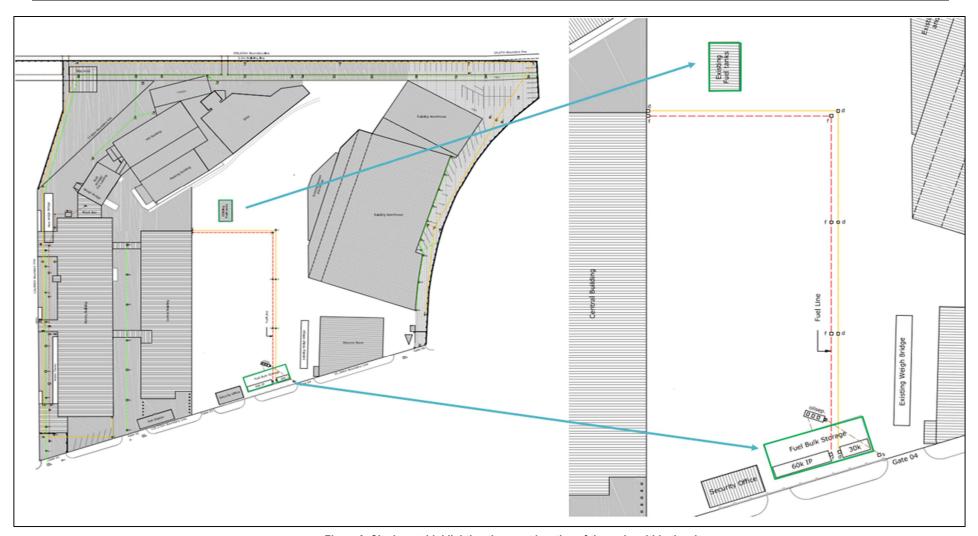
Figure 2: Site layout highlighting the exact location of the tanks within the site.

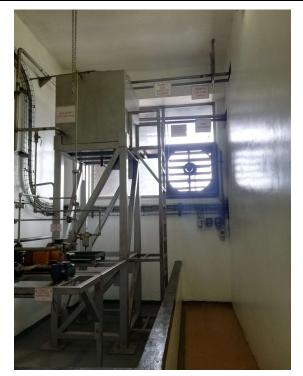
Plate 5: 1000 litre diesel day tank

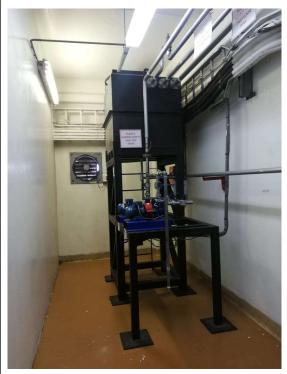
Plate 6: 1000 litre paraffin day tank

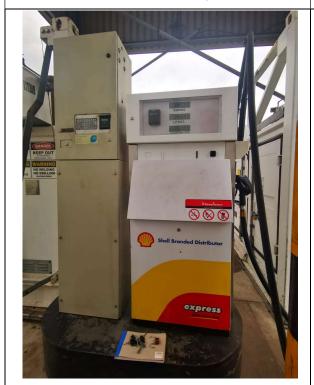
Plate 7: Fuel dispensing equipment

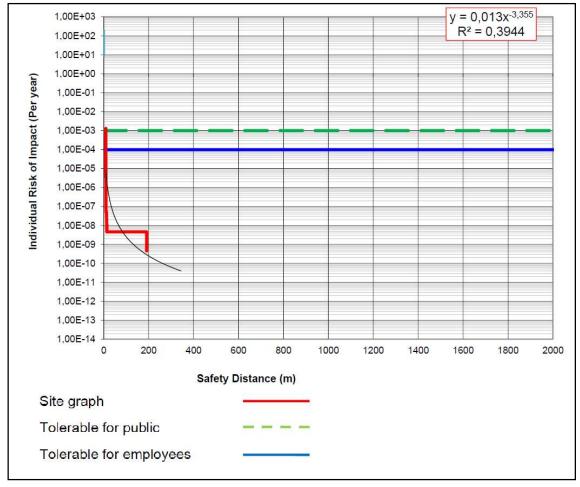
Figure 9: Individual Risk Transect

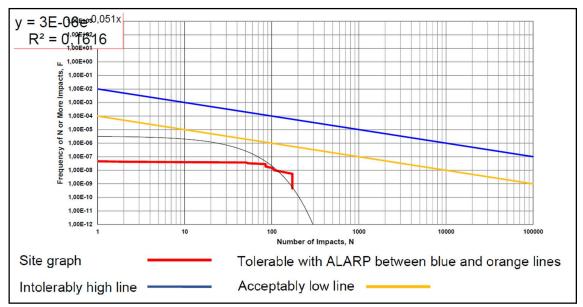
According to the Societal Risks - Frequency vs Number of impacts curve generated and shown below, Vapor Cloud Explosions (VCE) associated with the storage and road LPG tankers, considered the first and second priorities respectively, are classified to be as low as reasonably practicable (ALARP)

Figure 10: FN Curve for societal risk

The individual safety risk for both employees and the public is classified as low, whilst the risk of Vapour Cloud Explosions caused by the aboveground storage tankers is classified as low as reasonably practicable. (ALARP).

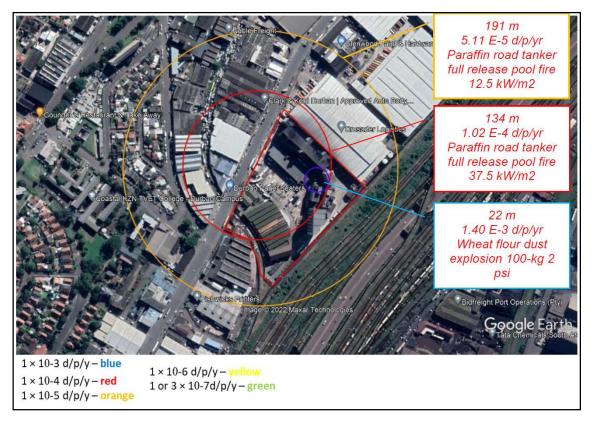
Maximum extent of the 1% consequence-based lethality effect zone from major hazards show that the probit value for thermal radiation exposure from a pool fire confirms that 1% fatalities could occur at a thermal radiation flux of 12.5 kW/m2. This thermal radiation flux corresponds with an impact distance of 191 meters.

Figure 11: Individual Risk Contours
