ENVIRONMENTAL IMPACT ASSESSMENT FOR THE PROPOSED BRANDVALLEY

WIND ENERGY FACILITY:

FAUNA & FLORA SPECIALIST IMPACT ASSESSMENT REPORT

March 2016

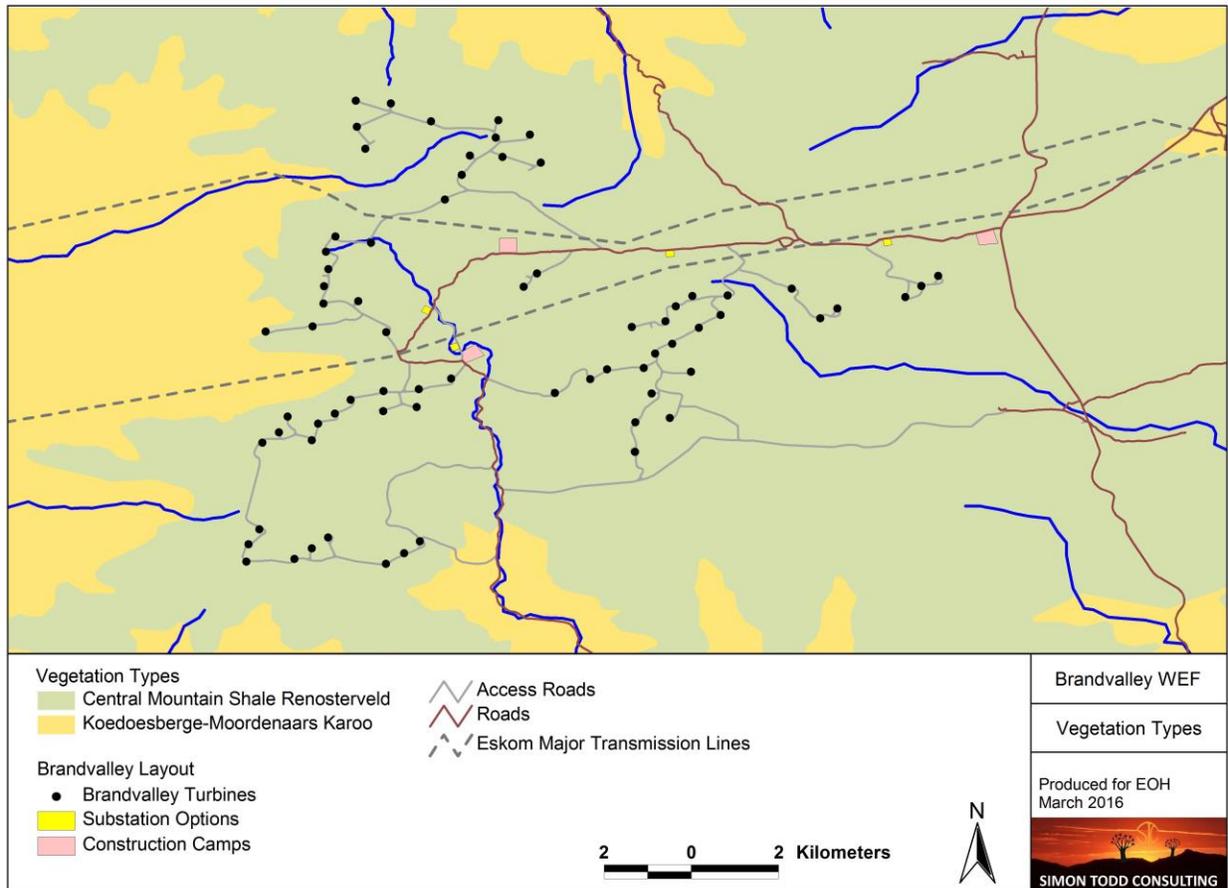
Figure 2. Vegetation map (Mucina and Rutherford 2006) of the Brandvalley Wind Farm study area. The majority of the affected area falls within the Central Mountain Shale Renosterveld with marginal impact on Koedoesberge-Moordenaars Karoo.

According to the national vegetation map, two vegetation types occur within the study area (Figure 2). The vast majority of the site is mapped as Central Mountain Shale Renosterveld while several smaller areas are mapped as Koedoesberge-Moordenaars Karoo.

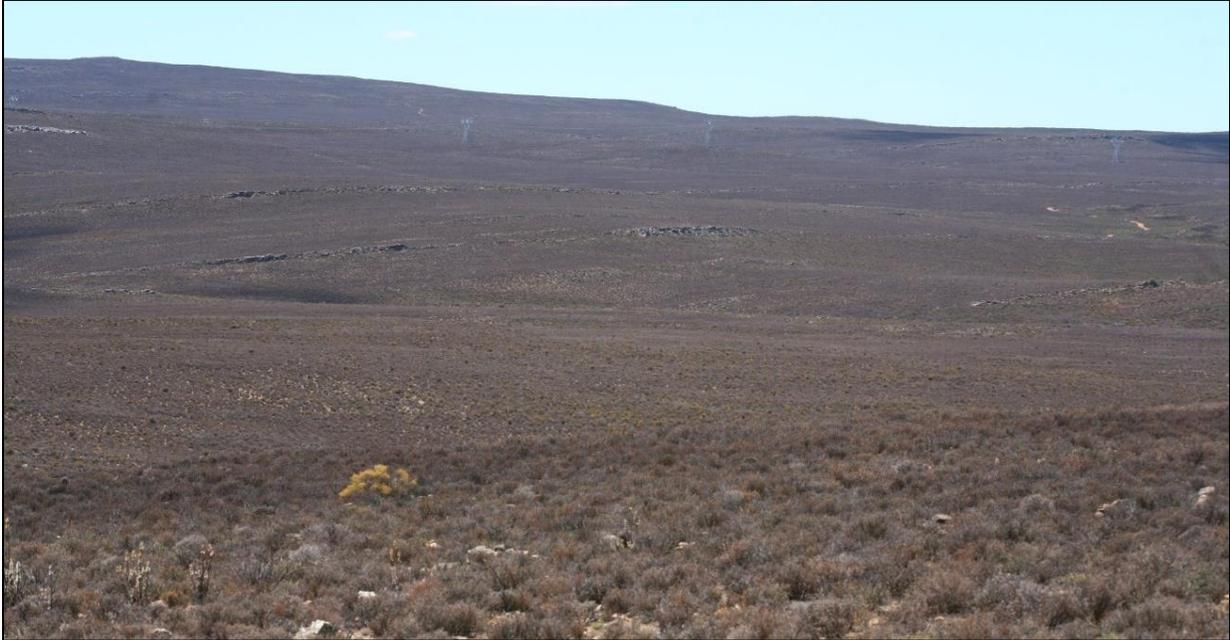
Figure 3. Looking out over the northern part of the site, showing the homogenous nature of the vegetation of this area. The existing 400kV line is visible traversing the plain in the distance. This vegetation is considered consistent with the Central Mountain Shale Renosterveld vegetation type of Mucina & Rutherford.

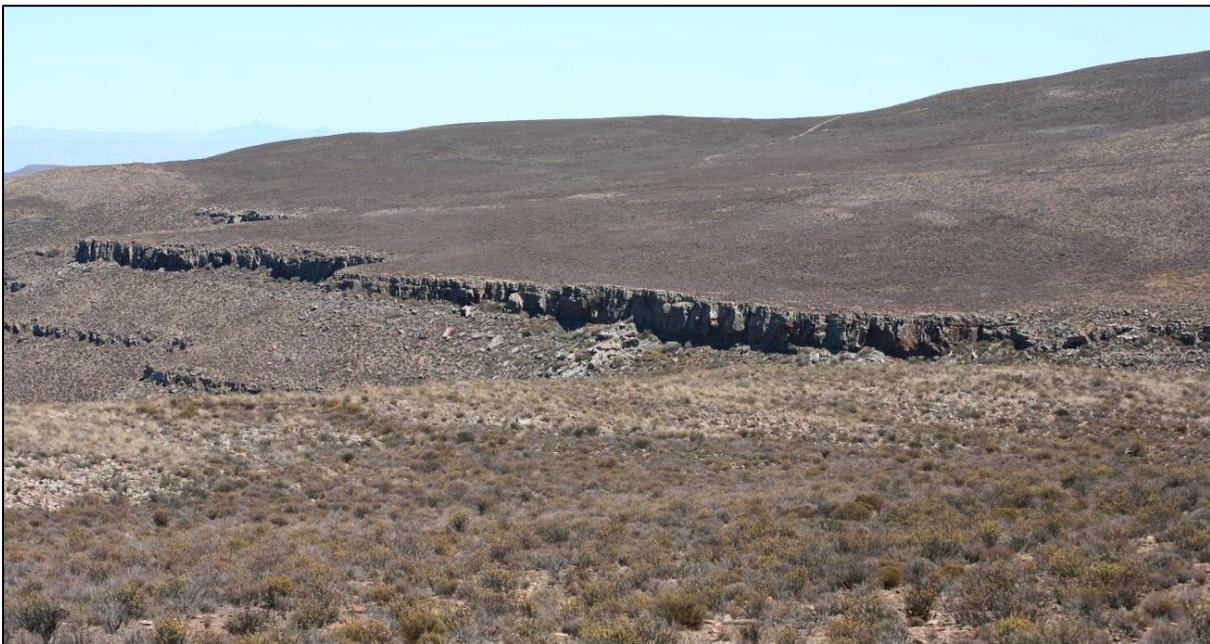
Figure 4. The majority of turbines are located around the margin of the site, towards the edges of the escarpment, where there may be more sensitive features such as cliffs present.

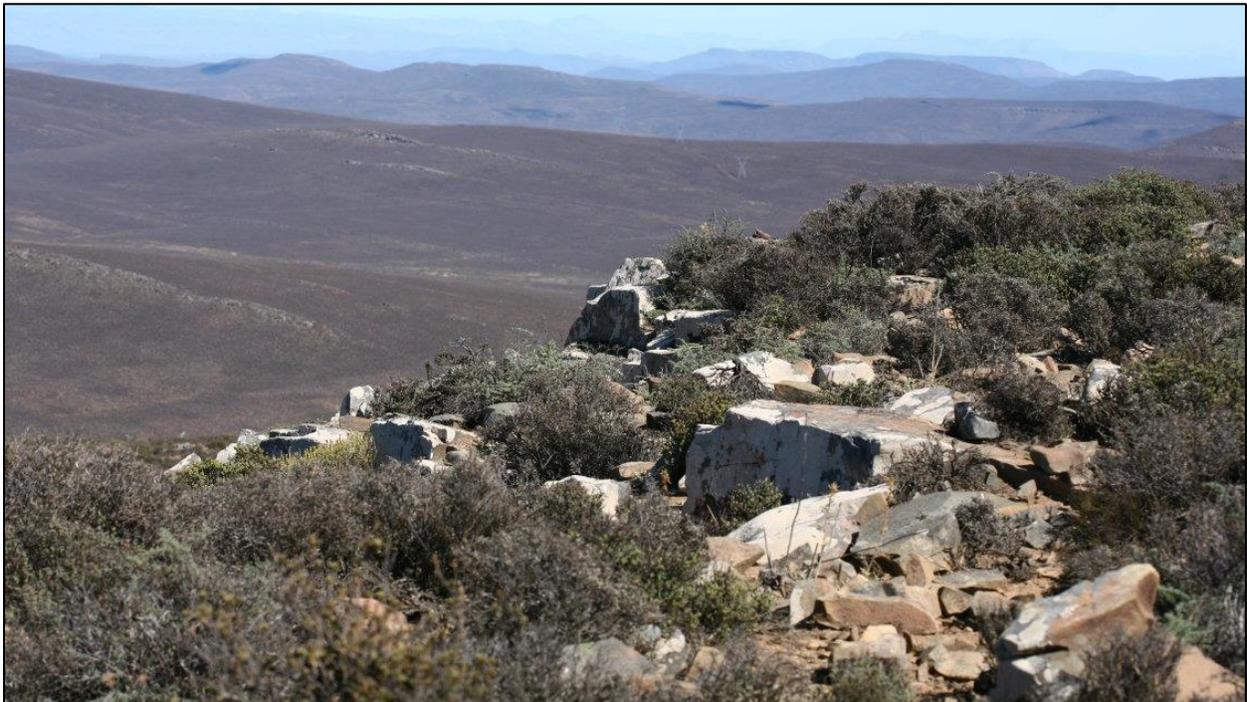
Figure 4. The vegetation composition of the highest-lying ridges is clearly different from the lower-lying plains below and includes a number of listed species which are not found at lower elevations.

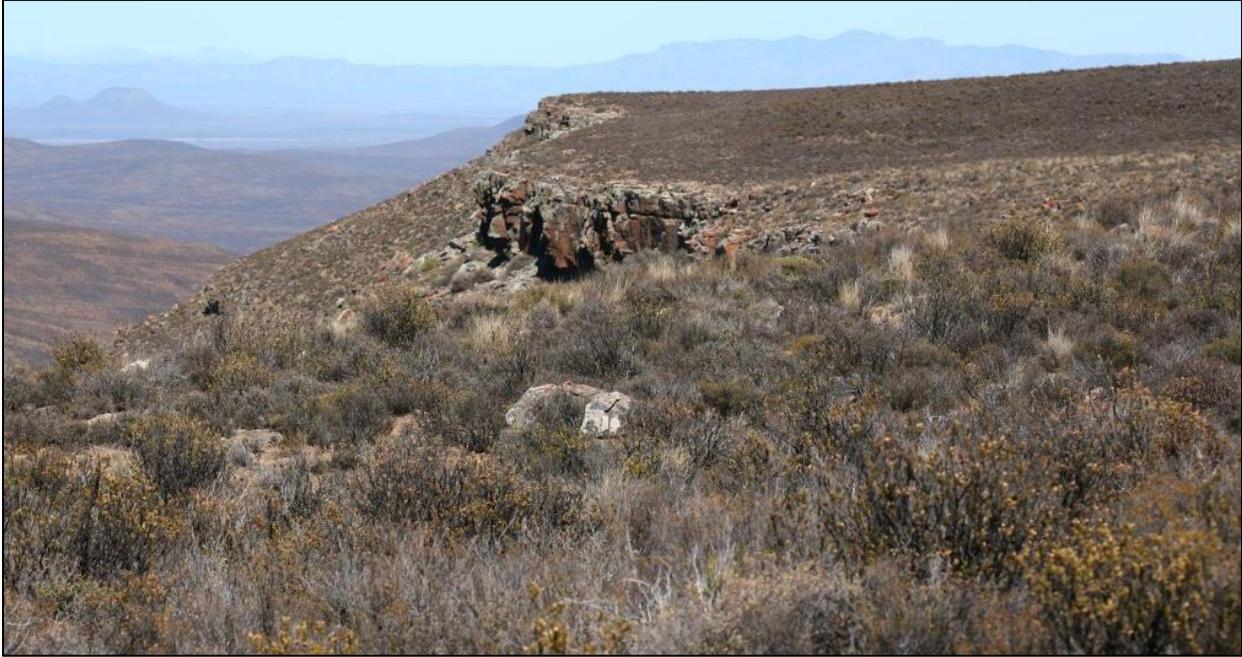
Figure 5. The high-lying plateau which forms the northern-most extension of the wind energy facility is considered particularly sensitive.

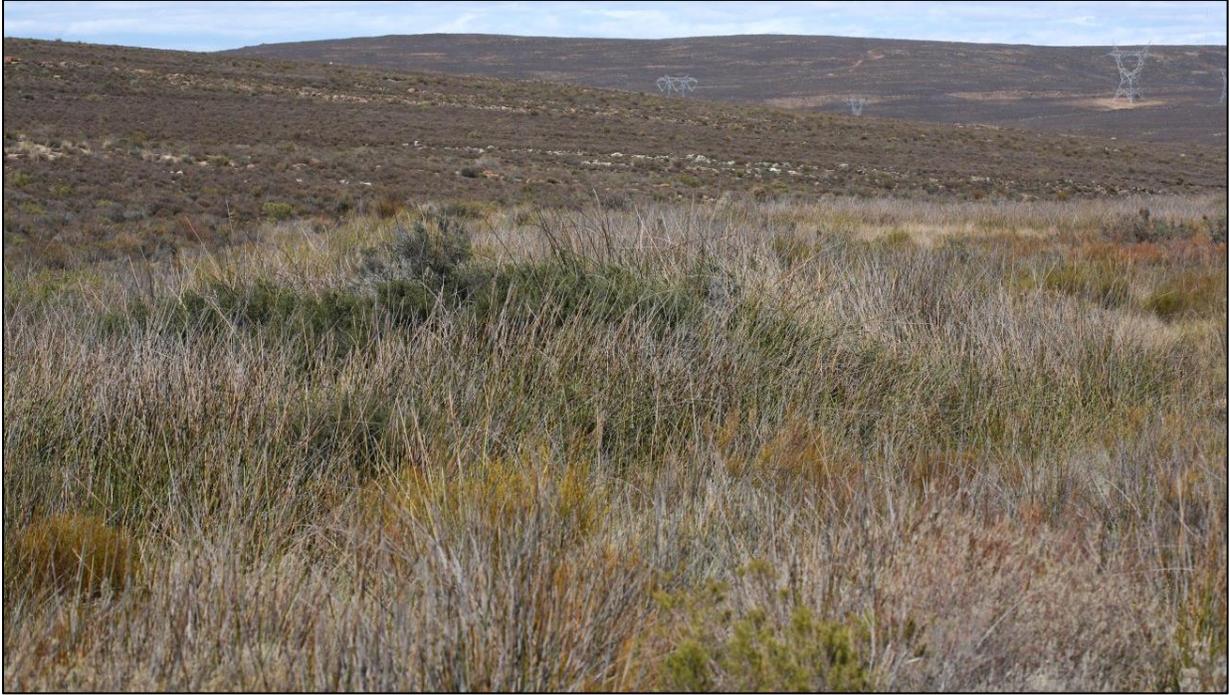
Figure 7. Reed beds in the upper reaches of the Groot Rivier, dominated by *Pseudoschoenus inanis* with occasional woody species such as *Dicrothamnus rhinocerotis*.

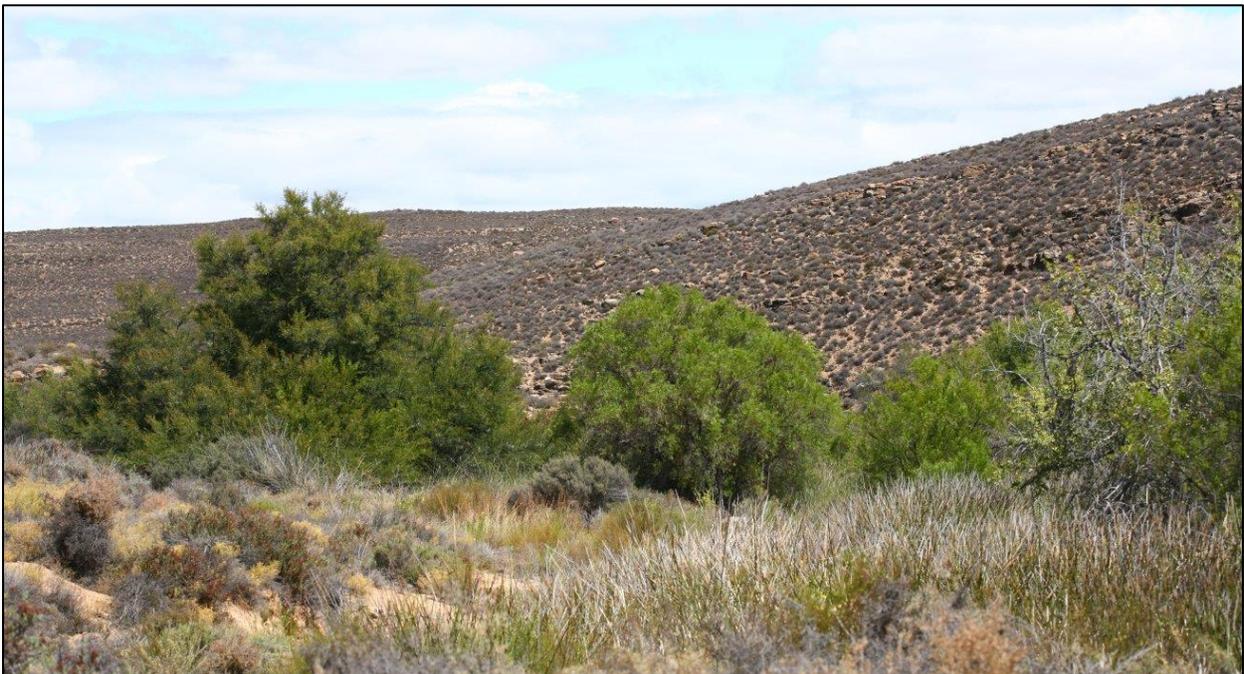
Figure 8. Further down the Groot Rivier, showing *Acacia karoo*, *Searsia lancea* and *Salix mucronata* as well as large shrubs such as *Diospyros austro-africana* and the large sedge *Pseudoschoenus inanis*.

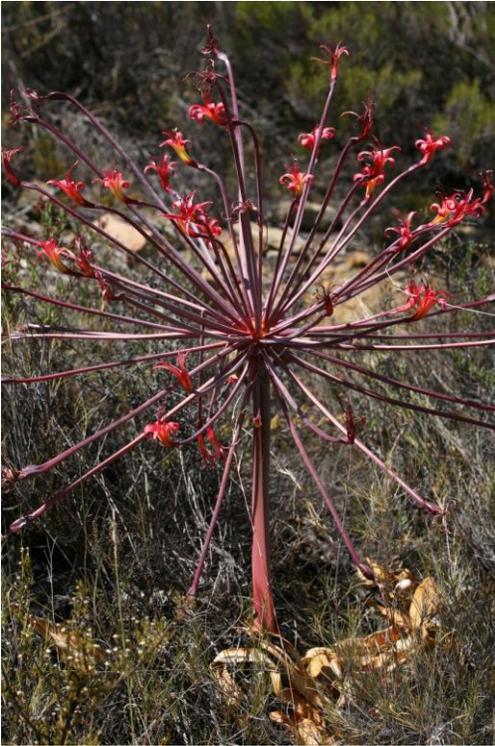
Brunsvigia josephinae which is listed as Vulnerable is common in parts of the Groot Rivier. This species has large flower heads up to 1m or more across.

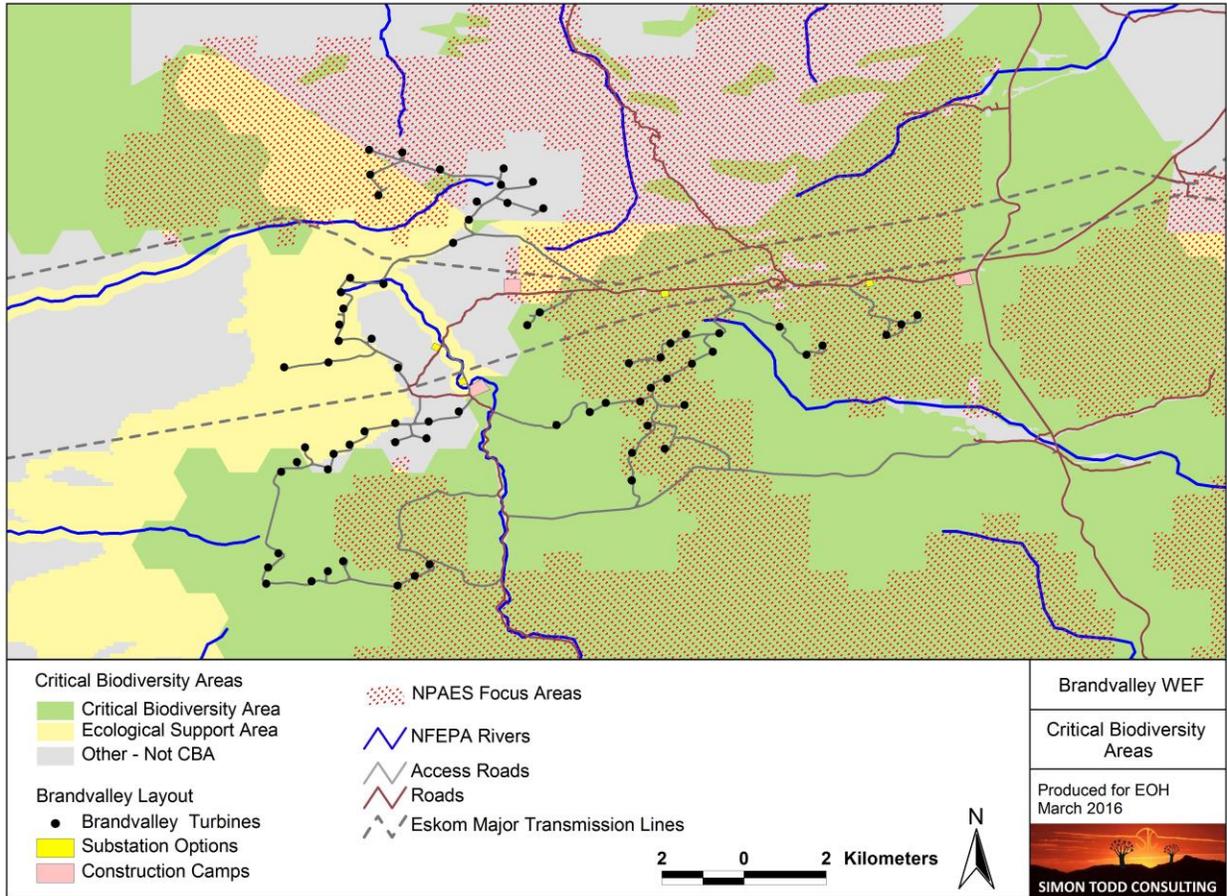
Figure 9. Amalgamated Critical Biodiversity Areas map of the proposed Brandvalley Wind Farm and the surrounding area.

The site itself lies along the boundary of the Western Cape and Northern Cape as well as along the boundary between the Central Karoo and Winelands District Municipalities within the Western Cape. As a result, the site lies at the junction of three different conservation plans and Figure 9 below is a composite of all these different plans. Those parts of the site within the Northern Cape fall within the planning domain of the Namakwa District Biodiversity Sector Plan (Desmet & Marsh 2008), while the Western Cape Sections are within the Biodiversity Assessment of the Central Karoo District Municipality as well as that for Cape Winelands District Municipality (Skowno et al. 2009). These district-wide biodiversity assessments were commissioned to inform Spatial Development Frameworks (SDFs), Biodiversity Sector plans, Environmental Management Frameworks (EMFs), Strategic Environmental Assessments (SEAs) and the Environmental Impact Assessment (EIA) process. The Biodiversity Assessments identify Critical Biodiversity Areas (CBAs) which represent biodiversity priority areas which should be maintained in a natural to near natural state. The CBA maps indicate the most efficient selection and classification of land portions requiring safeguarding in order to meet national biodiversity objectives. Once gazetted, and incorporated into municipal SDFs and bioregional plans, such fine-scale plans are recognized under NEMA and the various activities listed under the act as described in Section 2.4 come into effect. The CBA map for the general area surrounding the site is depicted below in Figure 9.

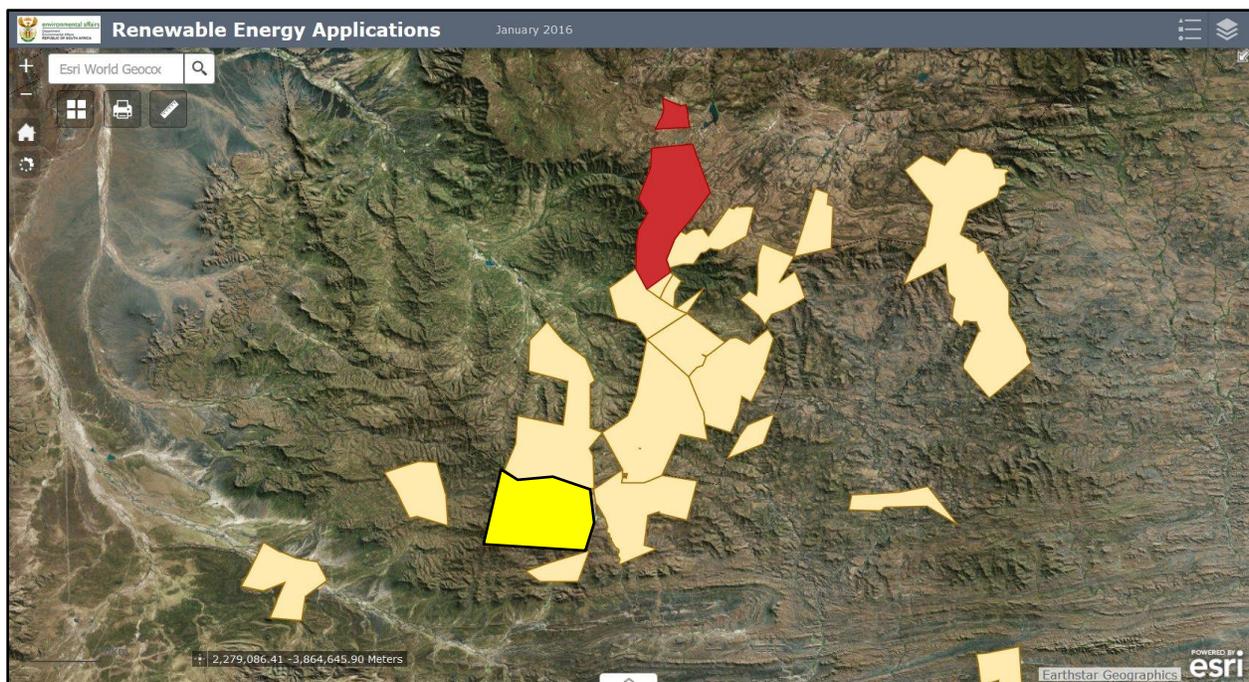
Figure 9. Current DEA-registered projects known from the vicinity of the Brandvalley Wind Energy Facility which is indicated in yellow. There are some errors and omissions on the map as well as not all affected land parcels have been indicated, but it nevertheless illustrates that high development pressure in the area, especially on the high-lying ground below the escarpment. The red land parcel is the proposed Gunstfontein WEF which is still in process

and is depicted in red as it was initially intended to include solar PV as well as wind energy development, but this is no longer the case and it currently only includes wind energy.

According to the map of DEA-registered projects as at January 2016, there are a large number of renewable energy projects in the area (Figure 10). The authorized Roggeveld and Karreebosch facilities are immediately north of the site, while there are several developments to the east as well. Due to the topographic diversity of the area, the region is diverse in terms of the different vegetation types represented in the area, with the result that each facility tends to impact different vegetation types or plant communities. There has however been significant cumulative impact on Central Mountains Shale Renosterveld, which occurs on the rugged hills and mountains south of the escarpment and has borne the brunt of most of the approved facilities to date. Cumulative impacts on Central Mountains Shale Renosterveld appear to be a particular concern as this vegetation type has a relatively limited extent and a significant proportion, especially in the west, is within renewable energy development application areas. As this stage, the number of projects which have won bids and are therefore likely to be built is still relatively low and includes the ACED Hidden Valley facility north east of the site as well as the Roggeveld Wind Farm immediately north of the site. Although the actual footprint of each facility is likely to be in the order of 200ha or less, even taking an extreme scenario of 500ha per development, the current total loss of Central Mountains Shale Renosterveld would remain at less than 1% of the current total.

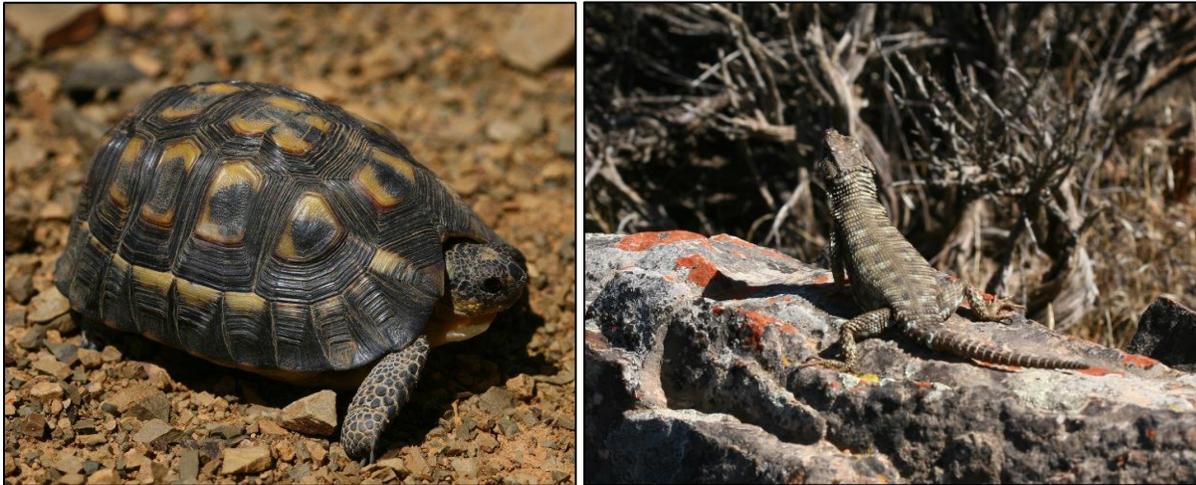
Figure 10: Common reptiles at the Brandvalley site include the Angulate Tortoise left and the Karoo Girdled Lizard right.

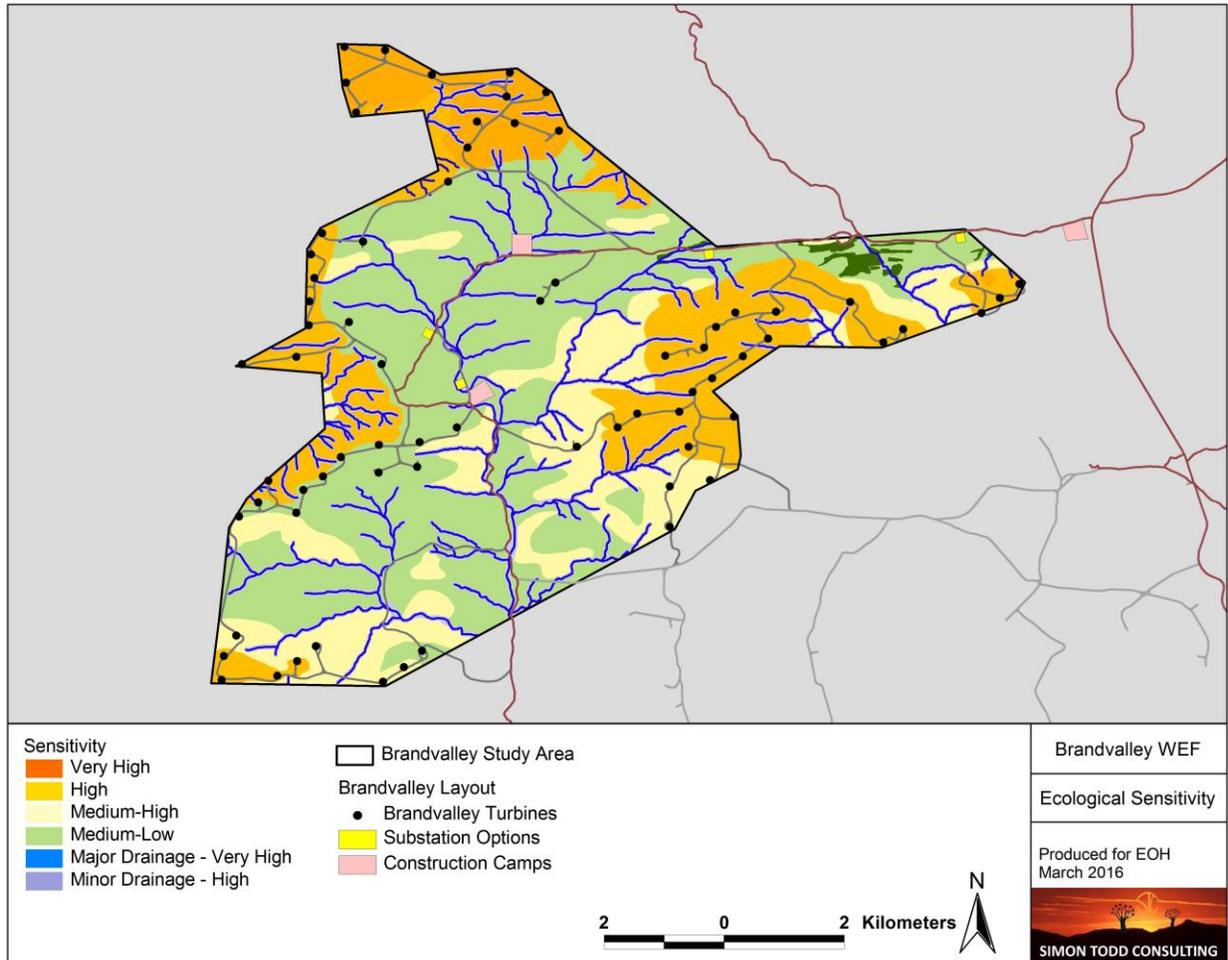
Figure 10. Ecological Sensitivity map of the Brandvalley WEF site, showing the distribution of turbines within the site. The recommendations for mitigation and avoidance for the various turbines is detailed below.

The ecological sensitivity map of the site is depicted in Figure 10 below. The high-lying areas within the central, northern and western part of the site are considered the most sensitive areas. Although the large basin which forms the central part of the site is considered relatively low sensitivity, there are few turbines in this area and the majority of the turbines are in fact within the higher sensitivity areas. In terms of the higher sensitivity areas, the northern extension of the site in the Snydersberg area is considered the most sensitive area due to the high elevation of this area as well as the current low levels of human impact the likely presence of a number of species of conservation concern in this area.

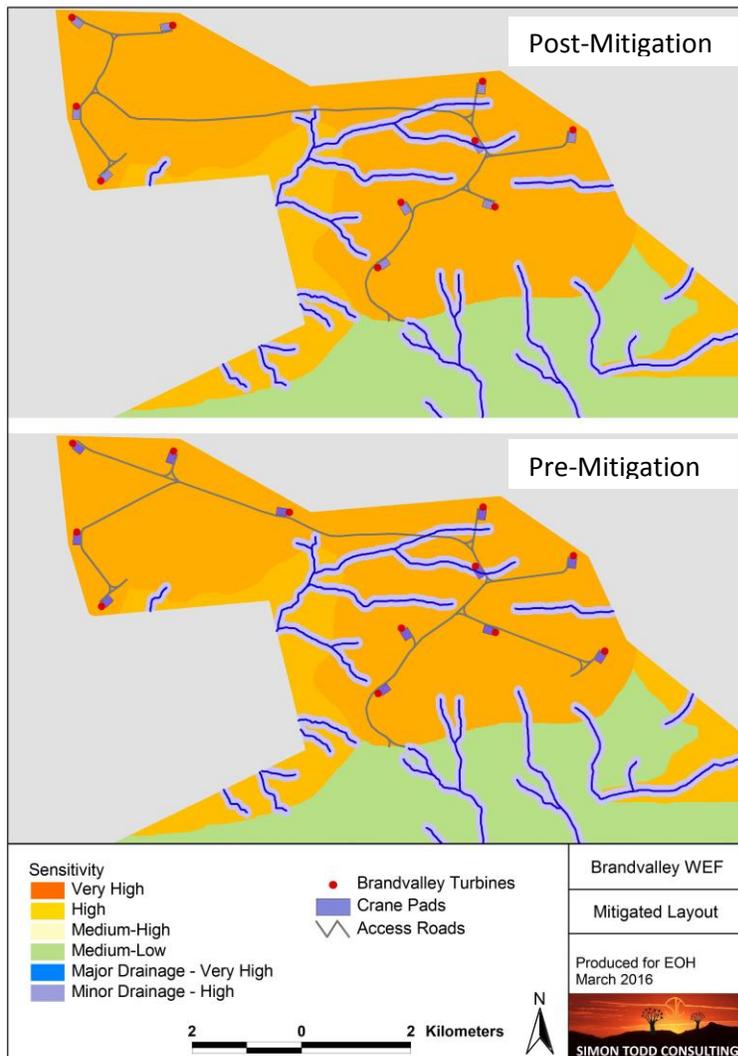
Figure 11. Pre and post-mitigation layout of the Snydersberg area, which is considered the most sensitive part of the site. Two turbines have been dropped from the layout and the overall footprint of the development decreased by 39% within the affected area.

In response to the findings of this study the developer has implemented avoidance and mitigation within the high sensitivity parts of the site in order to minimize the negative effects of the development within these areas. This includes dropping certain turbines from the layout and reducing the extent and size of the access roads in the sensitive areas. The revised layout is depicted below in Figure 11. Two turbines have been dropped from the layout and the access roads have been re-routed to align with existing farm roads where possible. The overall impact of the mitigation is not immediately apparent from the map, but in terms of footprint, this

has been reduced from 163 347 m² to 99 300 m² which is equivalent to an overall reduction in footprint of 39% within the affected sensitive area. Further mitigation would require dropping additional turbines from the layout which would have implications for the output of the facility as the remaining turbines are within a high-wind resource area. Apart from the above reduction in footprint, a preconstruction walk-through with micro-siting of turbines and access roads would be important in further reducing the impact of the development within this area. A persistent concern would however be the impact of the wind turbines on fauna. It is recommended that pre- and post-construction monitoring of key fauna within this area be conducted to improve our understanding of the impacts of wind turbines on fauna and inform mitigation for future wind development in the country. The steps taken by the developer to reduce the footprint and the additional avoidance and monitoring requirements, represents an acceptable balance between the needs of the developer and the environment within this part of the site.
