**ENVIRONMENTAL IMPACT REPORT:**

**THE CONSTRUCTION OF A NEW DAM  
AND ASSOCIATED INFRASTRUCTURE  
AS PART OF THE UPGRADING  
OF THE BULK WATER SUPPLY SCHEME  
TO AMSTERDAM, MPUMALANGA**

Report prepared for: Gert Sibande District Municipality

Report dated: October 2017 (draft)

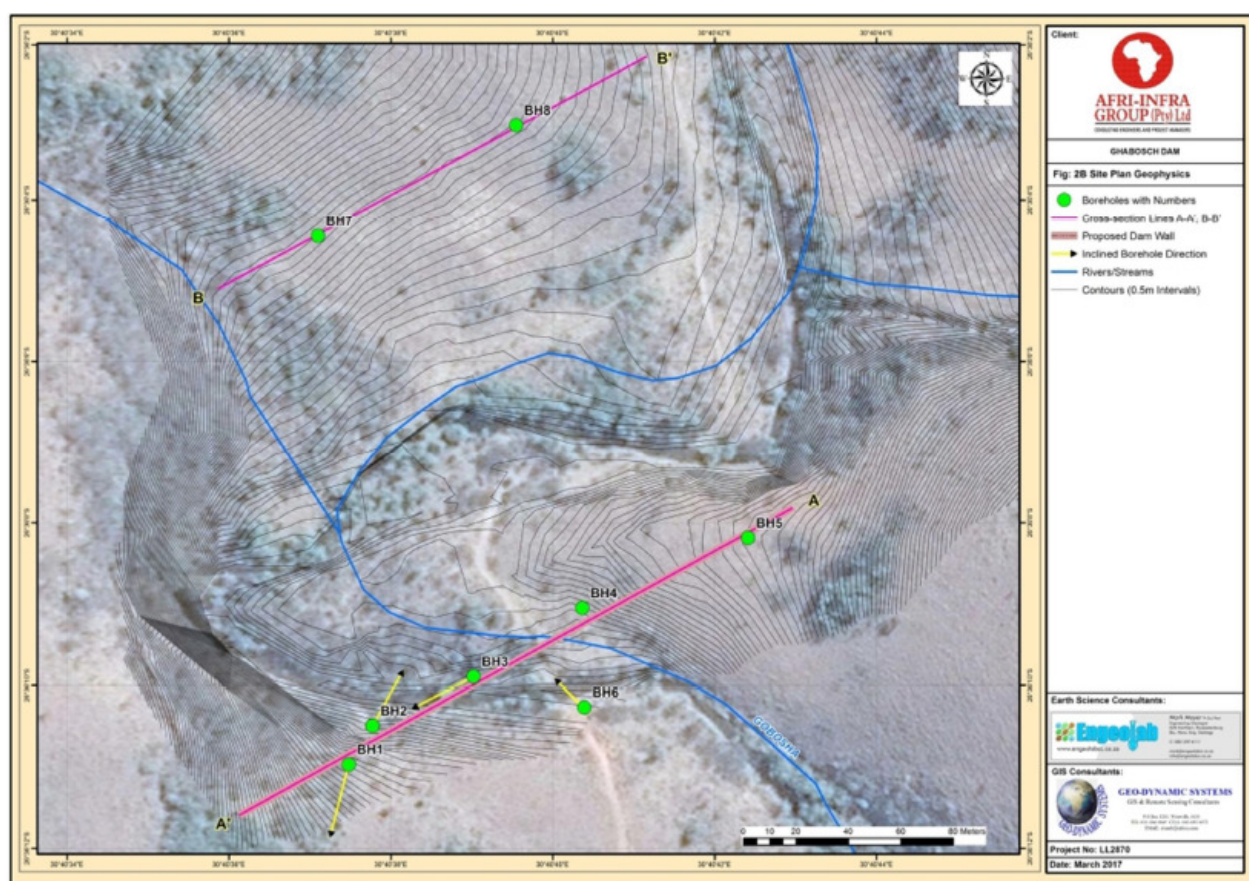
Figure 5.2e: Borehole positions at Dam Site B (taken from Meyer, 2017b)

Three inclined boreholes were oriented to intersect the most prominent geological structures identified during the geophysics exercise, while borehole BH1 was drilled into the hillside to determine the depth to competent material. BH4, BH5, BH7 and BH8 were drilled vertically. Figure 5.2f provides the cross-sections obtained from the borehole data.

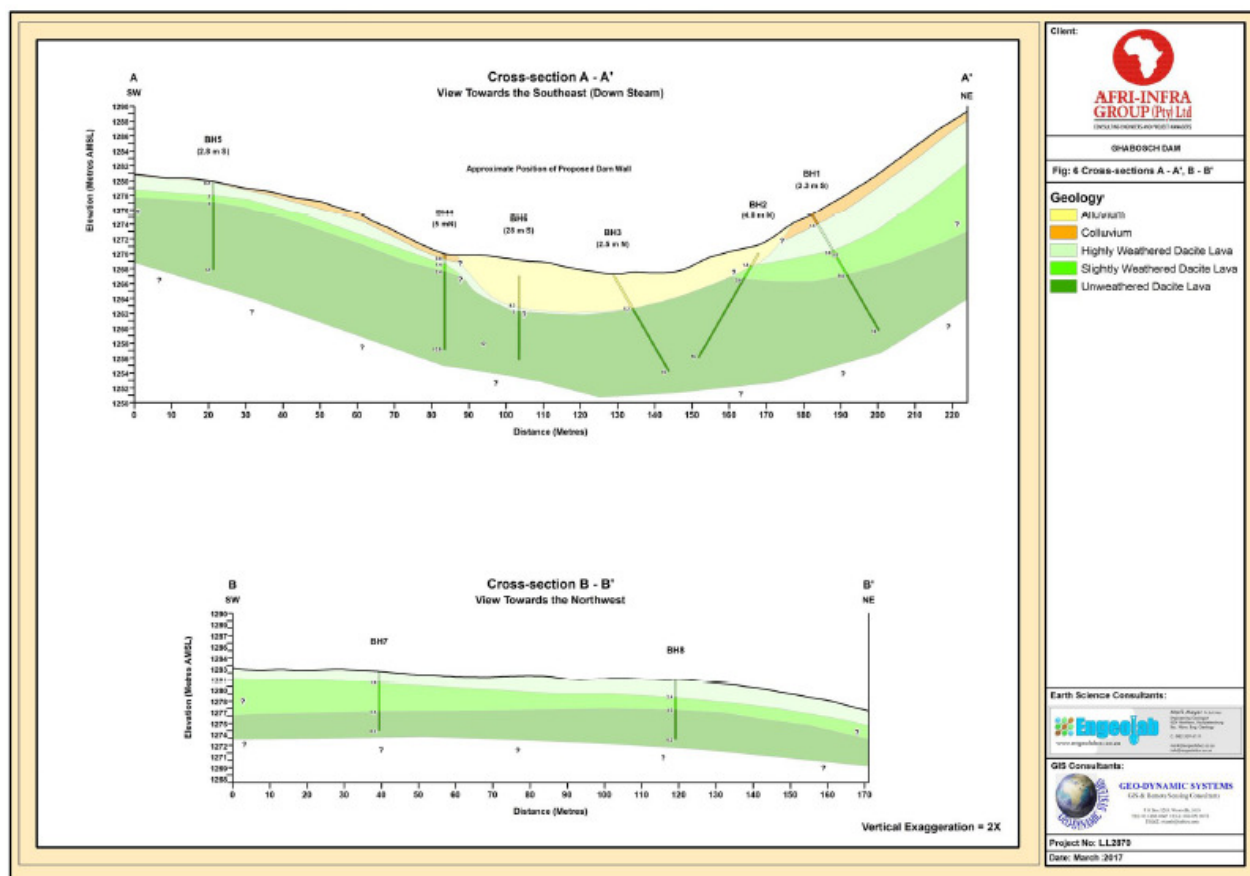
**Figure 5.2f: Cross-sections at Dam Site B (taken from Meyer, 2017b)**

The borehole logs and resultant cross sections (Figure 5.2f) indicate the depth to solid unweathered material on which the dam should be founded. The overburden material (colluvium on the slopes and alluvium adjacent to and below the stream) as well as residual highly weathered dacite bedrock was classed as 'Soft' excavatable. The slightly to moderately weathered highly jointed dacite rock was classed as 'Intermediate' excavatable. The excavatability of the unweathered dacite bedrock is expected to be 'Hard'.

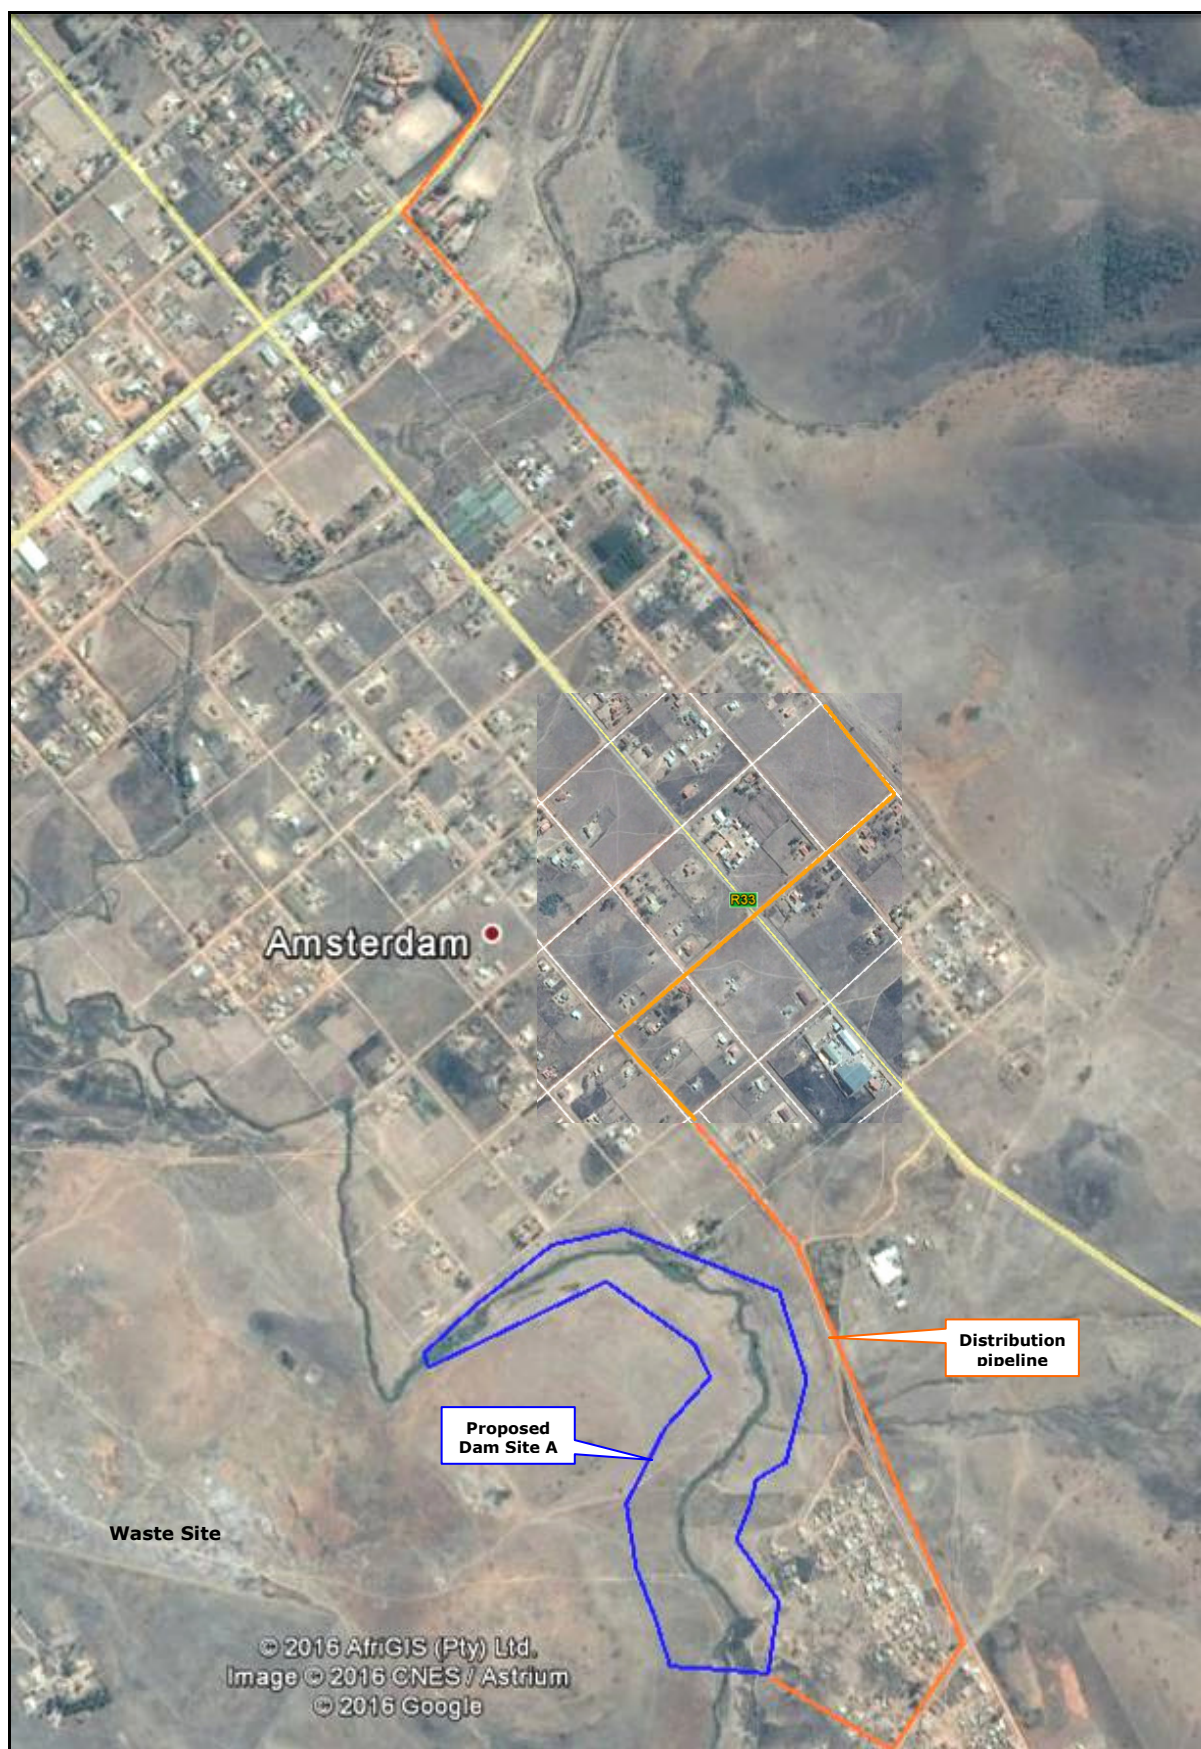
**Figure 5.8a: Aerial view of Dam Site A and Distribution Pipeline.**

The Distribution Pipeline would extend through the residential area of Amsterdam (Figure 5.8a and Figure 9).

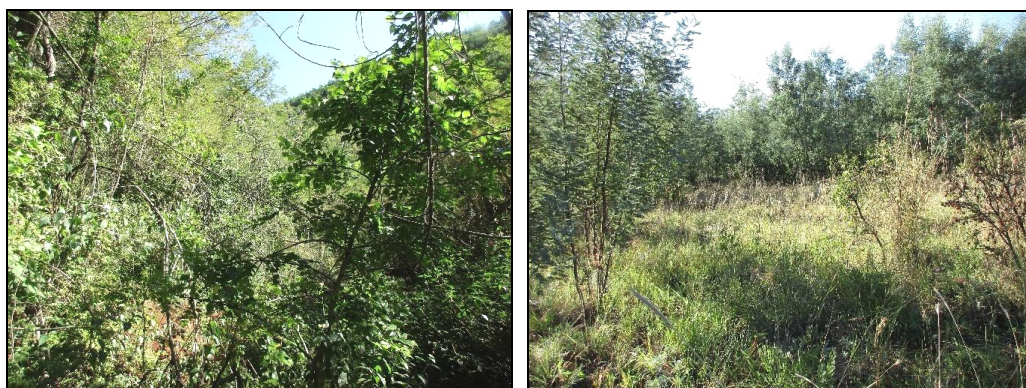
**Photo 5.1: View of indigenous woody vegetation and invasive woody vegetation (taken from Venter and Niemand, 2017b)**

- Indigenous woody vegetation – Dam Site B, Distribution Pipeline and Bulk Water Pipeline (Table 5.3);
- Invasive woody vegetation – Dam Site B, Distribution Pipeline and Bulk Water Pipeline (Table 5.3).

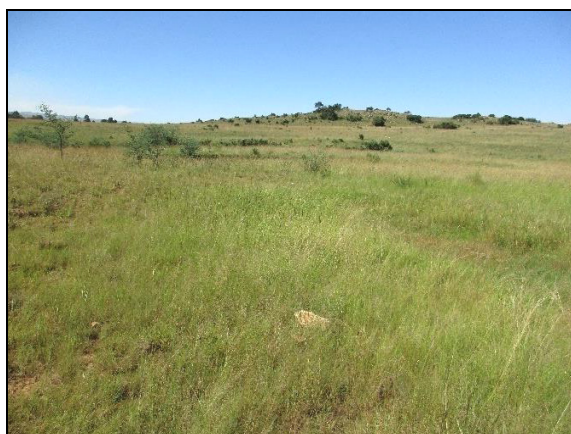
**Photo 5.2: View of Modified Grassland at Dam Site A (taken from Niemand and Venter, 2017b).**

An area of 7.64 ha (Table 5.3) of Modified Grassland is present at Dam Site A (Photo 5.2) within areas of deeper soils and appears to be heavily grazed. Dominant species include *Eragrostis chloromelas*, *Aristida congesta*, *Cymbopogon caesius*, *Hypoxis longifolia*, *Helichrysum rugulosum* and *Ledebouria ovatifolia*.

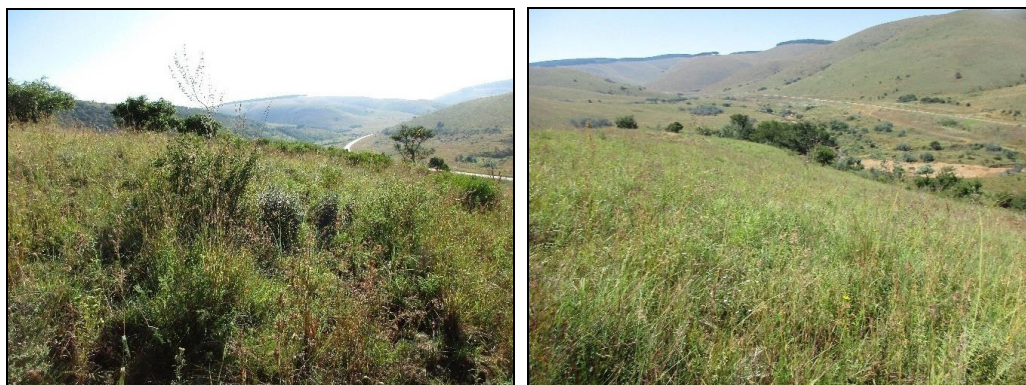
**Photo 5.3: View of Montane Grassland at Dam Site B (taken from Venter and Niemand, 2017b).**

Patches of the Montane Grassland (8.44 ha; Table 5.3) is interspersed with Weedy grassland, Indigenous woody vegetation and Invasive woody vegetation at Dam Site B (Figure 5.14), with the River vegetation unit passing approximately through the centre of the site (Figure 5.14). The grassland in this area is very similar to the grassland present at Dam Site A. Several typical grassland species are present, including *Cymbopogon caesius*, *Eragrostis chloromelas*, *Eragrostis capensis*, *Dicoma zeyheri*, *Helichrysum oreophilum*, *Heteropogon contortis* and *Ledebouria revoluta*.

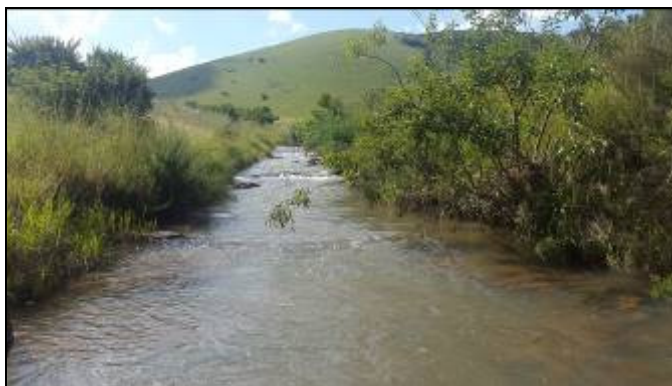
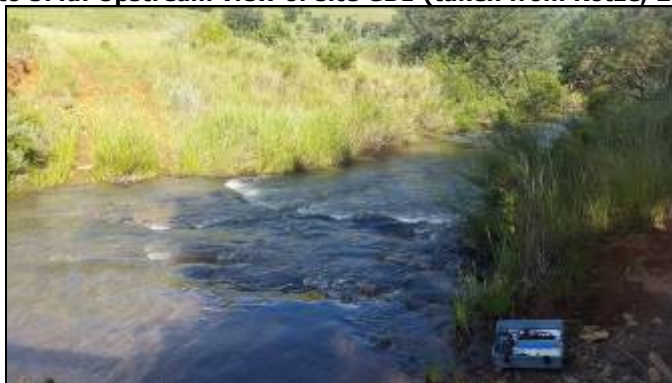
Kotze (2017) indicated that the site based IHI of **Site GB1** (upstream of proposed Dam Site B) is currently in a very good condition, being classified in a category A/B (Largely natural/slightly modified) (Photo 5.4a & 5.4b). The riparian habitat integrity of this site was also in a very good condition being classified in a category A (Largely natural).

**Photo 5.4a: Upstream view of site GB1 (taken from Kotze, 2017).**

**Photo 5.4b: Downstream view of site GB1.**

Site GB1 is situated on a private farm and the surrounding area is primarily used for cattle grazing. The only notable impact at the site was from livestock farming (slight bank erosion due to cattle trampling) and an informal river crossing. Very little alien vegetation (Wattle trees) was noted. The flows are also modified by irregular releases upstream of the site from a water transfer scheme (based on land owner, requires verification) into the upper Gabosha River. These releases can result in scouring of bed substrates, increased bank erosion and also lead to unnatural cues for fish migration. The habitat integrity of this site is not expected to be impacted by any activities related to the proposed development.

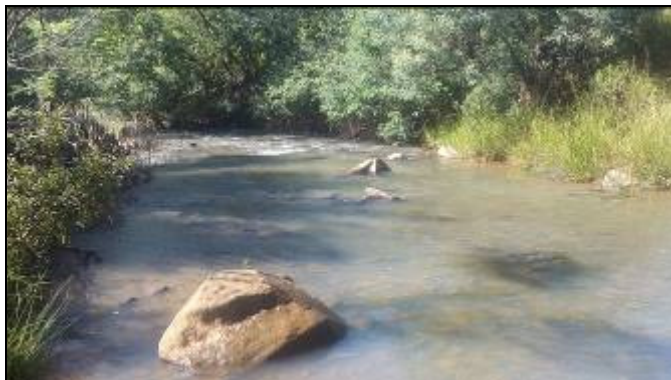
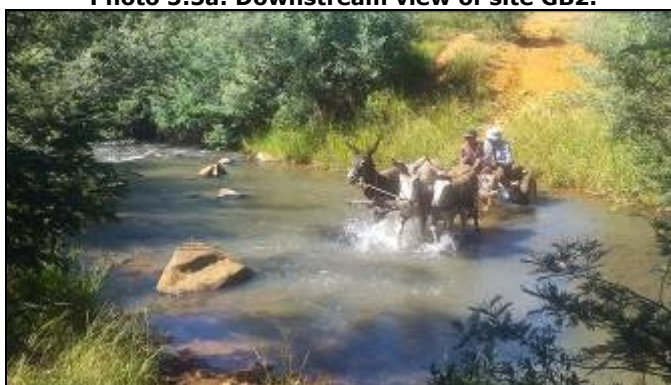
Kotze (2017) indicated the instream habitat integrity of **Site GB2** also to be in a very good condition (category A/B), while there was a notable deterioration in the riparian zone condition (Category C) (Photo 5.5).

**Photo 5.5a: Downstream view of site GB2.**

**Photo 5.5b: View of site GB2.**

The instream impacts at this site are similar to those observed at Site GB1, and aggravated by extensive growth of alien invader trees (Black/Silver wattle). These trees will reduce flows and have a notable impact on flows (flow modification) during dry seasons and especially during droughts. The alien trees were also the most significant impact on the riparian zone, replacing natural vegetation and increasing bank erosion. The wattle (and potentially also indigenous) trees are being removed actively (using chain saws) by the local community and various donkey carts were observed on the day crossing the river at Site GB2 and transporting people, equipment and wood (Photo 5.5b). These continuous crossings of the river also contributed slightly to a localised increase in sedimentation and embeddedness of bottom substrates.

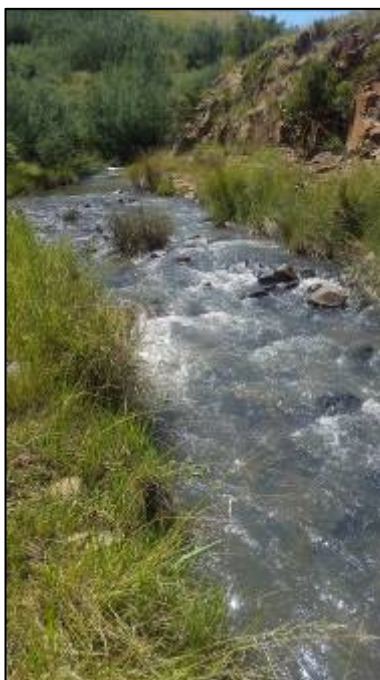
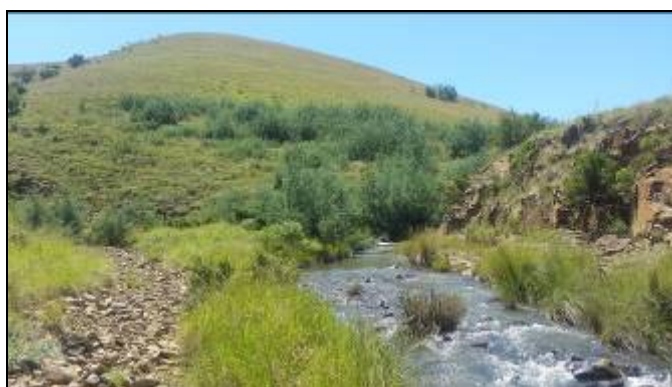
Kotze (2017) indicated that the habitat integrity was very similar at **Site GB3** than at Site GB2. Instream impacts were similar (category A/B) while the riparian zone improved slightly towards a category B/C (Photo 5.6a & 5.6b). This was primarily attributed to lower infestation of alien invader trees (potentially due to higher removal rate by locals as it is closer to main road and hence more accessible).

**Photo 5.6a: Upstream view of site GB3.**

**Photo 5.6b: Downstream view of site GB3.**

The habitat integrity of this site can be expected to be impacted by the proposed development (Dam Site B and Bulk Water Pipeline) during construction phase (physical removal of vegetation for access road and pipeline, increased sedimentation) as well as operational phase (Dam B) due to flow modification.

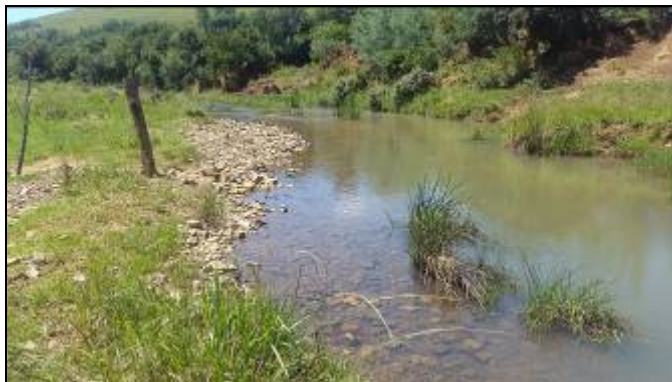
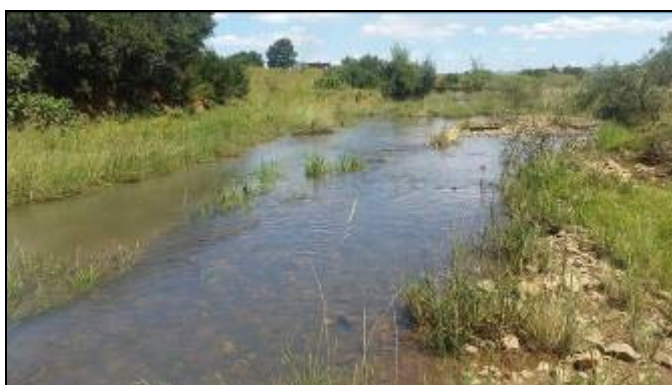
The riparian zone at this site is in a very poor condition due to agricultural activities, grazing, erosion, alien trees and an informal river crossing (Photo 5.7a & 5.7b).

**Photo 5.7a: Upstream view of site PLC1.**

**Photo 5.7b: Downstream view of site PLC1.**

The habitat at this site is already in a poor condition and can be expected to be impacted by the proposed pipeline crossing. Secondary impacts can also be expected at this site due to flow modification by the proposed Dam Site B, desilting of the Dorps Dam and upgrading of the water purification works.

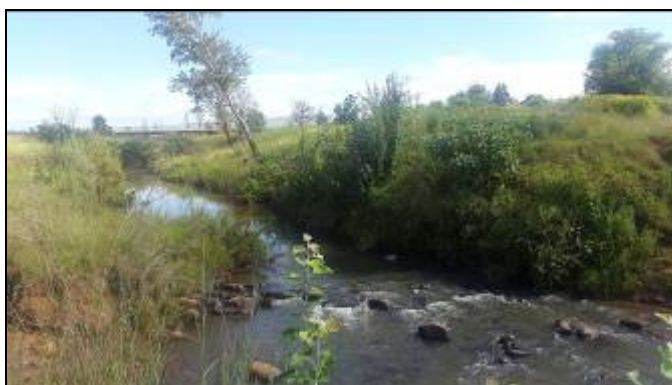
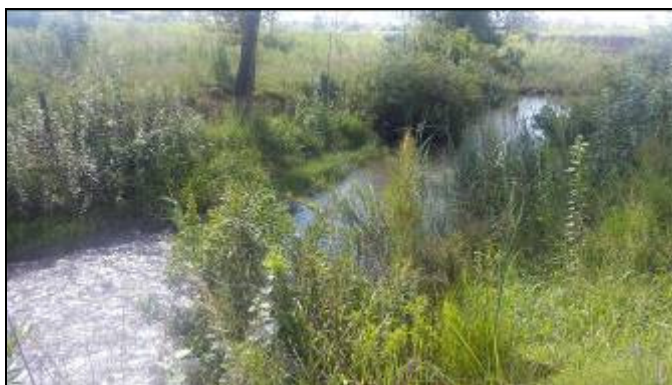
Kotze (2017) indicated that the habitat integrity of both the instream and riparian zones of **site TR-US** in the Thole River were classified in a category C (Moderately modified) (Photo 5.8a & 5.8b).

**Photo 5.8a: Upstream view of site TR-US.**

**Photo 5.8b: Downstream view of site TR-US.**

This site is located within the town of Amsterdam and hence directly impacted by the various urban related activities. Notable impacts observed at the site included:

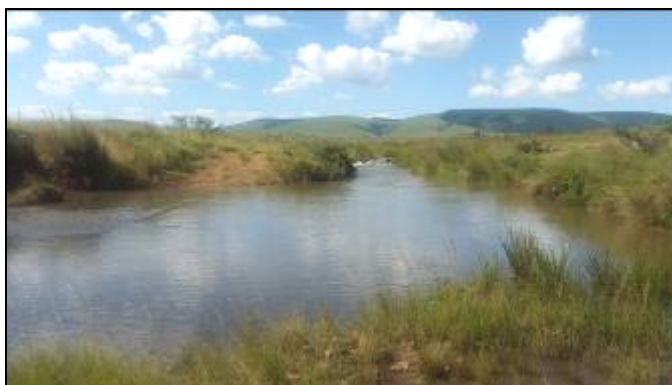
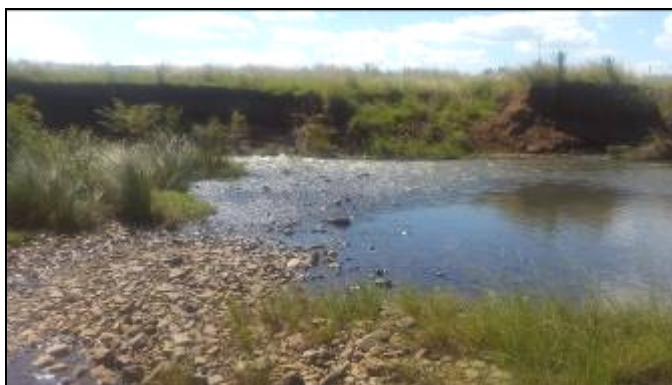
Kotze (2017) indicated that the habitat integrity remained very similar between sites TR-US and **TR-DS**, with the instream and riparian zones of the downstream site also being classified in a category C (Photo 5.9a & 5.9b).

**Photo 5.9a: Upstream view of site TR-DS.**

**Photo 5.9b: Downstream view of site TR-DS.**

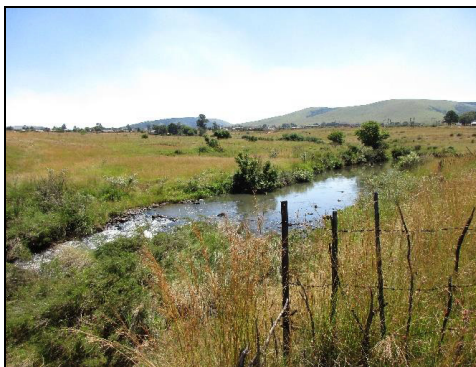
**Photo 5.10: The Thole River at Dam Site A (taken from Venter and Niemand, 2017b)**

Dam Site A is located within the Thole River (Figure 5.12). At this location, the river banks are mostly dominated by grass species, with a number of woody, forb and sedge species also present (Photo 5.10).

Dominant species include *Agrostis continua*, *Buddleja* species, *Combretum erythrophyllum*, *Cymbopogon caesius*, *Cynodon dactylon*, *Eragrostis plana* and *Panicum maximum*. Several signs of disturbance are present and development takes place close to the river, but the vegetation is still dominated by indigenous species. A total of 3.64 ha of this vegetation unit falls within Dam Site A and its 50m buffer (Table 5.28).

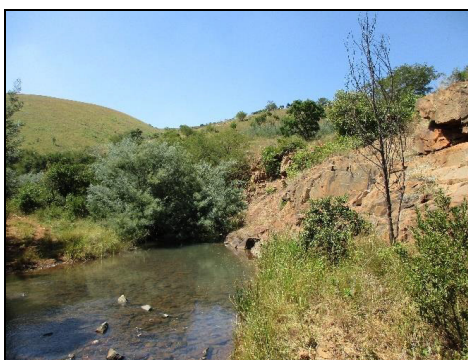
**Photo 5.11: View of the Gabosha River at proposed Dam Site B (taken from Venter and Niemand, 2017)**

Dam Site B is located within the Gabosha River (Figure 5.28). The portion of the Gabosha River at this location has a strong woody component, in addition to the grass, sedge and forb species present (Photo 5.11).

Several alien and invasive plant species are present, including *Acacia dealbata*, *Ipomoea purpurea*, *Lantana camara*, *Solanum mauritianum*, *Tagetes minuta* and *Verbena rigida*. Indigenous species include *Diospyros lycoides*, *Sporobolus africana*, *Eragrostis plana*, *Clematis brachiata*, *Fimbristylus complanata*, *Scadoxus* and *Kyllinga erecta*. The indigenous to alien species mix is approximately even.

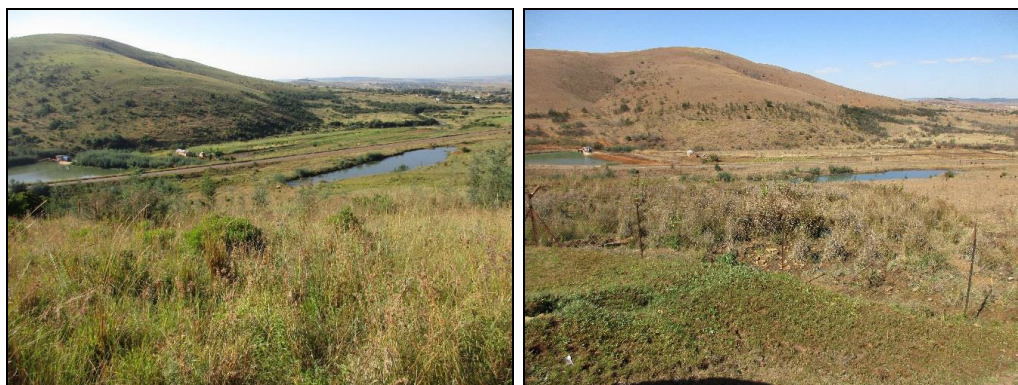
**Photo 5.12: Dams and artificial seep downslope of the water treatment works (taken from Venter and Niemand, 2017b)**

**Dams** are present downslope of the Water Treatment Works, but are unlikely to be affected by the pipeline. In addition, water is continually leaking from the Water Treatment Works and causing a temporary **artificial seep** on the steep slope between the Water Treatment Works and the dam. The vegetation is similar to the vegetation in the natural seep wetlands (Photo 5.12).

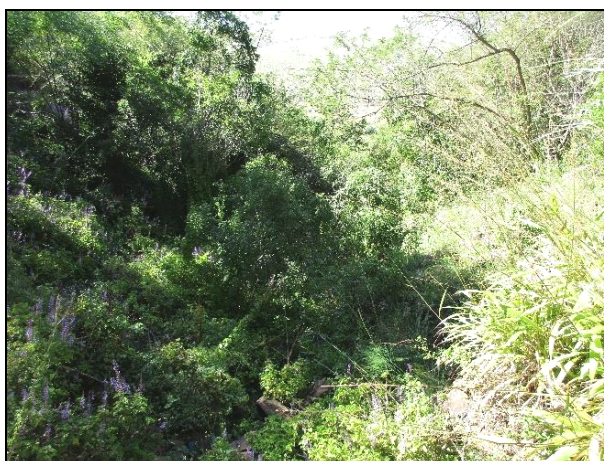
**Photo 5.13: View of one of the drainage lines to be crossed by the proposed Bulk Water Pipeline (taken from Venter and Niemand, 2017b).**

Three **drainage lines** (Figure 5.15) will be crossed by the proposed Bulk Water Pipeline, with a surface area of 0.9ha. The vegetation of the drainage lines in this area is the same as at the proposed Dam Site B (Photo 5.13). The drainage lines cannot be classified as either wetland or riparian areas, since they are first order drainage lines and none of the characteristics of wetlands or riparian areas are present. No PES or EIS calculations are applicable to drainage lines.
