5. BIOPHYSICAL DESCRIPTION OF THE SITE

The proposed filling station will be located on Portion 1 of Erf 10769, Middelburg X26, Middelburg. The site is located south of La Roca Boulevard (i.e. access road to the Middelburg Mall) and west of Samora Machel Street (R35). Figure 5.1 indicates the location of the site.

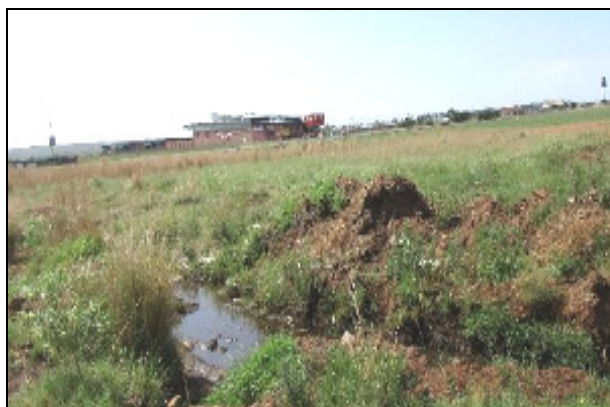
Photo 5.2: A view of the storm water trench on the northern boundary of the site

A storm water trench is present on the northern boundary of the site (Figure 5.3 and Photo 5.2). Building rubble was dumped adjacent to this trench in the form of a berm. The trench channels storm water from the adjacent Retail City across the site towards a culvert underneath La Roca Boulevard (Figure 5.3 and Photo 5.4). Another storm water trench drains water from the Public Open Space located on the eastern boundary of the site underneath La Roca Boulevard (Figure 5.3 and Photo 5.5).

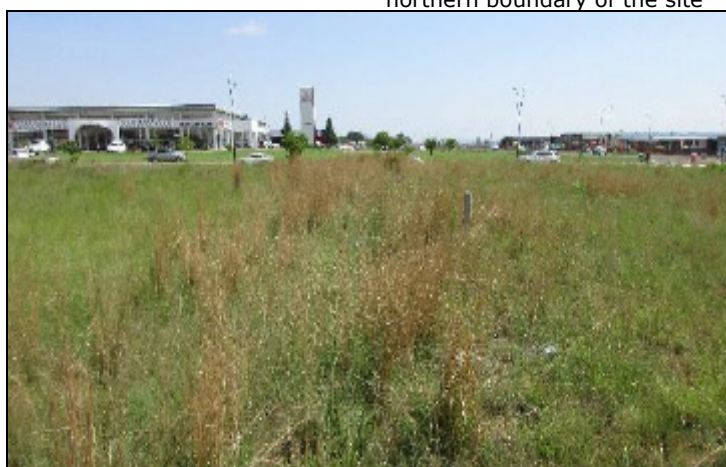
Photo 5.3: A view of the bulk water pipeline on the eastern boundary of the site

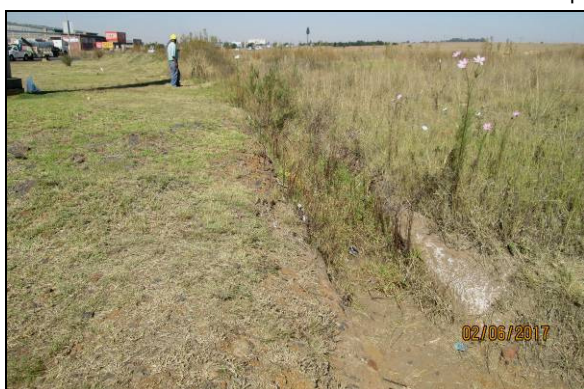
Photo 5.4: A view of the trench located east of the site

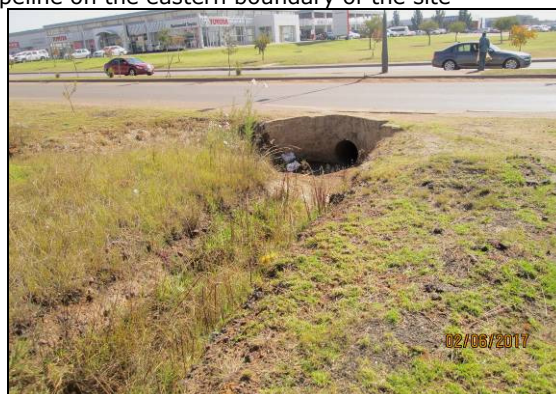
Photo 5.5: A view of the storm water culvert underneath La Roca Boulevard

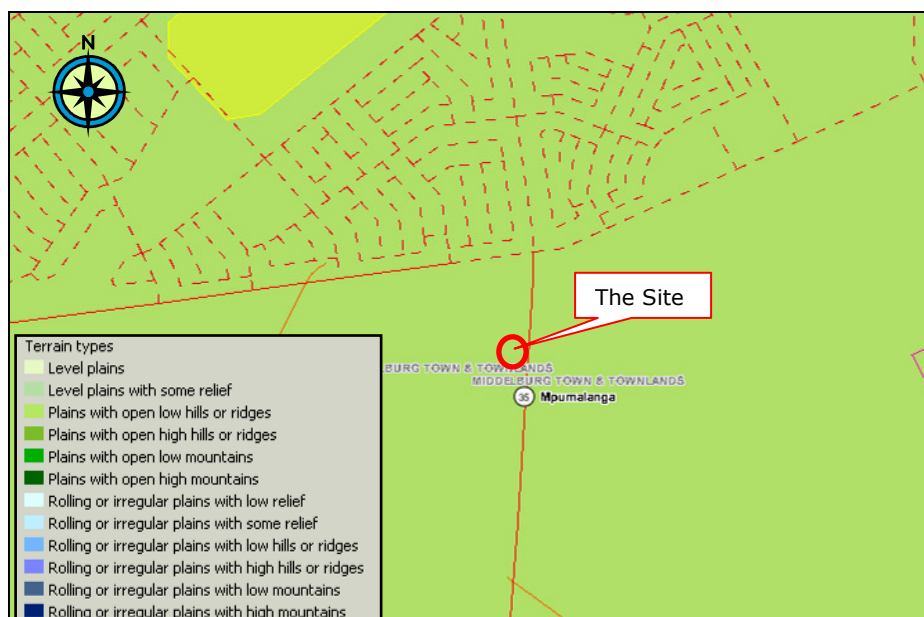
Figure 5.5: Terrain type of the proposed site (taken from Department of Agriculture, Forestry and Fisheries)

According to the AGIS Comprehensive Atlas of the Department of Agriculture, Forestry and Fisheries, the terrain type is plains with open low hills or ridges as indicated in Figure 5.5.

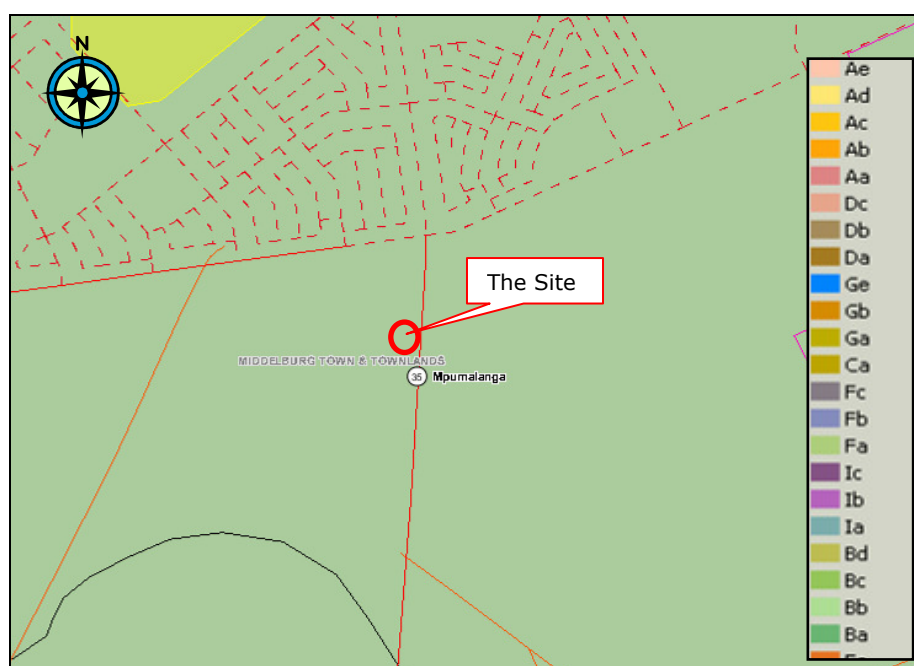
Figure 5.6: Land type of the proposed site (taken from Department of Agriculture, Forestry and Fisheries)

According to the AGIS Comprehensive Atlas of the Department of Agriculture, Forestry and Fisheries, the said site falls within the Ba land type (Figure 5.6). The Ba land types comprise of plinthic soils (with subsurface accumulation of iron and manganese oxides due to fluctuating water table) with low to intermediate base status. Red soils are not widespread. Upland duplex and black clay soils are rare. According to Rehab Green (2004), these soils have a Moderate to High agricultural potential.

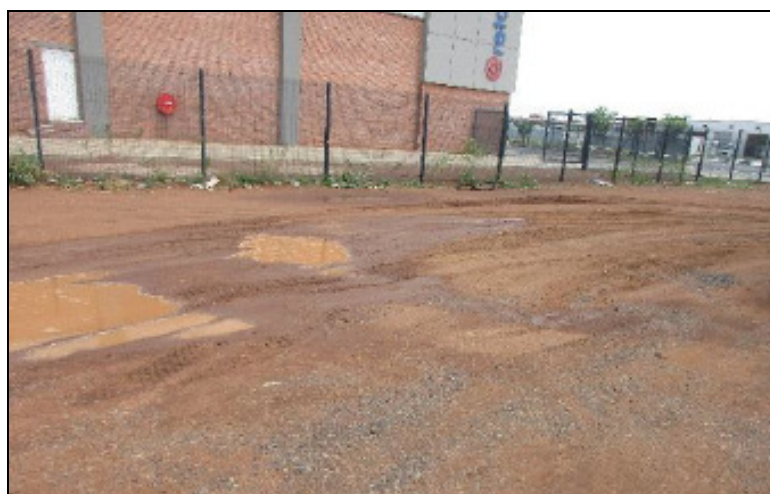
Photo 5.6: A view of the western portion of the site where the vegetation was cleared and gravel/soil was dumped

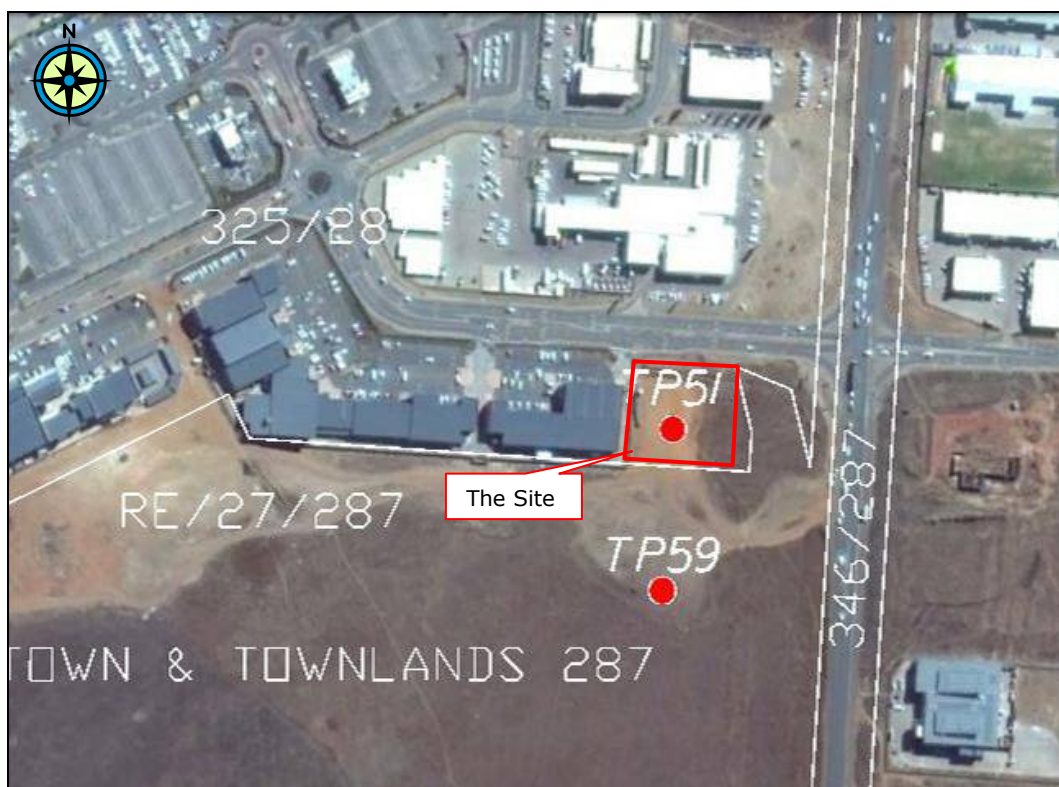
Figure 5.9a: Location of test pits in relation to the site

Hansmeyer (2004) indicated that no seepage was recorded in test pit TP59. A copy of the test pit profile is provided in Appendix 4.

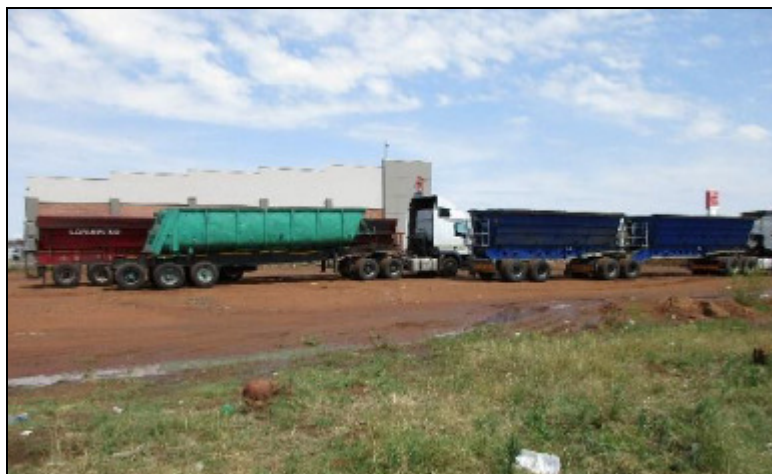
Photo 5.7: A view of the cleared western and central portions of the site.

The western and central portions of the site as well as a portion of the vacant property south of the site are being used by heavy vehicles as an informal parking area (Photo 5.7). The vegetation was thus removed and a gravel layer dumped on site to prevent wheel entrenchment. Only a few pioneer species (mostly alien species) are present within the cleared area. Venter (2017) recorded a total of 17 species in the cleared area e.g. *Acanthospermum australe*, *Datura stramonium*, *Hypochaeris radicata*, *Malvastrum coromandellianum*, *Schkuhria pinnata* and *Solanum sisymbriifolium*. A full list of species noted is provided in Addendum E of Appendix 5.

Due to the high level of disturbance, this area is considered to be of Very Low conservation importance from a vegetation point of view.

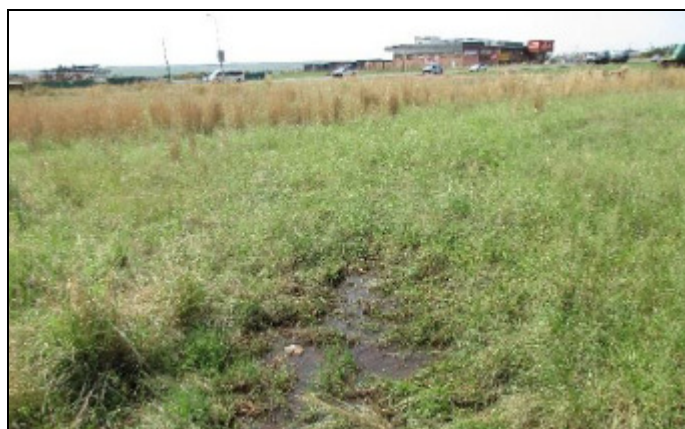
Photo 5.8: A view of the grassland vegetation located south and east of the filling station site

No grassland vegetation is present on the proposed filling station site. However, the proposed access road will extend across disturbed grassland vegetation south of the site as indicated in Figure 5.13 and Photo 5.8.

According to Venter (2017), the grassland closely resembles the Rand Highveld Grassland with a fair representation of grass and forb species. A few alien species are also present due to disturbances such as adjacent development, the dumping of rubble, littering, etc.

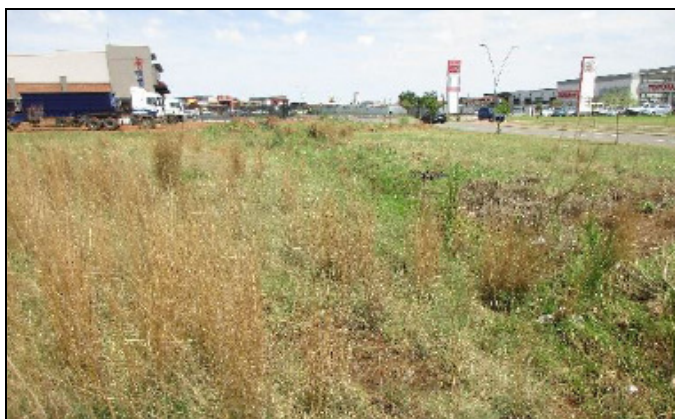
Photo 5.9: A view of the wetland vegetation in the north eastern portion of the site. Note the disturbance as a result of excavation.

Due to the disturbances on site (e.g. excavation of storm water trenches, installation of water pipeline, etc.; Photo 5.9) and surrounding development, several weedy and alien species were also noted in this unit. The wetland area on the corner of La Roca Boulevard and Samora Machel Street (R35) is invaded by Kikuyu Grass as evident in Photo 5.10. Other species indicating disturbance include *Cyperus esculentus*, *Conyza bonariense* and *Verbena bonariense*. A full list of recorded species is provided in Addendum E of Appendix 5.

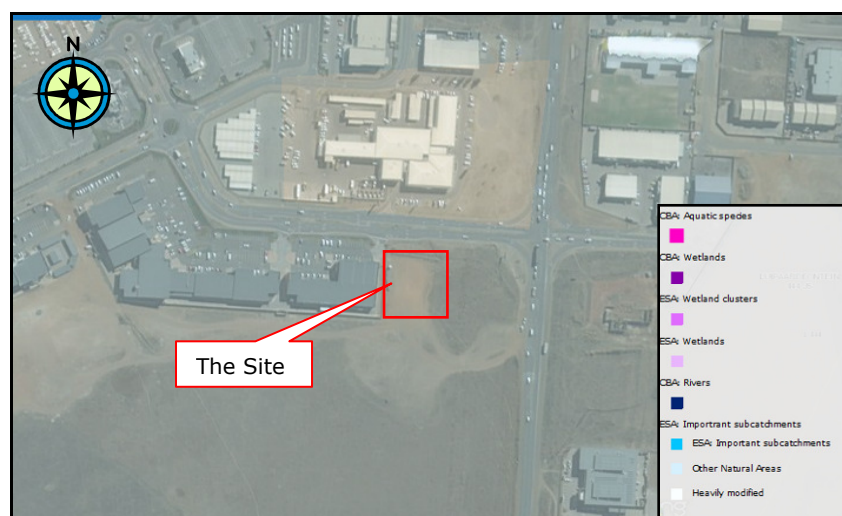
Figure 5.14: Freshwater biodiversity assessment - Mpumalanga Biodiversity Sector Plan, 2013

The entire site and surrounding area are classified as **Other Natural Areas** in terms of the Freshwater Biodiversity Assessment (Figure 5.14).

No Critical Biodiversity Areas (CBA's) for aquatic species, Ecological Support Areas (ESA's) for fish, wetlands or wetland clusters are present on or near the site (Figure 5.14).

The Mpumalanga Biodiversity Sector Plan (MBSP, 2013) does not indicate any important wetlands or wetland clusters on or near the site (Figure 5.14).

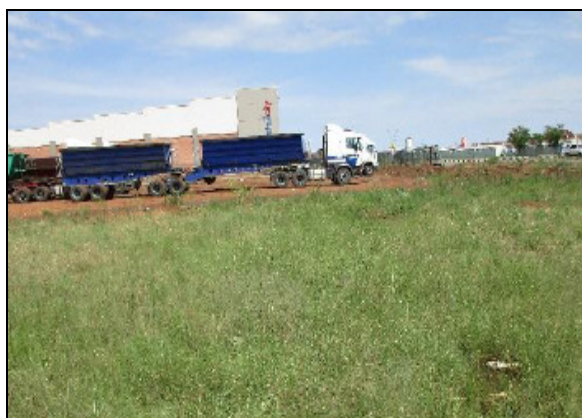
Photo 5.11: A view of the remaining seep wetland vegetation in the eastern portion of the site (taken from Venter, 2017).

Some of the vegetation within this seep wetland was cleared for truck parking or roads, but the majority of the wetland is intact (Figure 5.15). The seep wetland in the eastern portion of the site (0.196 ha) has also been impacted, but is still intact (Figure 5.15 and Photo 5.11).

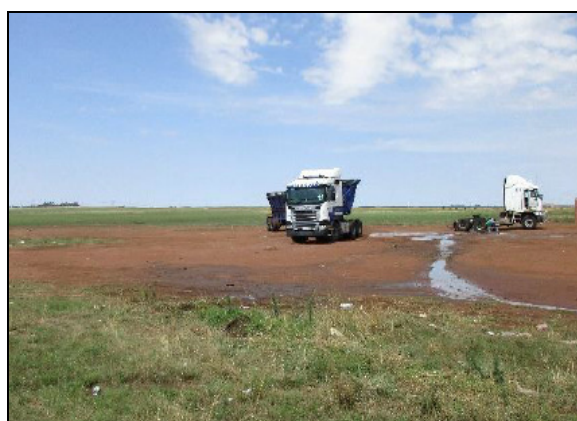
Photo 5.12: A view of the cleared portion of the seep wetland on site (taken from Venter, 2017).

As indicated in Section 5.7, the western and central portions of the site were cleared of vegetation (Cleared seep wetland; 0.2272 ha in extent; Figure 5.15) in order to allow heavy vehicles to use this area for parking. Soil/gravel was imported and spread on site to prevent wheel entrenchment. Venter (2017) could not sample the soil in the western portion of the site due to the imported gravel/soil and compaction of the soil layer by trucks.

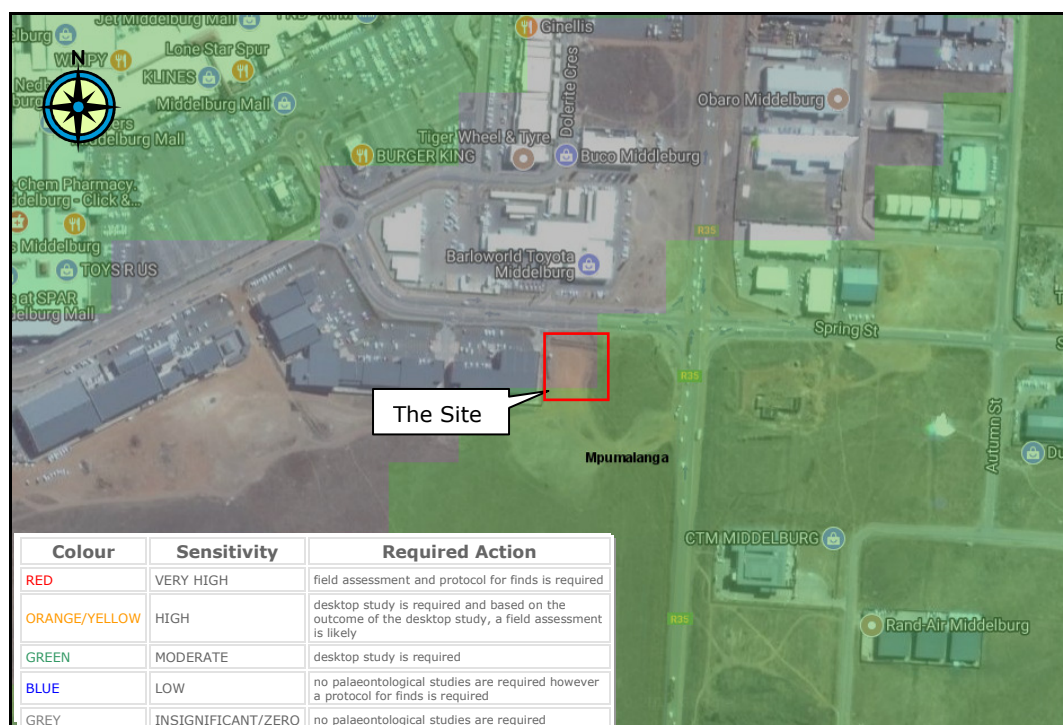
Figure 5.19: Requirement for palaeontological study (taken from SAHRA, 2014)

SAHRA requested (letter dated: 26 June 2017; Appendix 10) that a desktop Palaeontological Desktop Study be commissioned since the site is located in a moderately sensitive area for fossiliferous rock strata (Figure 5.19).

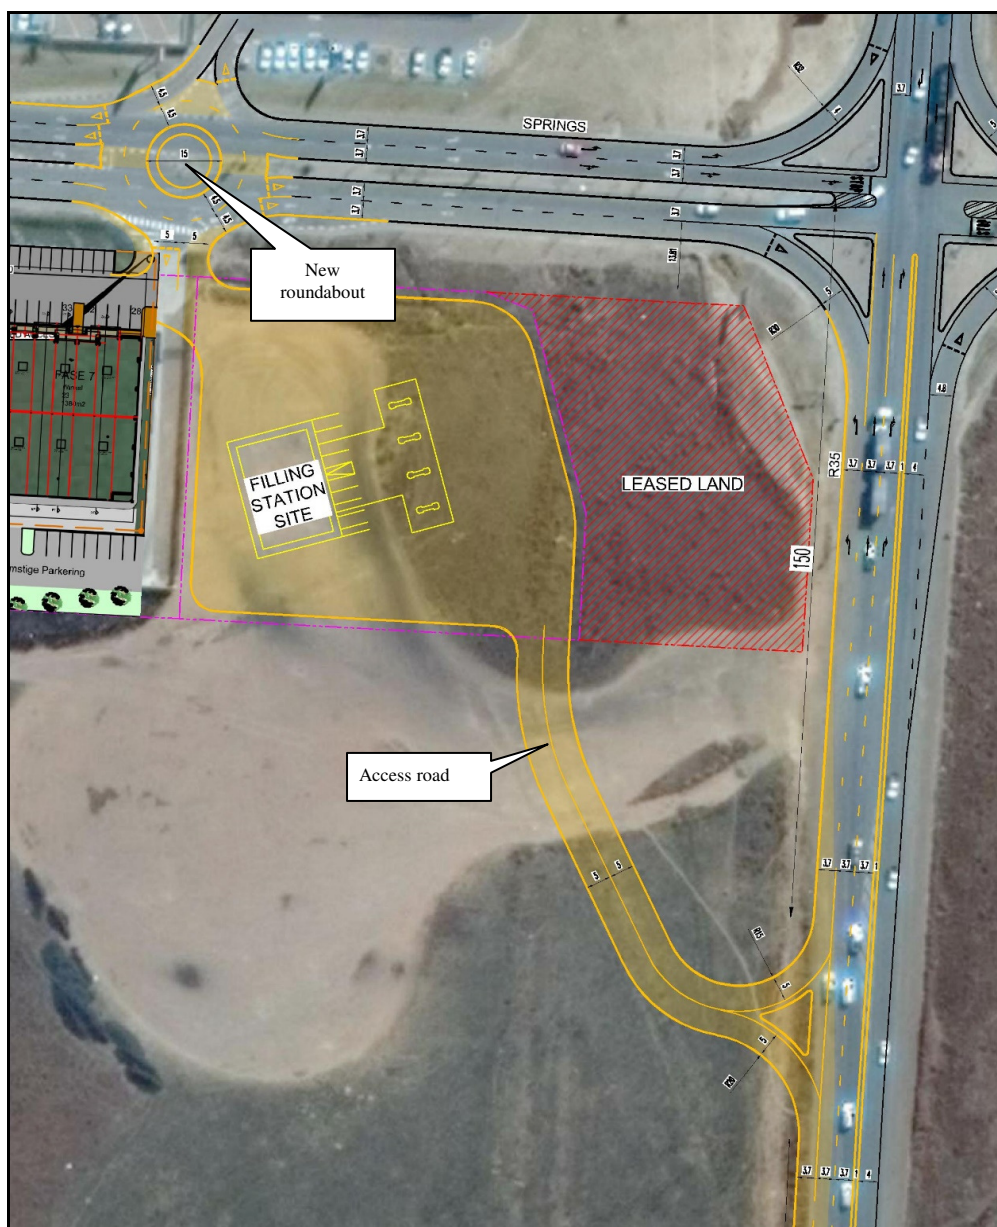
Figure 5.20: Proposed access from Samora Machel Street (R35) and La Roca Boulevard (taken from Roberts, 2017)

Roberts (2017) made the following recommendations:
