5. BIOPHYSICAL DESCRIPTION OF THE PROPOSED SITE

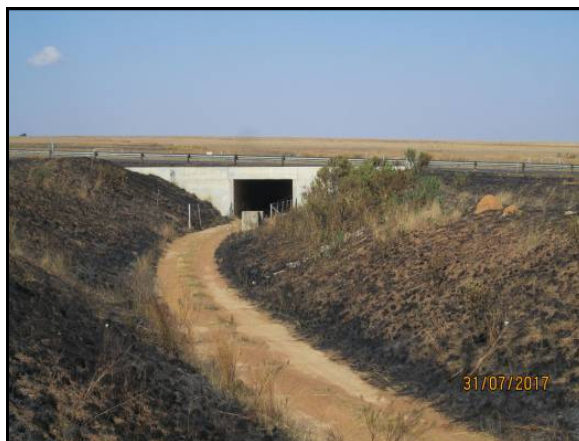
Photo 5.5: View of road underneath the N4 national road

The proposed development site is connected to the southern portion of the property by means of a gravel road underneath of the N4 national road as indicated in Photo 5.5.

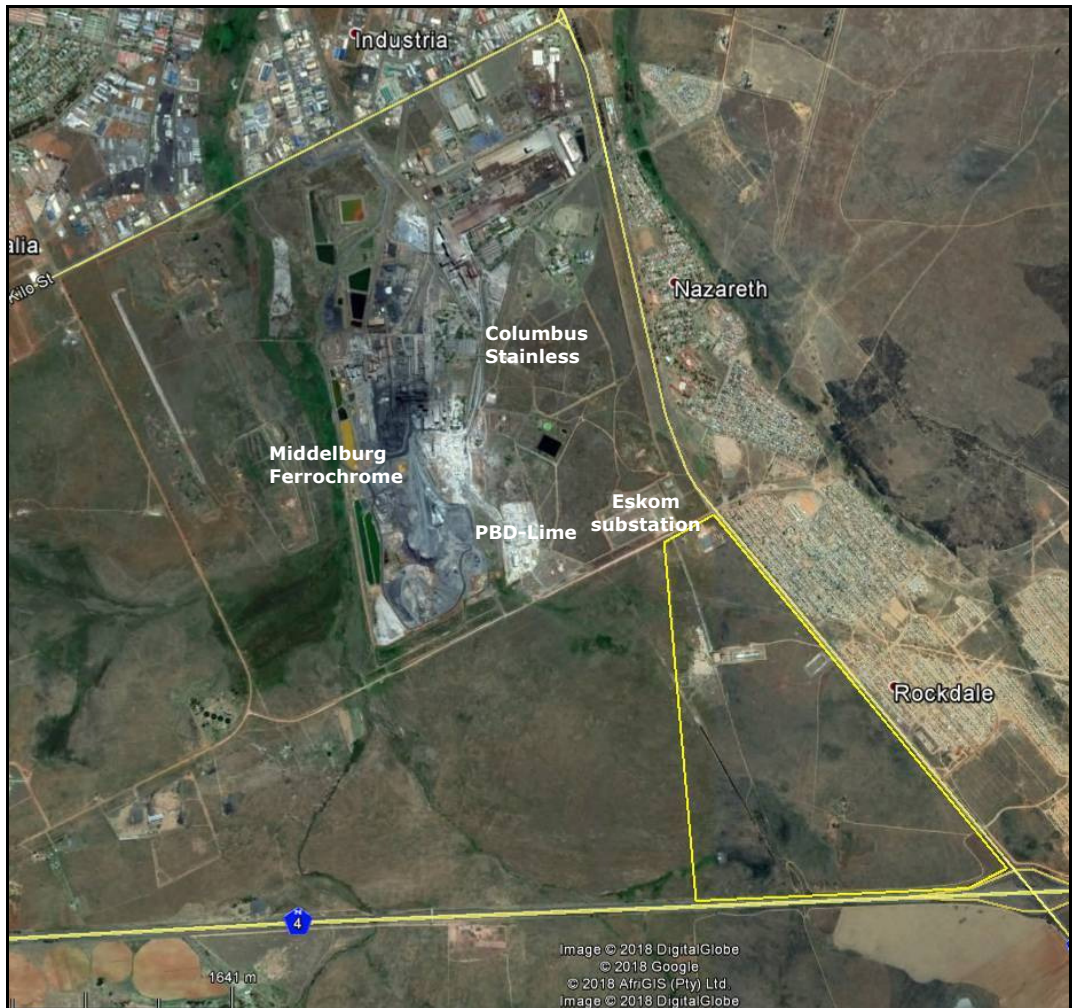
Figure 5.3a: An aerial view of Columbus Stainless and Middelburg Ferrochrome in relation to the said site.

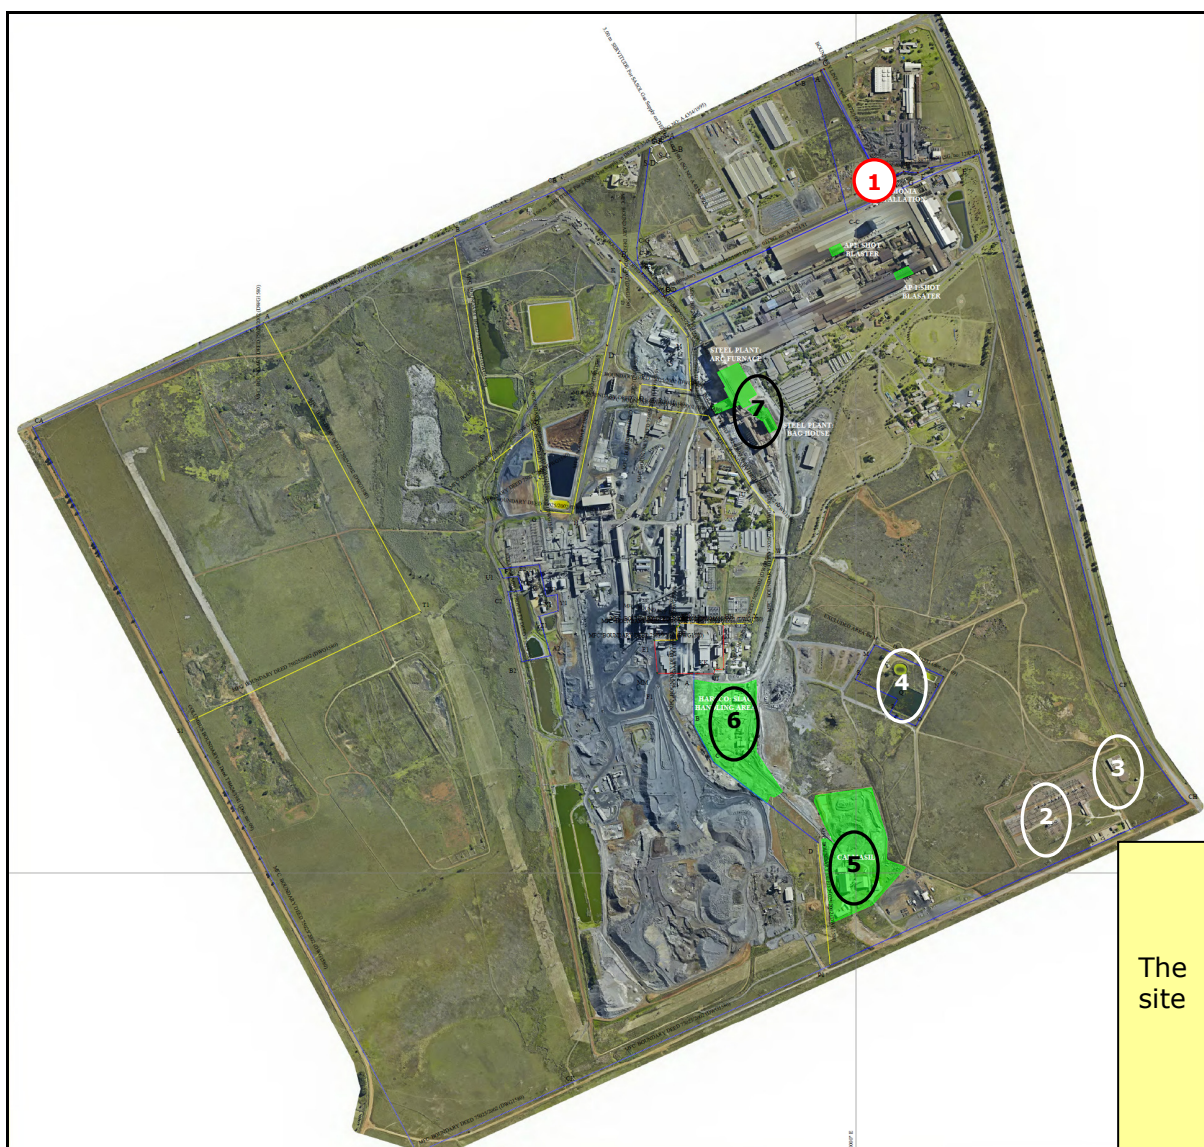
Figure 5.3b: An aerial view of the Columbus Stainless and Middelburg Ferrochrome facilities.

(Legend: 1: Ammonia Installation; 2: Eskom substation; 3: Nasaret Reservoir; 4: Main water reservoir; 5: PBD-Lime: Calmasil Plant; 6: Steel Plant & Furnaces; 7: Shot blaster).

Columbus Stainless was founded in 1966 and is Africa's only producer of stainless steel flat products. The facility comprises of a steel plant and furnaces (Figure 5.3b; no 6), shot blaster (Figure 5.3b; no 7), slag handling area, etc. An Ammonia installation (which is registered as a Major Hazard Installation (MHI)) is also present within the Columbus Stainless site (Figure 5.3a; no 1). This installation is located approximately 3km from the proposed Rockdale residential area.

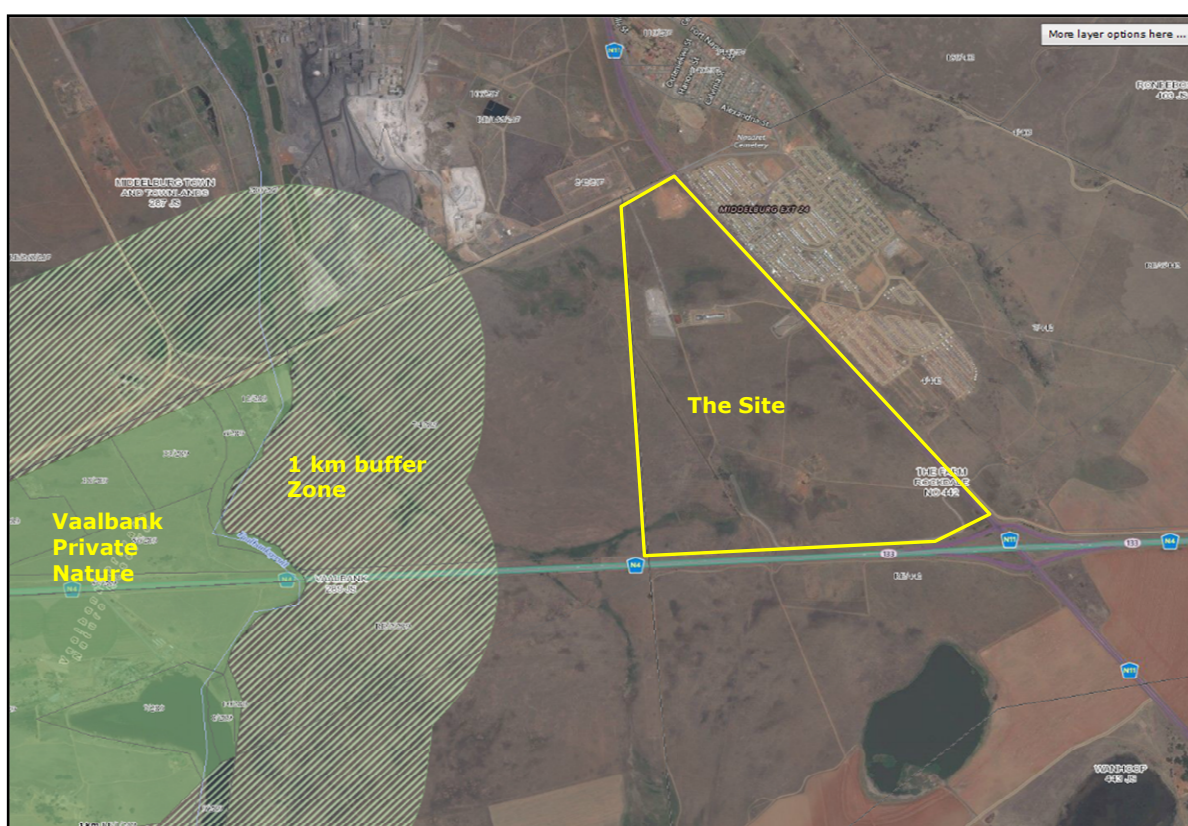
Figure 5.3c: The proposed site in relation to the Vaalbank Private Nature Reserve

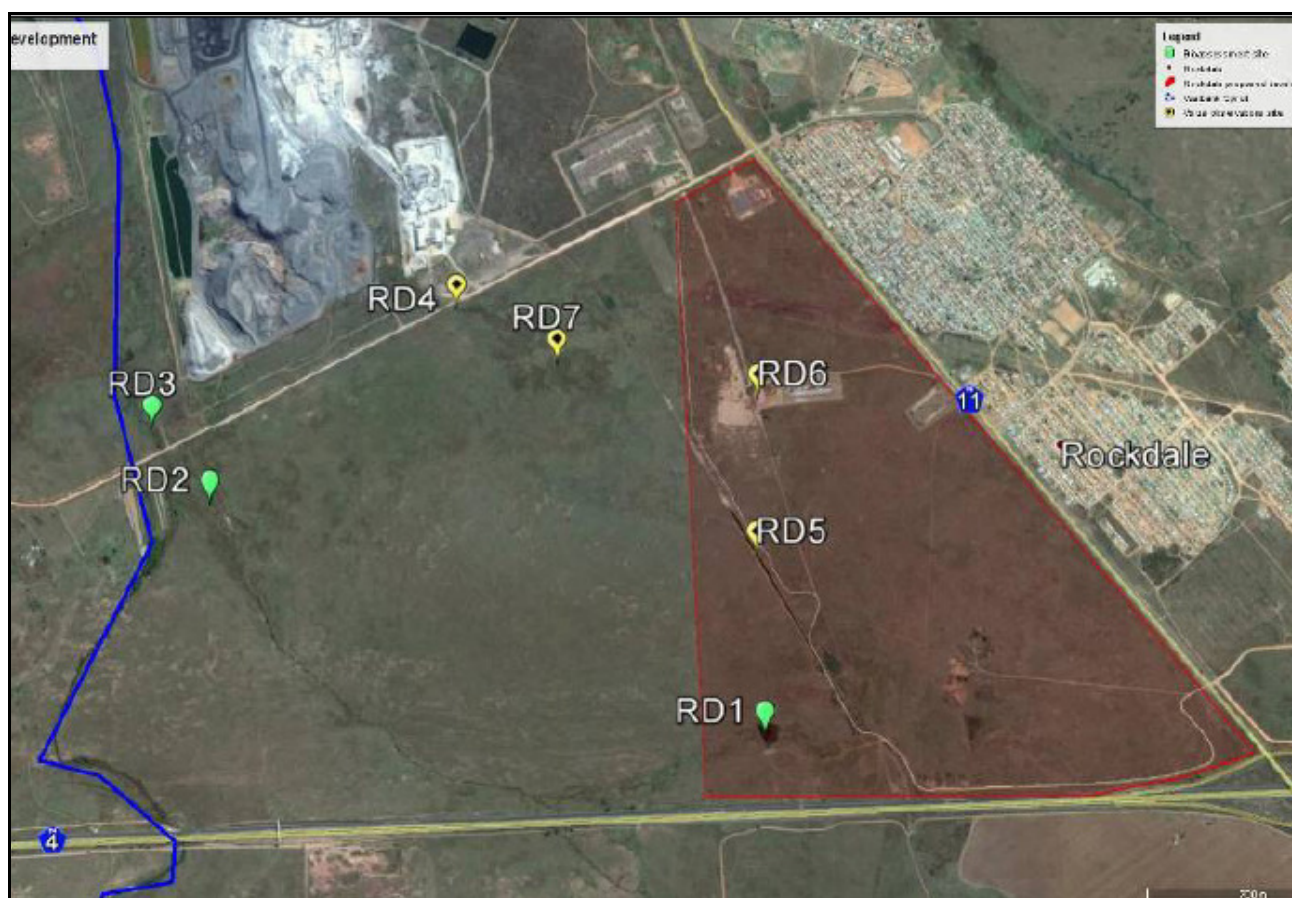
Figure 5.20: Aerial of the location of the aquatic sampling sites (taken from Kotze, 2017)

Kotze (2017) selected three (3) sites (RD1, RD2, RD3) for aquatic sampling (i.e. in-situ water quality, habitat assessment, macroinvertebrates and fish) and 4 visual (RD4, RD5, RD6, RD7) observation sites as indicated in Table 5.21. Figure 5.20 indicates the location of the said sites.

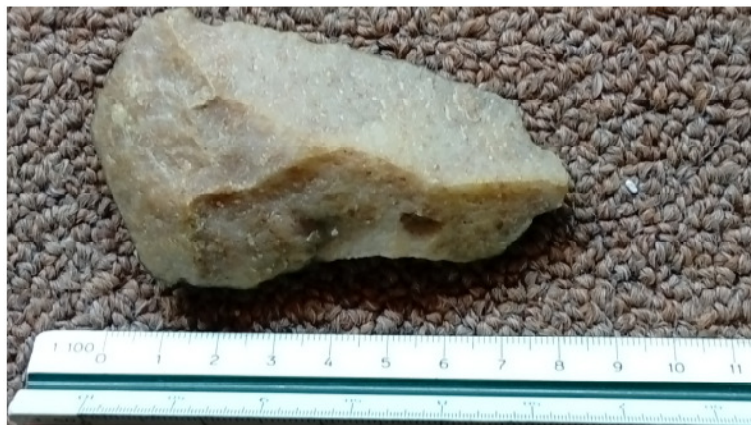
Photo 5.6: MSA Tool found within the surveyed area (taken from Van Vollenhoven, 2017).

prime spot for hunting and obtaining water in the past. Therefore one may assume that Stone Age people probably would have moved through the area. In fact, one Middle Stone Age artefact was identified out of context, within the study area (Photo 5.6).

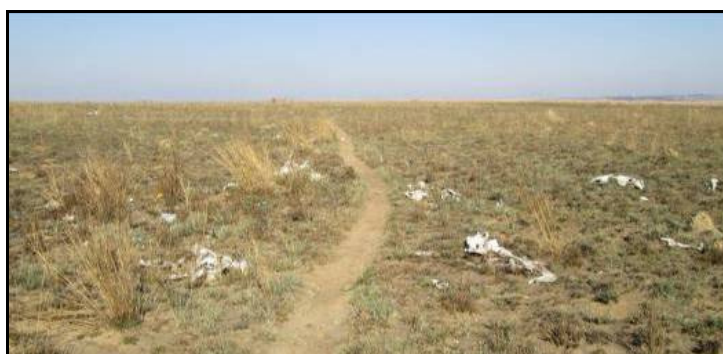
Photo 5.7: Site of possible ritual cattle slaughtering

Three sites where cattle may be slaughtered for ritual purposes was also identified adjacent to the N11 national road – bones were noticed at these sites as indicated in Photo 3.6. Van Vollenhoven (2017) indicated that these sites have no real heritage significance (Van Vollenhoven, 2017).
