# ECOLOGICAL IMPACT ASSESSMENT

**CONSTRUCTION OF RESIDENTIAL  
DWELLINGS AT 99 COLWYN  
DRIVE, SHEFFIELD BEACH,  
KWADUKUZA**

**(REM OF PTN 292 OF LOT 61 NO  
1521)**

**ECOLOGICAL IMPACT ASSESSMENT FOR THE PROPOSED  
RESIDENTIAL DEVELOPMENTS AT 99 COLWYN DRIVE,  
SHEFFIELD BEACH, KWADUKUZA**

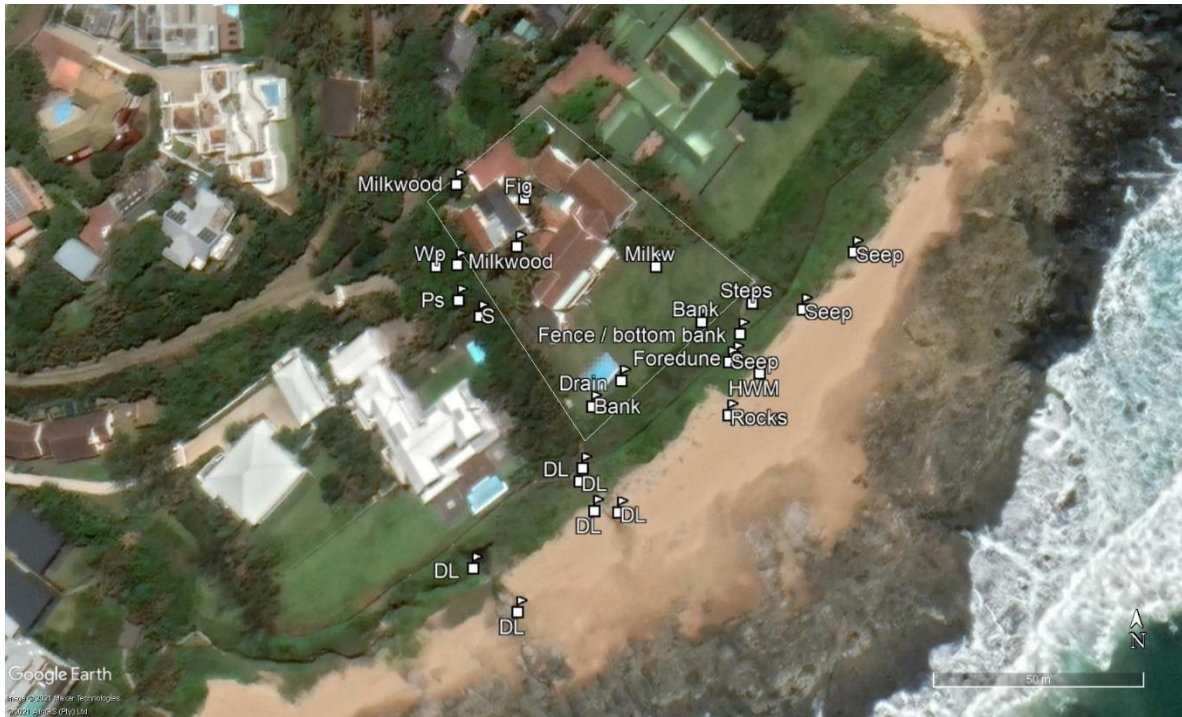
**Figure 5.** Features noted during site reconnaissance (source: Google Earth 2021).

- Specific features of the beach and dune environments were identified and logged using a Garmin Montana V GPS (Figure 5).

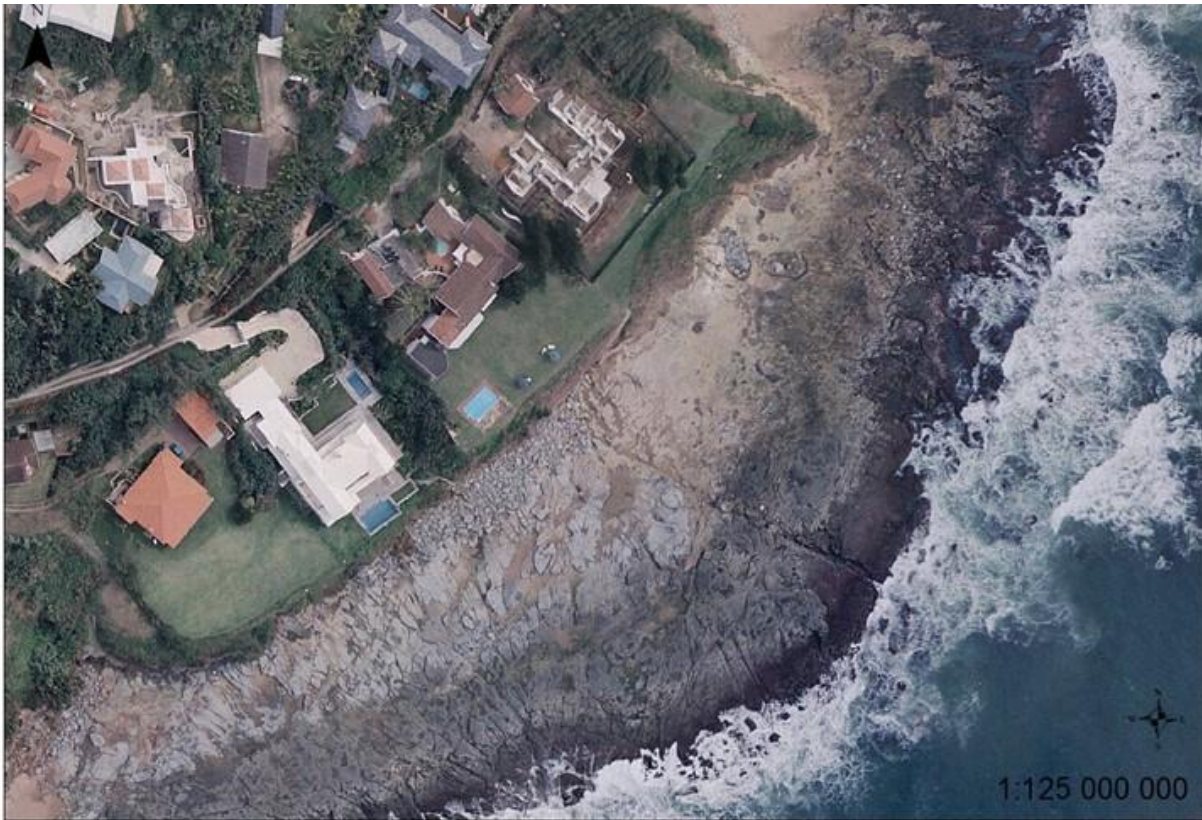
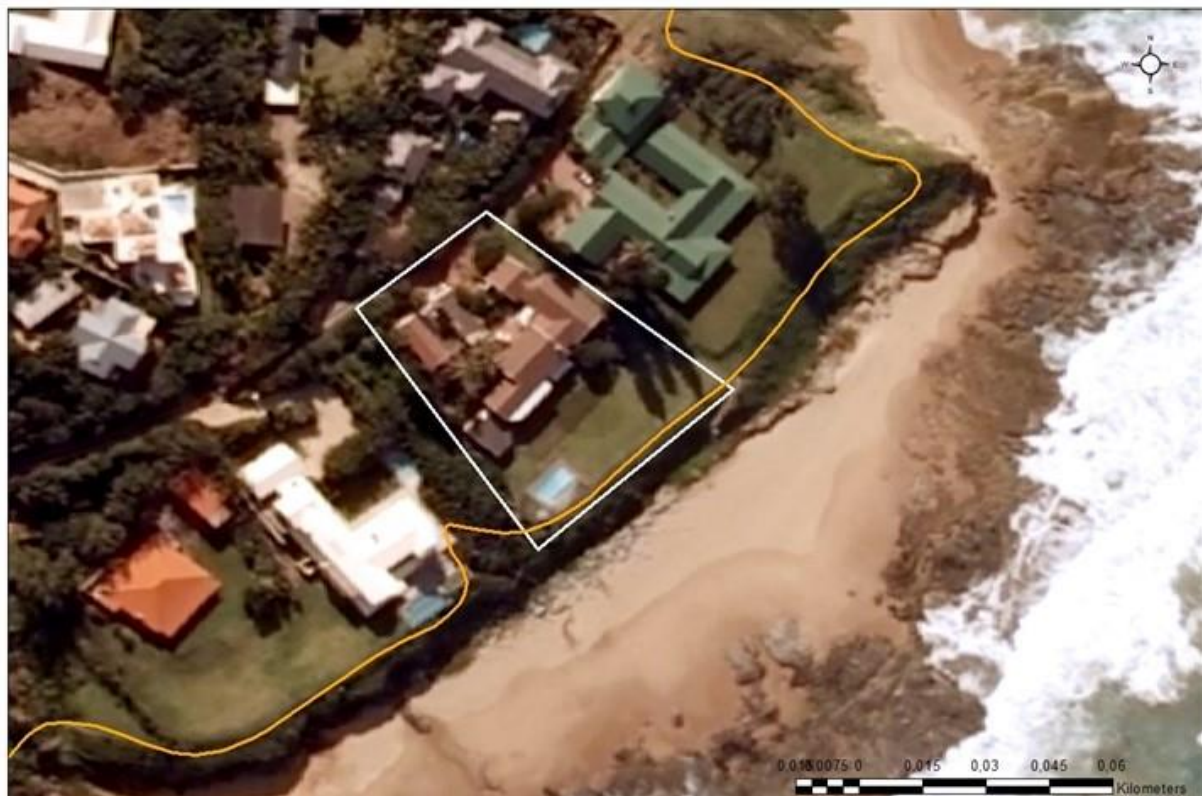
**Figure 16.** Image showing site in 2007 following significant storm erosion (above) and recent imagery – 2020, showing site and 10m contour, in orange (below).

The beach form lying immediately below the property is primarily a boulder strewn hummock dune formation, with the earthen – rocky cliff form leading to the subject sites being composed of early seral dune vegetation, including *Gazania rigens* and *Carpobrotus dimidiatus*. A fence lies along a platform at approximately 4 – 6m amsl and marks the seaward property cadastral (Figure 16).

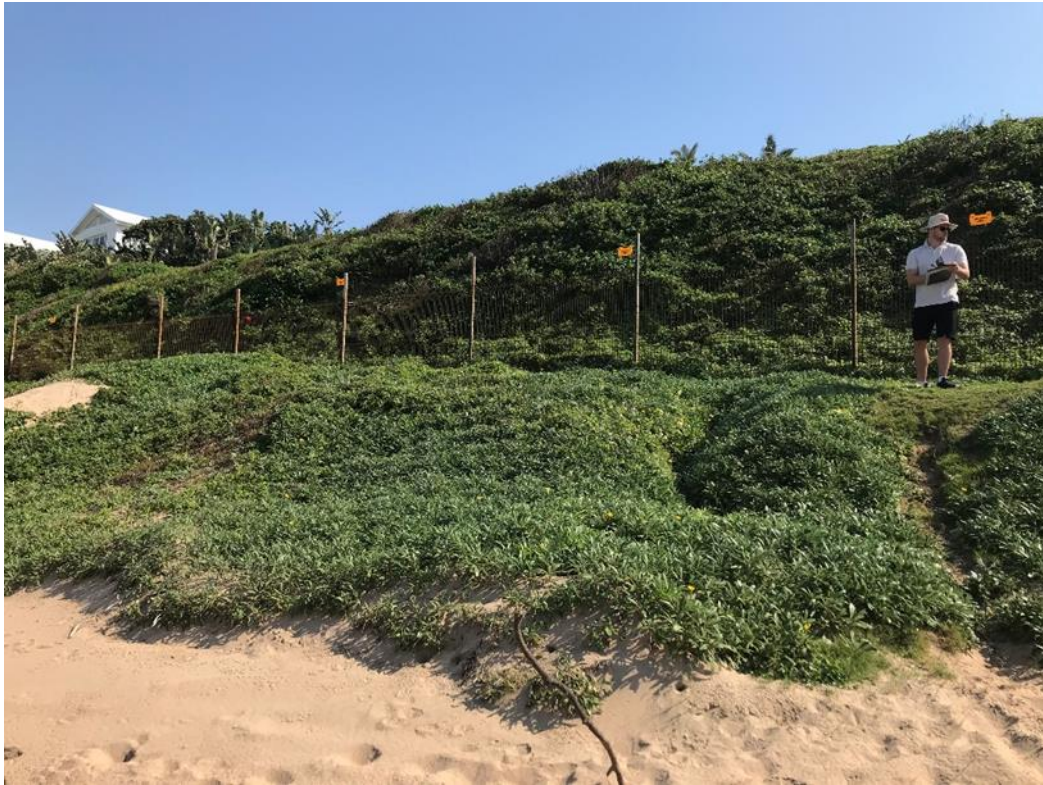
**Figure 17.** Image showing frontal dune and security fence and approximate point of establishment of the new wooden walkway.

It is proposed that a new access point to the beach will be established across this dune form to replace the existing damaged stairway and allow independent, but collated access for both properties to the beach once subdivision has been approved.

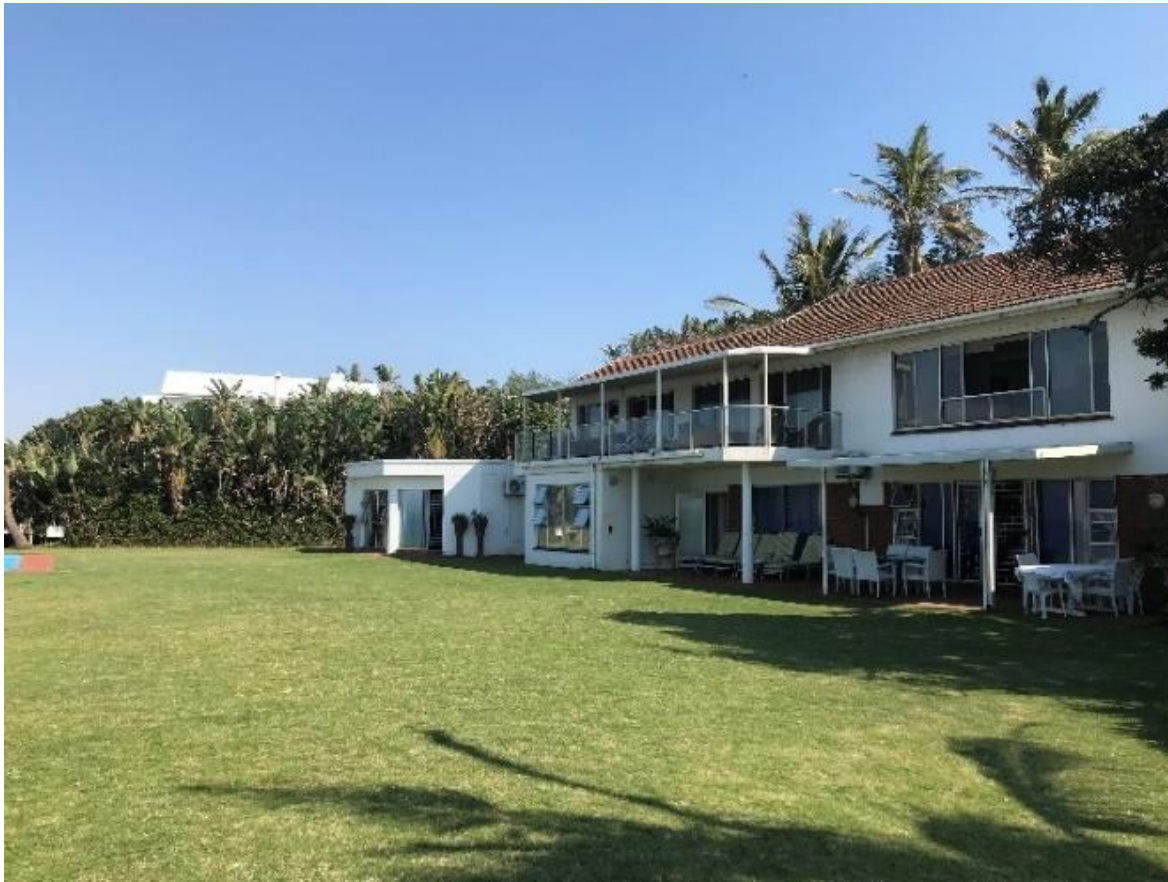
**Figure 18.** Image across subject site, showing structure to be demolished and lawn where septic tanks are to be situated.

As indicated above, the subject property is primarily a gardenscape, showing only limited psammoseral or coastal/ dune habitat (Figure 18). The vegetated component of the site comprises of tended lawns with occasional woody species, such as *Ficus lutea* and *Strelitzia nicolaii*. Other occasional species associated with the site include *Carissa macrocarpa*, *Aloe thraskii* and *Chrysanthemoides monilifera* which have in most instances been incorporated into the horticultural regime. Two species of conservation interest and significance noted on site include *Mimusops caffra* and *Hibiscus tiliaceus*. The former are two individual specimens while the latter is found within an association that primarily arises on the neighbouring property and is associated with a minor drainage feature.

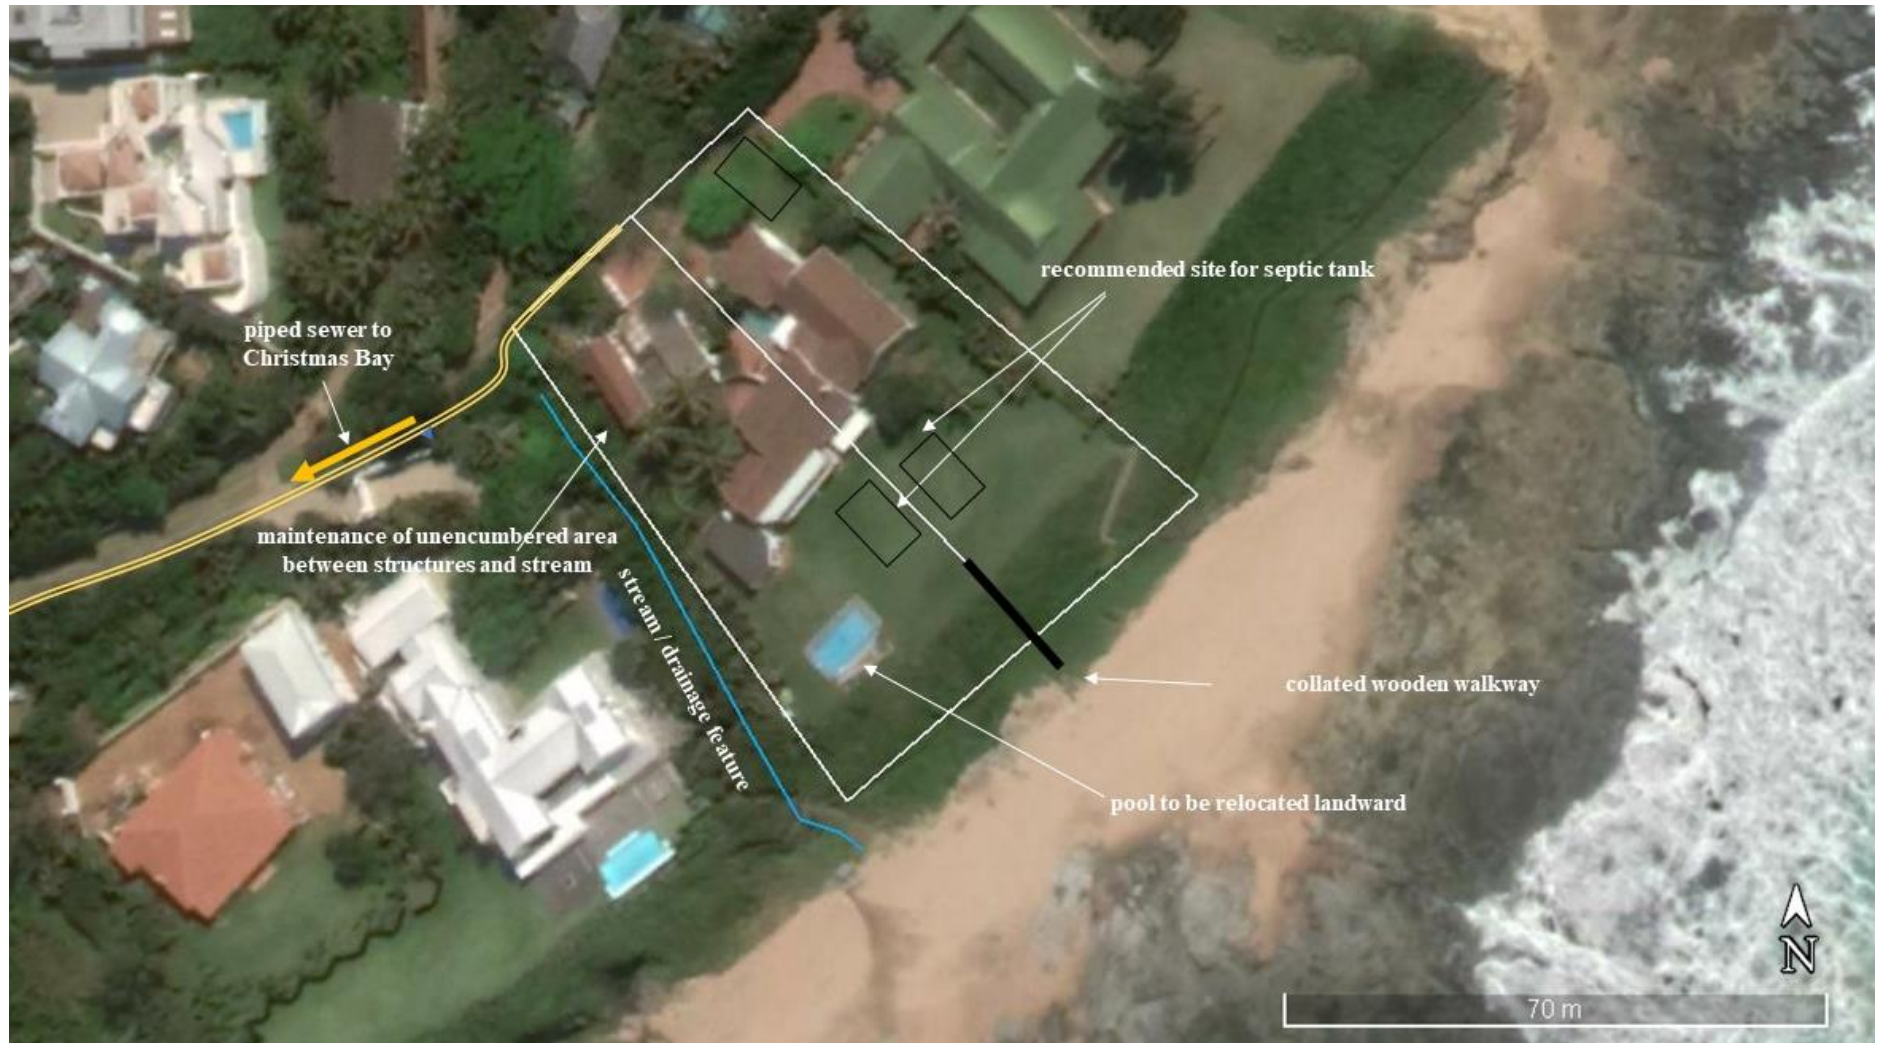
**Figure 19.** Aerial image indicating specific measures to be employed in respect of the proposed construction of homes at 99 Colwyn Drive. Note recommended evapo transpiration areas and alternative measures for disposal of sewerage to Christmas Bay.

Subject to a more detailed geotechnical investigation, it is recommended that septic tanks are positioned distally from the identified stream and beach environments. Figure 20 identifies proposed points of establishment. These points will allow for suitable evapo transpiration areas to be established around the tanks, as well as allowing for increased percolation and subsurface flow through terrestrial edaphics and geology. It is important to avoid the placement of the tanks proximal to the seaward edge (cliff face) of the property. The option to modify the surface soils around the septic tanks, as well as ameliorate the edaphic and vegetative state around the tanks may be considered in order to improve the biochemical remediation of discharge.

No encroachment towards the identified “spring / well” identified on the neighbouring, southerly property should occur. New structures should remain within the footprint of existing structures adjacent to the building line. Measures, such as a cordon should be implemented during construction to ensure no encroachment towards the “spring” arises.
