**Archaeological and Heritage EMP Walk down  
Report for proposed Emkhiweni Substation and  
400 kv line from Emkhiweni substation to Silimela  
in Limpopo and Mpumalanga Province.**

**August 2019**

<b>TITLE:</b> ARCHAEOLOGICAL AND HERITAGE EMP WALK DOWN REPORT FOR: Emkhiweni substation and 400 Kv line from Emkhiweni substation to Silimela	
<b>PURPOSE OF SCOPE:</b> The purpose of this document is to describe the cultural values and heritage factors that may be impacted on by the proposed construction of the proposed development. The proposed electrification is located in Limpopo and Mpumalanga Province.	
<b>DOCUMENT VERIFICATION</b>	
<b>Signature:</b>

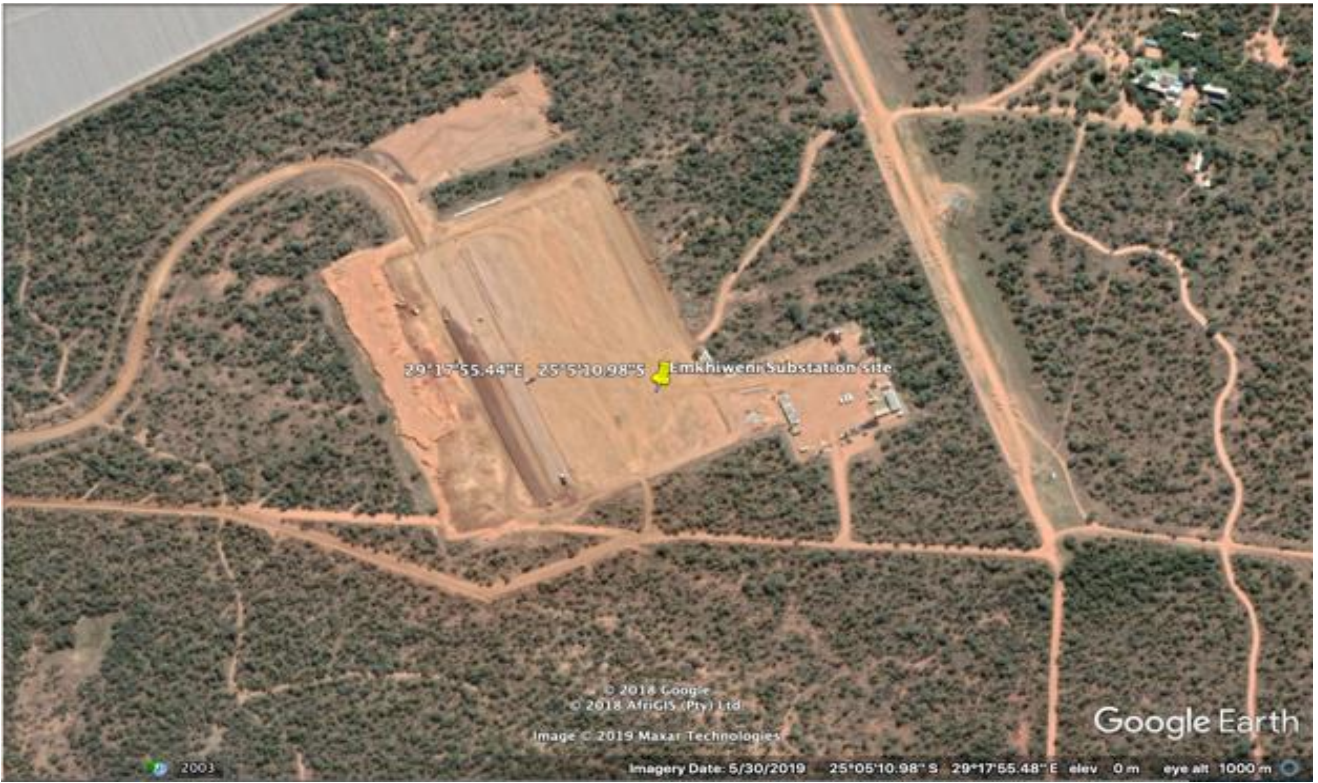
**Figure 3 & 4: The Powerline will traverse from Silimela substation (top). The line will run through largely agricultural landscape bypassing farm settlements, villages and town settlement**

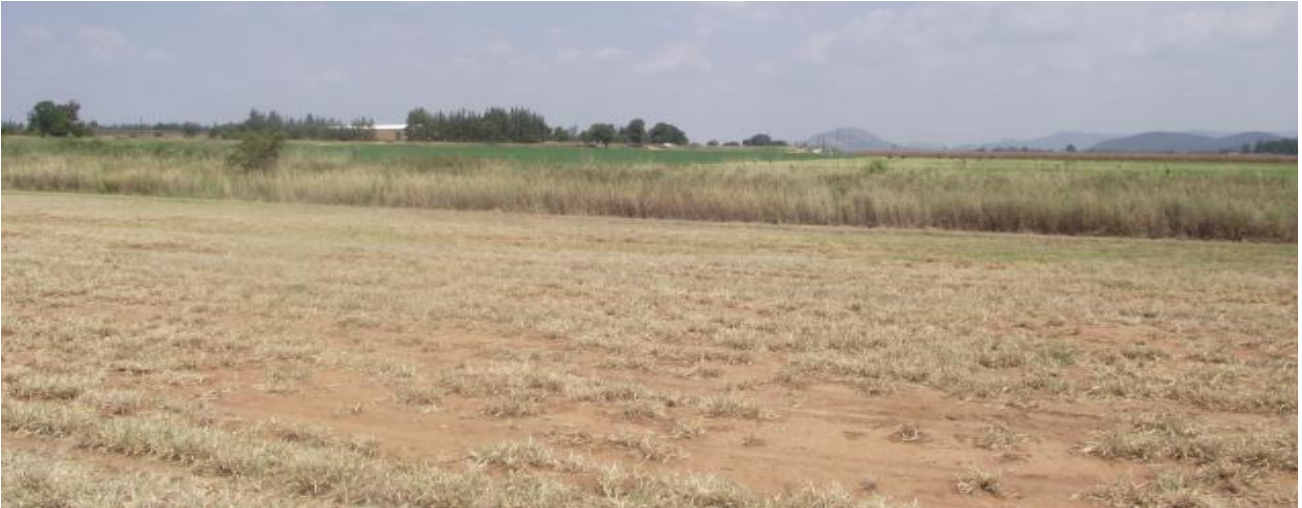
**Figure 5: The powerline will cut through agriculture fields. Note the irrigation pivots in the background**

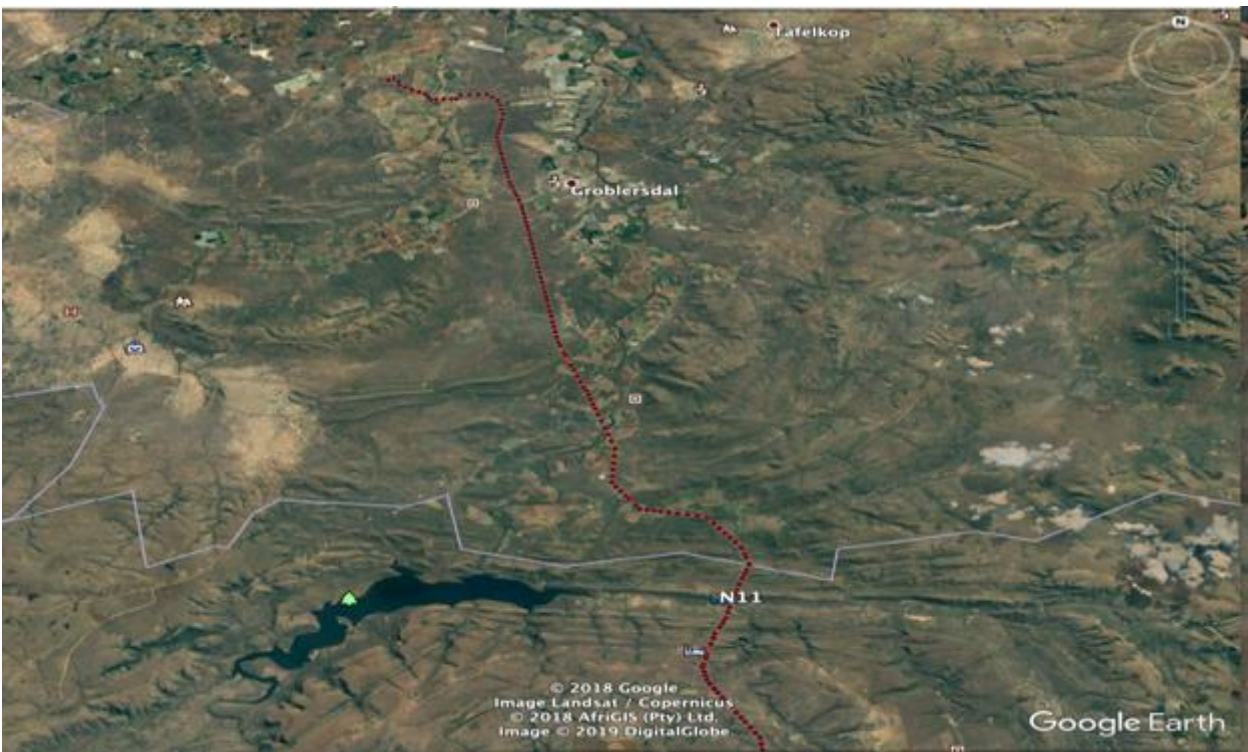
**Figure 6: The location of the proposed transmission line running from Silimela through the agricultural landscape southwards past Groblersdal town and across the Olifants River Valley east of the Loskop Dam.**

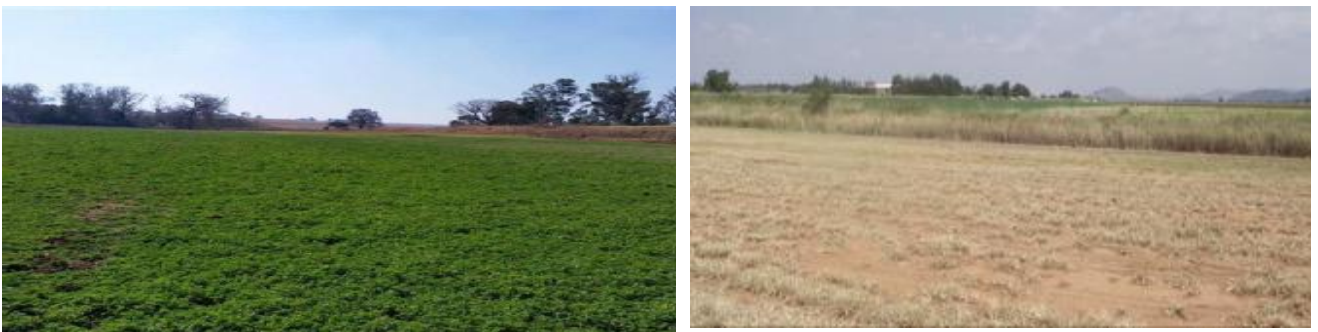
**Figure 8 and 9: The proposed powerline will cut through agriculture fields.**

Figure 8 and 9 shows portions of previously degraded and disturbed land portions where existing minor reticulation powerlines already traverses across the farm marked with irrigation infrastructure, farm roads, boundary fence lines. Inspection of the disturbed sections did not yield archaeological materials or possible sites on direct path of the powerline.

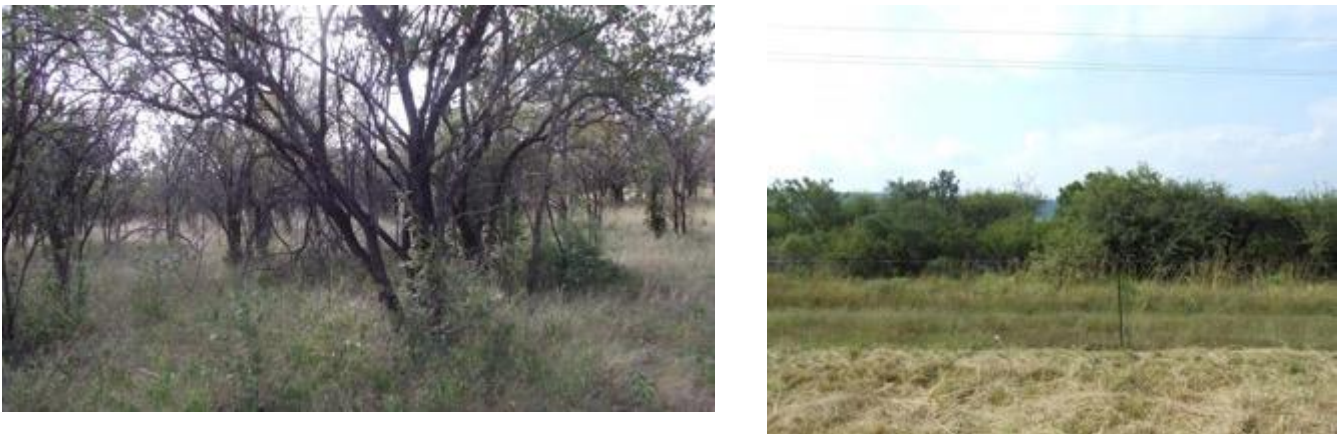
The area is significantly disturbed from previous and current agricultural land use activities (Figure 10 & 11). The proposed powerline servitude runs parallel to Groblersdal –Wolwekraal 88 kv powerline.

**Figure 10 & 11: Thickly vegetated grazing areas. Note the thick grass cover and leaf cover which compromised visibility of possible surface remains.**

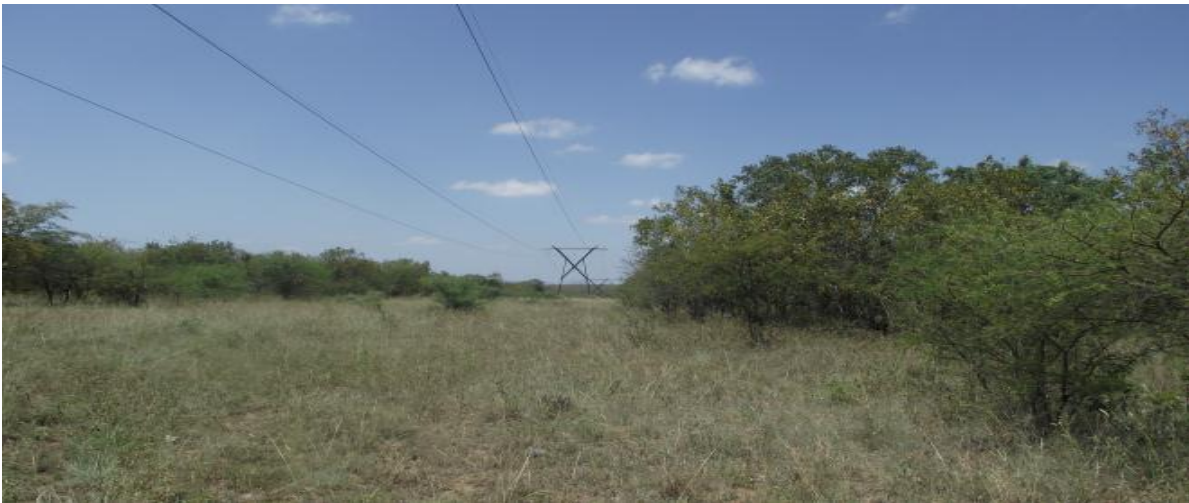
The area between Groblersdal and the Olifants River Valley is characterised by existing high and medium voltage powerlines, irrigation infrastructure, farm settlements, farm tracks, farm processing sites, farm labourer’s dwellings, boundary fence lines. There is an existing 88kv powerline that runs parallel to the proposed powerline. As such, the development will be an in situ addition to an already altered cultural landscape.

Figure 12: From Groblersdal toward the Olifants river valley, the proposed powerline will run along existing 88kv powerline servitude.

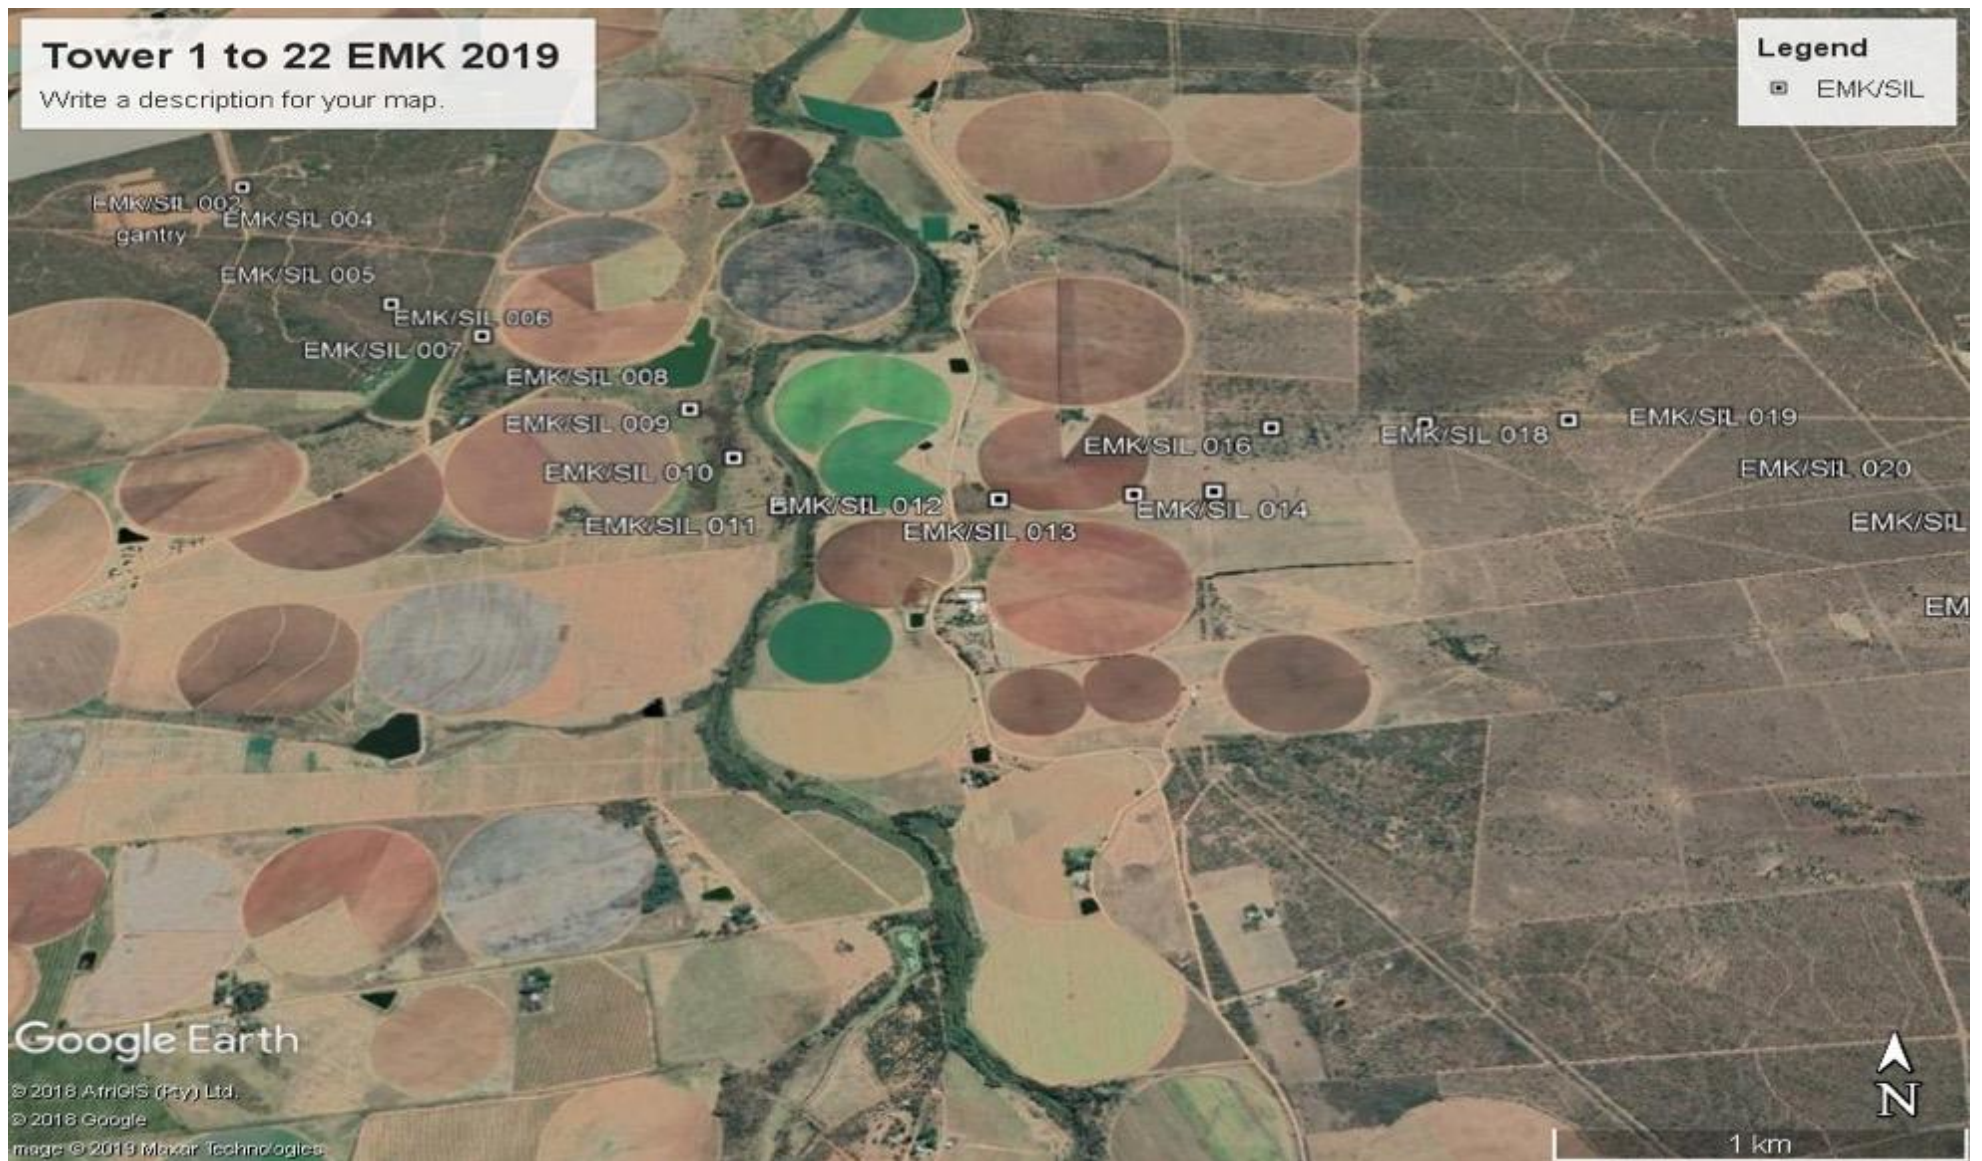
Structures 1 to 22 shown in Figure 13 are all situated on portion of previously degraded and disturbed land portions where existing minor reticulation powerlines already traverses across the farm marked with irrigation infrastructure, farm roads, boundary fence lines and an 88kv powerline. The survey of Pylon Structures positions 1 to 22 did not yield archaeological materials or possible sites on direct path of the powerline development.

**Figure 13: The powerline pylon positions follow the servitude that cuts across commercial farming area characterised by agriculture fields, irrigation infrastructure settlements, along main roads and across open lands with existing powerlines and other developments.**

None required. All towers are positioned within currently and previously cultivated land which left no trace for surficial visible archaeological material (Plate 1). However, in the unlikely event that chance archaeological materials are disturbed at any of the tower position, salvage and chance finds procedures should be implemented.

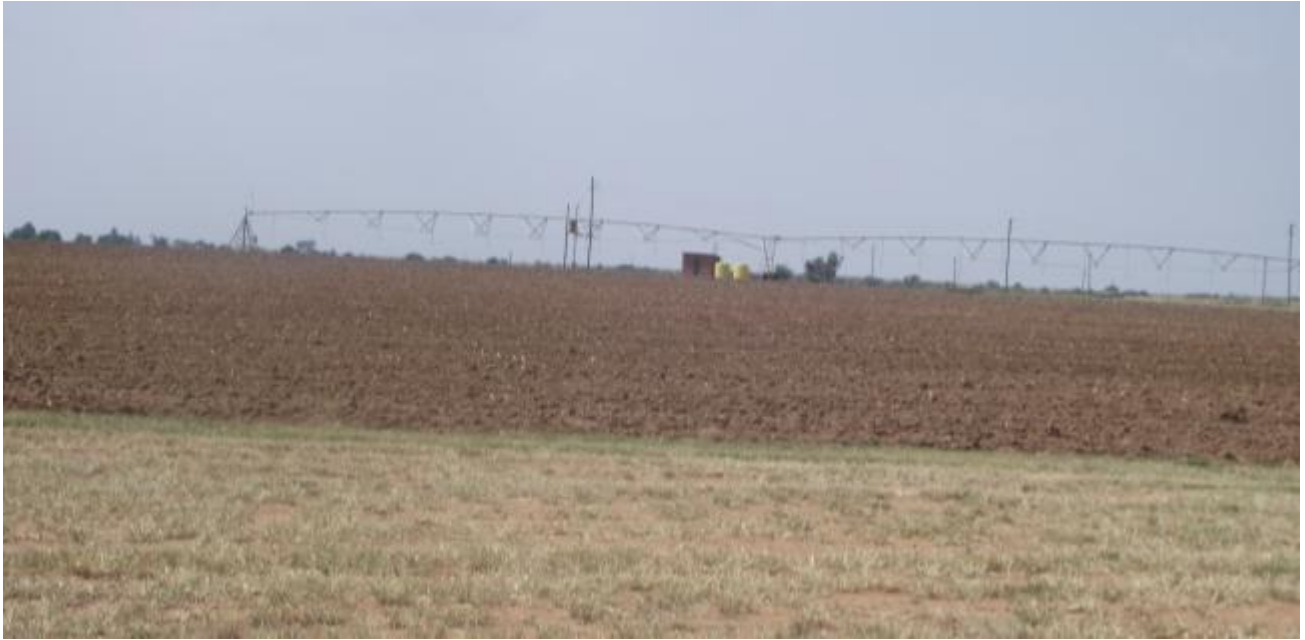
**Figure 14: Pylon Structures 1 to 22 are located in predominantly commercial agriculture area characterised by commercial farming infrastructure**

Towers 22 to 44 are located within Portion 6 Vaalfontein 14, Portion 996 Loskop Noord 12 JS, Portion 39, 47 & 54 Klipbank 26 JS. The area is significantly disturbed from previous and current agricultural land use activities (see Figure 14). The proposed powerline servitude runs parallel to Groblersdal – Wolwekraal 88 kv powerline.

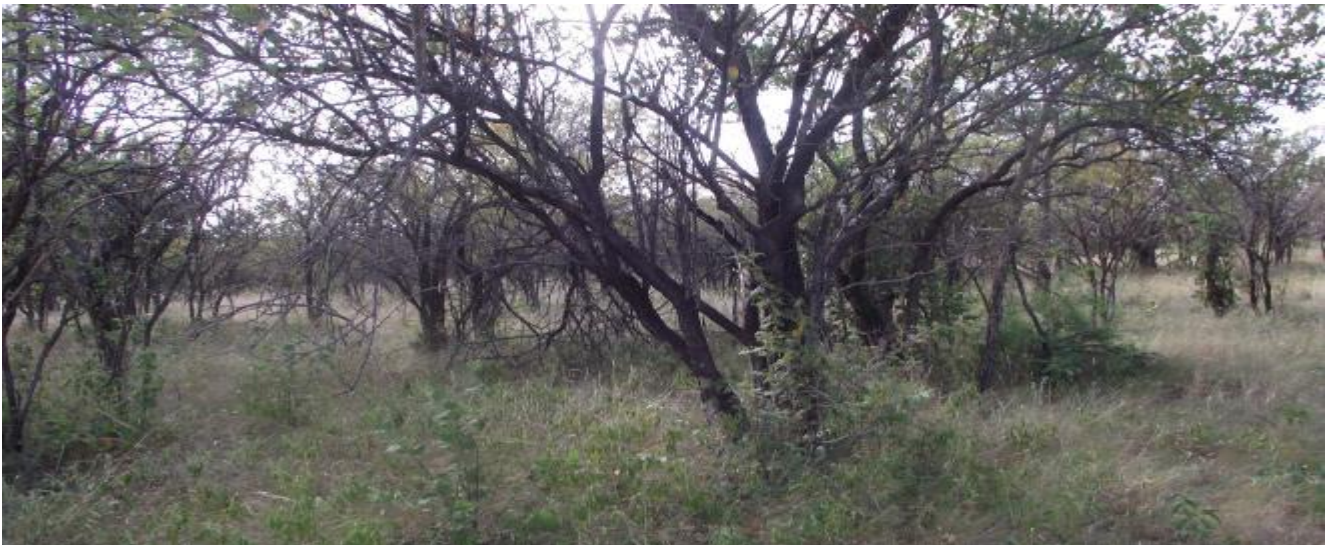
**Figure 15: Some pylons from tower 22 to 44 will cut through thickly vegetated grazing areas. Note the thick grass cover and leaf cover which compromised visibility of possible surface remains.**

No further mitigation is required prior to construction phase. However, in the unlikely event that chance archaeological materials are disturbed at any of the remaining tower positions in this section, salvage and chance finds procedures should be implemented.

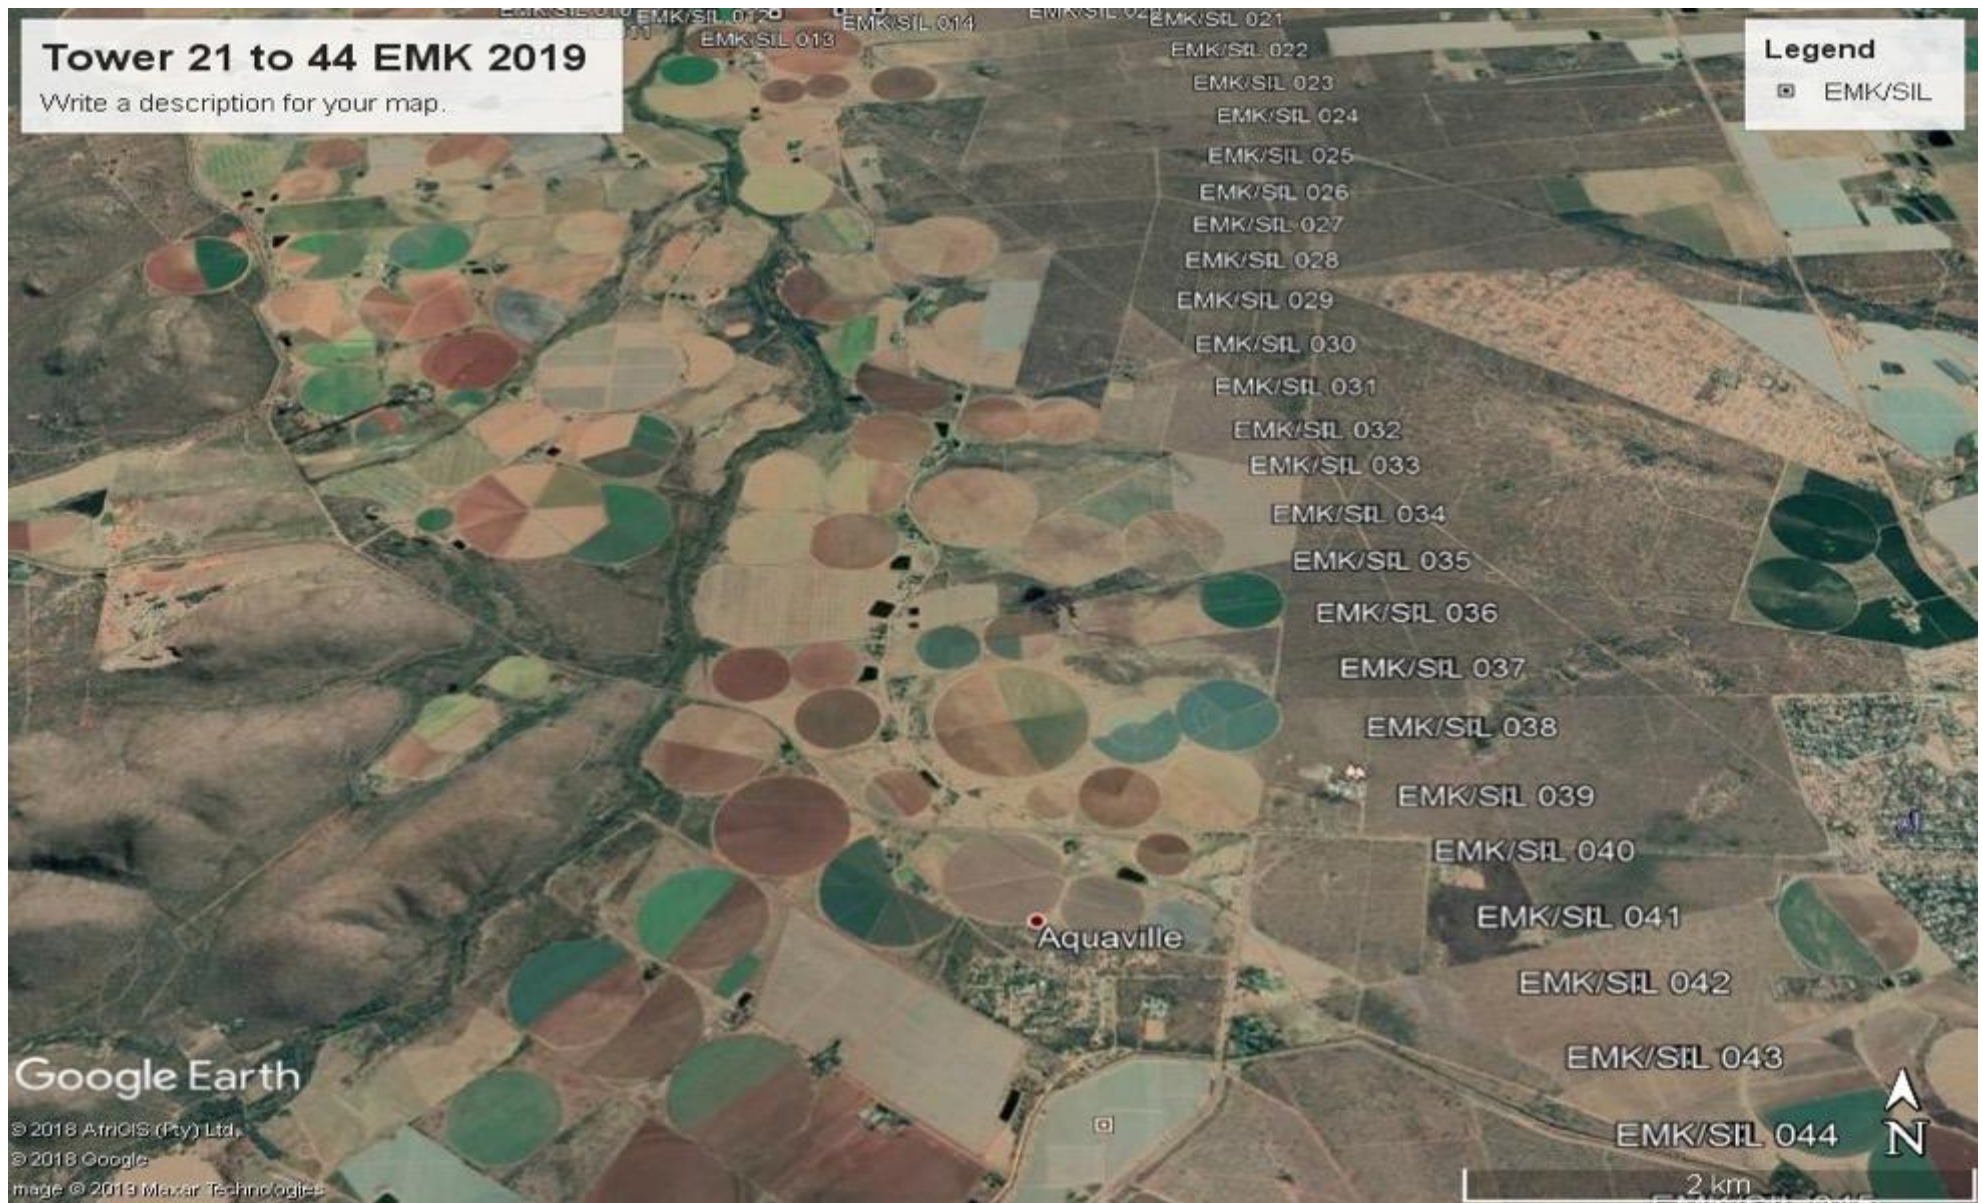
Figure 16: Powerline Pylon Structures 21 to 44 are also located in commercial agriculture lands characterised by cultivated land and irrigation infrastructure.

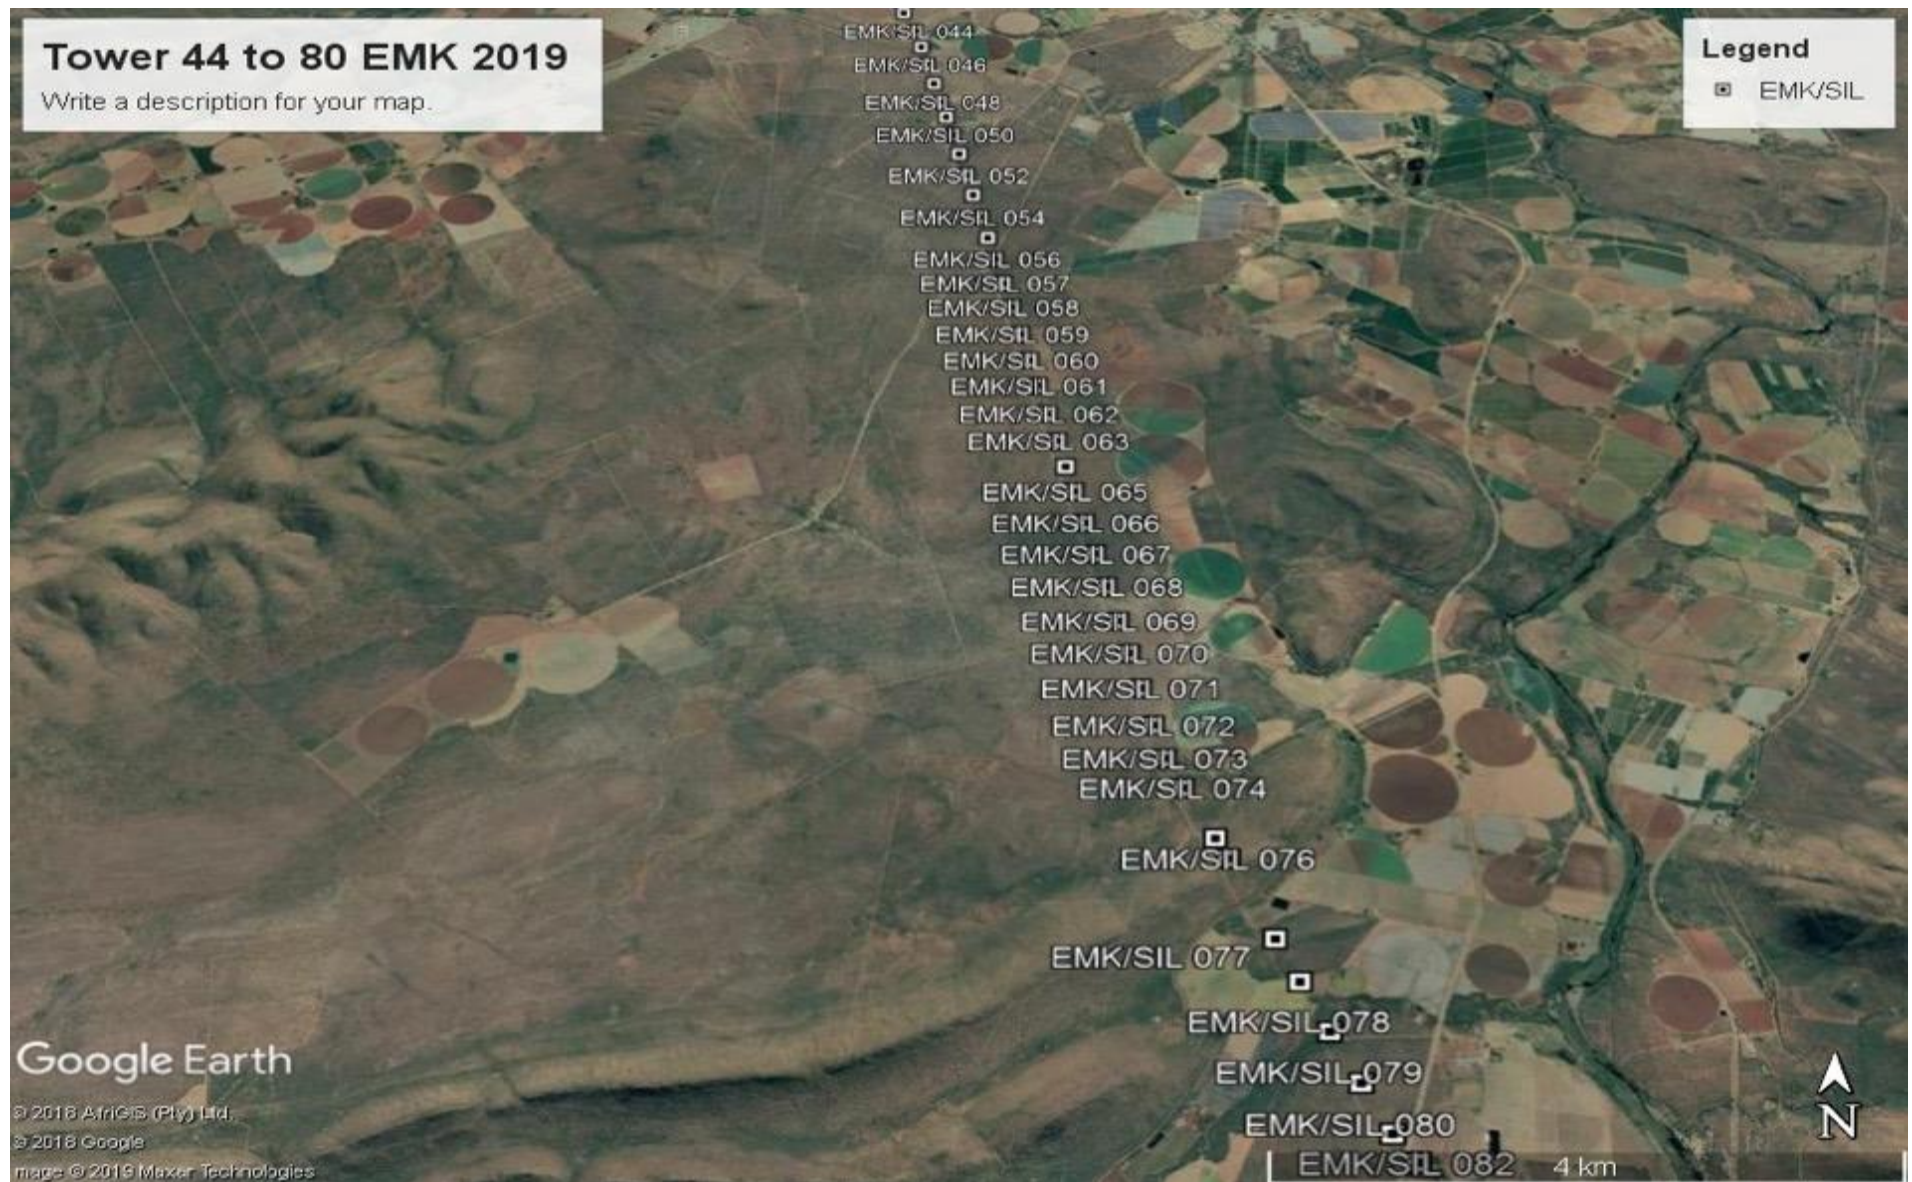
Figure 17: Structures 44 to 80 are situated along commercial grazing and agriculture area. Note some farm dwellings in the vicinity of tower 41 to tower 45

No further mitigation is required prior to construction phase. However, in the unlikely event that chance archaeological materials are disturbed at any of the remaining tower positions in this section, salvage and chance finds procedures should be implemented.

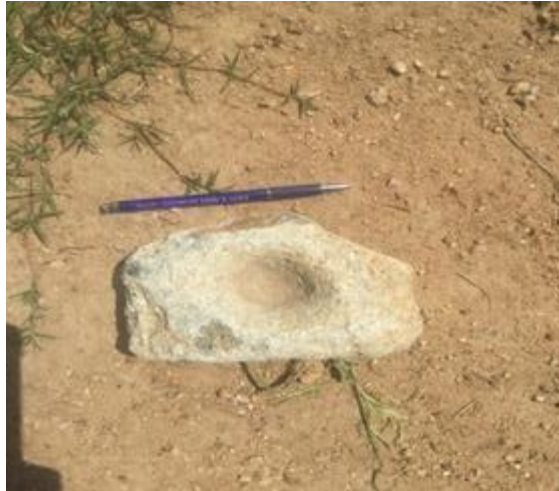
The survey of Pylon Structures positions 80 to 90 archaeological small pieces of potsherd materials on between specifically tower 83 and 84 within the servitude path of the development. Where the servitude crosses the N11 after Groblersdal, inspection of the farm road on agricultural land yielded archaeological potsherds and small grinding stone (Fig. 18).

**Figure18: small pieces of potsherds and grinding stone recovered on farm road cut. These finds did not yield a clear provenance but they indicate the presence of Iron Age site in this vicinity.**

The survey of area close to the N11 after Groblersdal yield archaeological materials or possible sites on direct path of the powerline development (Fig 18). These archaeological materials were identified at at **Lat. 29°24' 31.09" ELong. 25°18'51.60" S** on cultivated and disturbed land.

The artefacts indicate the presence of archaeological sites in the project foot print. (Fig. 19). CEO should closely monitor the area. In the event that chance archaeological materials are disturbed at any of the tower positions in this area, salvage and chance finds procedures should be implemented as would be directed by the SAHRA.

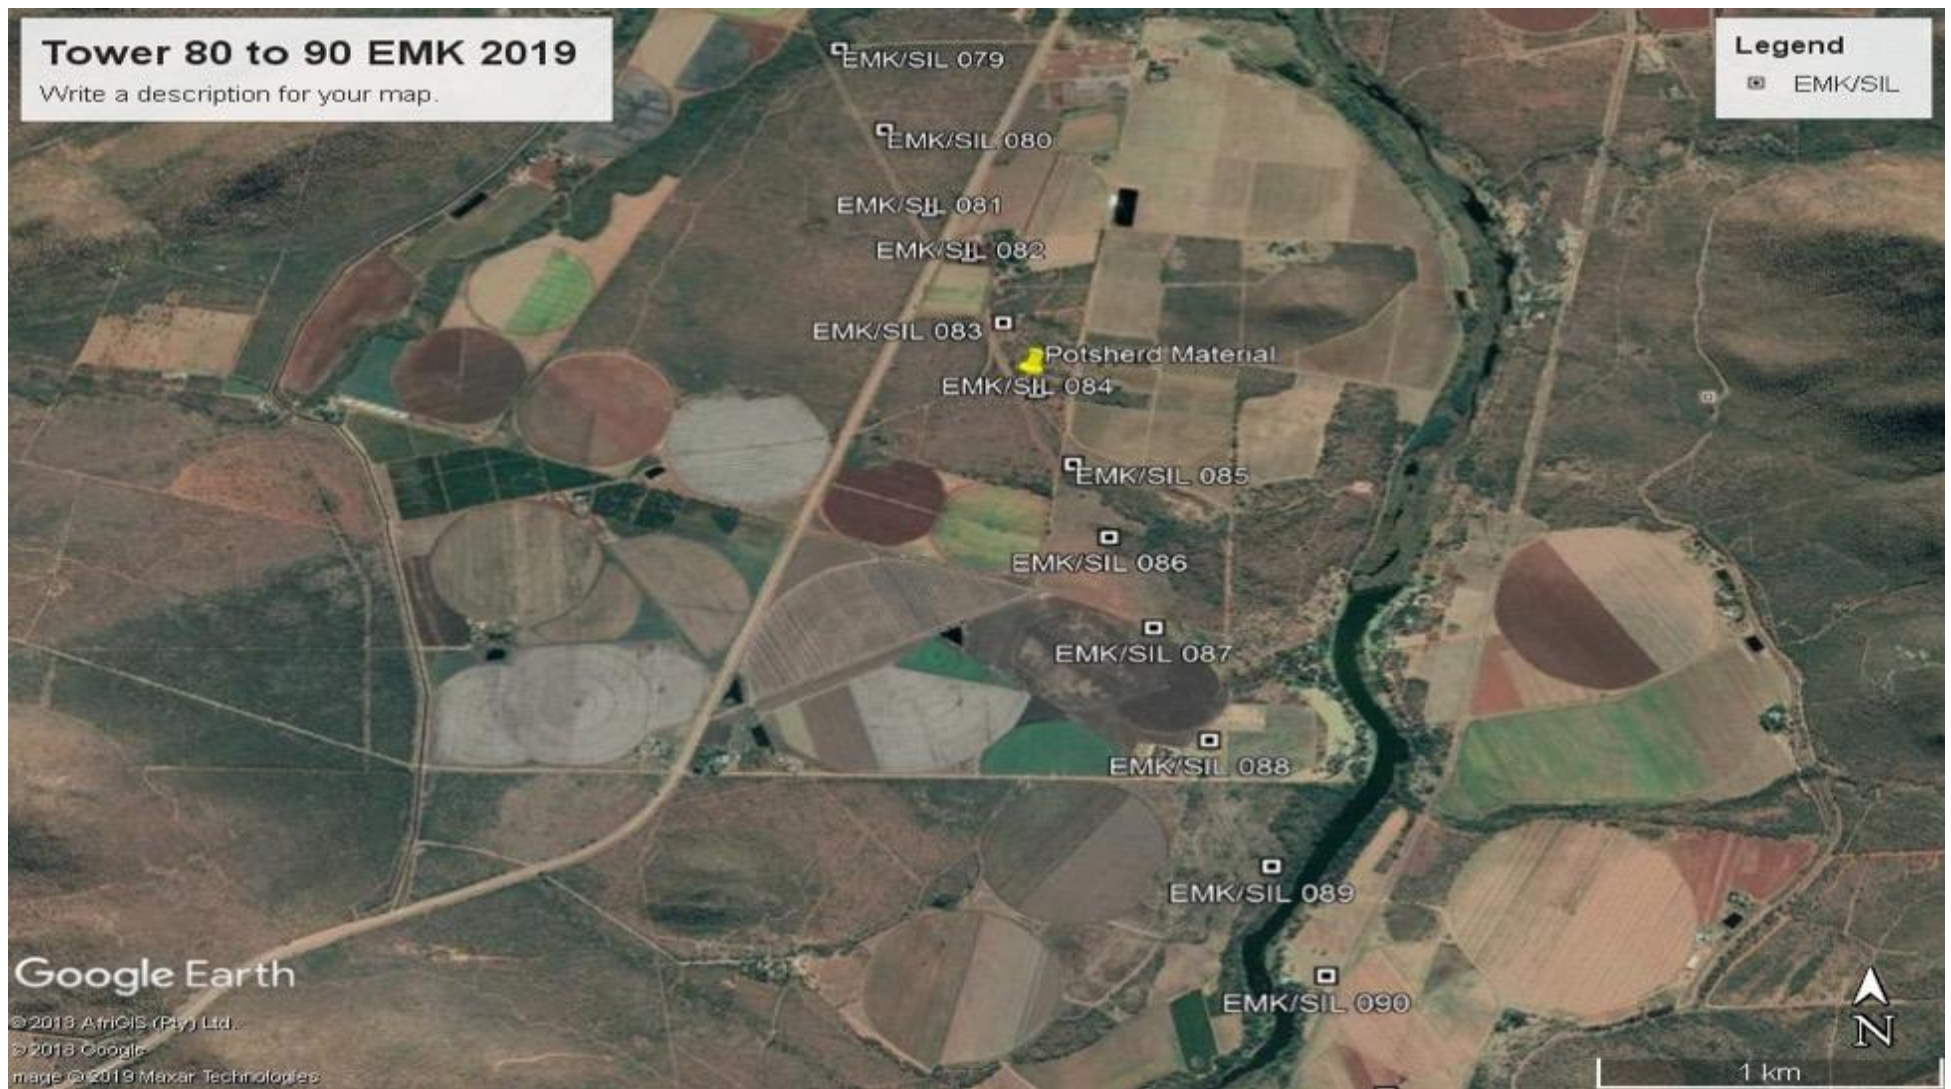
**Figure 19: TWR 80 to 90 located along the meandering Olifants River valley within a mixture of disturbed agricultural land, river valley and ravines. Prehistoric potsherd materials were identified in the vicinity of towers 82 and 88. The powerline will cross the Olifants River between tower 89 and tower 90.**

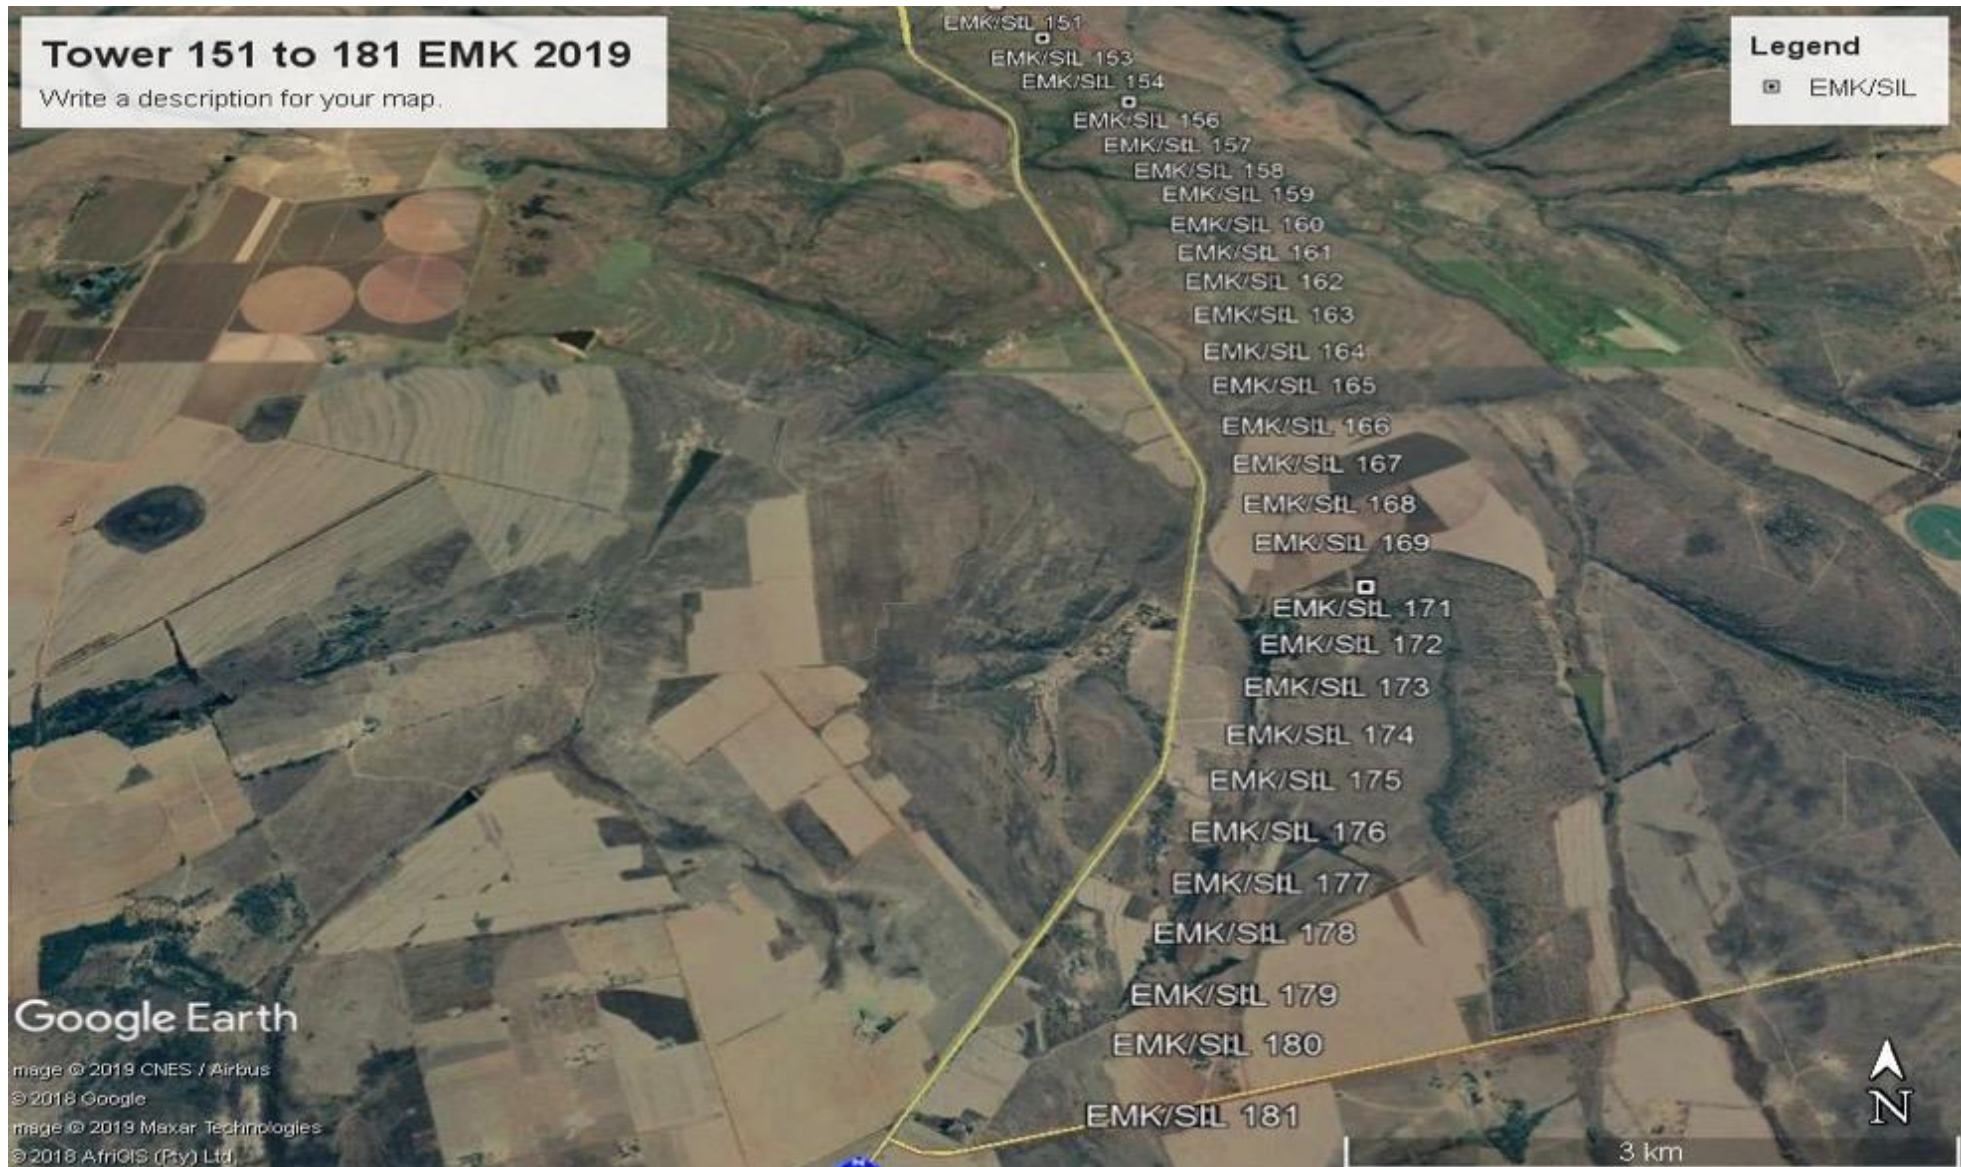
Figure 22: Power line towers from 151 to 181

Structures 151 to 181 shown in Figure 22 are all situated on portions of land consisting of main road servitude, farm dwellings, high and low voltage powerlines, irrigation agricultural land and infrastructure, and grazing lands. Most of the receiving land portions were previously degraded and disturbed with existing powerline, access roads, rural homesteads and agricultural fields.

No further mitigation is required prior to construction phase. However, should chance archaeological materials are disturbed at any of the remaining tower positions in this section, salvage and chance finds procedures should be implemented. Abandoned historic homesteads should not be interfered with without a clearance of Destruction Permit from SAHRA since some of the building remains may be 60 years of. Such old structures enjoy automatic legal protection from the NHRA. Such site may also yield previously unknown burial sites.

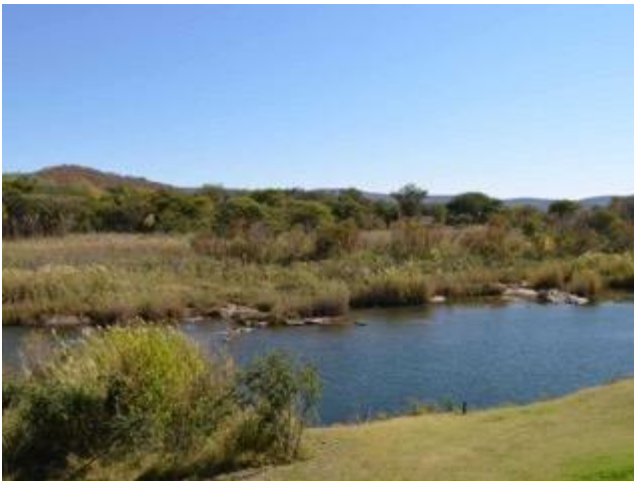
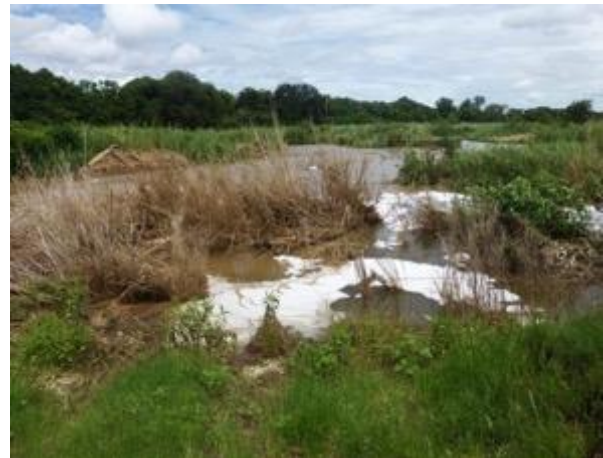
The powerline route traverses deeper into Mpumalanga Province descending into the Olifants River valley (Fig. 23 & 24). The area is hilly with some steep sided hills. From here on, the route cross the river and run long the N11 national road.

Figure23& 24: View of section of the Olifants River whose banks were surveyed for potential archaeological materials being washed into the river bed.

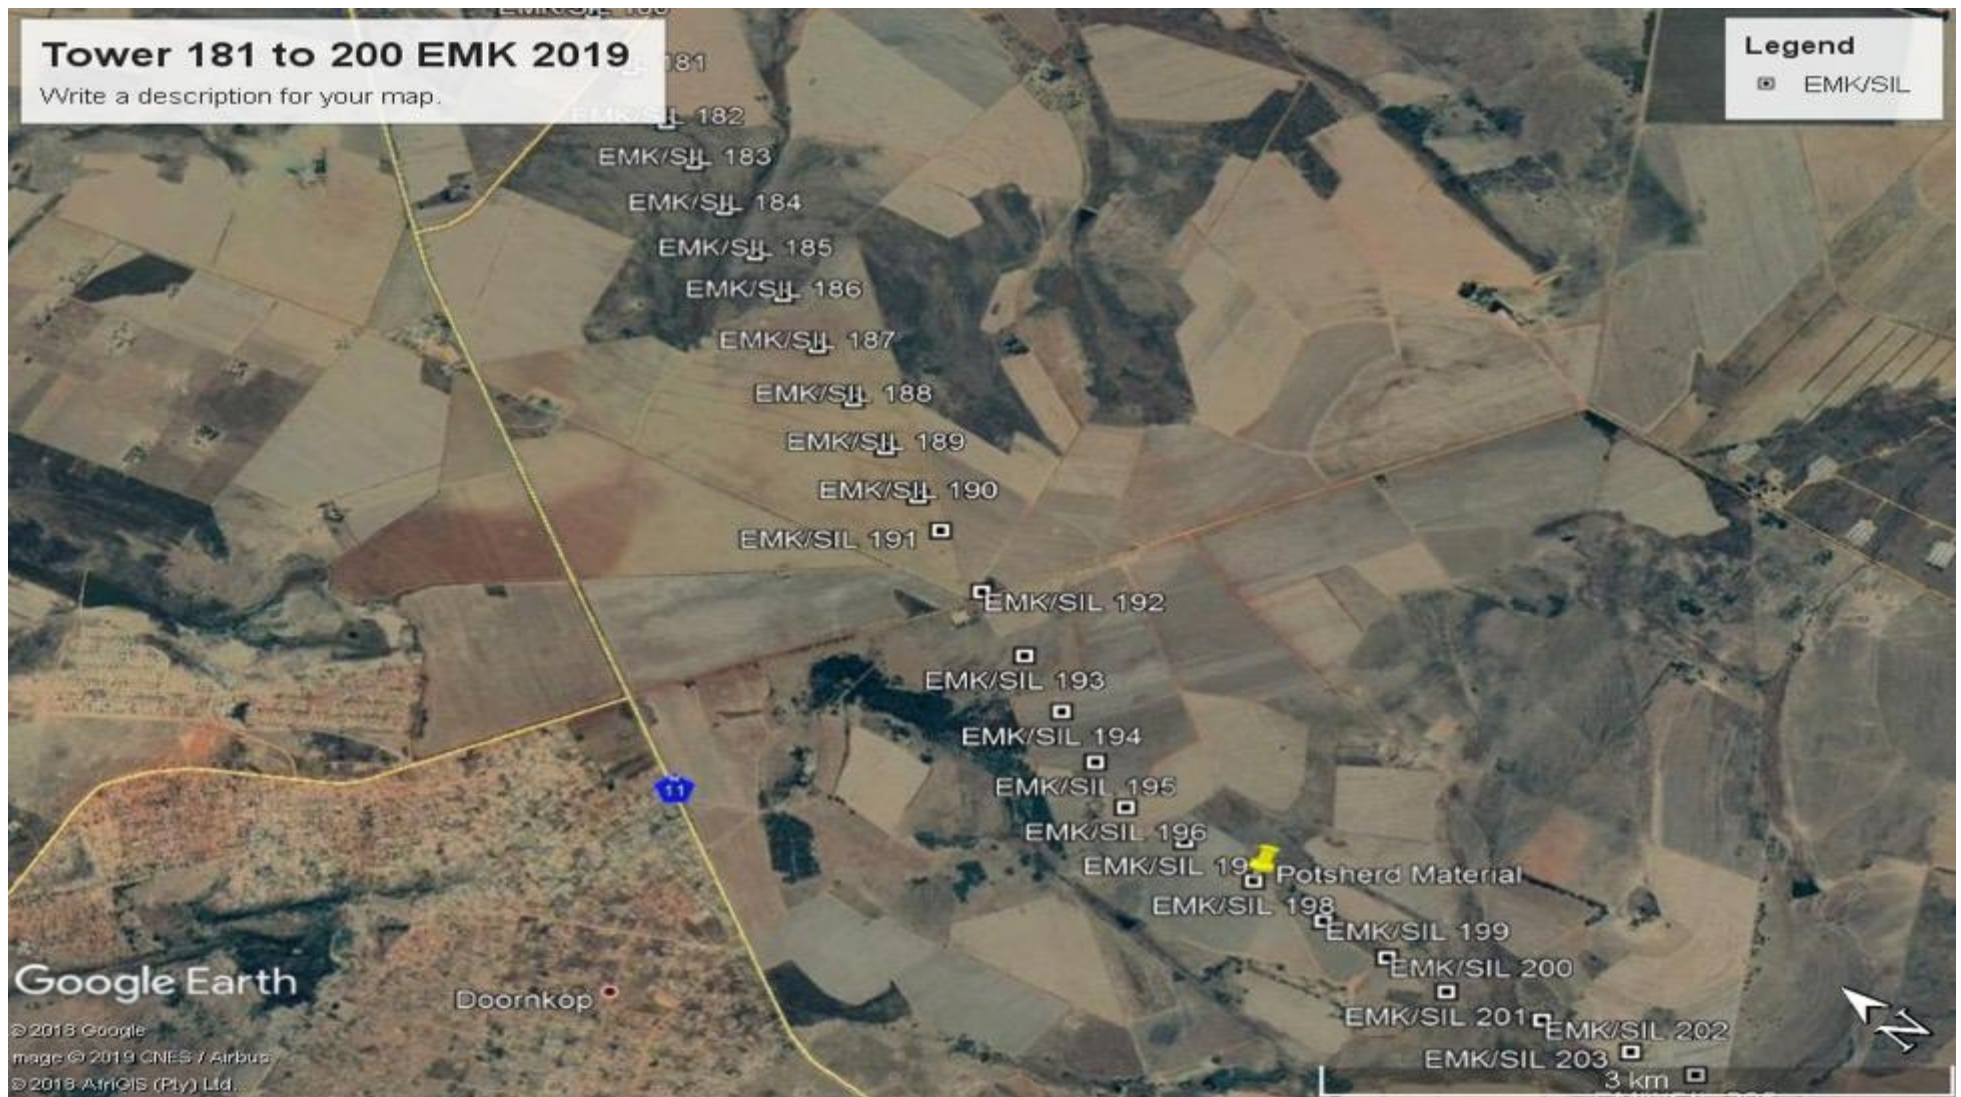
Structures 181 to 200 shown in Figure 25 are all situated on portions of land consisting of main road servitude, farm dwellings, high and low voltage powerlines, substation, irrigation agricultural land, irrigation infrastructure, streams and grazing lands. Most of the receiving land portions were previously degraded and disturbed with existing powerline, access roads, rural homesteads and agricultural fields. Two 88kv powerlines run parallel to the proposed powerline servitude. The survey of Pylon Structures positions 181 to 200 yielded prehistoric potsherd material between tower 197 and 198 directly on the path of the development (Fig 26). Several isolated potsherd were identified highlighting the existence of possible archaeological sites on direct path of the powerline development (Fig 25). A fair density of archaeological potsherd materials were identified at **Lat. 29°27' 32.38" E Long. 25°37'51.94" S** on previously cultivated and disturbed land (Fig. 25). The potsherd scatter could not be confirmed as part of a distinct archaeological site.

Figure 25: Powerline is located in a heavily disturbed area and built up residential area.

ECO should closely monitor the foundation excavations and installation construction work for Towers 190 to 200 where potsherd materials were identified. By association, these towers locations have high potential to yield subsurface discernable archaeological remains that may require to be recorded during construction work. No further mitigation is required prior to construction phase. However, should chance archaeological materials be disturbed at any of the unmonitored tower positions in this section, salvage and chance finds procedures should be implemented. Abandoned historic homesteads should not be interfered with without a clearance of destruction Permit from SAHRA since some of the building remains may be 60 years of. Such old structures enjoy automatic legal protection from the NHRA.
