**Archaeological and Heritage EMP Walk down  
Report for proposed Emkhiweni Substation and  
400 kv line from Emkhiweni substation to Silimela  
in Limpopo and Mpumalanga Province.**

**August 2019**

<b>TITLE:</b> ARCHAEOLOGICAL AND HERITAGE EMP WALK DOWN REPORT FOR: Emkhiweni substation and 400 Kv line from Emkhiweni substation to Silimela	
<b>PURPOSE OF SCOPE:</b> The purpose of this document is to describe the cultural values and heritage factors that may be impacted on by the proposed construction of the proposed development. The proposed electrification is located in Limpopo and Mpumalanga Province.	
<b>DOCUMENT VERIFICATION</b>	
<b>Signature:</b>

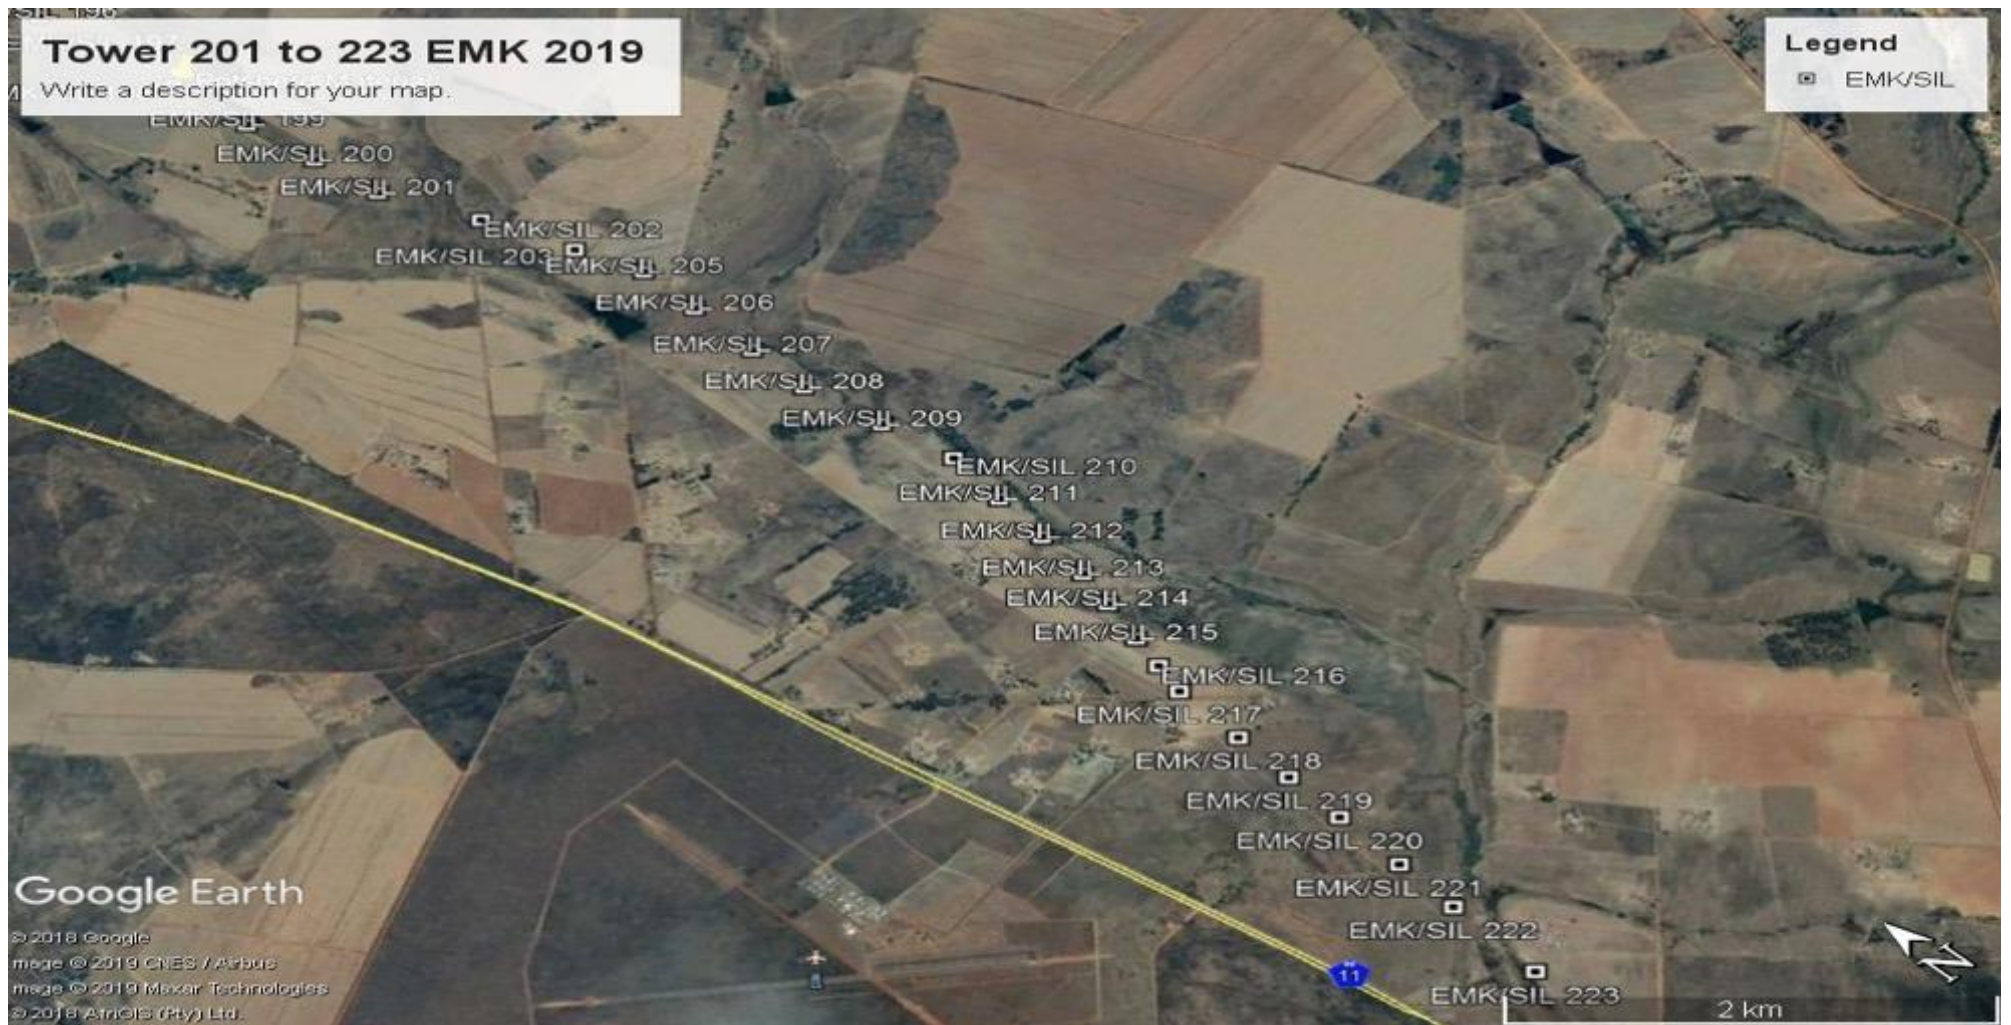
Figure 26: This section of the powerline is located near Middleburg; the area is heavily disturbed by urban development, farming and mining activities that are characteristic of the area.

None required. However, in the unlikely event that chance archaeological materials are disturbed at any of the tower position, salvage and change finds procedures should be implemented. Abandoned homesteads should be avoided since they may yield burial sites. No further mitigation is required prior to construction phase. However, should chance archaeological materials are disturbed at any of the remaining tower positions in this section, salvage and change finds procedures should be implemented. Abandoned historic homesteads should not be interfered with without a clearance of Destruction Permit from SAHRA since some of the building remains may be 60 years of. Such old structure enjoy automatic legal protection from the NHRA. Such site may also yield previously unknown burial sites.

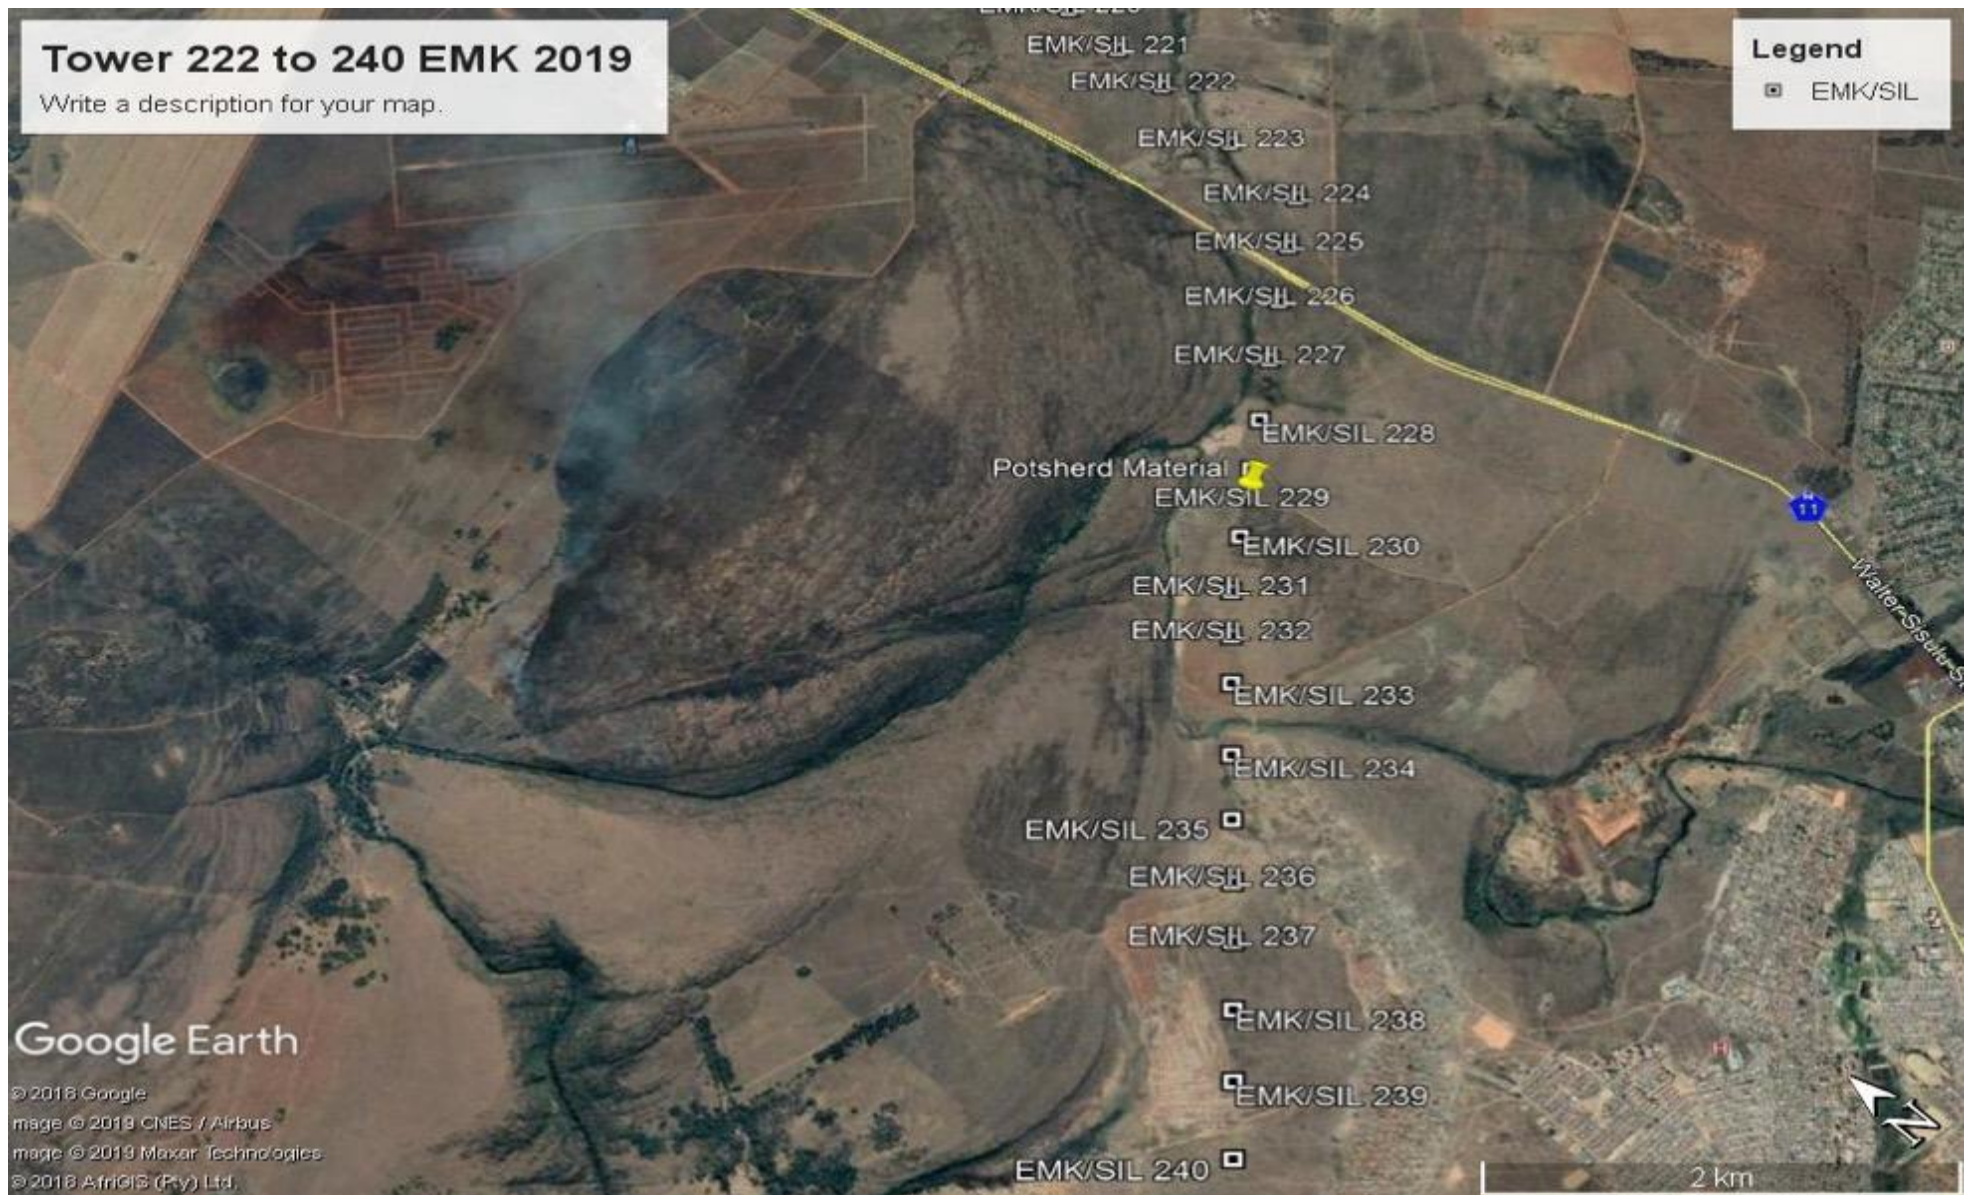
Structures 222 to 240 shown in Figure 27 are all situated on portions of land consisting of N11 main road servitude, farm tracks, telephone lines, farm dwellings, built up residential areas, high and low voltage powerlines, eroded sections, irrigation agricultural land, irrigation infrastructure, streams and grazing lands. Most of the receiving land portions were previously degraded and disturbed with existing powerline, access roads, rural homesteads and agricultural fields. Two 88kv powerlines run parallel to the proposed powerline servitude. The survey of Pylon Structures positions 221 to 240 identified archaeological potshed material between tower 228 and 229 directly path of the development.

Figure 27: Powerline cuts through disturbed and built up area.

Sub surface construction work for tower 220 to 240 should be closely monitored by ECO during construction work. In the event that chance archaeological materials are disturbed at any of the tower positions during construction, salvage and change finds procedures should be implemented in line with SAHRA regulations and NHRA requirements. No further mitigation is required prior to construction phase. Abandoned historic homesteads should not be interfered with without a clearance of destruction Permit from SAHRA since some of the building remains may be 60 years of. Such old structures enjoy automatic legal protection from the NHRA.

The area north of Middleburg has a long history of rural and peri urban settlements. Such areas have potential to yield previously unknown recent historic human burial and grave sites usually associated with some abandoned human settlements which are common in this region. As such, excavation of tower foundations between tower 220 and 2240 should be monitored by a professional archaeologist during the construction works.

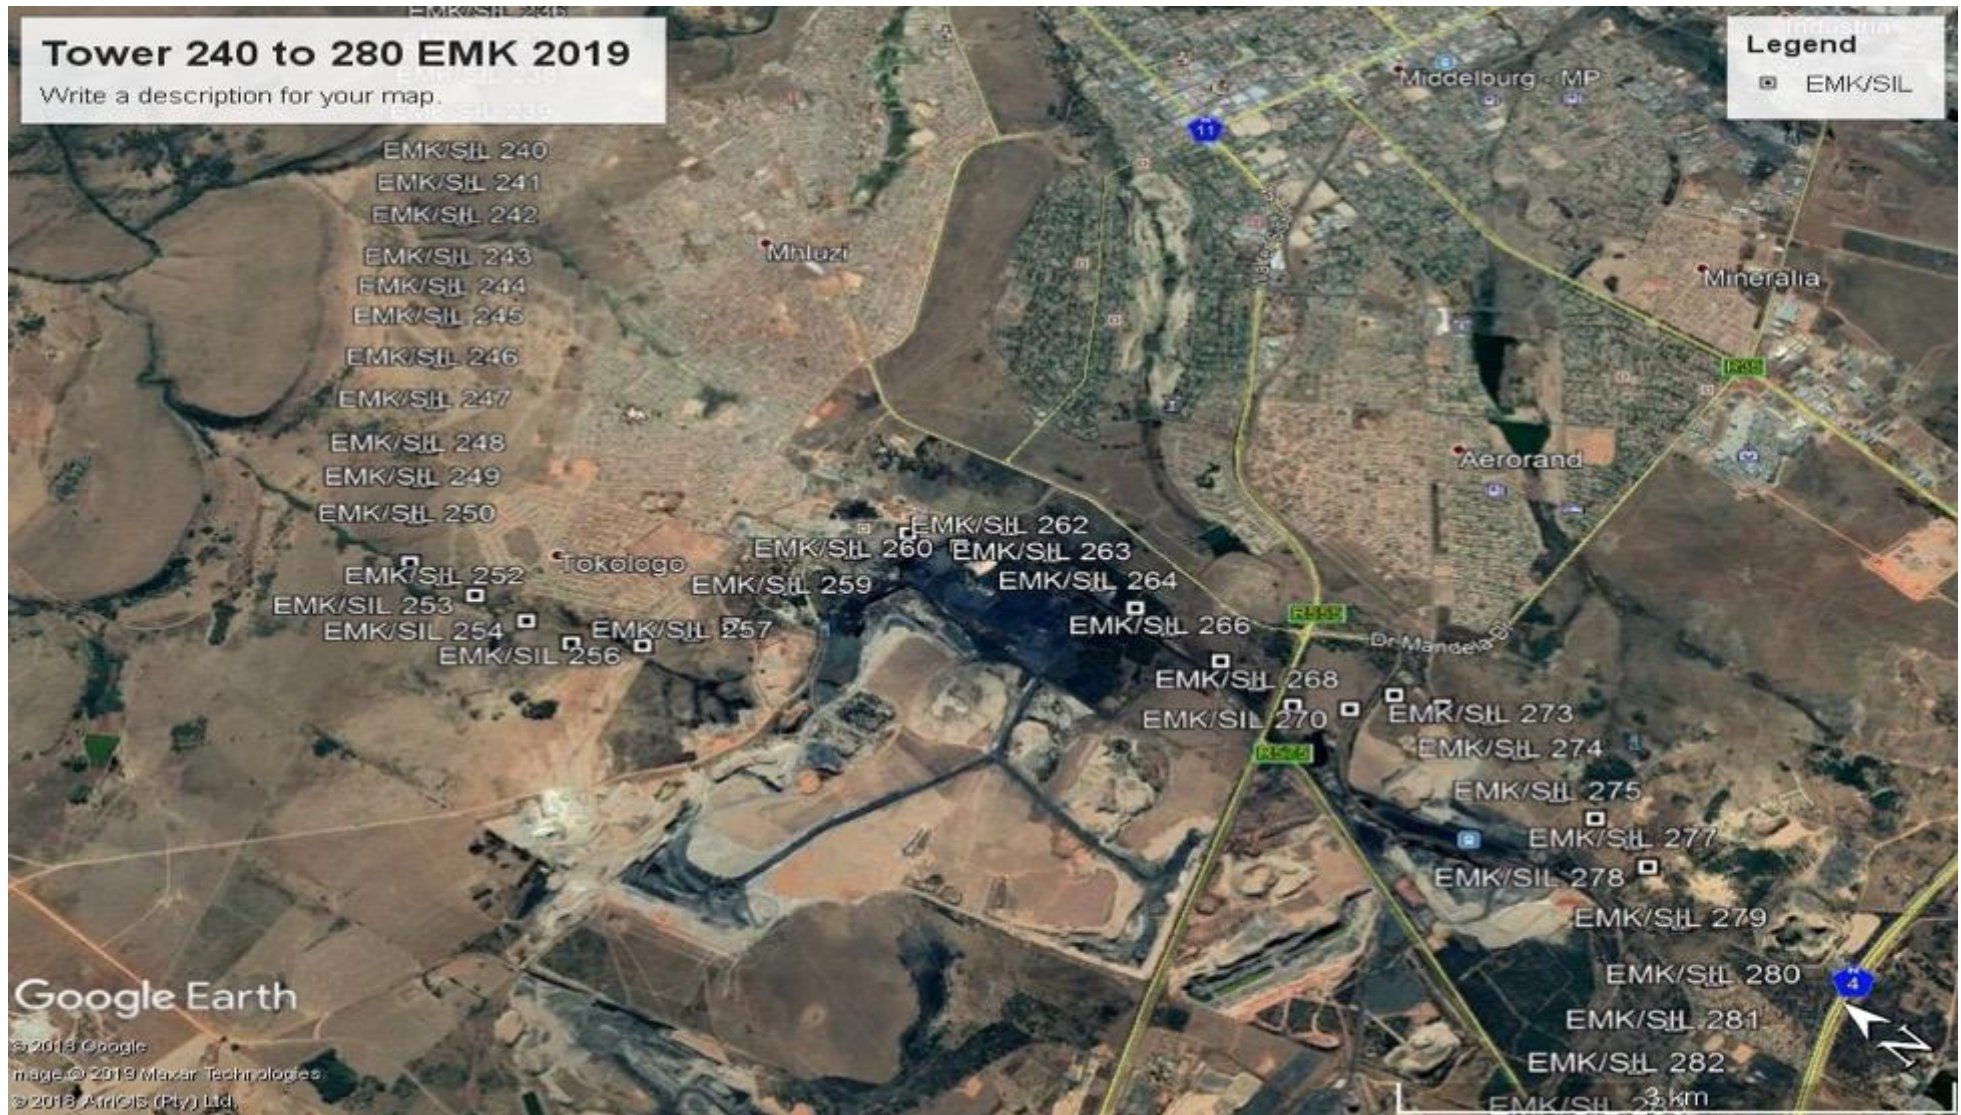
Figure 28: Powerline cuts through disturbed and built up area, all cutting through main roads R575 and R555

None required. However, in the unlikely event that chance archaeological materials are disturbed at any of the tower position, salvage and change finds procedures should be implemented. No further mitigation is required prior to construction phase. However, should chance archaeological materials are disturbed at any of the remaining tower positions in this section, salvage and change finds procedures should be implemented. Abandoned historic homesteads should not be interfered with without a clearance of Destruction Permit from SAHRA since some of the building remains may be 60 years of. Such old structures enjoy automatic legal protection from the NHRA. Such site may also yield previously unknown burial sites.

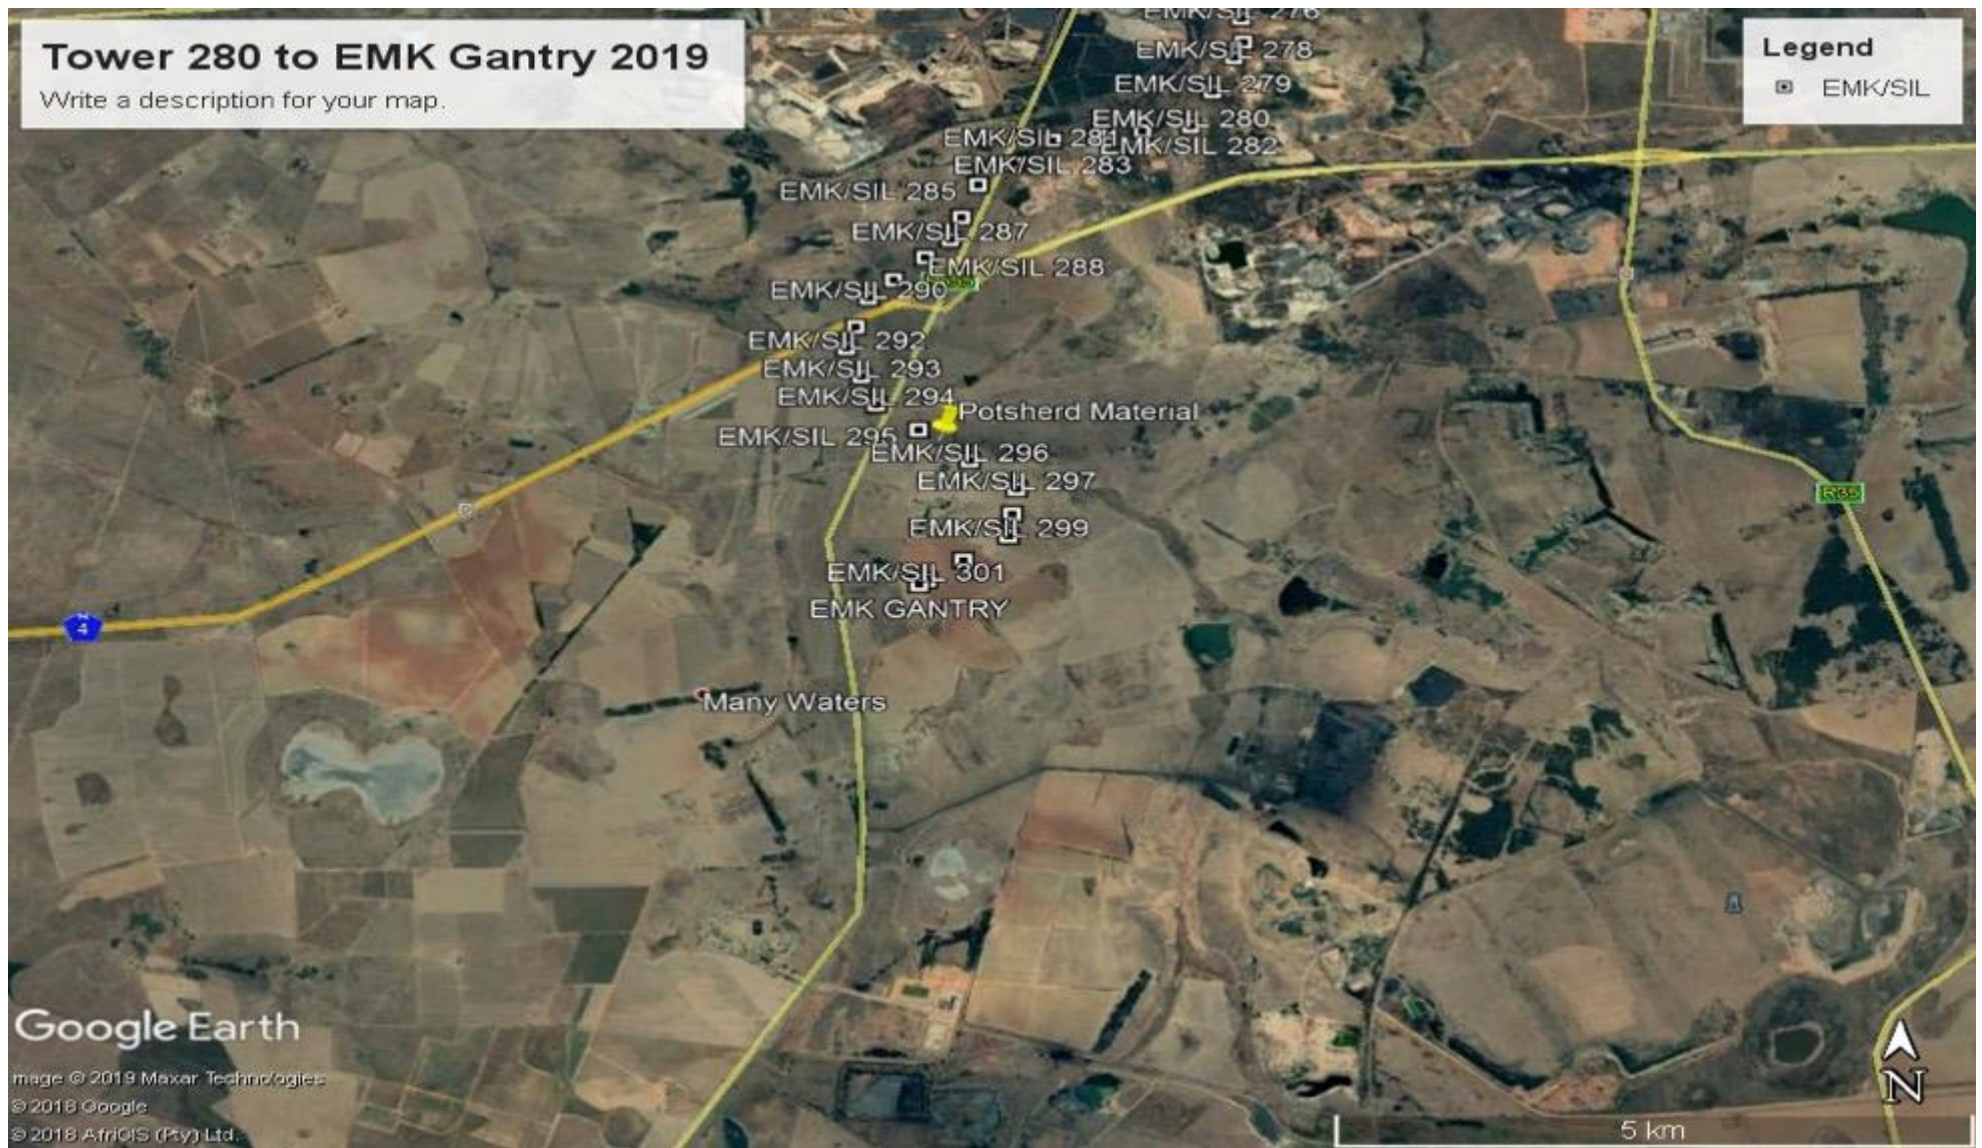
Structures 281 to 302 shown in Figure 29 are all located on portions of land consisting of urban infrastructure that include main road servitudes, high and low voltage powerlines, substation, streams, mining and industrial infrastructure. Most of the receiving land portions were previously degraded and disturbed with existing powerline, access roads, rural homesteads and agricultural fields. Two 88kv powerlines run parallel to the proposed powerline servitude. The survey of Pylon Structures positions 281 to 302 identified potshed material directly on path of the development.

Figure 29: Powerline will terminate EMK gantry.

ECO should closely monitor installation of Towers 292 to 298 during foundation excavations. By association, these towers locations have high potential to yield subsurface discernable archaeological remains. No further mitigation is required prior to construction phase. However, should chance archaeological materials be disturbed at any of the unmonitored tower positions in this section, salvage and chance finds procedures should be implemented.
