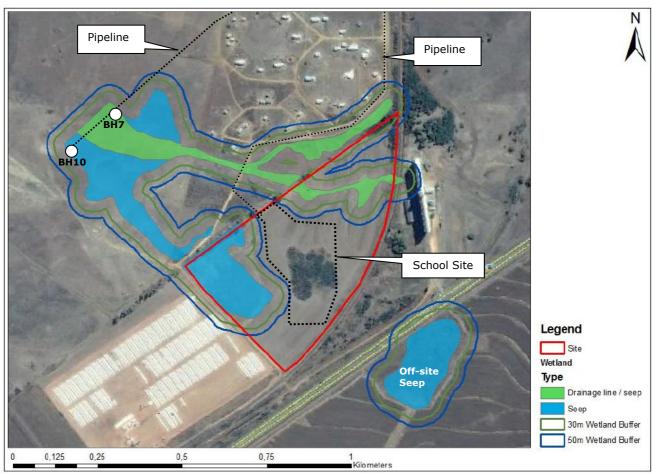
Figure 5.16: Wetland units identified (taken from Venter, 2016)

As indicated in Figure 5.16, this seep is located on the western boundary of the proposed school site and drains towards the north west. Borehole 10 (BH10) and a portion of the western water pipeline will be located within this seasonal seep.

According to Venter (2016), it appears that the gravel road located north of the site leads to some damming of water. This has resulted in the seep being wider south of the gravel road (Figure 5.16).

As indicated in Figure 5.16, this drainage line/seep is located on the northern boundary of the proposed school site. It appears to receive storm water from the silos and railway line and extends in a north westerly direction. Borehole 7 (BH7) and a portion of the water pipeline will be located within this drainage line/seep.

Wetlands are however, located near the proposed school site and along the pipeline routes (Figure 5.16). According to Venter (2016), the identified wetland areas are considered to be of high sensitivity as indicated in Section 5.9. Venter (2016) recommended that buildings be placed outside of the 50 m buffer zone while the sports fields, parking areas and access route be located outside of the 35m wetland buffer (Figure 5.17).

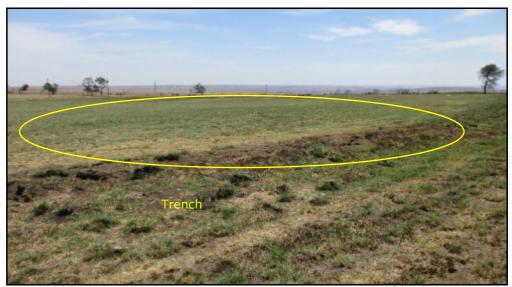
The seep was previously cultivated and currently comprises planted pastures and kikuyu (Photo 5.17). An earthen trench (Photo 5.17) was excavated along the eastern boundary of the seep, possibly to drain the seep or to divert water to the drainage area in the north. Several artificial canals/berms are present within the seep wetland, which has resulted in a change in the overland flow patterns.

Photo 5.17: A view of the temporary to seasonal seep (taken from Venter, 2016)

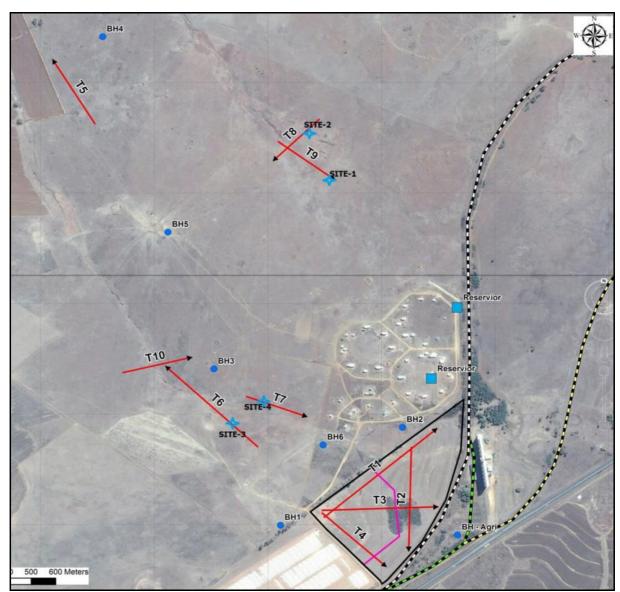
Figure 5.17: Location of geophysical traverses, existing boreholes and potential borehole sites identified (taken from Du Preez, 2016)

As indicated in Figure 5.17, the 4 potential borehole sites are located on geophysical traverses T6, T7, T8 and T9. Cilliers (2017) rated each of the potential boreholes in terms of yield potential and determined the drilling priority as indicated in Table 5.14. Site 1 and Site 2 (located north of the site; Figure 5.17) were identified as the first and second priority boreholes with a yield potential of Good.

The highest yielding borehole was found to be BH1 with a yield of 0.5 - 1 l/s, with the second highest yielding borehole being Afgri at 0.2 - 0.7 l/s (Table 5.13 and Figure 5.17).

The rotary air flush percussion drilling method was utilized to drill all four (4) boreholes identified during the geophysical survey (Figure 5.17). Figure 5.18 indicates the location of the newly drilled boreholes (green markers; BH7, BH8, BH9 and BH10) in relation to the proposed school site.

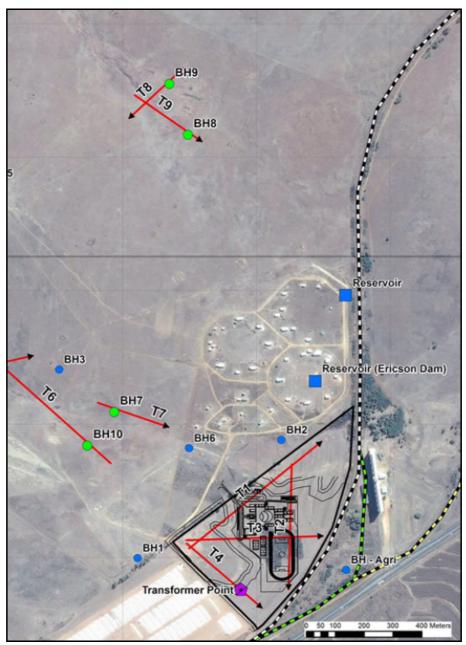
Figure 5.18: Location of the newly drilled boreholes (taken from Du Preez, 2017)

All four (4) boreholes (BH7 - BH10; Figure 5.18) intersected weathered fractures and change in geological formations between basalt and andesite (Cilliers, 2017). The depth of each water strike (including seepage) as well as the blow yield was recorded by the drilling contractor, since this information is required for the testing and equipping of the borehole. Table 5.15 indicates the drilling results.

Based on the test pumping results, Cilliers (2017) recommended that of the 4 new boreholes drilled (BH7 to BH10; Figure 5.18), only BH8 and BH9 be equipped and utilized.

The sustainable daily yield of BH2, BH3, BH4 and BH6 were found to be relatively low between 2.3 and 4.8 $\rm m^3/day$ (Table 5.17). BH9 (Figure 5.18) has the highest sustainable daily yield of 225 $\rm m^3/day$. The recommended daily pump cycle for all the boreholes is 9 hours, except for BH8 which is 12 hours (Table 5.17).

- Of the 4 new boreholes drilled (BH7 to BH10; Figure 5.18), only BH8 and BH9 should be equipped and utilized.
- Both BH8 and BH9 can be equipped with a suitable windmill capable of delivering the water required by the school. Recommendations in this regard are provided in Section 8 (EMP).
- Abstraction at BH8 and BH9, which are located further north and geohydrologically down gradient from existing boreholes, (Figure 5.18)

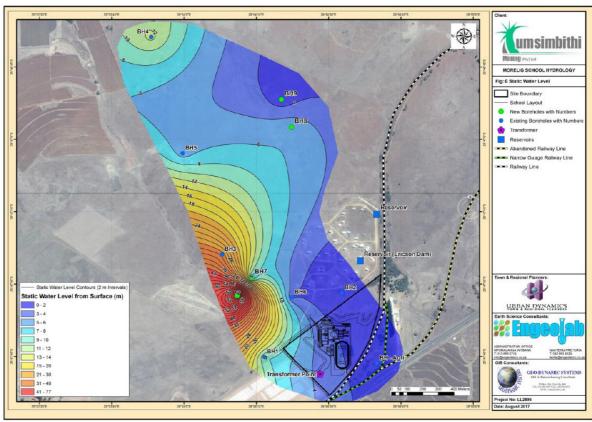
Figure 5.19: Static water level contour lines (taken from Cilliers, 2017)

As indicated in Figure 5.19, the static groundwater levels in the area vary between 2m to 77m below surface. The static groundwater level is relatively shallow in the eastern portion of the investigated area and gradually becomes deeper towards the west, specifically at the BH10 location (Figure 5.19).

Cilliers (2017) plotted the static water levels and water level elevation as recorded during the pump testing as indicated in Figures 5.19 and 5.20 in order to determine the hydraulic characteristics of the aquifer.

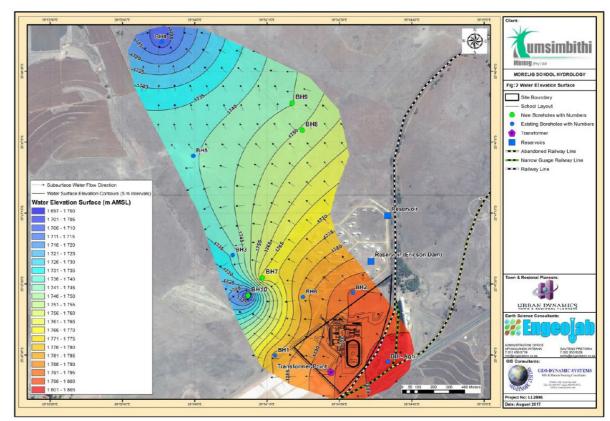
Figure 5.20: Water elevation surface (taken from Cilliers, 2017)

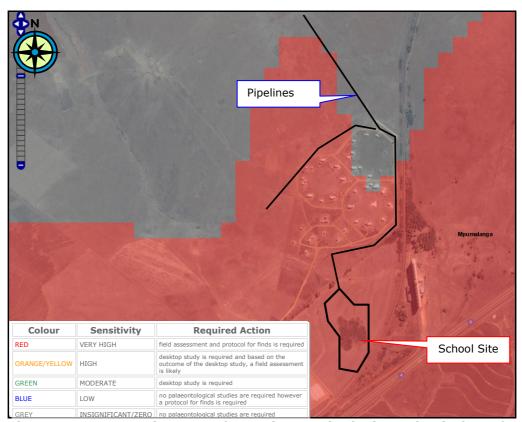
A portion of the pipeline route falls within an area of insignificant/zero sensitivity (area indicated in grey; Figure 5.22). This area is underlain by basalt and andesite of the Dullstroom Formation.

Figure 5.22: Requirement for palaeontological study (taken from SAHRA, 2014)

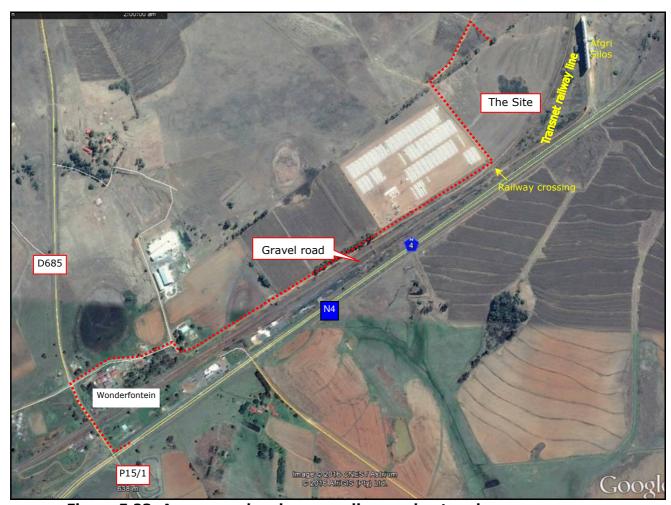
The existing gravel road also extends to the east towards the Afgri Silos, where it connects directly to the N4 national road after crossing the railway line (Figure 5.23).

According to a letter from SANRAL (dated: 22 December 2014) regarding access to the Generaalsdraai Village, the access route from the N4 across the railway line (near the Afgri Silos; Photo 4.2) may not be used to provide access to the village. The school will thus be accessed via the gravel road extending through Wonderfontein (Figure 5.23).

Figure 5.23: Access road and surrounding road network

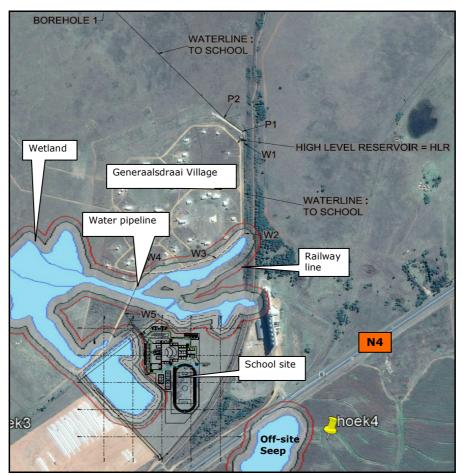
In view of this, Venter (2016) recommended that buildings be placed outside of the 50 m wetland buffer zone while the sports fields, parking areas and access route be located outside of the 35 m wetland buffer zone (Figure 8.1).

As indicated in Figure 8.1, a small section of the proposed water pipeline will extend across the drainage line/seep wetland and will be located within the 50m wetland buffer zone. Mitigation measures would have to be implemented as indicated in Section 8.5.

Figure 8.1: Sensitive landscapes identified
