GEOTECHNICAL DESKTOP STUDY

TOURNÉE SOLAR 2 PV GEOTECHNICAL DESKTOP STUDY

REPORT (REV2) CONFIDENTIAL

PROJECT NO. 41104569

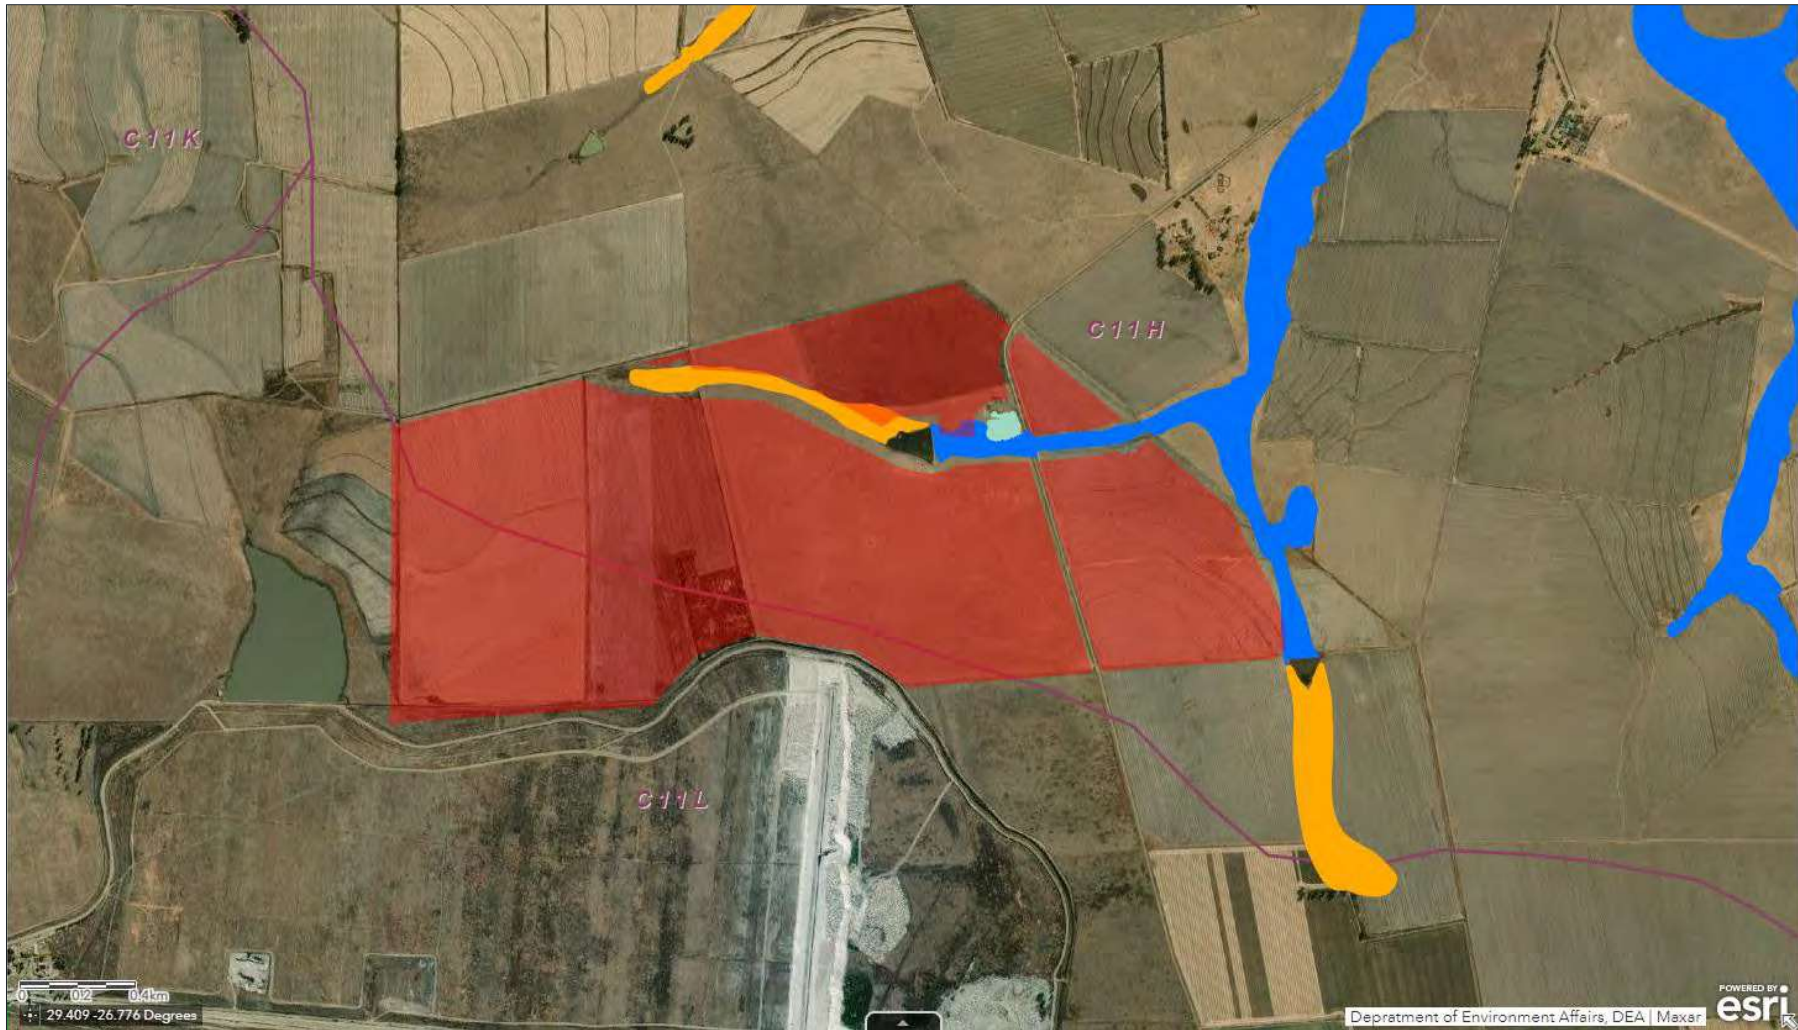
Figure 2-2 - Quaternary catchment and surface water across the site

The site lies within the C11H and C11L quaternary catchment areas as shown in Figure 2-2. The area receives on average annual rainfall of approximately 645mm/year (Kaponda, et al., 2021). The highest rainfall and temperature occur during the month of December.

The site is relatively flat with an elevation ranging between 1618mabsl and 1649mabsl and the overall slope gradient is less than 2.5%.

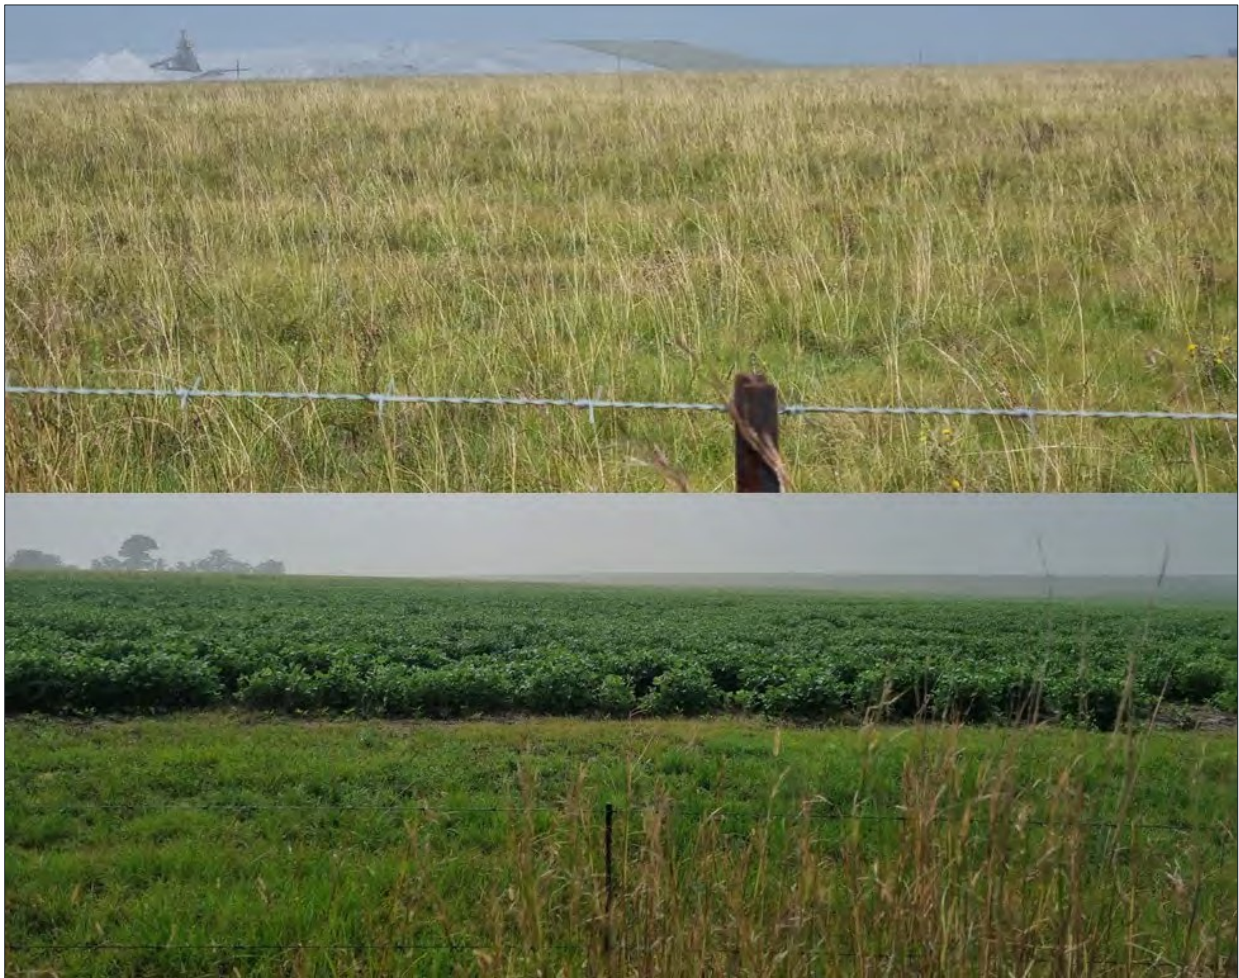
Figure 5-1 - Vegetation across the site.

The slope on site, as well as the soil structure will influence the amount of erosion. The low site gradient makes the probability of erosion unlikely. As is shown Figure 5-1, the site is covered in grassland, tall grass and crops, the presence of which reduces the risk of erosion.
