# HERITAGE STATEMENT HOUSE 85

The statement is a supplement to the application for a permit for repairs and maintenance to the exterior of the structure to be made to SAHRA in terms of the National Heritage Resources Act, 25 of 1999.

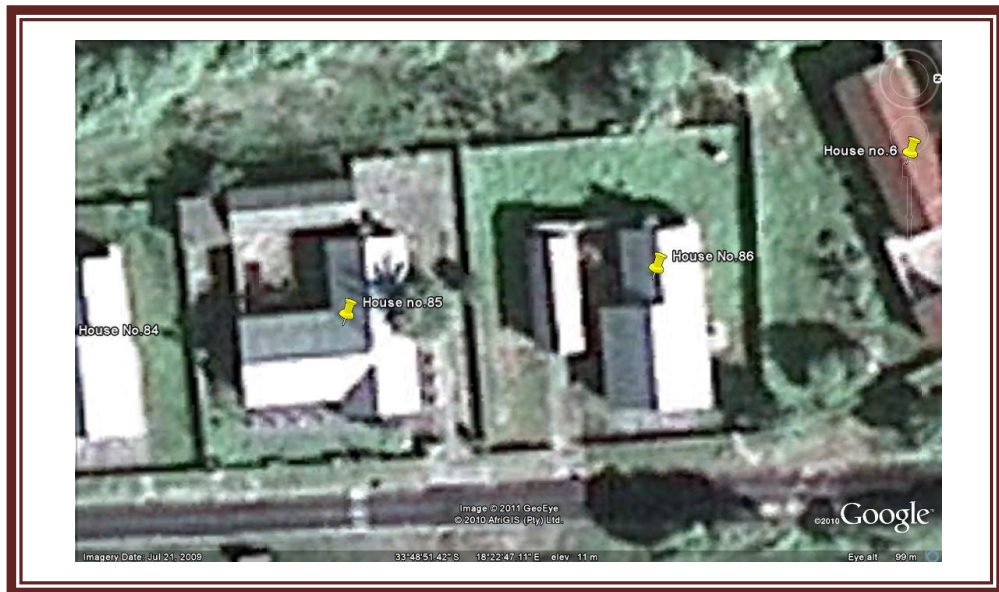
Fig.3.2. House 85, 86 showing difference in shape And position of outbuildings

The style and decoration is functional modernism dating from the mid 1970's. The building has a T shape, which distinguishes it from the rectangular shapes of the other 3 houses in the cluster. The garage and outbuildings are also placed behind the main building as opposed the other 3 houses, which have their outbuildings along the side. The verandah is markedly different from that of the other 3 houses in the cluster.

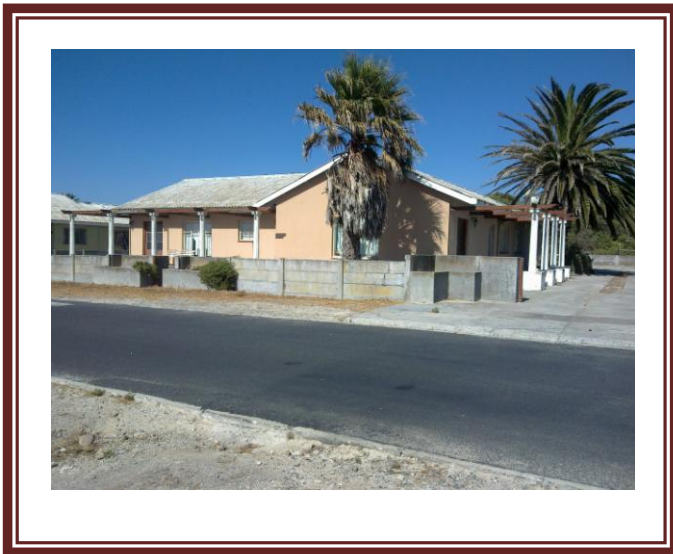
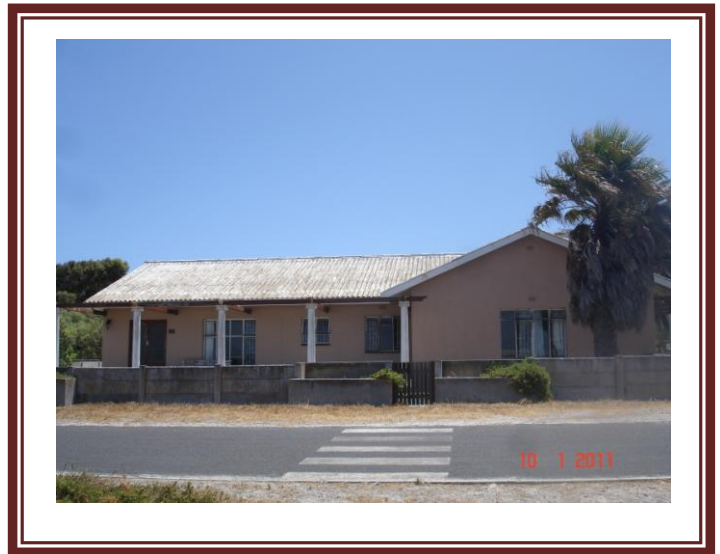
Built from Robben Island brick [refer to technological significance] and mortar, smooth plastered walls, two uncovered verandahs on east and on north faces with pergola consisting of Roman type concrete columns on square brick and mortar plinths, SA pine beams integrated with main house walls, verandah floors from Malmesbury shale quarried on the island, Asbestos roofing, fascia, gutters, downpipes and water tanks. Main Entrance doors from Meranti with glass panes, window frames standard steel. Enclosed courtyard integrates main building with outbuildings. Malmesbury shale and concrete apron around and along walls of house.

Fig.6.1.& 6.2 . NE corner left, east face right

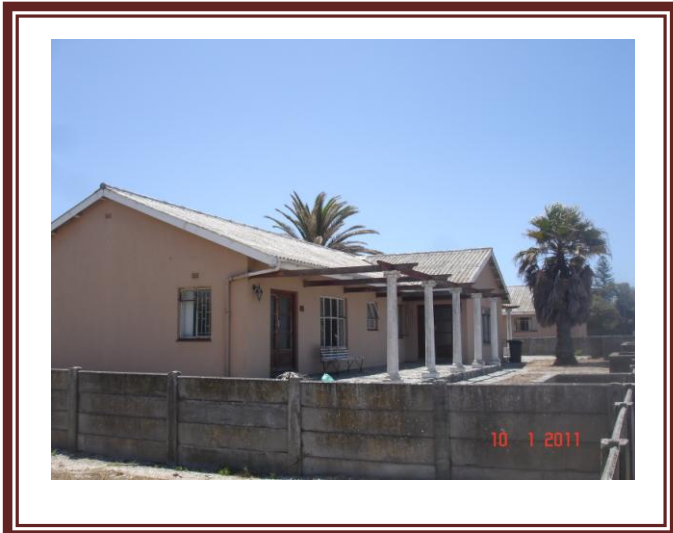
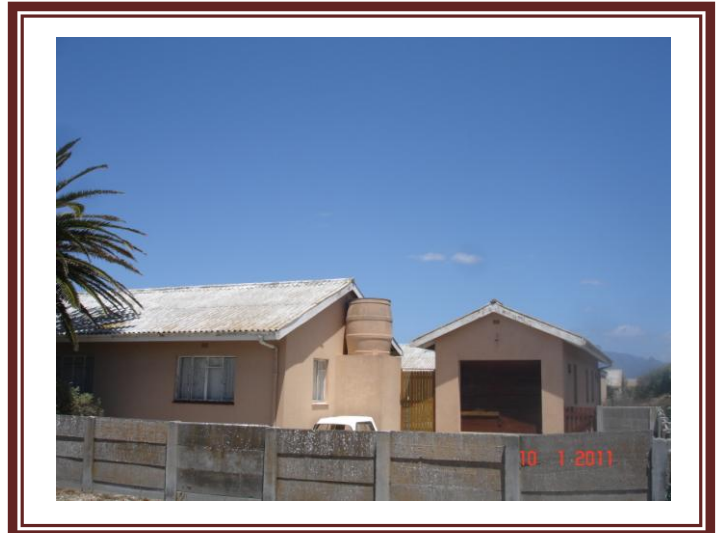
Fig.6.3.& 6.4. SE corner left, NW corner right

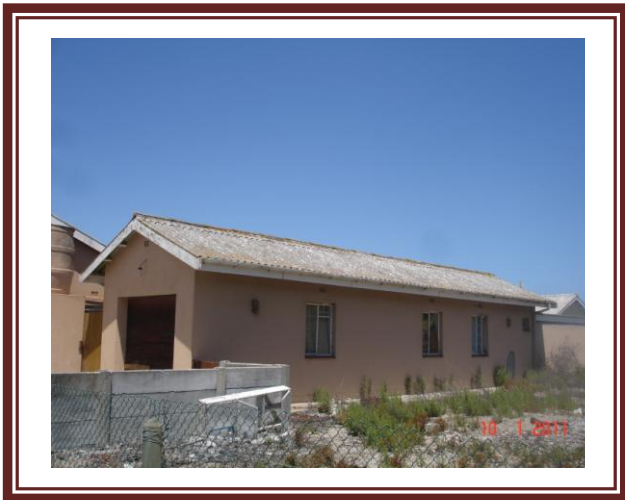
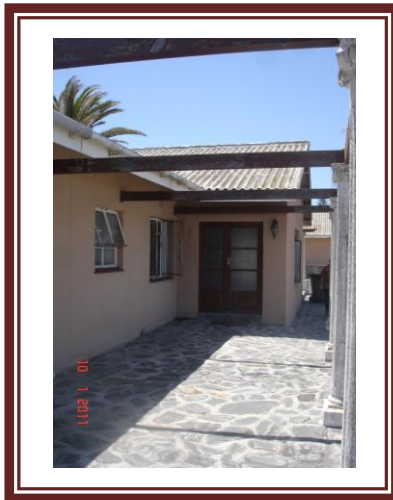
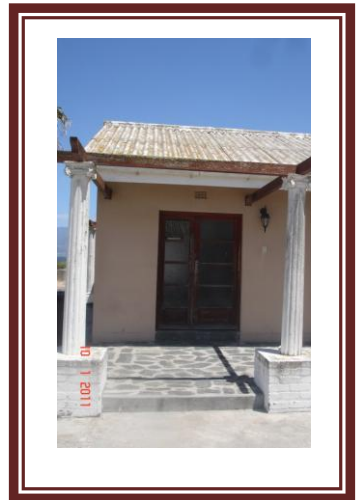
Fig.6.5. West face garage & servants quarters Fig.6.6.&6.7. Verandah E face left, N face right

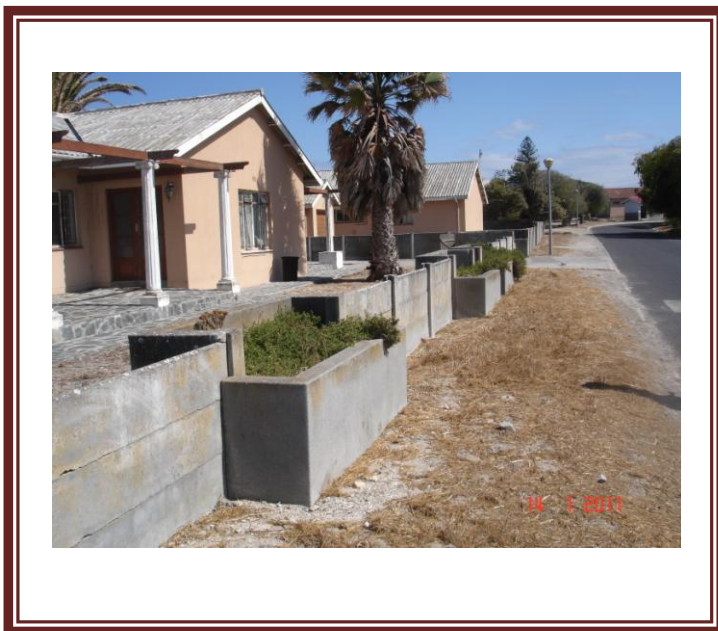
Garden path and main vehicle entrance on eastern side flanked by brick and mortar plastered walls with flower boxes. Flower boxes also placed at intervals with remainder of wall consisting of vibracrete.

Fig.6.8. Flower boxes E face

10.6. Indigenous Island vegetation should be planted in the flower boxes, as well as in the garden.

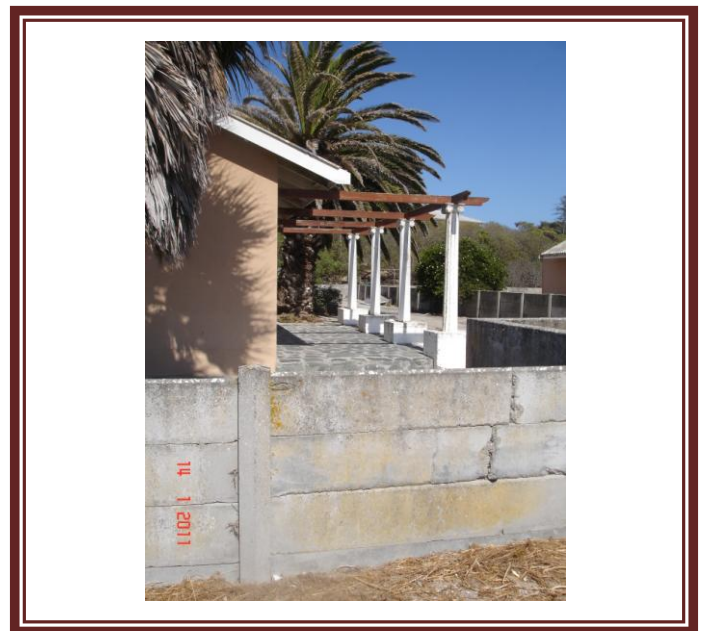
Fig.6.9. S face vibracrete

10.5. The boundary walls must not be washed, sealed, painted or in any other way treated. A patina has built up that protects the fabric. Removal of this patina will negatively affect the long term conservation of the fabric.

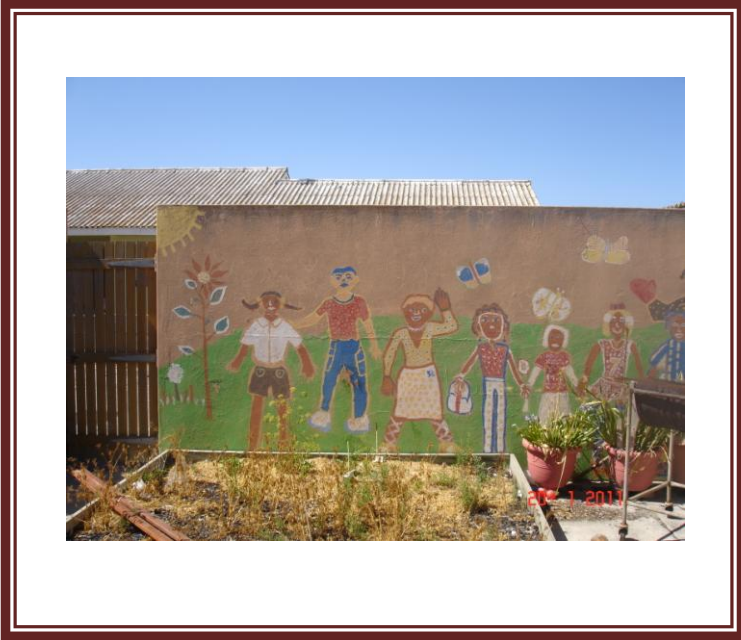
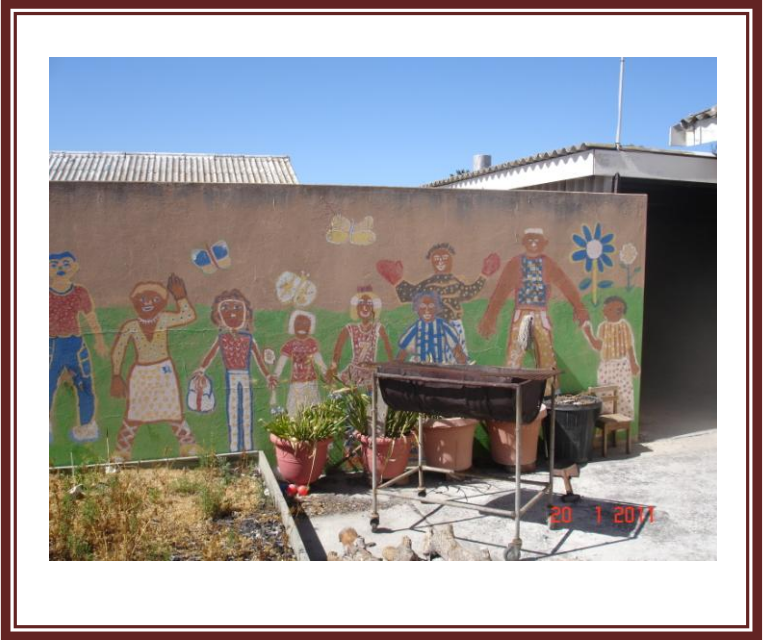
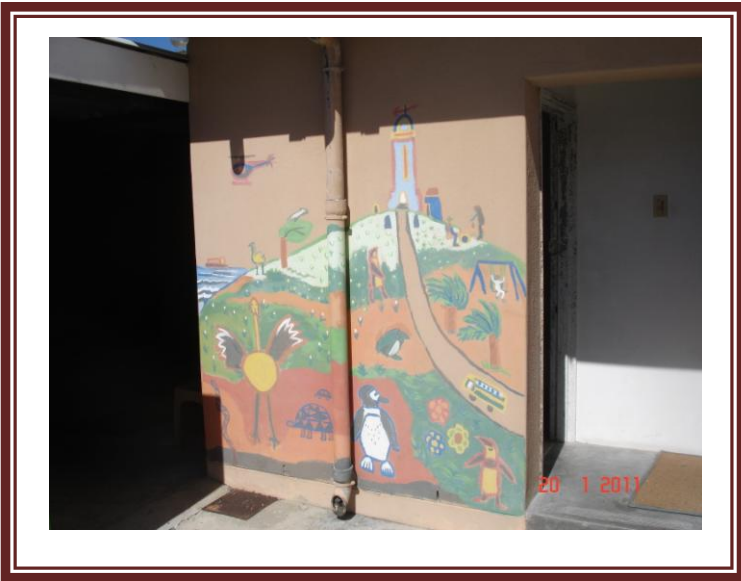
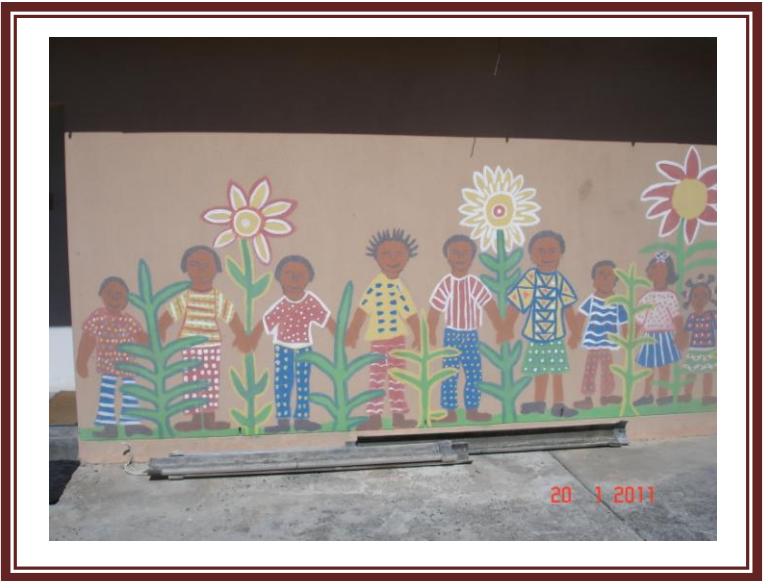
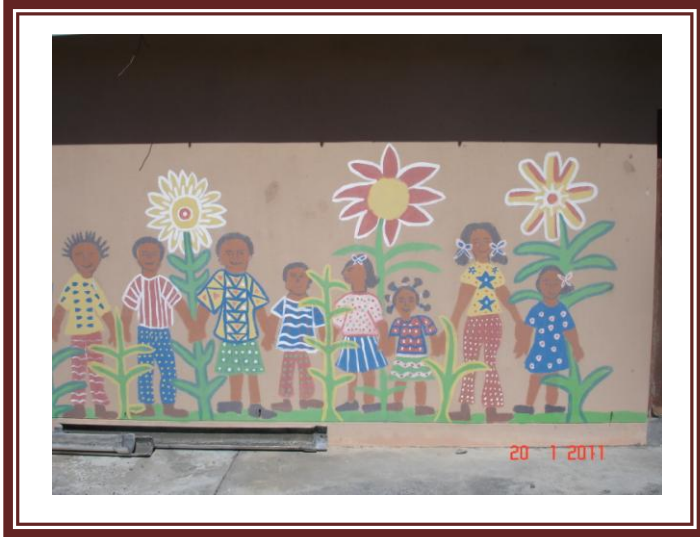
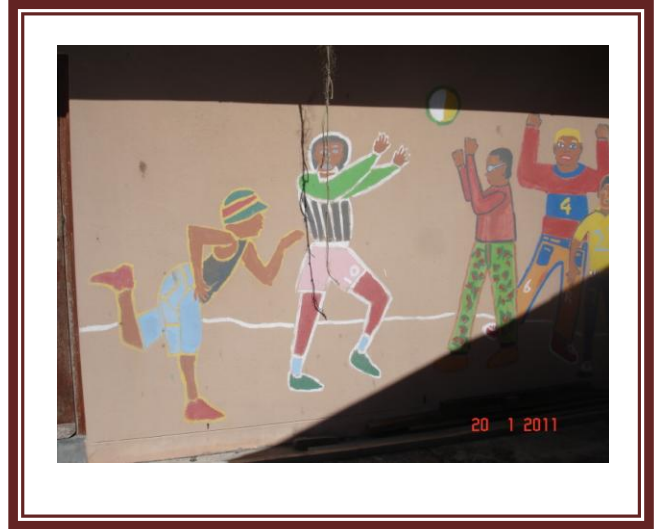
COURTYARD IMAGES

The murals in the courtyard are a legacy of Ruth Carneson's work with the children of the creche. Ruth's artwork was used by the ANC for marketing 'T' shirts, posters and postcards. Examples of her art can be seen in Fig.6.10 and 6.11.

Normal weathering. The murals are sensitive and may weather faster than other decoration.

10.2. The murals must not be painted over. RIM must provide a conservation and maintenance management plan specifically designed for the long term conservation of these murals.
