ENVIRONMENTAL MANAGEMENT PLAN

The Proposed Utilisation of Borrow Pits Road: DR08367 (Amathole District Municipality)

Department of Roads and Public Works Province of the Eastern Cape

Report Number 2011-R522

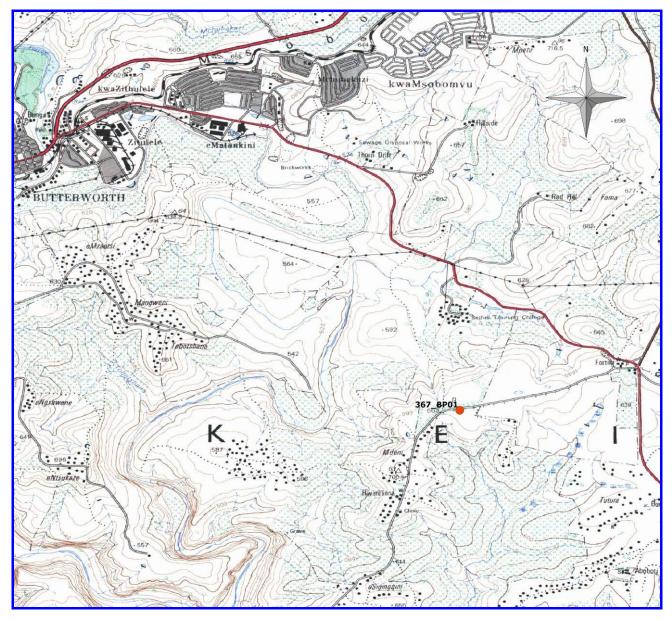
Figure 1: The location of the borrow pit (1: 50 000 map).

A number of borrow pits were identified in the initial investigation for material sources along the DR08367; of these, only one (1) was identified to be suitable for utilisation as material sources for the re-gravelling/patch gravelling. The location of the borrow pits are as follows:

Road #	Borrow pit #	Latitude	Longitude ————————————————————————————————————
DR08367	367_BP01	32° 22' 05.1"	28° 12' 22.6"

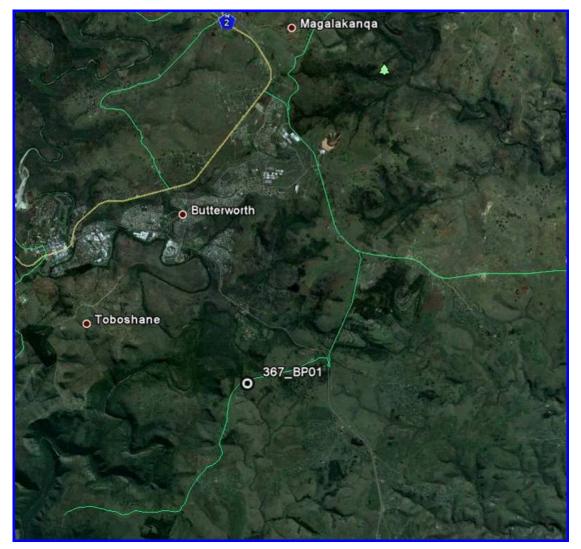
Figure 2: Aerial Image - Road DR08367 & associated BP.

It is proposed here to utilise one (1) borrow pit identified along the DR08367, for the routine maintenance/re-gravelling/patch gravelling of this district road (Table above). The nearest formal town is Butterworth. The borrow pit is located adjacent to the DR08367.

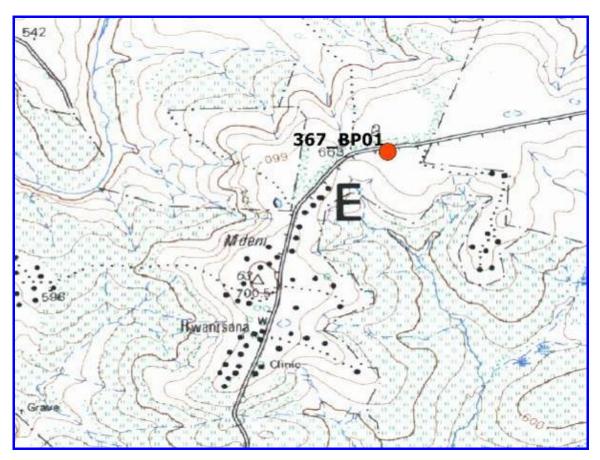
Figure 3: Topographical Location of 367_BP01 - 1:50 000 map

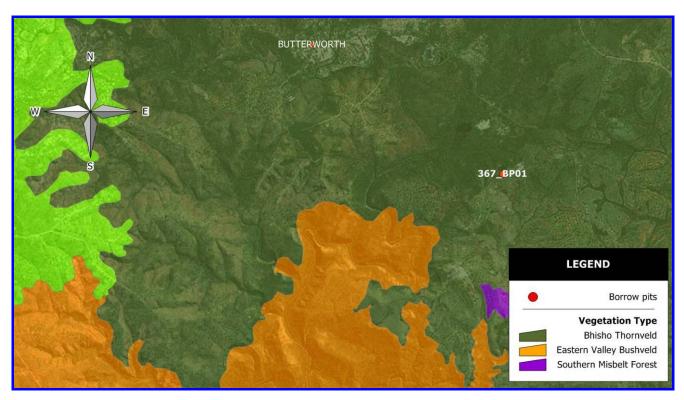
Figure 5: General vegetation and the location of the borrow pits.

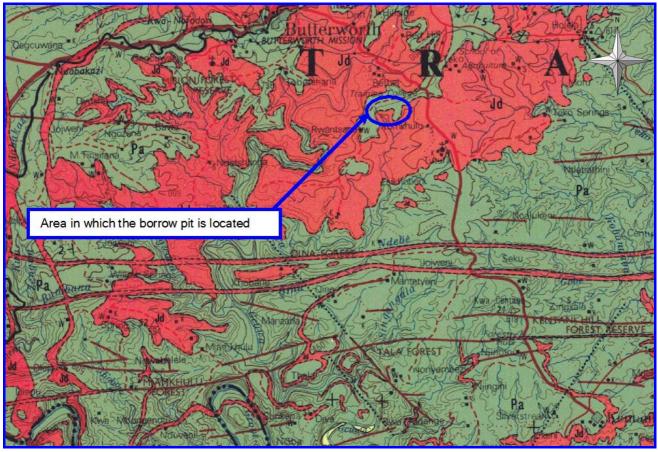
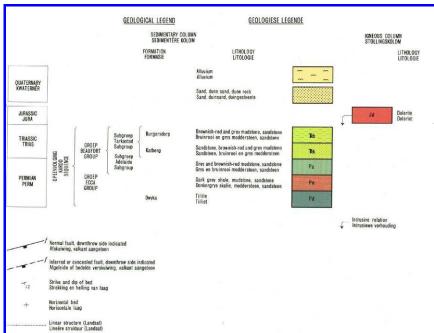
Figure 6: The geology of the area in which the Borrow pits are located (3228 Kei Mouth)

The investigation undertaken by Control Civil Services (section 21.1) indicated that the type of material

found at the borrow pit was shale.

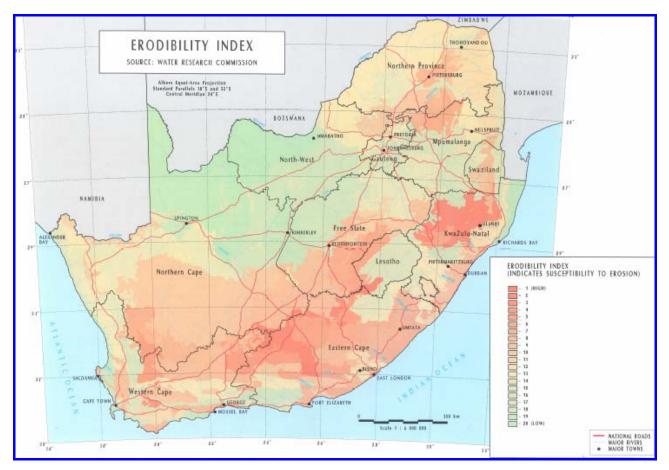
Figure 7: Erodibility Index

According to the Environmental Potential Atlas for South Africa, the study area falls within an Erodibility Index of between 7 and 9, which is at the lower end of the scale (1 being High and 20 being Low), indicating that the area is moderately to highly susceptible to erosion (Figure 7).

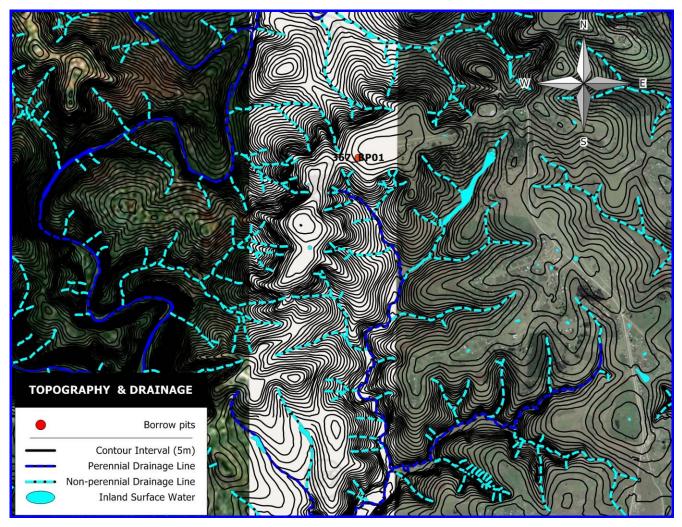
Figure 8: Drainage of the area in which the proposed borrow pit is located.

The study area falls in the primary drainage area S70. Within this primary drainage all the identified borrow pits fall within the quaternary catchment area of S70E. The mean annual precipitation of S70E quaternary is 741.95 mm with a mean annual runoff of 64.1 mm.

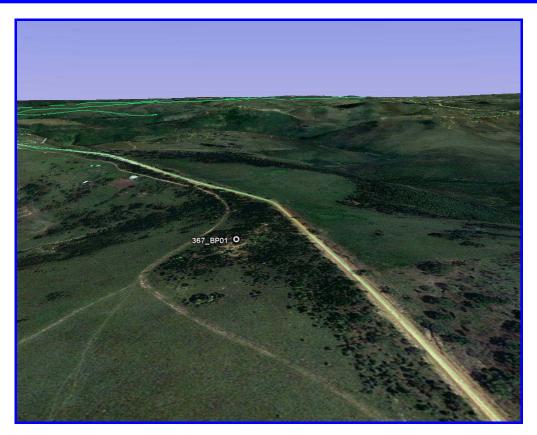
Figure 9: Terrain view indicating the position of the borrow pits in the landscape.

The topography may be impacted upon by the excavation of the existing borrow pits which in turn could have an effect on the storm water runoff and drainage of the immediate surrounding area. Areas of concentrated storm water runoff could be subject to increased erosion if not mitigated against appropriately by means of erosion control techniques and/or structures dissipating the velocity and flow of storm water runoff. The non-perennial drainage lines are referred to as such due to the fact that they are dry for the majority of the year, and some instance only flow during periods of high rainfall.

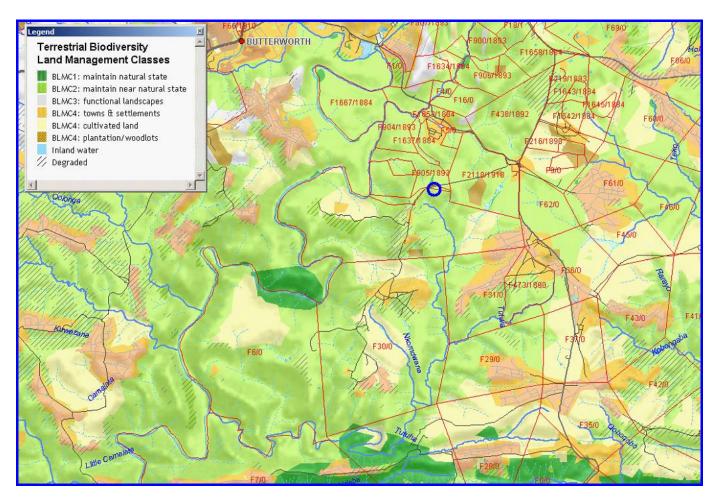
Figure 10: Eastern Cape Biodiversity Conservation plan and the location of the Borrow pit.

According to the ECBCP the area in which the borrow pit is located is identified as being predominantly Biodiversity Land Use Management Class 2 (BLMC 2 or CBA 2 - Maintain Near Natural State - with degraded areas) (Figure 10).

It must be noted that while the borrow pit is located in an identified CBA 2 area, not more than 0.98 hectares of indigenous vegetation will be removed from the borrow pit during the mining activities.
